**Site Visit and Community
Consultation Report**

September 18-20, 2003

Nanisivik Mine and Arctic Bay

Patrick Duxbury
Mine Reclamation Coordinator
Nunavut Water Board

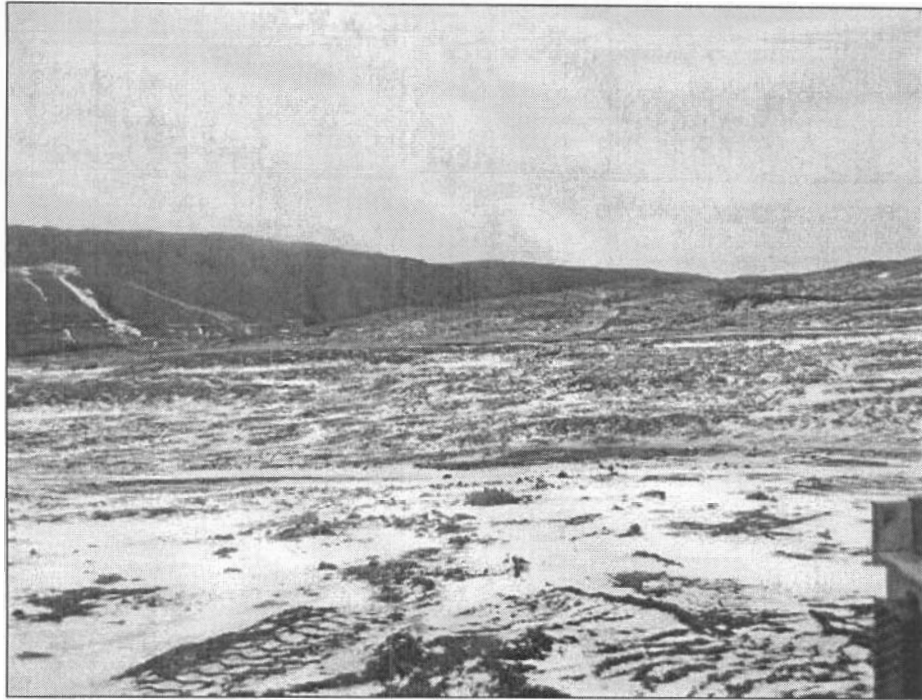
As the group traveled towards the WTDA, Murray Markle pointed out an area where mine employees had excavated soil which had been contaminated due to a tailings break during mine operation. CanZinco will keep the tailings lines intact until it has decided how it wishes to proceed with cleaning of the industrial facilities. Once the tailings lines are no longer of use they will be dismantled and probably placed either underground or on top of the WTDA prior to its covering.

Photo 1 – Photograph taken along the road to the WTDA; tailings line is visible in background

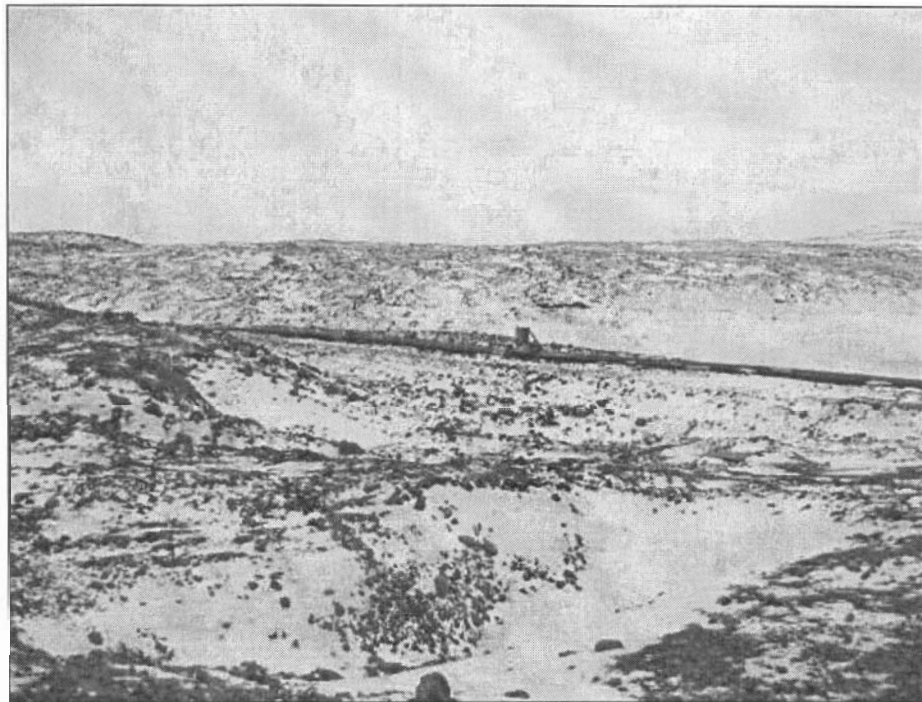
Photo 2 – Site of excavation where tailings spill had occurred; tailings line is clearly visible

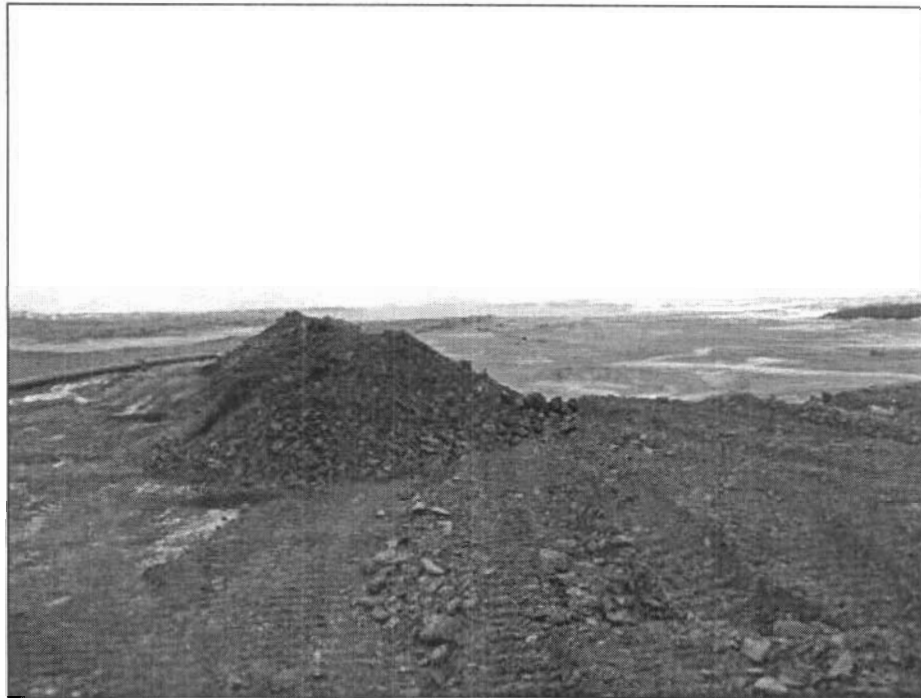
At the WTDA, the sub-aerial tailings were being covered by a layer of recently quarried shale. Murray Markle noted that the depth of the shale layer being applied exceeded the rather minimal required layer to prevent tailings from being blown by strong winds. He thought that the excess material could perhaps be considered a contribution to the 1.25 m cover that has been proposed. Murray stated that he was apprehensive about sending heavy machinery over certain parts of the WTDA because of a unusually intense rain event in August had made areas of it mucky and possibly dangerous to work on.

Photo 3 – Stockpiled crushed shale awaiting placement on top of the sub-aerial portion of WTDA

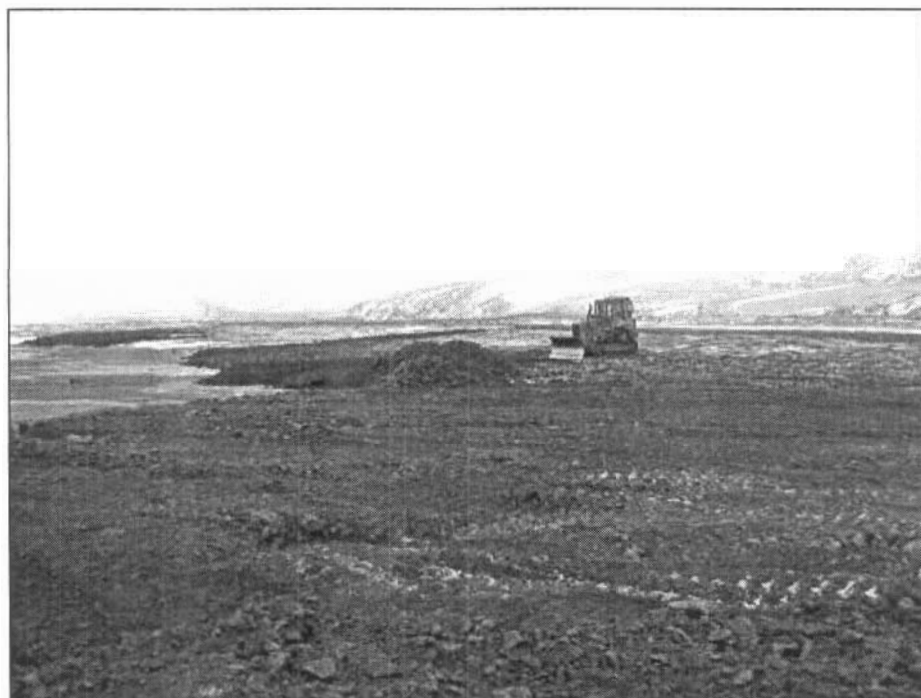
Photo 4 – Heavy machinery was placing crushed shale over WTDA, however due to wet conditions this activity had been temporarily halted.

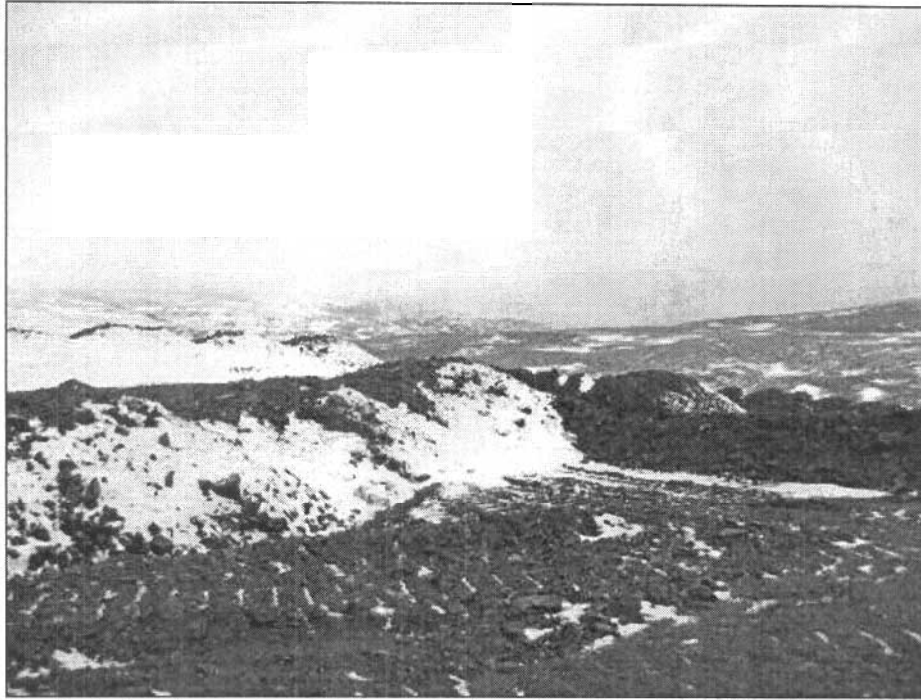
Since the cessation of mining and milling operations, the quantity of material being placed in the landfill has diminished. At the time of the site visit it was noticed that an application of crushed shale had been placed on top of the waste and some subsequent land leveling had occurred. This is a practice that has been occurring throughout the life of the mine. Some small piles of crushed shale were left at the periphery of the landfill, presumably for future waste covers.

Photo 5 – Shale has been mixed with waste at the landfill and bulldozed into layers

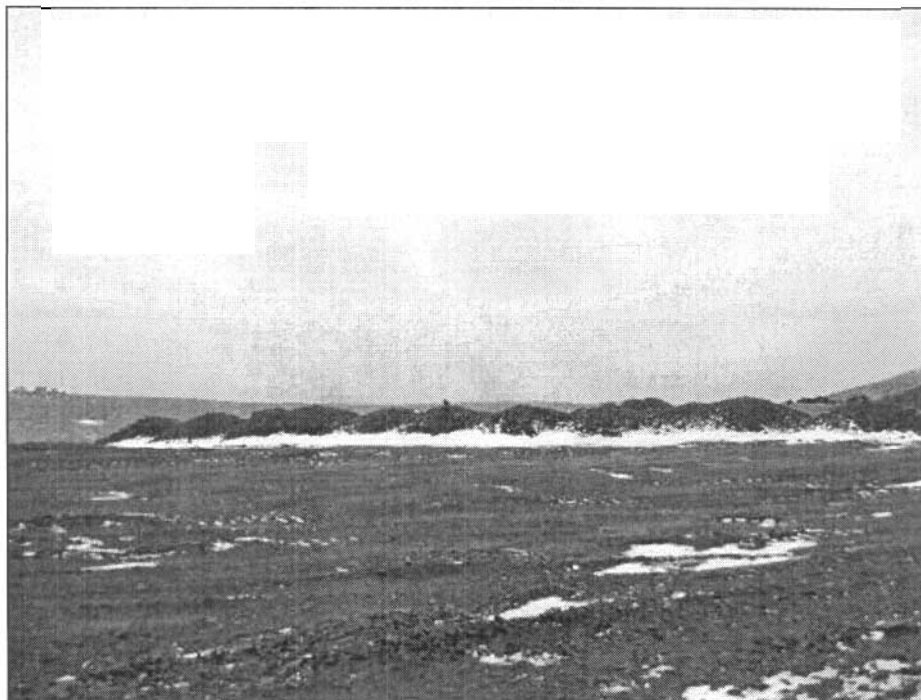
Photo 6 – Landfill with fresh shale cover
