## **NANISIVIK MINE, A DIVISION OF CANZINCO LTD.**

### **2007 ANNUAL GEOTECHNICAL INSPECTION**

### **NANISIVIK MINE, NUNAVUT**

PROJECT NO.: 0255-016-03  
DATE: MARCH 26, 2008

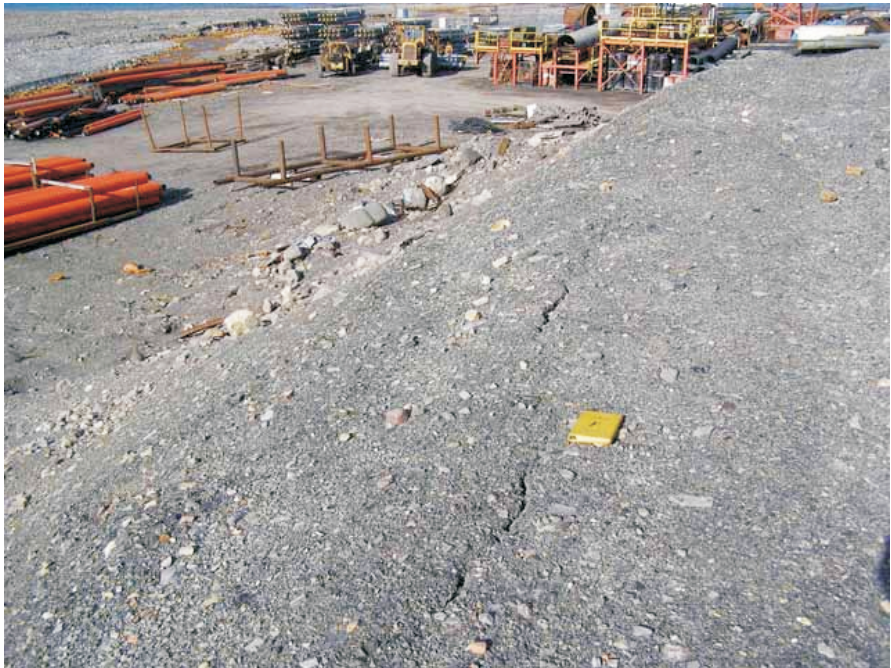
Photo 6  
Cracking in crest of containment berm along west side of containment area.

In general, the berm appears to be in a satisfactory condition, except for the area affected during excavation of nearby hydrocarbon soils. The affected area should be re-sloped to match the grade of the adjacent slopes and the GCL liner should be re-buried to prevent damage to the liner. It is also recommended that any area of exposed liner within the berm be covered to prevent damage from occurring. Also, any torn portions of the liner should be repaired.

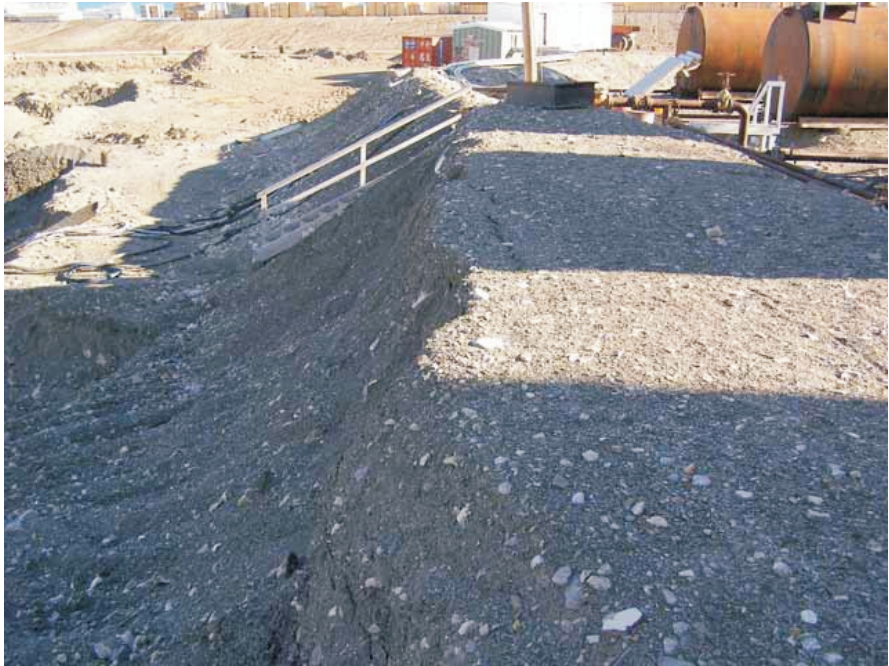
Photo 8  
Affected area of Main Tank Farm berm which was partially excavated during reclamation of contaminated soils.

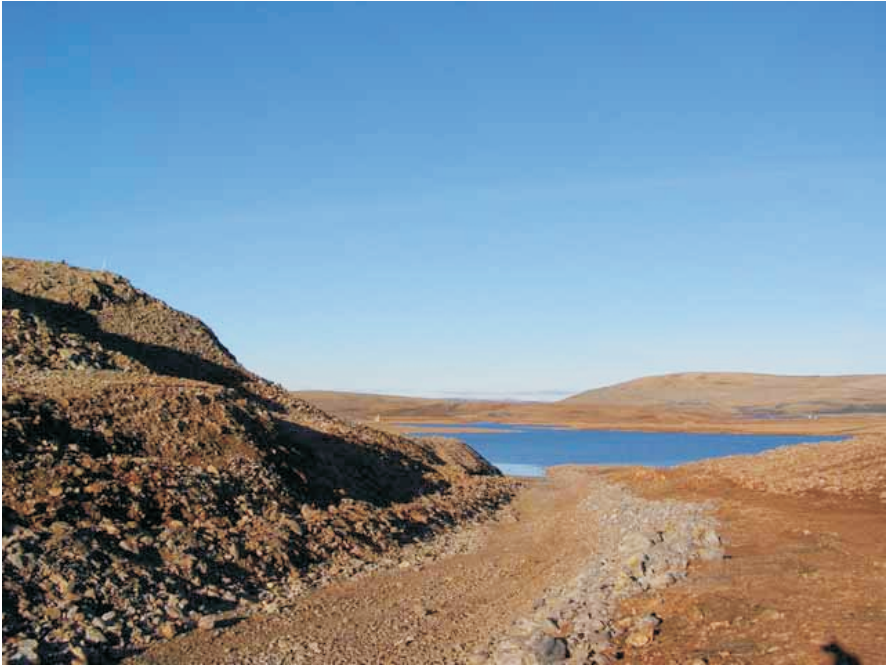
- No slope debris was noted in the bottom of the channel as it had been during previous inspections. This may suggest the weathered diabase area is beginning to reach thermal equilibrium and the additional armouring applied to the north side of the channel has increased stability of this area.

Photo 10  
Bottom of spillway looking downslope.  
Note left (north) side of spillway has been riprapped as recommended in 2006.

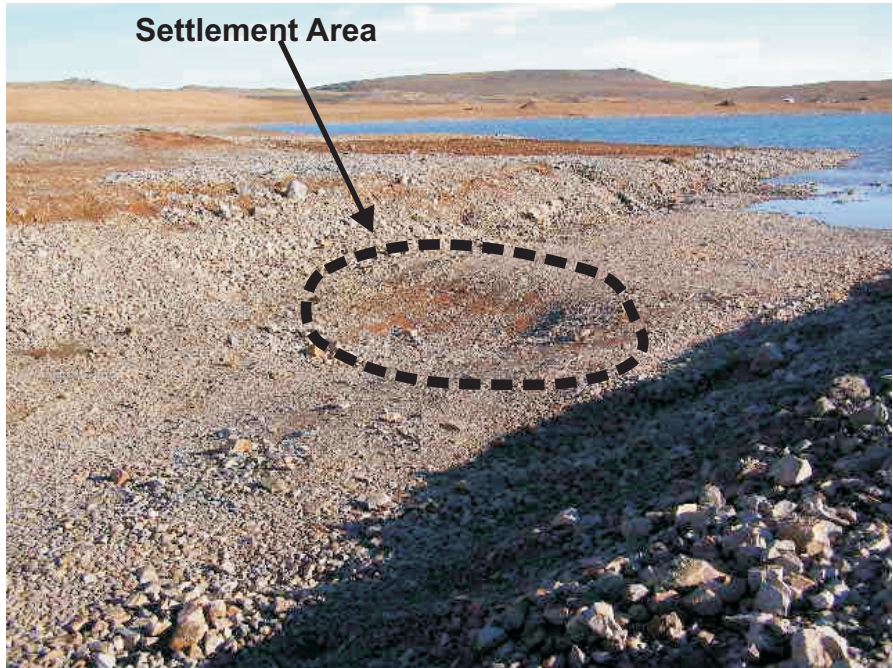
Photo 11  
Settlement depression near spillway outlet.

- Re-level the access road along the edge of the spillway channel to prevent ponding and improve long term stability.
- Place additional rockfill in the settlement area near the spillway outlet.
- Re-grade the rutted area near the deflection berms.
- Apply additional armour to the edge of the south side of the access ramp where erosion has been noted.
- General grading of the spillway area may be undertaken to improve the long term stability of the spillway channel.

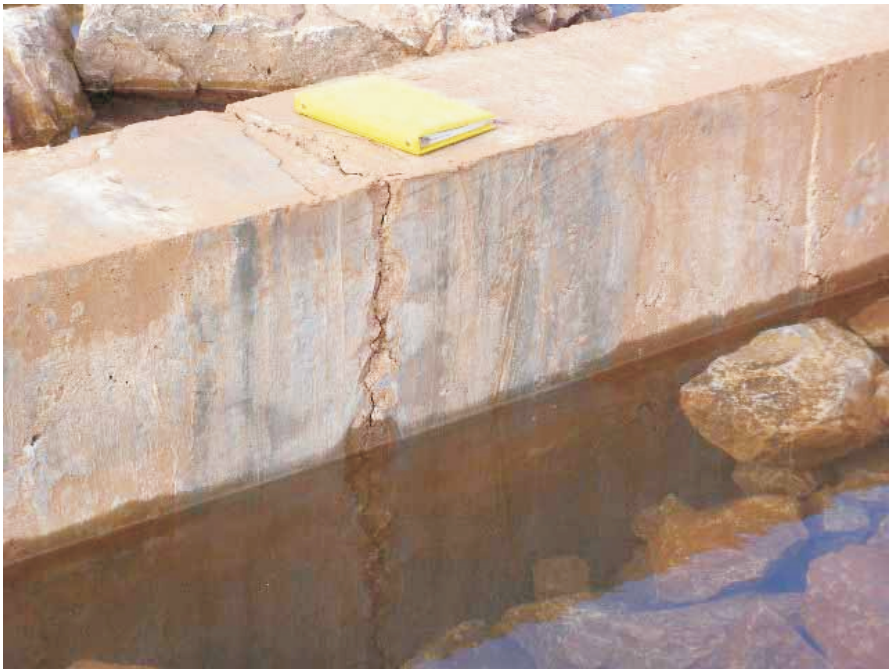
Photo 14  
Crack in West Twin Outlet wall.  
View looking at downstream face of the concrete wall.

- Continue to inspect the wall for further cracking.
- Monitor the water level upstream of the wall to assess continued seepage losses.

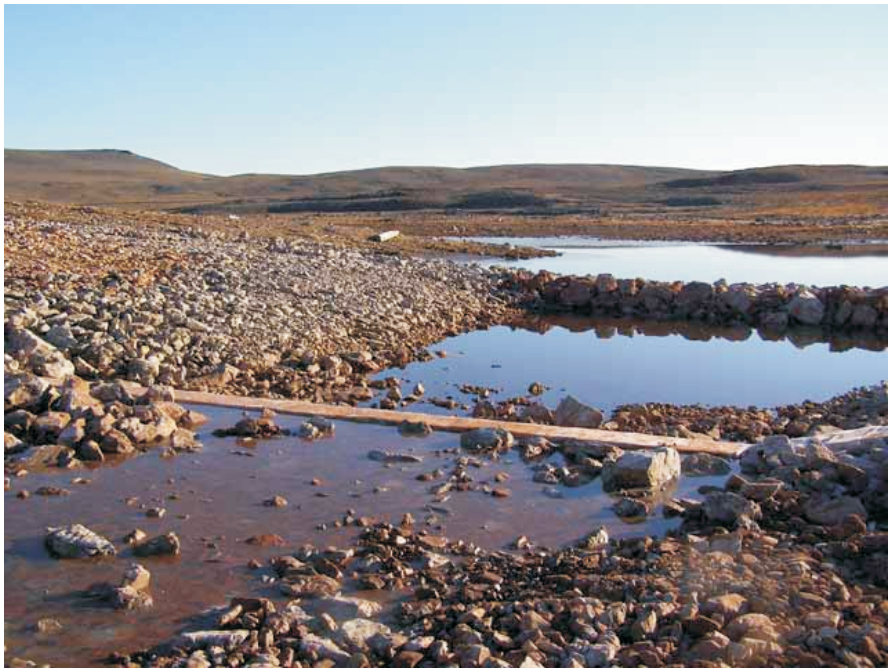
Photo 16  
West Twin Outlet Channel after GCL installation.  
Note rising water level upstream of wall.

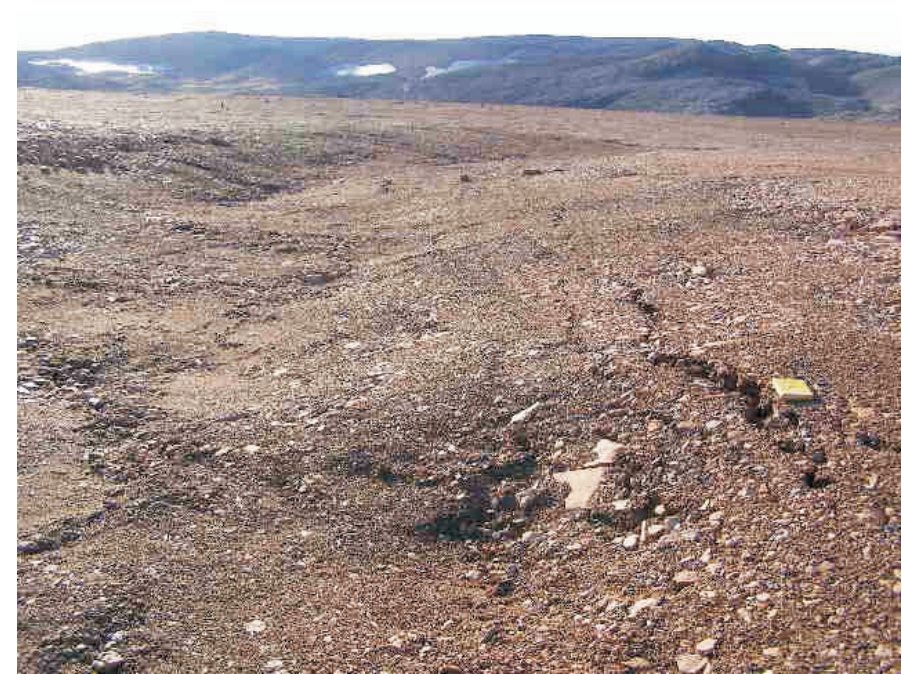
Photo 21  
East/West drainage swale.  
Note minor cracking along edge of swale.

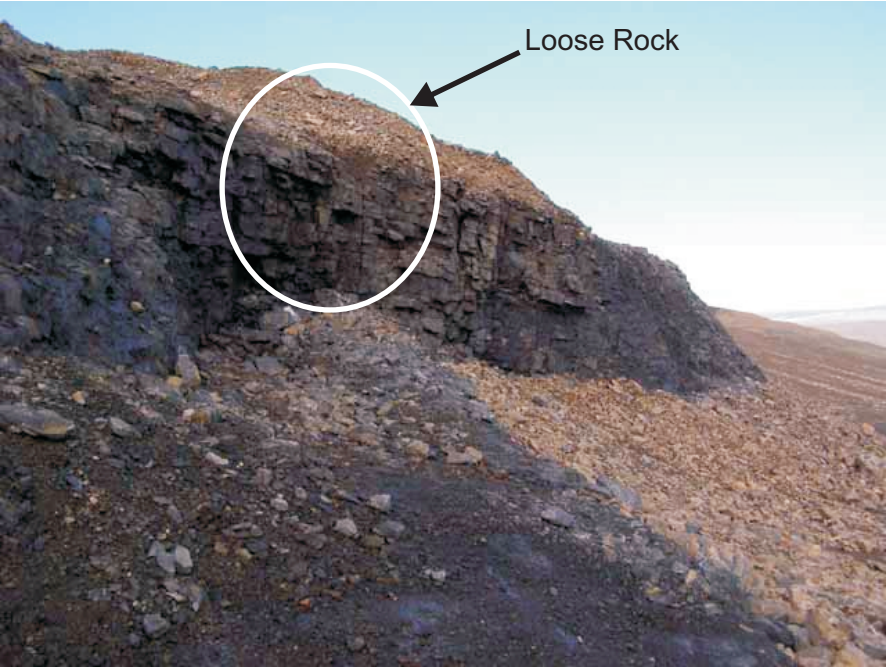
Photo 45  
Area along highwall were some loose rock was noted.

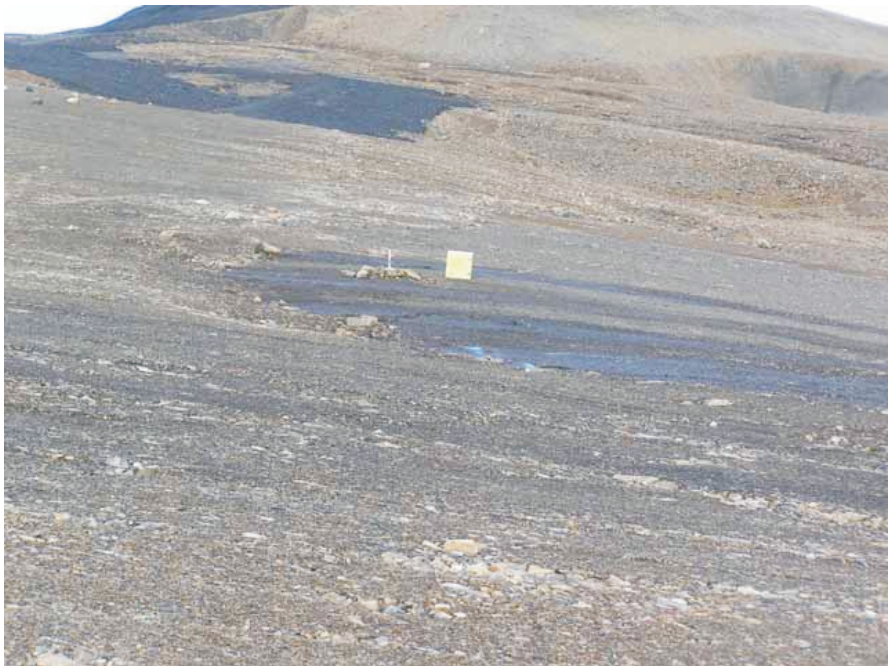
Photo 47  
Intermediate level of East Open Pit Cover.  
Note dark area where seepage exits on face of cover.

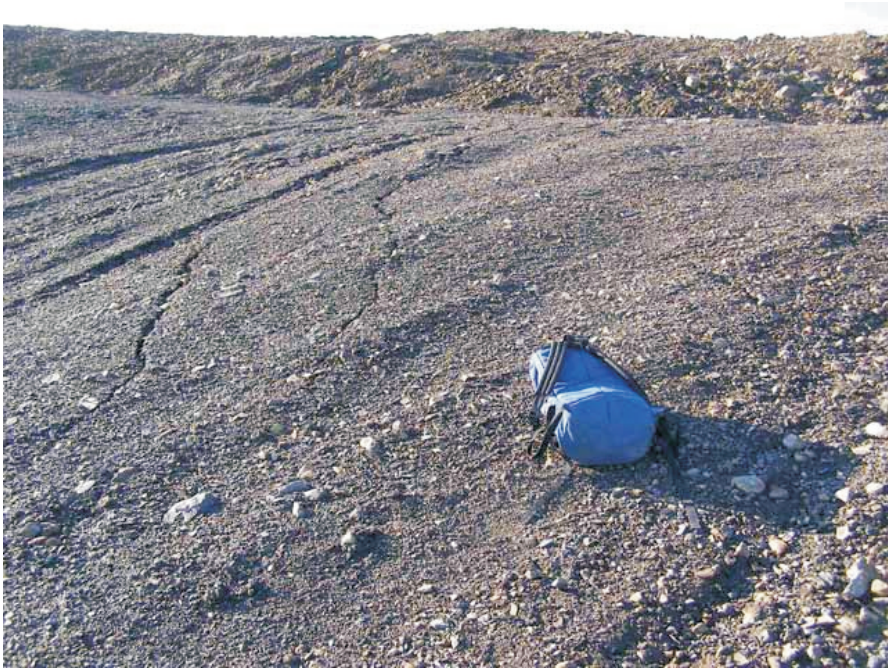
Photo 51  
Cracking in southwest corner of Oceanview Open Pit cover.

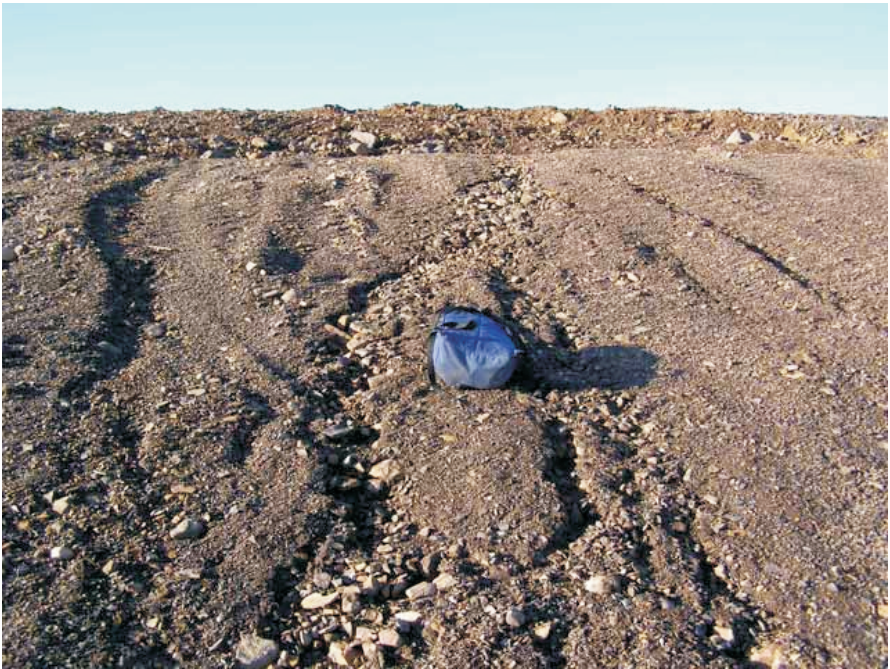
Photo 52  
Minor rill erosion in southwest corner of Oceanview Open Pit cover. Note self armouring occurring.

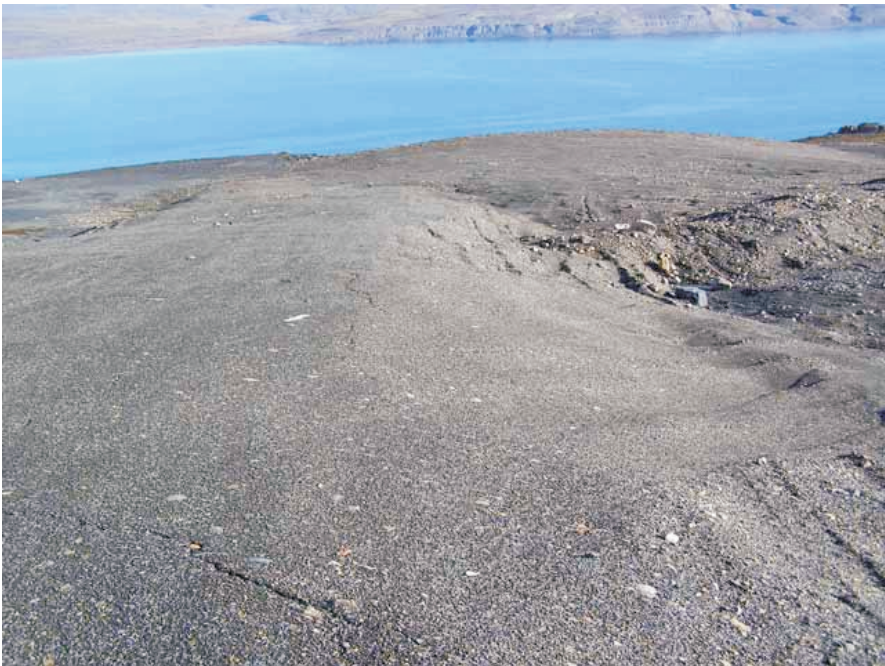
Photo 63  
Oceanview Portal cover as seen from the upslope edge of the cover.  
Note minor cracking along the right (east) edge of the cover.

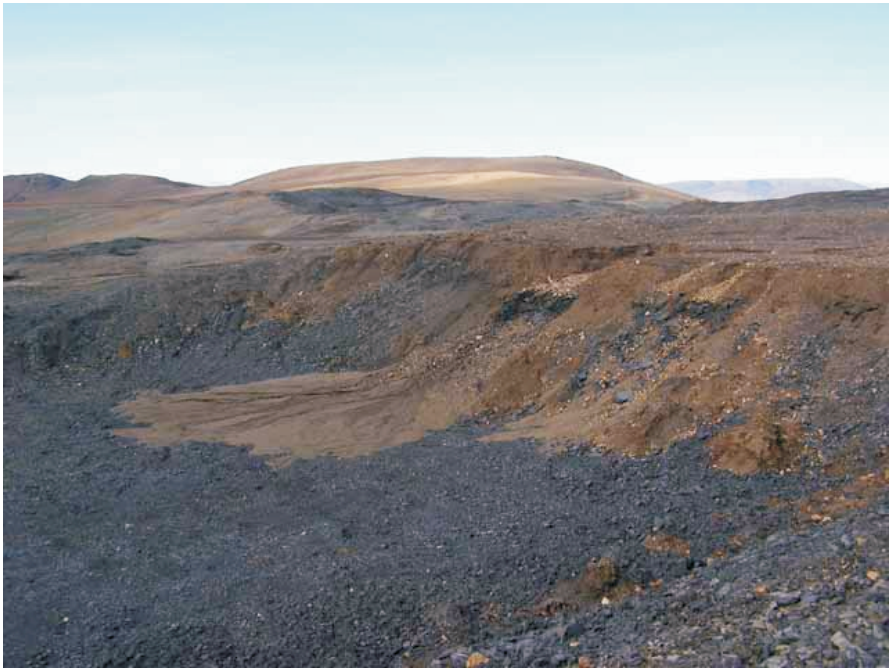
Photo 75  
Area 14 Shale borrow area.  
Note erosion and subsequent deposition of overburden into bottom of pit. Similar to conditions observed in 2006.

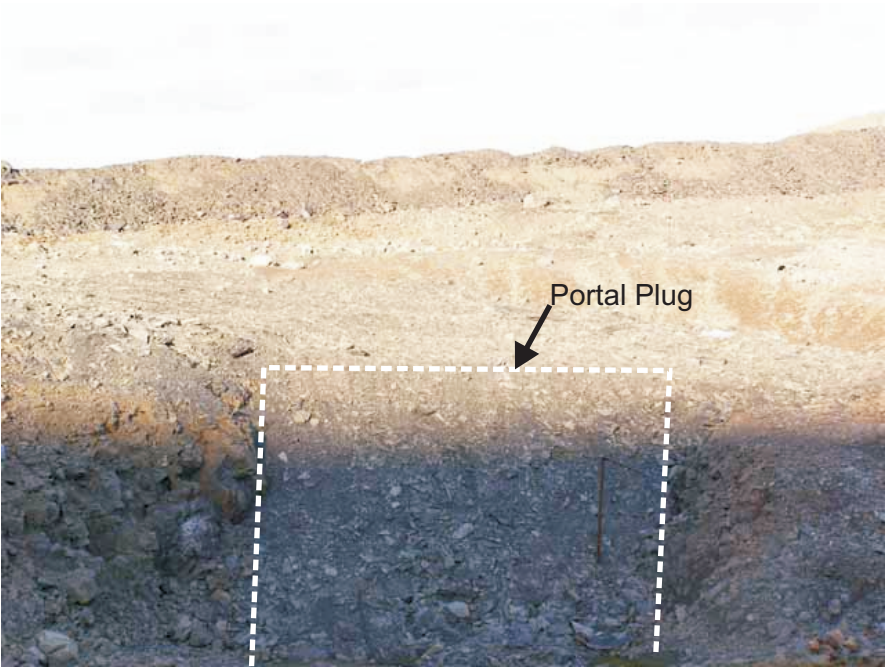
Photo 85  
Mill foundation portal plug.  
Note no armour material has been applied to the face of the plug.
