RECLAMATION OF MINE OPENINGS AS-BUILT REPORT

NANISIVIK MINE, NU

FINAL REPORT

PROJECT NO.: 0255-012-03
DATE: APRIL 30, 2008

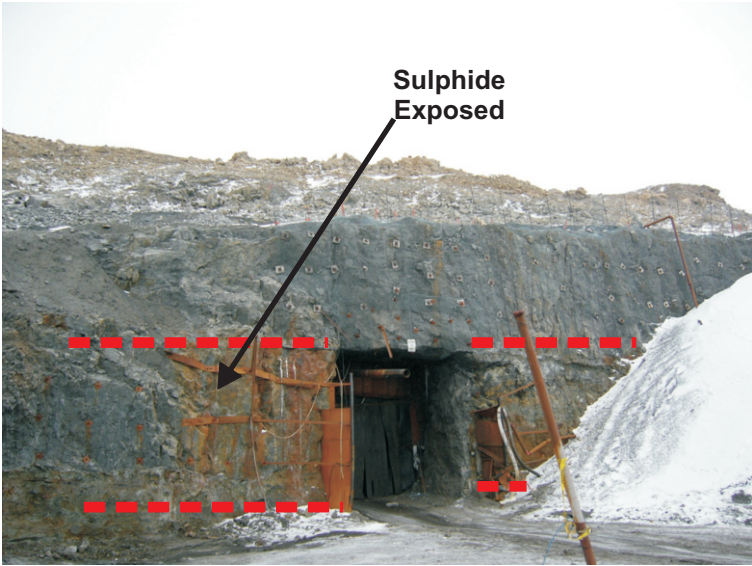
Photo 1 - 00 Portal prior to closure.
Date: October 2, 2005

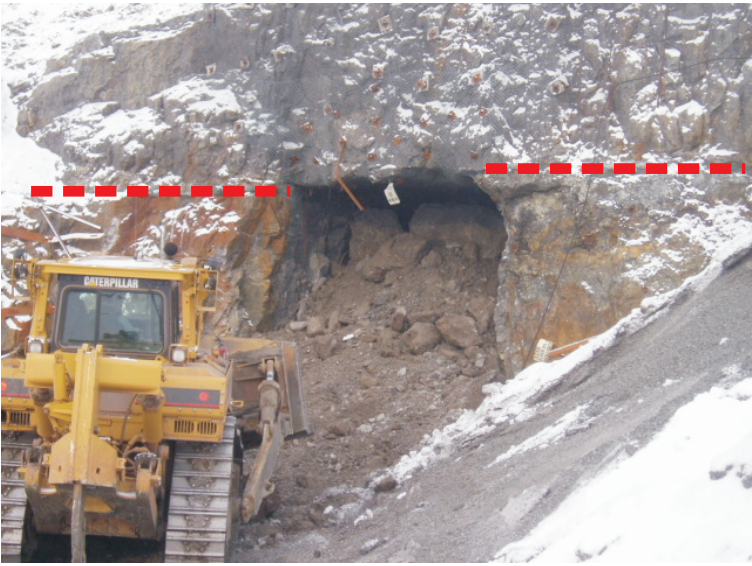
Photo 2 - 00 Portal partially closed.
Date: October 2, 2005

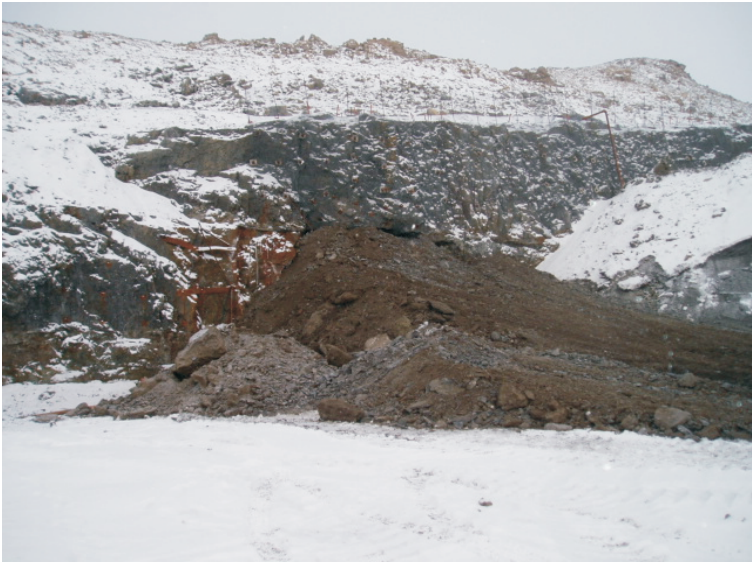
Photo 4 - Backfilled 00 Portal.
Date: October 2, 2005

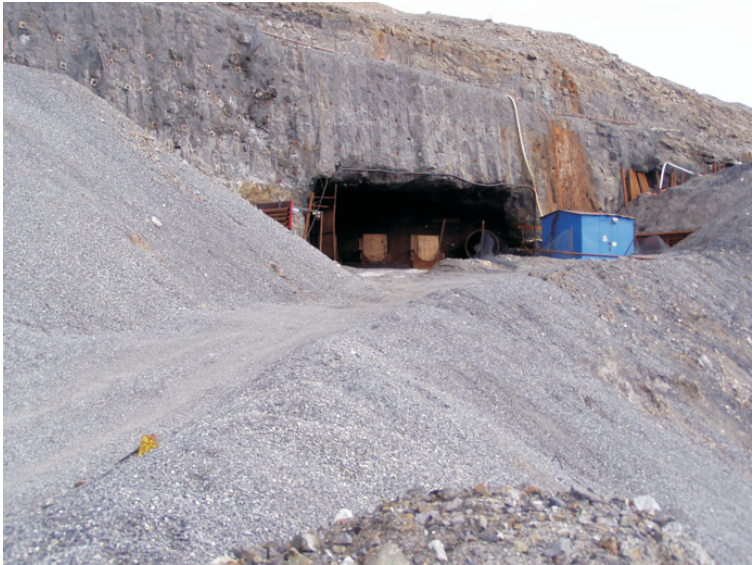
Photo 1 - 01 Portal prior to backfill.
Date: July 24, 2005

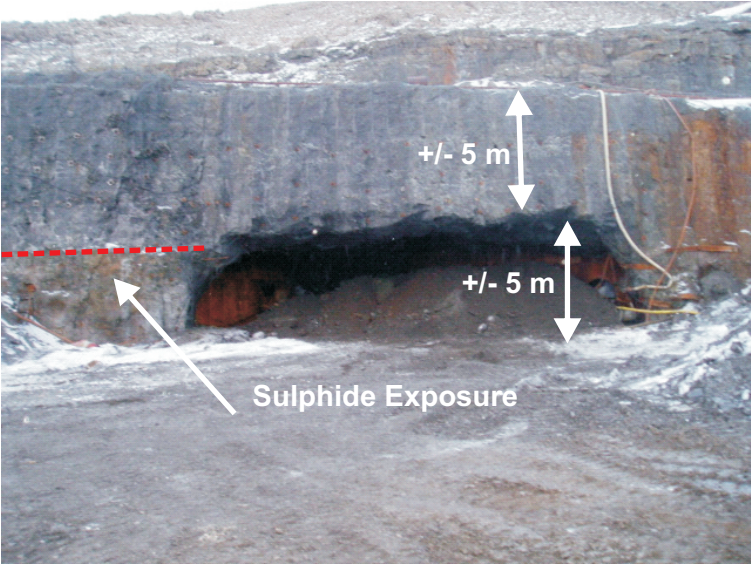
Photo 2 - Backfill material pushed up against the bulk head in 01 Portal.
Date: September 29, 2005

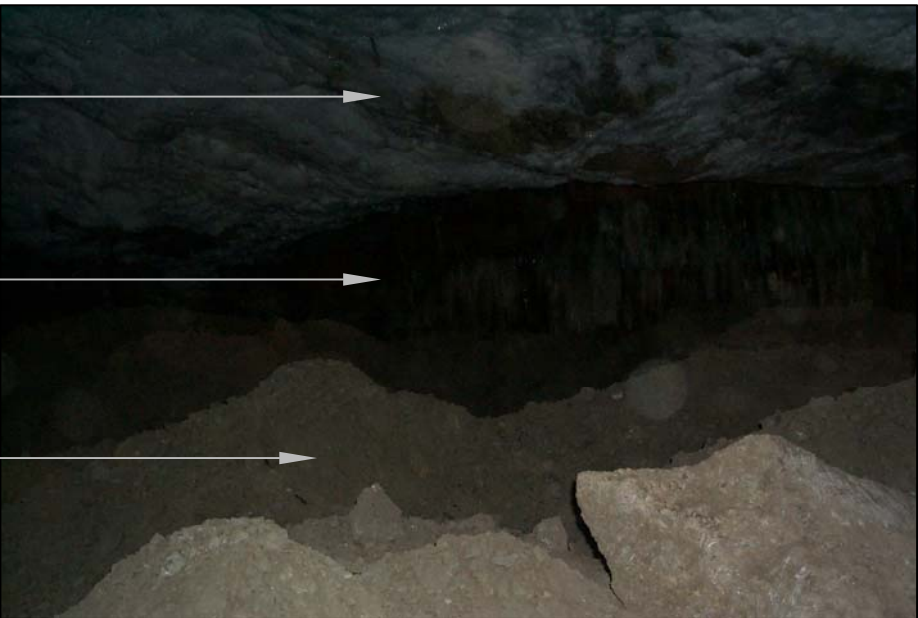
DATE: OCTOBER 2005
FILL PILLAR CONSTRUCTED IN EXCAVATED AREA 00-01 RIB PILLAR.
NOTE BACKFILL LEVEL IN REFERENCE TO STEEL PIPES IN BACKGROUND.

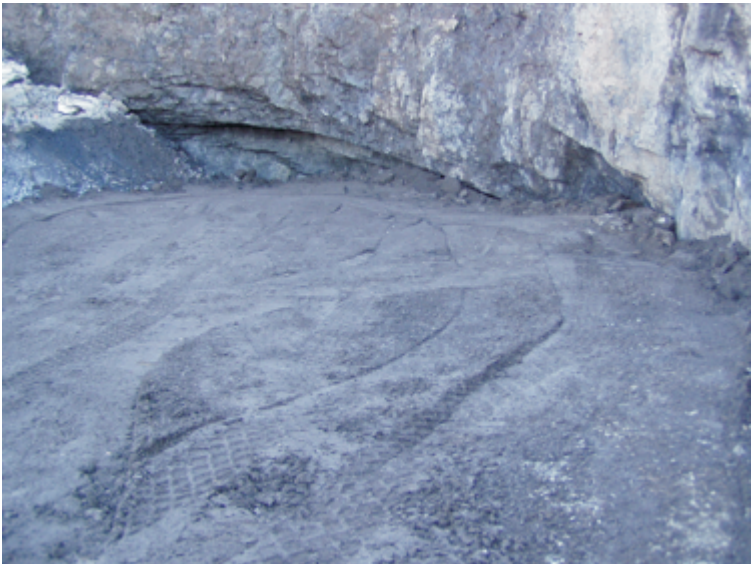
Photo 4 - Coarse fill in 38-11 stope after levelling.
Date: July 3, 2005

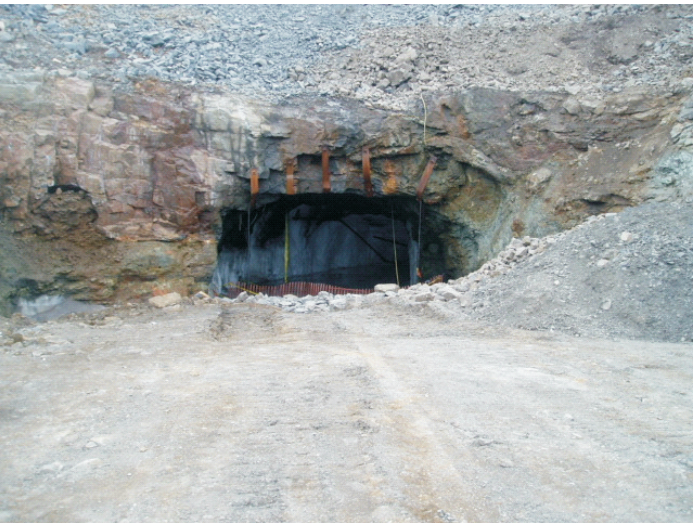
Photo 1 - 88 Portal prior to closure.
Date: August 1, 2005

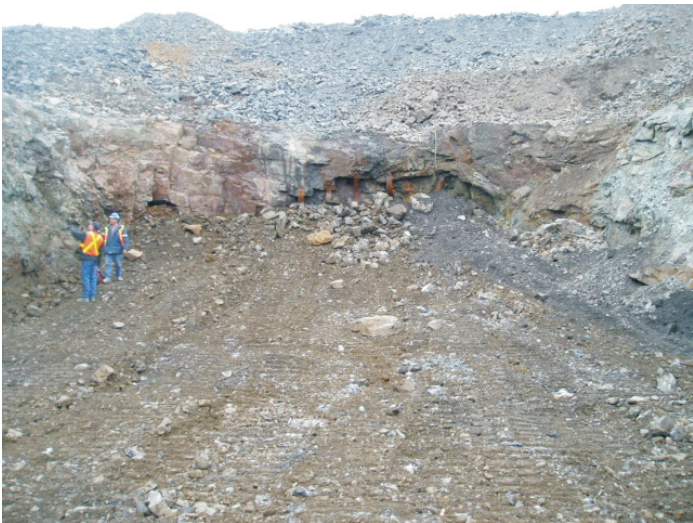
Photo 5 - 88 Portal completely backfilled with waste rock.
Date: August 1, 2005

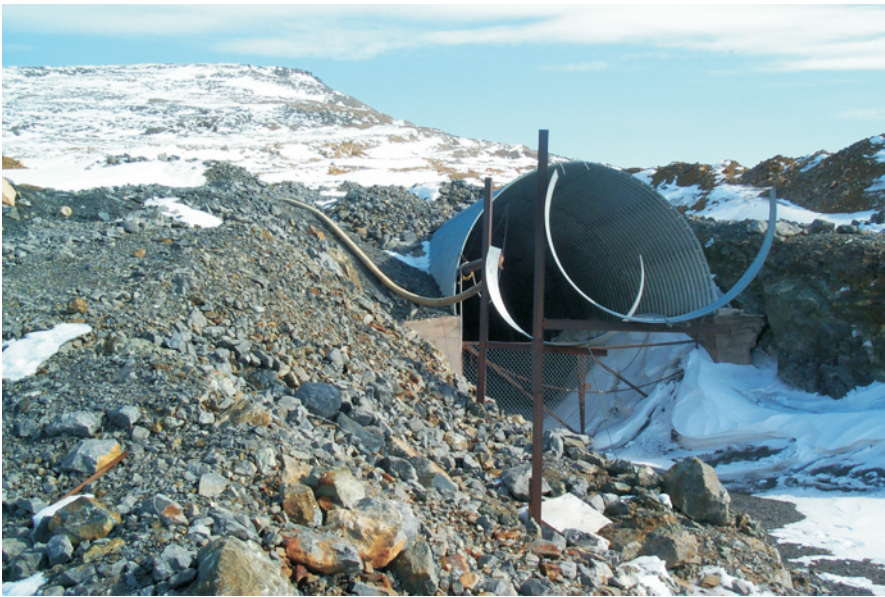
Photo 1 - K-Baseline Portal prior to backfilling.
Date: July 23, 2004

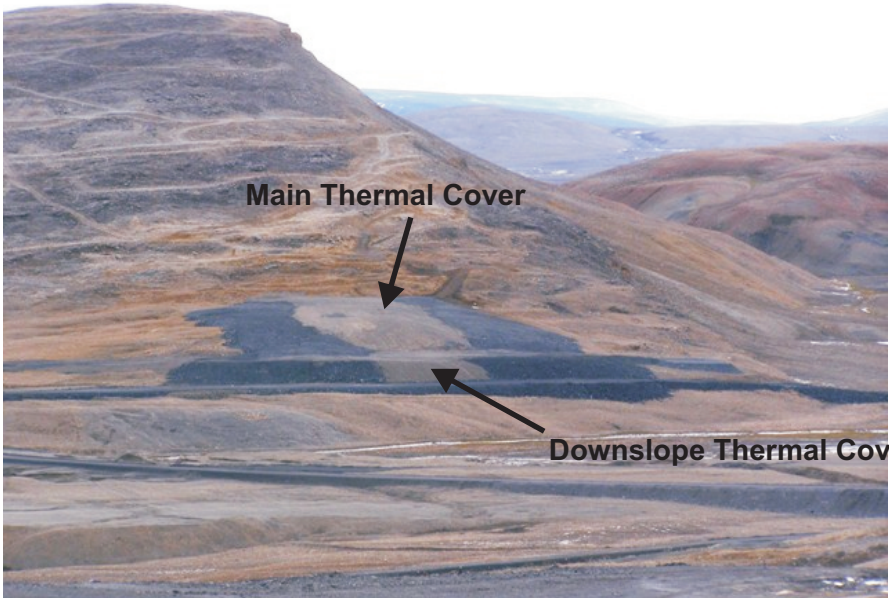
Photo 4 - Completed K-Baseline portal and waste rock cover.
Date: August 24, 2006

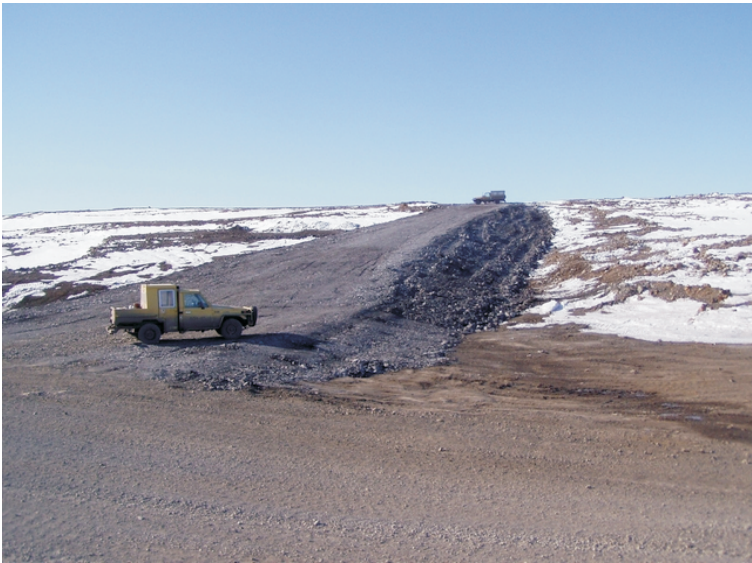
Photo 4 - Completed Oceanview Portal cover.
Date: May 30, 2005

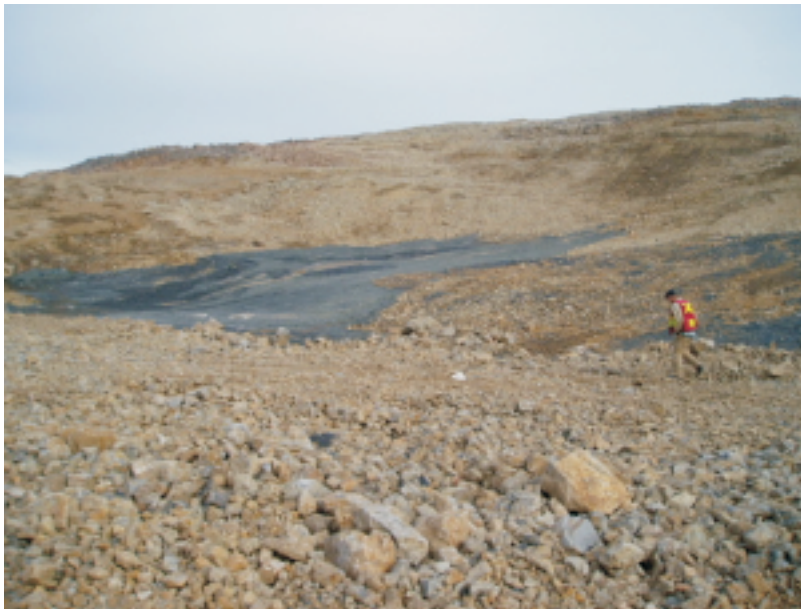
Photo 1 - Area 14 Portal prior to armour placement.
Note portal is surfaced with shale.
Date: August 18, 2005

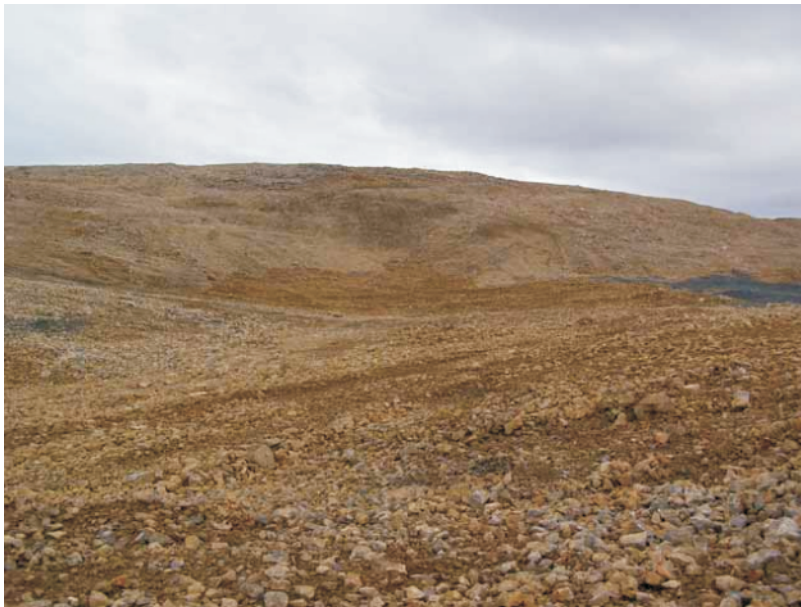
Photo 2 - Area 14 Portal after armour placement.
Date: August 30, 2007

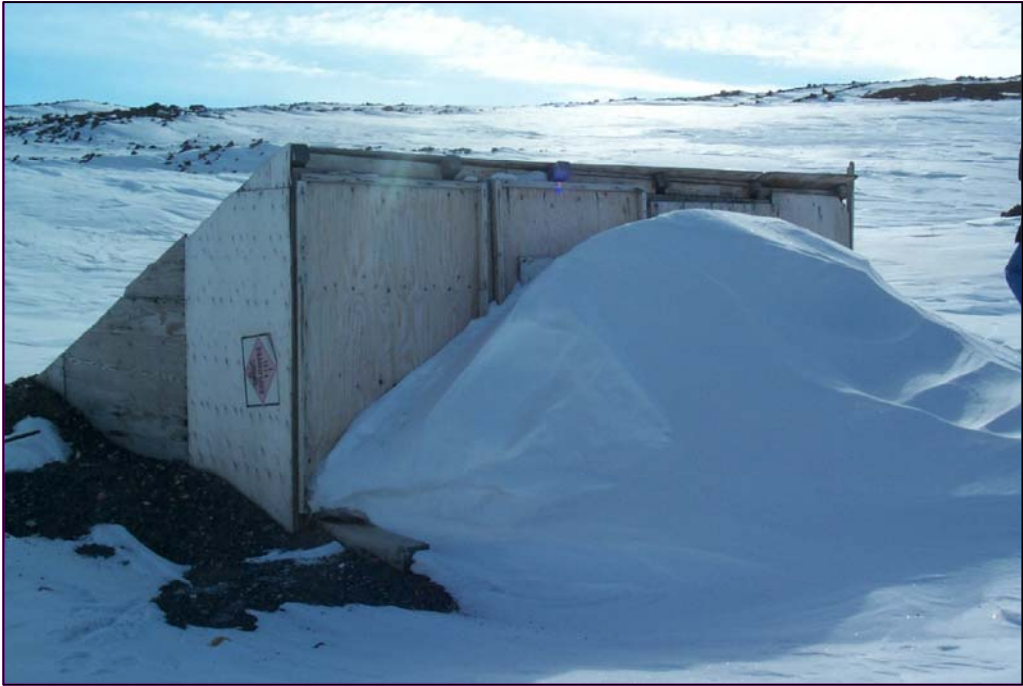
VIEW OF OCEANVIEW EAST RAISE PRE-RECLAMATION (SEPTEMBER 2002).

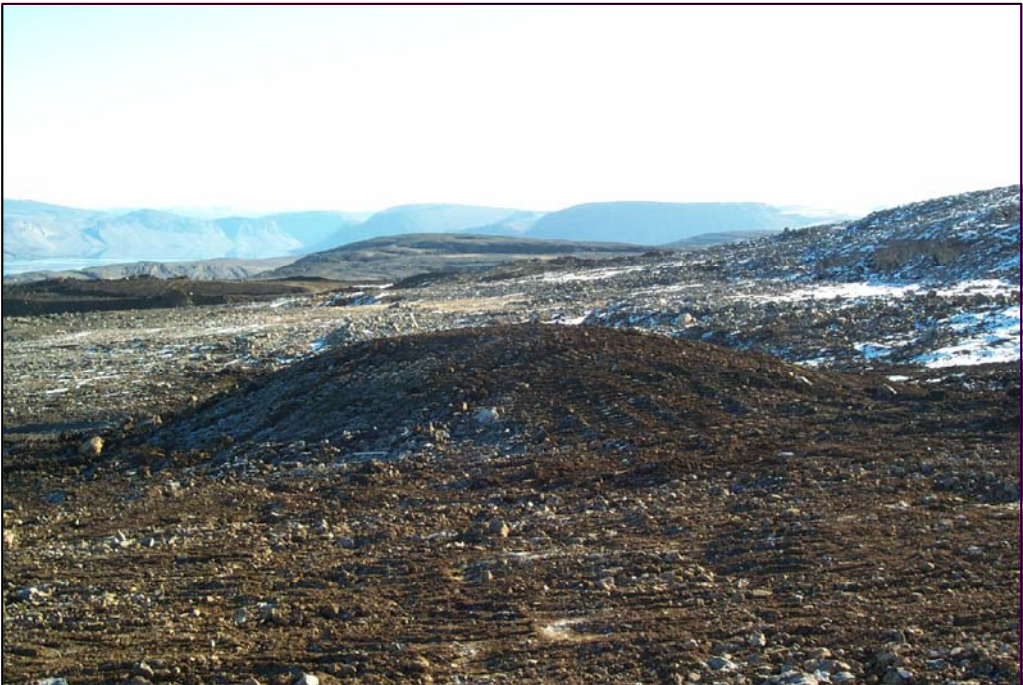
VIEW OF SHALE CAP ON OCEANVIEW EAST RAISE POST-RECLAMATION (SEPTEMBER 2002).

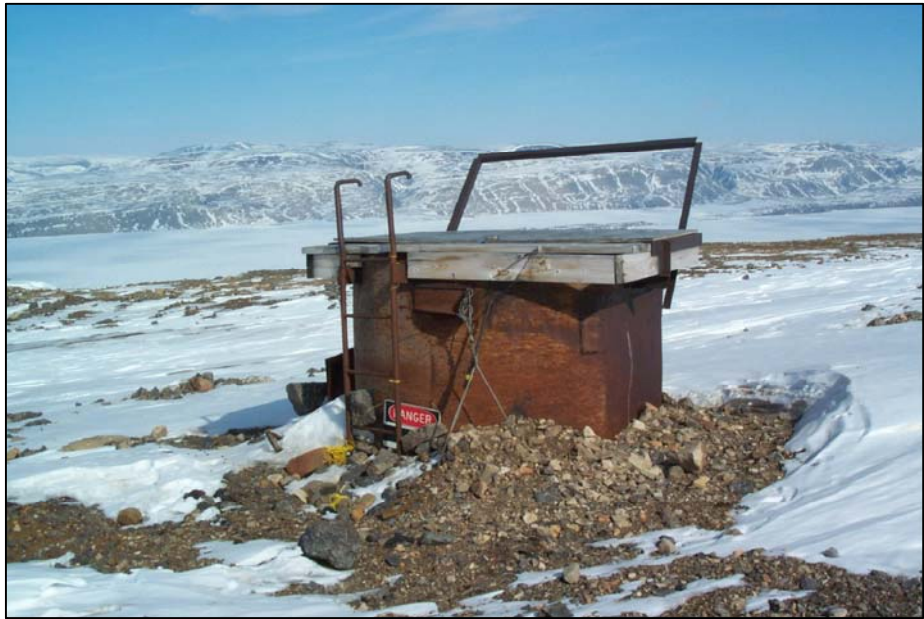
VIEW OF OCEANVIEW WEST RAISE PRE-RECLAMATION (SEPTEMBER 2002).

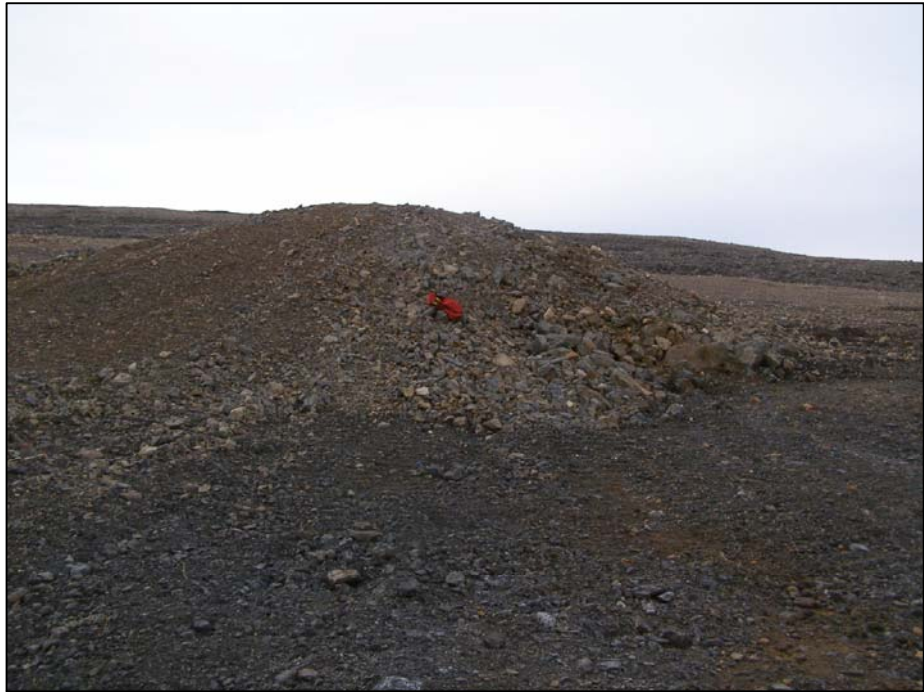
VIEW OF SHALE CAP ON OCEANVIEW WEST RAISE (AUGUST 2006).

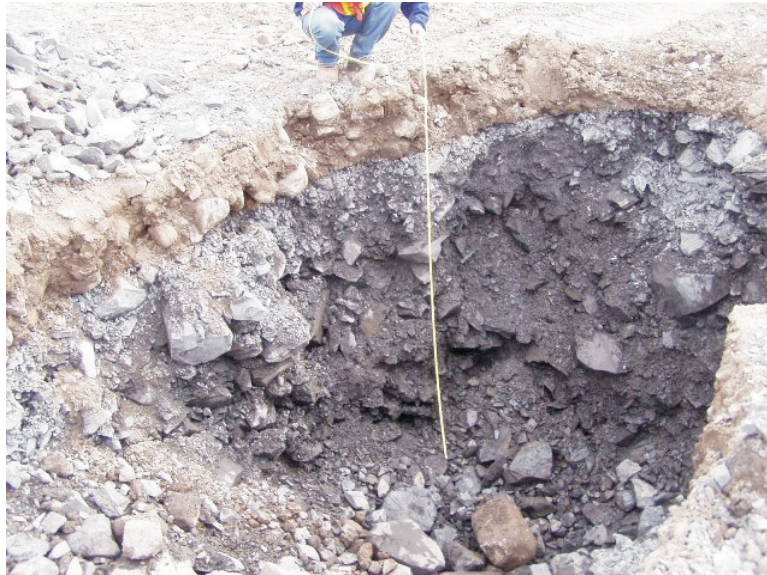
June 22, 2005
K-Baseline Portal Cover thickness test pit.
Note particle size distribution of shale file.

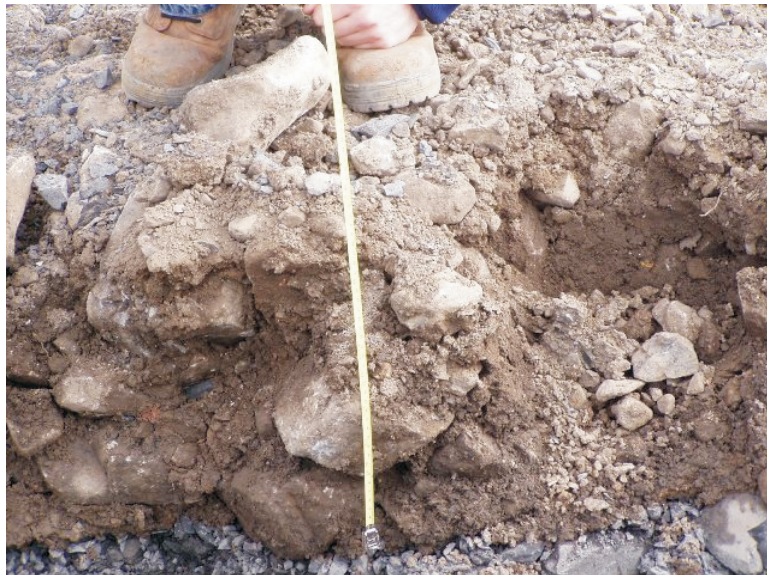
June 22, 2005
K-Baseline Portal cover thickness test pit.
Note particle size distribution and thickness of armour material.
