## **NYRSTAR**

### **NANISIVIK MINE, NUNAVUT**

## **2013 ANNUAL GEOTECHNICAL INSPECTION**

PROJECT NO.: 0255-023  
DATE: February 27, 2014  
DOCUMENT NO.:

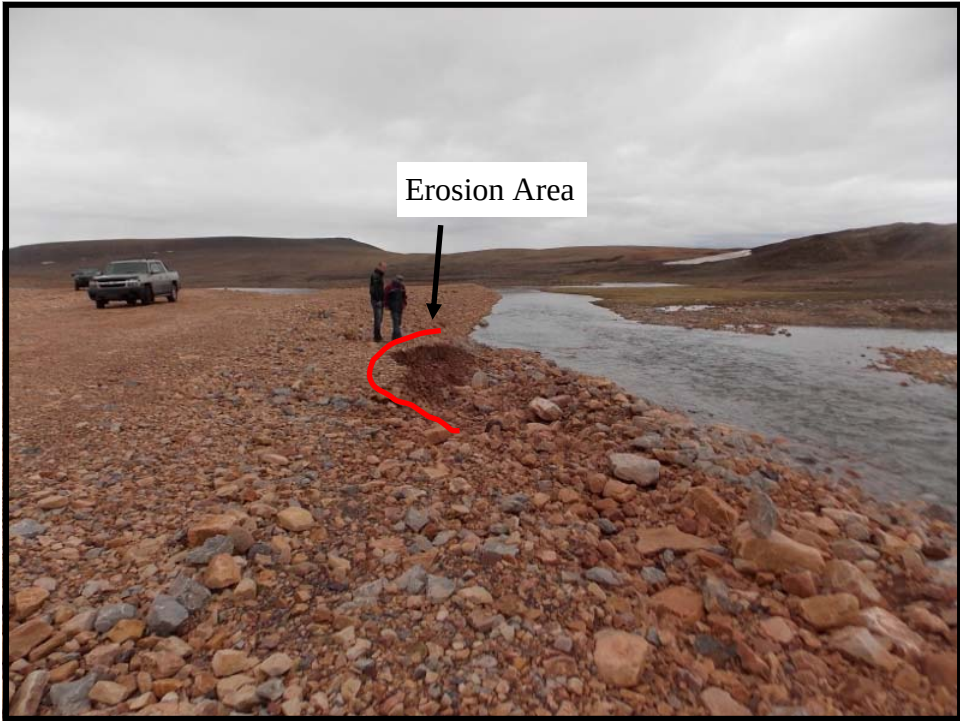
Some erosion at the East Twin Diversion Dyke was noted during the inspection. The erosion was likely due to elevated flows during freshet in combination with snow blockage in the channel. The erosion appeared to be more advanced in 2013 compared to 2012. In general the dyke remains in stable condition. However, it is recommended that visual observations of flow during freshet be recorded in 2014. Seepage was observed at the toe of the East Twin Diversion Dyke in 2013 upstream of the convergence of flow from West Twin. This seepage is likely originating in the remnant polishing pond. There is no concern with respect to the integrity of the dyke due to the presence of this seepage. However, it is recommended that this seepage point be monitored for increased flows in 2014.

Photo 13. East Twin Creek Diversion Channel– Erosion area noted above seepage discharge point.

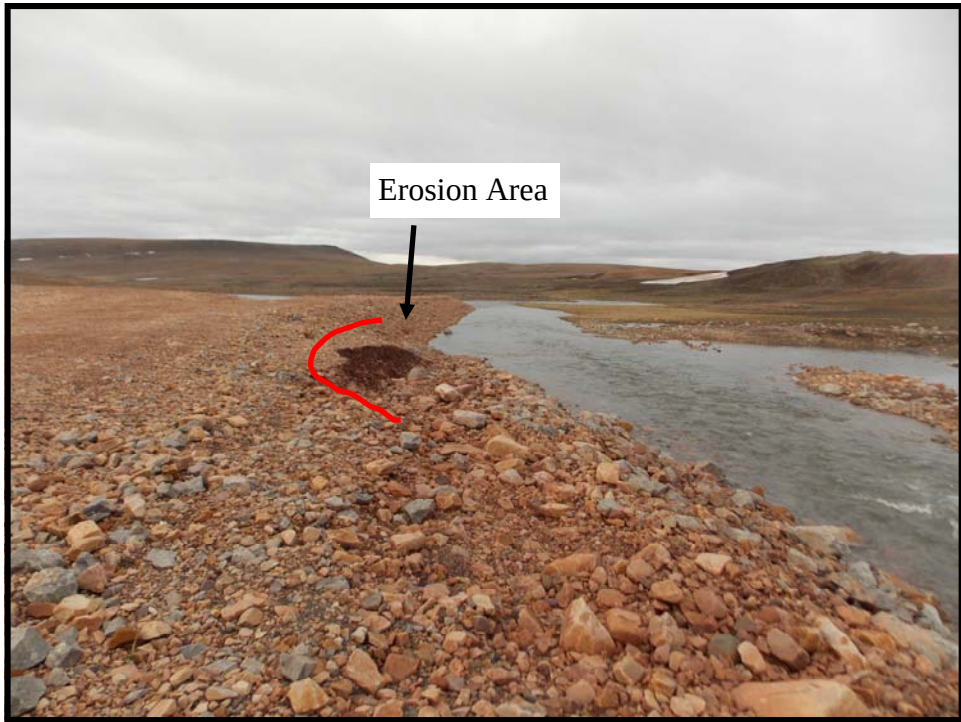
| Inspection Item | Recommended Action items (2012) | 2013 Comments / Actions |
|---|---|---|
| East Twin Creek Diversion Channel | Monitor creek flows during freshet to assess causes of noted erosion. Monitor seepage discharge point at toe of dyke. | Additional erosion of left bank of channel observed.<br>No change in seepage discharge noted. |

Photo 14. East Twin Creek Diversion Channel– Erosion area noted above seepage discharge point. Erosion is further advanced compared to 2012.

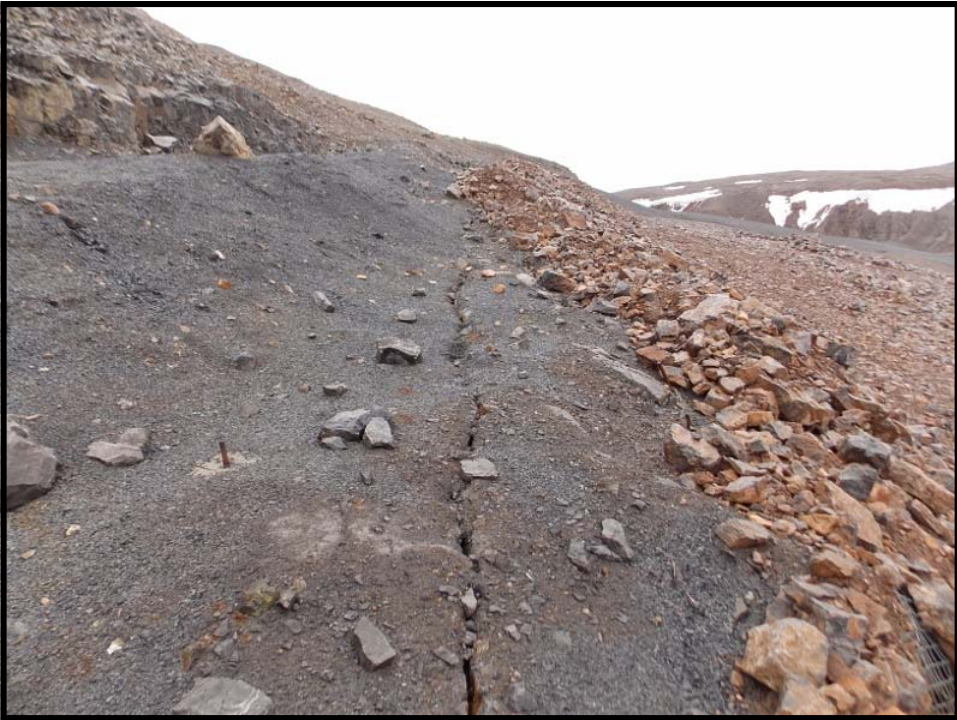
| Inspection Item | Recommended Action items (2012) | 2013 Comments / Actions |
|---|---|---|
| 00/01 Portals and crown pillar | Continue to monitor cracking in WOP crown pillar. | No additional cracking of WOP crown pillar observed. |

Photo 33. West Open Pit—Crack in crown pillar.

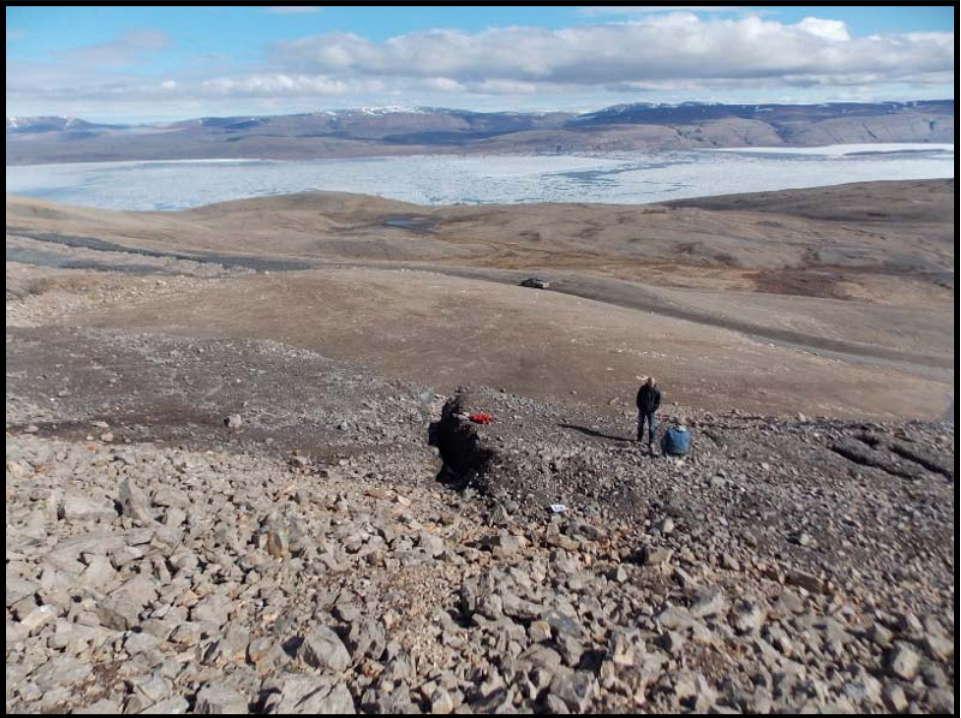
The covers constructed over the mine openings generally appear to be physically stable. Cracking at the East Open Pit crown pillar does not appear to have progressed since 2011. No maintenance is recommended, but continued visual inspection is warranted.

| Inspection Item | Recommended Action items (2012) | 2013 Comments / Actions |
|---|---|---|
| East Open Pit/ East Trench Waste Rock Cover | Continue to visually monitor cracking in EOP crown pillar and minor surficial erosion of EOP and East Trench covers. | No additional cracking of EOP crown pillar observed.<br>No additional erosion of surface of EOP or East Trench covers observed. |

Photo 40. East Open Pit—Cracking in crown pillar. Similar condition to 2012.
