# Site Visit and Community Consultation Report

September 18-20, 2003

## Nanisivik Mine and Arctic Bay

Patrick Duxbury  
Mine Reclamation Coordinator  
Nunavut Water Board

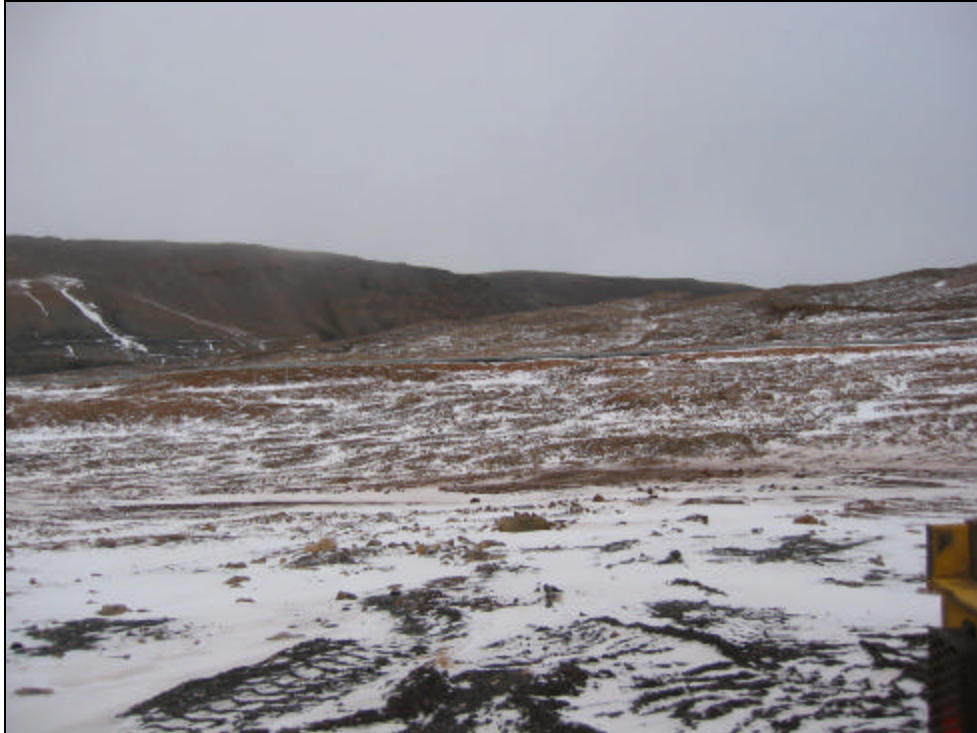
As the group traveled towards the WTDA, Murray Markle pointed out an area where mine employees had excavated soil which had been contaminated due to a tailings break during mine operation. CanZinco will keep the tailings lines intact until it has decided how it wishes to proceed with cleaning of the industrial facilities. Once the tailings lines are no longer of use they will be dismantled and probably placed either underground or on top of the WTDA prior to its covering.

Photo 1 – Photograph taken along the road to the WTDA; tailings line is visible in background

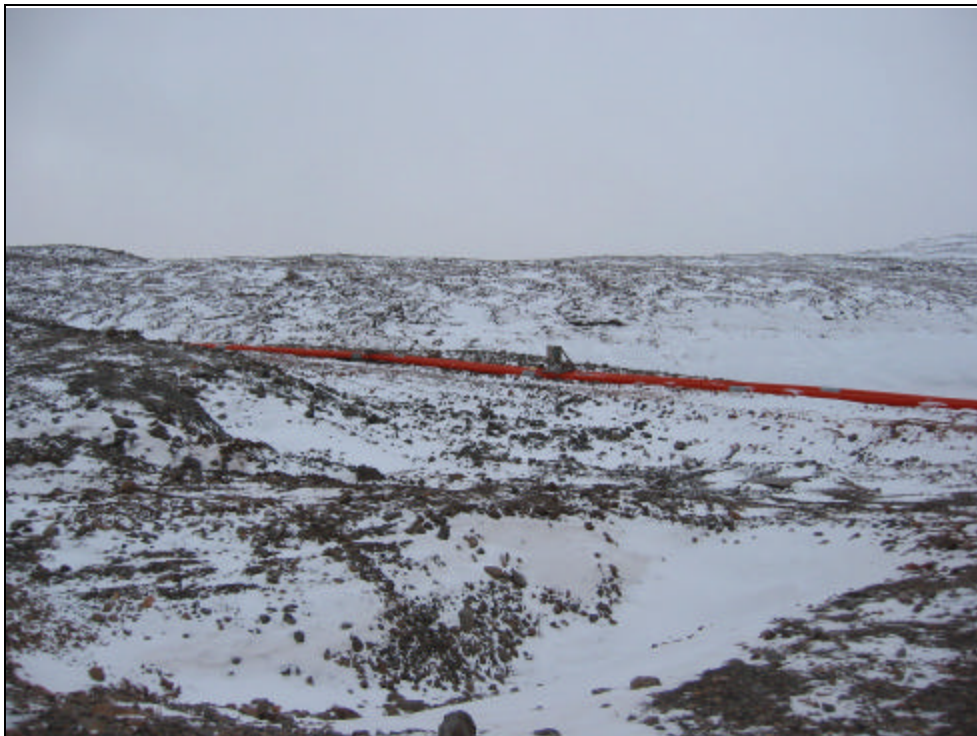
Photo 2 – Site of excavation where tailings spill had occurred; tailings line is clearly visible

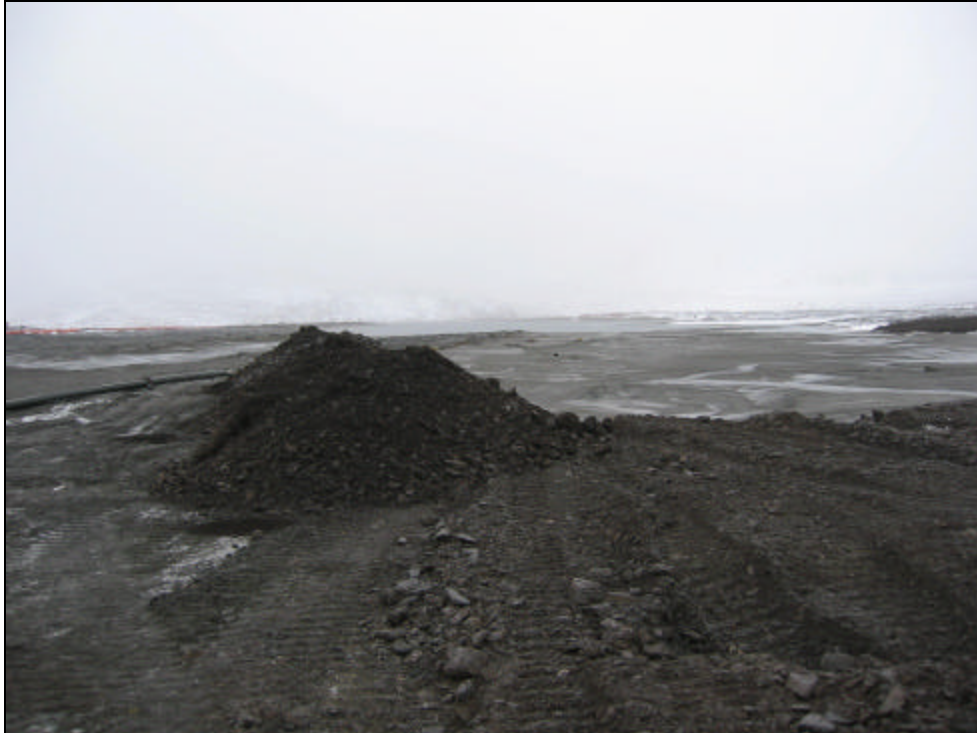
At the WTDA, the sub-aerial tailings were being covered by a layer of recently quarried shale. Murray Markle noted that the depth of the shale layer being applied exceeded the rather minimal required layer to prevent tailings from being blown by strong winds. He thought that the excess material could perhaps be considered a contribution to the 1.25 m cover that has been proposed. Murray stated that he was apprehensive about sending heavy machinery over certain parts of the WTDA because of a unusually intense rain event in August had made areas of it mucky and possibly dangerous to work on.

Photo 3 – Stockpiled crushed shale awaiting placement on top of the sub-aerial portion of WTDA

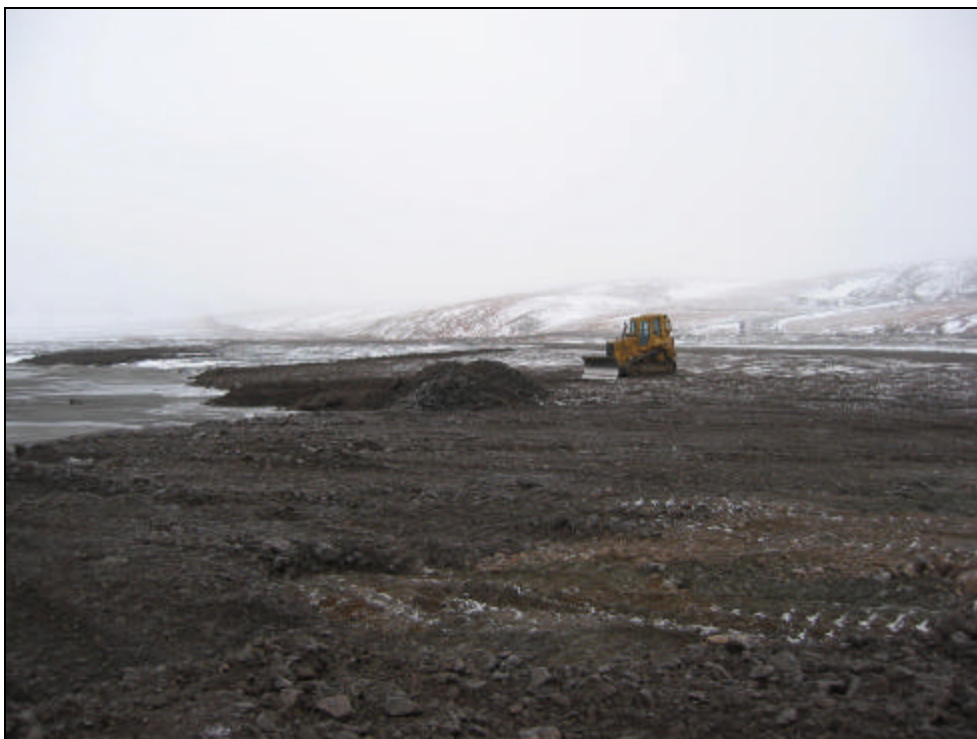
Photo 4 – Heavy machinery was placing crushed shale over WTDA, however due to wet conditions this activity had been temporarily halted.

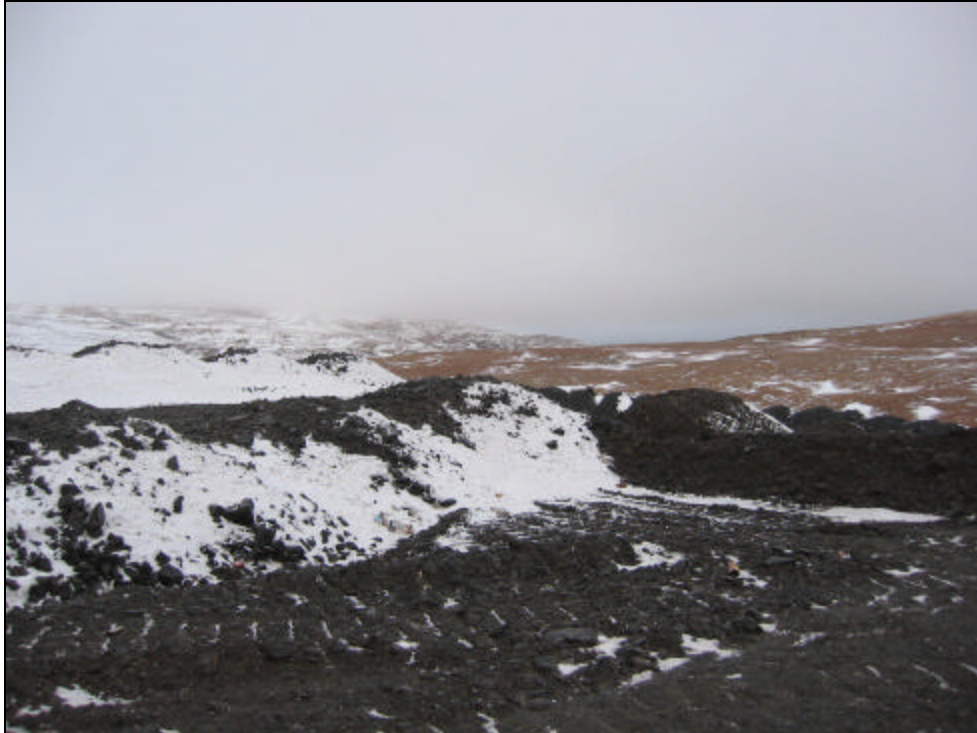
Since the cessation of mining and milling operations, the quantity of material being placed in the landfill has diminished. At the time of the site visit it was noticed that an application of crushed shale had been placed on top of the waste and some subsequent land leveling had occurred. This is a practice that has been occurring throughout the life of the mine. Some small piles of crushed shale were left at the periphery of the landfill, presumably for future waste covers.

Photo 5 – Shale has been mixed with waste at the landfill and bulldozed into layers

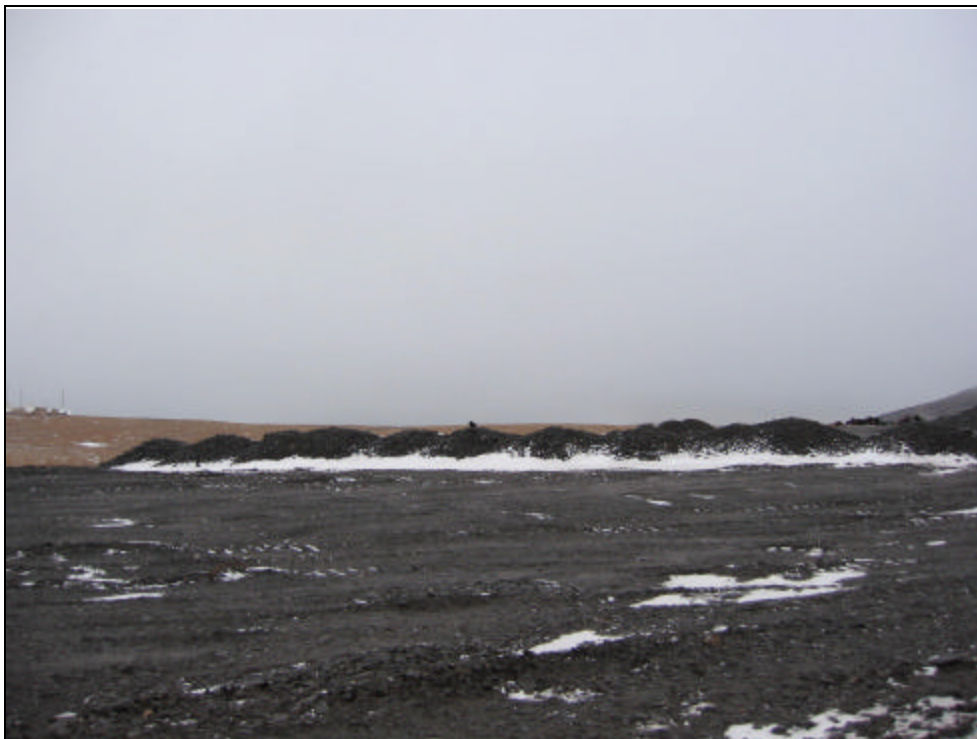
Photo 6 – Landfill with fresh shale cover
