NANISIVIK MINE RECLAMATION PROJECT COMPLETION REPORT

PROJECT NUMBER: 0255-017-05

DATE: JANUARY 30, 2009

PROJECT COMPLETION REPORT

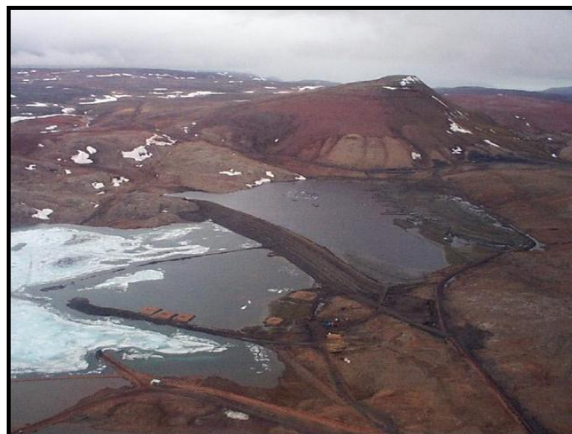
Prior to reclamation operations, the Surface Cell was comprised of a combination of aerially exposed tailings and sub-aqueous confined tailings. The average water cover over the sub-aqueous tailings in the Surface Cell, immediately prior to reclamation, was approximately 2 m. At that time, sub-aqueous confined tailings comprised approximately 40% of the aerial extent of the Surface Cell. It should be noted that the aerial extent of water cover in the Surface Cell was typically greater during mining operations.

Figure 1 – Pre-reclamation Conditions WTDA (2000)

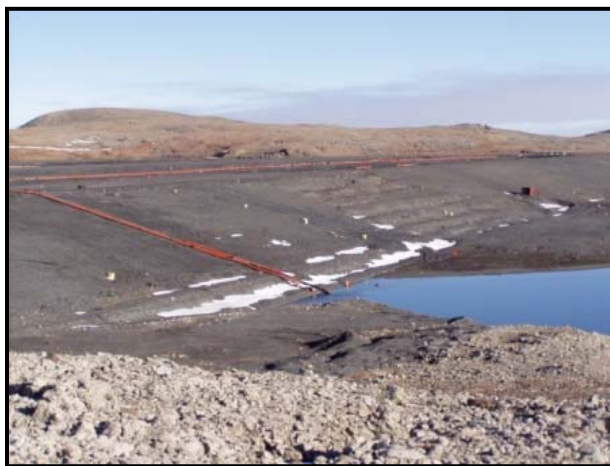
The West Twin Dike was an upstream constructed, frozen core, rockfill dike constructed on a foundation of frozen tailings. The dike was constructed between 1990 and 1998 to provide additional storage capacity for tailings at the WTDA. The dike was approximately 17 m high and the general slope of the downstream face of the dike was approximately 15° . The crest of the dike was approximately 10 m wide and 500 m long. The downstream face of the dike was benched until 2000 when the majority of the face was graded to form a uniform slope of approximately 15° . One section of the downstream face of the dike, approximately 100 m long, remained benched. The upstream face of the dike was buttressed with tailings to within approximately 1 m of the crest of the dike. A tailings beach was situated at the downstream toe of the West Twin Dike, separating the toe of the dike and the Reservoir. This tailings beach had a thin (approximately 5 to 15 cm thick) cover of shale constructed on top of it for dust suppression purposes. Immediately prior to reclamation, the aerial extent of the tailings beach was approximately 13,000 m², but was observed to range greatly depending on the elevation of the water level in the Reservoir.

Figure 2 – West Twin Dike Pre-reclamation (2002)

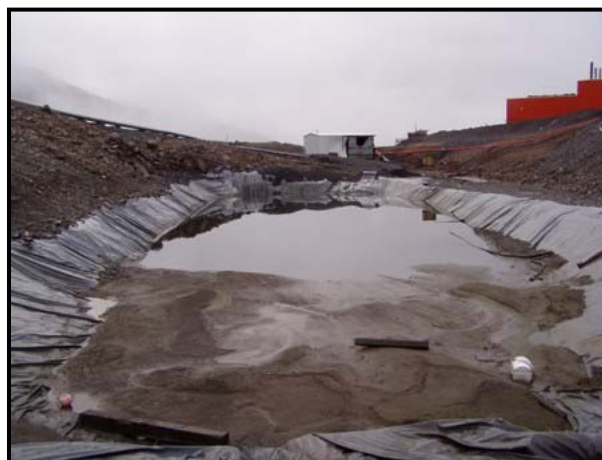
The tailings disposal system included two emergency dump ponds: the Lower Dump Pond, located below the mill near Twin Lakes Creek; and the Upper Dump Pond, located east of the town site along the pipeline right-of-way. The dump ponds were utilized to drain sections of the tailings line during emergency shutdowns and maintenance operations. The ponds were each about 10 m by 30 m in area, with perimeter containment berms about 1.5 to 2.0 m high and each pond was lined with HDPE.

Figure 5 – Lower Dump Pond Pre-reclamation (2005)

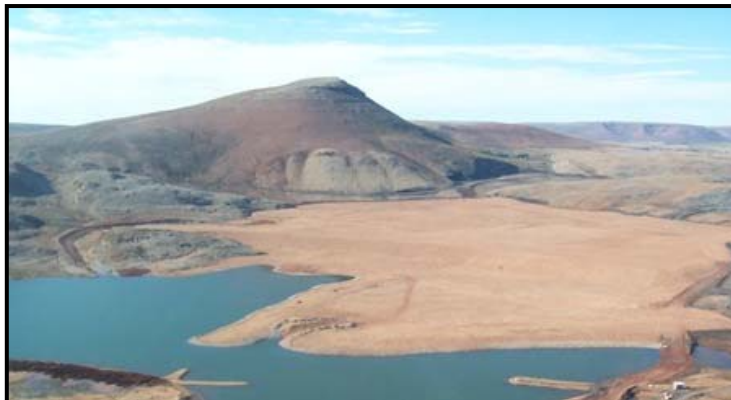
- Surface reclamation covers consisting of a minimum 1 m thickness of granular shale fill and a minimum thickness of 0.25 m of armour material were constructed over the tailings in the Surface Cell and Test Cell, and over the tailings beaches at the toe of the Surface Cell and Test Dike dikes.

Figure 6 – WTDA Post-reclamation (2006)

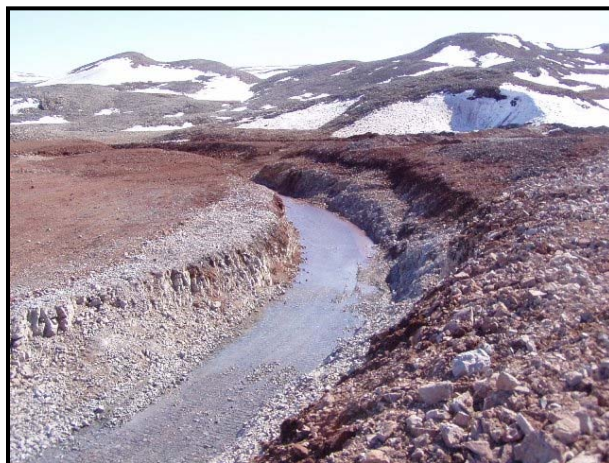
- The granular shale fill material was derived from the Mt. Fuji, West Twin, East Twin and Area 14 shale deposits and the armour material was sourced from the Twin Lakes Delta deposit.
- A layer of riprap was applied to the surface of the cover along the Reservoir shoreline to prevent erosion of the cover materials due to wave action. The riprap was sourced from the spillway excavation and from the dolostone outcrop near the south end of the West Twin Dike.
- The Surface Cell cover was graded such that surface water is directed to the inlet of the West Twin Dike Spillway

Figure 7 – West Twin Dike Spillway (2006)

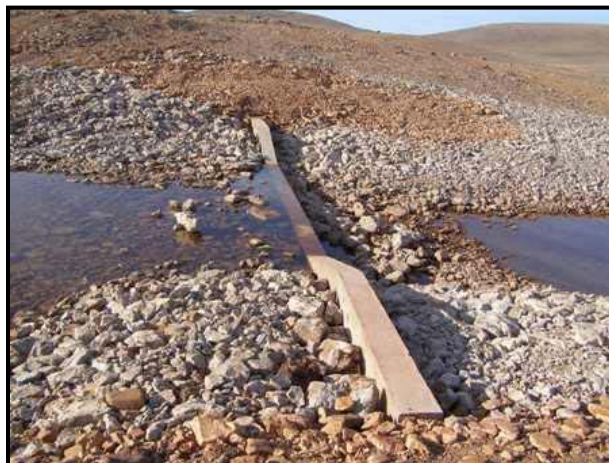
- The control structure at the Polishing Pond outlet was replaced with the West Twin Outlet Channel, an armoured channel and concrete weir, to provide passive elevation control of the water level in the Reservoir.
- The East Twin Lake pumping equipment was removed during the salvaging operations and either transported off-site or stored in the underground mine workings, depending on its condition.

Figure 8 – West Twin Outlet Channel (2006)

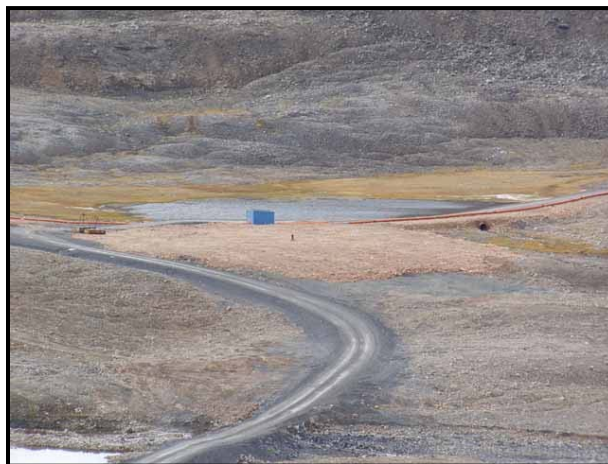
- The Upper Dump Pond was not excavated as per the original reclamation plan due to concerns related to contamination during transportation of the tailings (the volume of tailings contained in the Upper Dump Pond was significantly greater than the volume of tailings contained within the Lower Dump Pond, which was minimal). A thermal cover consisting of 1.95 m of granular shale and 0.25 m of armour rock was constructed over the tailings in the Upper Dump Pond. The perimeter berms were graded and covered with armour rock to blend into surrounding conditions.

Figure 9 – Upper Dump Pond Post-reclamation (2006)

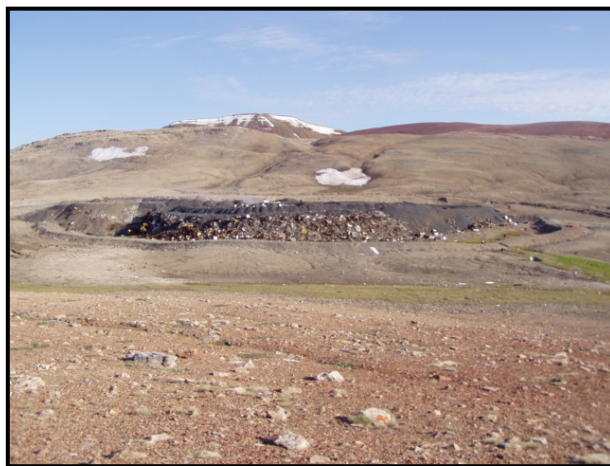
The Nanisivik Landfill is located approximately 1 km west of the town site. The Landfill contains waste materials from the town, the mine and the airport (GLL 2004b). The facility was operated from 1975 to 2005. During operations, waste volume was reduced by burning and crushing prior to being pushed over the advancing (northwards) crest and buried with shale fill (GLL 2004b). Prior to reclamation, a surficial layer of shale was present along the surface of the landfill. During operation of the landfill, a seepage collection berm was constructed at the toe of the landfill and a surface water deflection berm was constructed upslope of the landfill area. Additionally, a land farm for remediation of hydrocarbon

Figure 10 – Nanisivik Landfill Pre-reclamation (2004)

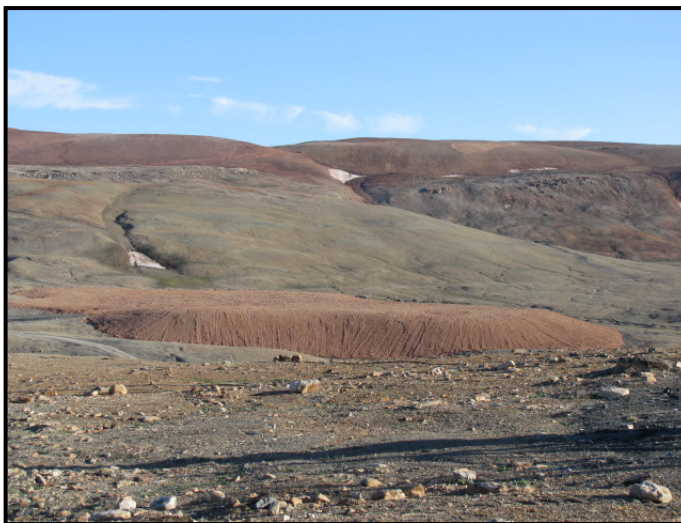
- A thermal cover consisting of a 2 m thick layer of granular shale overlain by a 0.25 m thick layer of armour material was constructed over the landfill area. The cover was constructed such that the surface grade provides positive drainage and is sloped no steeper than 3(H):1(V). It should be noted that shale thickness along the exposed sloping face of the landfill were overbuilt by 3 to 5 m in some areas to achieve the desired surface grades.
- One frost gauge and one thermistor were installed to monitor the geothermal performance of the cover and to confirm the frozen nature of the underlying landfill debris.

Figure 11 – Nanisivik Landfill Post-reclamation (2007)

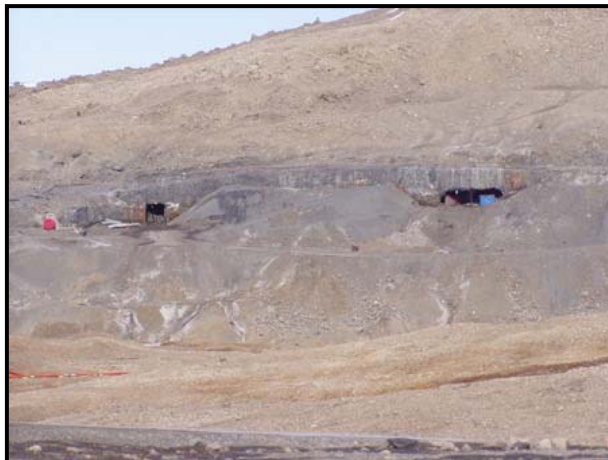
The West Open Pit is located approximately 1 km east of the Industrial Complex. The pit was actively mined from 1980 to 1995. The open pit covered an aerial extent of approximately 15,000 m² (75 by 200 m). The pit was developed largely as a shallow hole with a ramp providing access from the west side. The pit contained the 00 and 01 Portals, which provided access and ventilation, respectively, to the underground mine workings.

Figure 12 – West Open Pit Pre-reclamation (2004)

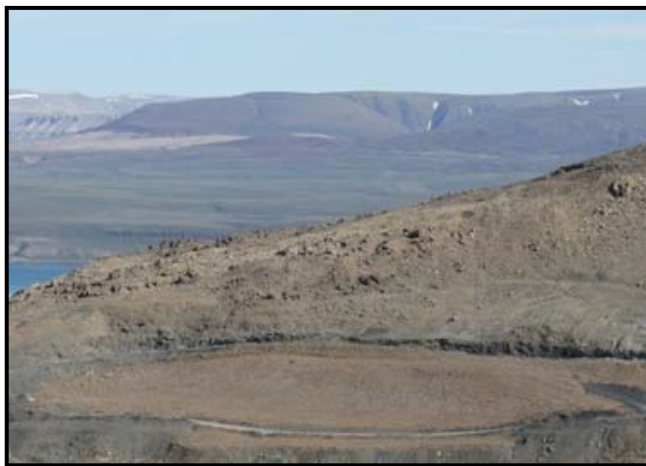
Figure 14 – West Open Pit Post-reclamation (2007)

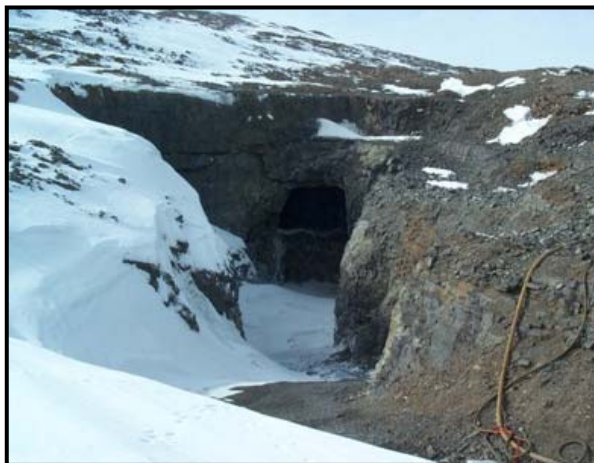
The East Trench was a relatively small surface excavation located to the east of the East Open Pit. The trench was mined in 2000 and 2001. The dimensions of the trench were approximately 10 m wide, by 50 m long by 15 m deep (GLL 2004a). Approximately 10 m of underground excavation was also completed into the south wall of the East Trench. This excavation did not connect to the main underground workings.

Figure 16 – East Trench Pre-reclamation (2002)

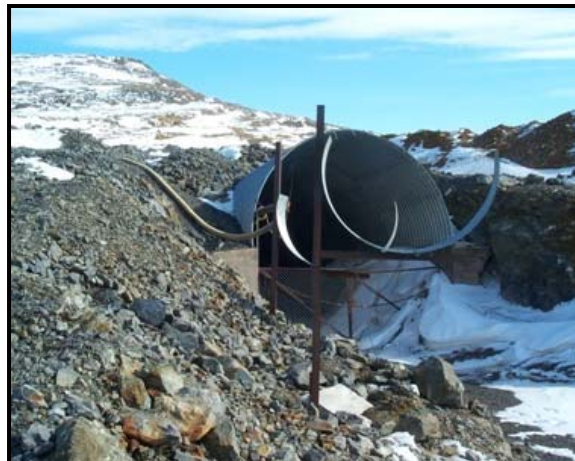
The K-Baseline portal was a culverted entry used to access the K-Baseline orebody. The portal had been inactive for a period of nearly 10 years and ice had completely filled the access to a point 20 m inside the culvert. The portal entrance was blocked with rockfill after mining operations ceased in September 2002. In October 2004, the top of the culvert was removed and the inside was backfilled with waste rock by mine staff.

Figure 21 - K-Baseline Portal Pre-reclamation (2002)

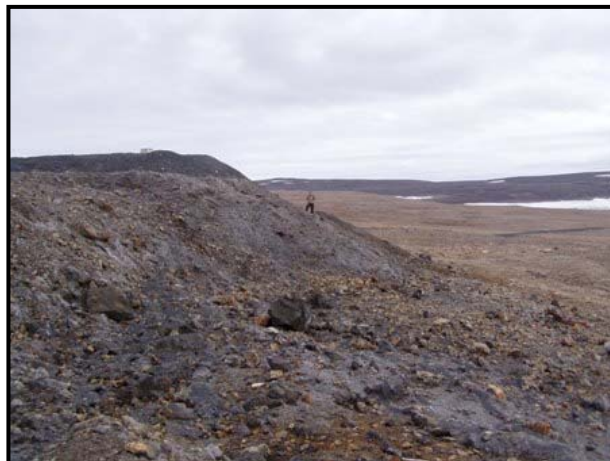
The Area 14 waste rock pile is located near the former access to the Area 14 underground development. Subsequent to the completion of mining in this area, a large portion of the rock dump was covered with a 2 m thick layer of shale as a test program to assess the thermal performance of the shale as a covering material over waste rock. The residual, uncovered volume of waste rock remaining in 2003 was estimated to be 10,300 m³.

**Figure 23 – Area 14 Waste Rock Pile
Pre-reclamation (2004)**

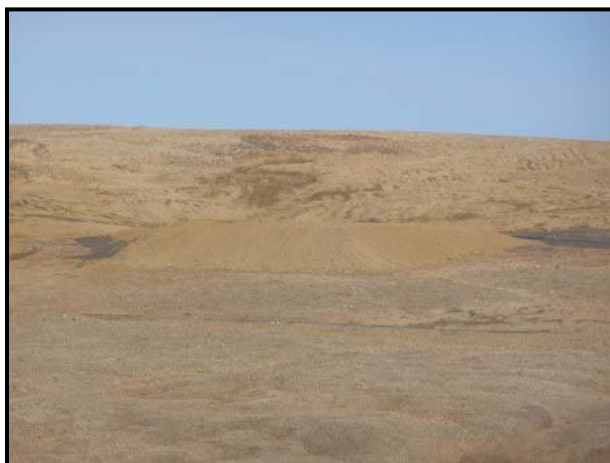
- The additional mineralized soil and waste rock was consolidated along the exposed face of the Area 14 waste rock pile.
- The hydrocarbon contaminated soil was relocated to the underground mine workings via the 09S portal.
- A thermal cover consisting of a 2 m thick layer of granular shale overlain by a 0.35 m thick layer of armour material was constructed over the exposed portion of the Area 14 waste rock pile. The cover was constructed such that the surface grade provides positive drainage and is sloped no steeper than 3(H):1(V).
- One frost gauge was installed at the Area 14 waste rock cover in 2005 to monitor the geothermal performance of the cover.

**Figure 24 – Area 14 Waste Rock Pile
Post-reclamation (2007)**

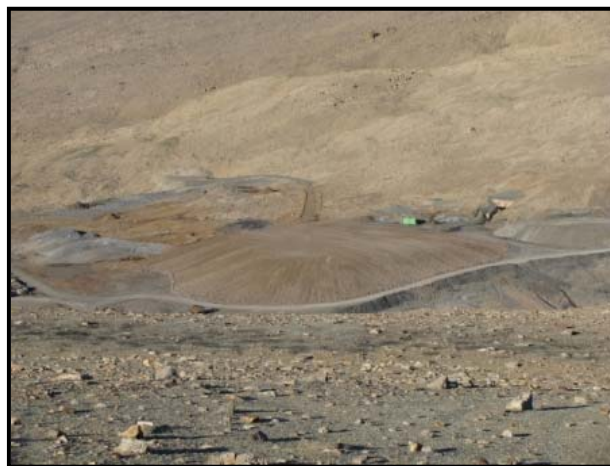
- The concrete floors of the Industrial Complex foundation were visually inspected and found to be generally intact (BGC 2006).
- The footprint of the Industrial Complex foundation was backfilled with metals contaminated soil from the Industrial Complex Yard, the area surrounding the Concentrate Storage Shed and the Polishing Pond.

**Figure 28 – Industrial Complex
Post-reclamation (2008)**

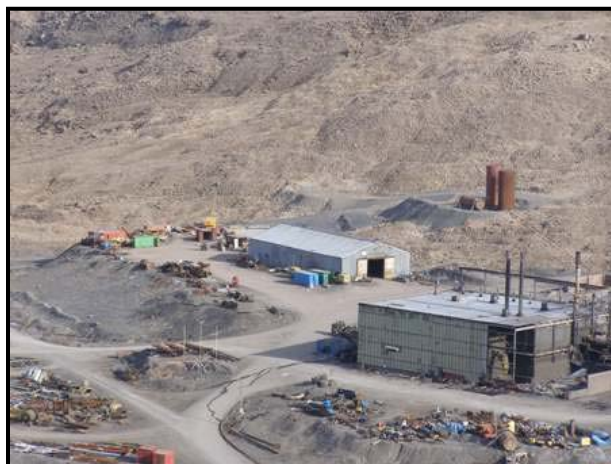
1. The ESA investigations (GLL 2004d) identified soil contaminated with both hydrocarbon and metals (est. 24,150 m³) in this area which was to be relocated to the underground mine workings.
2. The ESA investigations also identified soil contaminated with metals (est. 7,150 m³) in this area. This soil was to be excavated and consolidated into the area occupied by the concrete slab floors of the Industrial Complex, prior to construction of a thermal cover

Figure 36 – Industrial Complex Yard Pre-reclamation (2006)

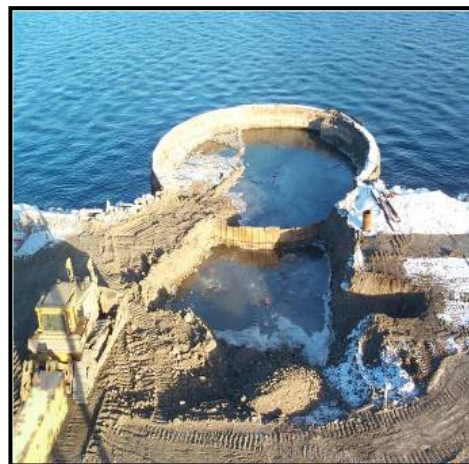
- The hydrocarbon and metals contaminated soil from the centre dock cell was excavated and relocated into the underground mine workings.

Figure 39 – Excavation of Hydrocarbon Contaminated Soils in Centre Dock Cell (2006)

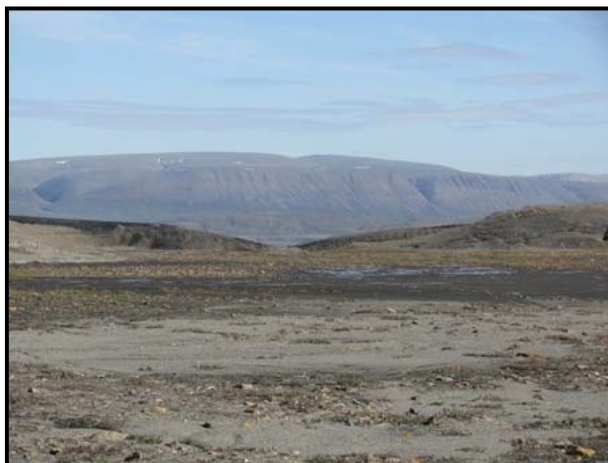
- A roadway capable of providing safe passage of heavy equipment and fuel haulage trucks to the dock area was preserved.
- Sections of service road beds that were deemed to cause an interruption to natural drainage were breached and contoured. This includes significant breaches of roadbed fills at Chris Creek and Area 14, West Twin Lake and Twin Lakes Creek near 09S portal.

Figure 40 – Breached Road Bed at Chris Creek (2007)

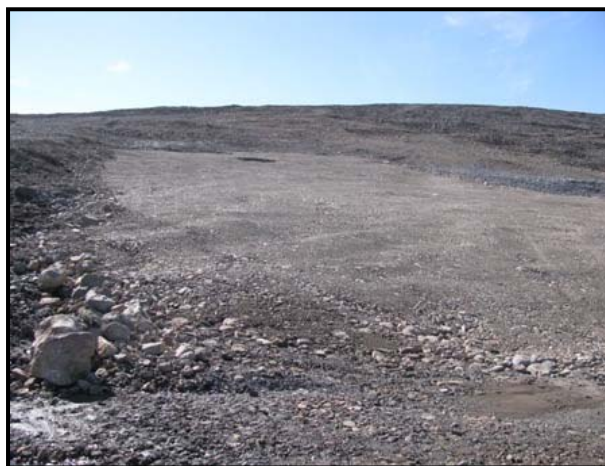
- All portals were sealed as per the reclamation plan documented in BGC (2005), preventing access to the underground mine workings and providing some support for the portal crown pillars.
- All raises were backfilled preventing access to the underground mine workings.

Figure 42 – 17N Portal Post Reclamation (2007)
