**RE: September 18, 2002 Industrial Water Use Inspection - Report**

## INDUSTRIAL WATER USE INSPECTION REPORT

**Licensee:** Nanisivik Mine, CanZinco Ltd.      **Licence No.:** NWB1NAN9702

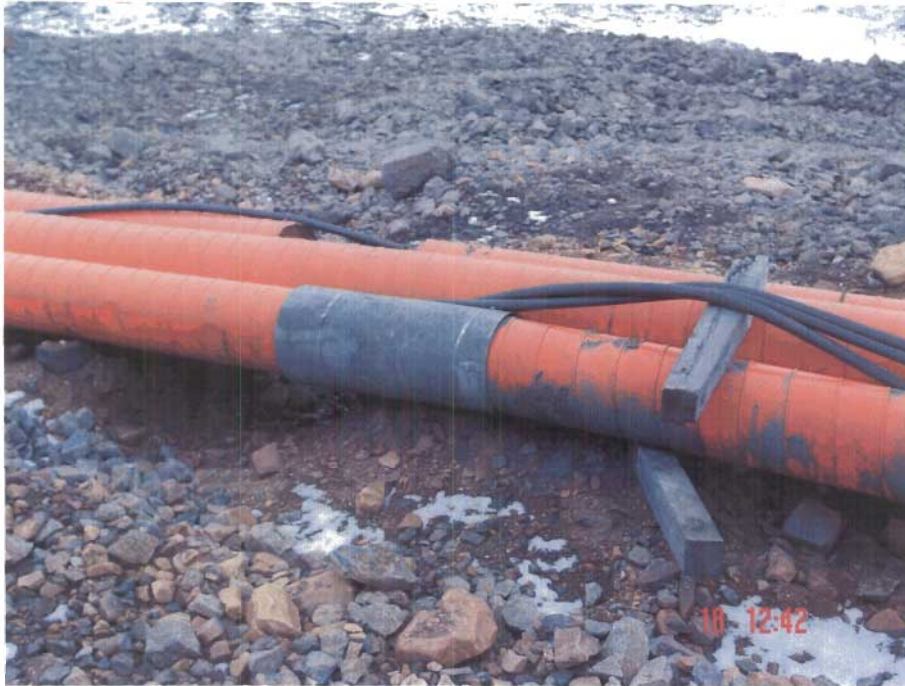
- ☐ **Tailings Line Spills:** As previous Licence inspections have noted, conveyance line clamping flanges have caused a number of spills. In order to address this problem the Licencee advised the WRO on November 16, 2001, that the Licencee had developed a maintenance program in which all of the conveyance line flanges were to be replaced. During the inspection on September 18, 2002 the WRO was informed that only conveyance line flanges that had previously failed have been replaced. The flange replacement preventative maintenance program has yet to be fully implemented. The latest tailings spill caused by a failure occurred on April 10, 2002 (Photo 1). This spill has occurred adjacent to the Duck Pond Tailings Dump. During the inspection of the spill site, Nanisivik mine representative stated that the spilled tailings were removed from the spill site. Visual inspection of the affected area revealed that mine tailings were still present at spill site 02-260 (Photo 2). Further cleanup of the spill site 02-260 will be required before the WRO suggests closure of the file.

Photo #1 Tailings conveyance line flange, cause of spill 02-260.

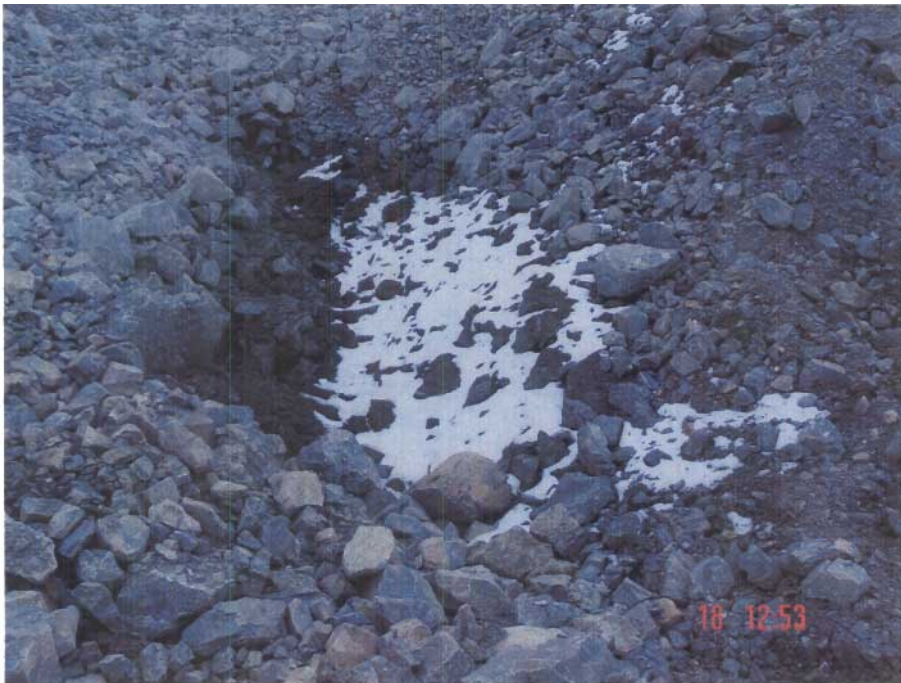
Photo # 2 Mine tailings present at spill site 02-260.

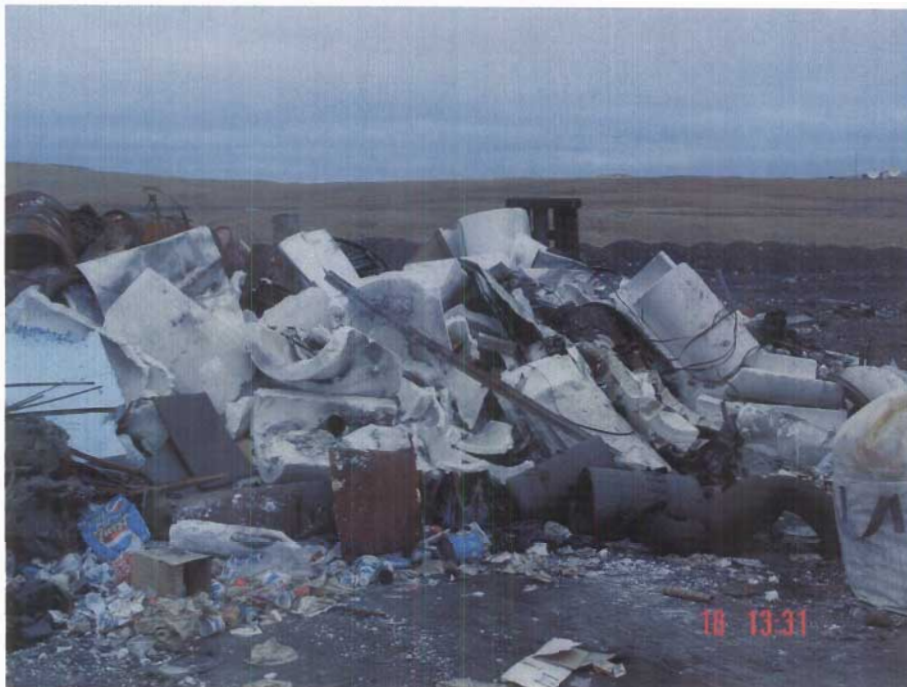
tipping face. A large portion of the dump consists of industrial waste that is periodically buried. During the inspection a large amount of asbestos pipe insulation was observed (Photo 3). This asbestos pipe insulation should be disposed of in accordance with Nunavut Department of Sustainable Development regulations. No seepage was visible emitting from the toe of the dump. The creek below the dump was sampled for dump seepage (Photo 4). Enclosed analysis indicate pH (7.90 vs 6-9.5) is within the Licence discharge criteria however Total Suspended Solids ( 405 mg/L vs 30 mg/L) are not in compliance with *Water Licence Discharge Maximum Allowable Concentrations*.

Photo # 3 Asbestos pipe insulation at Nanisivik dump.

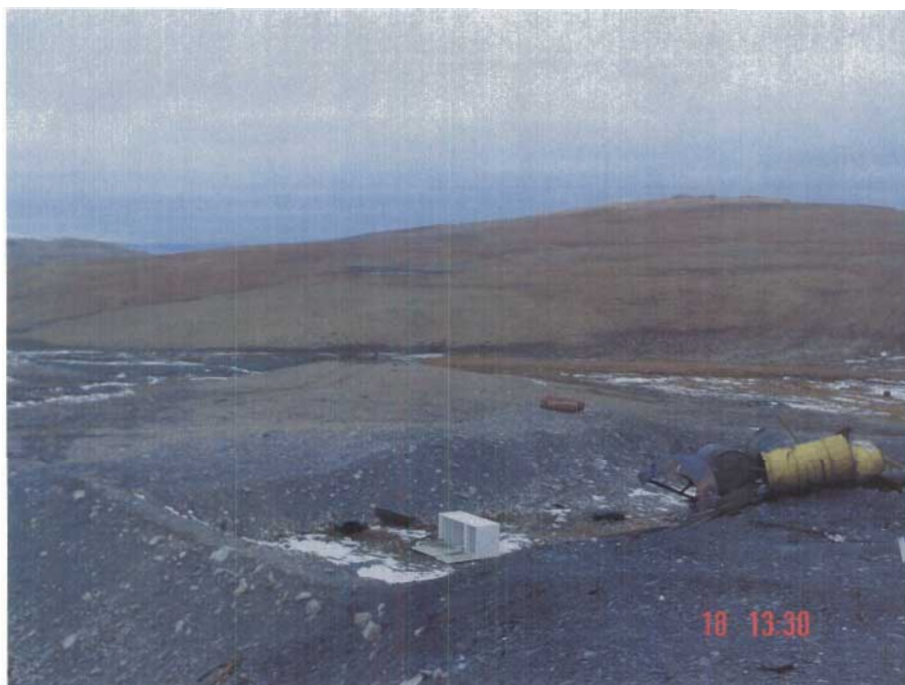
Photo # 4 Sample of dump seepage in creek behind dump, centre left of photo.

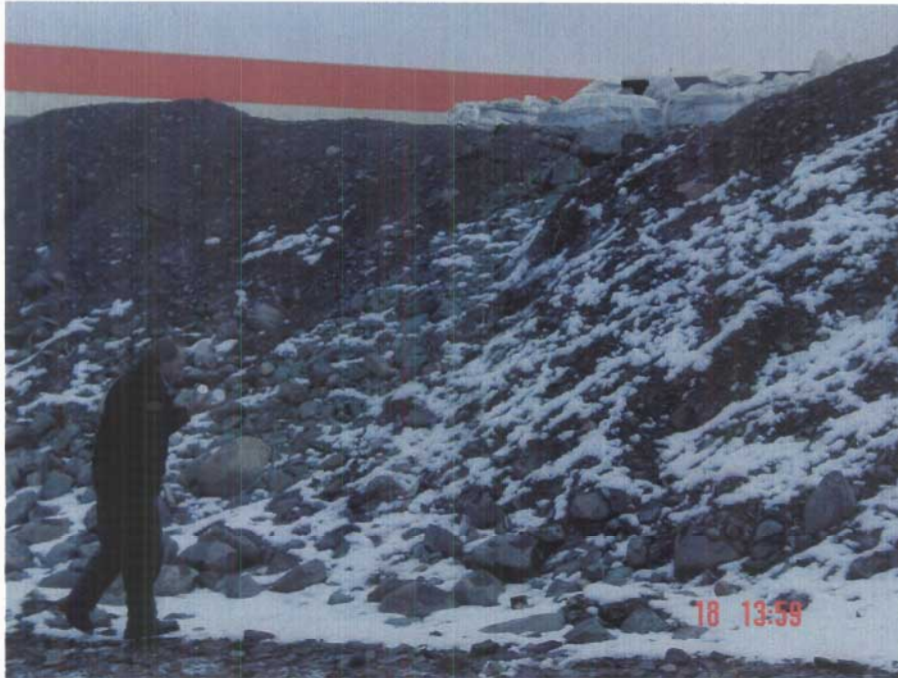
- ☐ **Chemical Storage Area:** Inspection of the lay down (chemical storage) area adjacent to the tank farm revealed a spill of production chemicals. The production chemicals stored at the lay down area are located within 10 meters of the high water mark (Photo 6). Production chemicals namely Copper Sulphate is purchased in 1,000 kilogram totes. Tote bags are damaged in transport or undergo weathering causing contents to leak or spill. The spilled production chemicals are transported by the action of rain and melting snow to the ocean. A flow path of Copper Sulphate was noted emitting from the lay down area to the shore. Copper Sulphate has entered a tidal pool of Strathcona Sound (Photo 5). No spill report had been submitted by Nanisivik in respect to the spill of Copper Sulphate. Enclosed analysis indicate that Total Suspended Solids (<3 mg/L vs 30 mg/L) is in compliance with the *Water Licence Discharge Criteria*. Further analysis have yet to be received by WRO, these chemical analysis results will be forwarded once received.

Photo # 5 Totes of Copper Sulphate at lay down area. Centre of photo, spill path of chemical down slope to shore.

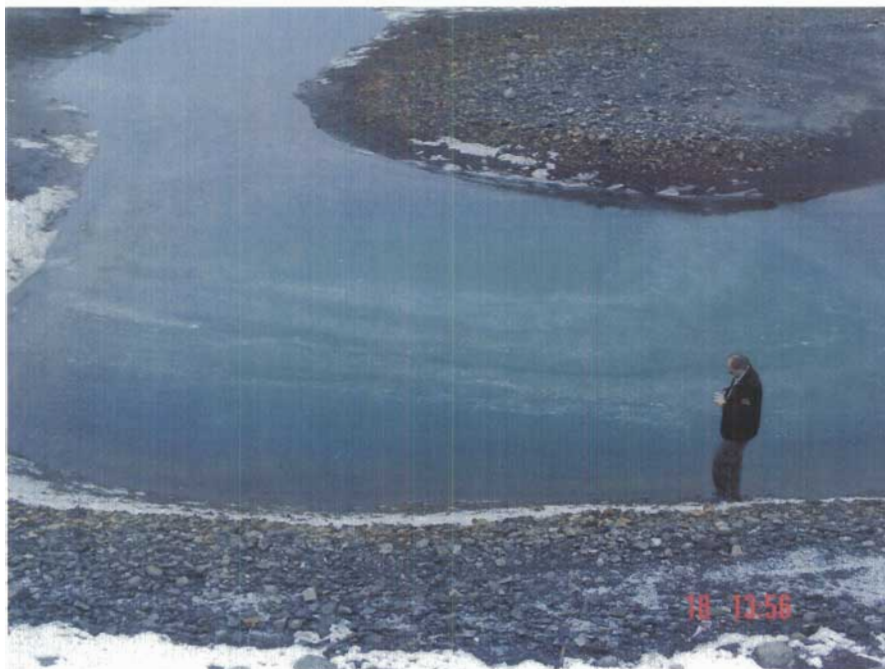
Photo # 6 Copper Sulphate in tidal pool of Strathcona Sound.

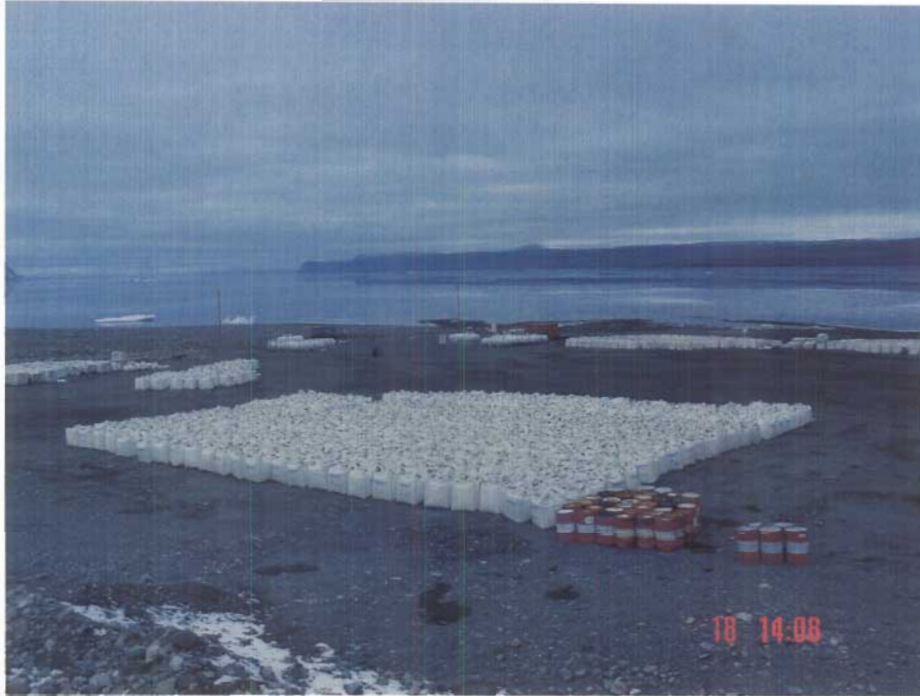
Photo # 7 Lay down (chemical storage) area.

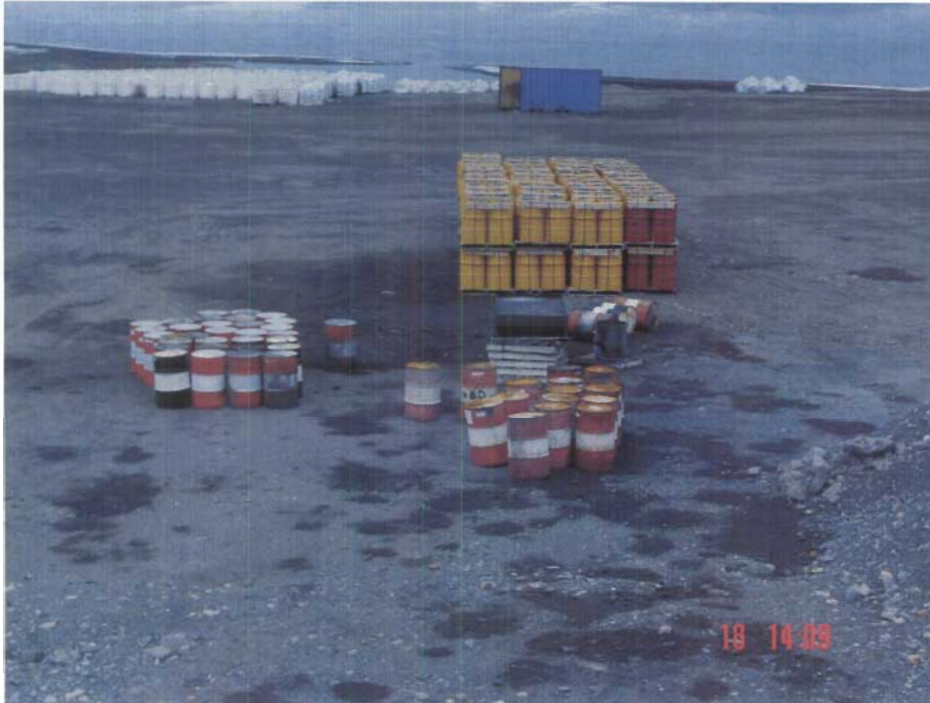
- ☐ **Tank Farm:** The tank farm retention berm is in good shape with most of the berm liner being covered with aggregate material. No accumulation of water or spilled fuel within the retention berm was observed. Considerable staining of waste oil or fuel oil was noted in the waste oil storage consolidation area (Photo 8). A open tray with waste oil was noted in the oil consolidation area, this oil tray should be emptied and covered to reduce the potential of oil spills associated with waste oil consolidation. No oil spill or remediation equipment could be located in the waste oil storage area. A fuel oil spill was observed under the pump house adjacent to the tank farm (Photo 11). Four drums were located beneath the pump house to capture spilled or leaking fuel oil. The use of drums to capture leaking fuel oil was a standard operating procedure. When inspected all of the four drums were at or near capacity. The WRO attempted to gain access to the pump house to locate the origin of the spill but the Nanisivik representative stated they did not have keys required to gain access to the building. Nanisivik representatives were told to address the fuel oil spill by the WRO's.

Photo # 8 Ground contaminated with waste oil at waste oil storage and consolidation area. Open oil tray in centre of photo.

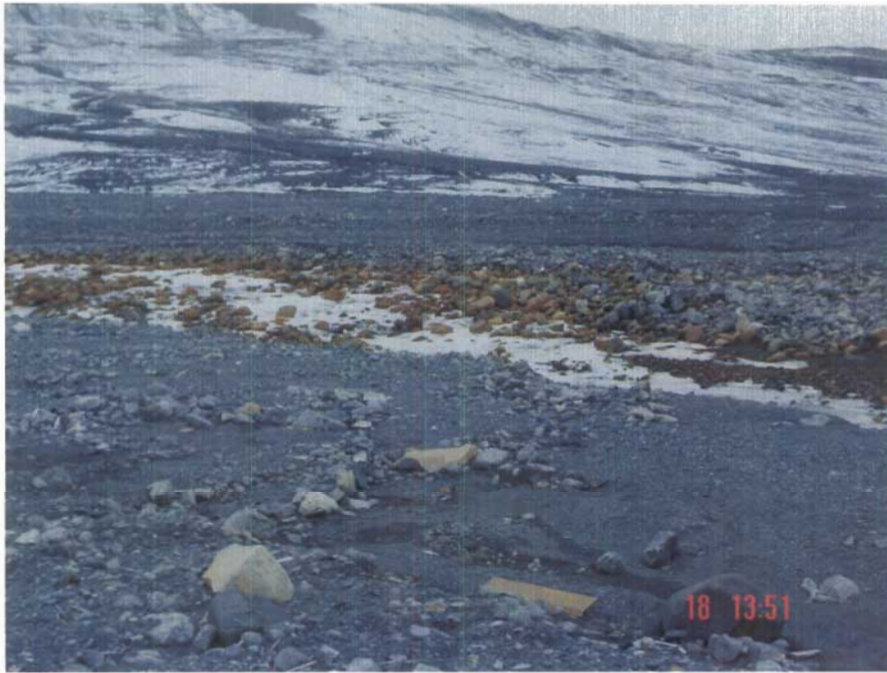
Photo # 9 Twin Lake Creek by chem storage area.

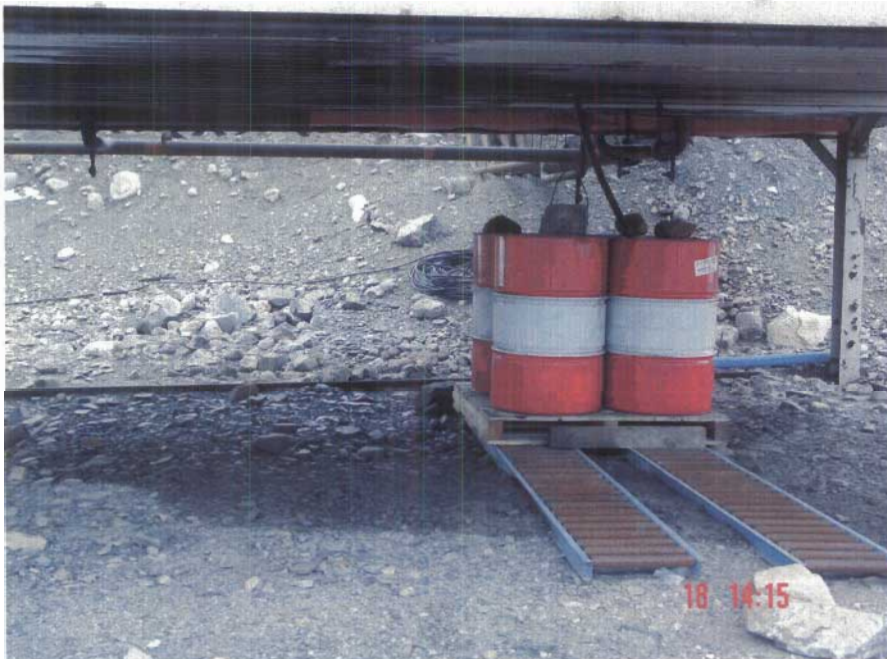
Photo # 10 Tank farm pump house spill. Note hose draining floor to drums below.

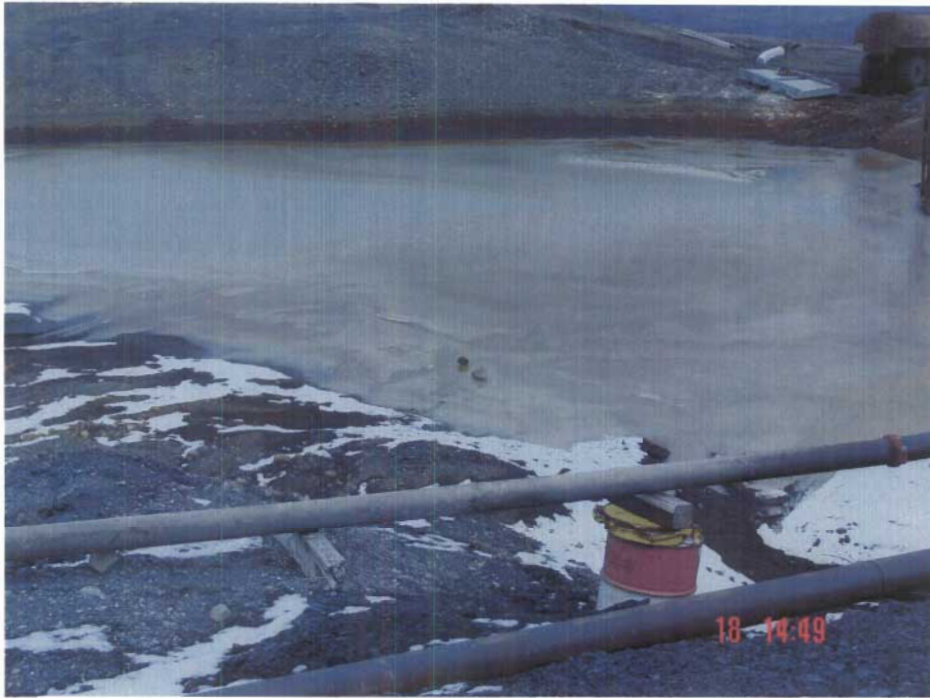
Photo # 11 East Adit Treatment Facility treatment pond.

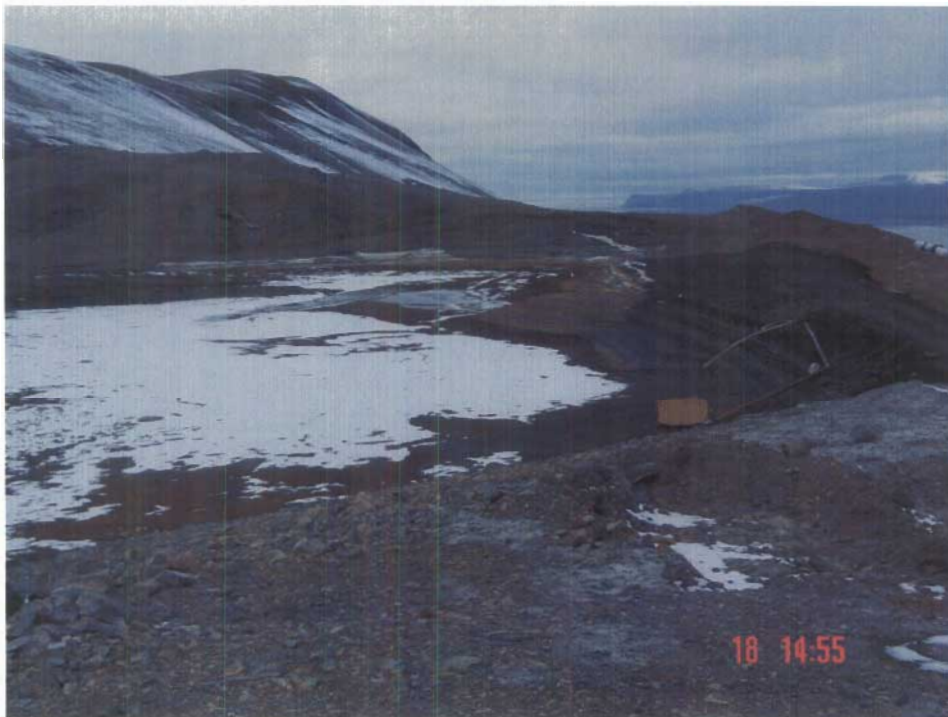
Photo # 12 East Adit Treatment Facility stabilization pond.

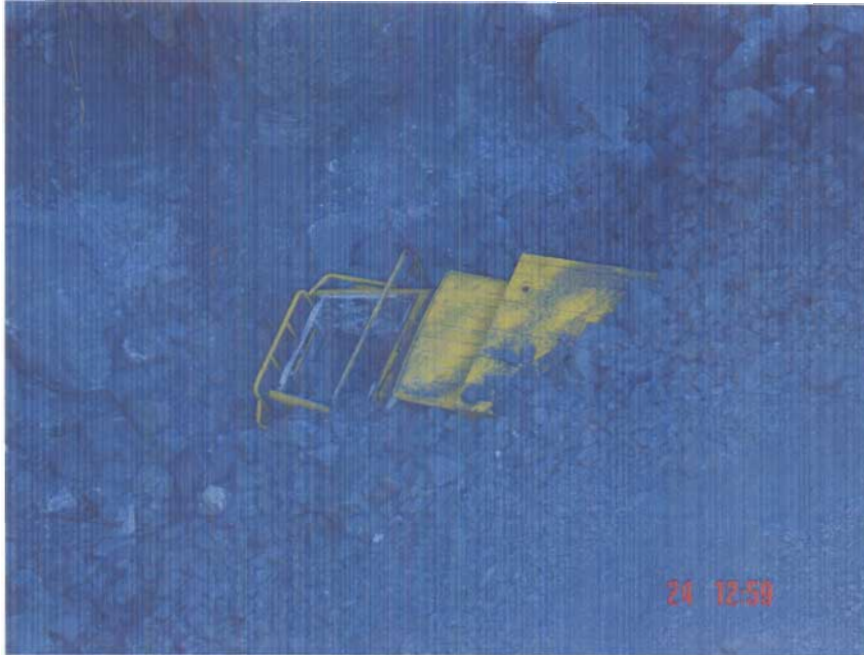
Photo # 13 East open pit, photo taken July 24, 2002.

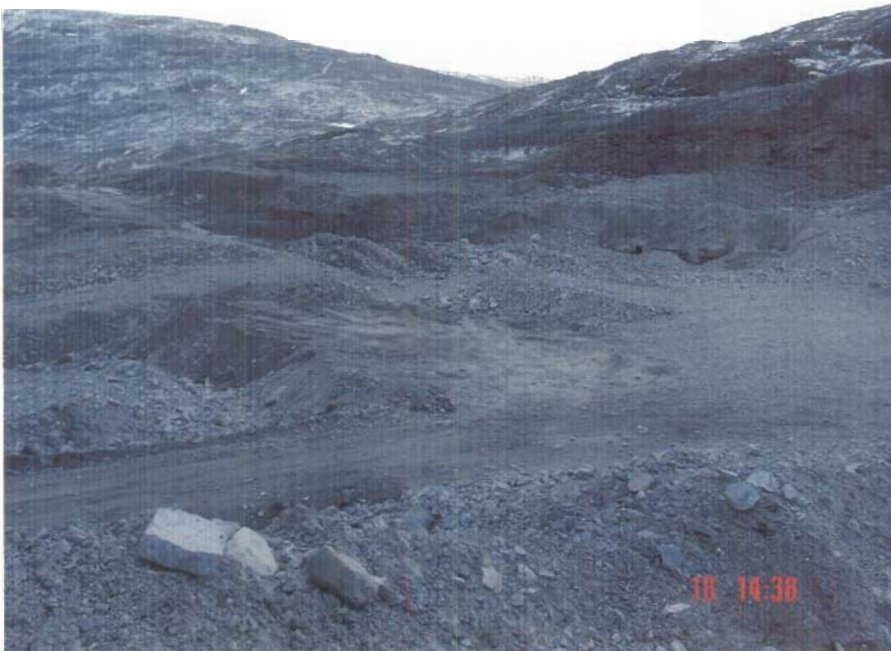
Photo # 14 East open pit, photo taken September 18, 2002.

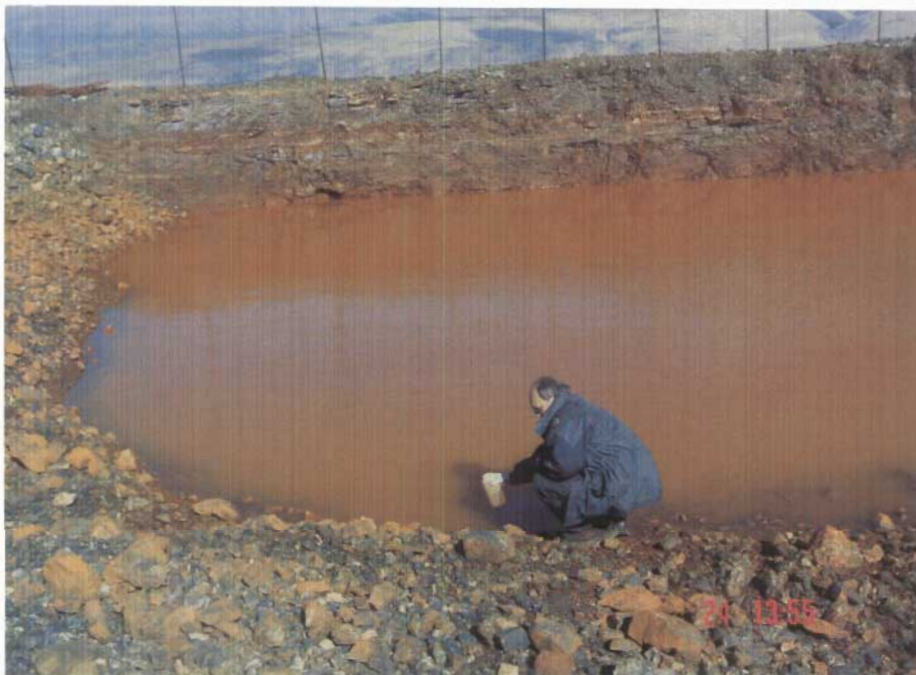
Photo # 15 Ocean View Open Pit, photo taken July 24, 2002.

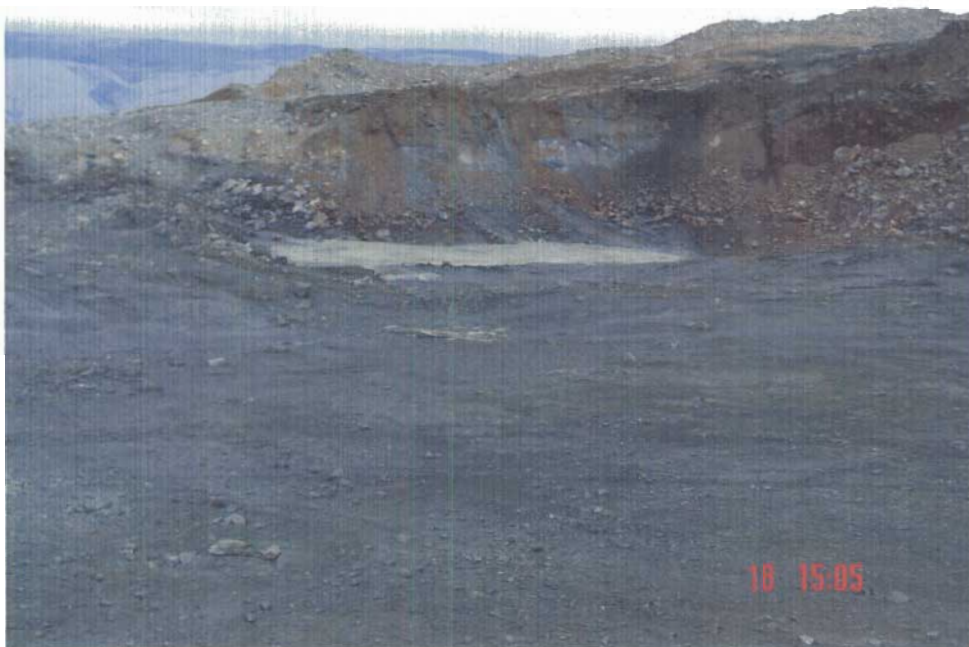
Photo # 16 Ocean View Open Pit, photo taken September 18, 2002.

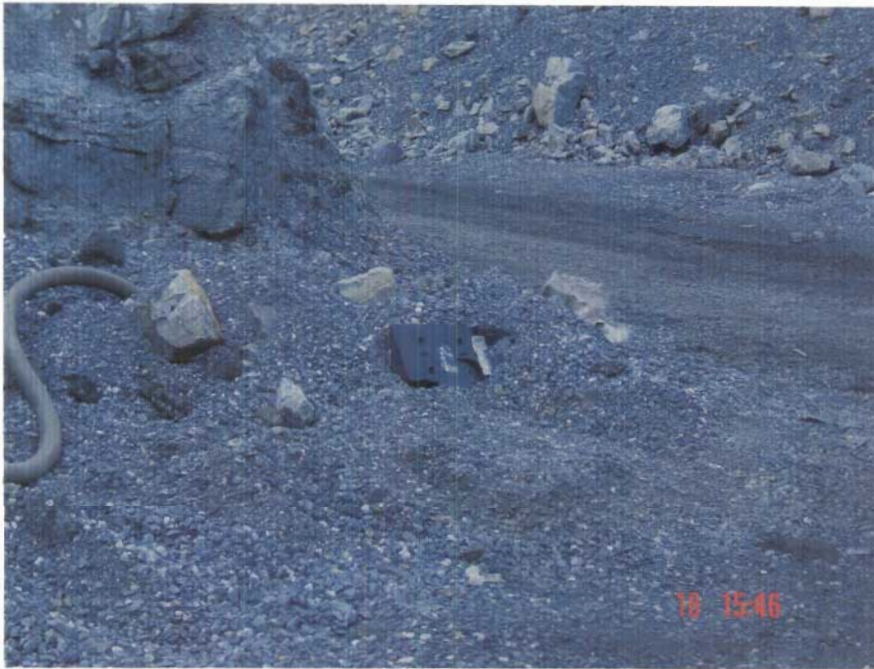
- ☐ **West Open Pit:** The water level in WOP was fairly low. A variety of waste were located in West Open pit, these waste include mine tailings, and waste batteries. (Photo 17 & 18). Enclosed analysis of samples indicate that Total Suspended Solids (221 mg/L vs 30 mg/L) pH (7.37 vs 6-9.5) are not in compliance with *Water Licence Discharge Maximum Allowable Concentrations*.

Photo # 17 West Open Pit, waste battery in Centre of photo.

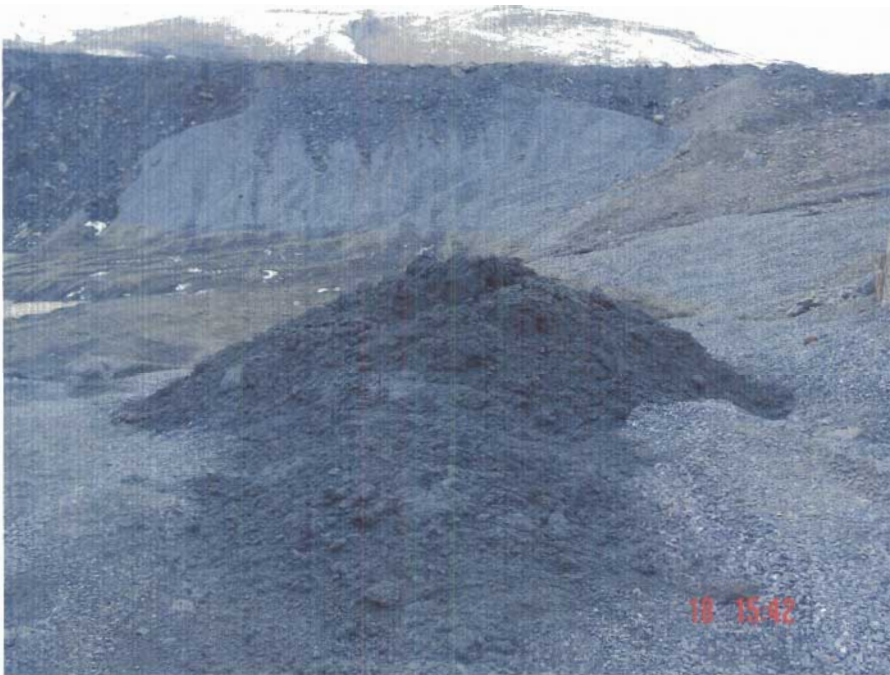
Photo # 18 West Open Pit, mine tailings observed in photo Centre.

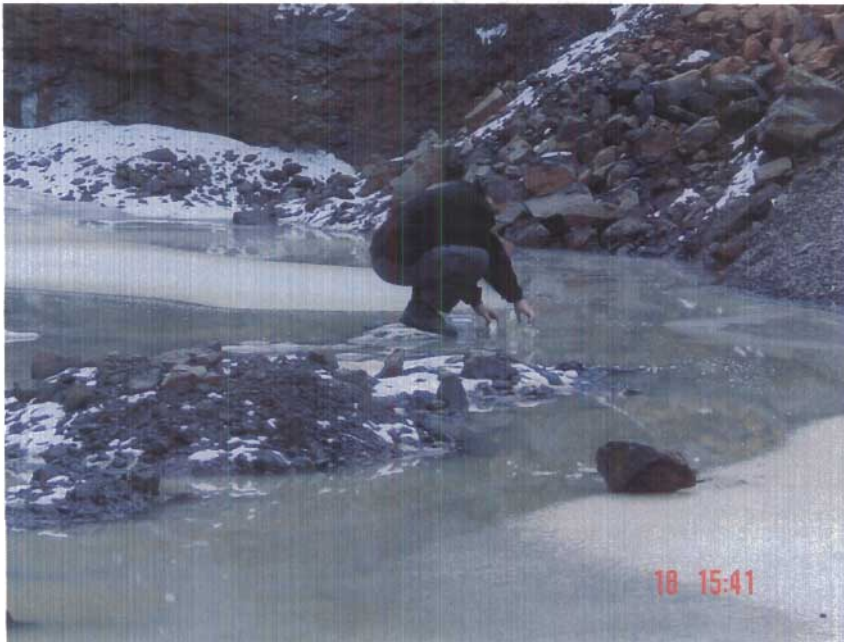
Photo # 19 Location of water sample in West Open Pit.
