Re: 1AR-NAN0208, Nanisivik Mine – INAC Site Inspection, July 2008

November 4, 2008
Project No.: 0255-017-04

RE: RESPONSE TO REVIEW COMMENTS IN INAC AUGUST 1, 2008 LETTER

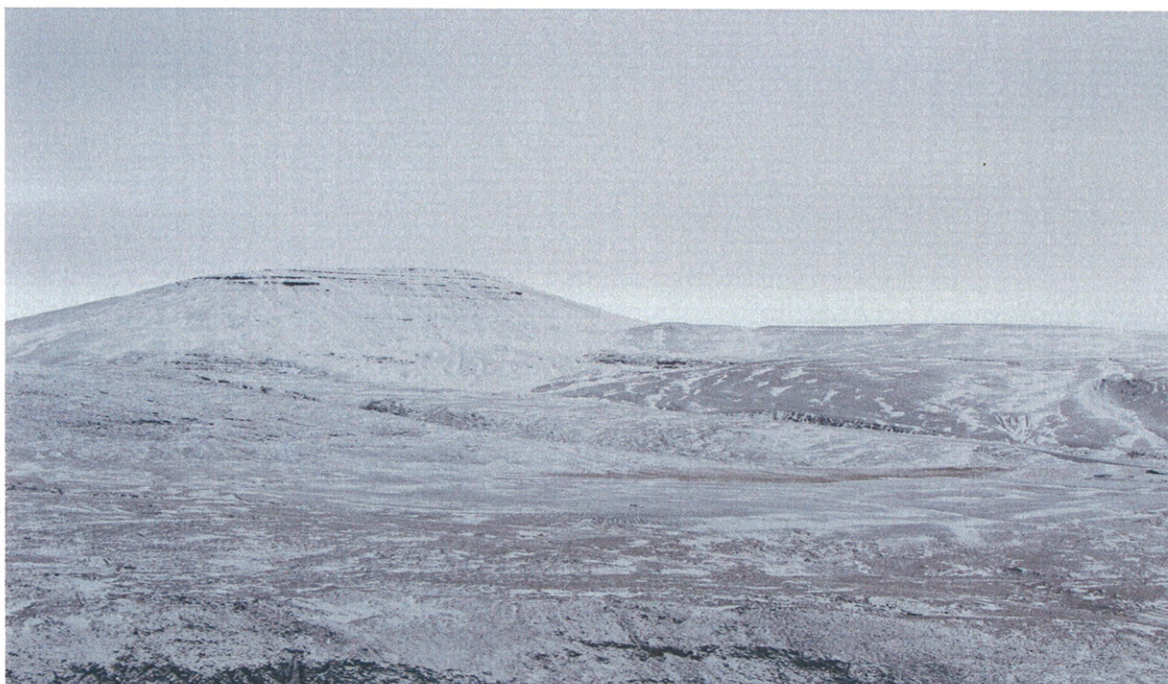
This outlines the major works which commenced in 2003 and were finalized in September of this year. In general terms, the town and mine site and all associated surface infrastructure (both Nanisivik Mine and Government of Nunavut owned) has been removed or remediated. A “footprint” remains, as it does at every site that man has touched, but the physical presence has been erased.

Former Townsite area.
