WATER LICENCE INSPECTION FORM

Licensee			Licensee Representative		
Johan Skoglund Group Environmental Manager, Americas Nyrstar 2840 – 650 West Georgia Street P.O. Box #11552 Vancouver, BC V6B 4N8 1AR-NAN0914			Arlene Laudrum, Stu McPhee (SRK Consulting)		
Licence No. / Expiry			Representative's Title		
1AR-NAN0914 March 31 st , 2014 (Expired)			Senior Consultant, and Staff Consultant respectively		
Land / Other Authorizations			Land / Other Authorizations		
Date of Inspection			Inspector		
13/07/14			A. Keim		
Activities Inspected					
<input type="checkbox"/> Camp		<input type="checkbox"/> Drilling		<input type="checkbox"/> Mining	
<input type="checkbox"/> Roads/Hauling		<input type="checkbox"/> Other: Water Discharge		<input type="checkbox"/> Construction	
				<input checked="" type="checkbox"/> Reclamation	
				<input type="checkbox"/> Fuel Storage	
				<input checked="" type="checkbox"/> Other: Fuel tank farm remediation

On July 13th, 2014 a Water License Inspection was completed at the Nanisivik Mine site. On site at the time of the Inspection were 2 representatives of SRK consulting and 2 Arctic Bay residents. All were actively working on the PH impacted soils at the site

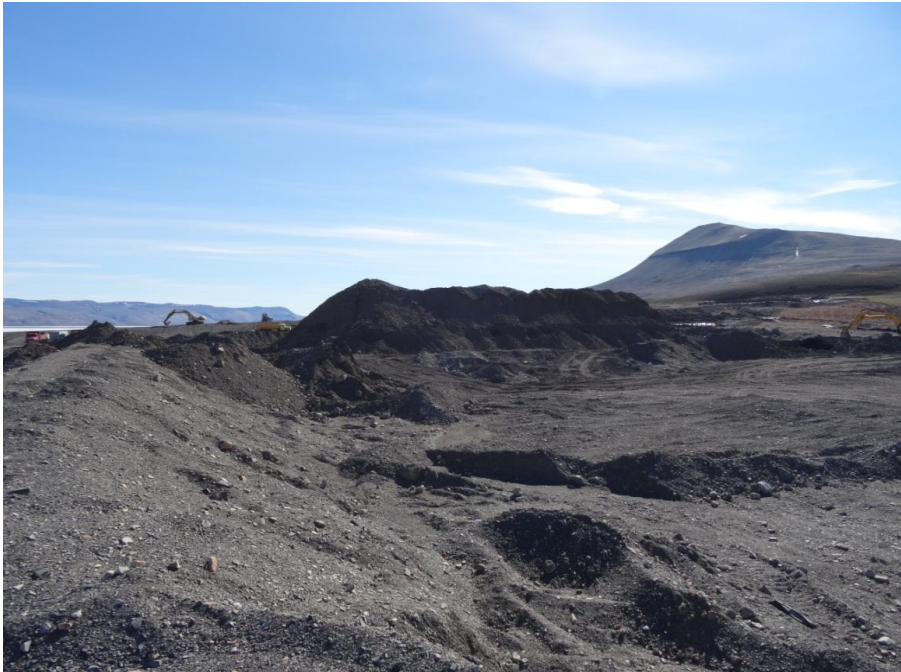
During the period of Inspection work was found to be continuing on the PHC soils at the shoreline tank farm. Estimates on the volume of contaminated/ impacted soils to be treated have reached up to approximately 20,000 M³. It was impossible to estimate what volume remained within the original footprint of the facility however it remains a substantial pile as documented and photographed during the Inspection.

Figure 2 Looking east toward unprocessed pile

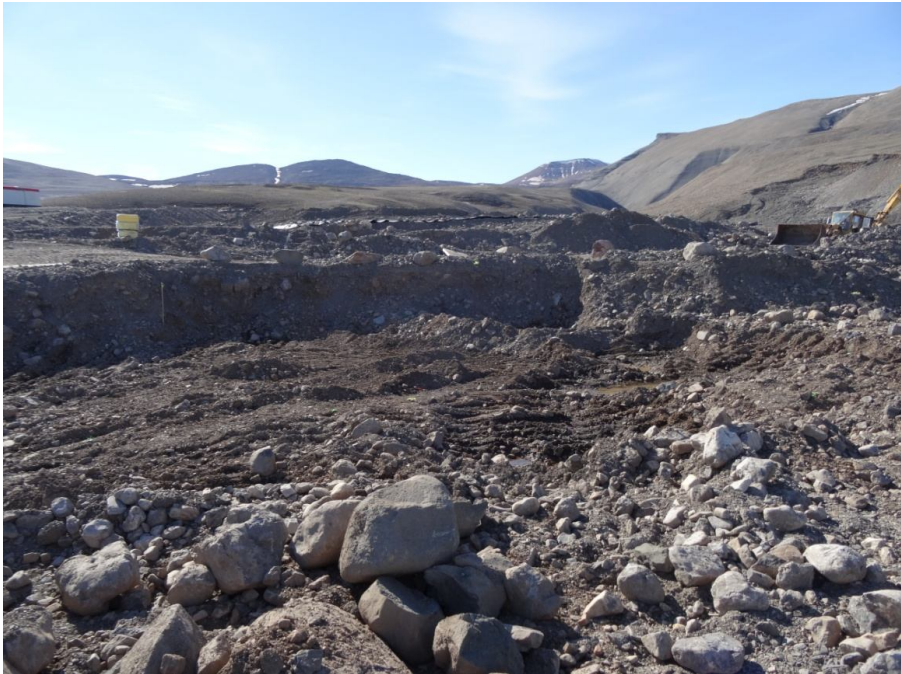
Areas of Higher PH contamination have been identified throughout the facility and are being excavated. These soils may take an additional season to remediate which may extend the duration of the project past the expected 2016 time frame currently planned. However, it was also identified that the contractor is currently working on and is expected to propose new site specific guidelines to the remediation criteria that would allow the site to progress in it’s work within the time frame currently in place.

Figure 3 Excavation into berm wall

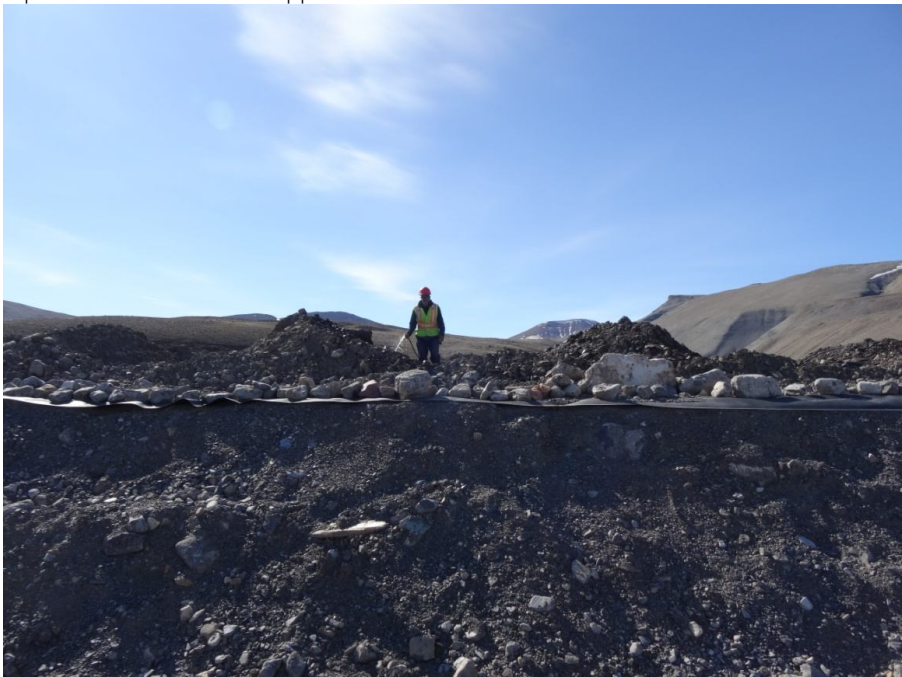
During the period of Inspection no water from a licensed source was being utilized on site. It was noted that water from Arctic Bay was being used on site to maintain moisture levels within the upper cells as well as at the “garden plot”. A question regarding the use of other sources of water for the on-going soil reclamation activities was posed by the contractor on site. A review of the license identifies the sources as listed and the use of any others would require the approval of the board.

Figure 4 Adding water to upper land farm cells

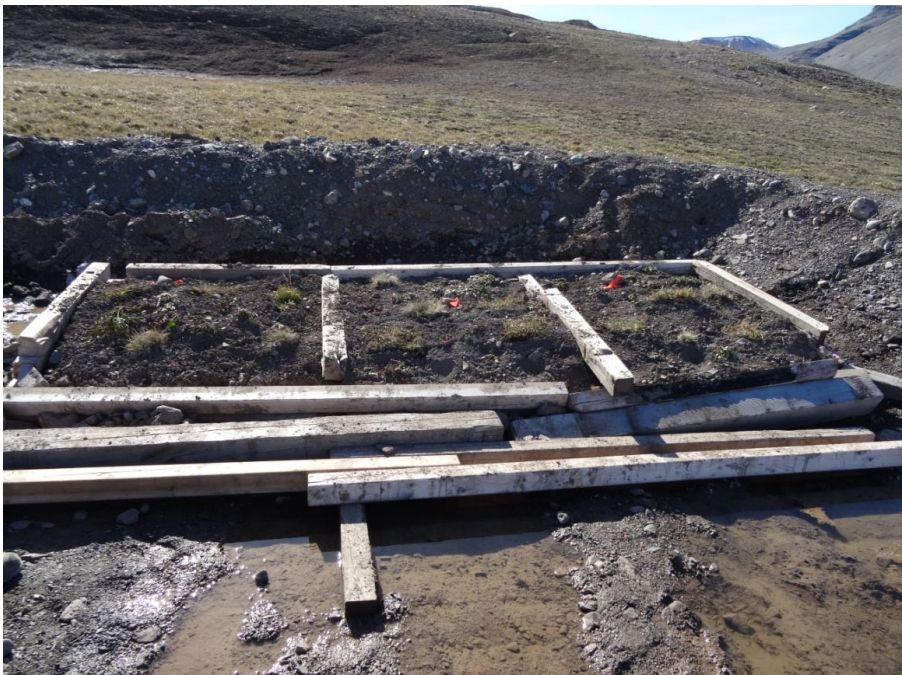
Figure 5 test garden

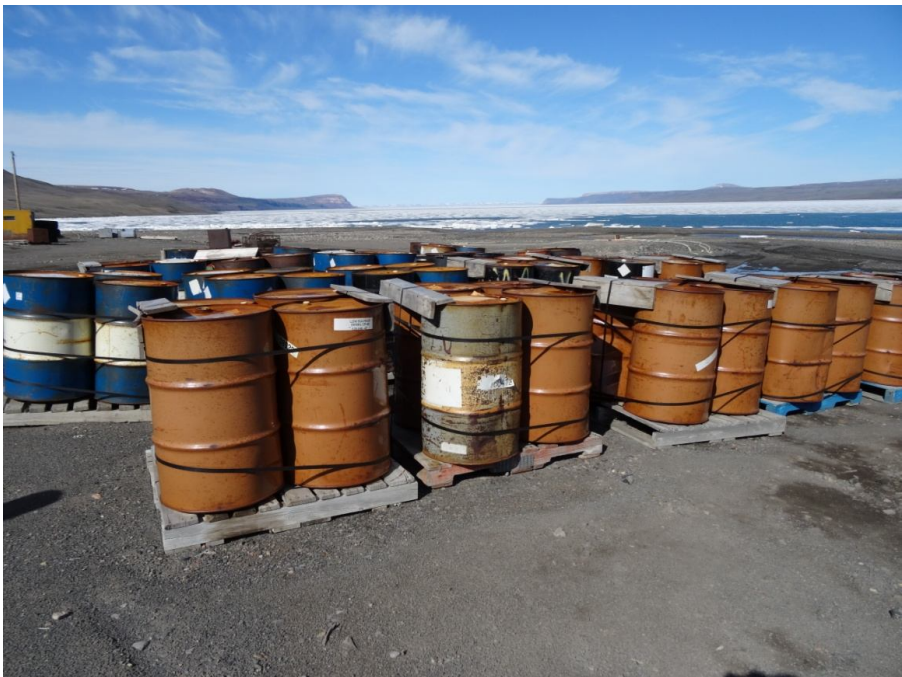
In one area of the lay down adjacent to the deep water port a number of barrels were identified. These barrels were found strapped to pallets and looked to have been there for a number of seasons. The contractor advised the inspector that Coast Guard had left these barrels at the dock site a number of years previously and were in fact the property of Environment Canada from Eureka. It is not clear what they contain but these should be removed from the site as soon as possible.

Figure 6 Barrels found on Dock side

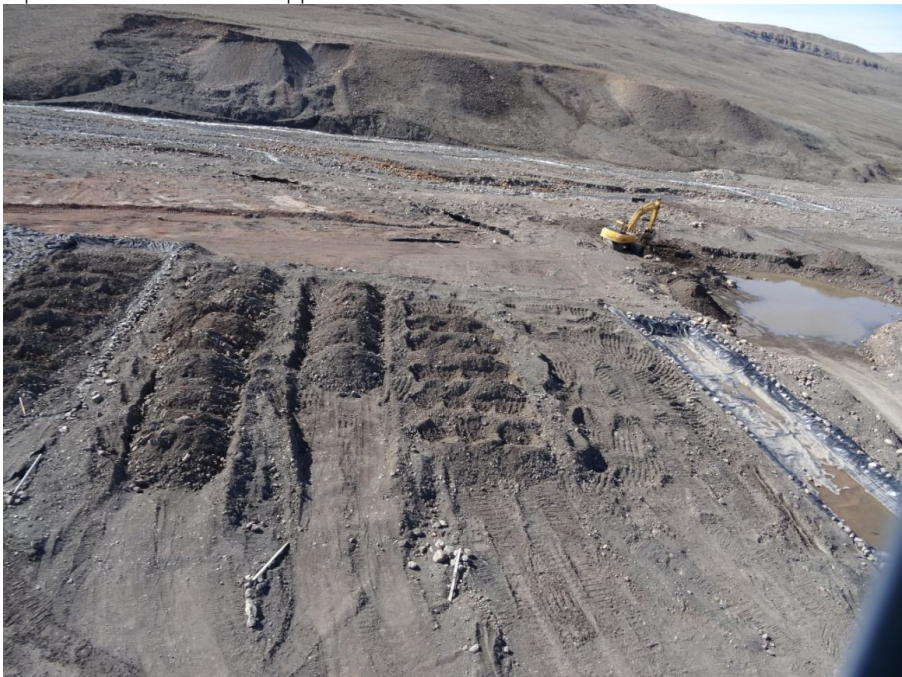
Treatment continues on site with the upper, lower cells as well as soils placed on the concrete pad cleared by DND (was the ore concentrate shed floor).

Figure 7 over view of lower cells

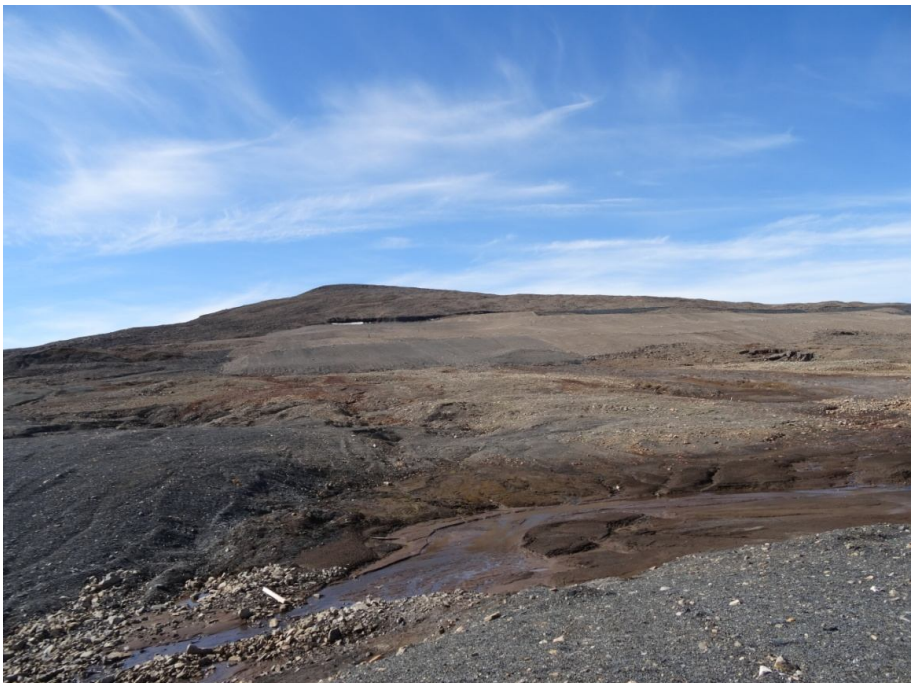
Figure 8 Breached Dam at East Adit 159-1

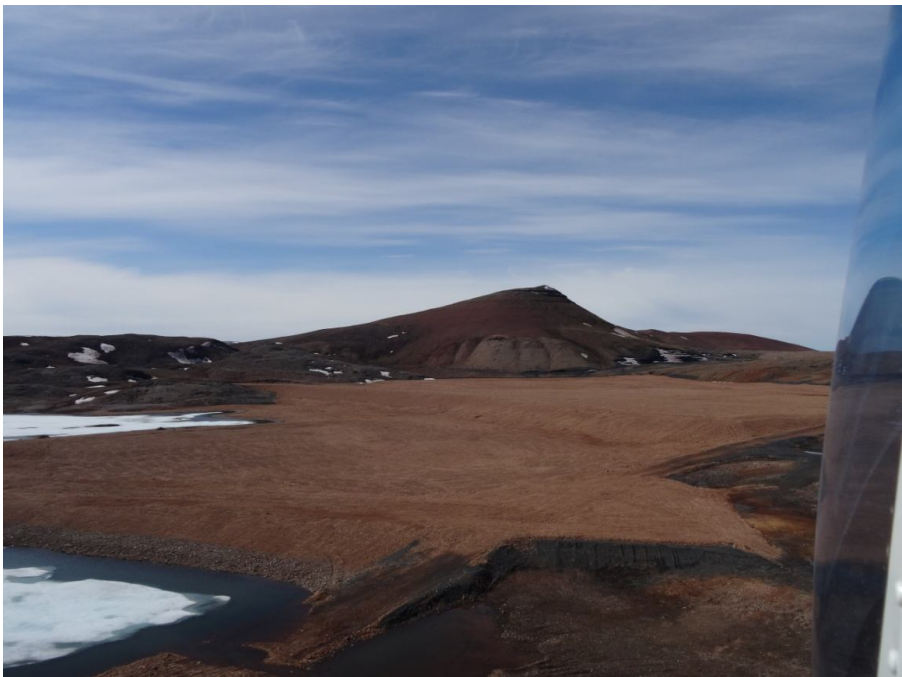
Figure 9 Tailings pond location and cover

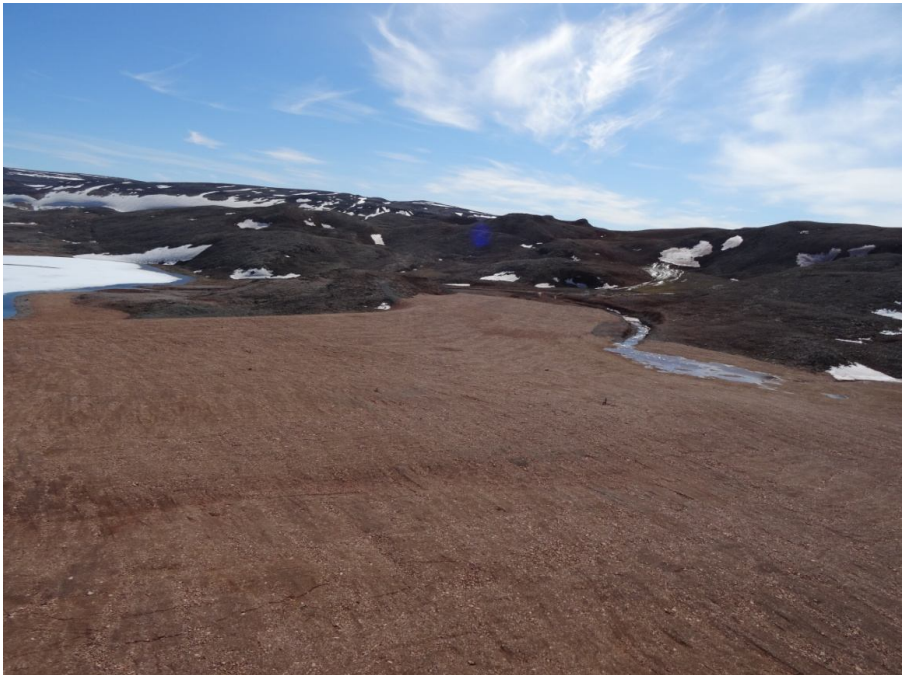
Figure 10 Tailings pond and spillway

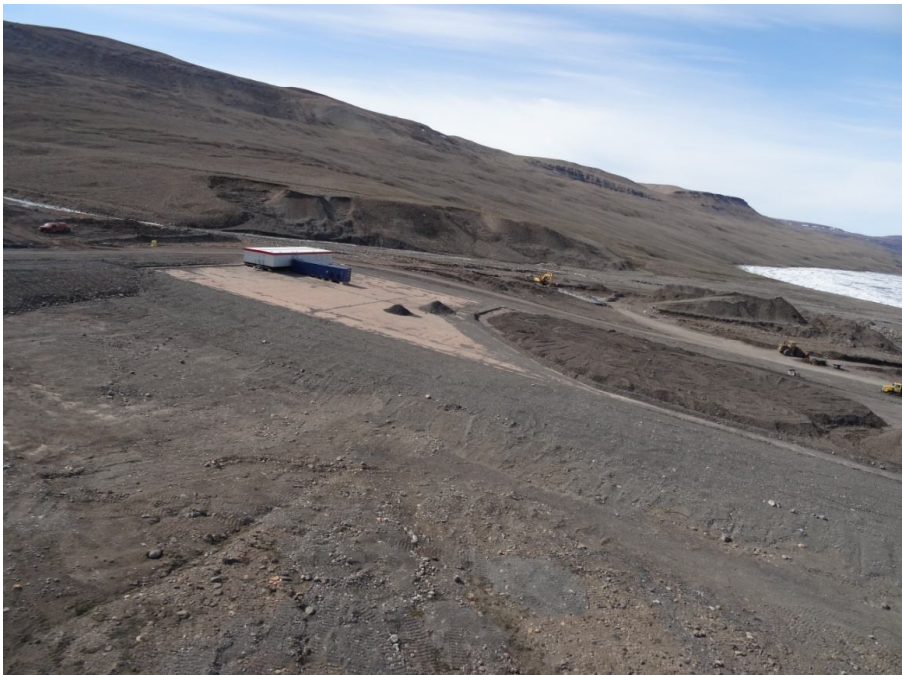
Figure 11 Pad where soils have been deposited for treatment
