## **NANISIVIK MINE, A DIVISION OF CANZINCO LTD.**

### **2009 ANNUAL GEOTECHNICAL INSPECTION**

### **NANISIVIK MINE, NUNAVUT**

PROJECT NO.: 0255-019-03  
DATE: MARCH 26, 2010

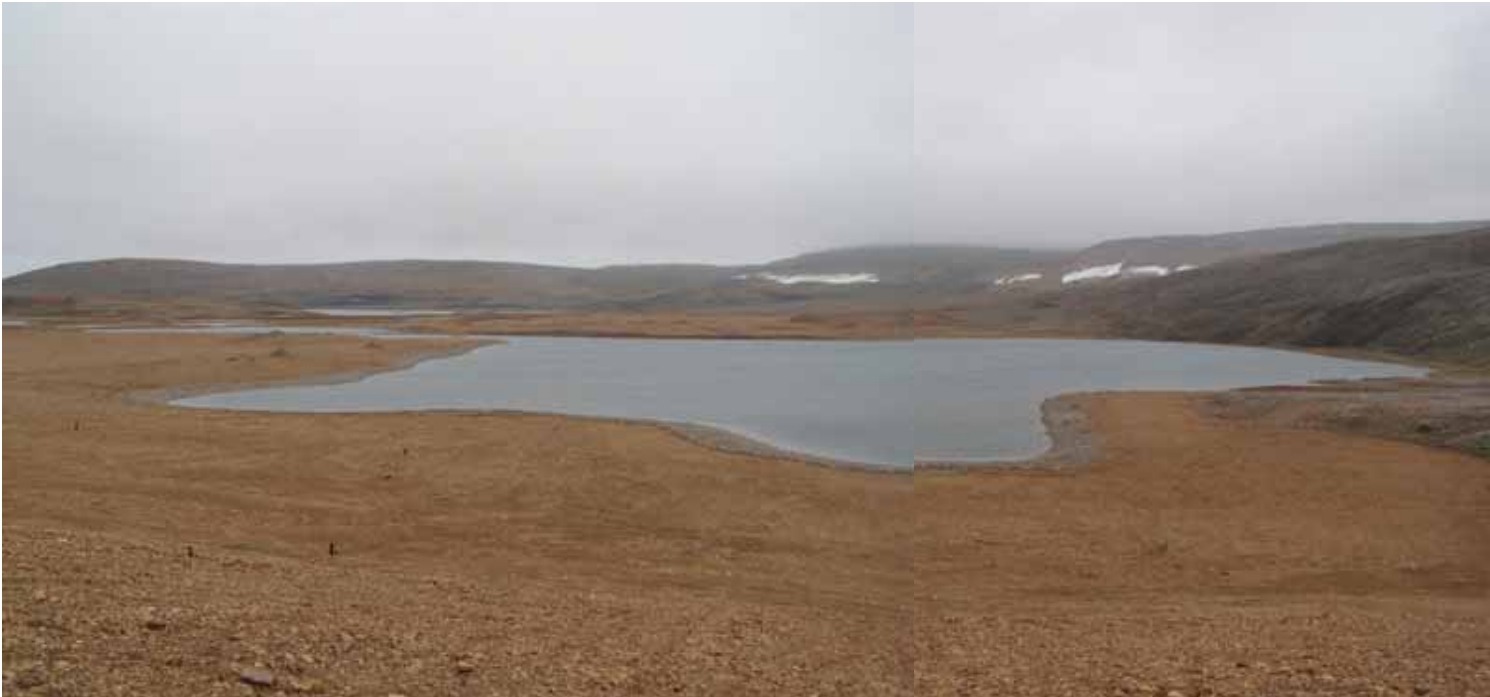
Photo 27 Riprap along shoreline of tailings cover at the toe of the West Twin Dike.

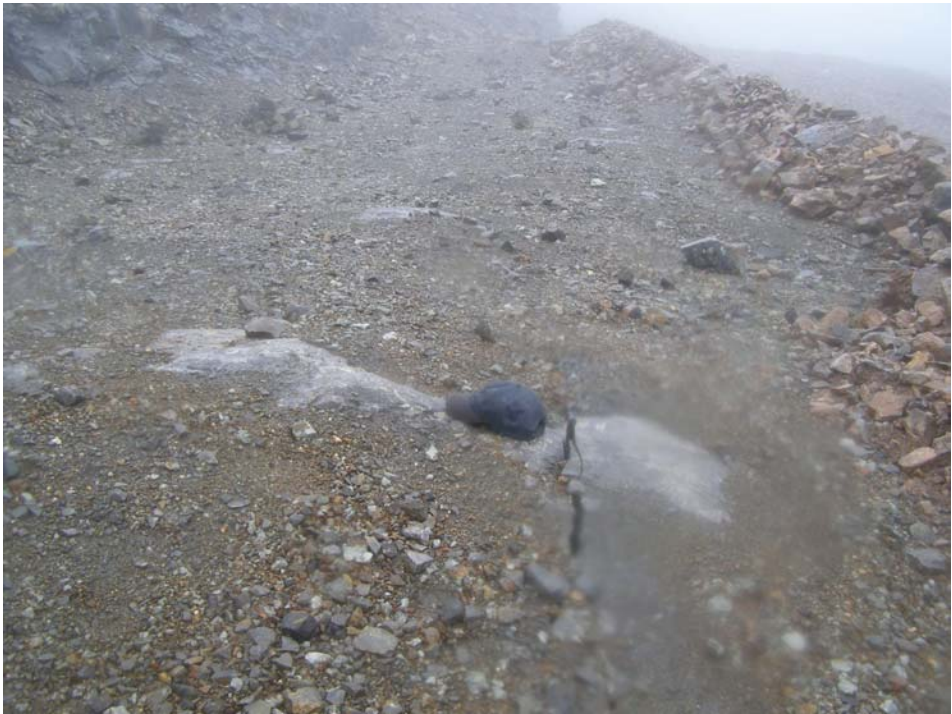
Photo 32 Crack in the West Open Pit crown pillar. Similar condition to what was observed in 2008.

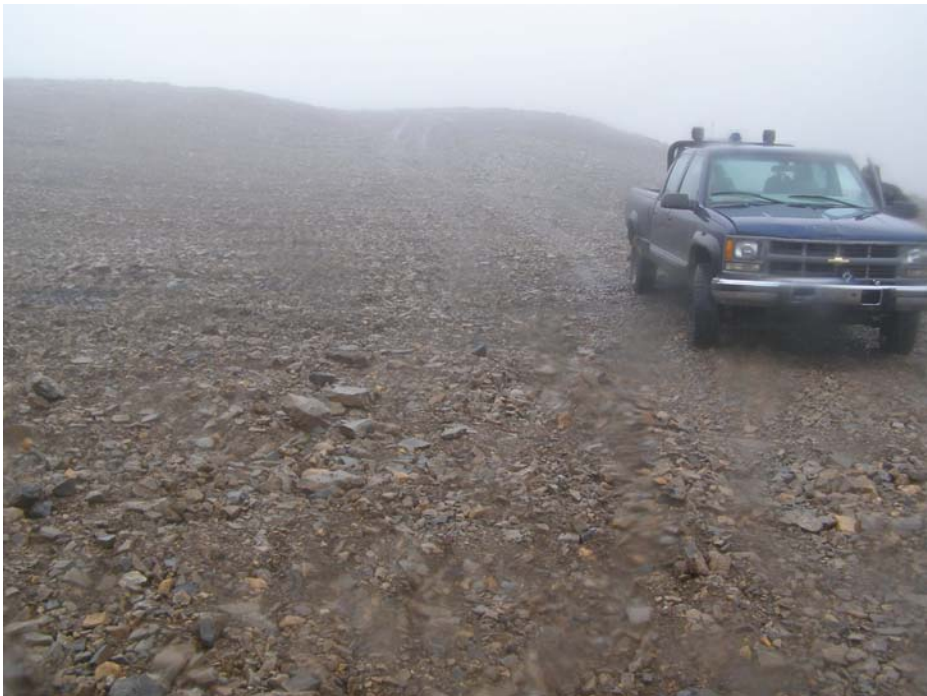
Photo 33 Surface of West Open Pit cover, roadway is armoured as requested in 2008.

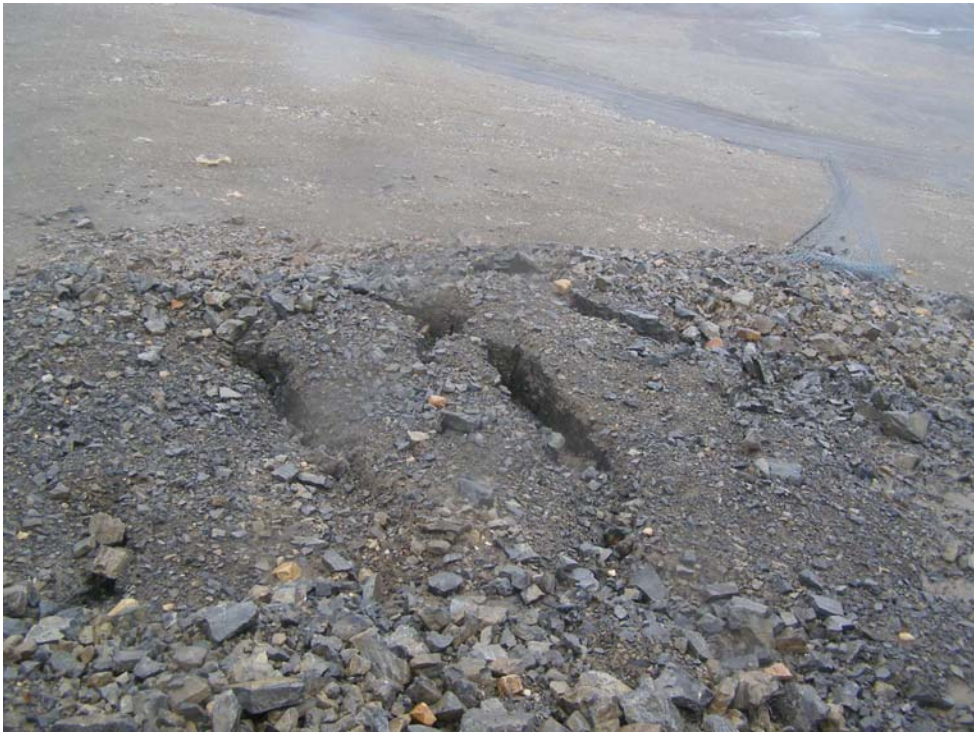
Photo 37 Crack in the crown pillar at the East Open Pit. No changes noted since 2008.

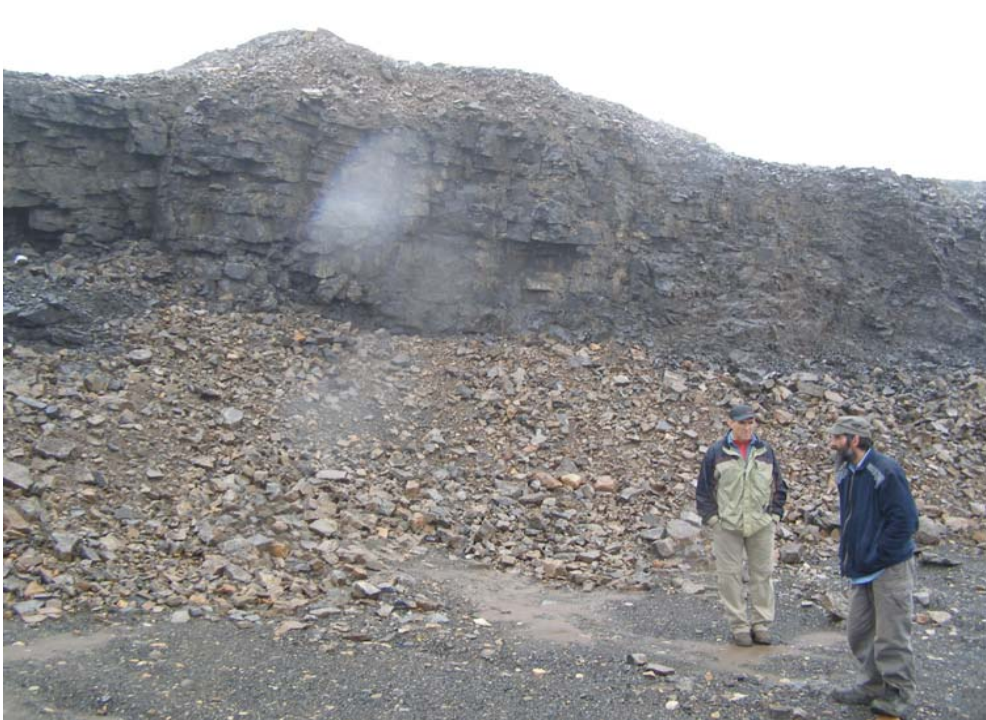
Photo 36 Base of the remnant East Open Pit highwall, some loose rock was noted.

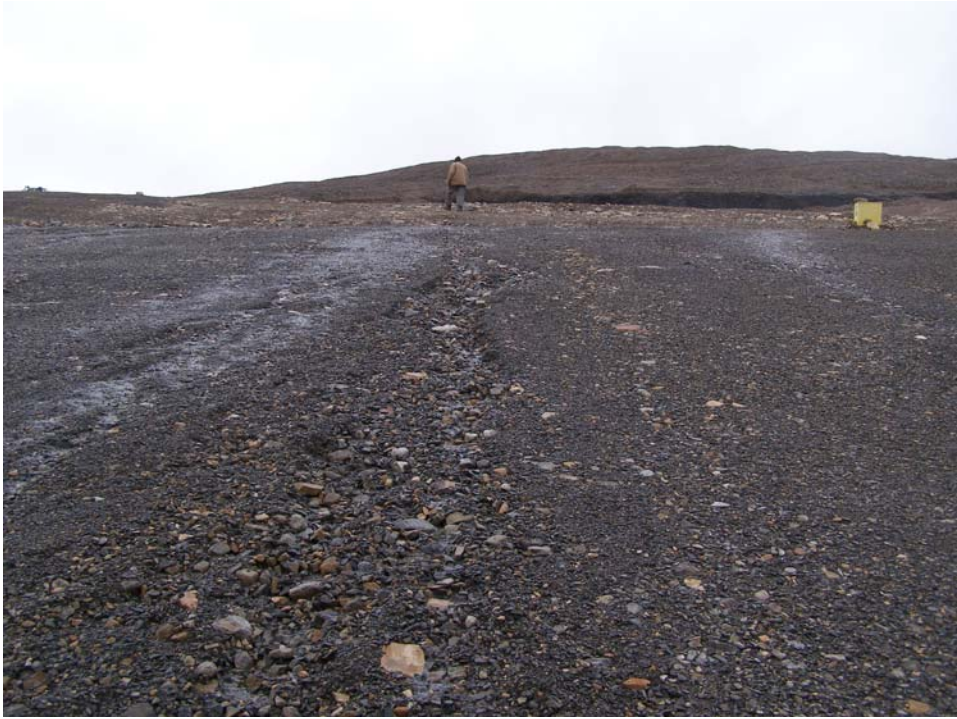
Photo 38 Minor surficial erosion observed on surface of East Open Pit cover.

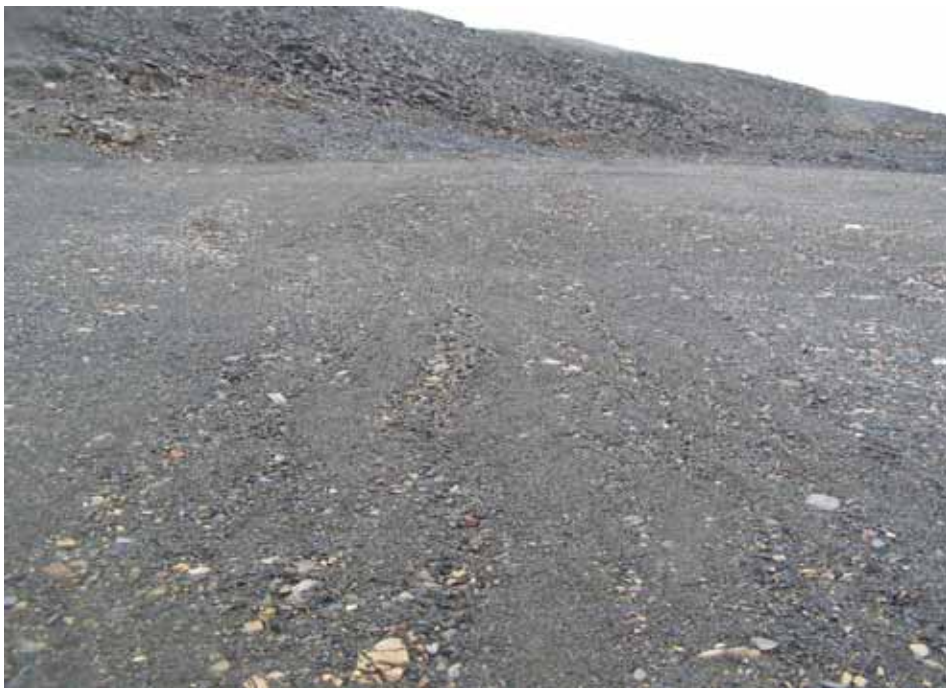
Photo 40 Very minor rill erosion attributed to constant seepage on surface of East Trench cover. Similar to what was observed in 2008.

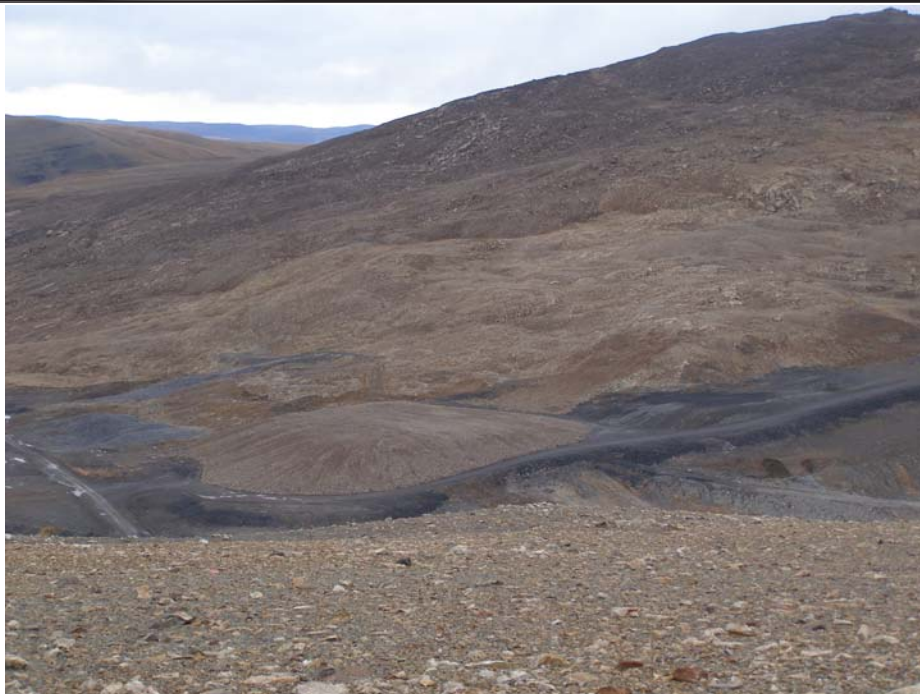
Photo 47 Industrial Complex cover as seen from Stol Port. Note that this cover was completed over metals contaminated soil and the original foundation during the summer of 2008.

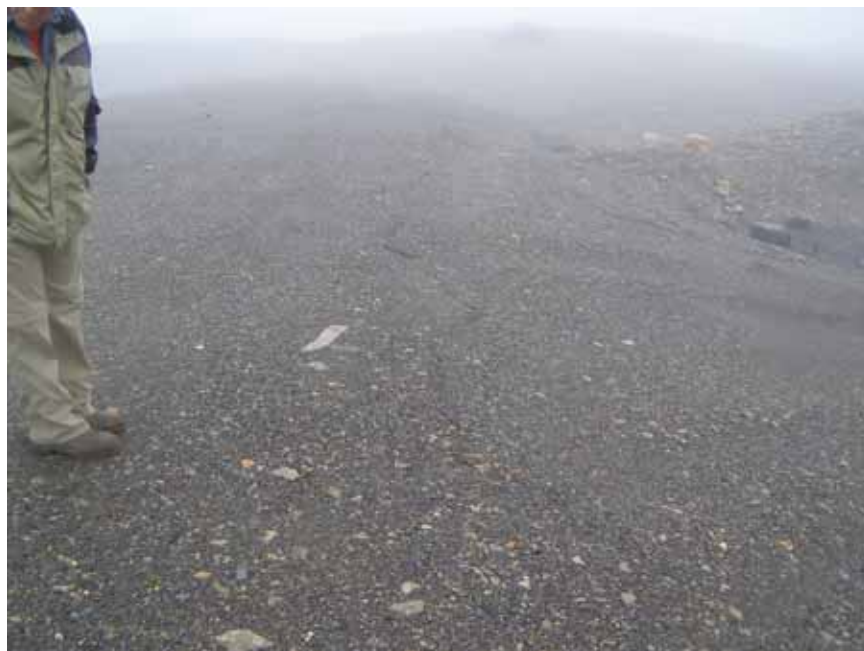
Photo 52 Oceanview Portal cover as seen from the upslope edge of the cover. Note minor cracking along the right (east) edge of the cover. No changes noted since 2008.

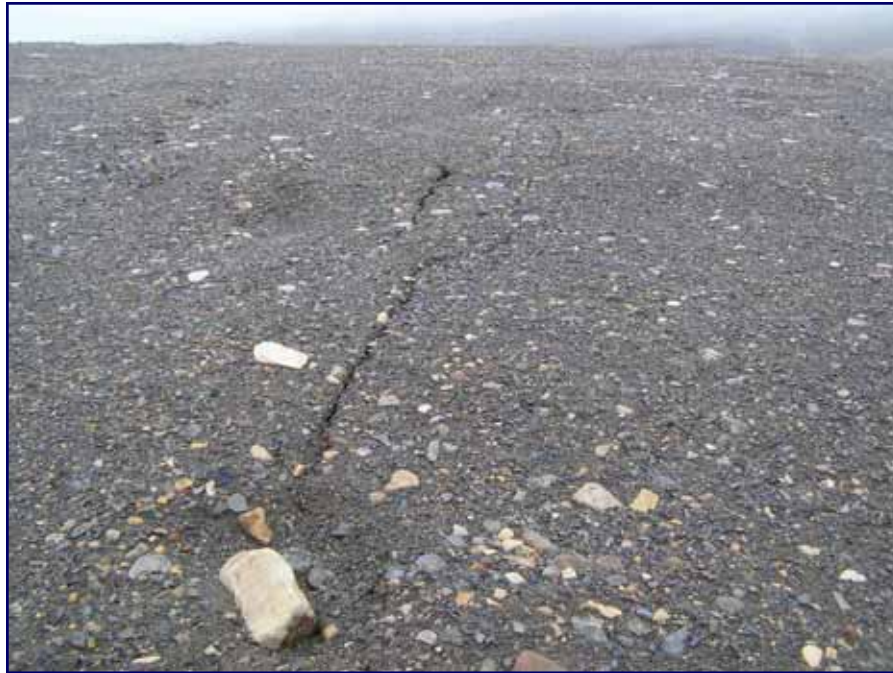
Photo 53 Surface of inclined face of K-Baseline Portal Cover. Note the cracking that is occurring.

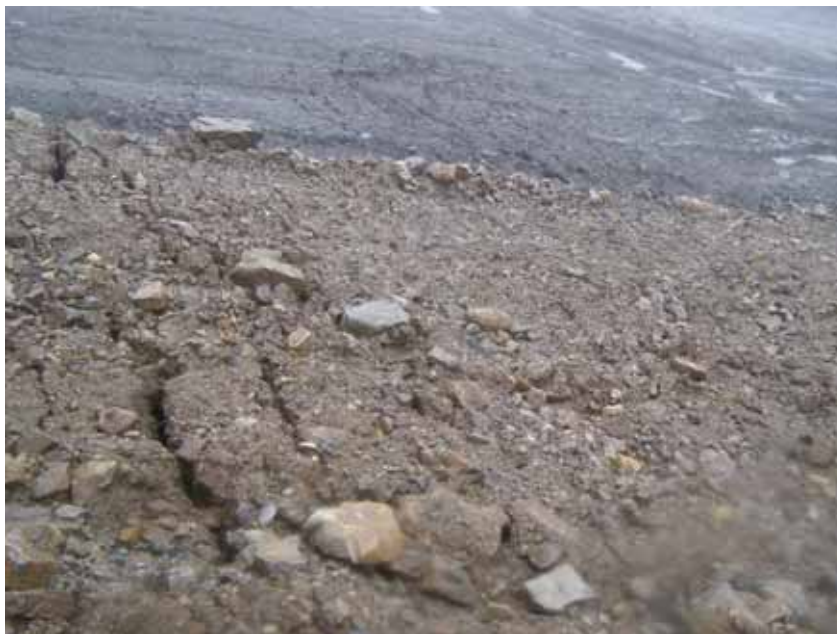
Photo 57 Cracking and deformation noted along east edge of portal cover.

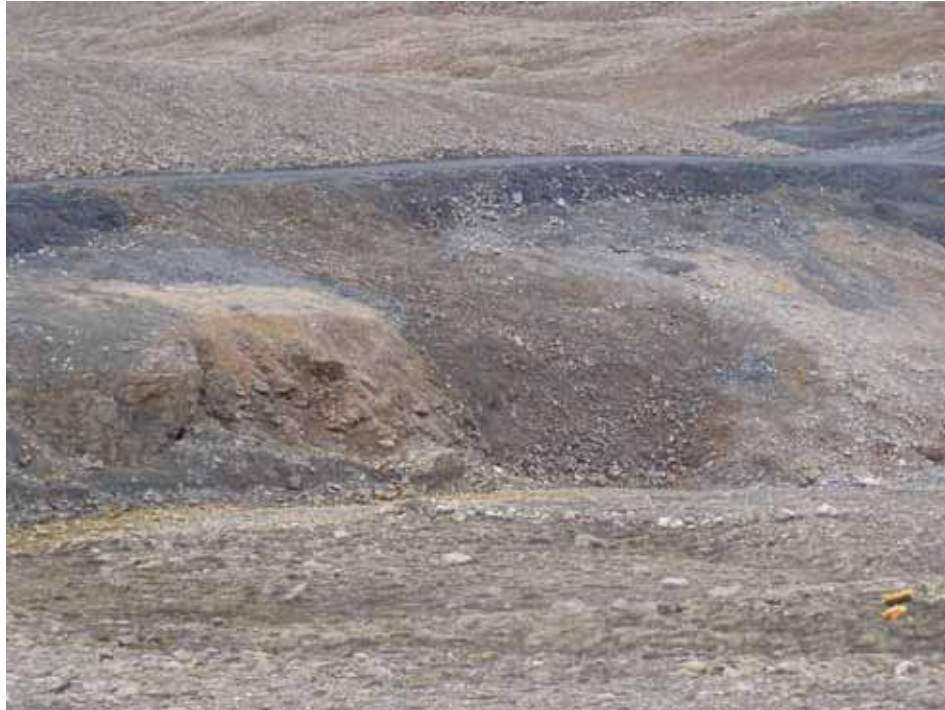
Photo 60 Mill Portal plug. Note that armour material was applied to the surface of the cover as recommended in 2008.
