NANISIVIK MINE, NUNAVUT

2013 ANNUAL GEOTECHNICAL INSPECTION

PROJECT NO.: 0255-023
DATE: February 27, 2014
DOCUMENT NO.:

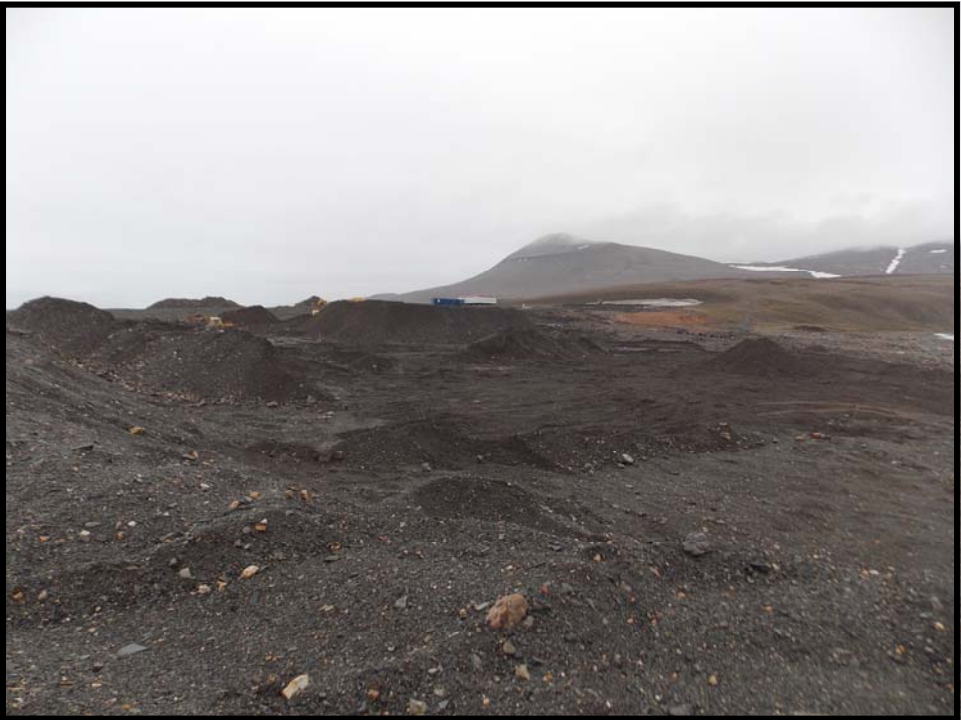
Photo 4. Main Tank Farm—Stockpiles of soil excavated from tank farm foundation.

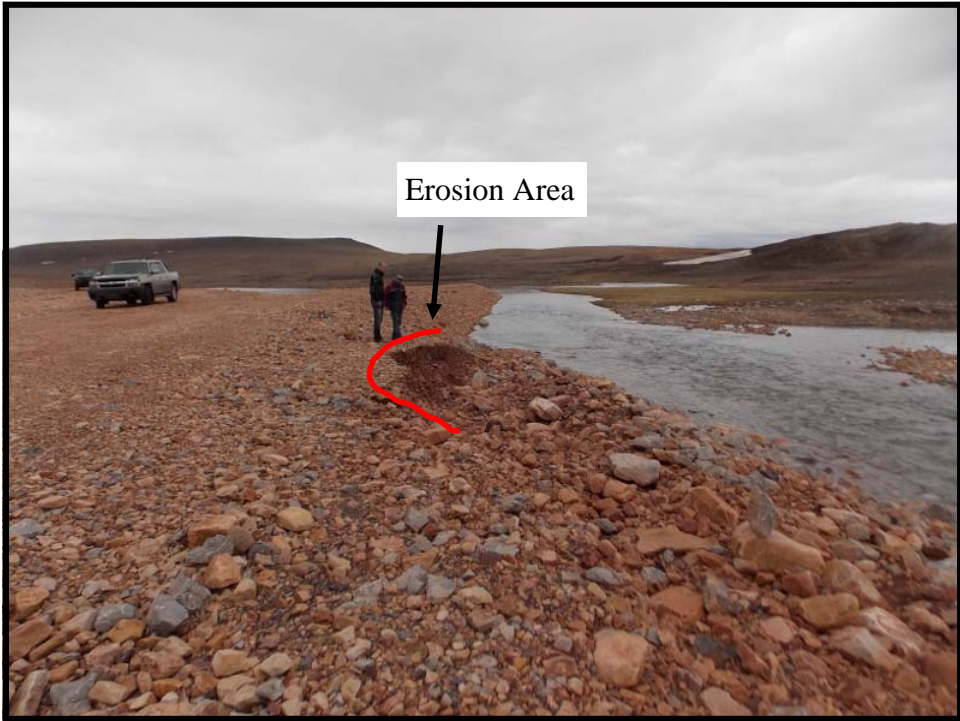
Some erosion at the East Twin Diversion Dyke was noted during the inspection. The erosion was likely due to elevated flows during freshet in combination with snow blockage in the channel. The erosion appeared to be more advanced in 2013 compared to 2012. In general the dyke remains in stable condition. However, it is recommended that visual observations of flow during freshet be recorded in 2014. Seepage was observed at the toe of the East Twin Diversion Dyke in 2013 upstream of the convergence of flow from West Twin. This seepage is likely originating in the remnant polishing pond. There is no concern with respect to the integrity of the dyke due to the presence of this seepage. However, it is recommended that this seepage point be monitored for increased flows in 2014.

Photo 13. East Twin Creek Diversion Channel– Erosion area noted above seepage discharge point.

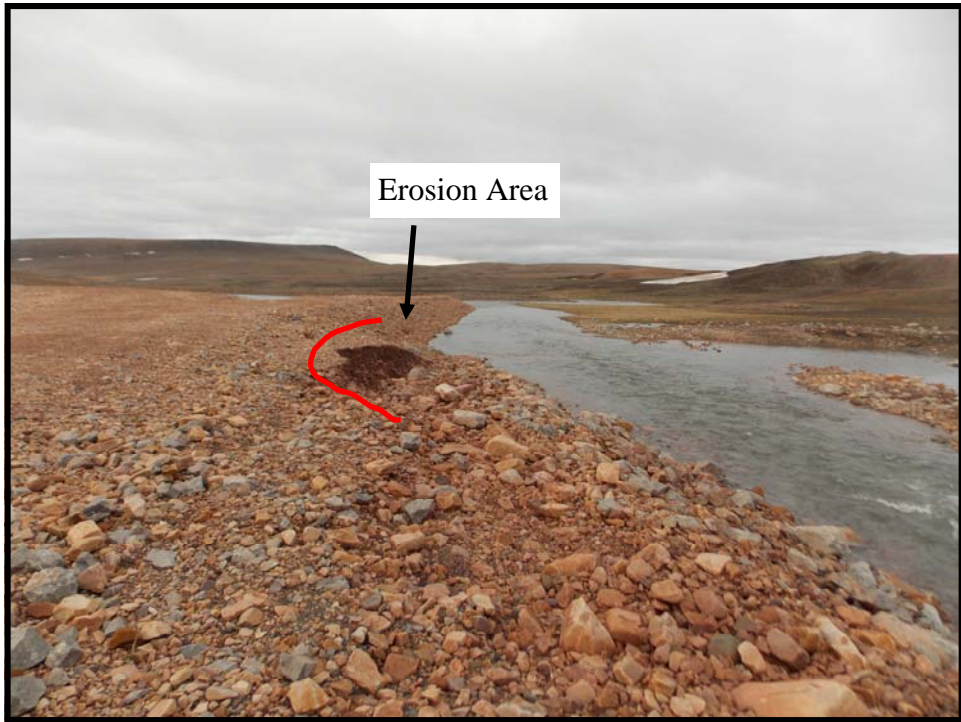
Photo 14. East Twin Creek Diversion Channel– Erosion area noted above seepage discharge point. Erosion is further advanced compared to 2012.

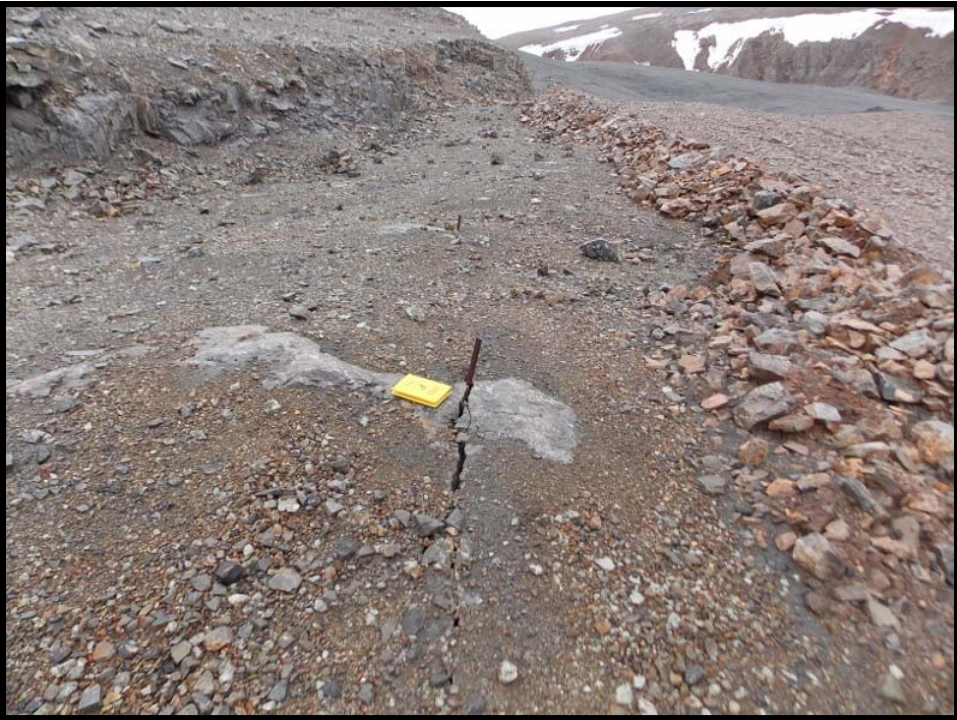
Photo 34. West Open Pit—Crack in crown pillar.

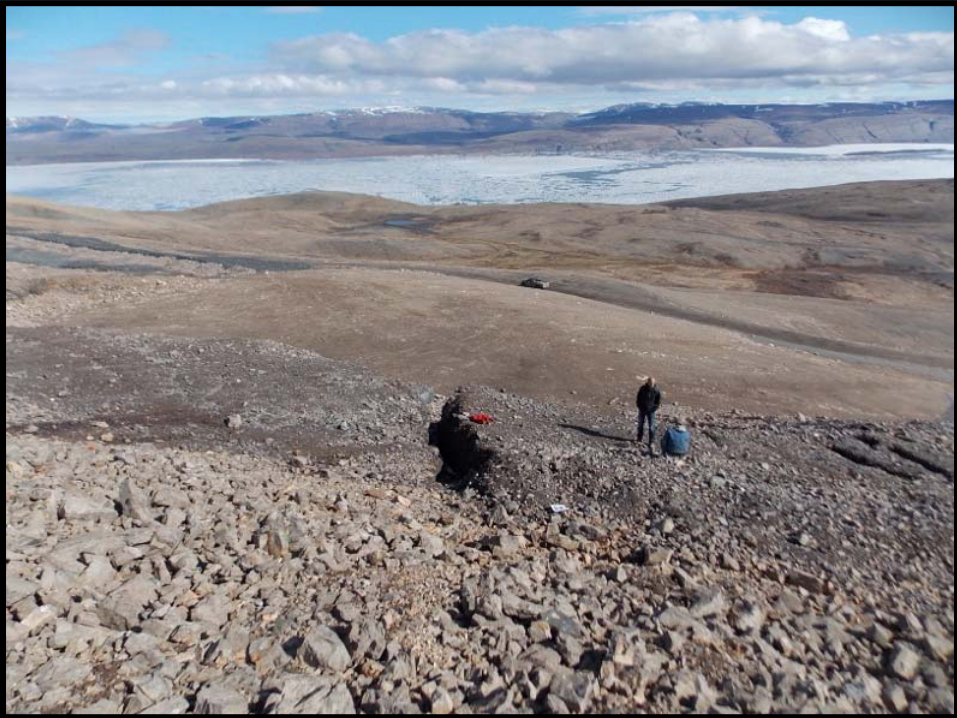
The covers constructed over the mine openings generally appear to be physically stable. Cracking at the East Open Pit crown pillar does not appear to have progressed since 2011. No maintenance is recommended, but continued visual inspection is warranted.

Photo 40. East Open Pit—Cracking in crown pillar. Similar condition to 2012.

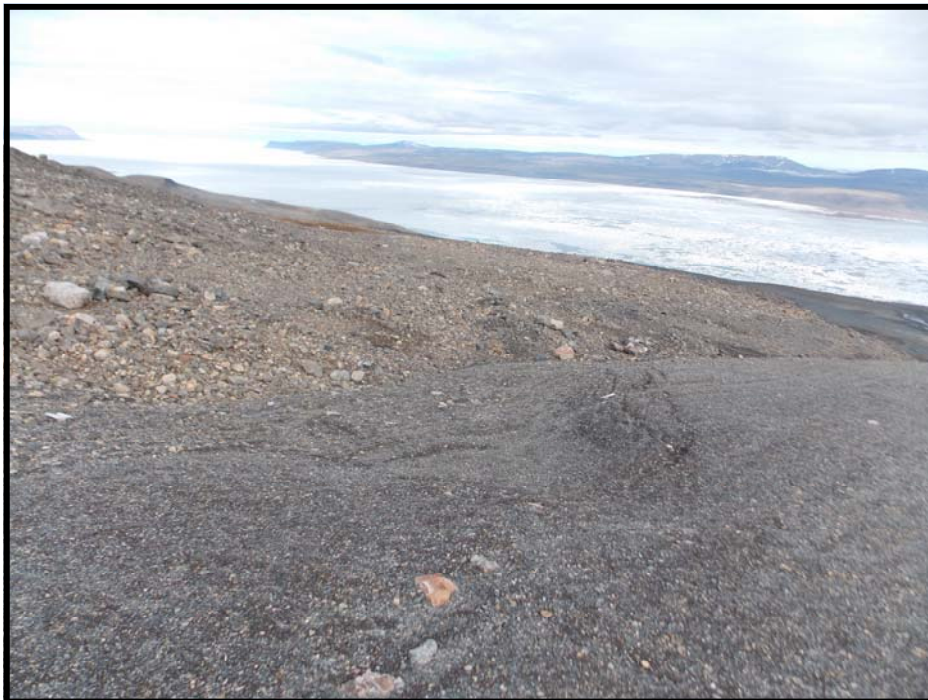
Photo 54. Oceanview Portal—Settlement area along west edge of cover. Nothing active noted.
