APPENDIX I INSPECTION PHOTOS

PROJECT:	NANISIVIK MINE 2015 ANNUAL GEOTECHNICAL INSPECTION
TITLE:	EAST ADIT TREATMENT FACILITY

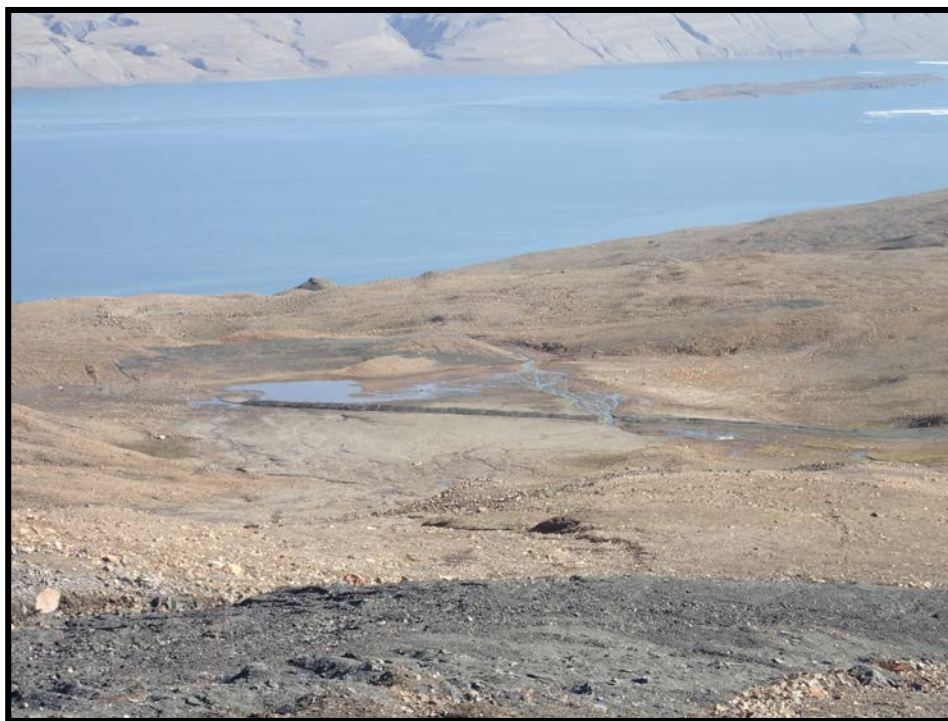
Photo 1. East Adit Treatment Facility—Looking east at breach in East Adit Treatment dyke.

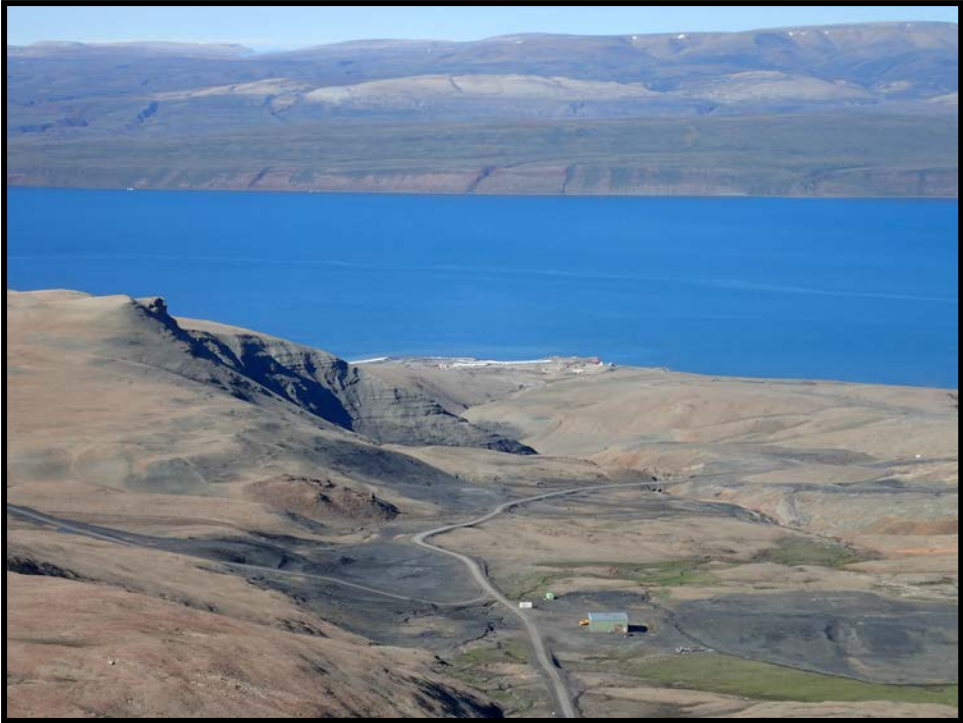
Photo 3. Port Area—As seen from Mt. Fuji.

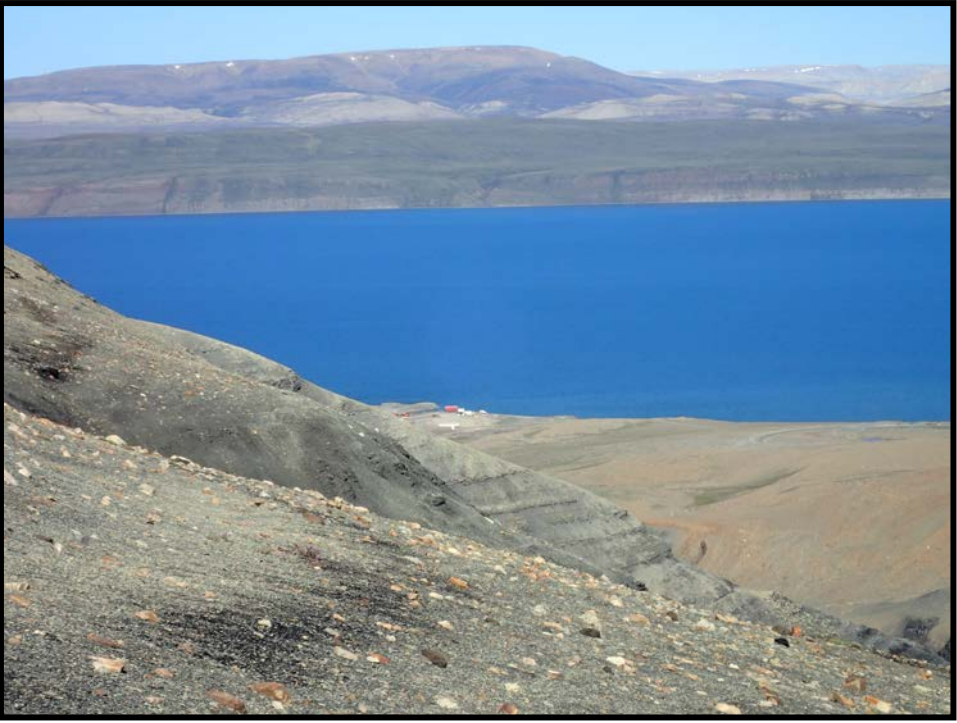
Photo 4. Port Area—As seen from communication tower area.

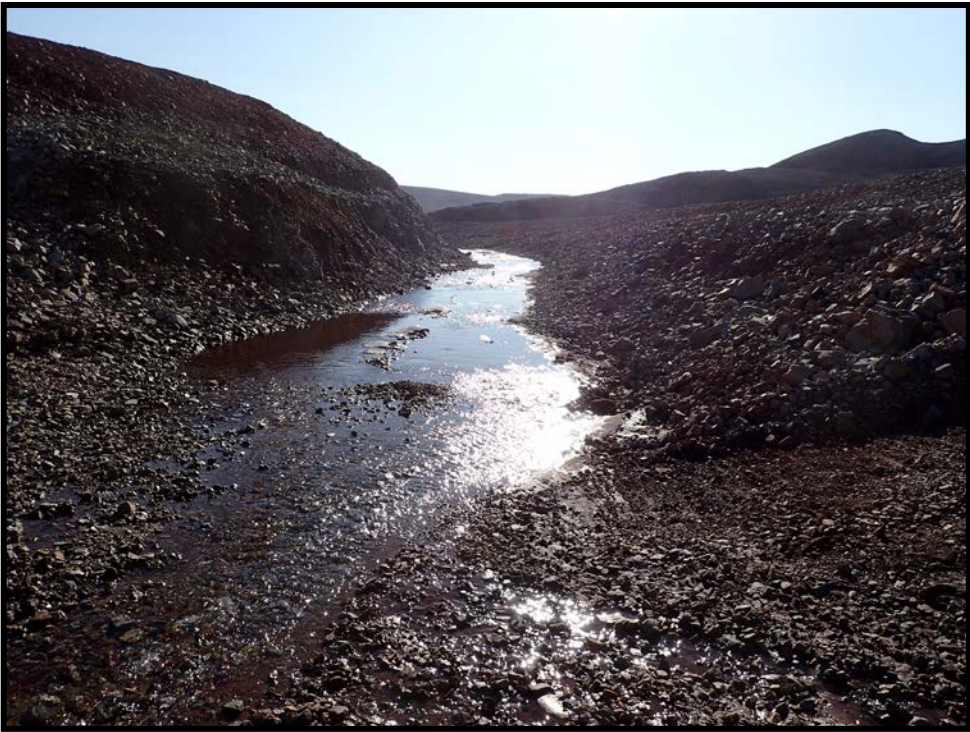
Photo 5. West Twin Dyke Spillway—Looking downslope along left edge of ramp on right bank of spillway. Note water flowing along channel.

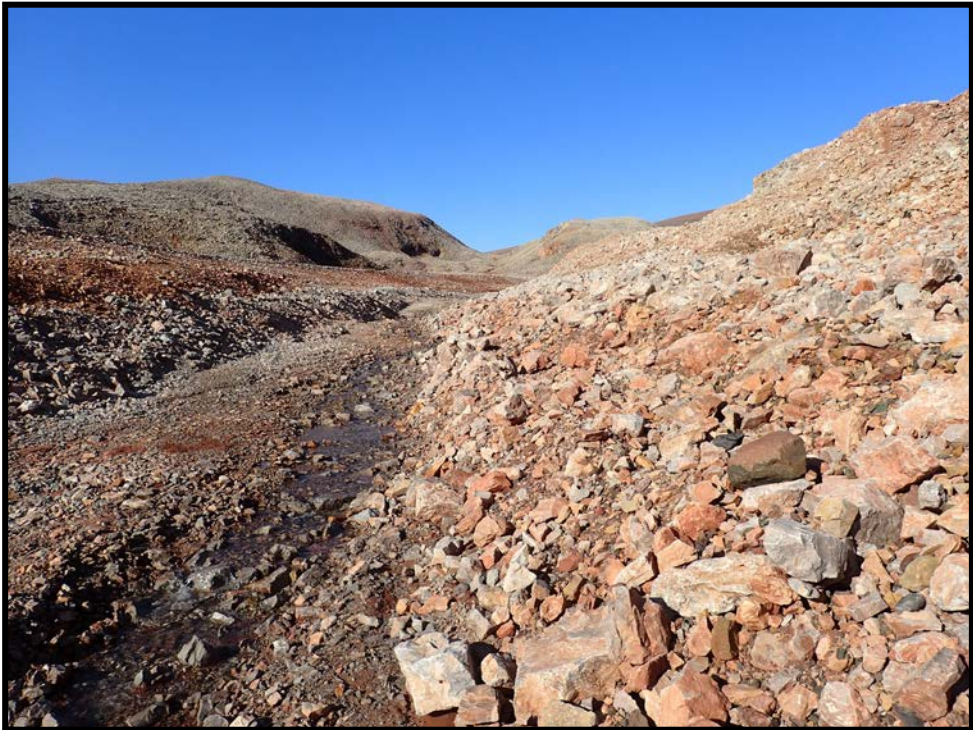
Photo 6. West Twin Dyke Spillway—Looking upstream along left bank of spillway. Note erosion scar approximately 1-2 m above base of spillway.

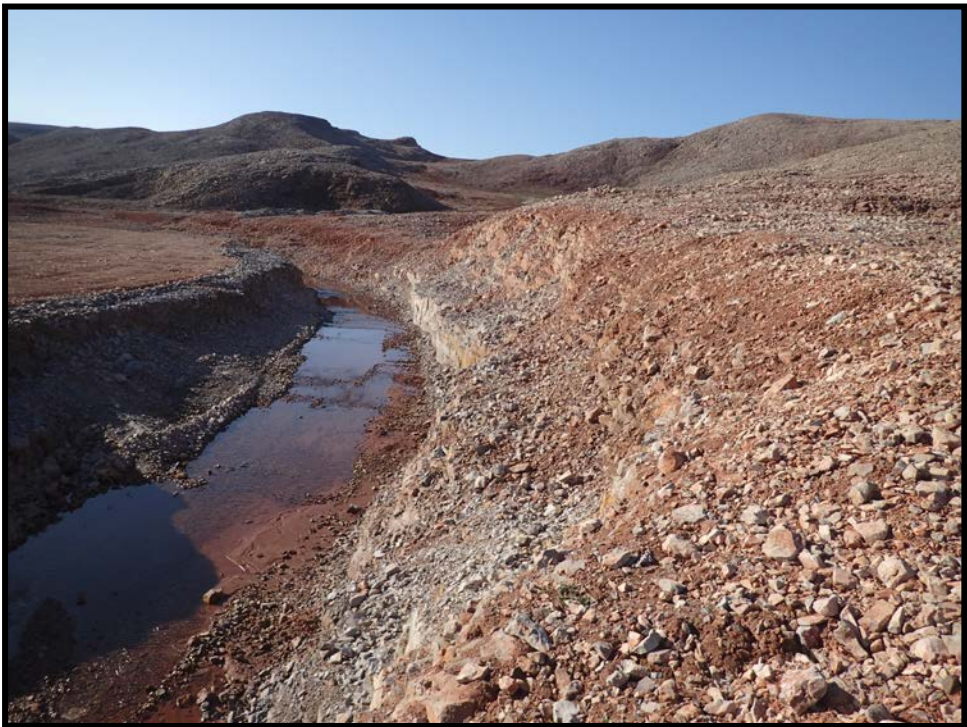
Photo 7. West Twin Dyke Spillway—Spillway as seen from top of right bank. View looking downstream.

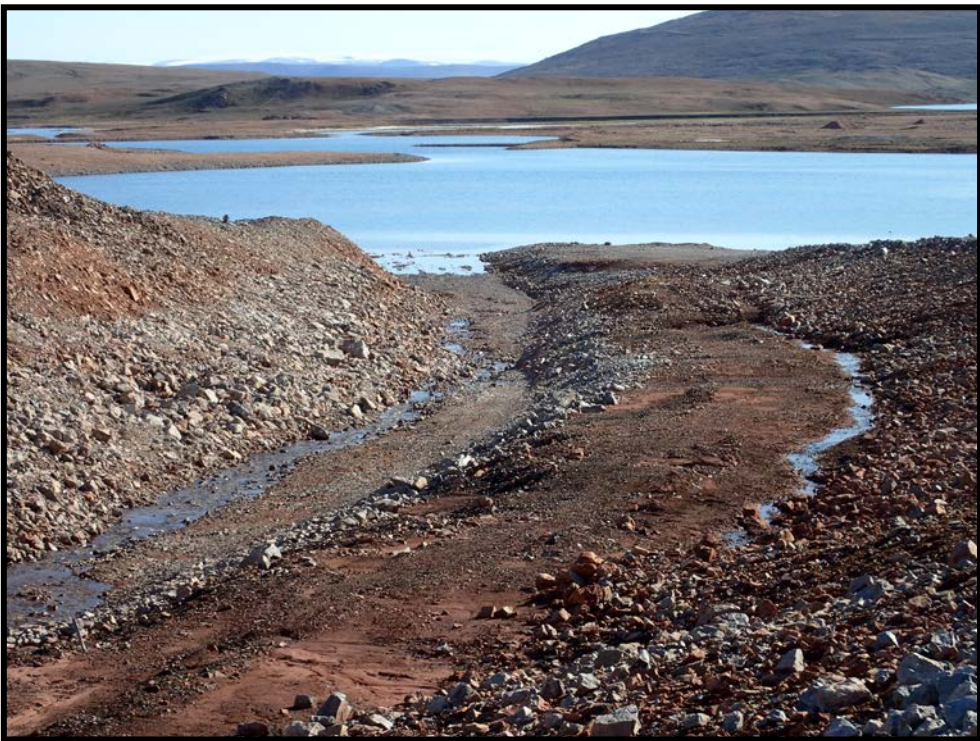
Photo 8. West Twin Dyke Spillway—Spillway outlet as seen from crest of right bank.

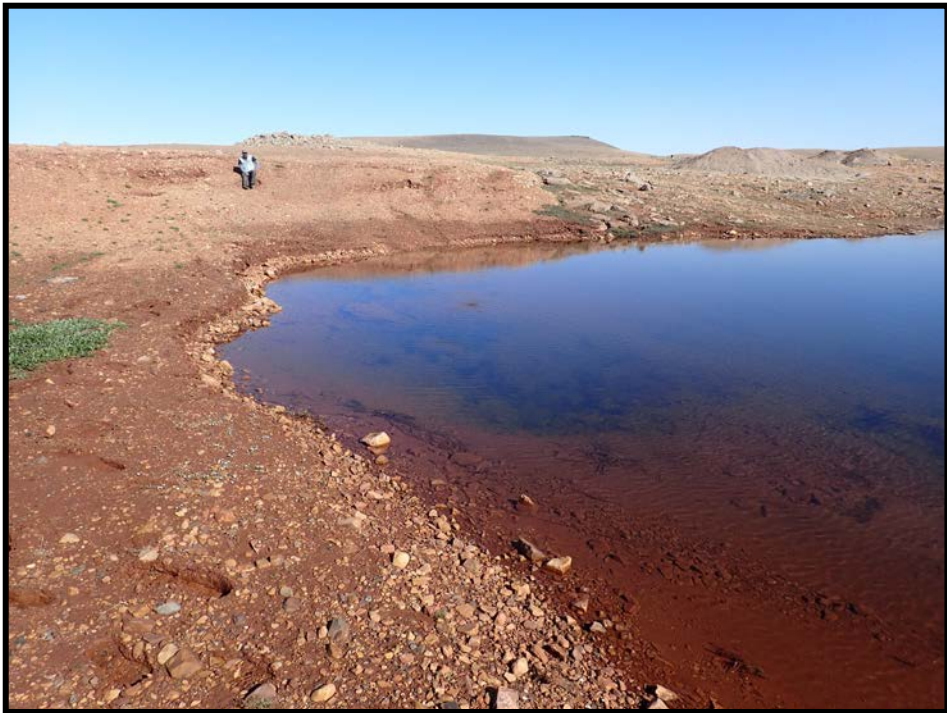
Photo 9. West Twin Outlet Channel—Thermokarst feature in bottom of polishing pond.

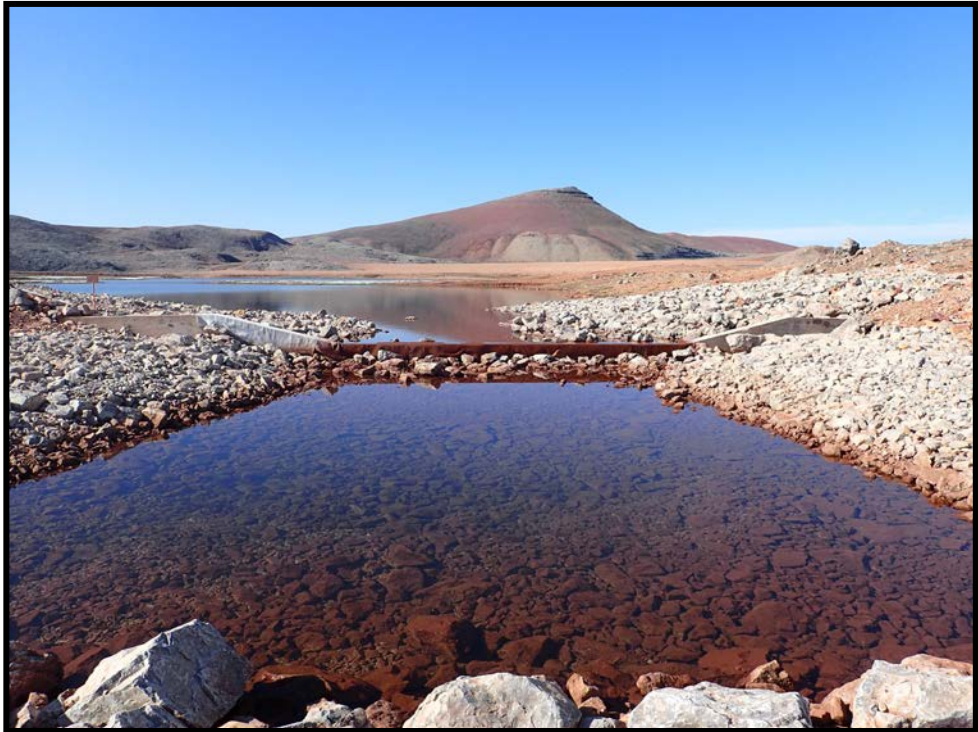
Photo 10. West Twin Outlet Channel—Looking upstream at wall.

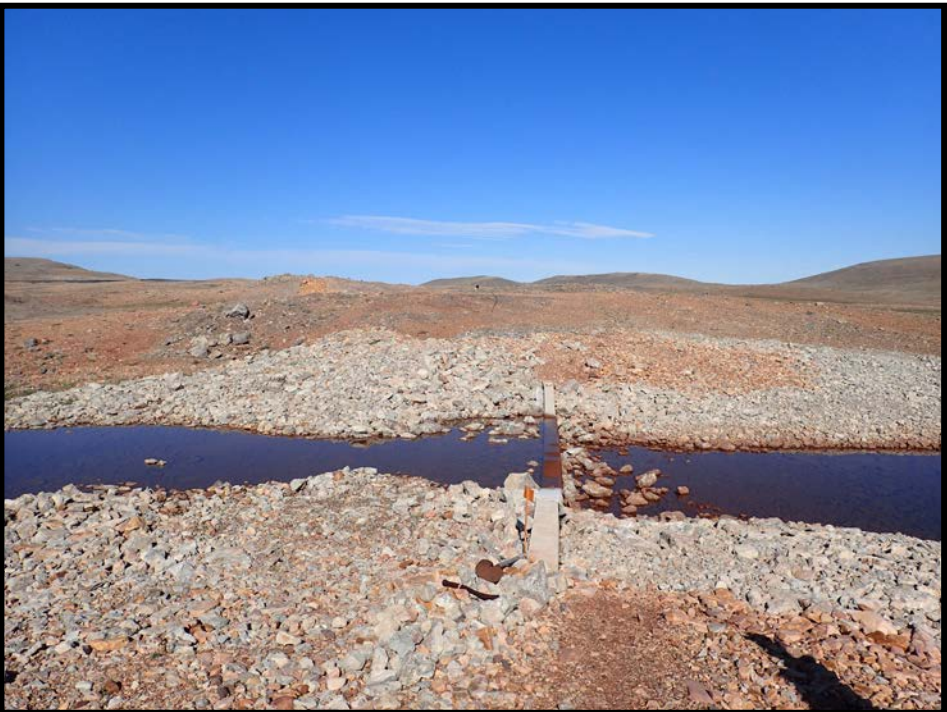
Photo 11. West Twin Outlet Channel—Looking north along wall.

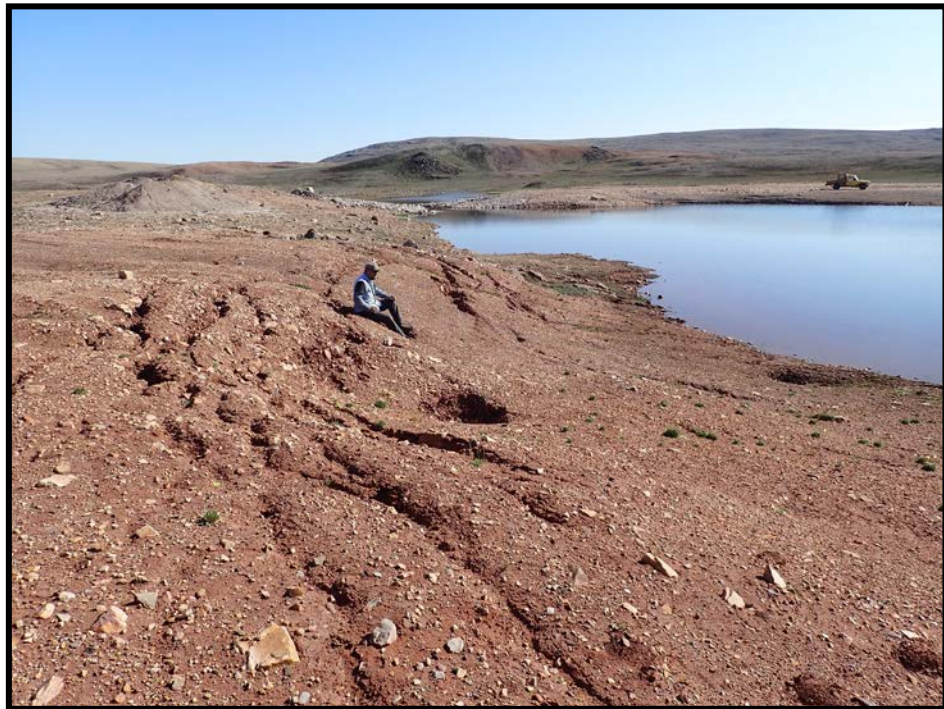
Photo 12. West Twin Outlet Channel—Settlement induced cracking along north edge of polishing pond.

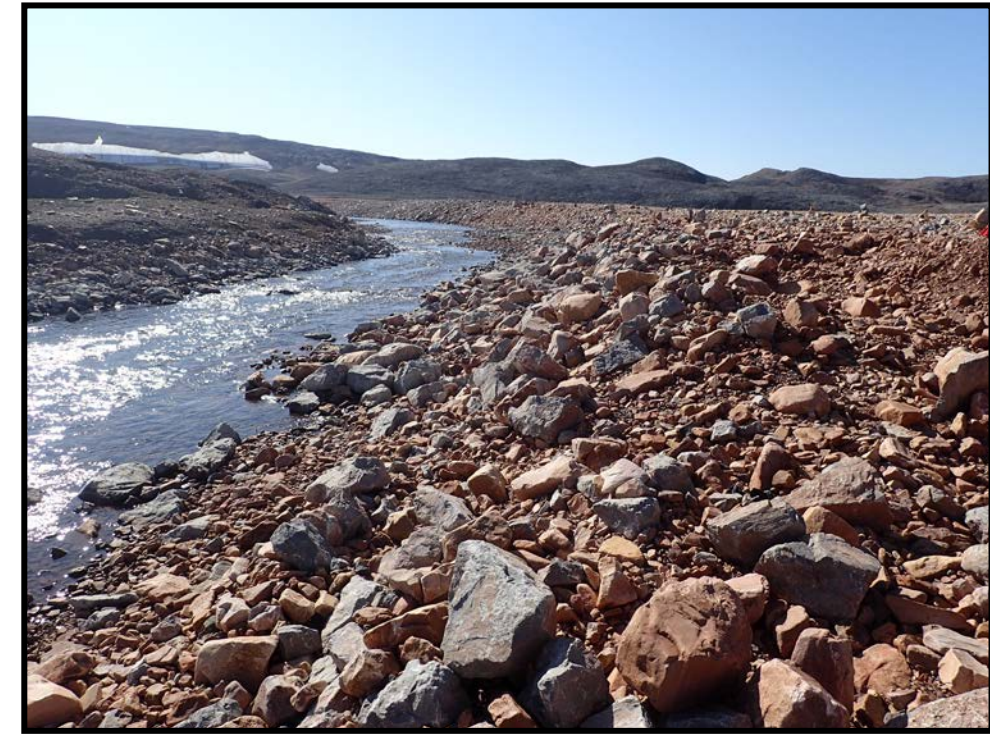
Photo 13. East Twin Creek Diversion Channel—View looking up gradient. Upstream of left bank erosion.

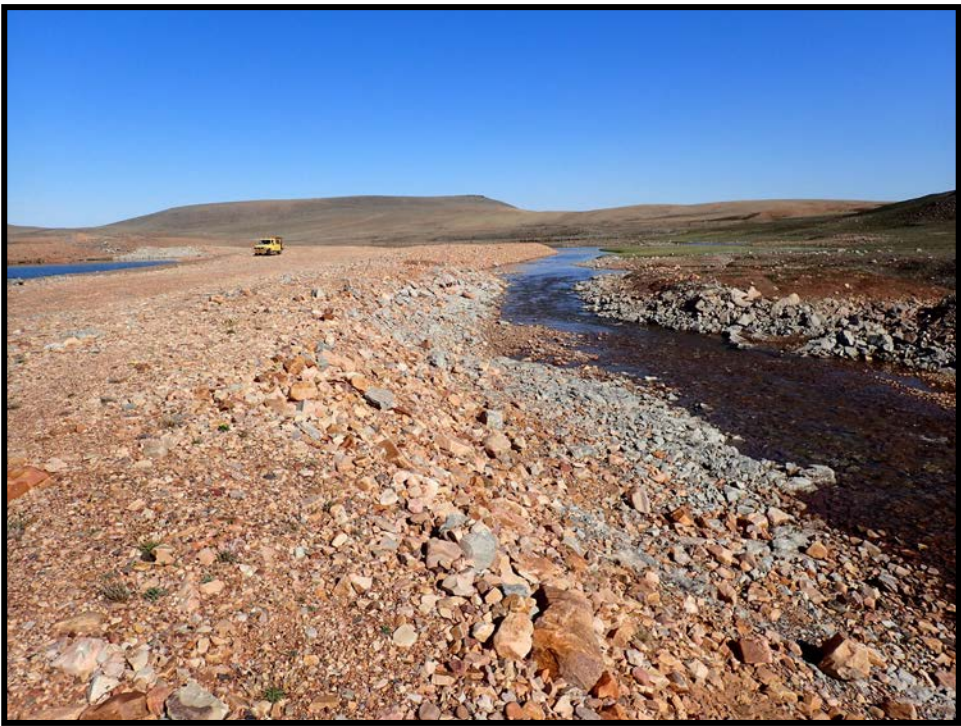
Photo 14. East Twin Creek Diversion Channel– View of area downstream of armoured area. Note bedrock outcrop along face of dyke and in bottom of channel.

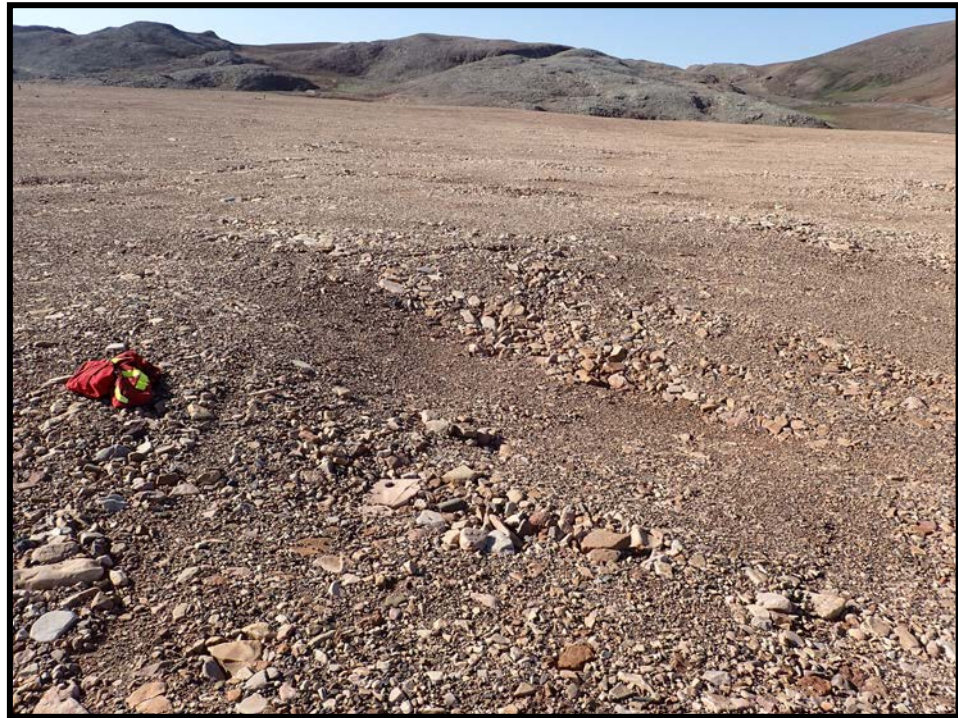
Photo 17. Surface Cell—Thermokarst settlement near E/W drainage channel.

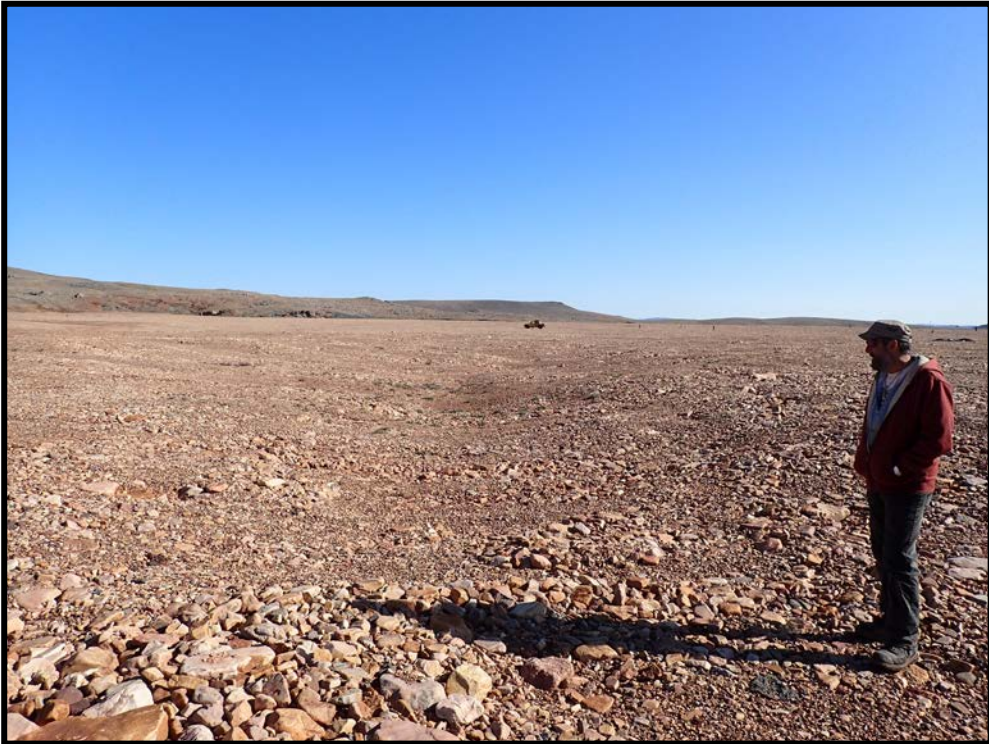
Photo 18. Surface Cell—Settlement area along east edge of main N/S drainage swale. View looking north.

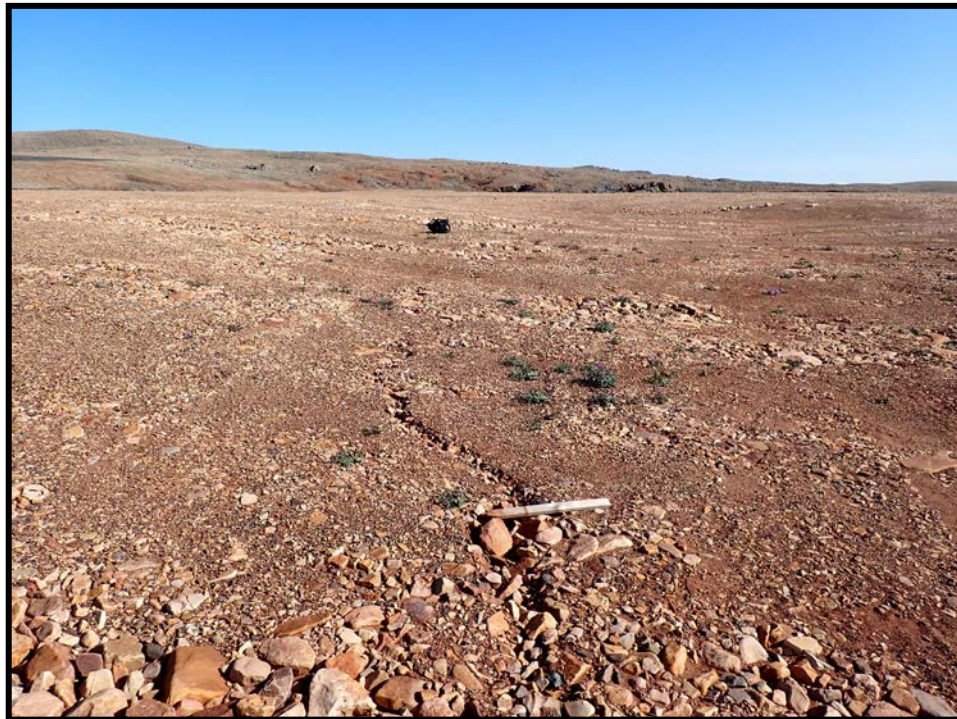
Photo 19. Surface Cell—Cracking in secondary N/S drainage swale. View looking north.

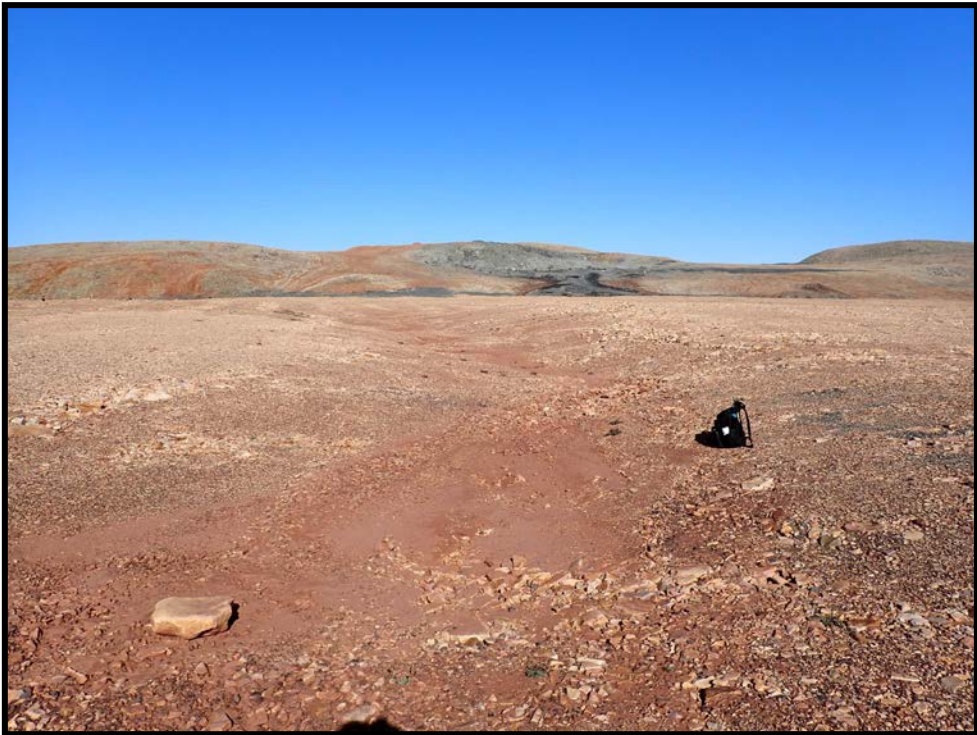
Photo 20. Surface Cell—E/W drainage channel on Surface Cell cover. View looking west.

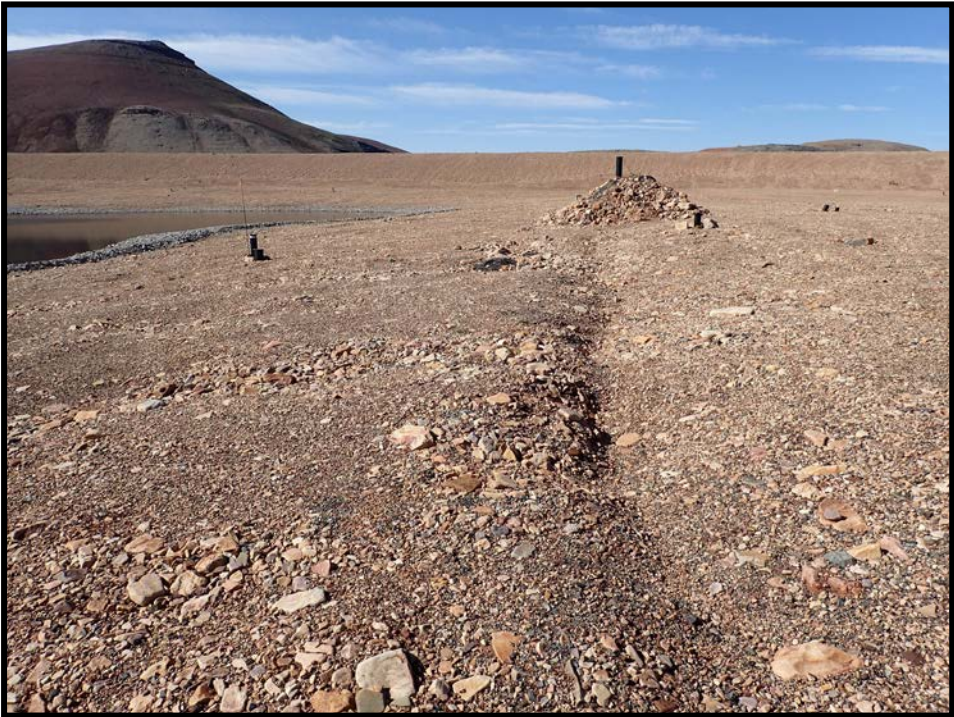
Photo 23. Test Cell—Settlement trough along edge of East/West Test Cell dyke.

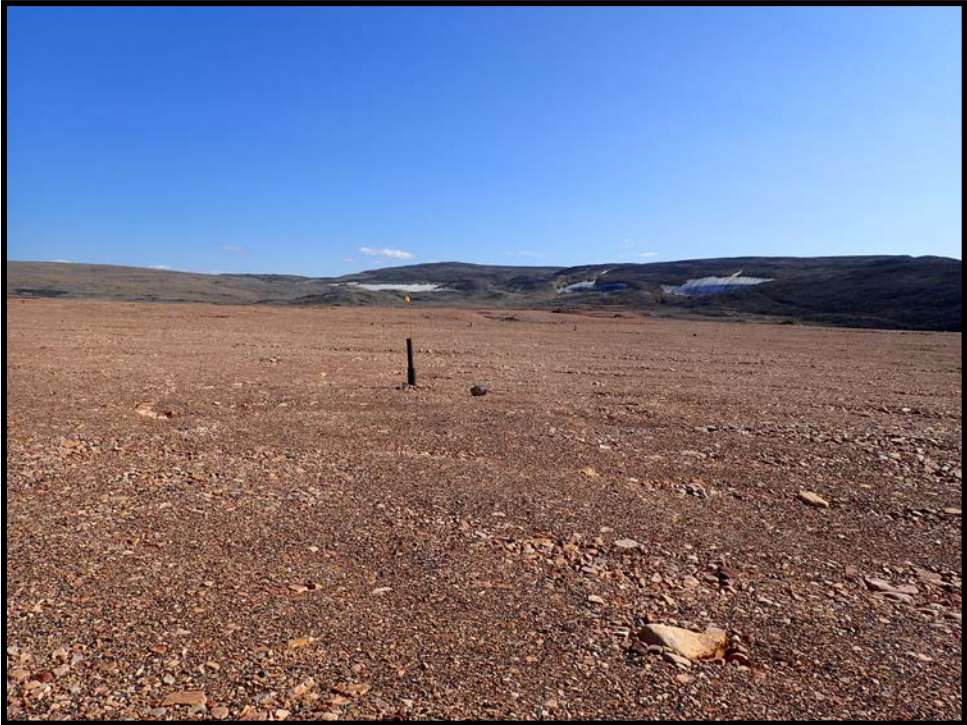
Photo 24. Test Cell—Looking toward outlet of Test Cell cover system.

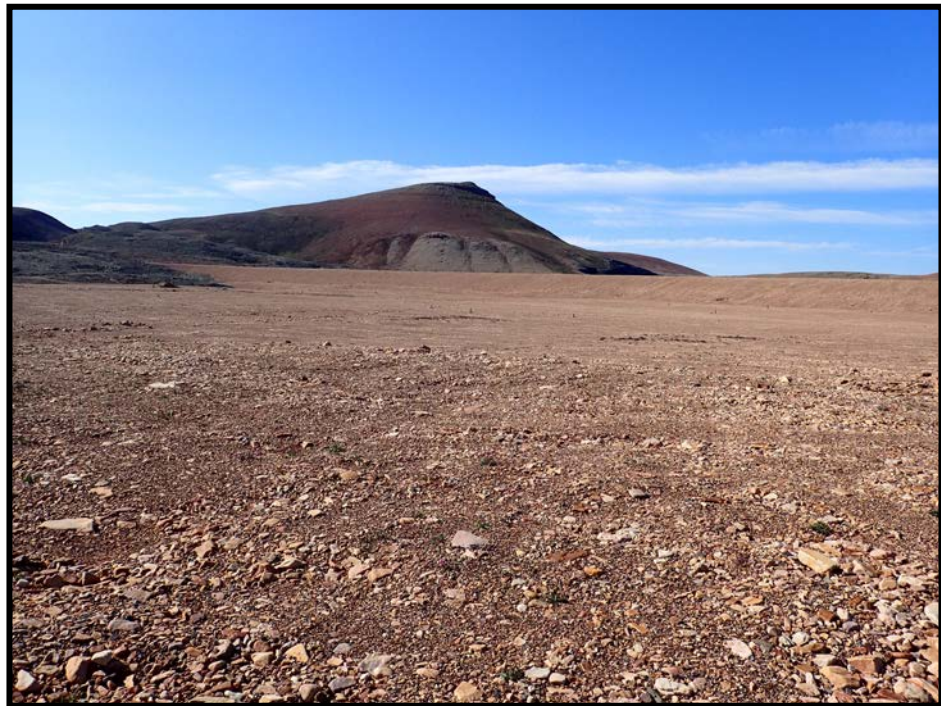
Photo 25. Test Cell—View looking southwest along centre of Test Cell cover system.

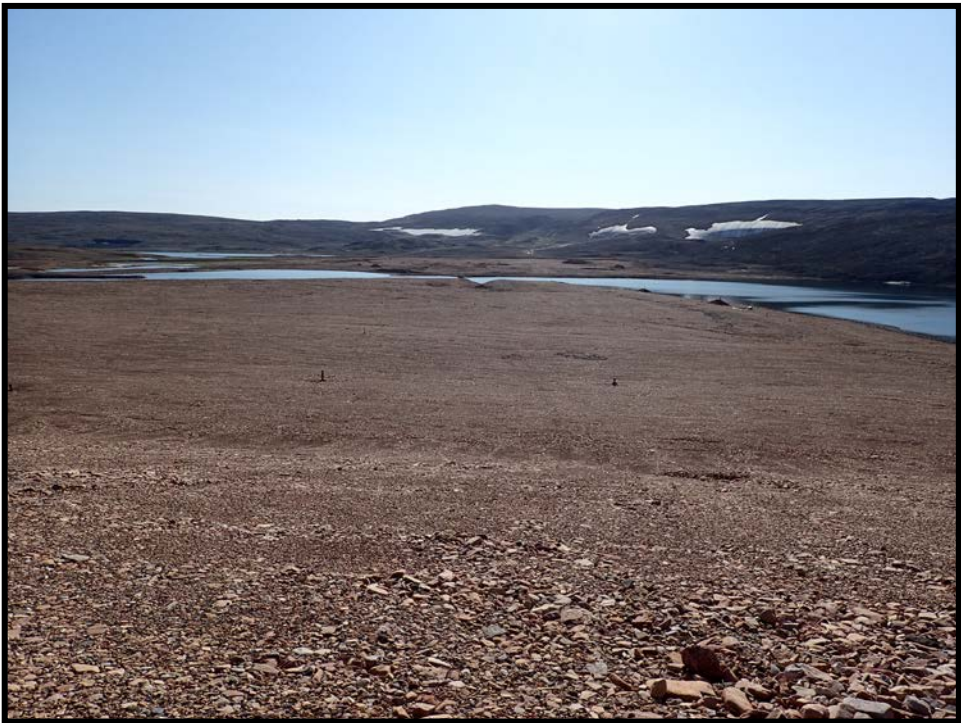
Photo 26. Test Cell—Test Cell area as seen from crest of West Twin Dyke.

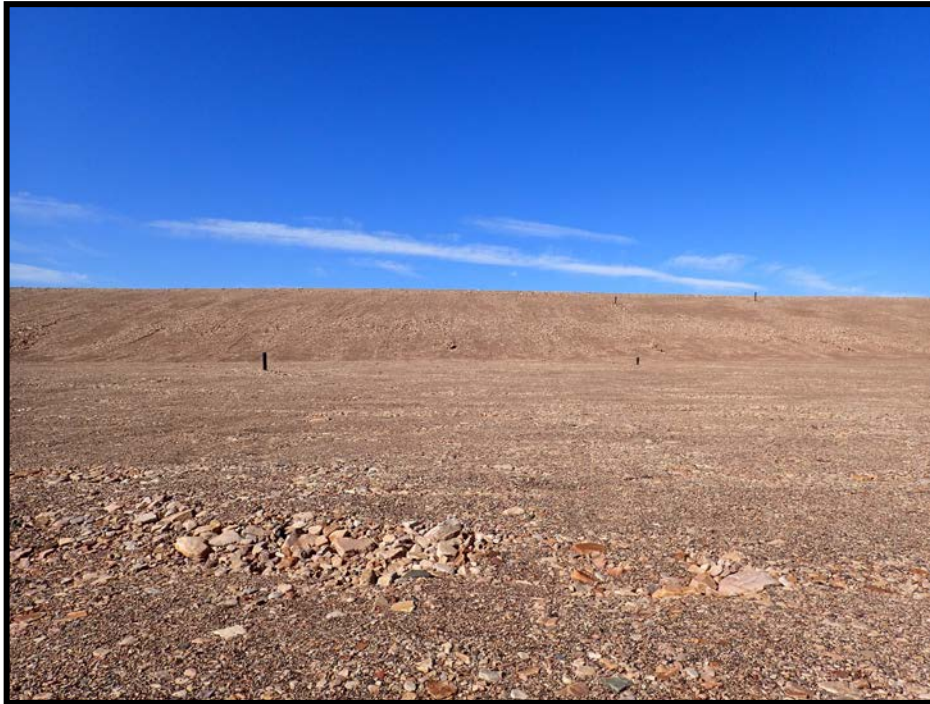
Photo 27. Test Cell—Looking towards toe of West Twin dyke from centre of Test Cell.

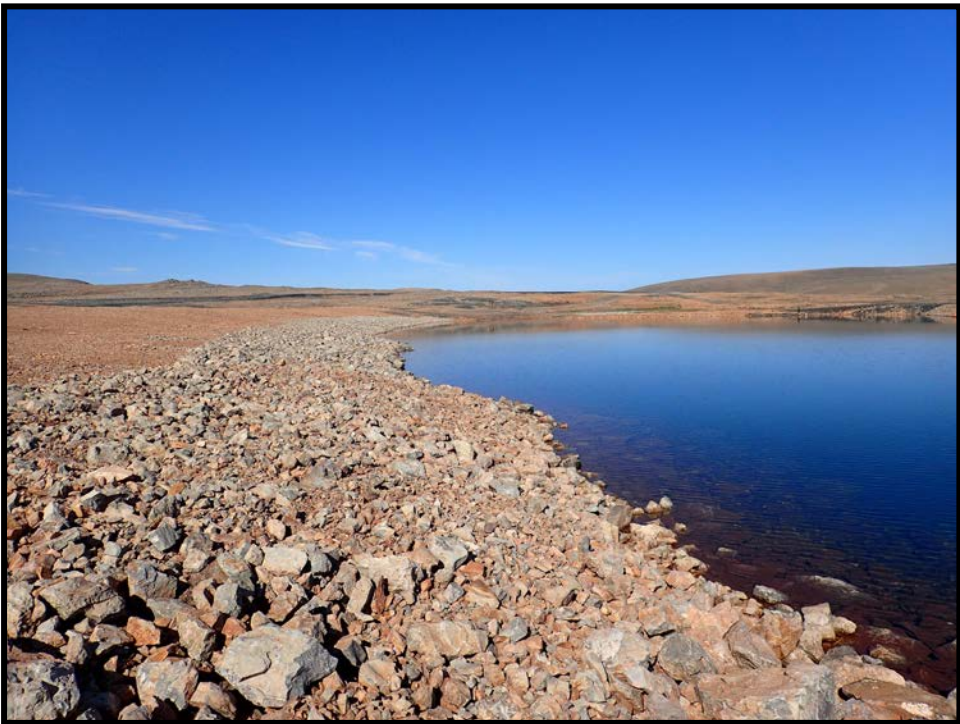
Photo 29. Toe of Test Cell Dyke—Armour along shoreline of cover at toe of Test Cell Dyke. East/West arm, view looking east.

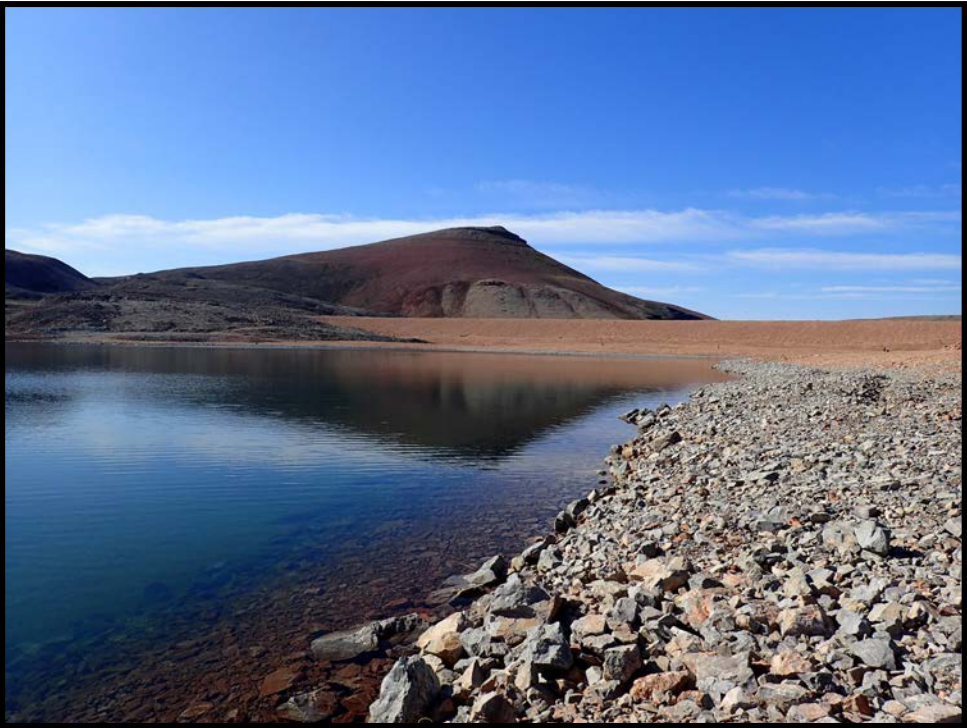
Photo 30. Toe of Test Cell Dyke—Armour along shoreline of cover at toe of Test Cell Dyke. East/West arm, view looking west.

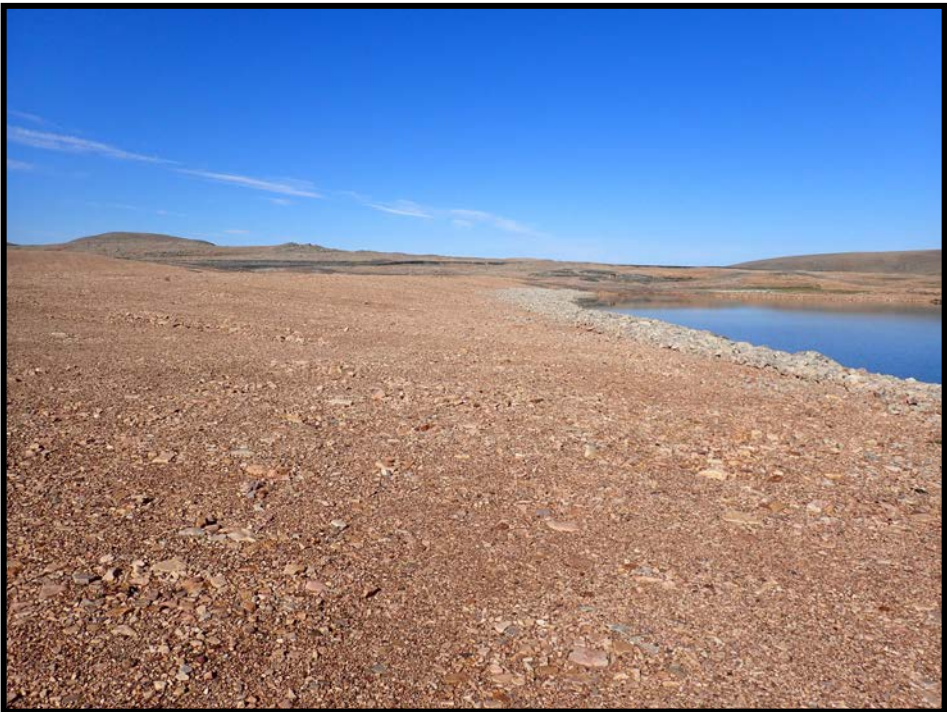
Photo 31. Toe of Test Cell Dyke—North/South arm, view looking south.

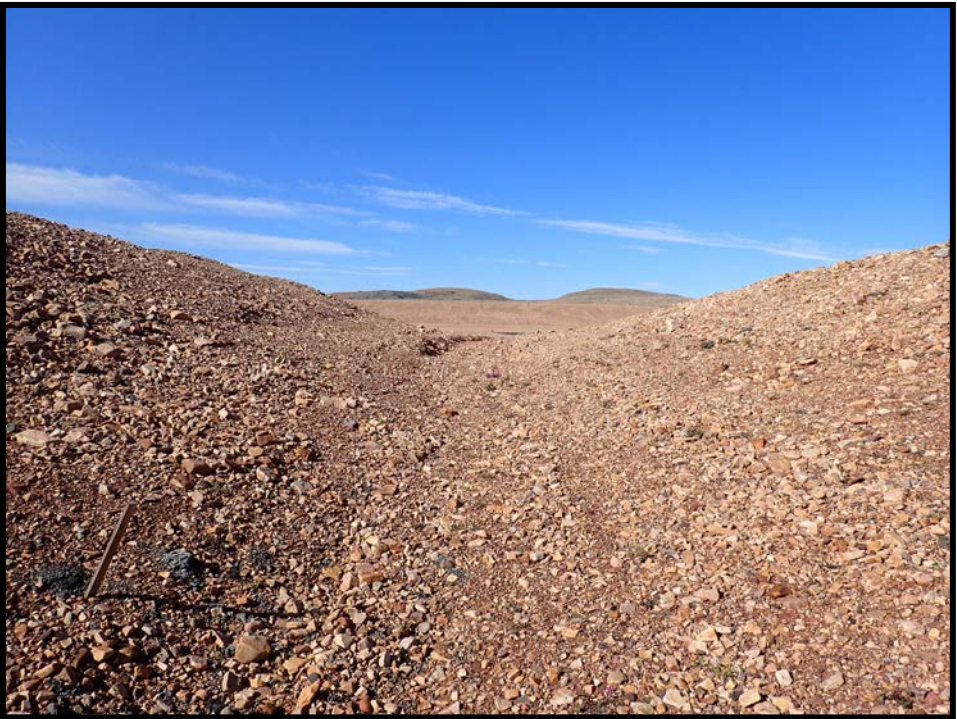
Photo 32. Toe of Test Cell Dyke—Outlet of Test Cell Cover

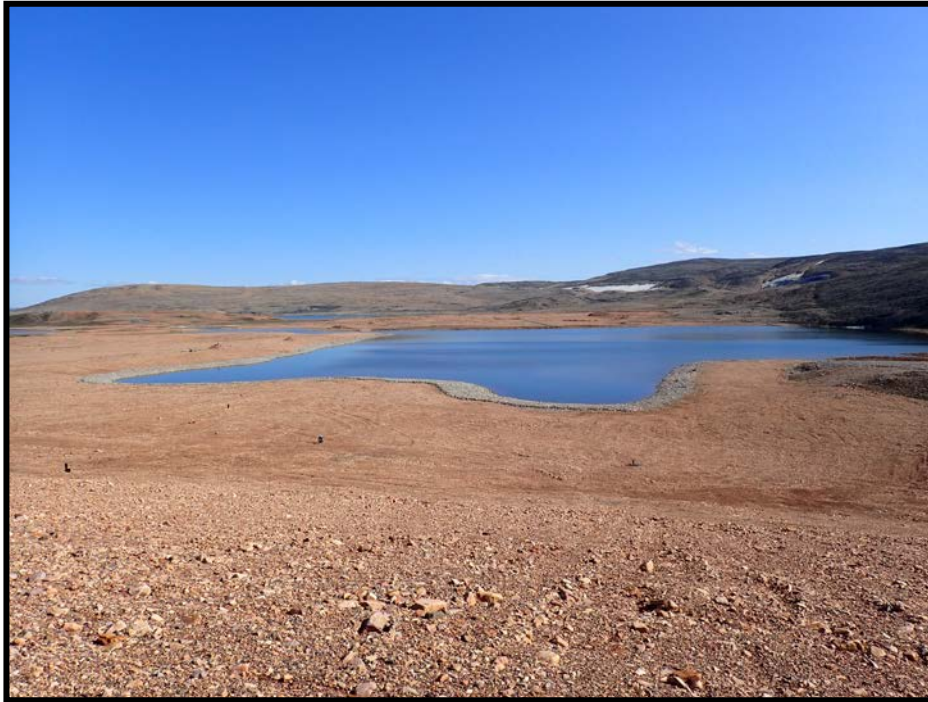
Photo 33. Toe of West Twin Dyke. As seen from crest of West Twin Dyke

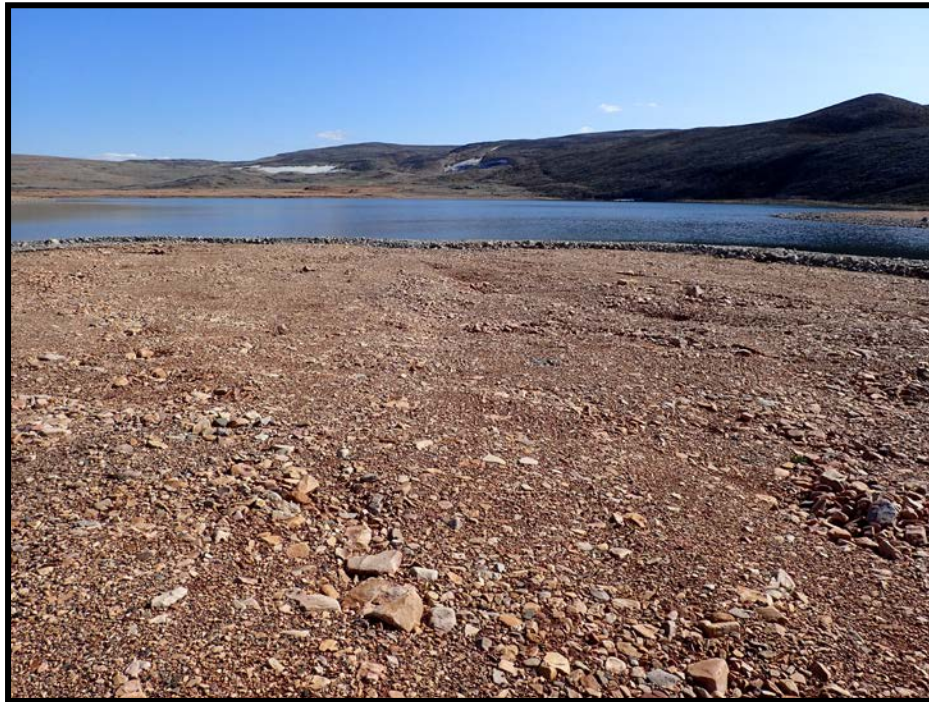
Photo 34. Toe of West Twin Dyke—Settlement Area.

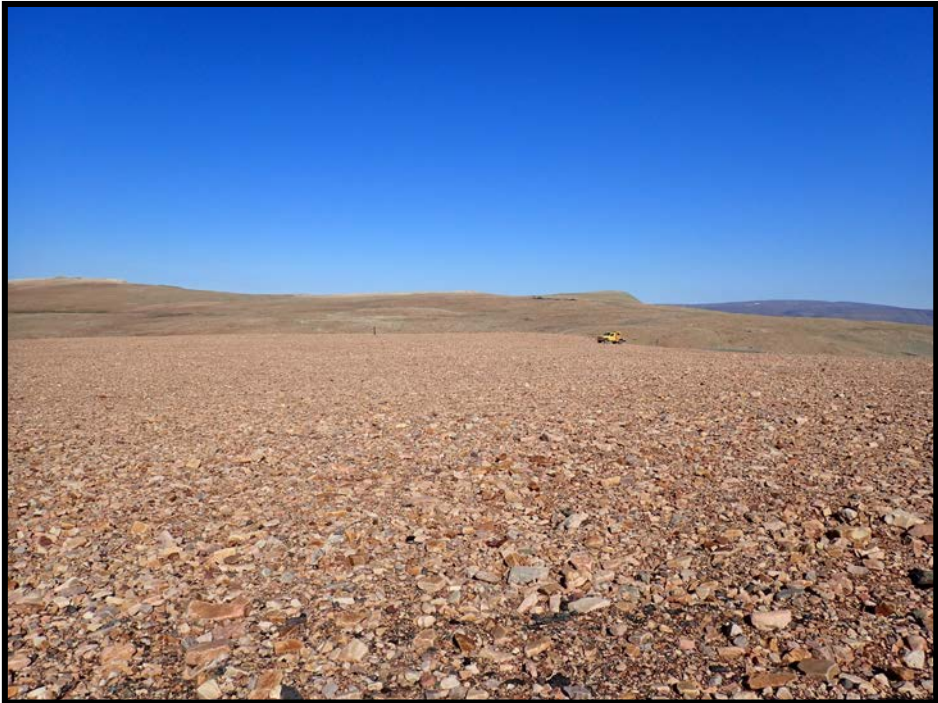
Photo 35. Landfill—Surface of landfill cover looking north.

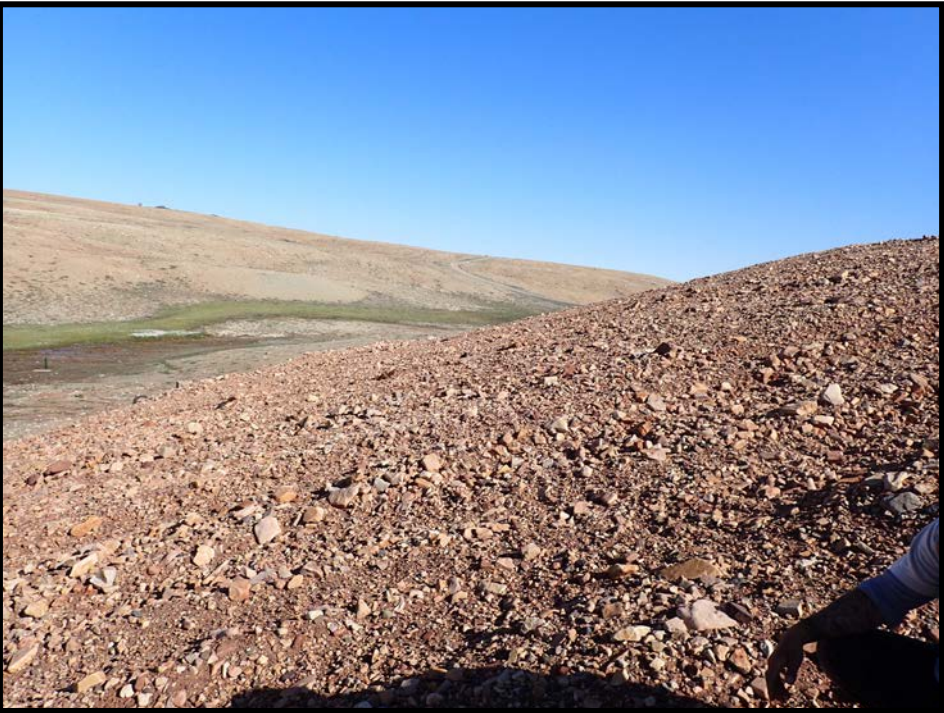
Photo 36. Landfill—North sloping face of cover.

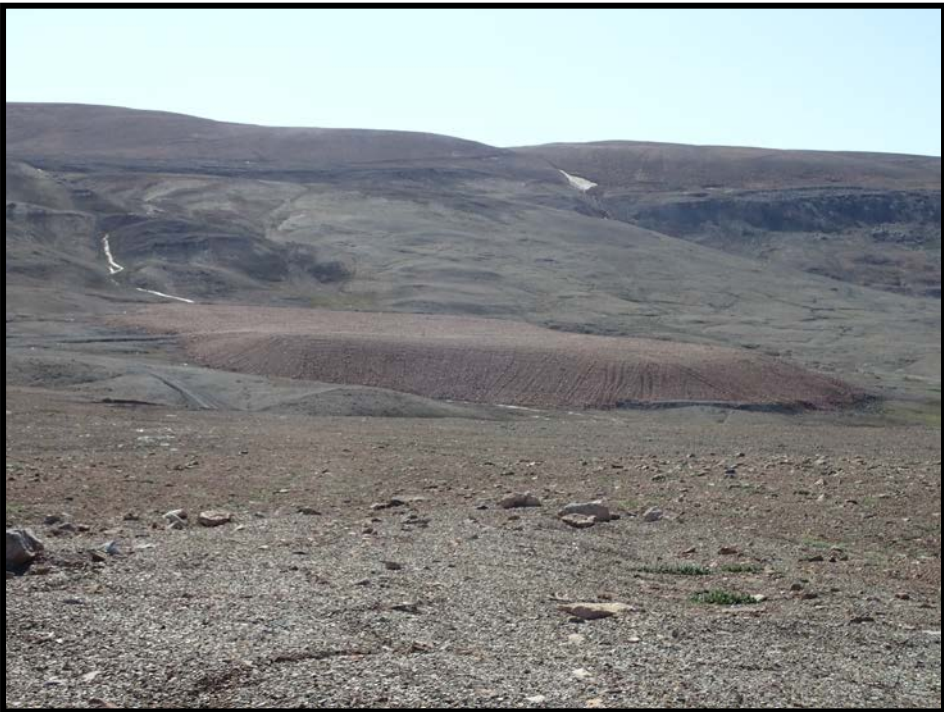
Photo 37. Landfill— As seen from the communication tower area.

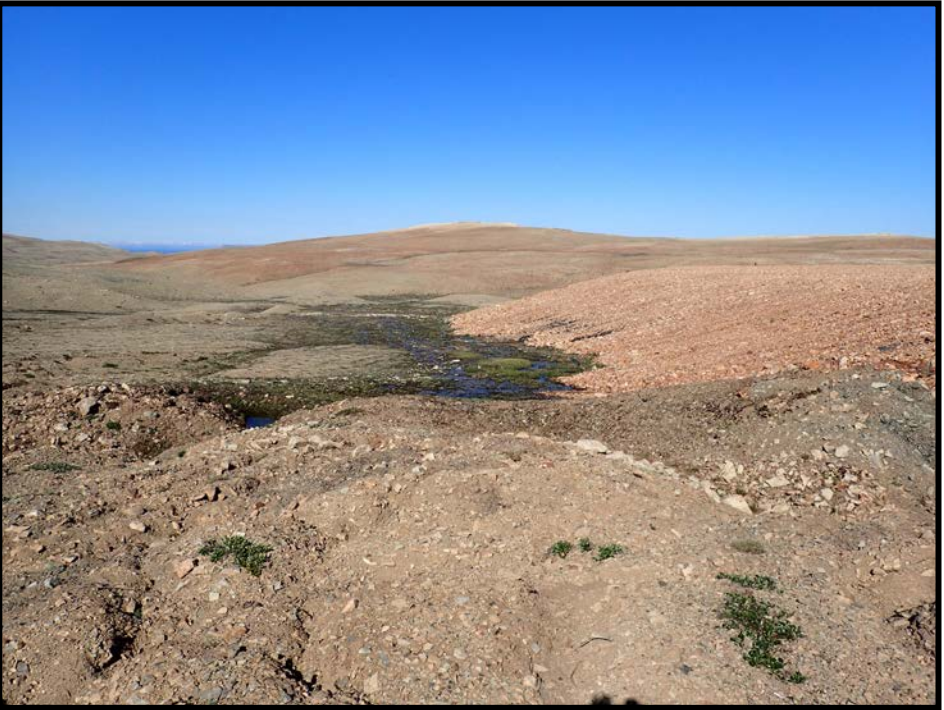
Photo 38. Landfill—West facing slope of landfill cover.
