APPENDIX I INSPECTION PHOTOS

PROJECT:	NANISIVIK MINE 2015 ANNUAL GEOTECHNICAL INSPECTION
TITLE:	EAST ADIT TREATMENT FACILITY

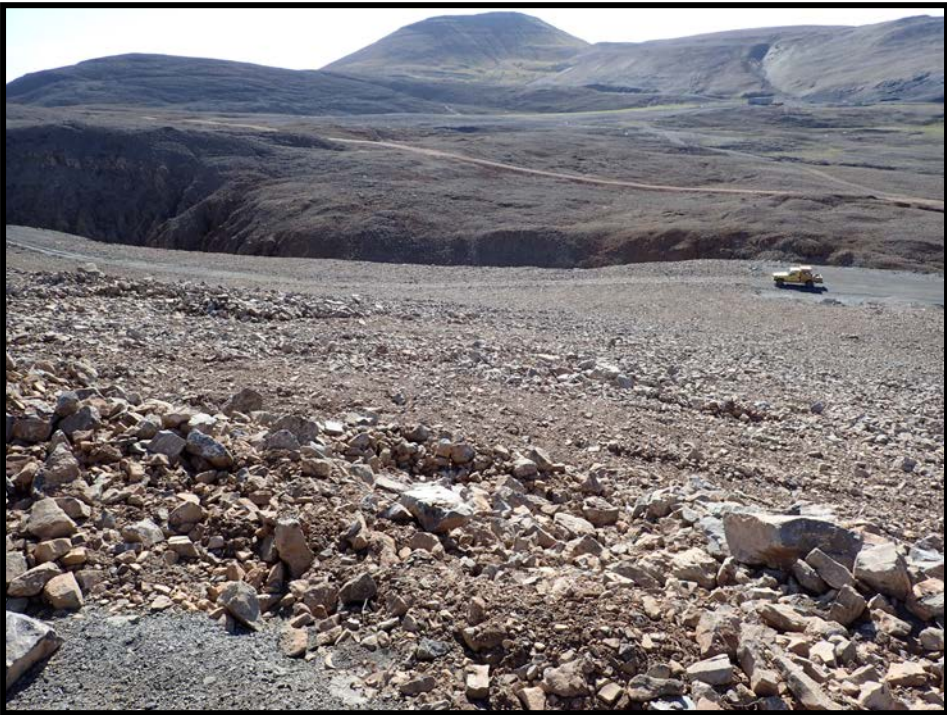
Photo 41. West Open Pit—Surface of cover system looking downslope.

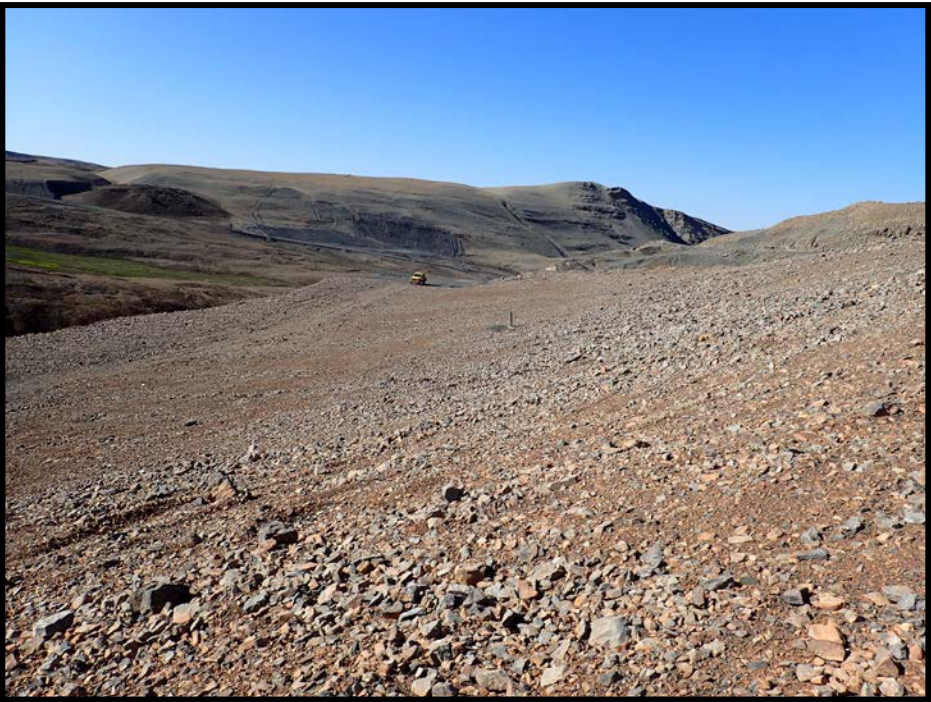
Photo 42. West Open Pit—Centre of surface cover system looking west.

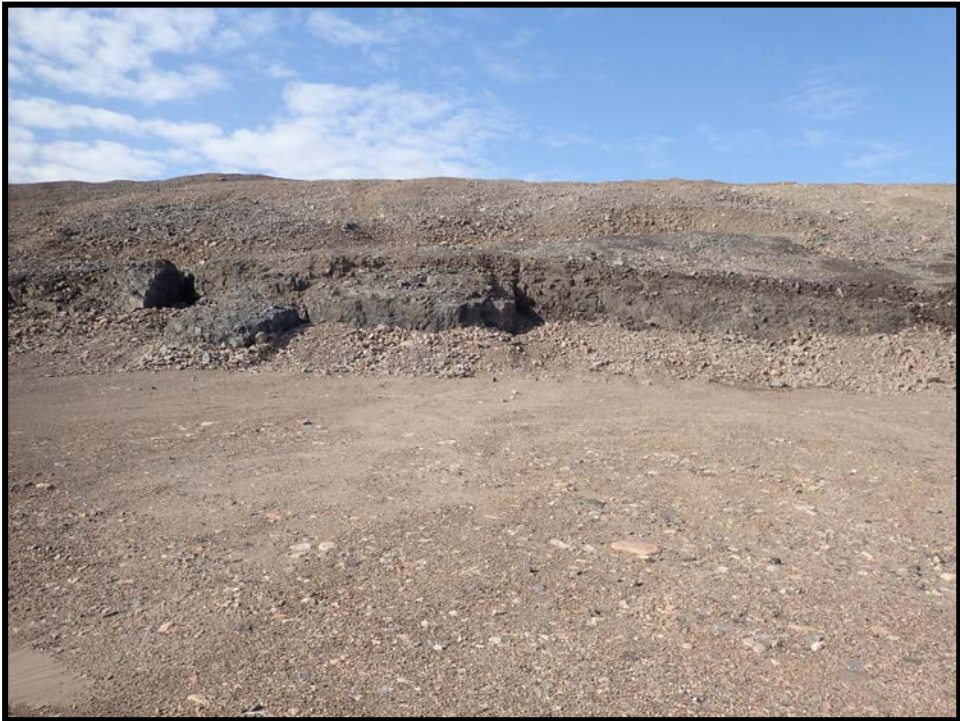
Photo 44. East Open Pit—Face of remnant highwall where cracking of crown pillar has been observed.

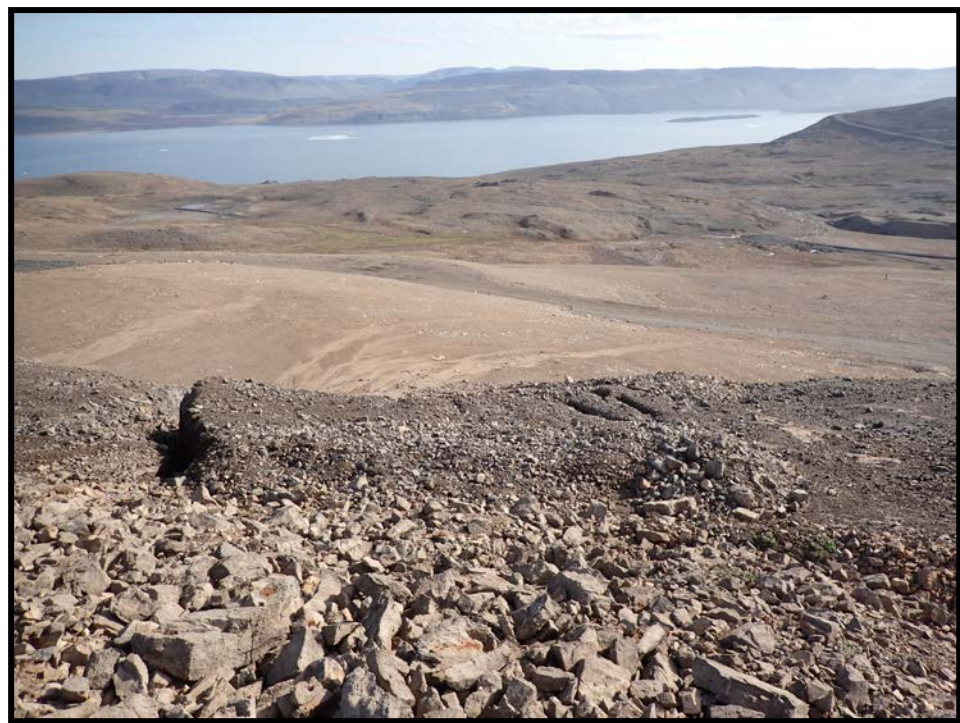
Photo 46. East Open Pit—Cracking in crown pillar. Similar condition to 2014.

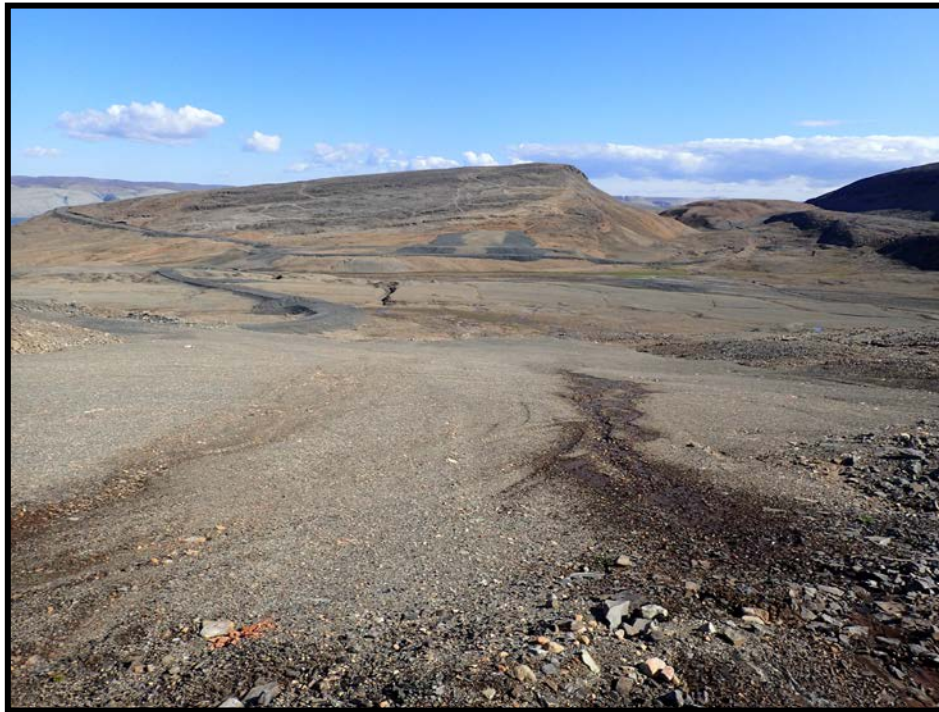
Photo 47. East Trench—Trench cover as seen from upslope edge. Not small flow of water on surface of cover causing minor rill erosion.

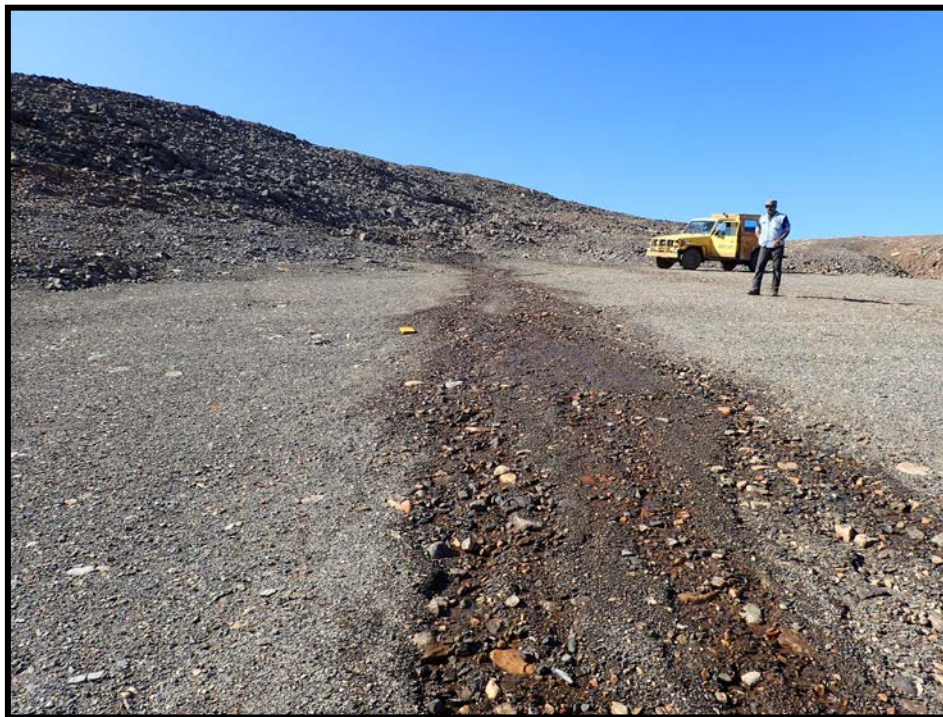
Photo 48. East Trench—Spring water running along surface of cover causing minor rill erosion

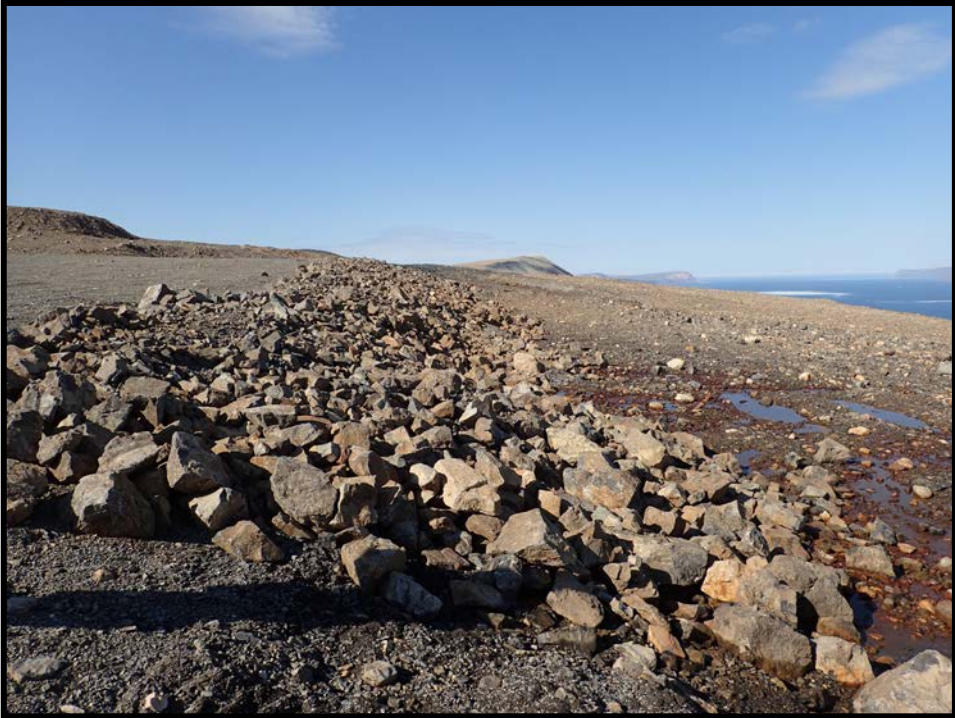
Photo 49. Oceanview Open Pit—Toe of cover system. Note seepage emerging at the bottom of toe.

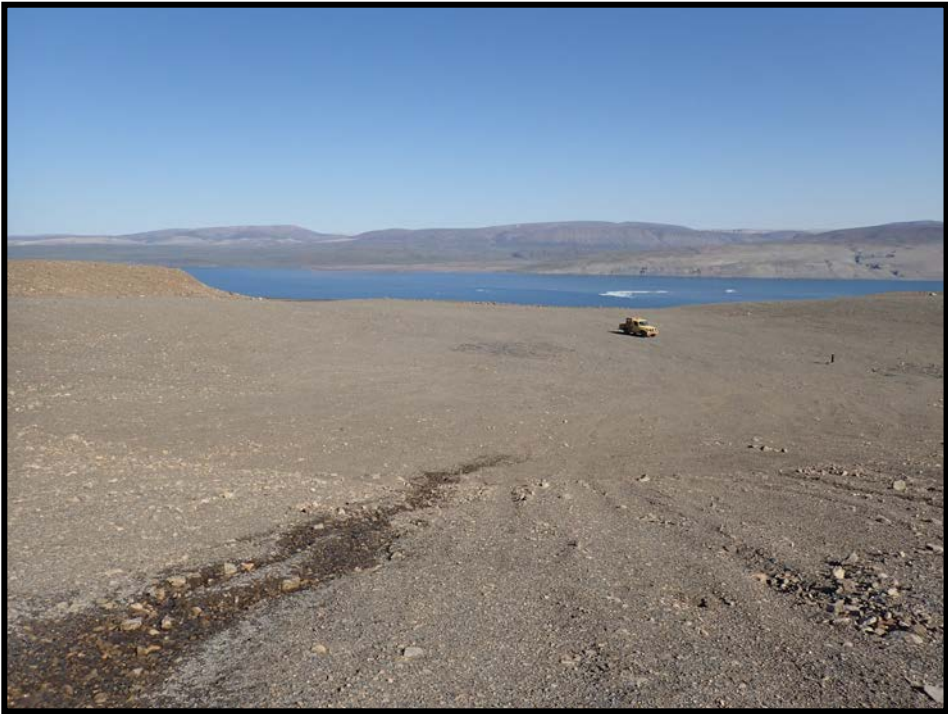
Photo 51. Oceanview Open Pit—Main pit area as seen from backslope.

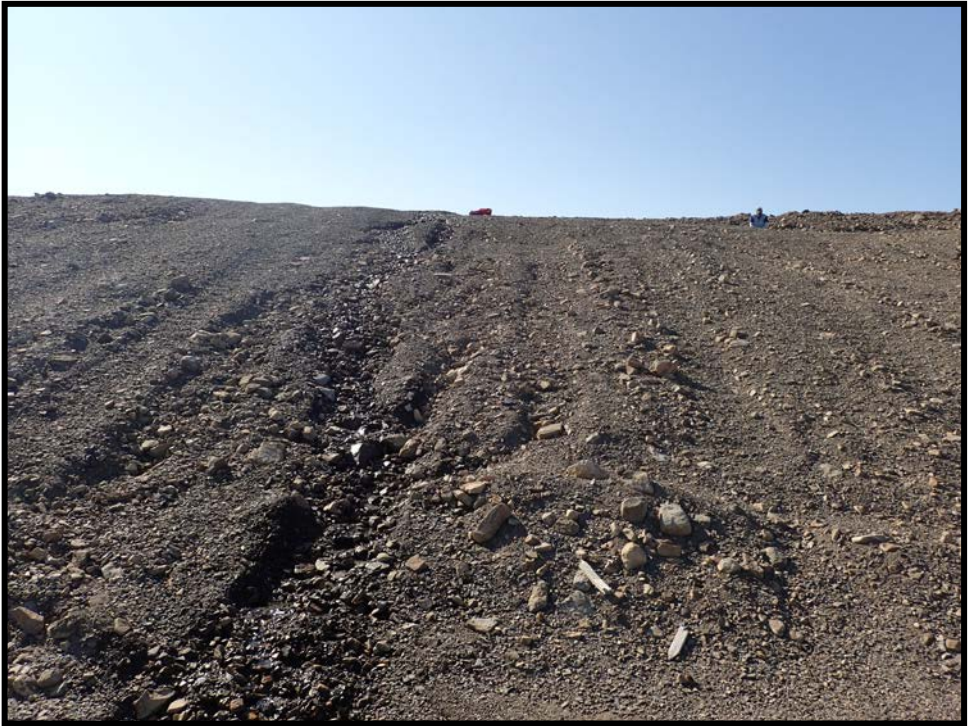
Photo 50. Oceanview Open Pit—Rill erosion along backslope. Note self armouring that is occurring.

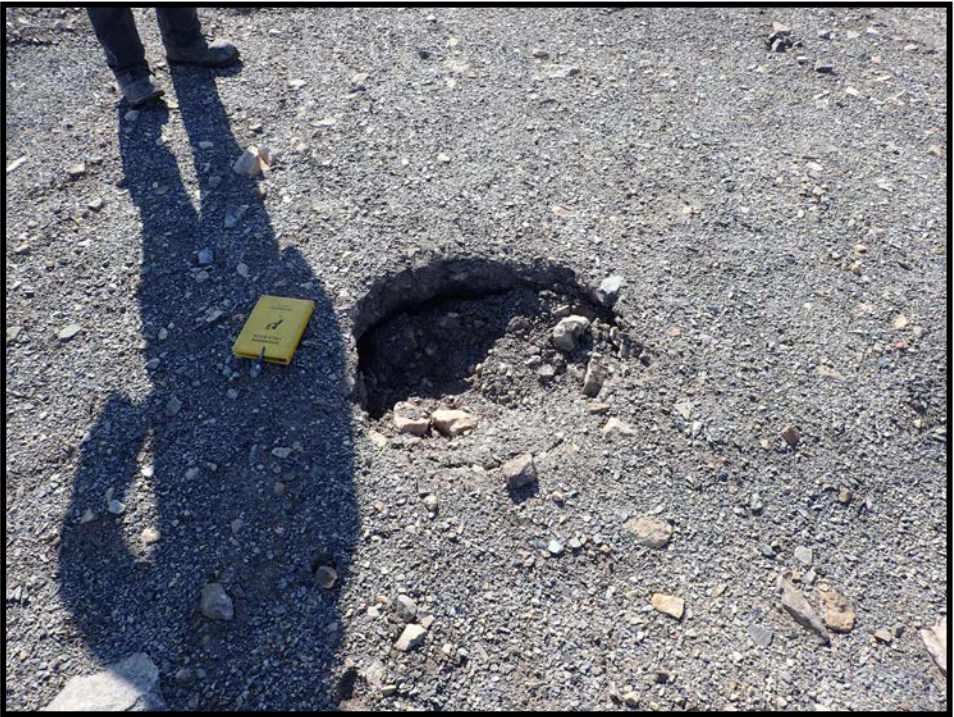
Photo 52. Oceanview Open Pit—Small sinkhole in middle of cover system. Note little visible change since 2014.

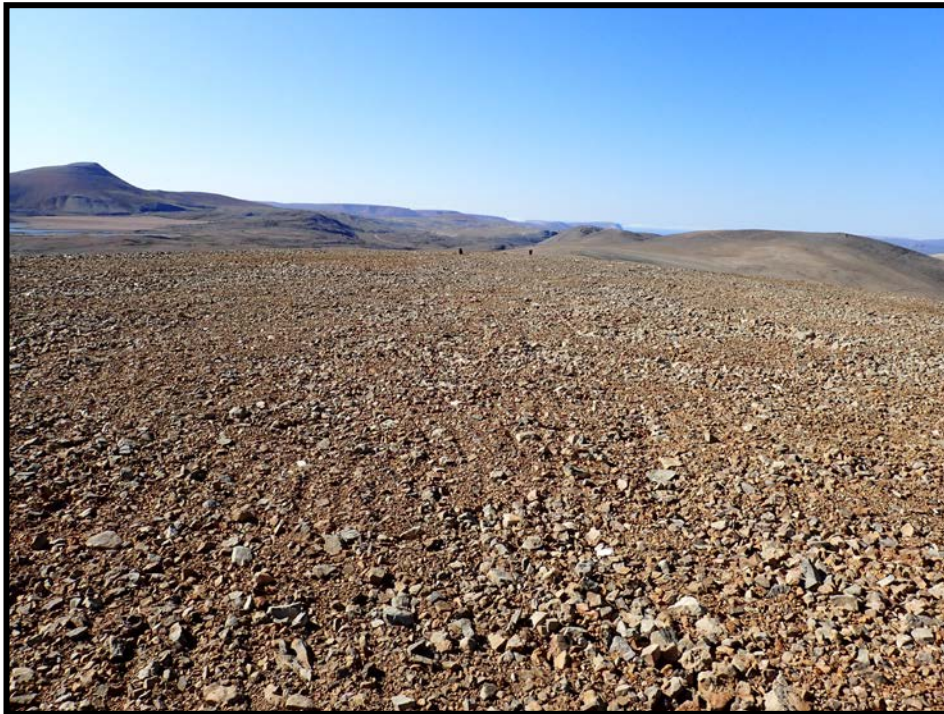
Photo 53. Area 14—Upper flat surface of waste rock cover.

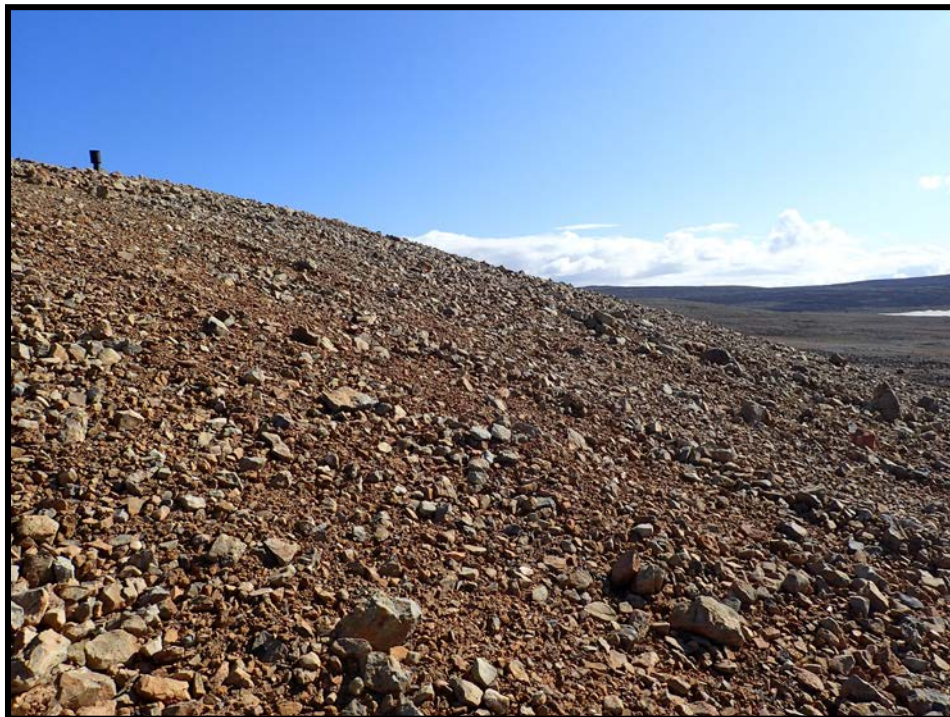
Photo 54. Area 14—Slope face of waste rock cover.

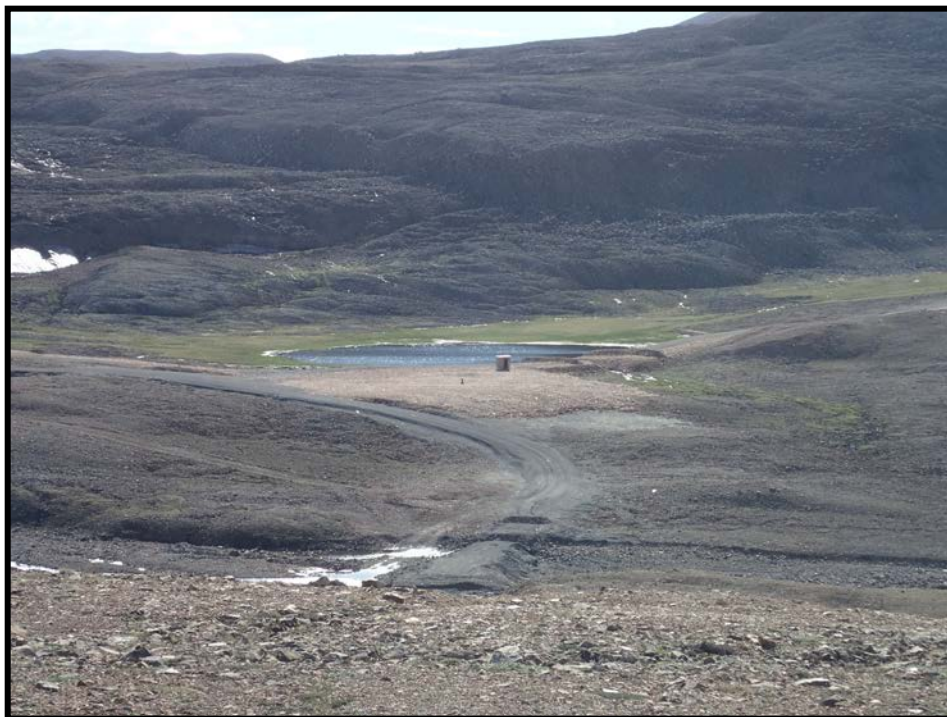
Photo 55. Upper Dump Pond—General view of cover system, as seen from road above 09S portal.

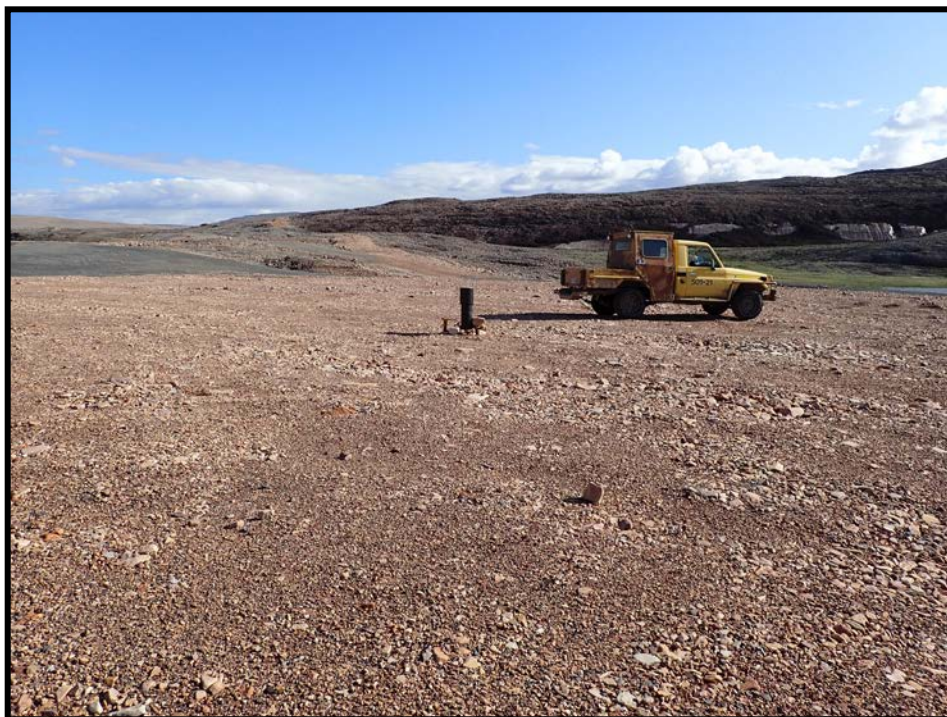
Photo 56. Upper Dump Pond—View of surface of cover.

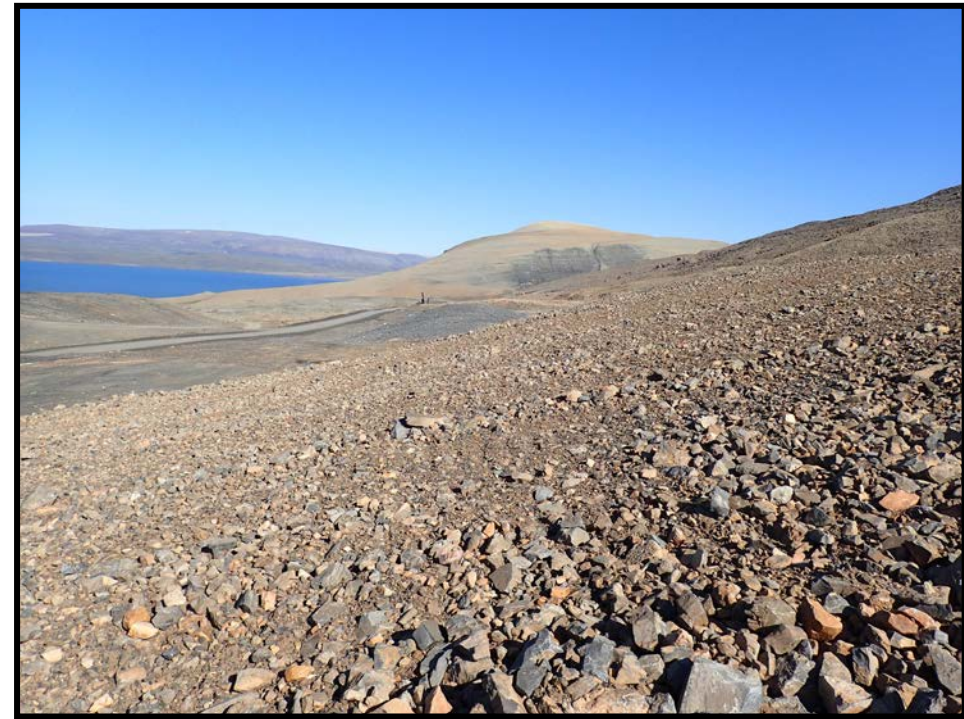
Photo 57. Industrial Complex Cover—View across sloping face of cover.

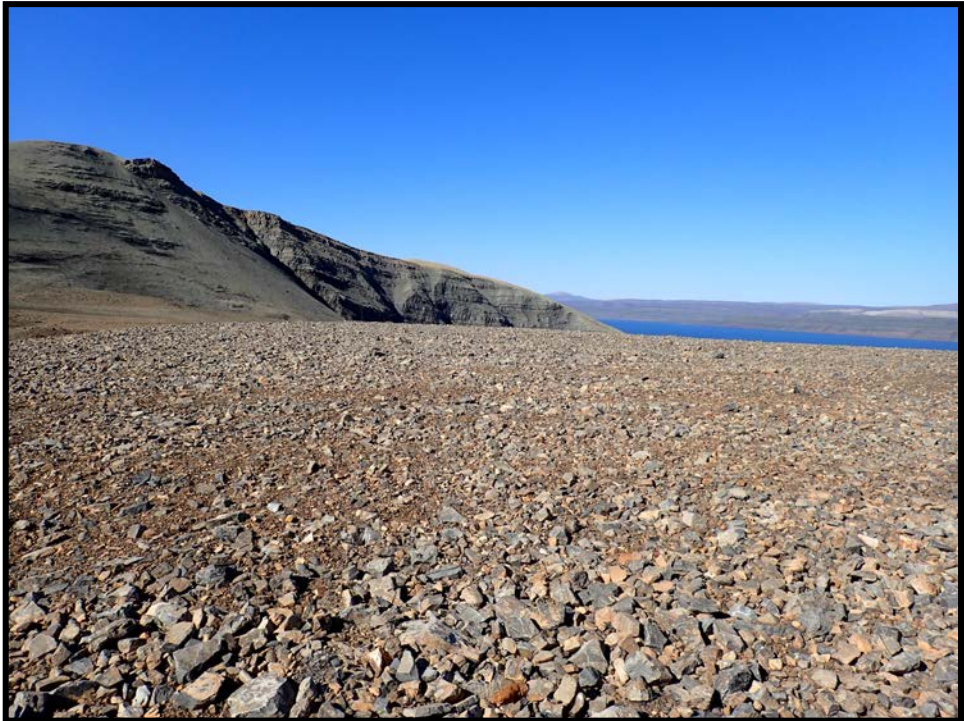
Photo 59. Industrial Complex Cover—Surface of cover system.

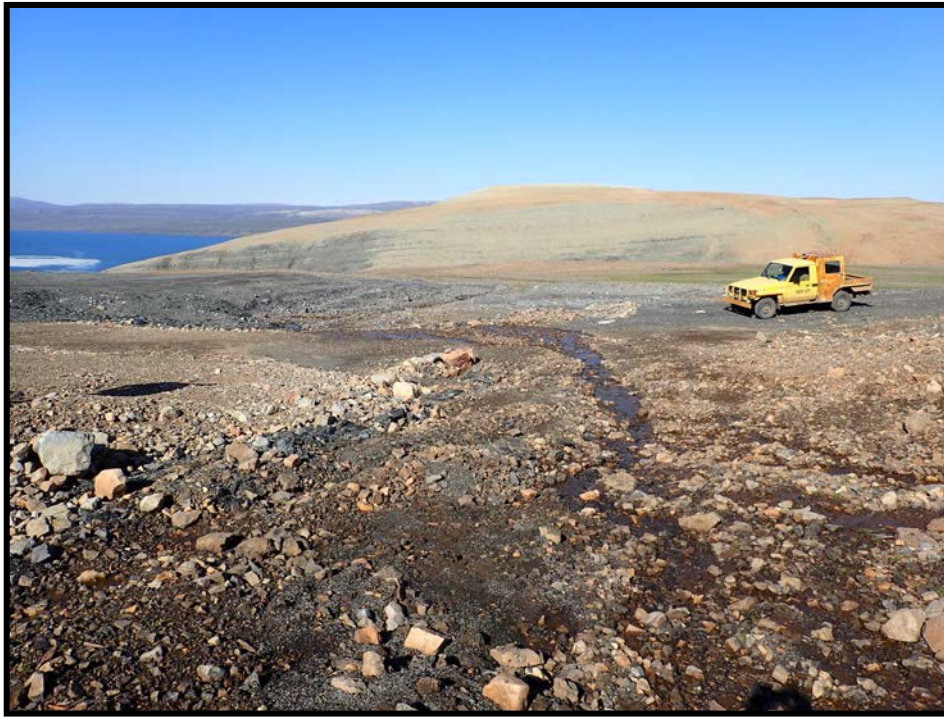
Photo 60. 17N Portal—Surface water running along east edge of portal cover.

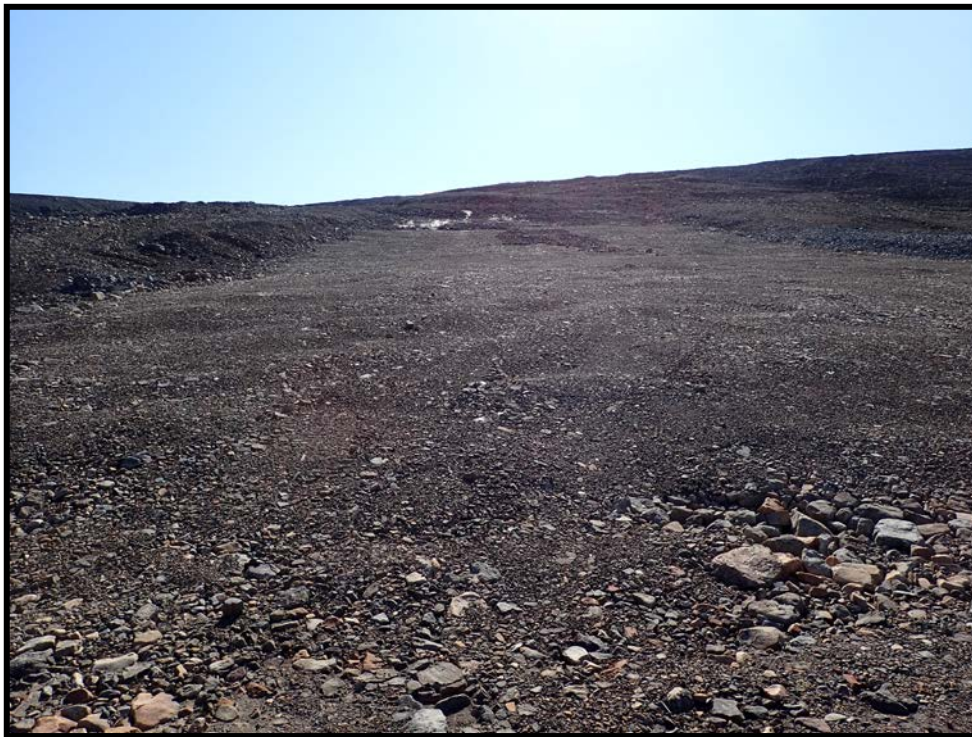
Photo 61. 17N Portal—Looking upslope along surface of cover.

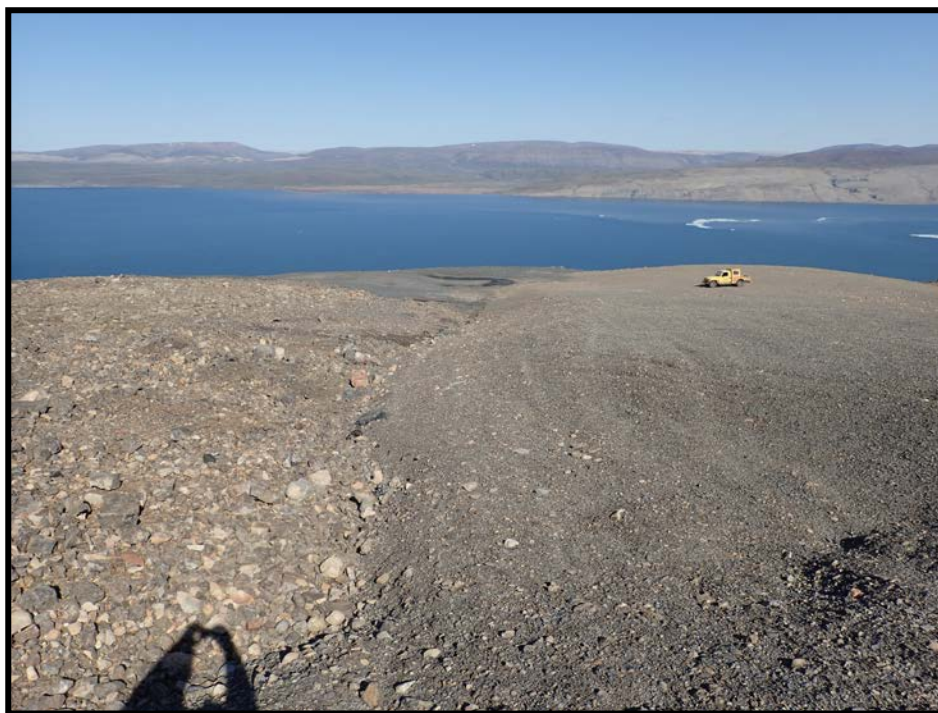
Photo 63. Oceanview Portal—Settlement area along west edge of cover. Note very little to no change in 10 years.

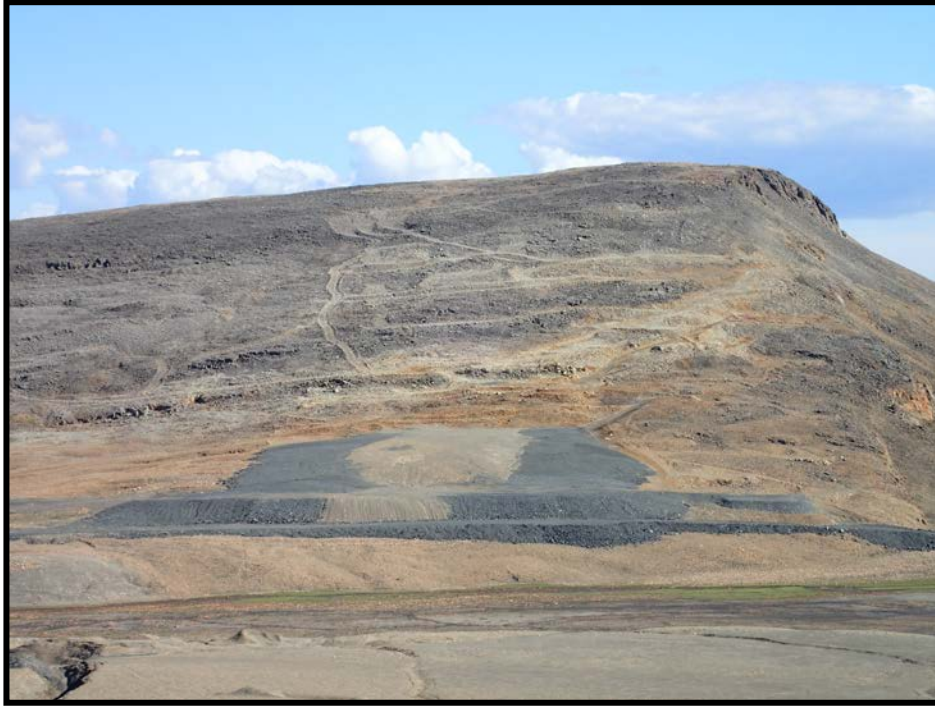
Photo 64. K-Baseline Portal—Surface of cover as seen from East Trench.

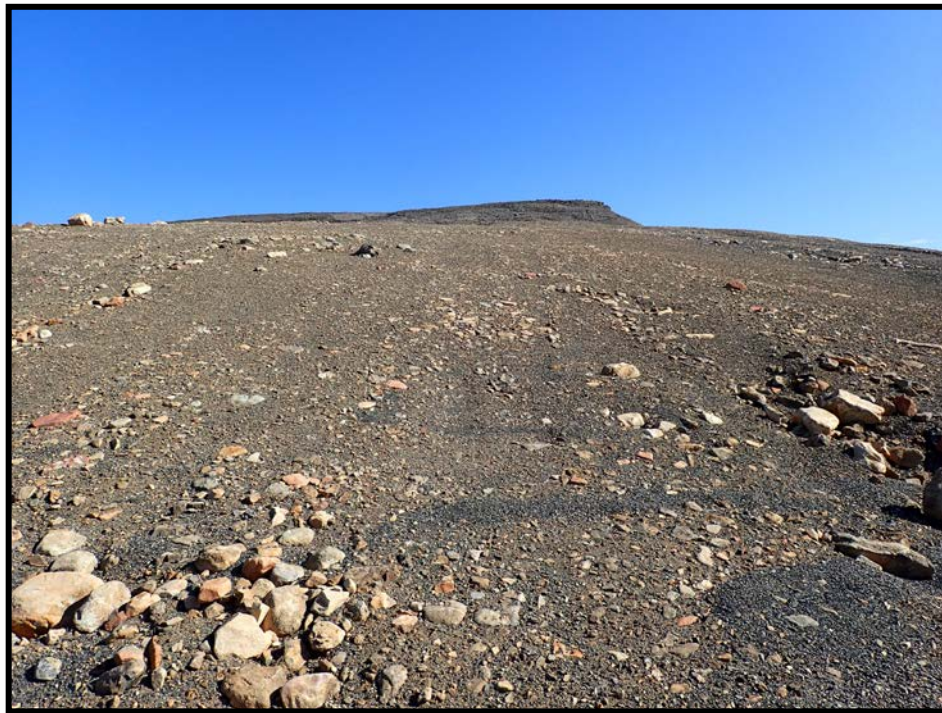
Photo 65. K-Baseline Portal—Sloping face of cover system looking upslope.

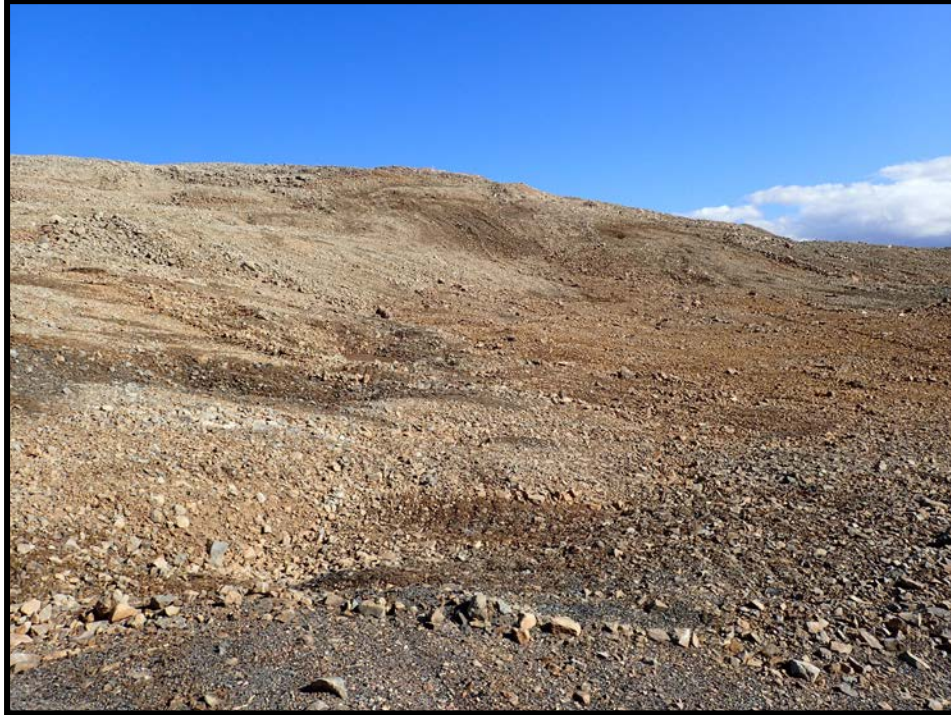
Photo 66. Area 14 Portal—Surface of portal cover system.

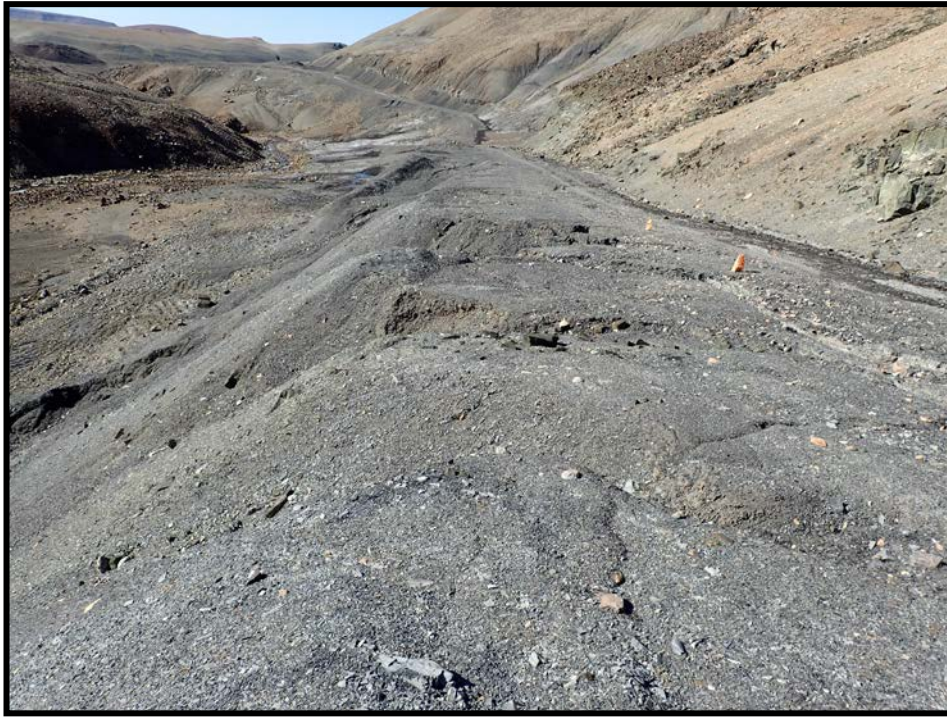
Photo 67. 09S Portal—Eroding road between 09S and 17N portals.

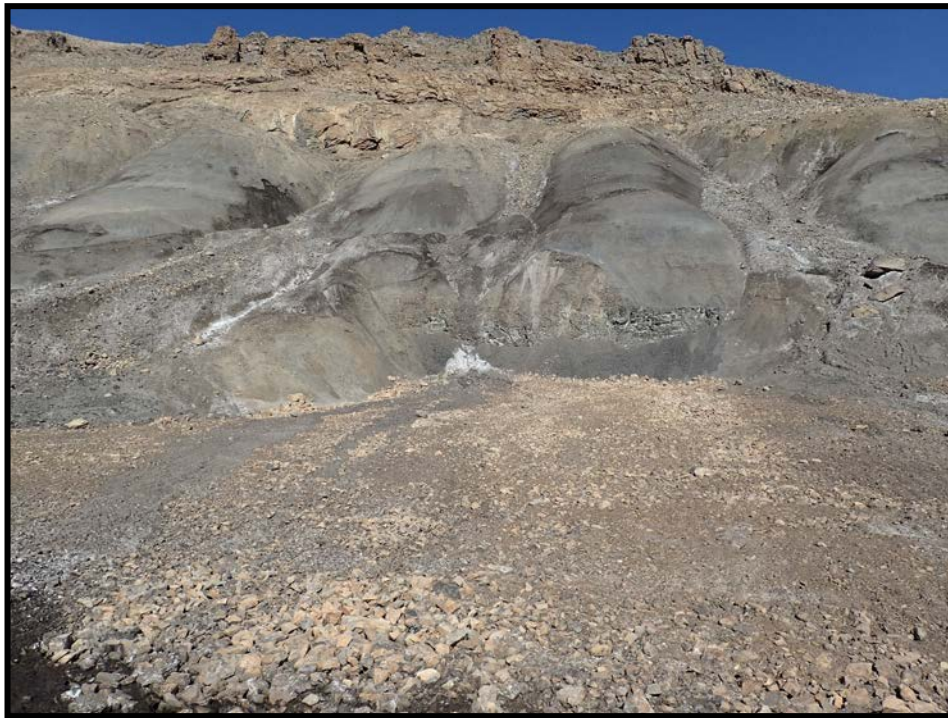
Photo 68. 09S Portal—Looking upslope along surface of cover. Note shale deposited on top of armour from upslope.

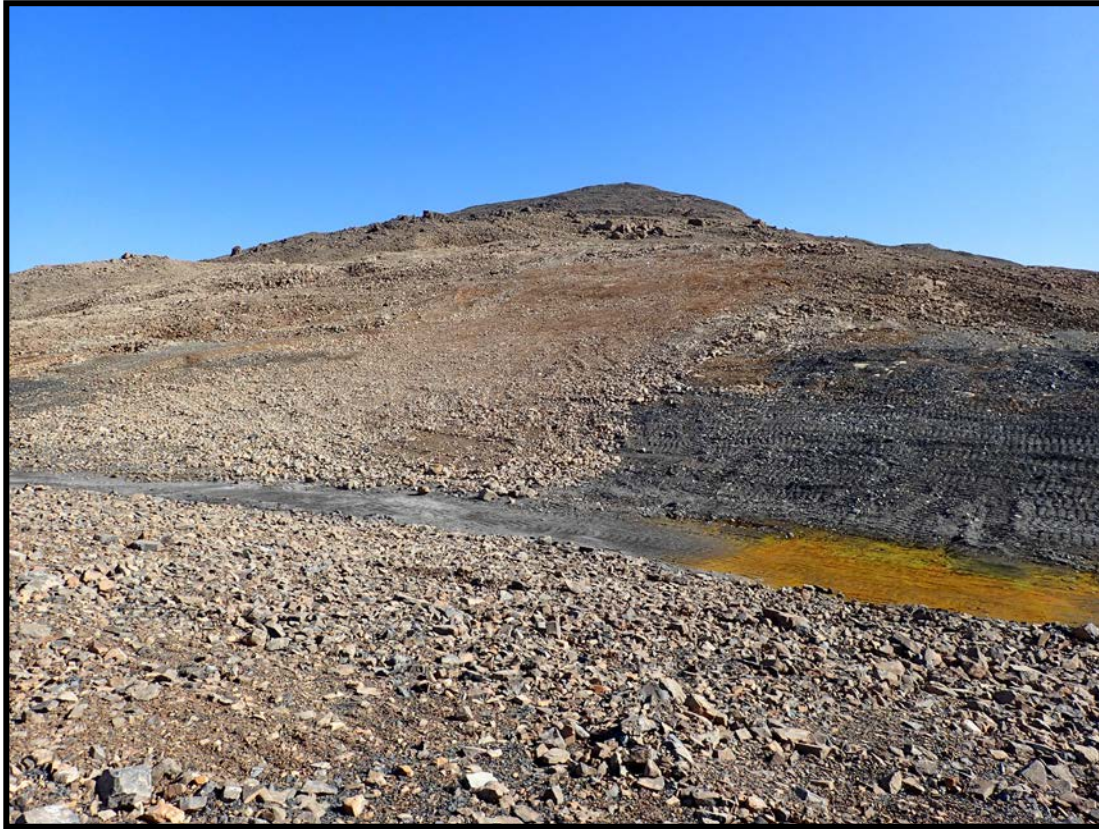
Photo 69. Lower Adit—As seen from Industrial Complex cover.

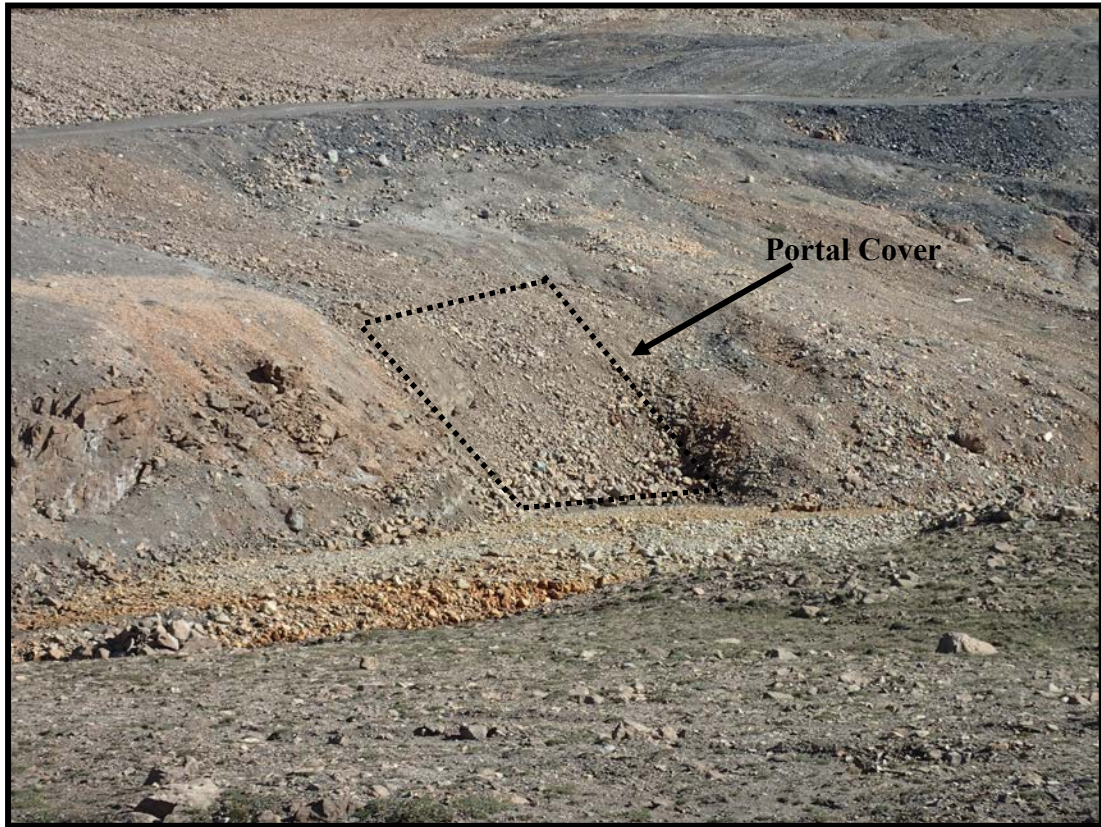
Photo 70. Mill Portal—Portal plug as seen from right bank of Twin Lakes Creek.

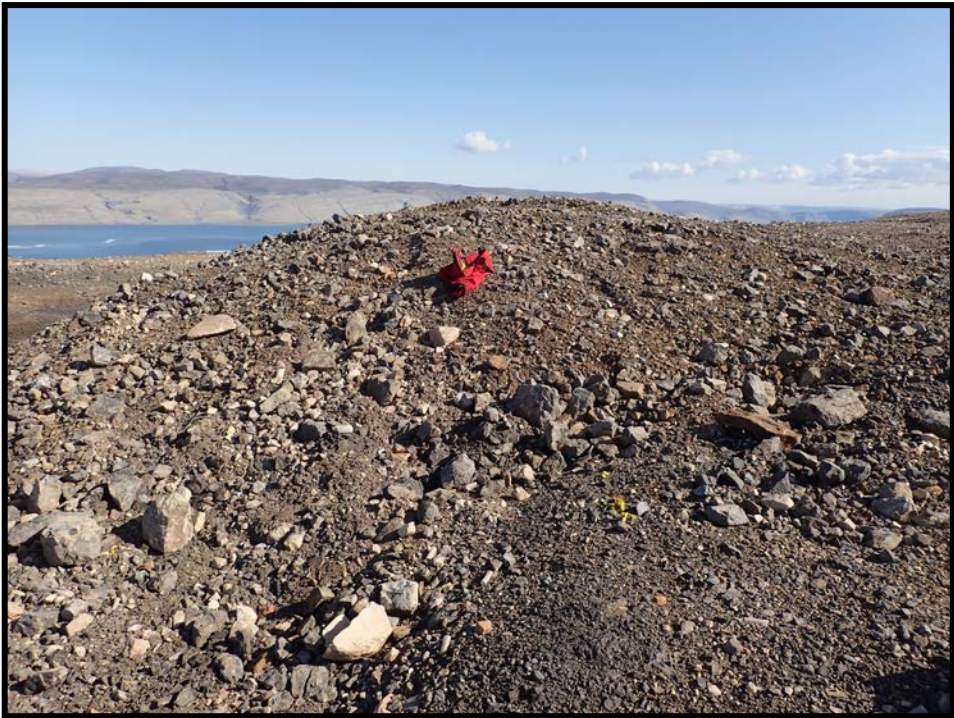
Photo 73. Oceanview West Raise— Mound over backfilled raise. No settlement has been observed.

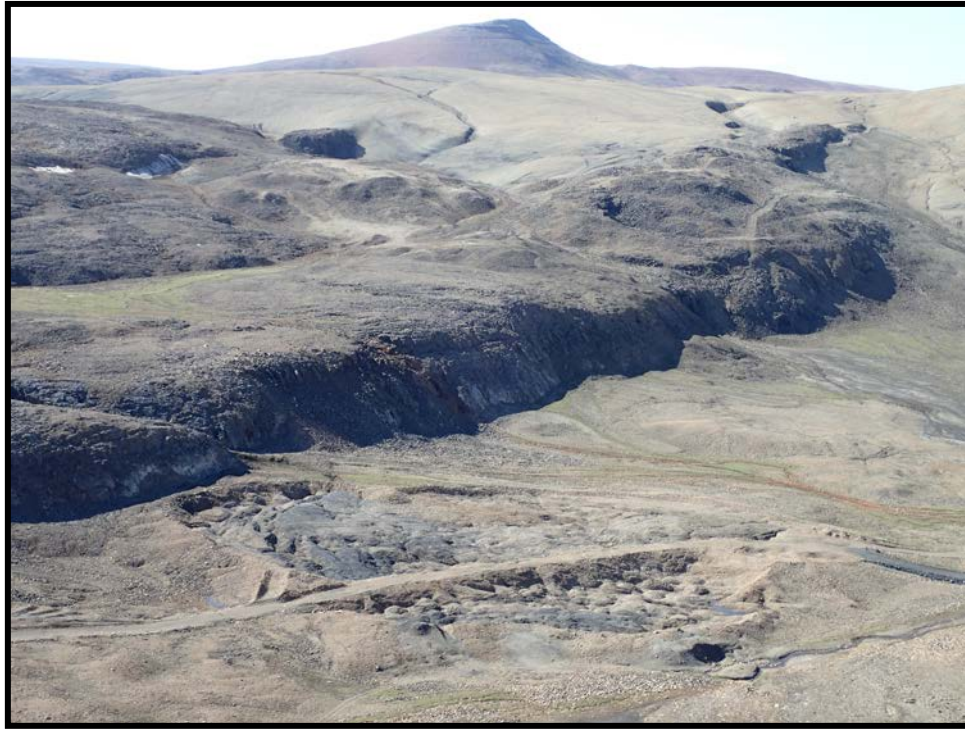
Photo 79. Kuhulu Lake Road Armour Quarry—Thermokarsting in floor of quarry. Note minor ponding near northwest corner.

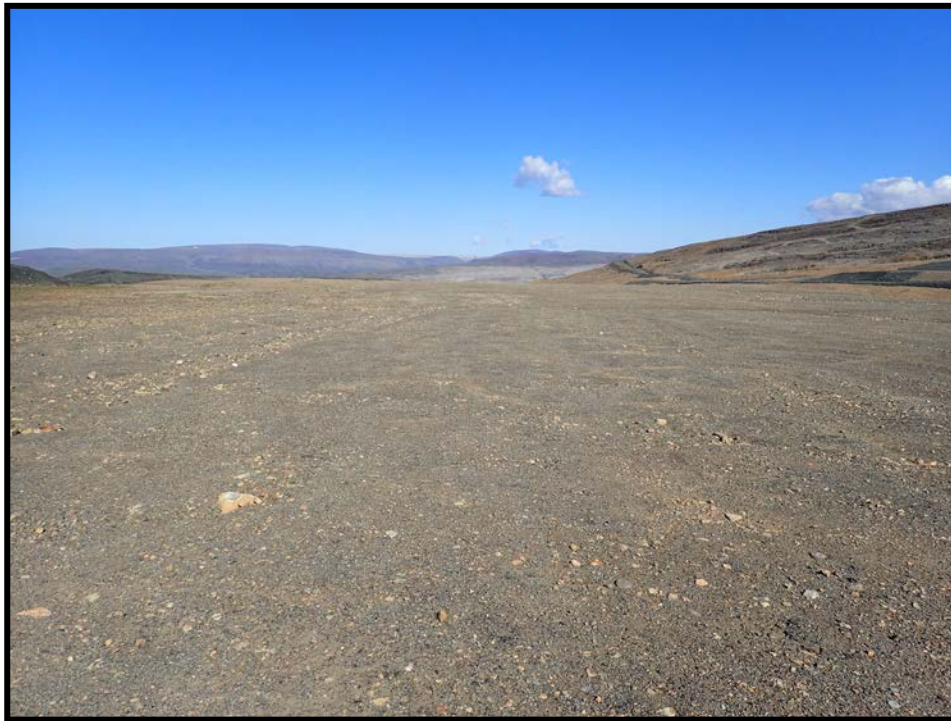
Photo 80. Chris Creek Armour Quarry—Surface of quarry floor.
