## **NYRSTAR**

### **NANISIVIK MINE, NUNAVUT**

## **2015 ANNUAL GEOTECHNICAL INSPECTION**

PROJECT NO.: 0255-026  
DATE: March 30, 2016  
DOCUMENT NO.:

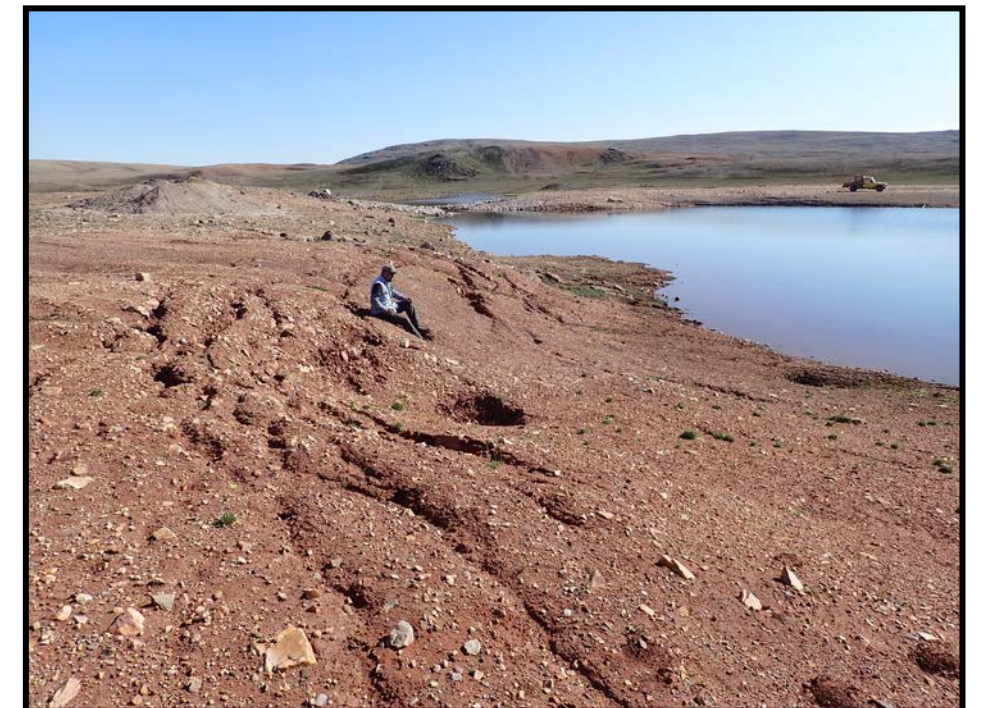
Photo 12. West Twin Outlet Channel—Settlement induced cracking along north edge of polishing pond.

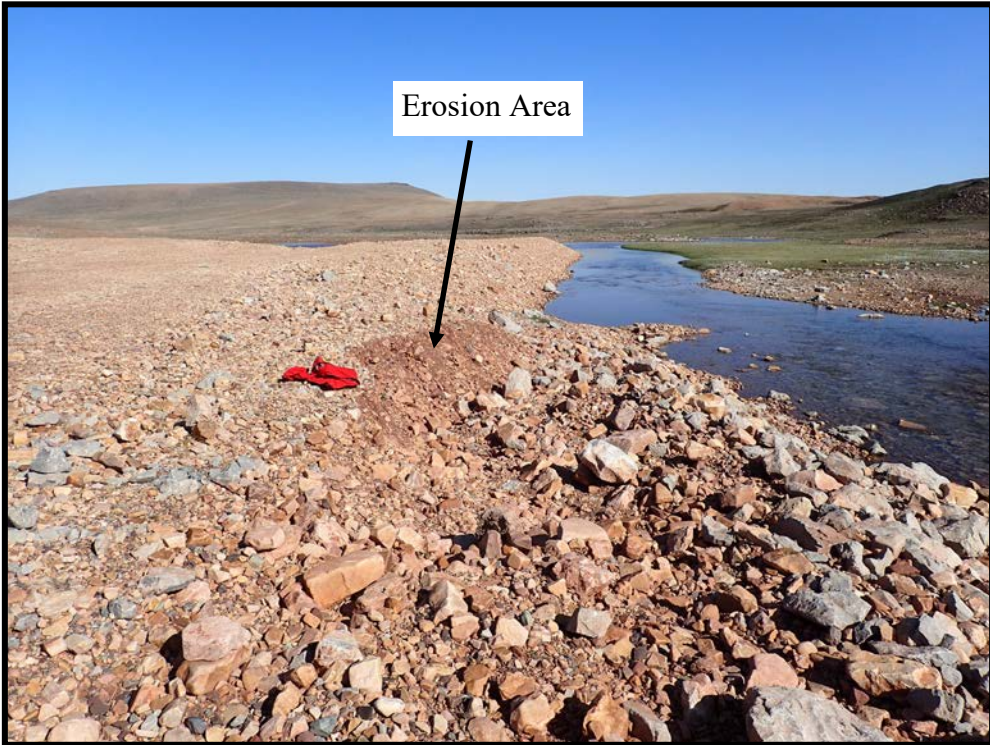
Some erosion at the East Twin Diversion Dyke was noted during the inspection. The erosion was likely due to elevated flows during freshet in combination with snow blockage in the channel. The erosion appeared to be similar to what was observed in 2015. In general the dyke remains in stable condition. However, it is recommended that additional re-sloping and armouring of select areas of the channel be undertaken to enhance long term performance. As has been observed during inspections over the past few years, seepage was observed at the toe of the East Twin Diversion Dyke in 2015 upstream of the convergence of flow from West Twin. The seepage flow rate was observed to have a similar flow rate compared to previous years. This seepage is likely originating in the remnant polishing pond. There is no concern with respect to the integrity of the dyke due to the presence of this seepage. However, it is recommended that this seepage be monitored for increased flows in 2016.

Photo 15. East Twin Creek Diversion Channel– Erosion area noted above seepage discharge point. Erosion is similar to 2013.

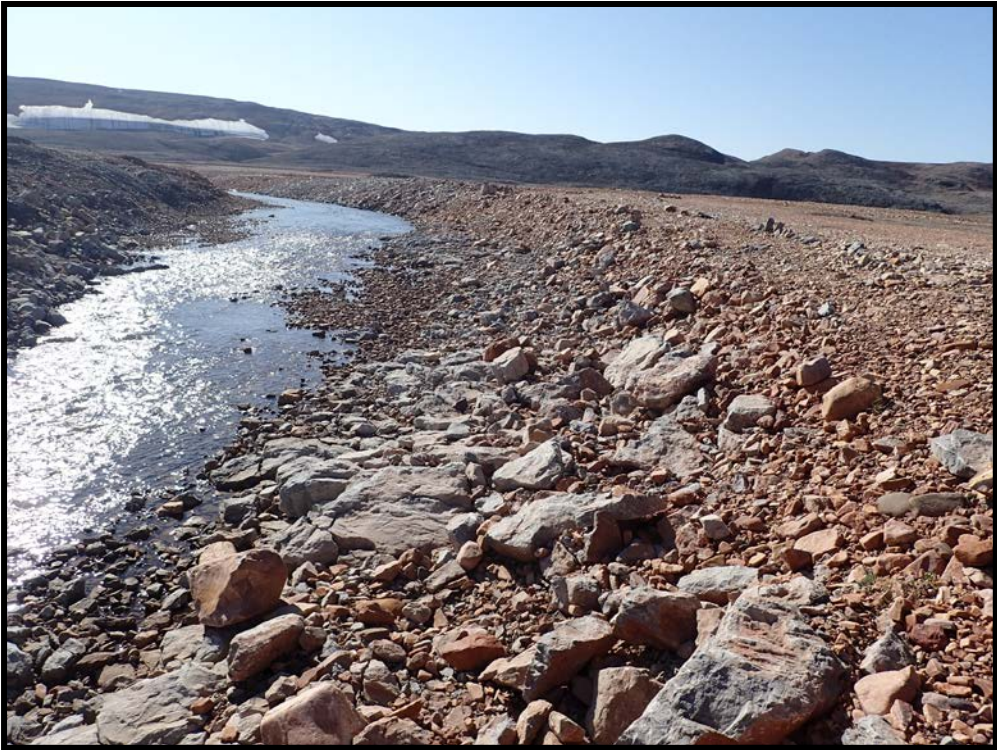
Photo 16. East Twin Creek Diversion Channel– View of area downstream of armoured area. Note bedrock outcrop along face of dyke and in bottom of channel.

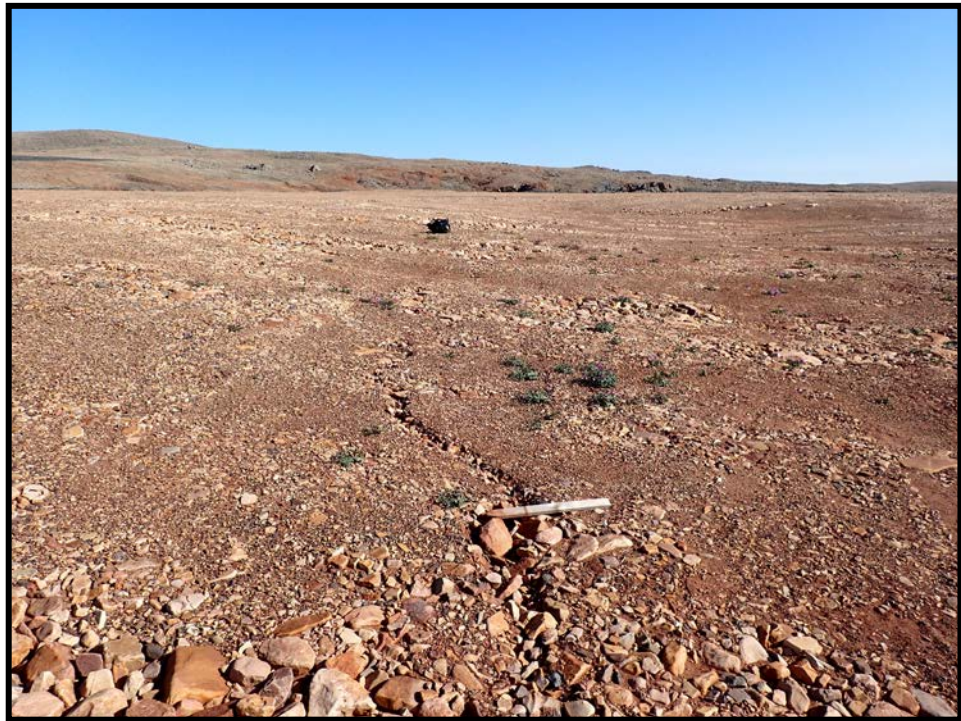
Photo 19. Surface Cell—Cracking in secondary N/S drainage swale. View looking north.

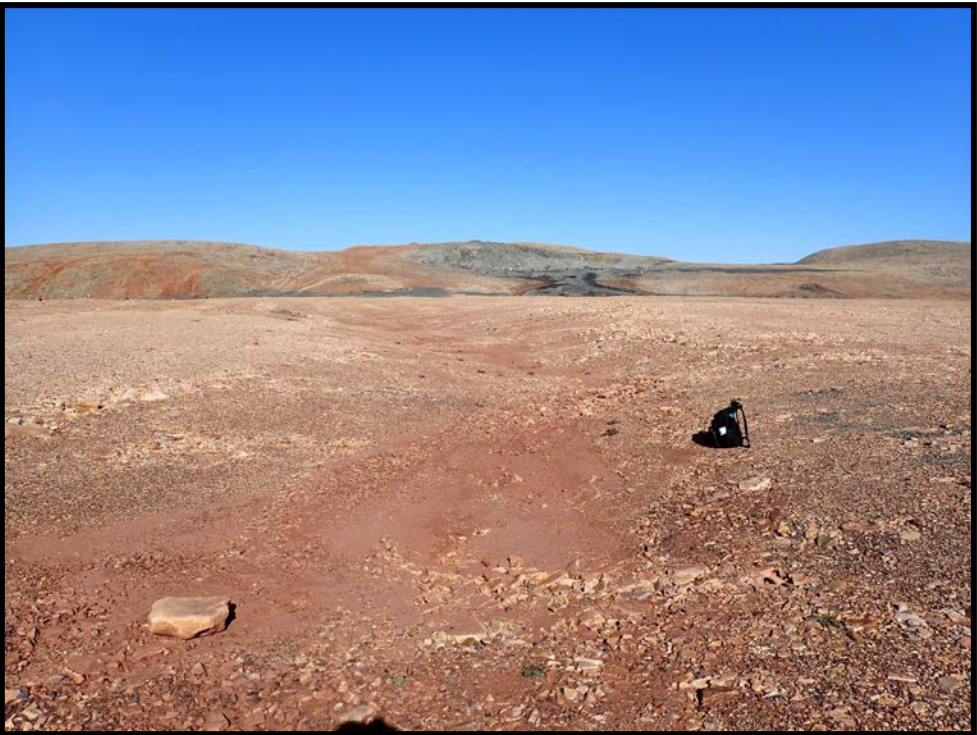
Photo 20. Surface Cell—E/W drainage channel on Surface Cell cover. View looking west.

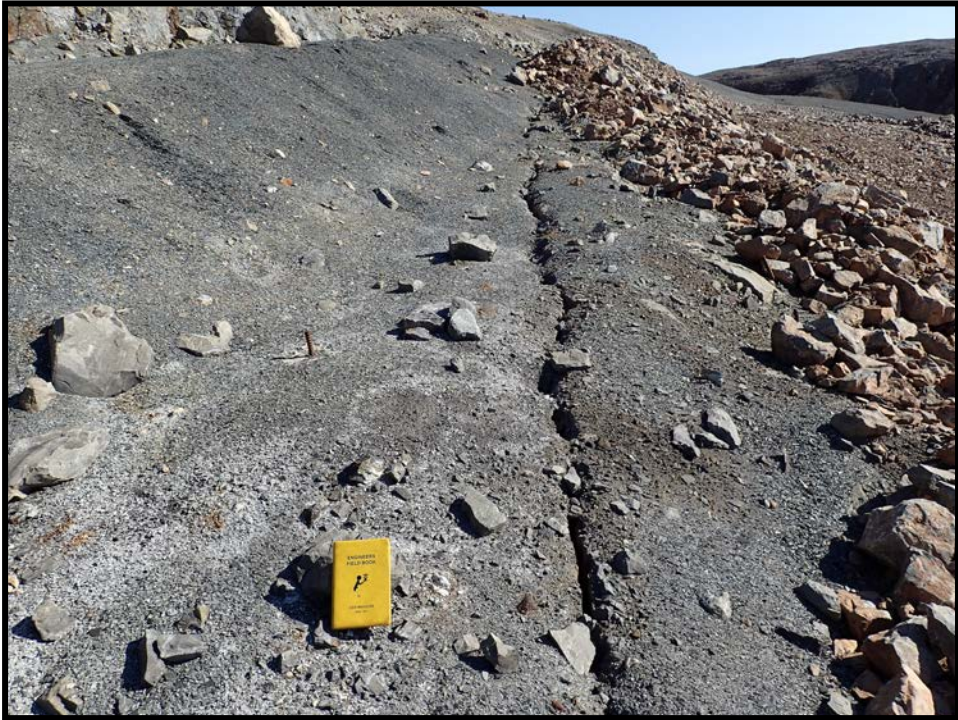
Photo 39. West Open Pit—Crack in crown pillar. Note that there has been no visual change in the 10 years since closure.

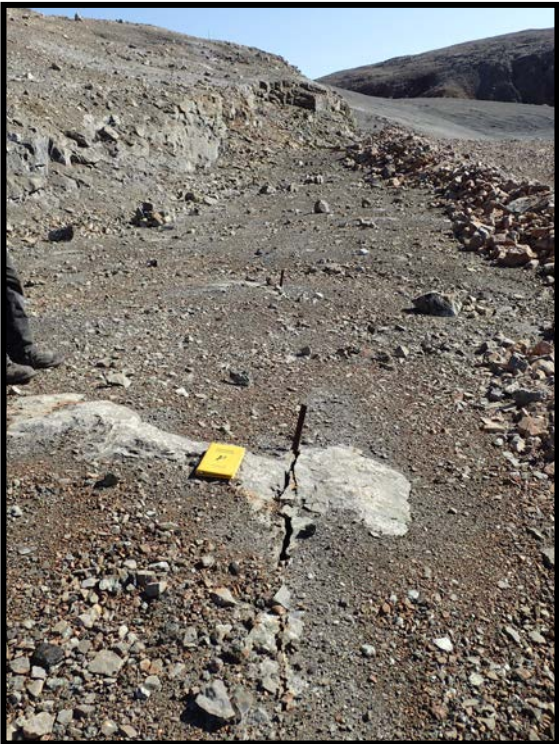
Photo 40. West Open Pit—Crack in crown pillar. Note that there has been very little change in the 10 years since closure.

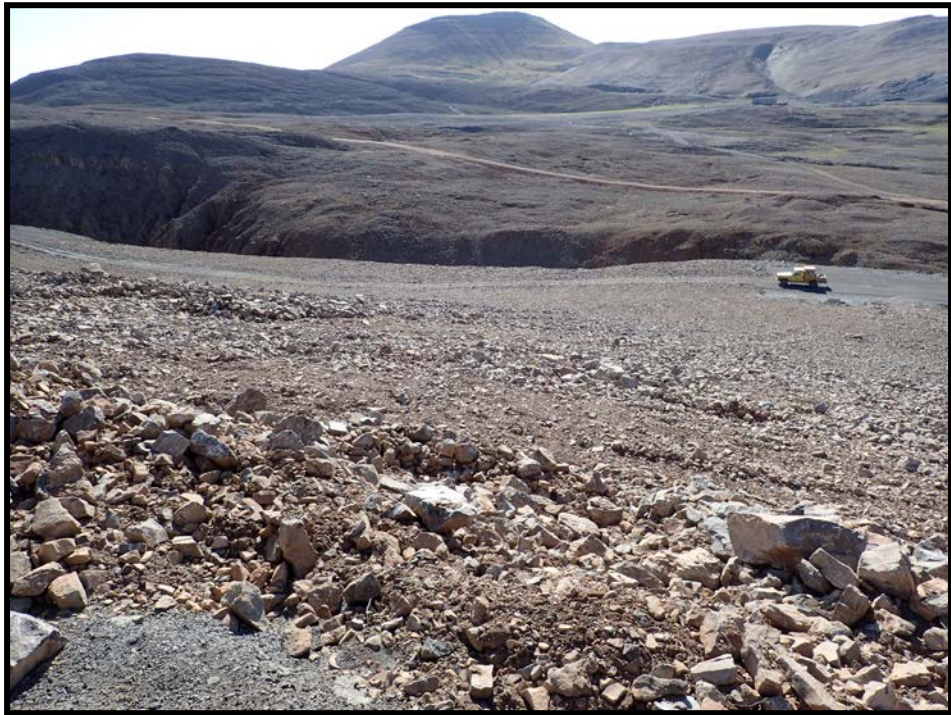
Photo 41. West Open Pit—Surface of cover system looking downslope.

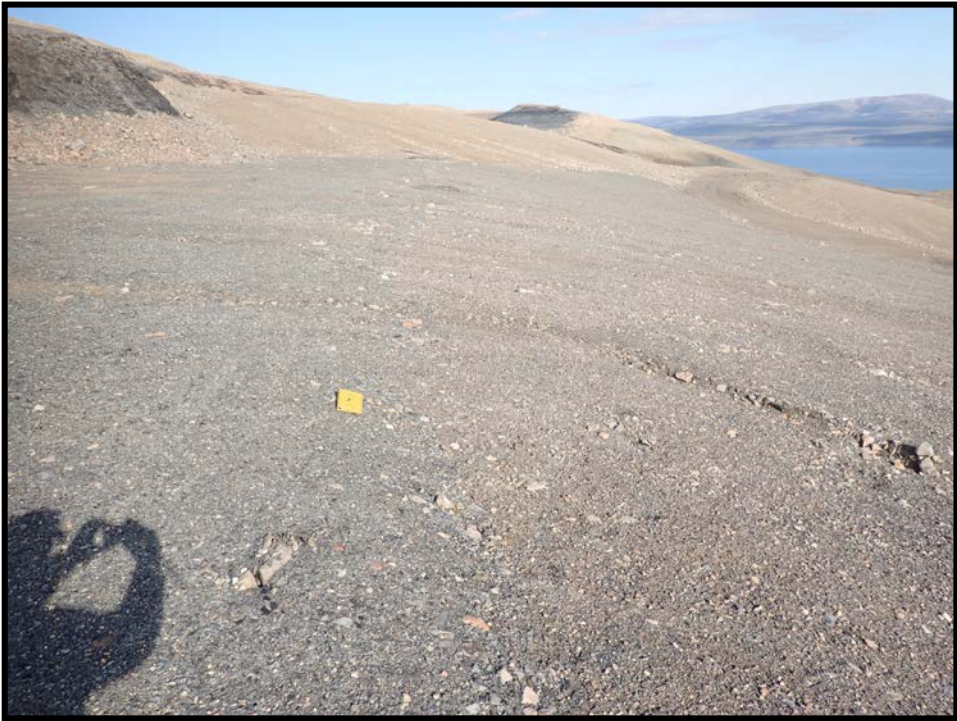
Photo 43. East Open Pit— At transition from flat to sloping upper surface of cover system. Note minor settlement and cracking.

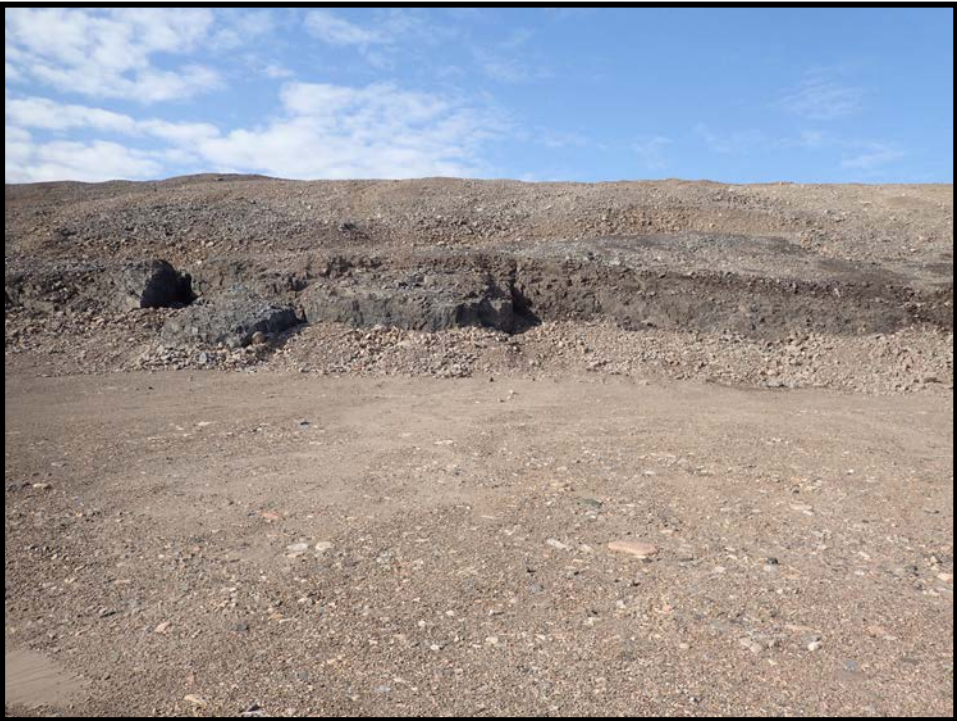
Photo 44. East Open Pit—Face of remnant highwall where cracking of crown pillar has been observed.

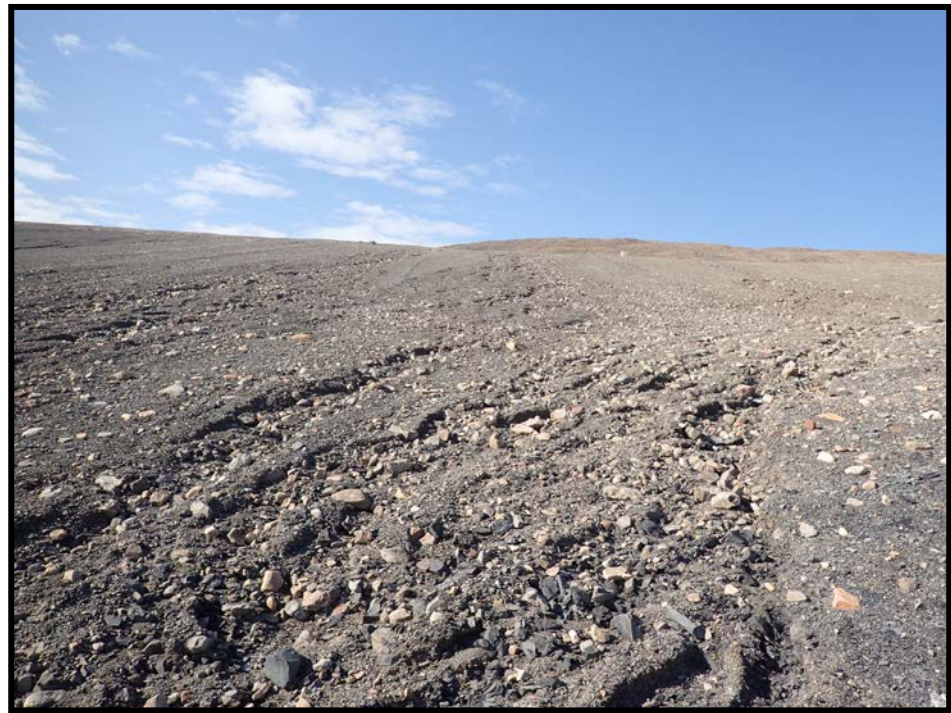
Photo 45. East Open Pit—Looking upslope along lower sloping face of cover. Note rill erosion.

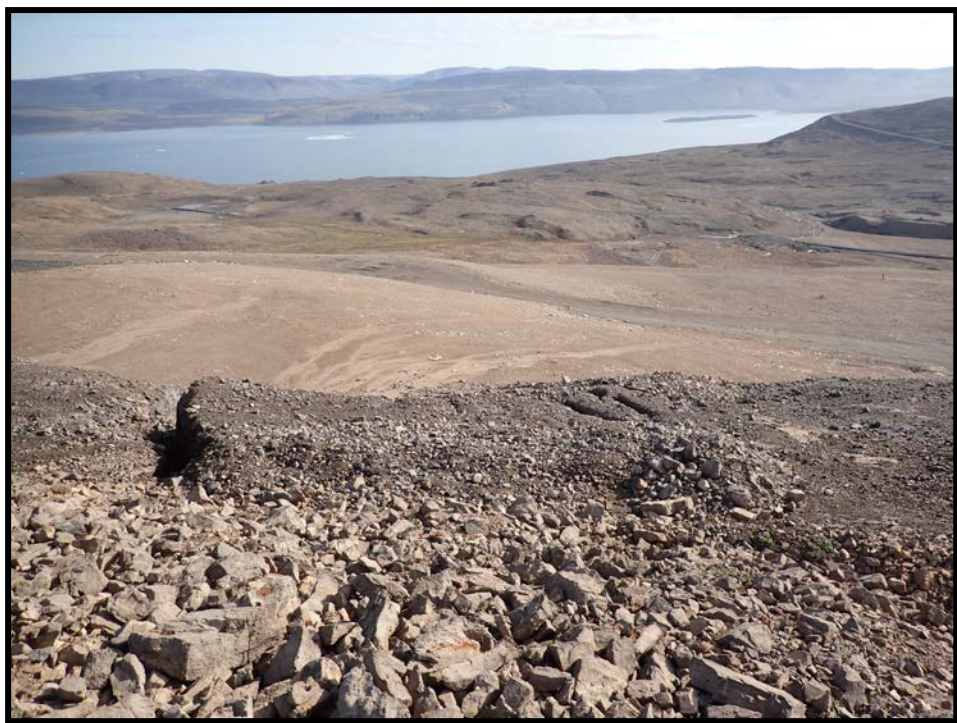
The covers constructed over the mine openings generally appear to be physically stable. Cracking at the East Open Pit crown pillar does not appear to have progressed since 2011. No maintenance is recommended, but continued visual inspection is warranted.

Photo 46. East Open Pit—Cracking in crown pillar. Similar condition to 2014.

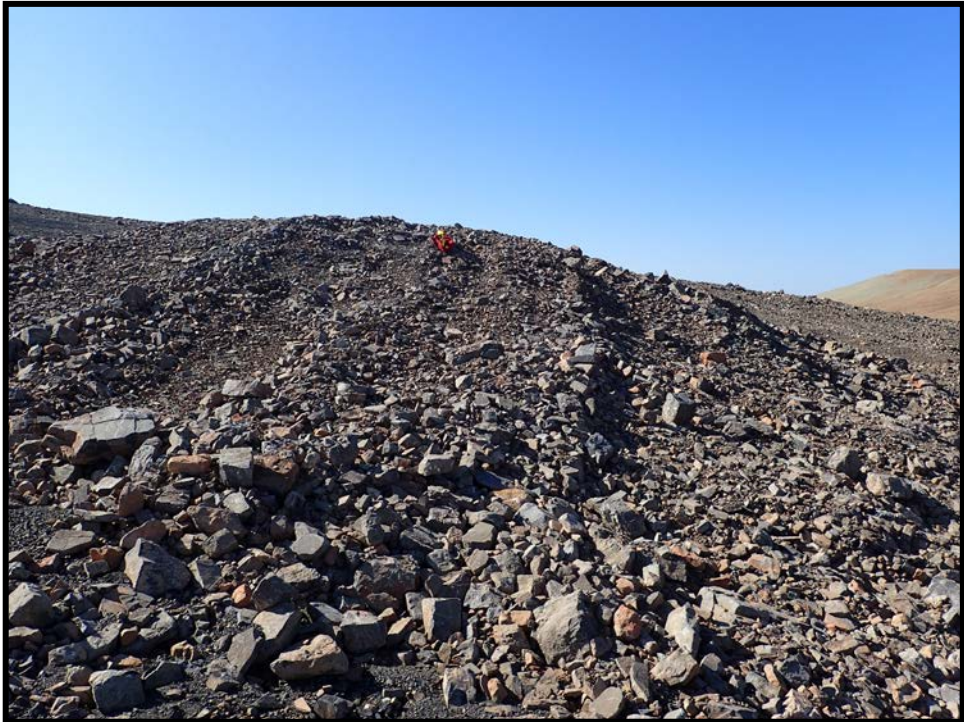
Photo 71. Shale Hill Raise—Mound over backfilled raise. No settlement has been observed.

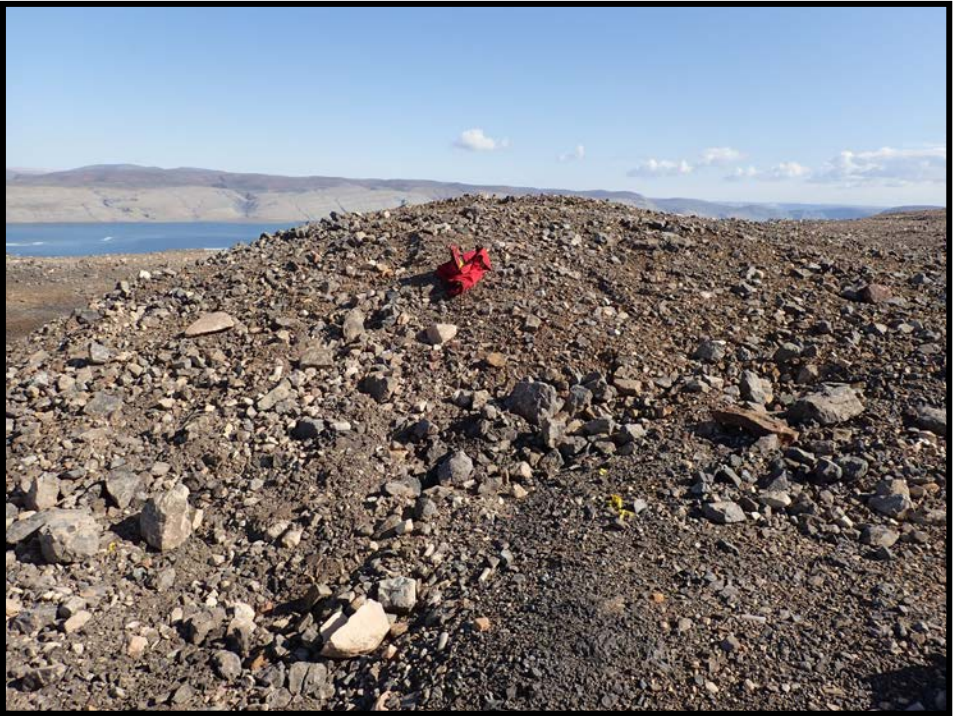
Photo 72. Oceanview East Raise. — Mound over backfilled raise. No settlement has been observed.

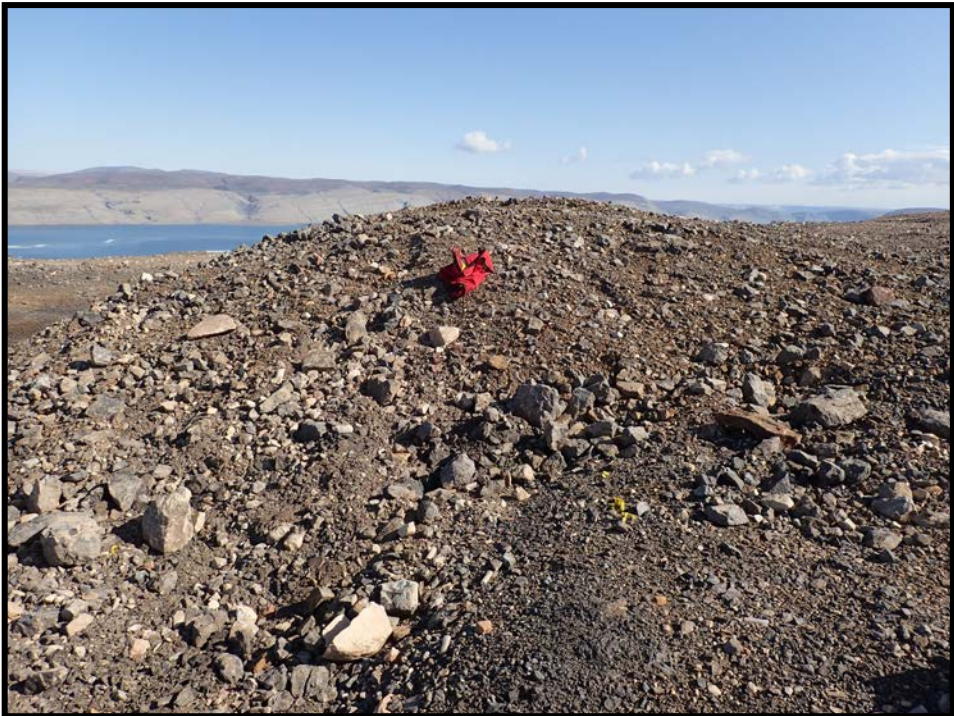
Photo 73. Oceanview West Raise— Mound over backfilled raise. No settlement has been observed.

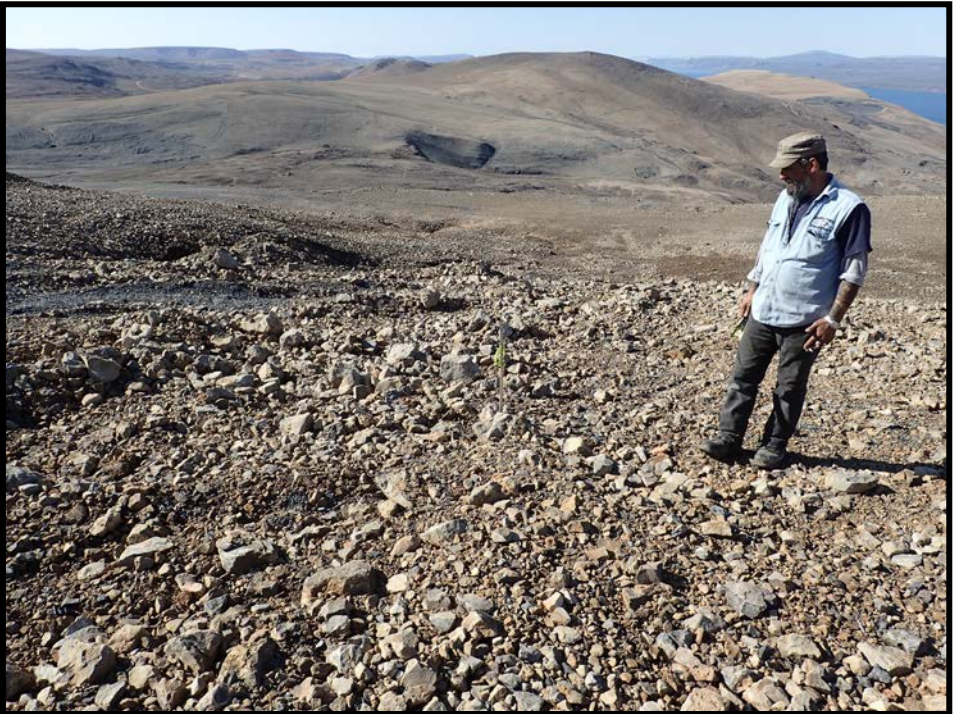
Photo 74. Area 14 Raise—Graded area above backfilled raise. Note stake with flagging denoting approximate location of raise.
