NYRSTAR

NANISIVIK MINE, NUNAVUT

2016 ANNUAL GEOTECHNICAL INSPECTION

PROJECT NO.: 0255027
DATE: March 7, 2017
DOCUMENT NO.:

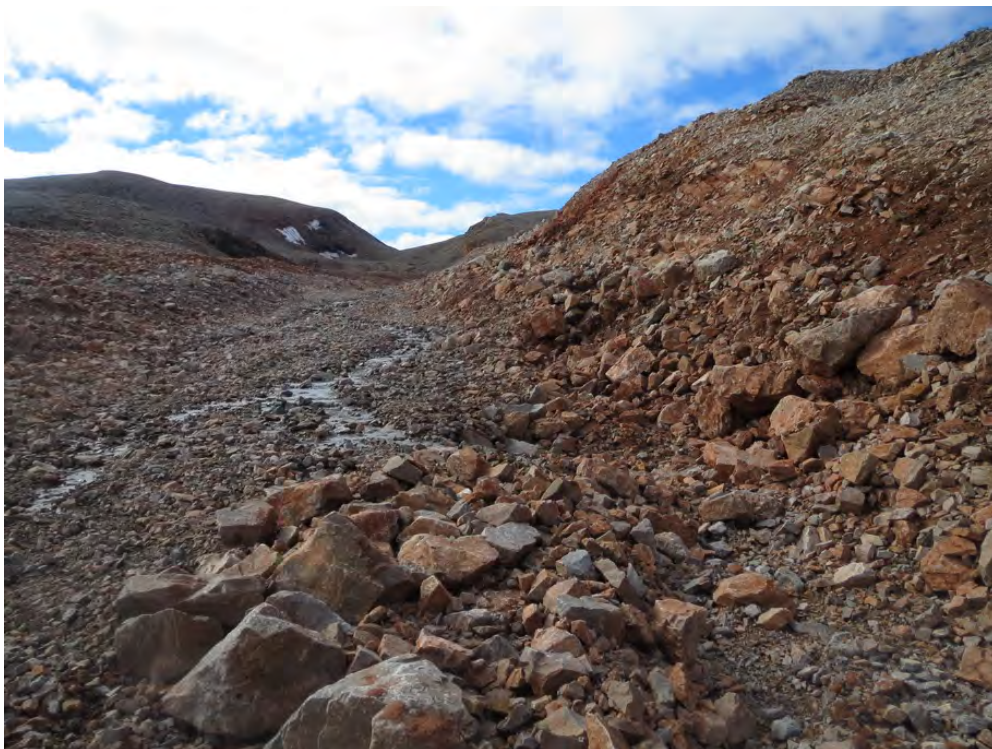
- Erosion of the left bank materials due to freshet flows breaching the ice-plug at the spillway entrance has been observed in previous years (Photo 6). During the spring of 2014, Mr. Claude Lavallee was on-site when the ice-plug breach occurred. The observations collected during this time provide further insight into the erosive event that occurs annually. Based on his observations collected during the event, the flow following the breaching of the ice-plug becomes focused along the left bank at an elevated level 1 to 2 m above the base of the spillway. Draining of the water that backs up on the Surface Cell cover occurred quickly, over a period of less than four hours. Some erosion of the bank armour materials occurred before the flow re-entering the spillway towards the outlet, depositing eroded material in the base of the spillway (Photo 8).

- Some armour material from the left bank was also observed to have raveled into the bottom of the spillway in response to the freshet erosion, restricting the width of the base of the spillway by about a third over a 10 m length of the spillway.

Photo 6. West Twin Dyke Spillway—Erosion along left bank of spillway.

While the spillway currently remains effective in directing and confining flow from the Surface Cell to the Reservoir, it is recommended that additional armouring of the left bank be considered to address these types of flow events in the future. Re-grading the base of the spillway to ensure the full design width is available for flow should be completed at the same time. Until these issues are addressed, it is recommended that the spillway channel continue to be inspected annually for stability of the side slopes and erosion of the side slopes and channel bottom.

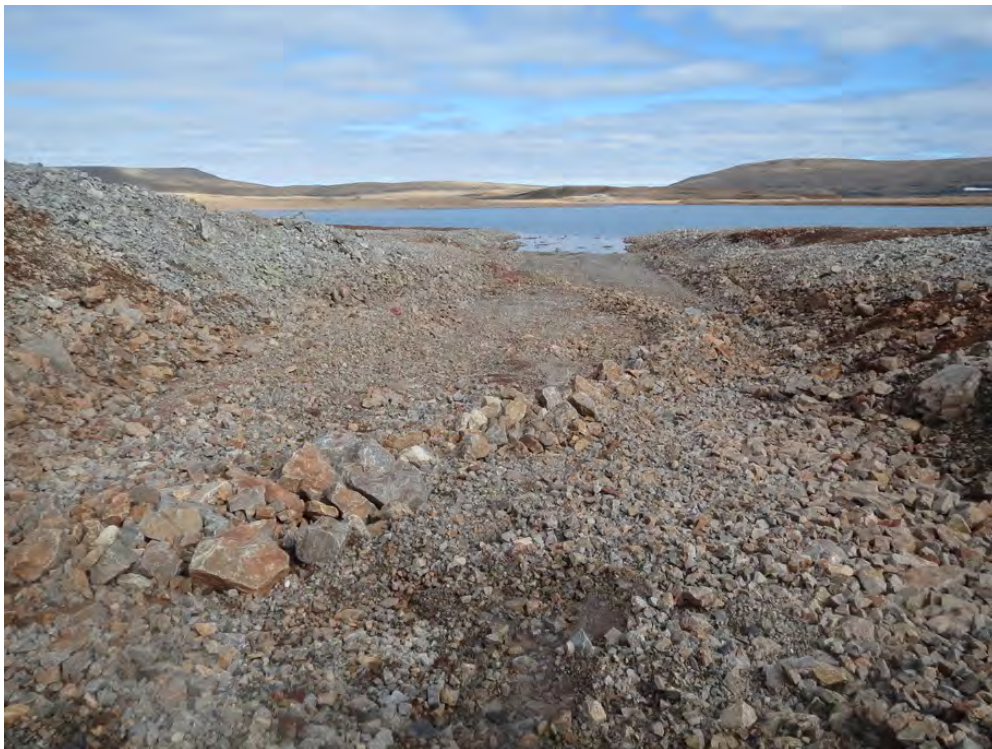
Photo 8. West Twin Dyke Spillway—Deposition of eroded material in bottom of spillway.

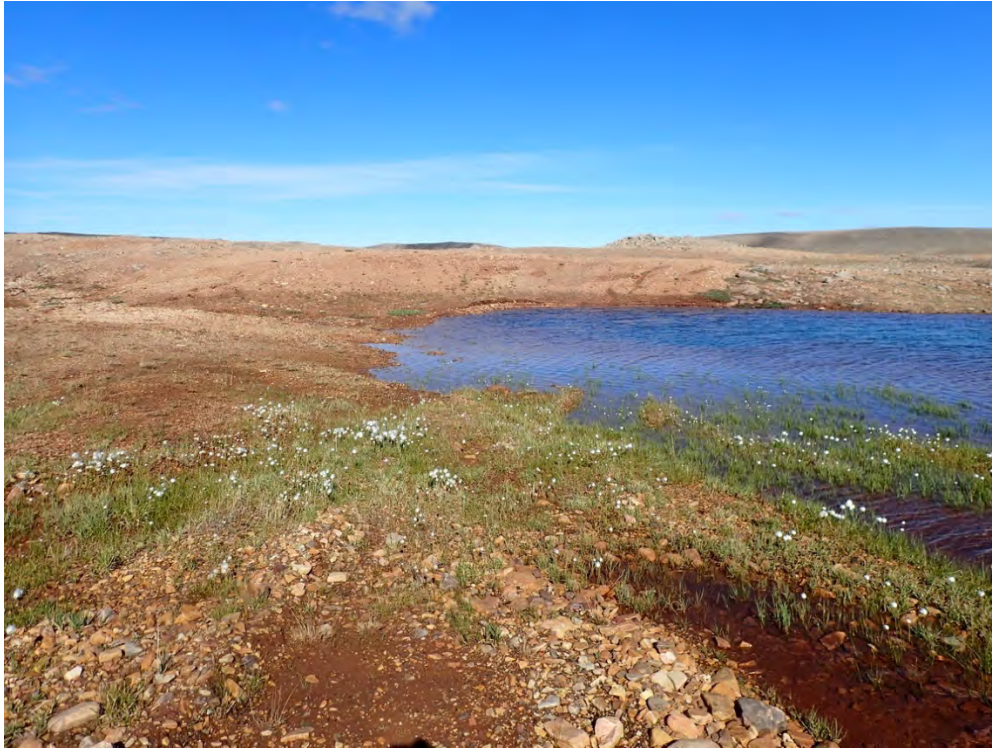
- Slumping and settlement of the perimeter slopes of the upstream polishing pond have been noted in recent years, but no further degradation was observed in 2016. This previous degradation is related to the deepening of the polishing pond (and associated water depths) during reclamation of this area.

Photo 9. West Twin Lake Outlet Channel—Cracking along edge of polishing pond. Similar condition to 2015.

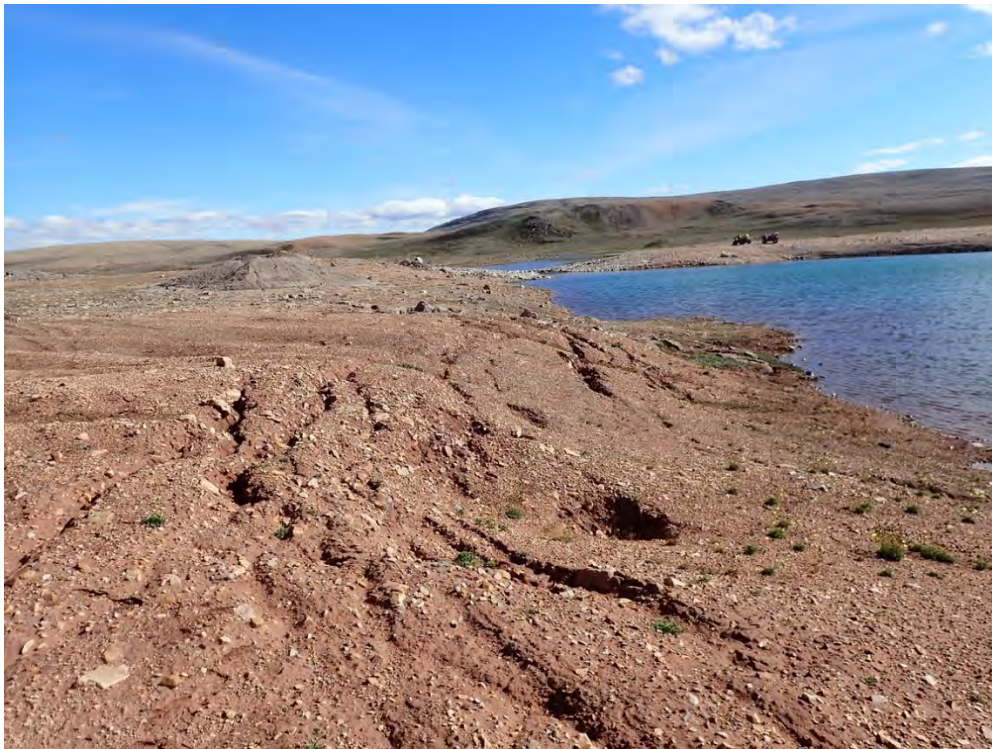
Photo 12. West Twin Lake Outlet Channel—Settlement and cracking along north edge of polishing pond.

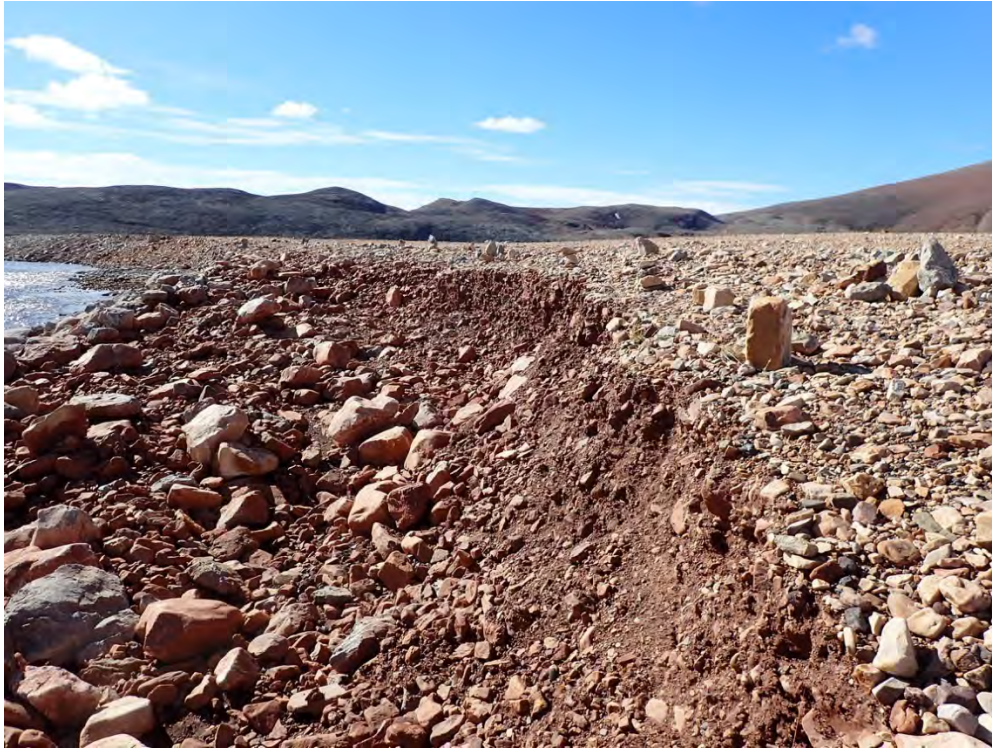
Select photos from the inspection are provided in Appendix I (Photos 13 through 16). During the inspection, the area where erosion of the left bank of the channel was observed during previous inspections was reviewed. No significant changes have been observed for at least two years, as the erosion was found to be in similar condition compared to 2015. The observed erosion at this location may be the result of a similar scenario as the erosion due to freshet in the West Twin Dyke Spillway. It appears that the flow in East Twin Creek was elevated near the crest of the diversion dyke by snow blockage and concentrated flow resulted in erosion of the berm as it re-entered the main channel of East Twin Creek. It is recommended that the noted area should be re-sloped and additional armour rock should be applied to the entire face of the dyke to enhance long term stability of this area.

Photo 13. East Twin Creek Diversion Channel—Erosion along face of dyke.

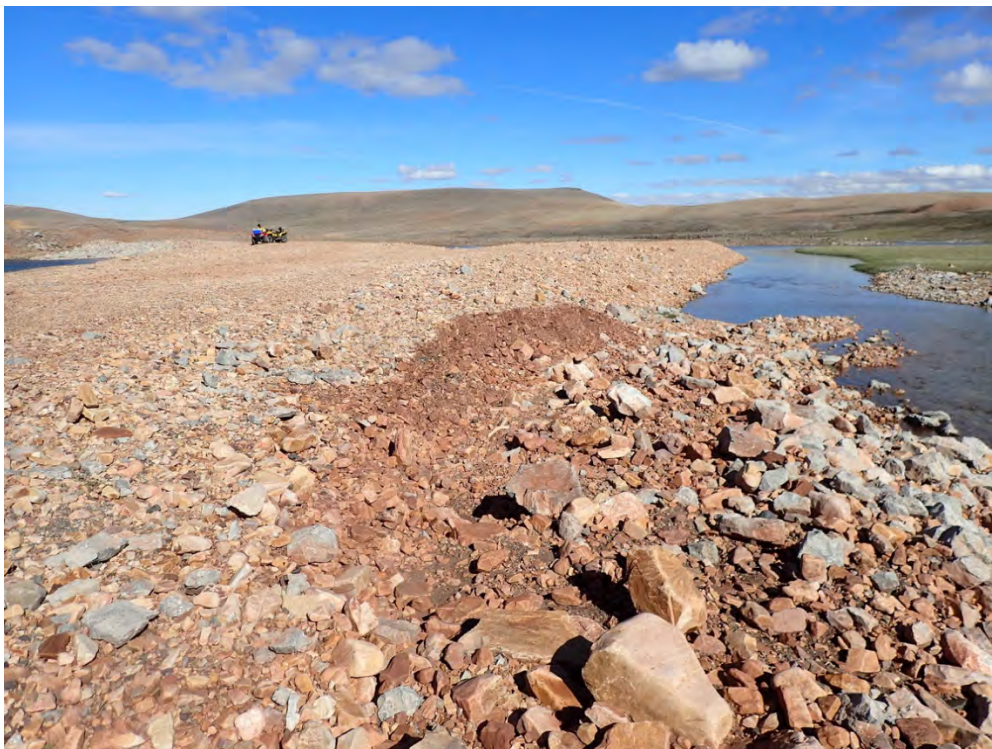
Photo 14. East Twin Creek Diversion Channel —Erosion along face of dyke.

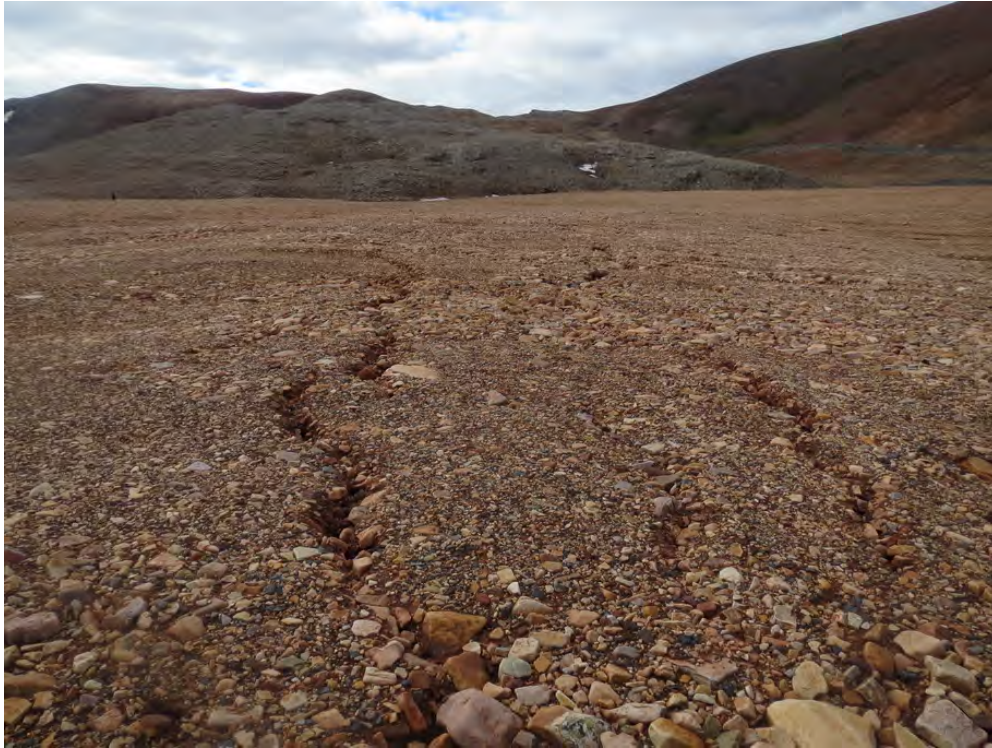
Photo 17. Surface Cell—Surface Cell cover system. Note cracking of surface of cover.

No maintenance is recommended for the Surface Cell cover system, though the surface of the cover should continue to be visually inspected for additional deformation and cracking.

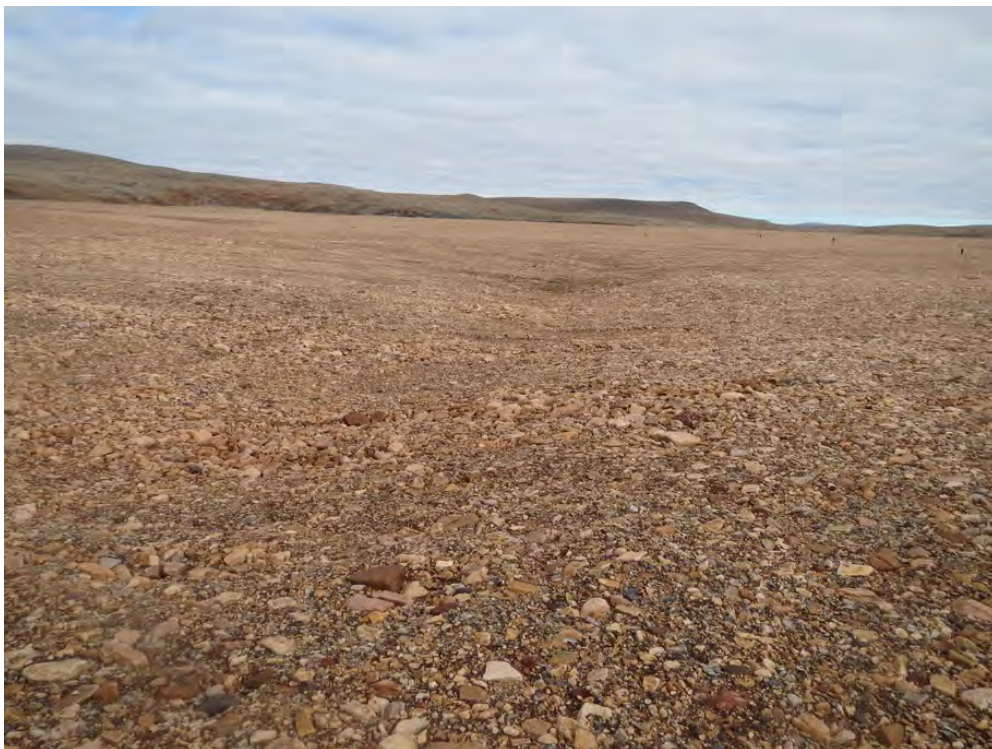
Photo 18. Surface Cell—Settlement area along east edge of main N/S drainage swale. View looking north.

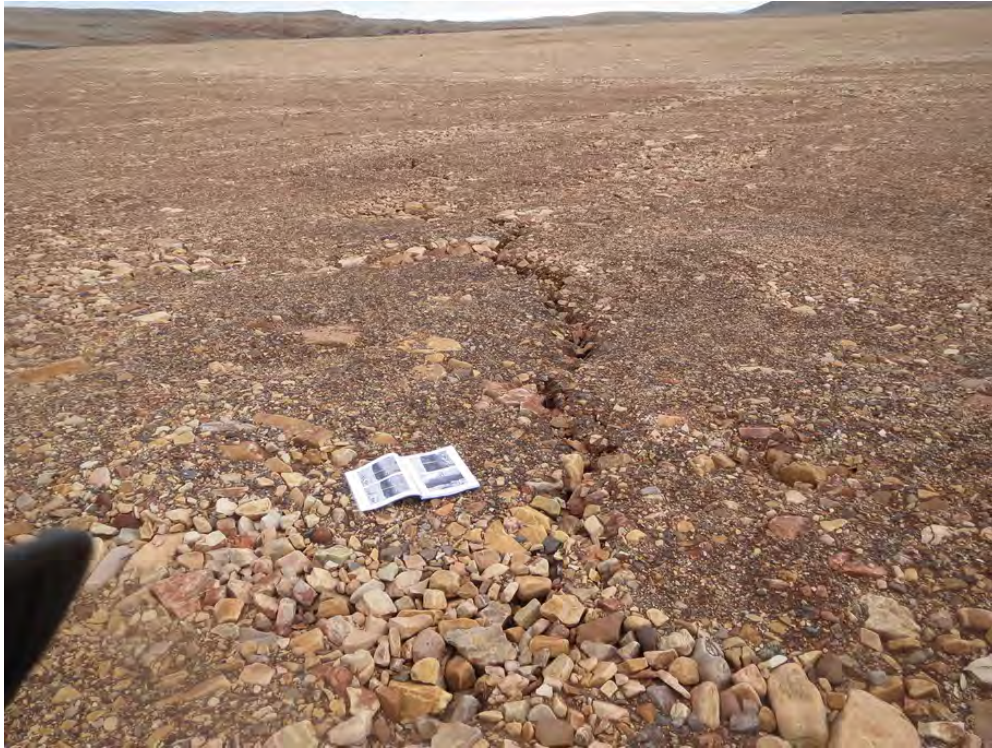
Photo 19. Surface Cell—Cracking in secondary N/S drainage swale. View looking north.

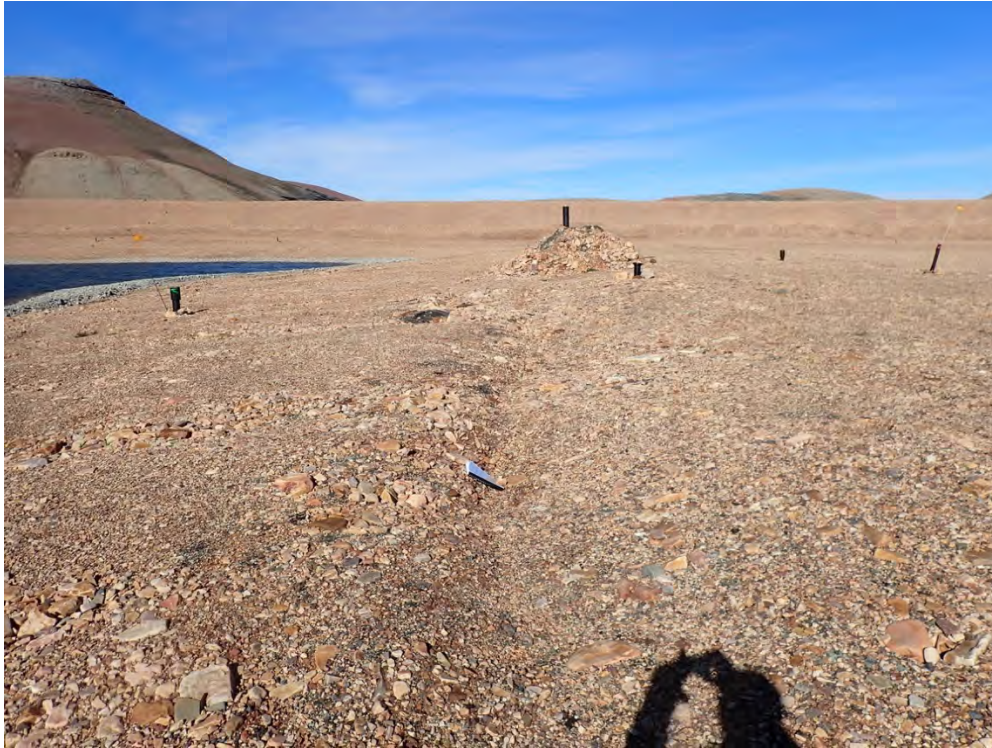
Photo 23. Test Cell—Settlement trough along edge of East/West Test Cell dike.

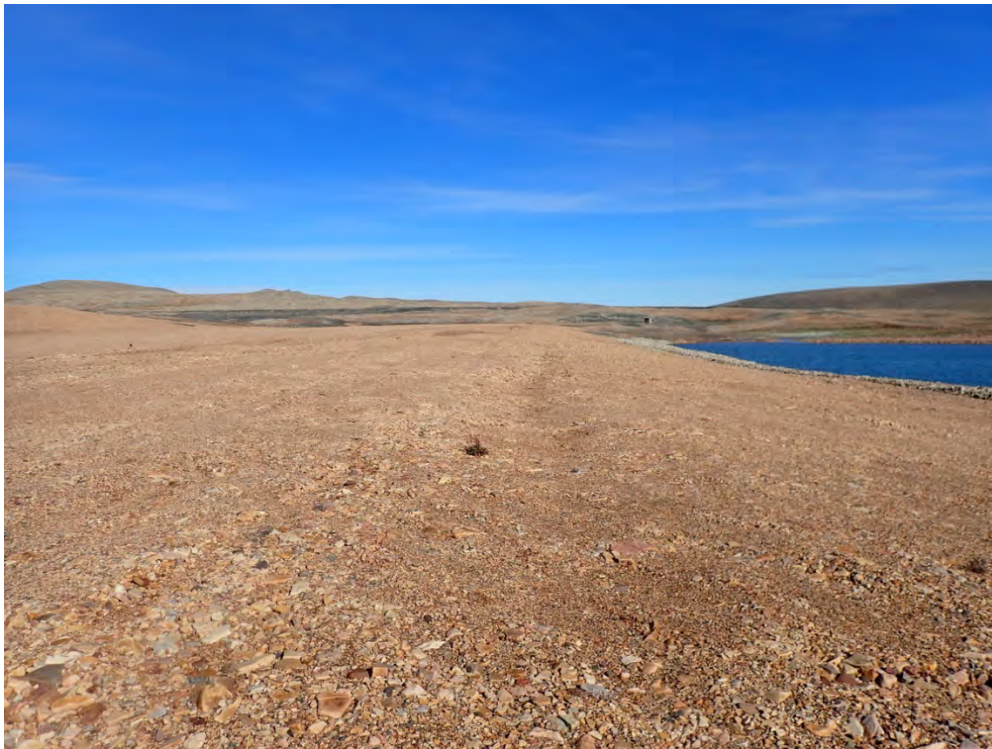
Photo 24. Test Cell—Settlement trough along north/south arm of Test Cell dike.

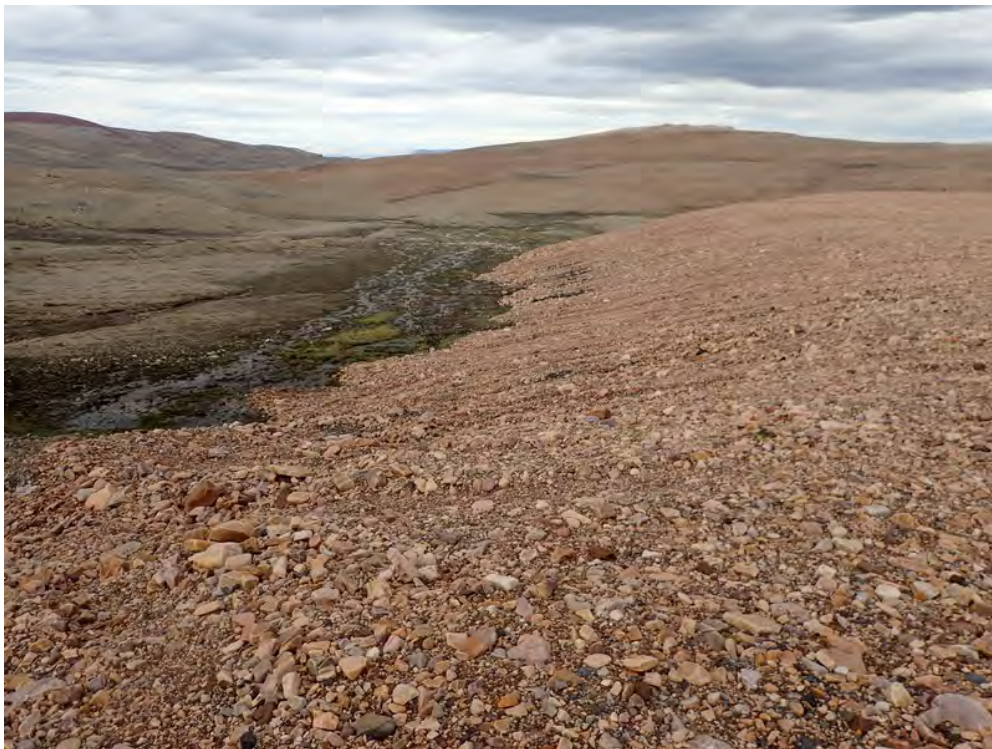
Photo 36. Landfill–Toe of landfill cover system. Note surface water flow along toe of cover.

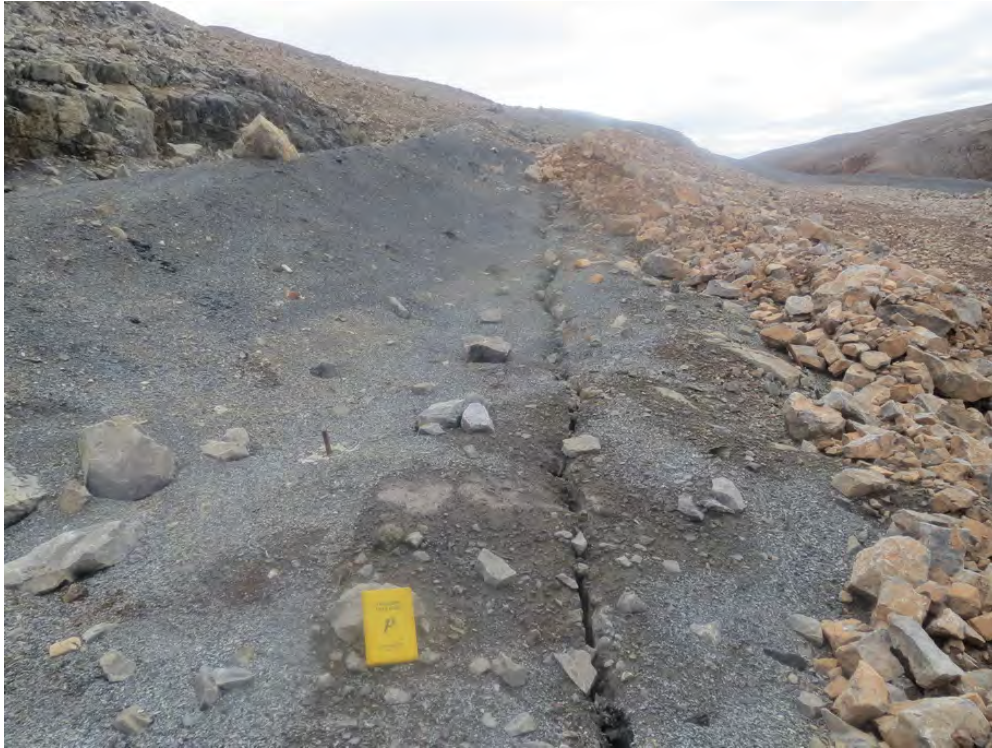
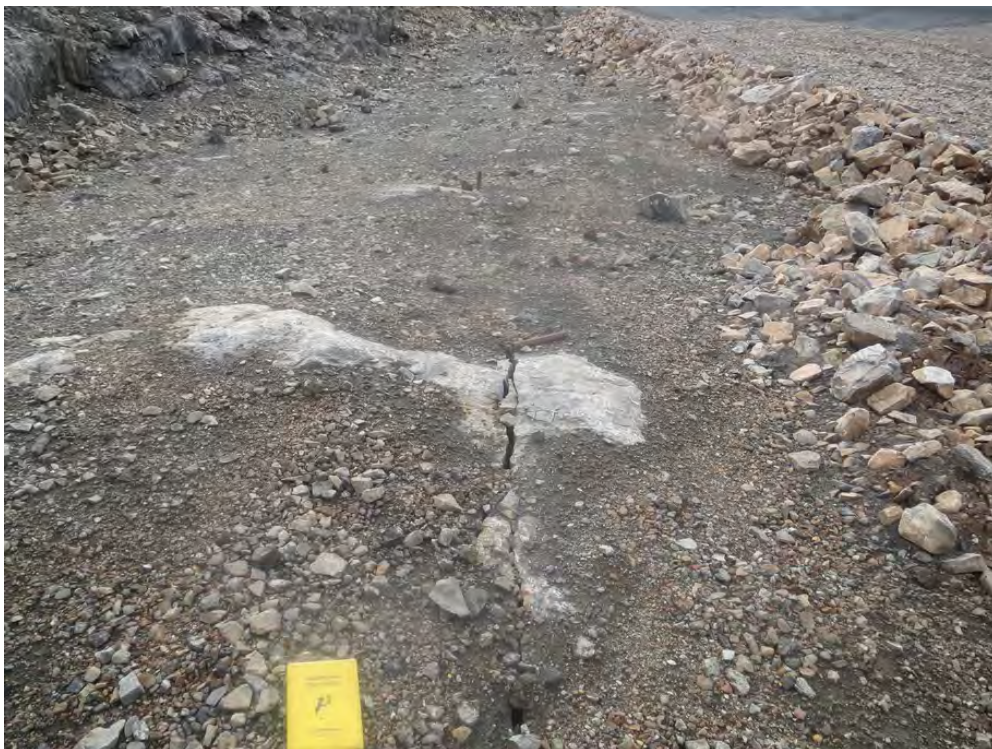
Photo 37. West Open Pit—Crack in crown pillar. No visual change in the 10 years since closure.

Photo 38. West Open Pit—Crack in crown pillar. No visual change in the 10 years since closure.

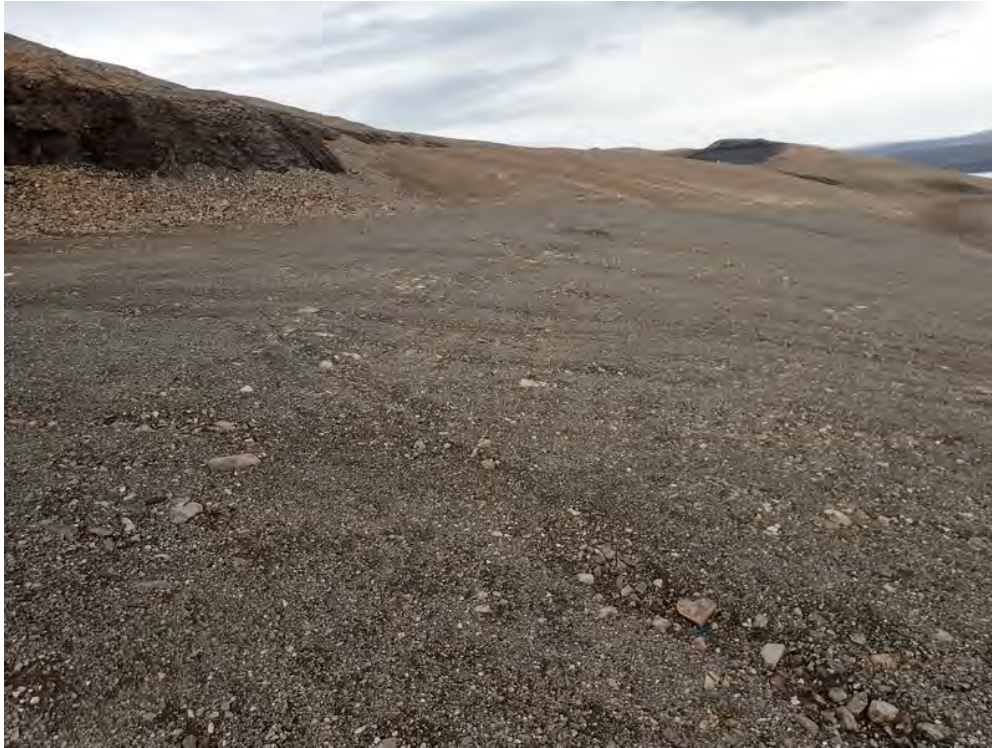
Photo 41. East Open Pit— At transition from flat to sloping upper surface of cover system. Note minor settlement and cracking.

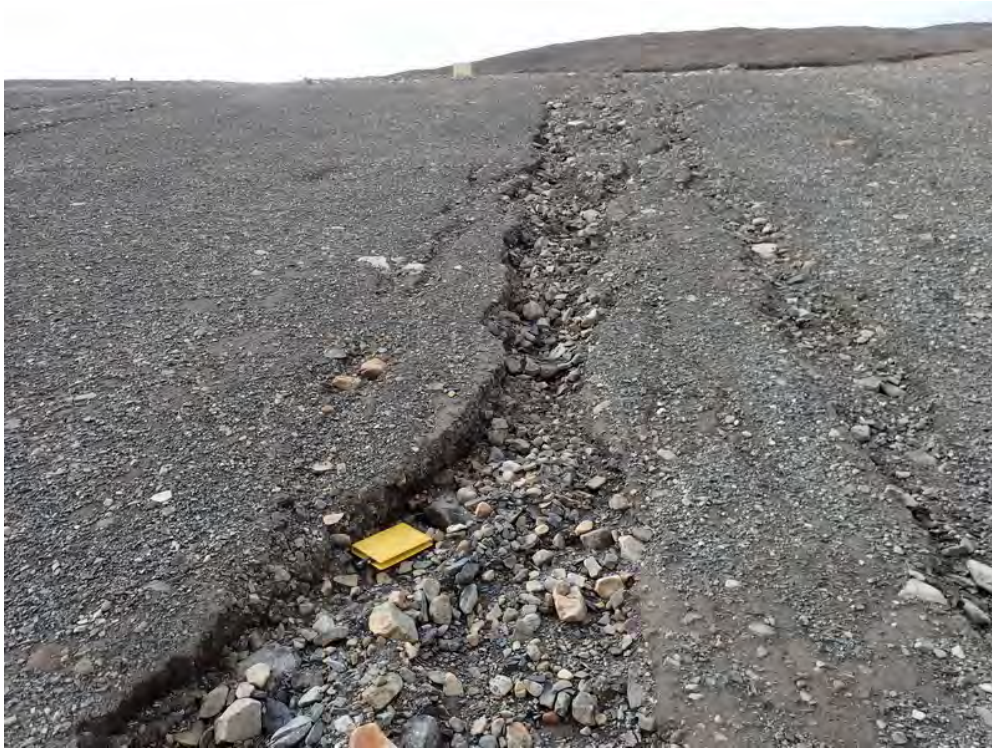
Photo 43. East Open Pit—Looking upslope along lower sloping face of cover. Note rill erosion.

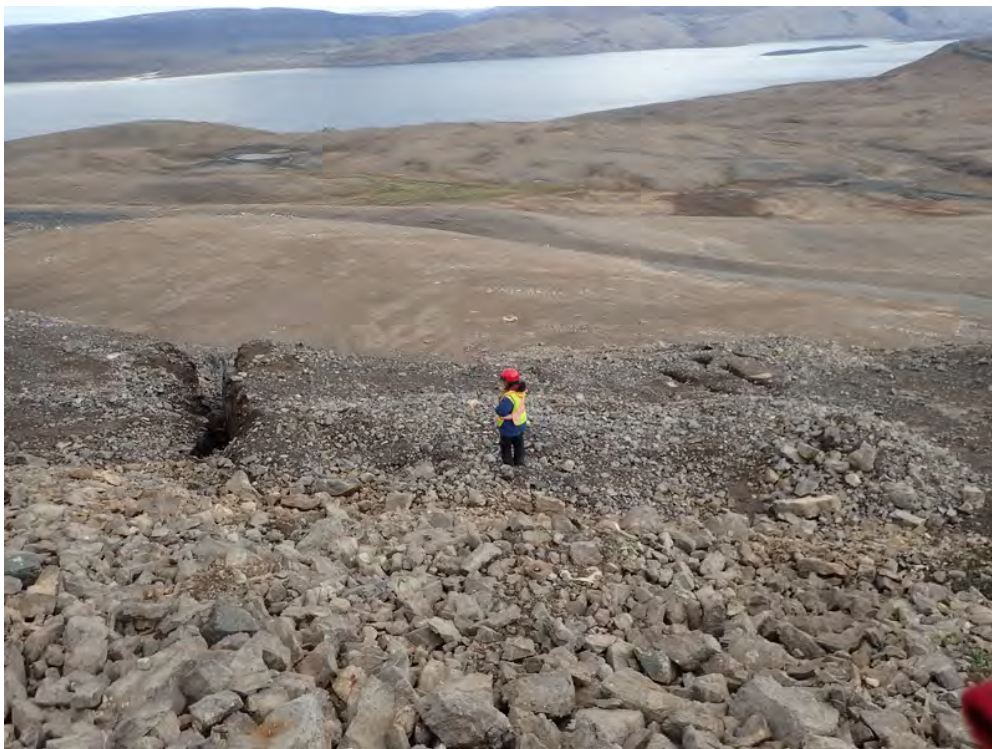
The covers constructed over the mine openings generally appear to be physically stable. Cracking at the East Open Pit crown pillar does not appear to have progressed since 2011. No maintenance is recommended, but continued visual inspection is warranted.

Photo 44. East Open Pit—Cracking in crown pillar. Similar condition to 2015.

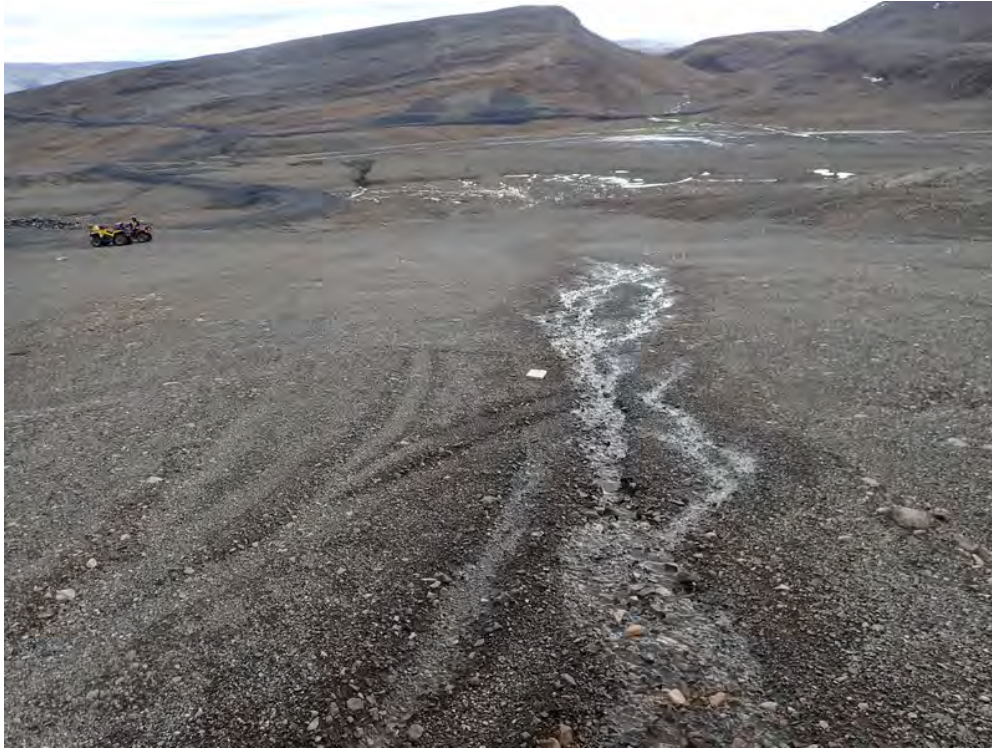
Photo 45. East Trench—Trench cover as seen from upslope edge. Note small flow of water on surface of cover causing minor rill erosion.

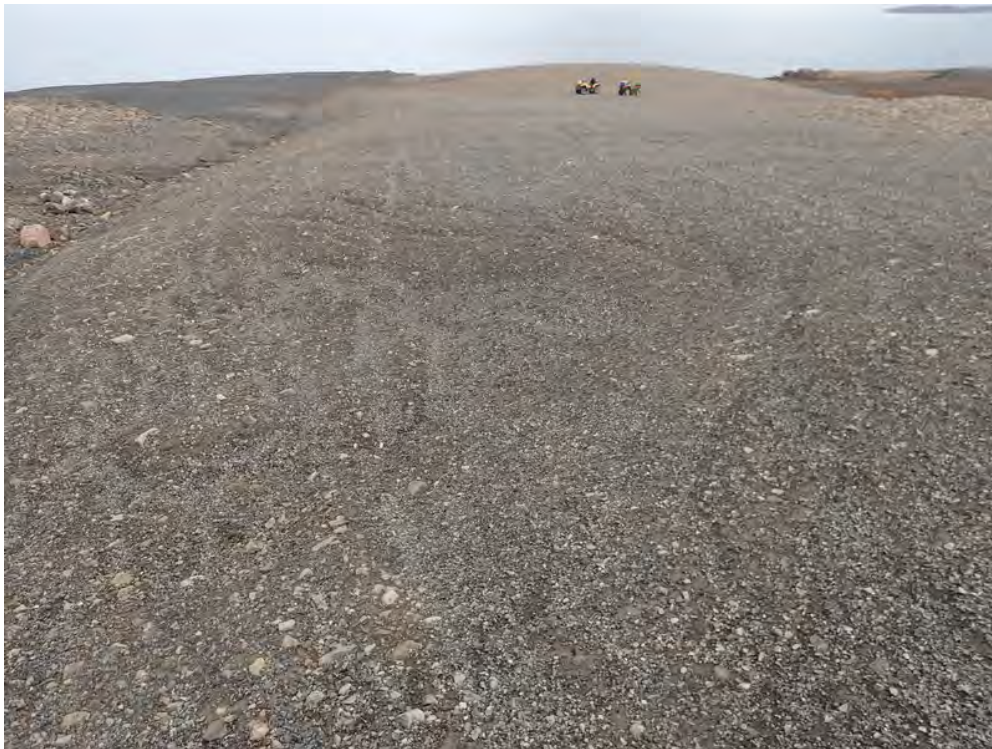
Photo 61. Oceanview Portal—Settlement area along west edge of cover. Note very little to no change in 10 years.

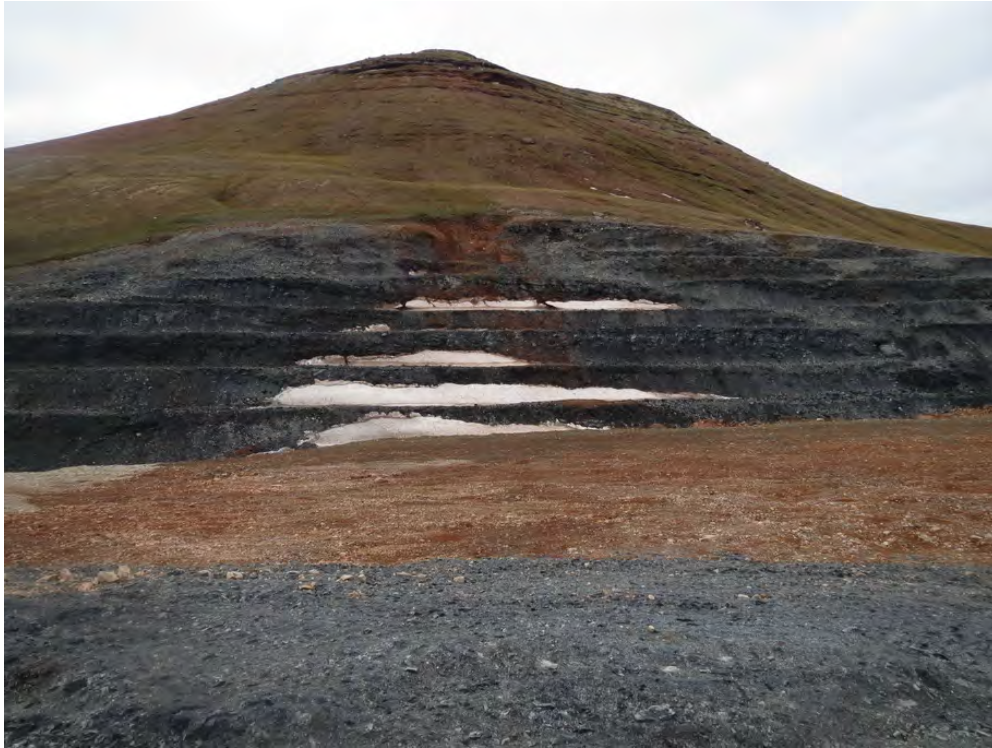
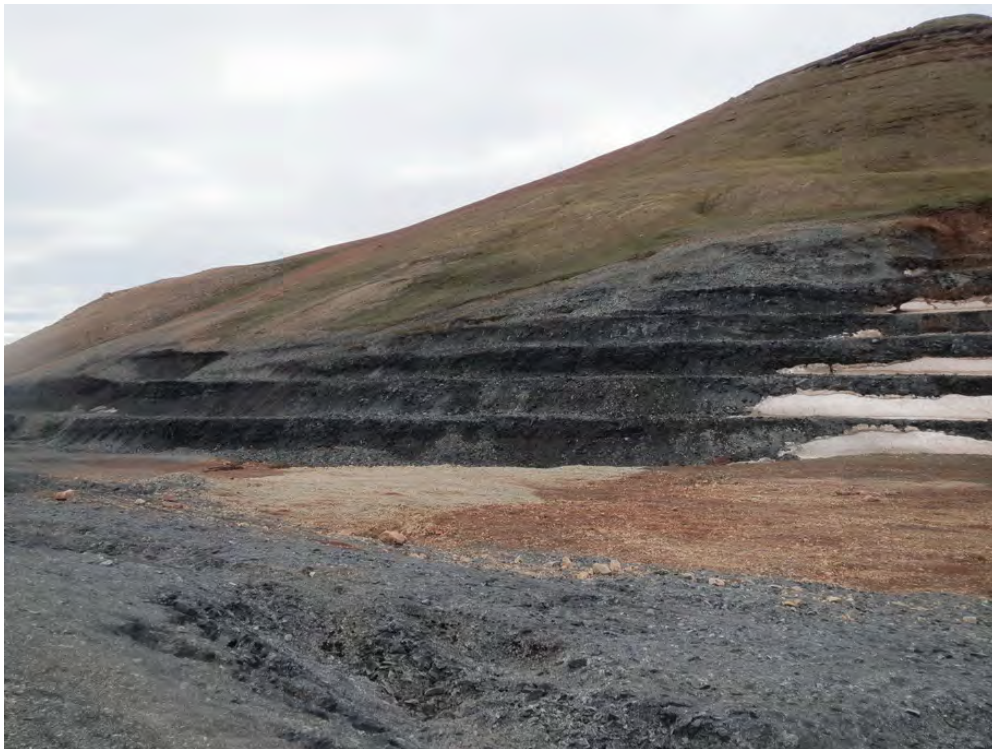
Photo 75. Mt. Fuji Shale Quarry—Note ongoing sloughing of bench faces reducing overall slope.

Photo 76. Mt. Fuji Shale Quarry—Note ongoing sloughing of bench faces reducing overall slope.
