NANISIVIK MINE, NUNAVUT

2017 ANNUAL GEOTECHNICAL INSPECTION

PROJECT NO.: 0255028

DATE: February 23, 2018

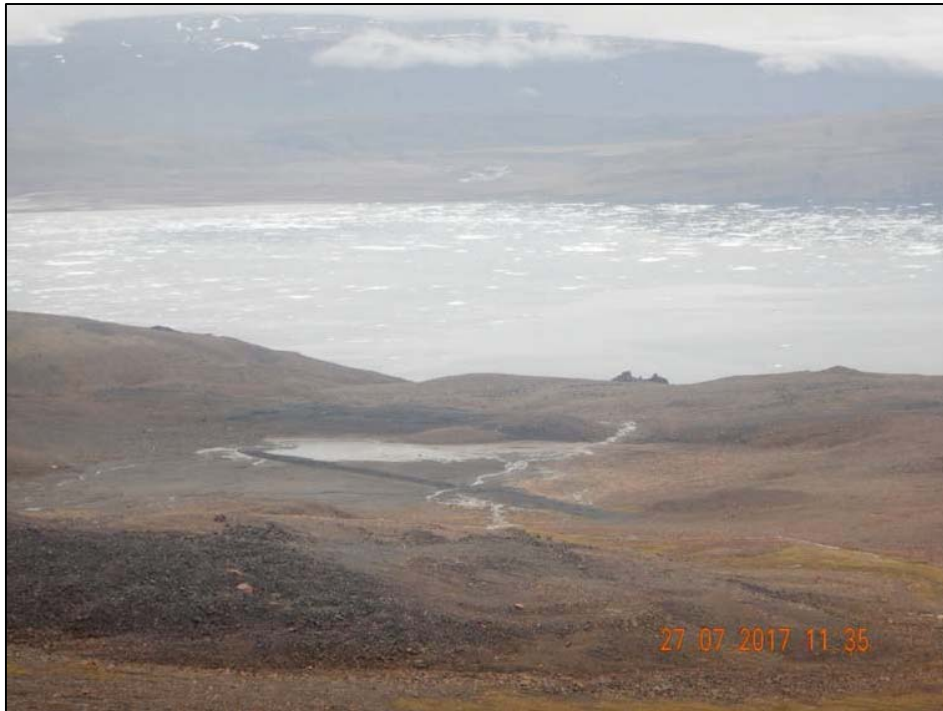
- Both the breach of the East Adit Retention Pond and the breach of the East Adit Treatment Pond promote drainage of the former pond areas as intended.
- As observed during previous inspections, a small remnant pond was observed in the East Adit Retention Pond area which has been present since breaching. The ponding has been reduced in aerial extent over time due to continued natural backfilling of the area by sediments, mostly weathered shale, being transported and deposited in this area from upslope.
- Some channelization of remnant sediments was observed in the bottom of the East Adit Treatment Pond.

Photo 1. East Adit – Retention Pond. Note the infilling of the basin and flow through conditions.

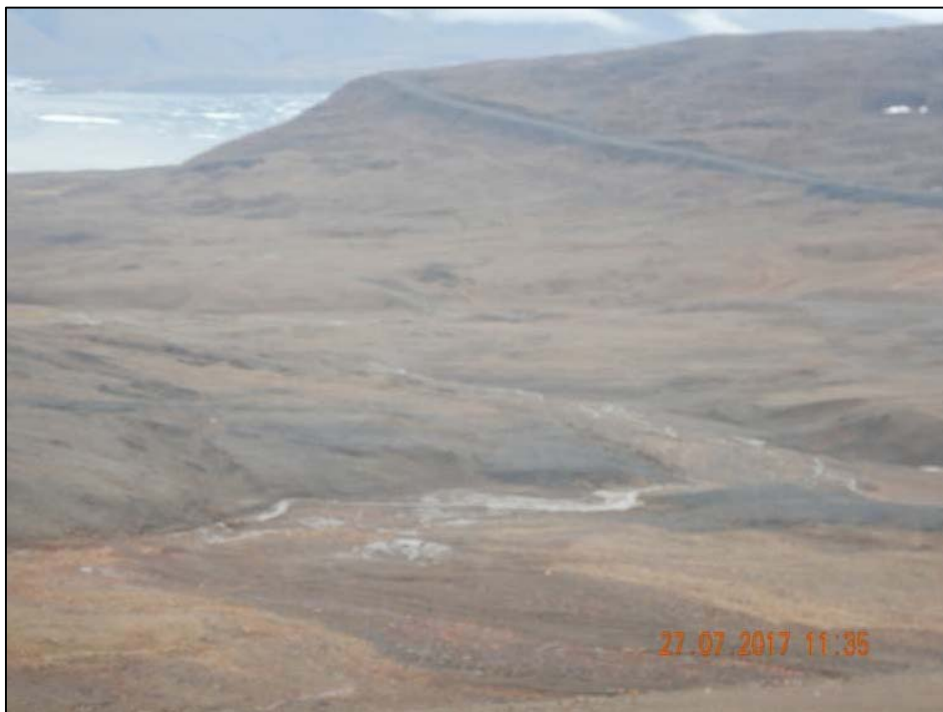
Photo 2. East Adit – Treatment Pond. Note flow through conditions.

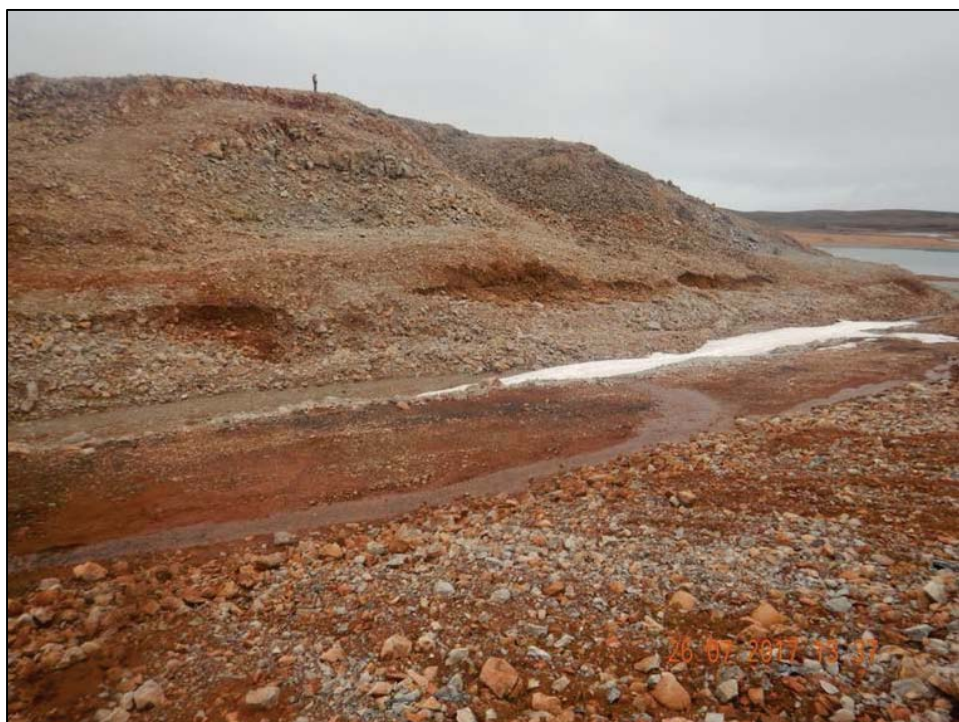
- Erosion of the left bank materials due to freshet flows breaching the ice-plug at the spillway entrance has been observed in previous years (Photos 4 and 5). During the spring of 2014, Mr. Claude Lavallee was on-site when the ice-plug breach occurred. The observations collected during this time provide further insight into the erosive event that occurs annually. Based on his observations collected during the event, the flow following the breaching of the ice-plug becomes focused along the left bank at an elevated level 1 to 3 m above the base of the spillway. Draining of the water that backs up on the Surface Cell cover occurred quickly, over a period of less than four hours. Some erosion of the bank armour materials occurred before the flow re-entering the spillway towards the outlet, depositing eroded material in the base of the spillway.

Photo 4. Spillway – View of erosion area along left bank of spillway as seen from crest of right bank.

While the spillway currently remains effective in directing and confining flow from the Surface Cell to the Reservoir, it is recommended that additional armouring of the left bank be considered to address these types of flow events in the future. Re-grading the base of the spillway to ensure the full design width is available for flow should be completed at the same time. Until these issues are addressed, it is recommended that the spillway channel continue to be inspected annually for stability of the side slopes and erosion of the side slopes and channel bottom.

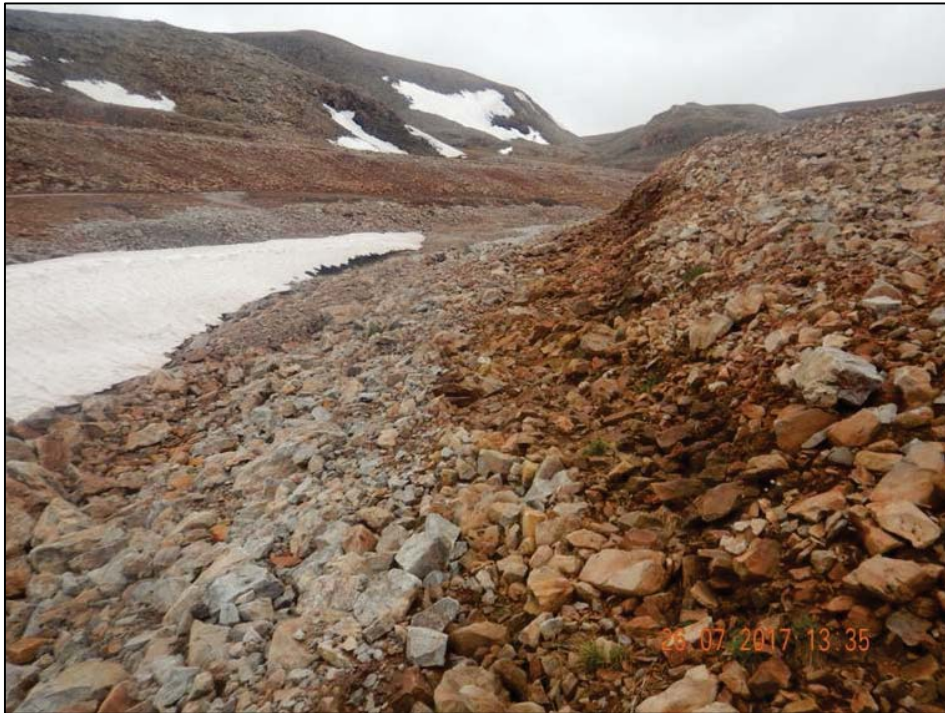
Photo 5. Spillway – Erosion along left bank of spillway. View looking upstream along left bank.

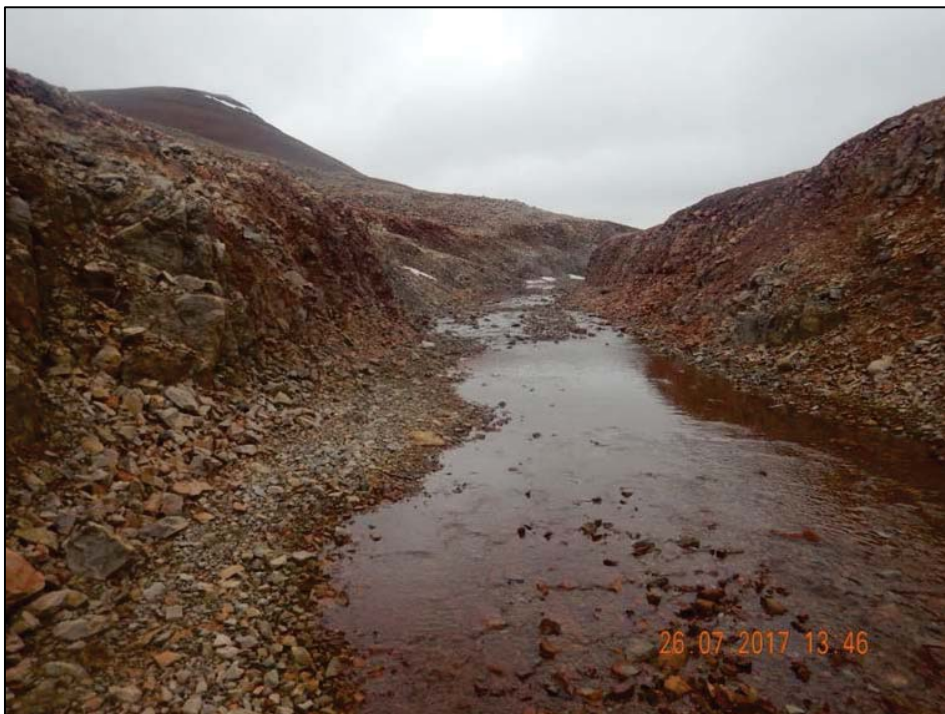
Photo 6. Spillway – Flow in bottom of spillway looking upstream from access ramp.

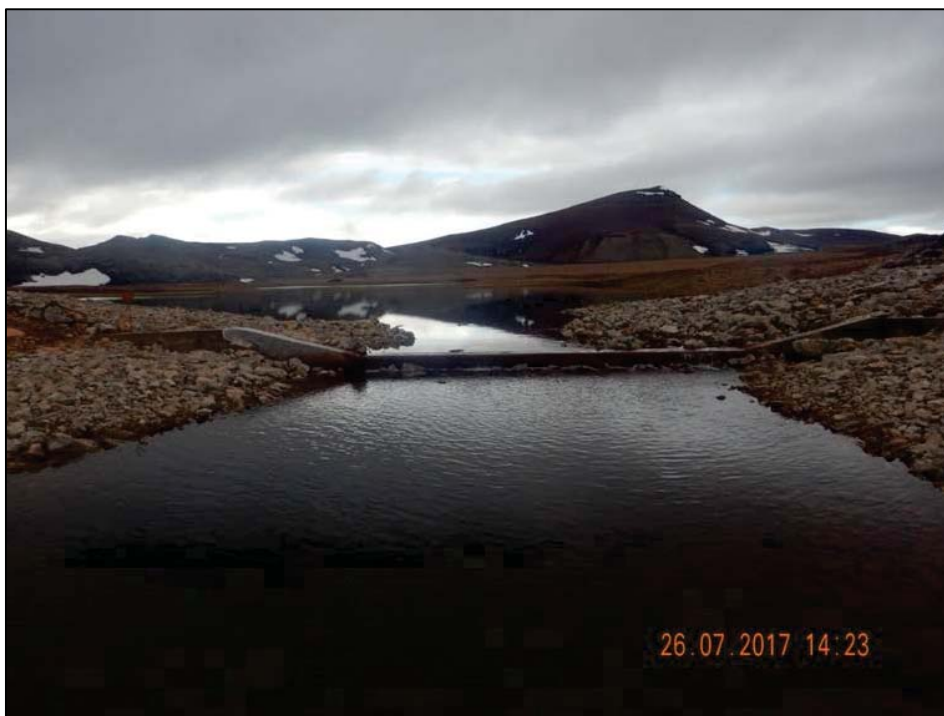
Photo 8. WT Outlet – Outlet wall. Note flow is approximately +4 cm.

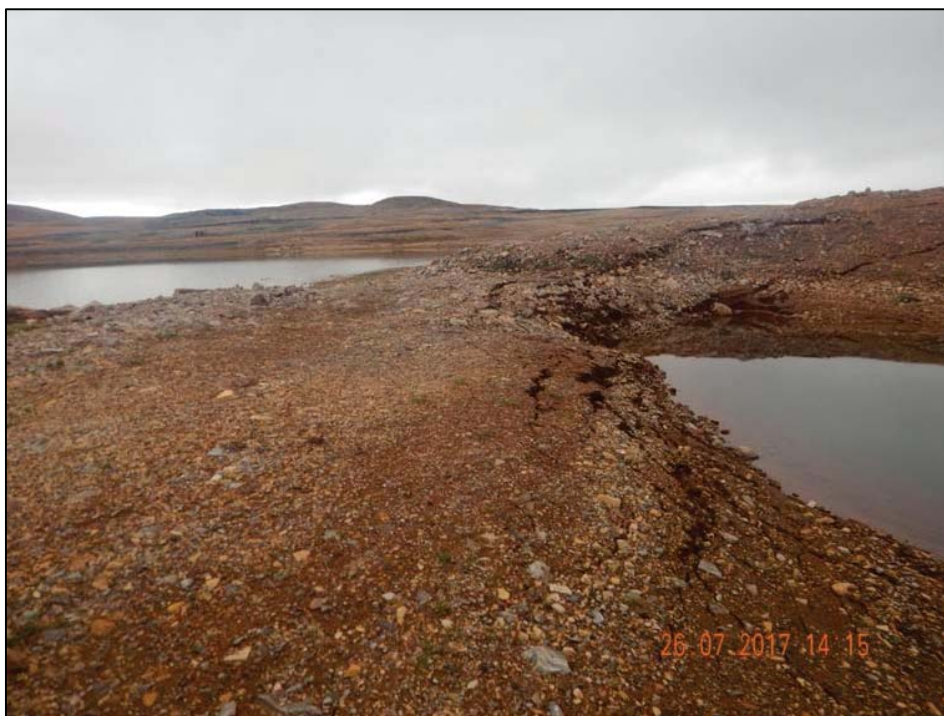
Additional deformation of the perimeter slopes of the upstream Polishing Pond was observed in 2017, though the area of instability was further removed from the outlet wall compared to previous

Photo 10. WT Outlet – Thermokarst/settlement area along north shoreline of remnant polishing pond.

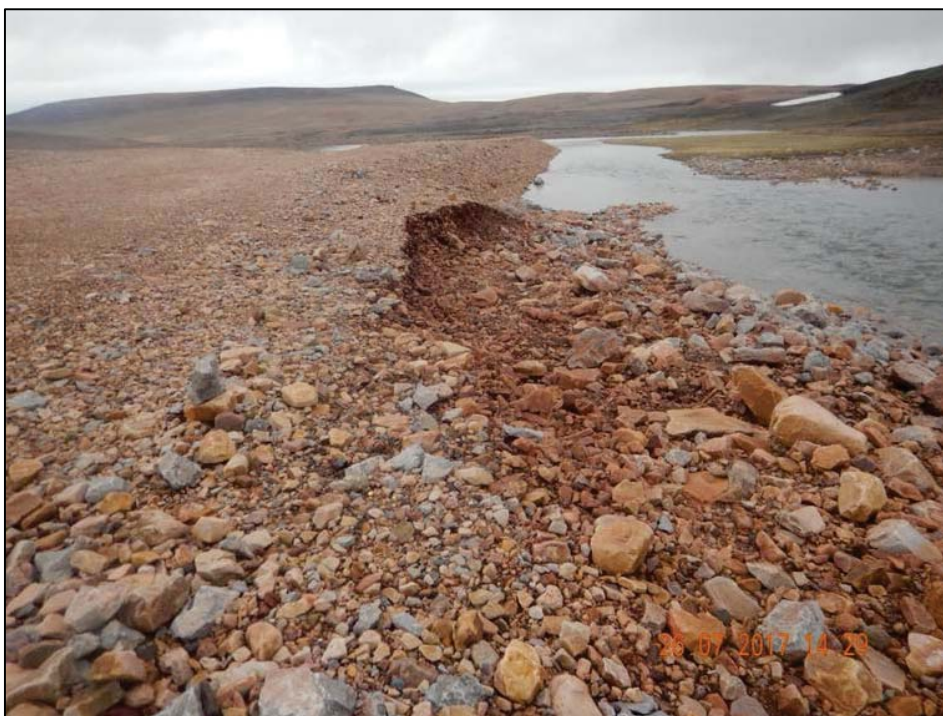
Some erosion at the East Twin Diversion Dyke was noted during the inspection. The erosion was likely due to elevated flows during freshet in combination with snow blockage in the channel. The erosion appeared to be similar to what has been observed since 2015. In general, the dyke remains in stable condition. However, it is recommended that additional re-sloping and armouring of select areas of the channel be undertaken to enhance long term performance. The seepage discharge observed at the toe of the left bank of the dyke in the spring of 2016 was not observed in 2017 due to the elevated flows in East Twin Creek, however it should continue to be monitored in future inspections.

Photo 12. ETC Diversion Channel – Erosion area along left bank of diversion channel.

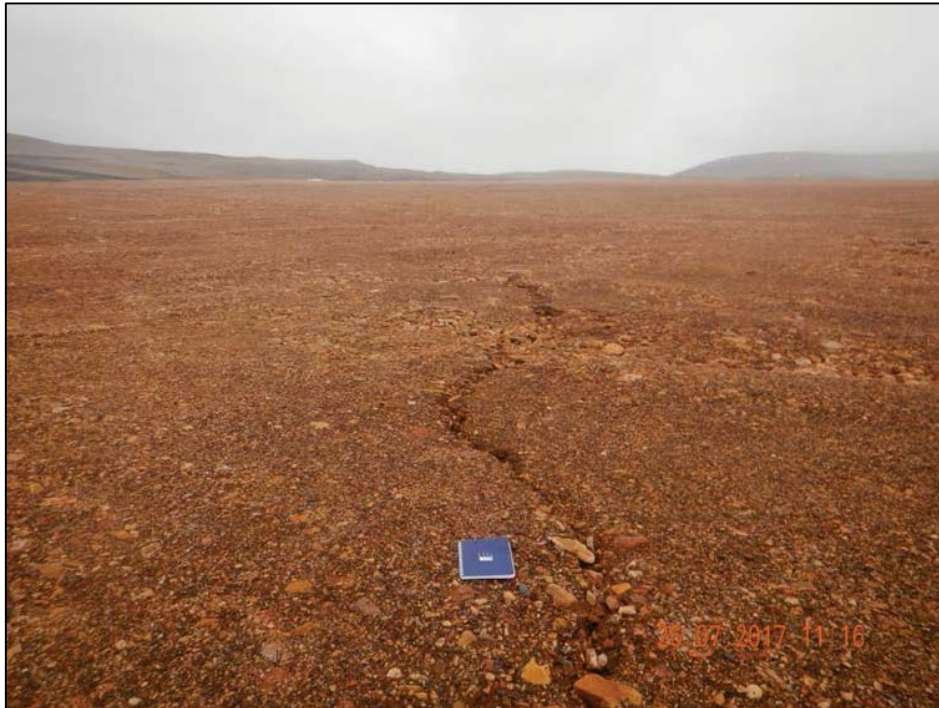
Photo 17. Surface Cell – Thermal cracking in southwest quadrant of Surface Cell cover system.

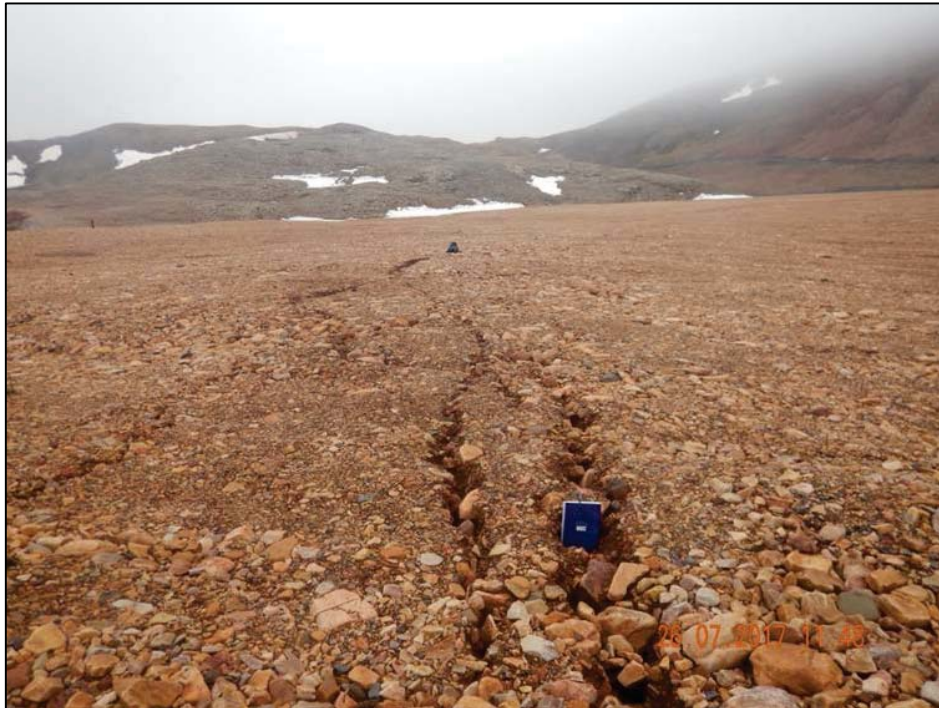
Photo 19. Surface Cell – Thermal cracking along edge of main swale.

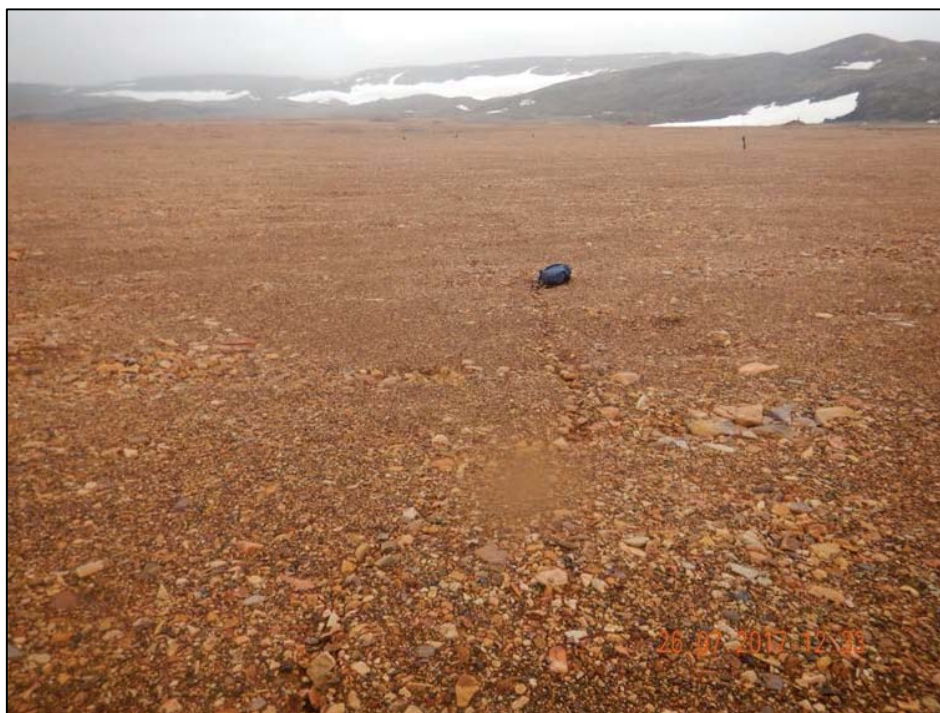
Photo 24. Test Cell – Thermal cracking in Test Cell cover system.

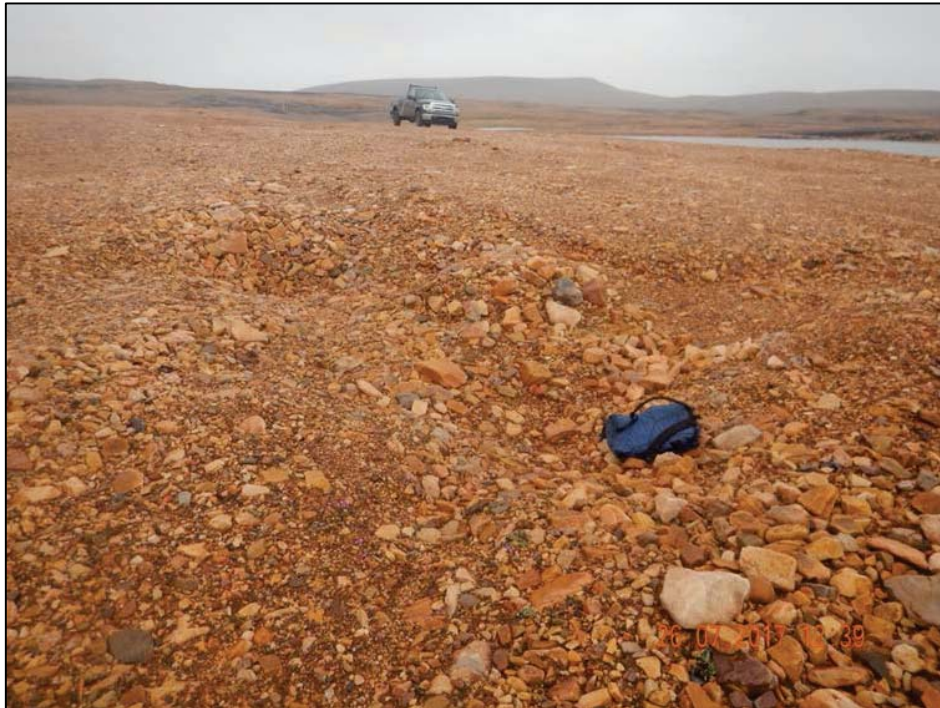
Photo 25. Test Cell – Thermokarst feature along inside of N/S arm of TC dyke.

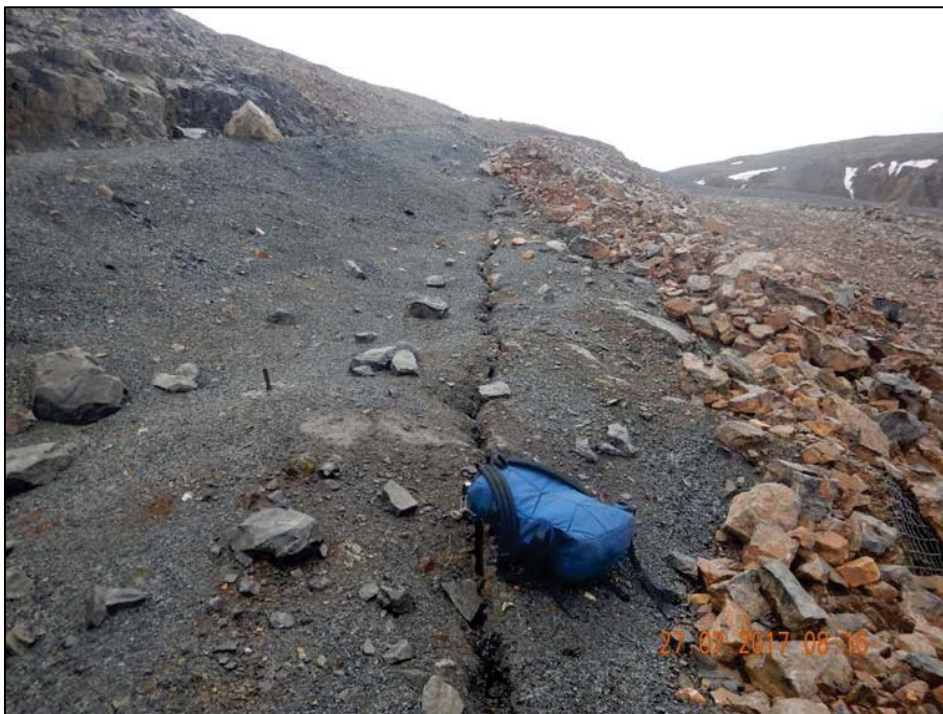
Photo 40. West Open Pit – Crack in crown pillar of WOP.

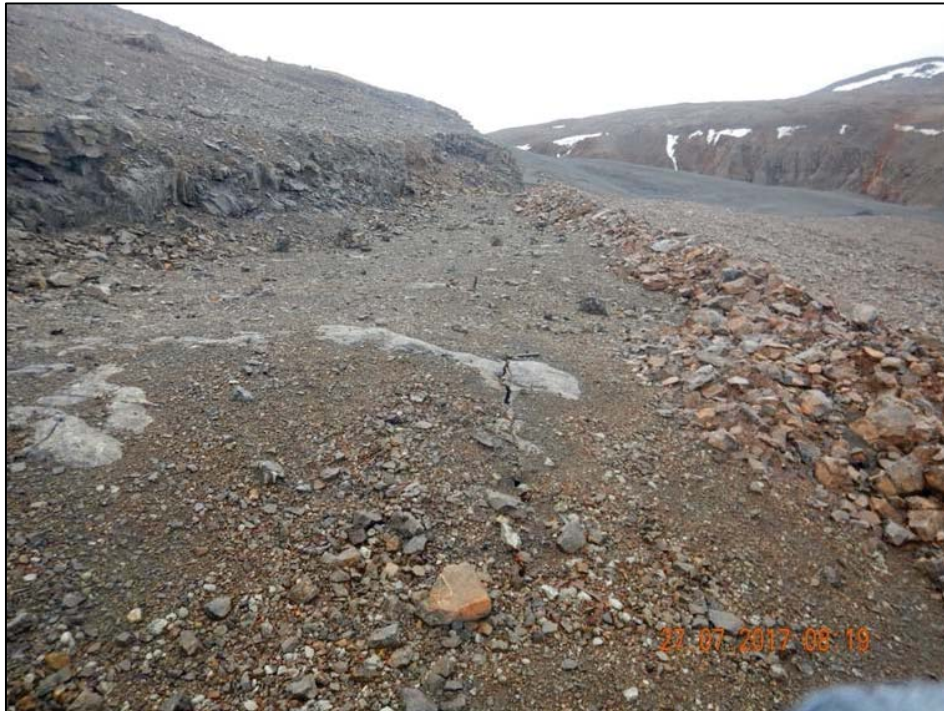
Photo 41. West Open Pit – Crack in crown pillar of WOP.

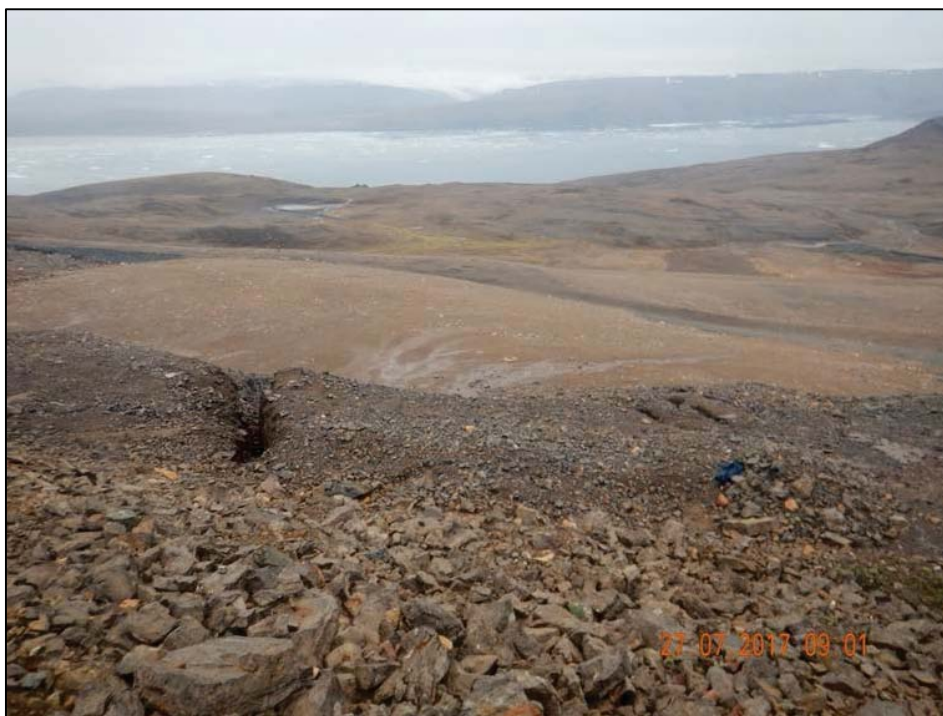
The covers constructed over the mine openings generally appear to be physically stable. Cracking at the East Open Pit crown pillar does not appear to have progressed since 2011. No maintenance is recommended, but continued visual inspection is warranted.

Photo 44. East Open Pit – Crack in crown pillar of EOP.

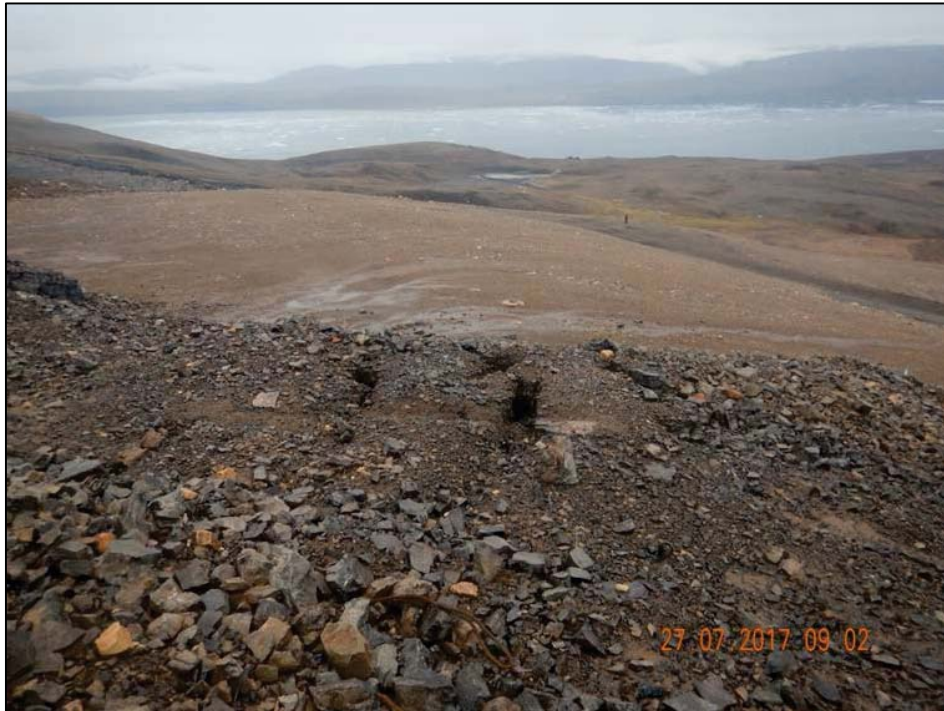
Photo 45. East Open Pit – Crack in crown pillar of EOP.

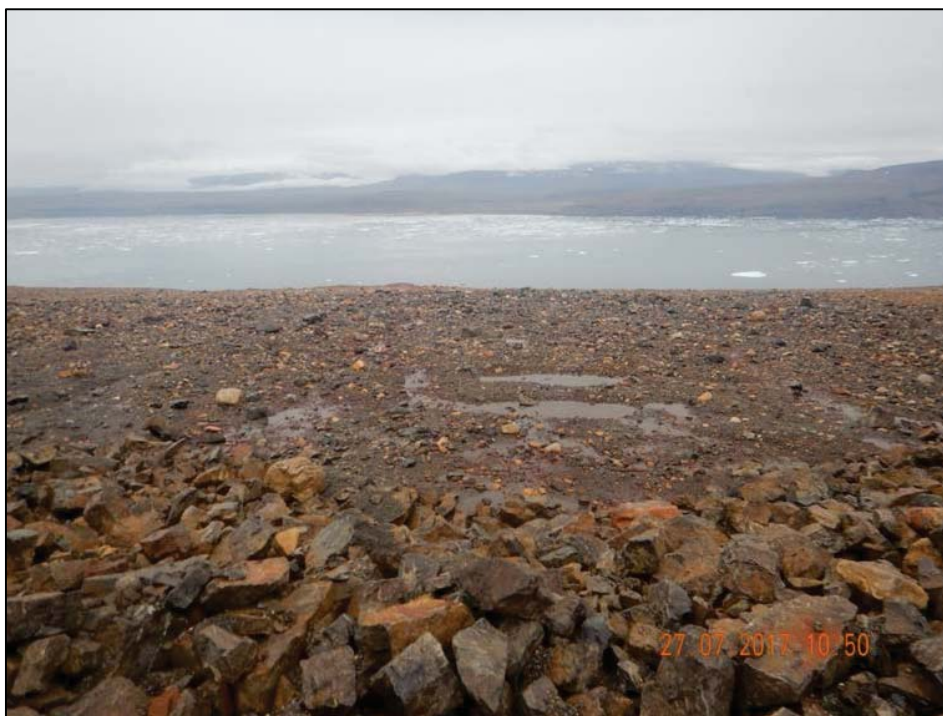
Photo 52. Oceanview Pit – Flow of water emerging from toe of cover system.

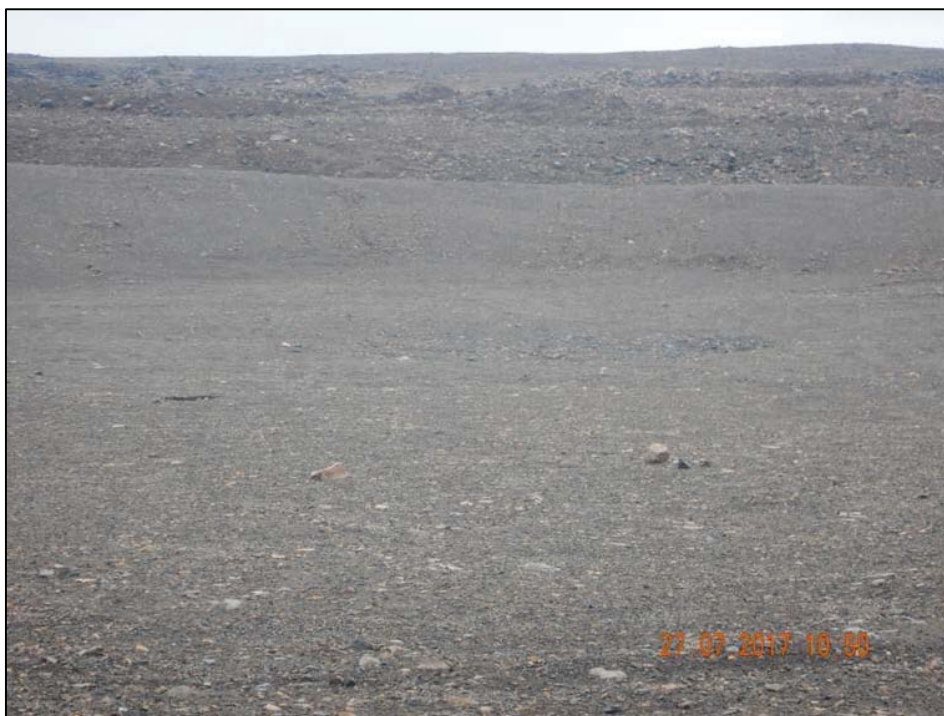
Photo 54. Oceanview Pit – Sloping face of cover system where rill erosion occurring as seen from toe area.

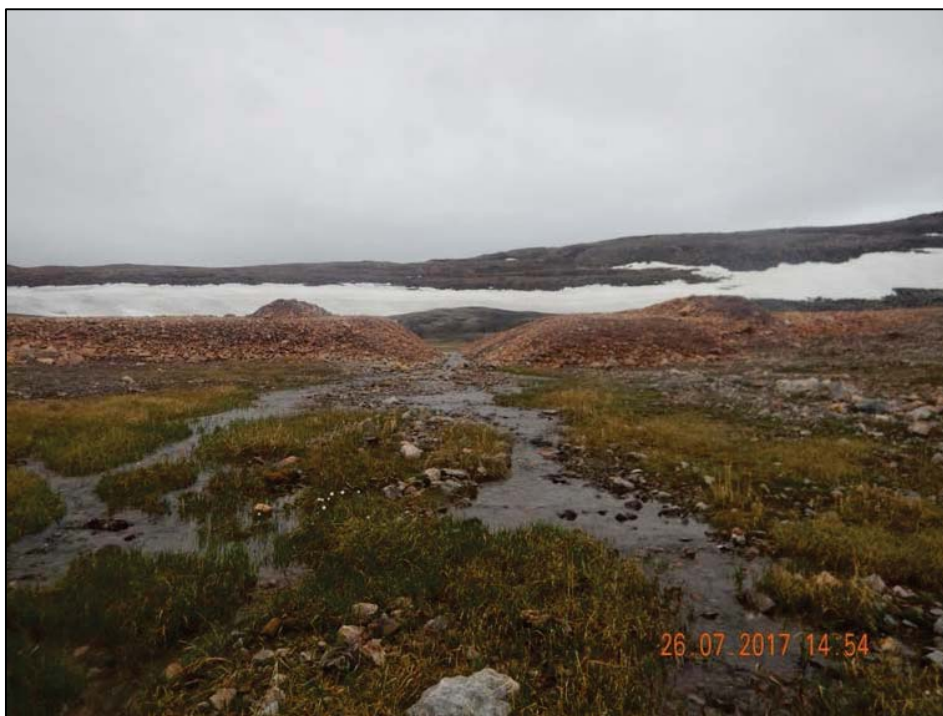
Photo 58. Upper Dump Pond – Breach in road to town site.

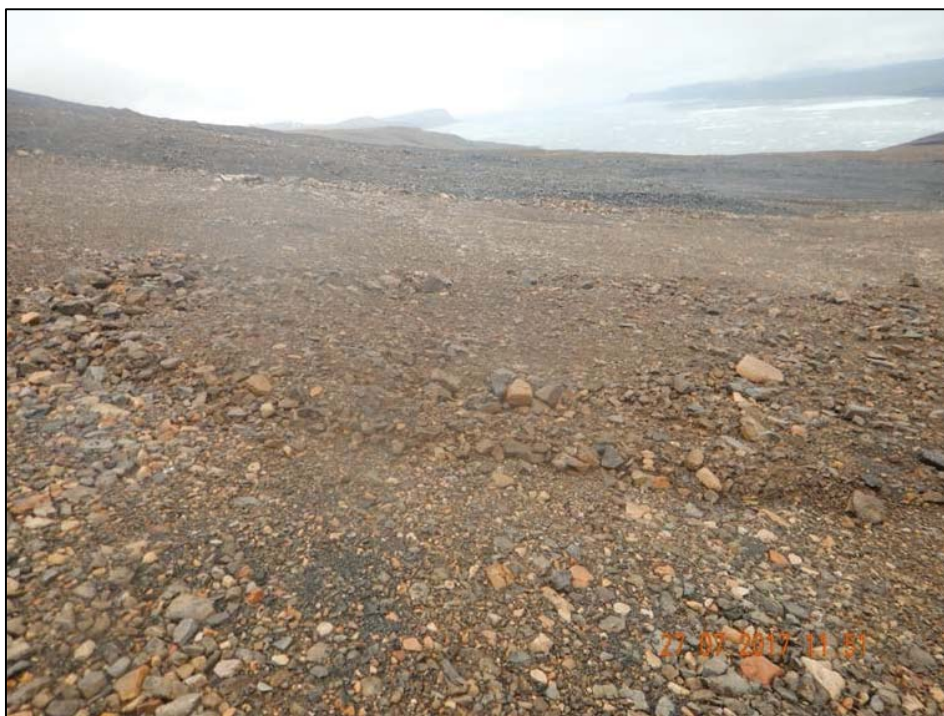
Photo 66. 17N Portal – Old thermokarst feature which was previously backfilled.

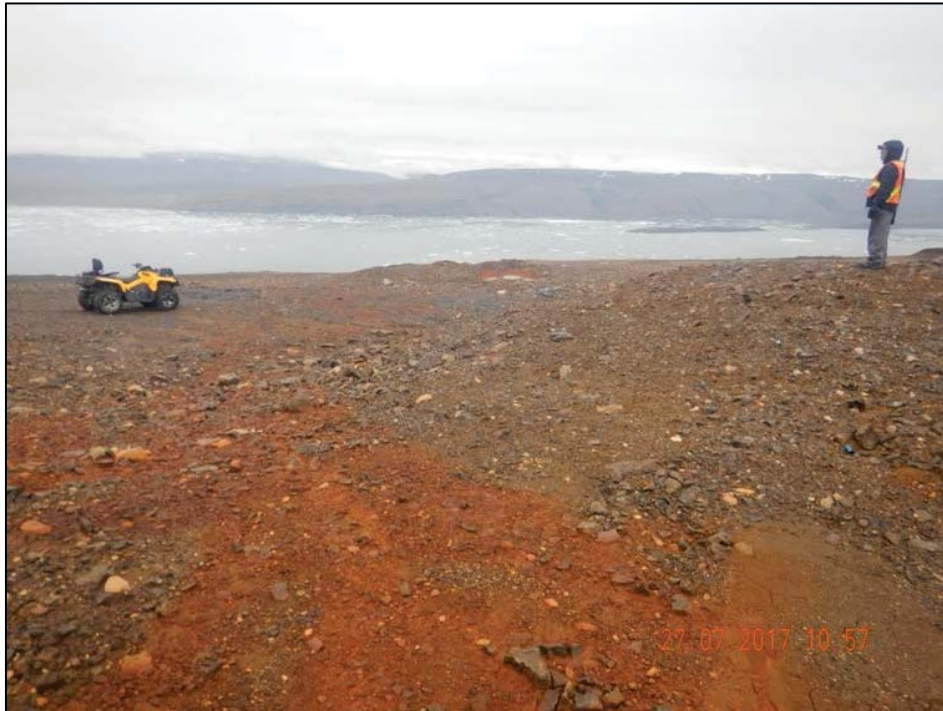
Photo 77. Oceanview East Raise – Staining from ARD drainage in East vent raise area.
