**NYRSTAR**

**NANISIVIK MINE, NUNAVUT**

**2019 ANNUAL GEOTECHNICAL INSPECTION**

PROJECT NO.: 0255030

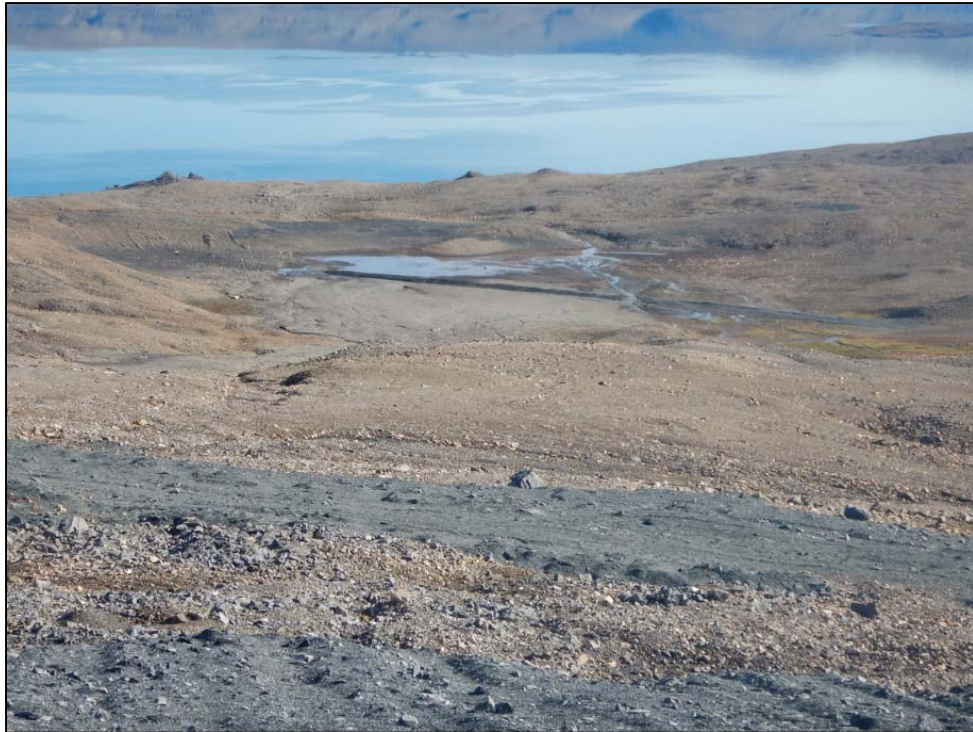
**Photo 1. East Adit Treatment Facility - Retention Pond as seen from road to East Open Pit.**

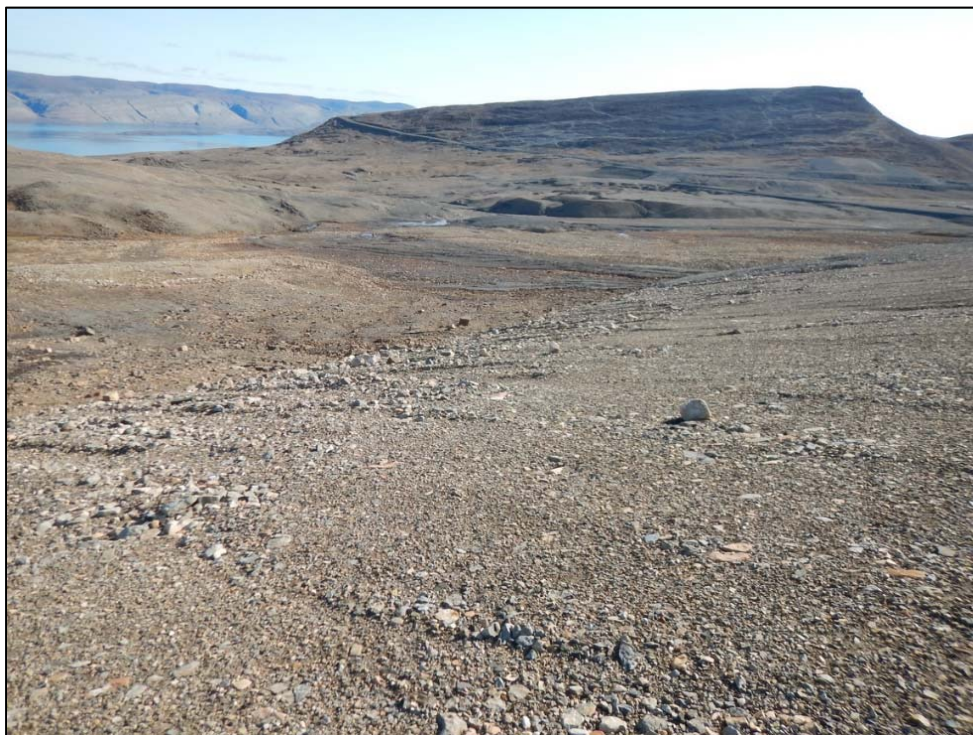
- Both the breach of the East Adit Retention Pond and the breach of the East Adit Treatment Pond promote drainage of the former pond areas as intended.
- As observed during previous inspections, a small remnant pond was observed in the East Adit Retention Pond area which has been present since breaching. The ponding has been reduced in areal extent over time due to continued natural backfilling of the area by sediments, mostly weathered shale, being transported and deposited in this area from natural deposits upslope.
- Some channelization of remnant sediments was observed in the bottom of the East Adit Treatment Pond.

**Photo 2. East Adit Treatment Facility - Breach in treatment pond dyke.**

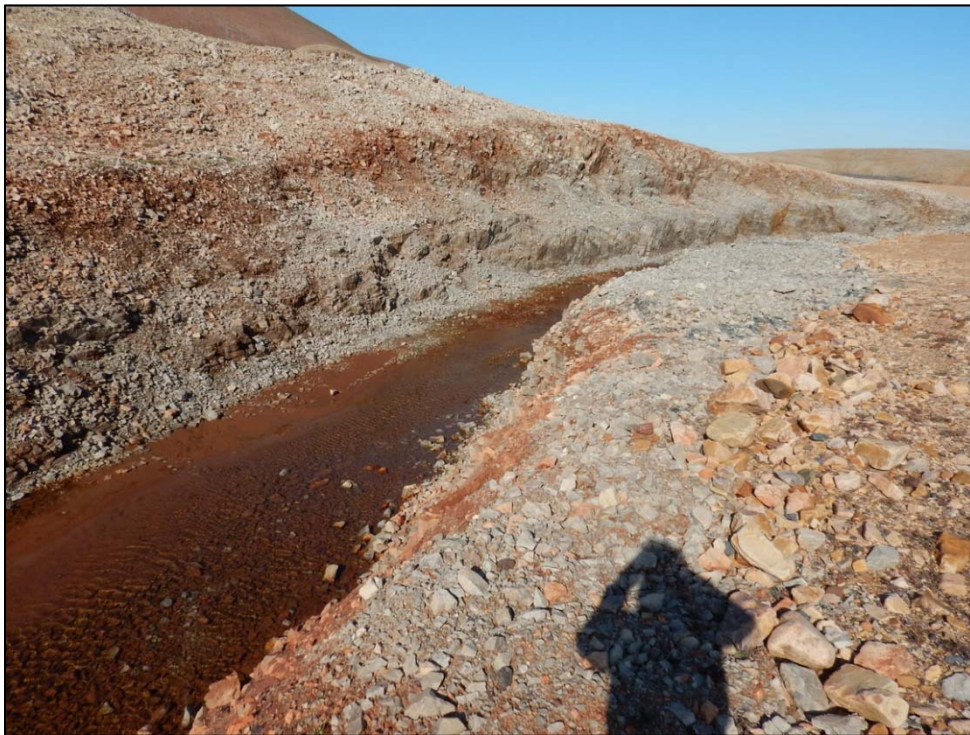
- The upper portion of the spillway (upstream of the access ramp) shows signs of minor erosion of the armour material but remains in satisfactory condition (Photos 4 through 6).

**Photo 4. West Twin Dyke Spillway – On the left bank of the spillway looking upstream at the upper spillway.**

While the spillway is effective in directing and confining flow from the Surface Cell to the Reservoir, additional maintenance may be required in the future. It is recommended that the spillway continue to be visually monitored for additional erosion and maintenance be undertaken as necessary.

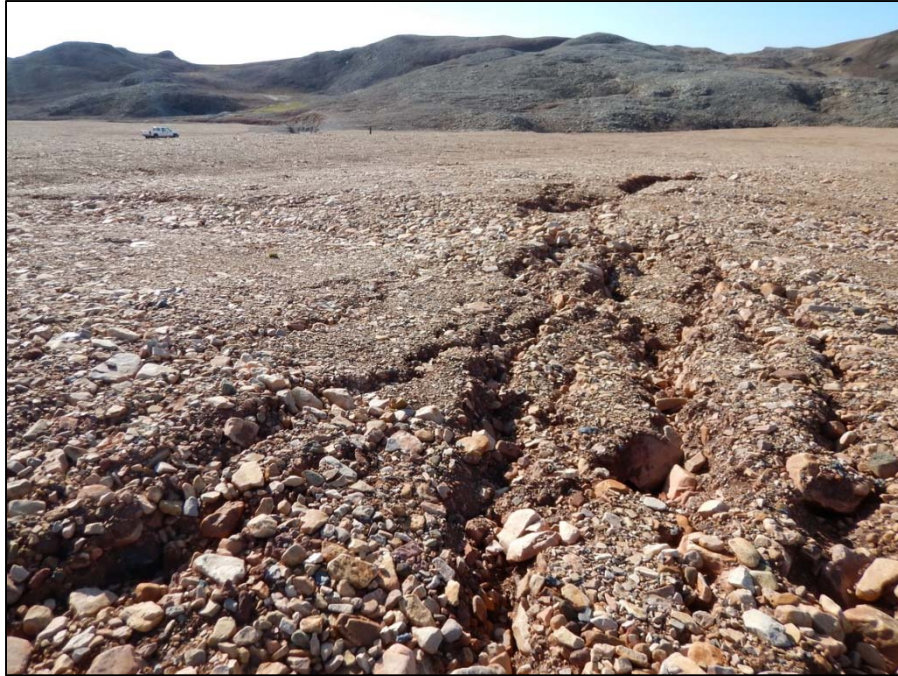
**Photo 21. Surface Cell Cover System – Thermal cracking along the edge of the main swale.**

No maintenance is required for the thermal covers at this time; however, visual monitoring is recommended to check for additional surface deformation and erosion.

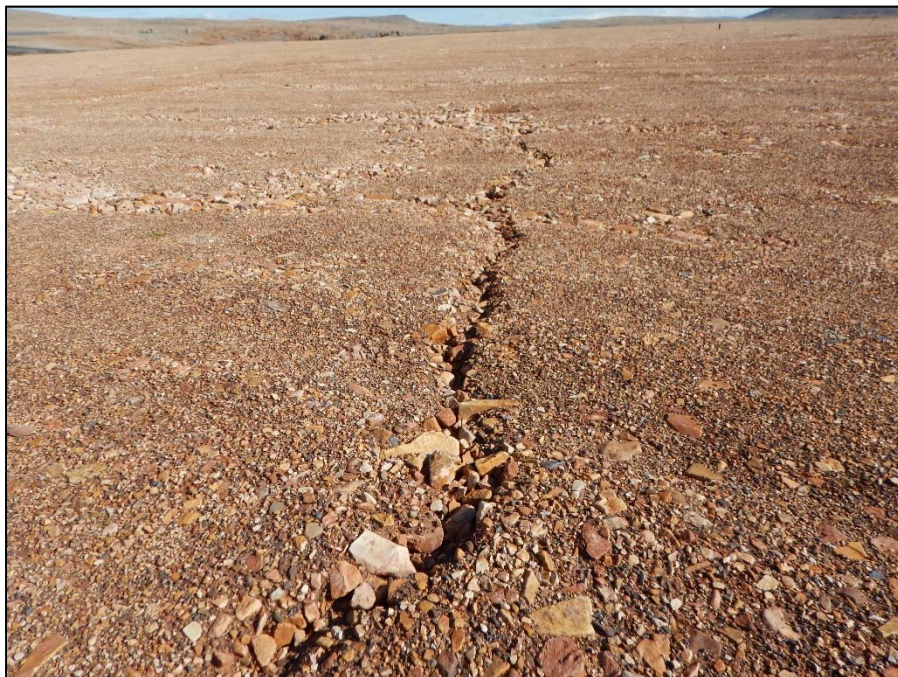
**Photo 22. Surface Cell Cover System – Thermal cracking in the southwest quadrant of the Surface Cell cover system.**

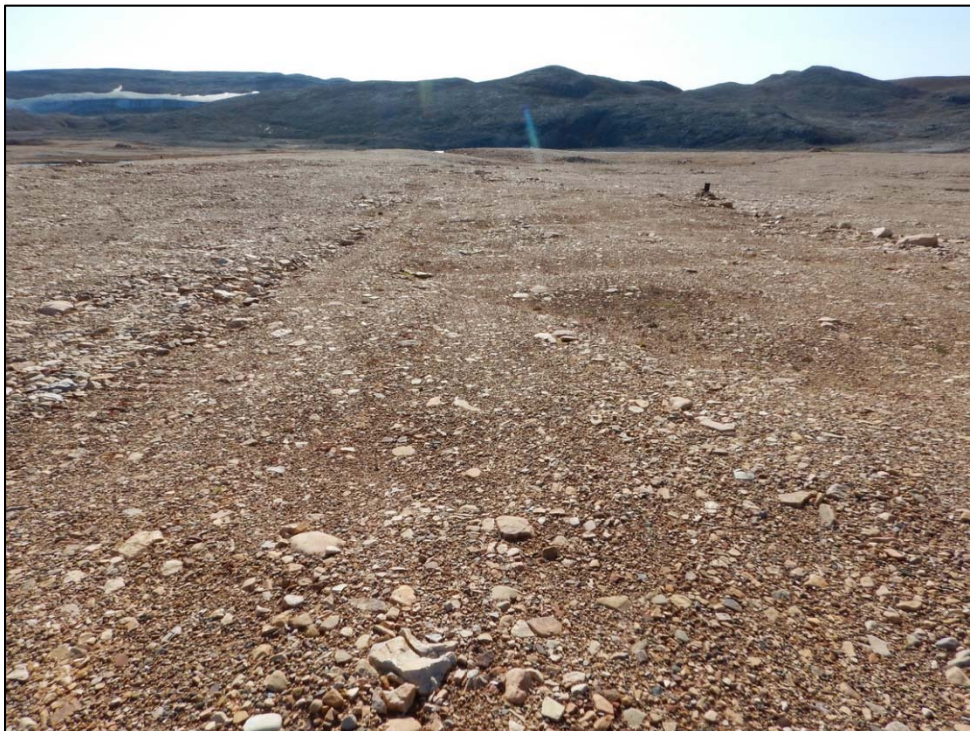
**Photo 30. Test Cell Cover System – Minor thermal cracking.**

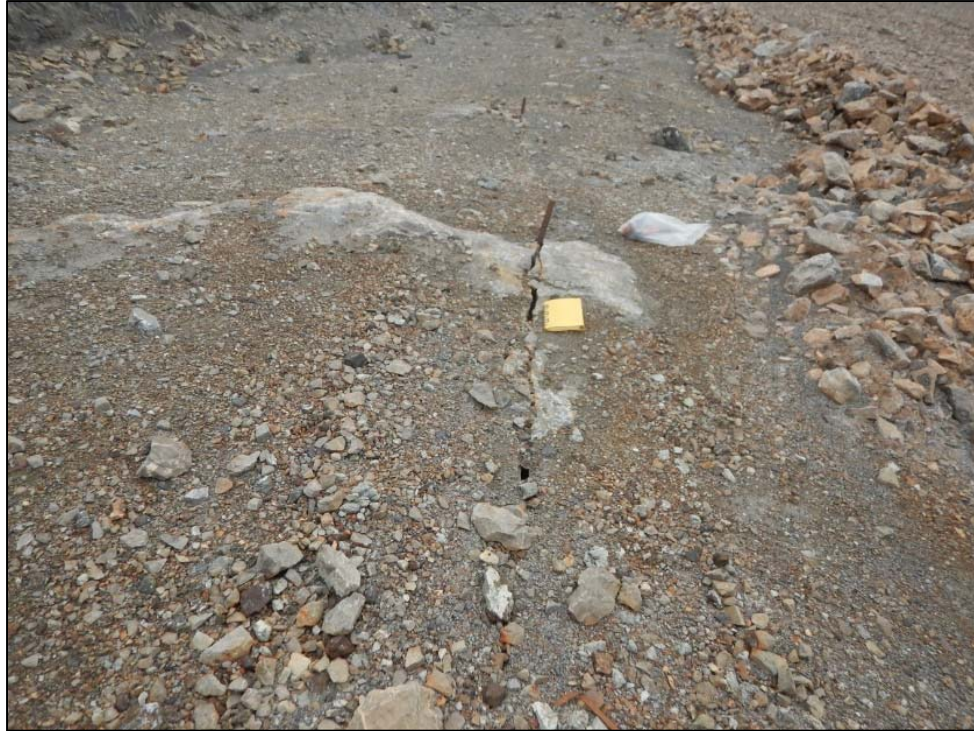
**Photo 45. West Open Pit – Crack behind remnant highwall.**

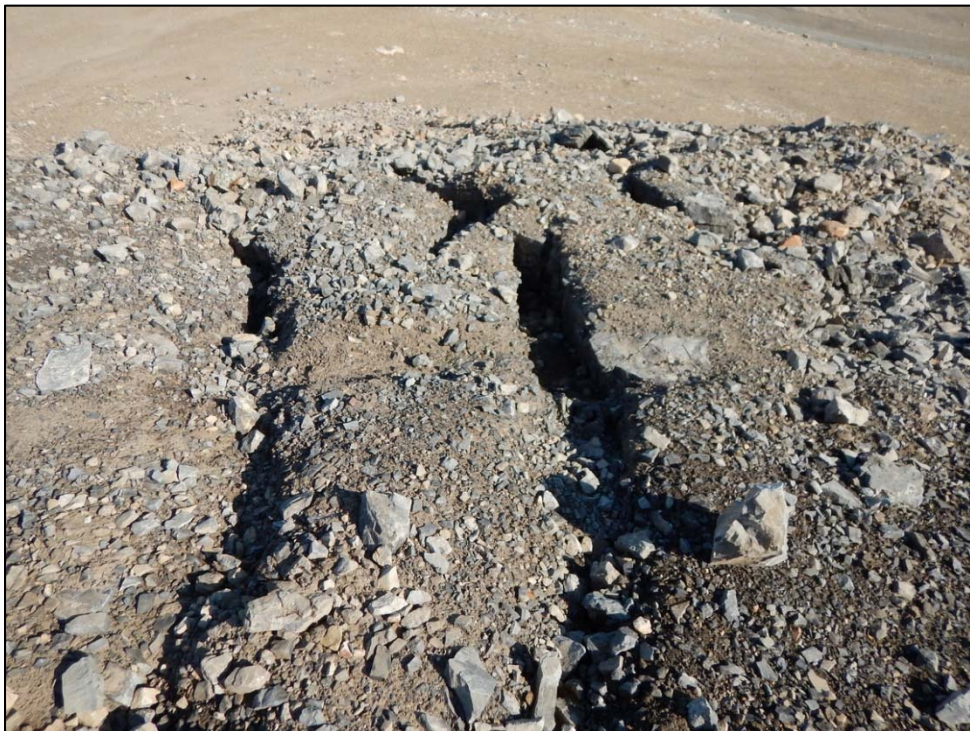
The covers constructed over the mine openings generally appear to be physically stable. Cracking at the East Open Pit crown pillar does not appear to have progressed in many years. No maintenance is recommended, but continued visual inspection is warranted.

**Photo 48. East Open Pit – Cracking in crown pillar.**

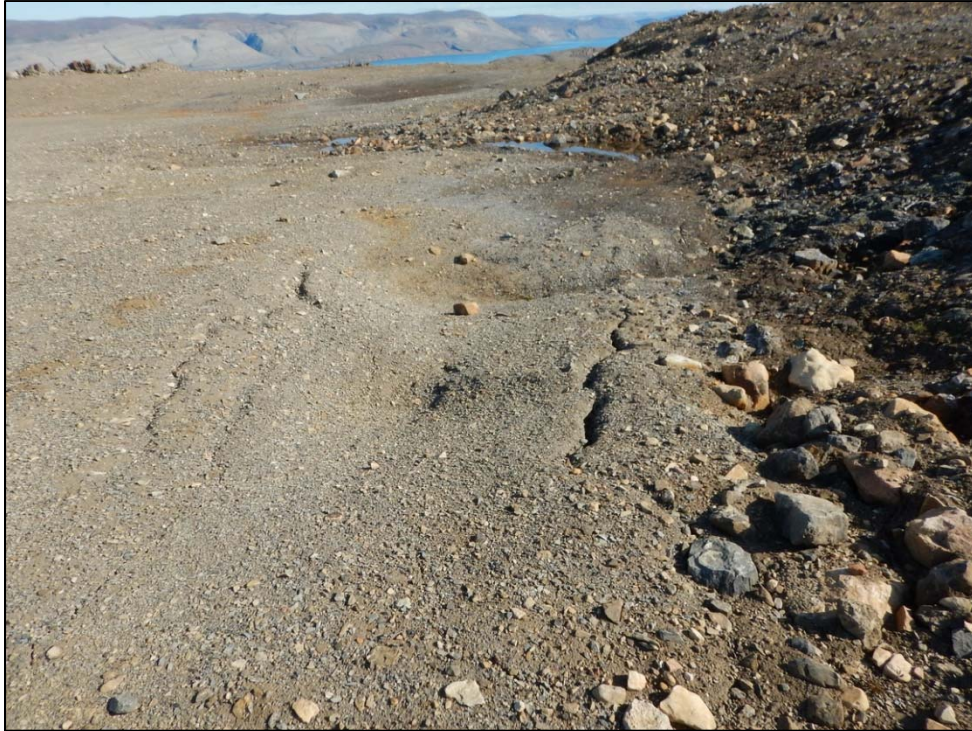
**Photo 57. Oceanview Pit – Minor thermal cracking on south end of the cover.**

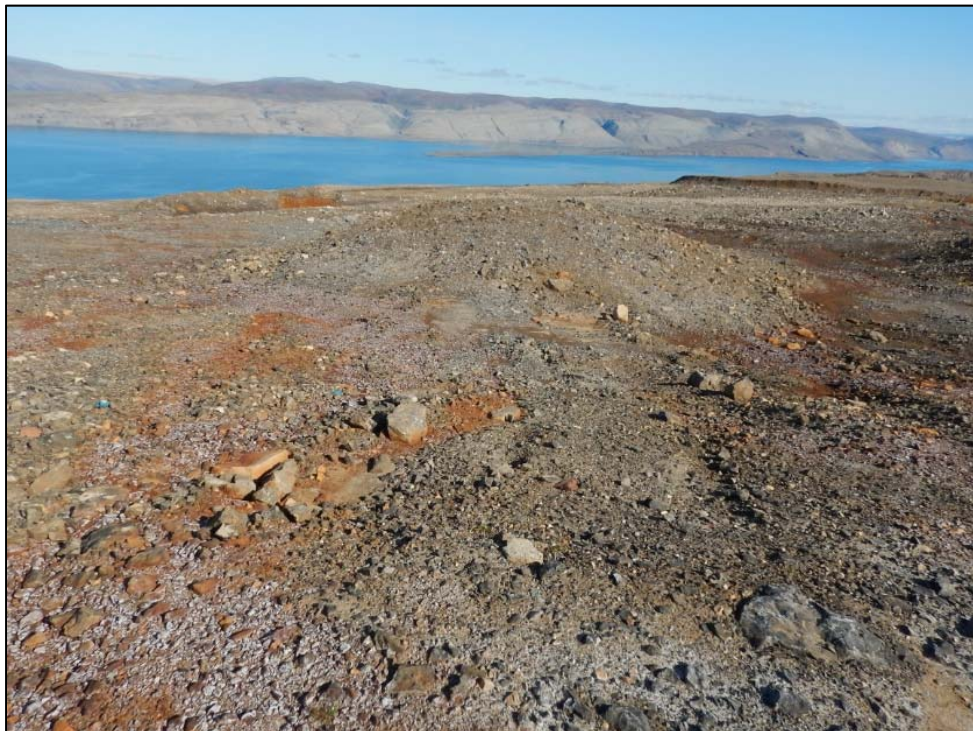
**Photo 72. Oceanview East Raise – ARD staining around the plug and mound.**
