CANZINCO MINES LTD.

NANISIVIK MINE, NUNAVUT

2021 ANNUAL GEOTECHNICAL INSPECTION

PROJECT NO.: 0255033

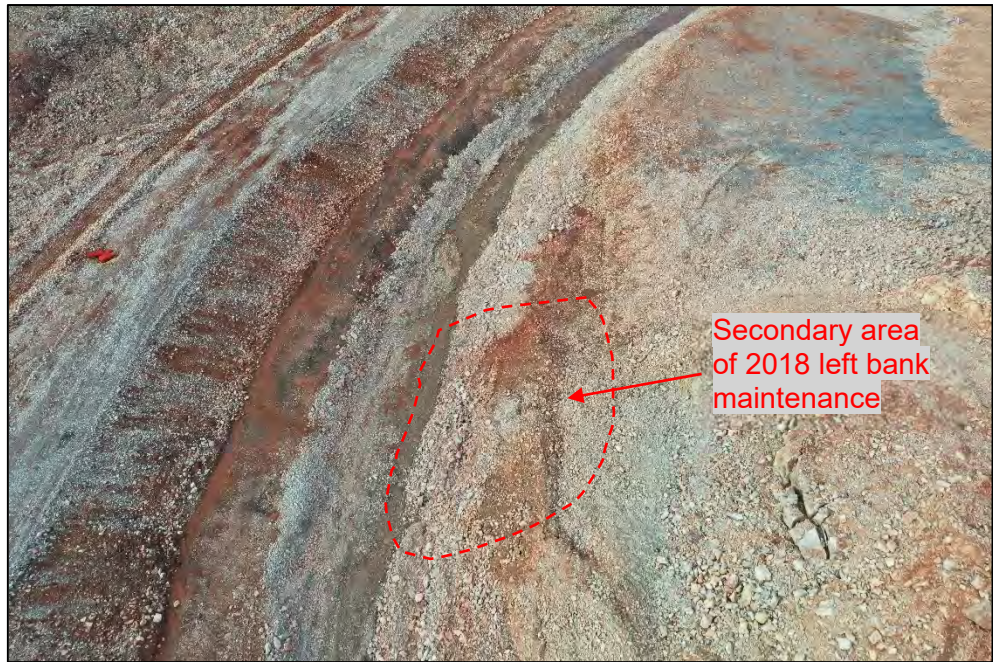
- The upper portion of the spillway (upstream of the access ramp) showed signs of further erosion of the armour material compared to 2020 but remained in satisfactory condition (Photos 5 and 6).

Photo 6. West Twin Dyke Spillway – Area approximately 100 metres downstream of the access ramp, as seen from UAV. Note secondary area of 2018 left bank maintenance.

While the spillway is effective in directing and confining flow from the Surface Cell to the Reservoir, additional maintenance may be required in the future. It is recommended that the spillway and side slopes continue to be visually monitored for additional erosion and maintenance be undertaken as necessary.

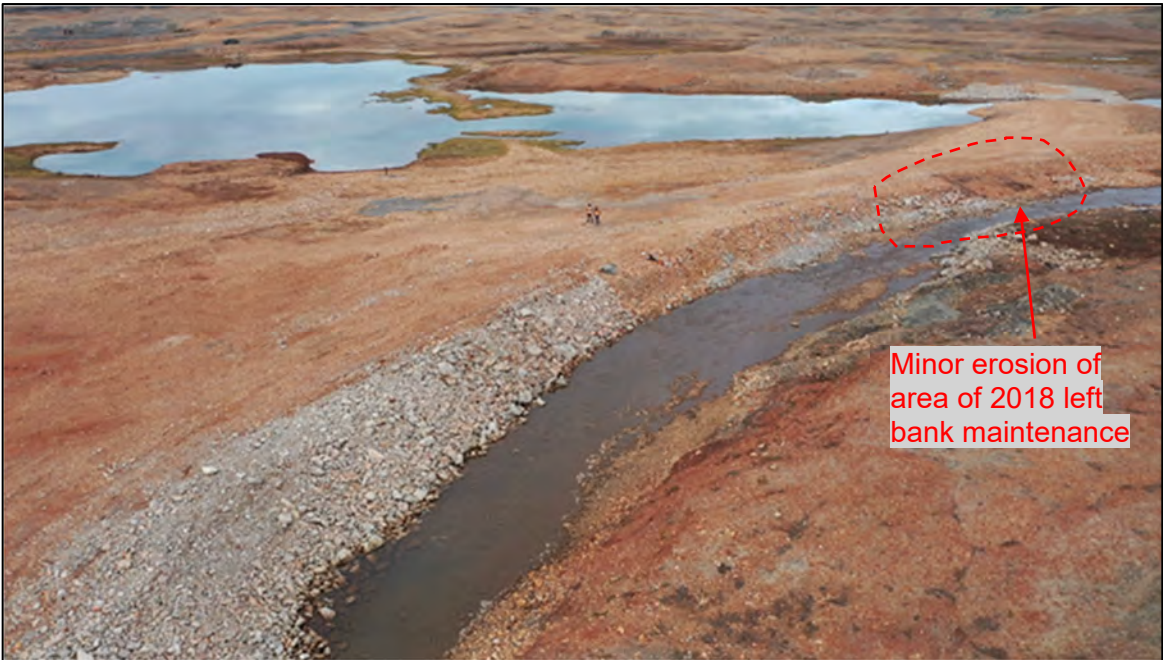
Photo 15. East Twin Creek Diversion – Overview, looking downstream from UAV. Note minor erosion near upper right.

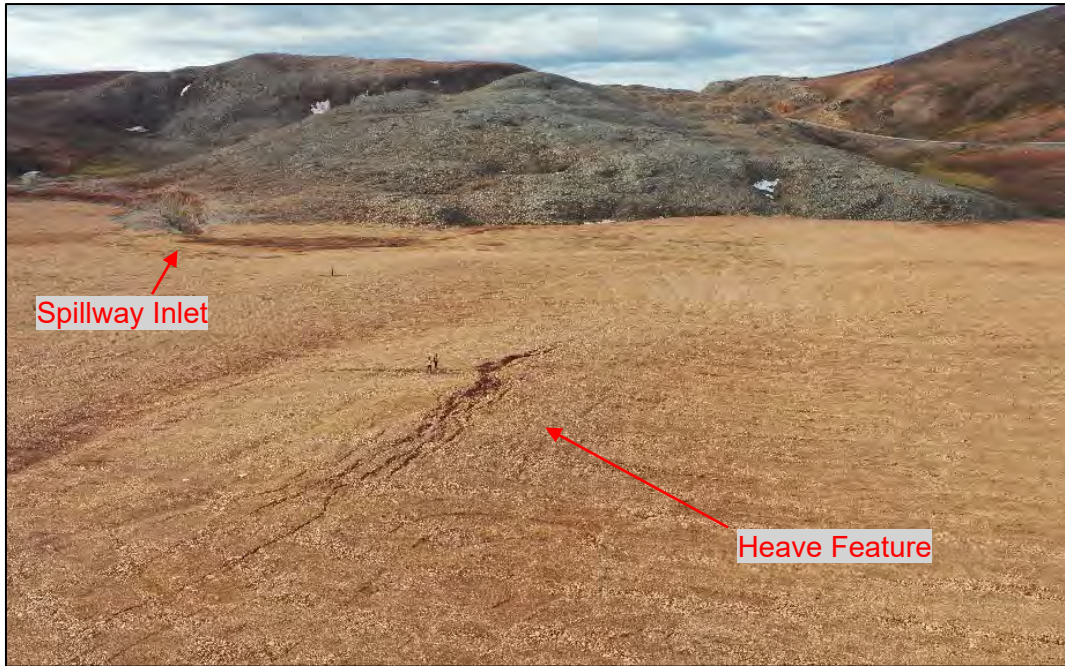
Photo 21. Surface Cell Cover System – Heave feature in the southwest quadrant of the Surface Cell cover system, as seen looking Southwest

No maintenance is required for the thermal covers at this time; however, visual monitoring is recommended to monitor for additional surface deformation and erosion, specifically the heave feature.

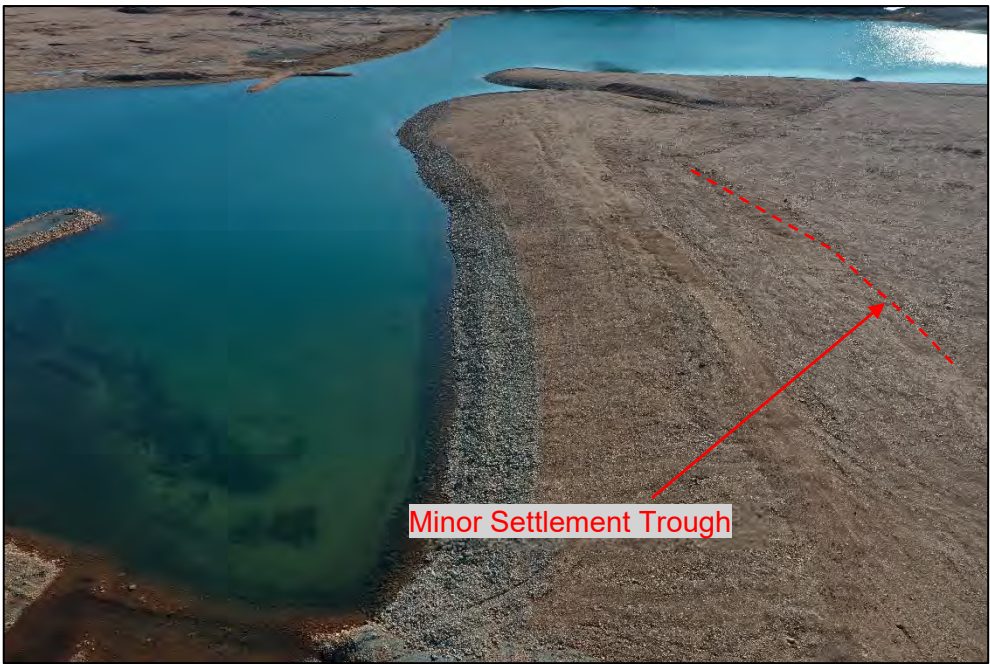
Photo 30. Test Cell Cover System – N/S arm of Test Cell Dyke, as seen from UAV. Note minor settlement trough.

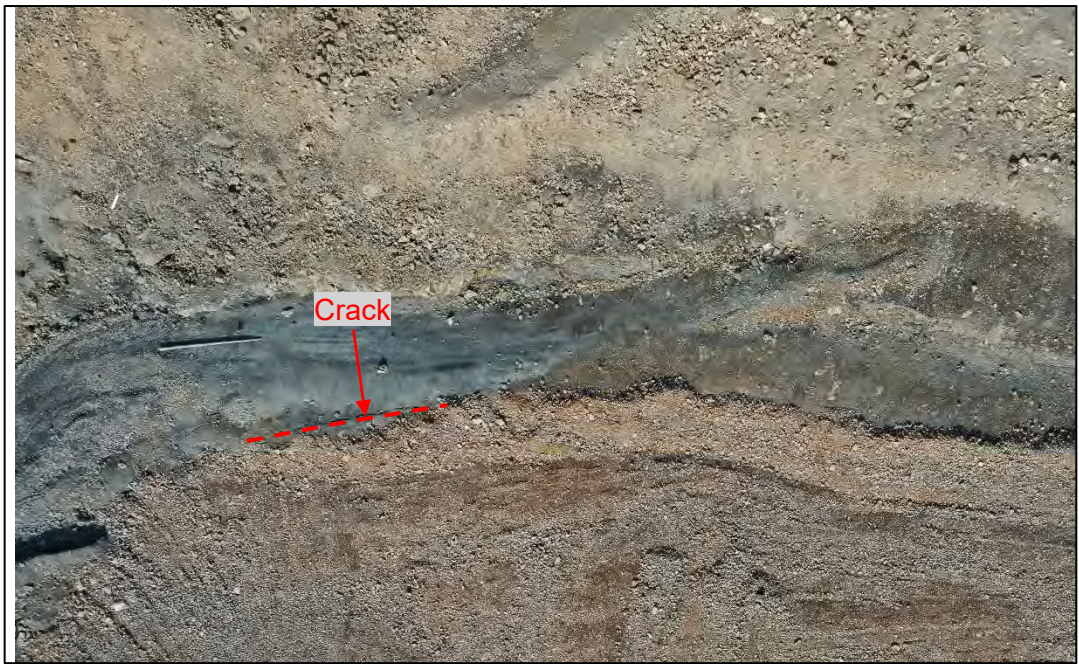
Photo 46. West Open Pit – Crack behind remnant highwall, as seen from above.

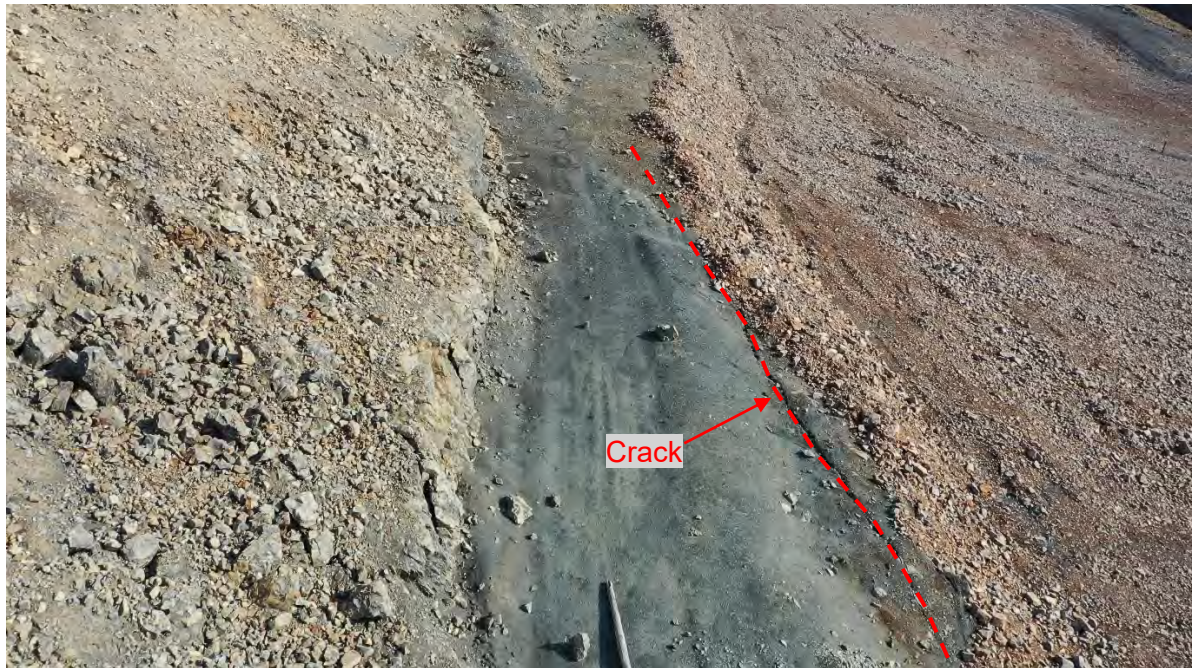
Photo 45. West Open Pit – Crack behind remnant highwall, as seen from above.

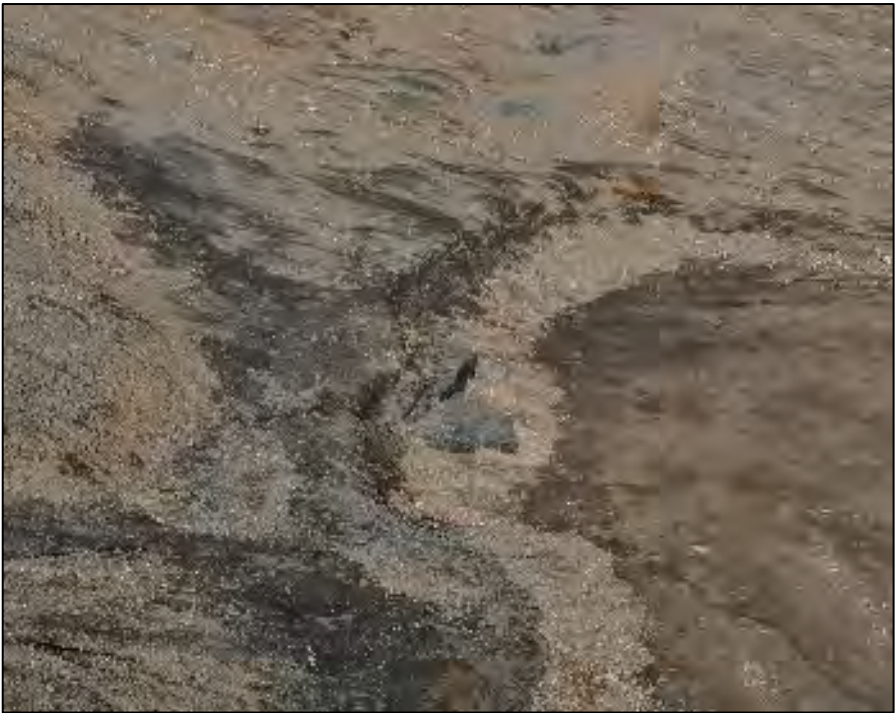
The covers constructed over the mine openings generally appear to be physically stable. Cracking at the East Open Pit crown pillar does not appear to have progressed in many years. No maintenance is recommended, but continued visual inspection is warranted.

Photo 50. East Open Pit - Uppermost portion of cover and cracking in crown pillar, as seen from UAV.

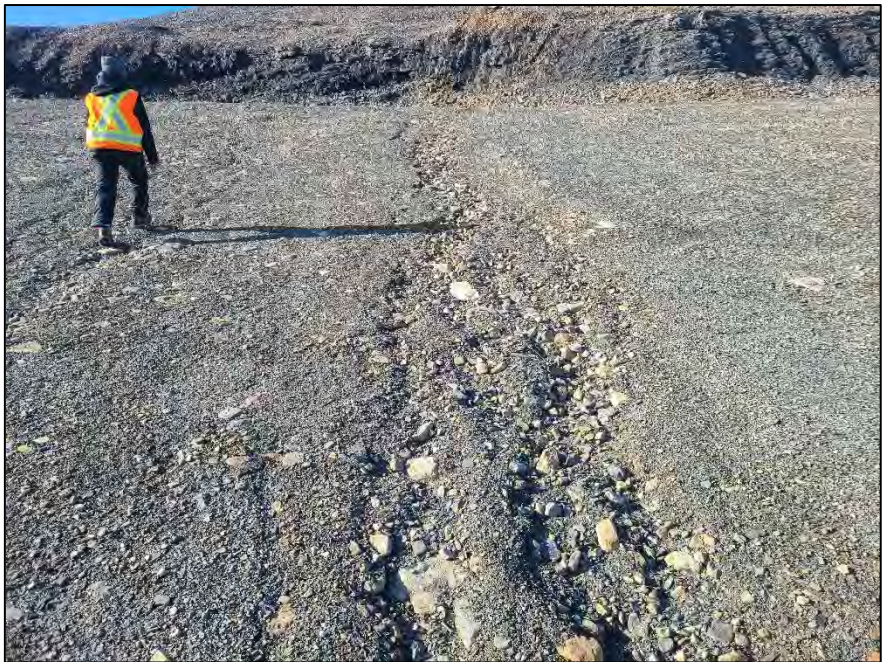
Photo 49. East Open Pit - Looking upslope at rilling on upper portion of cover. Note self-armouring.

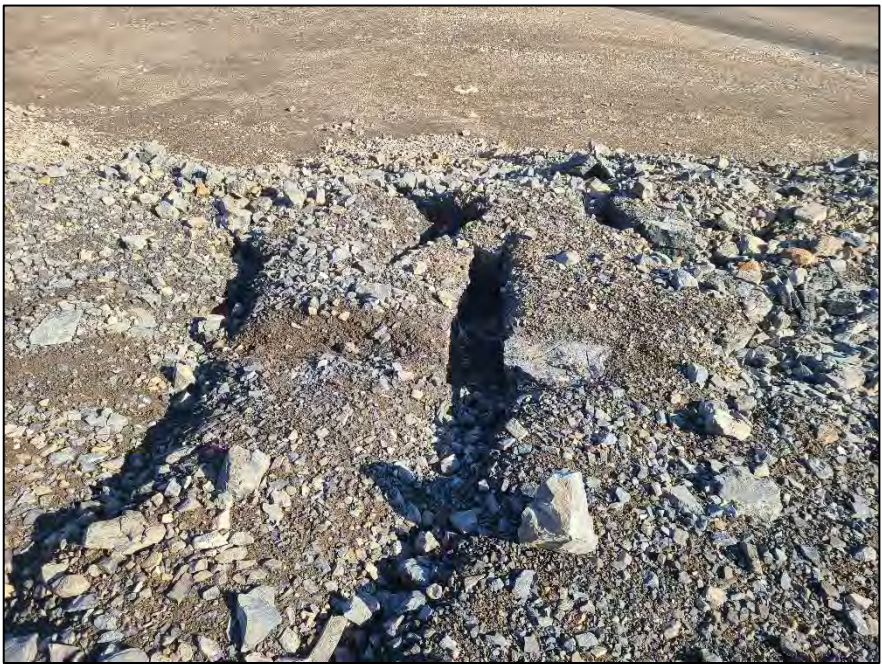
Photo 51. East Open Pit – Cracking in crown pillar.
