CANZINCO MINES LTD.

NANISIVIK MINE, NUNAVUT

2022 ANNUAL GEOTECHNICAL INSPECTION

PROJECT NO.: 0255034

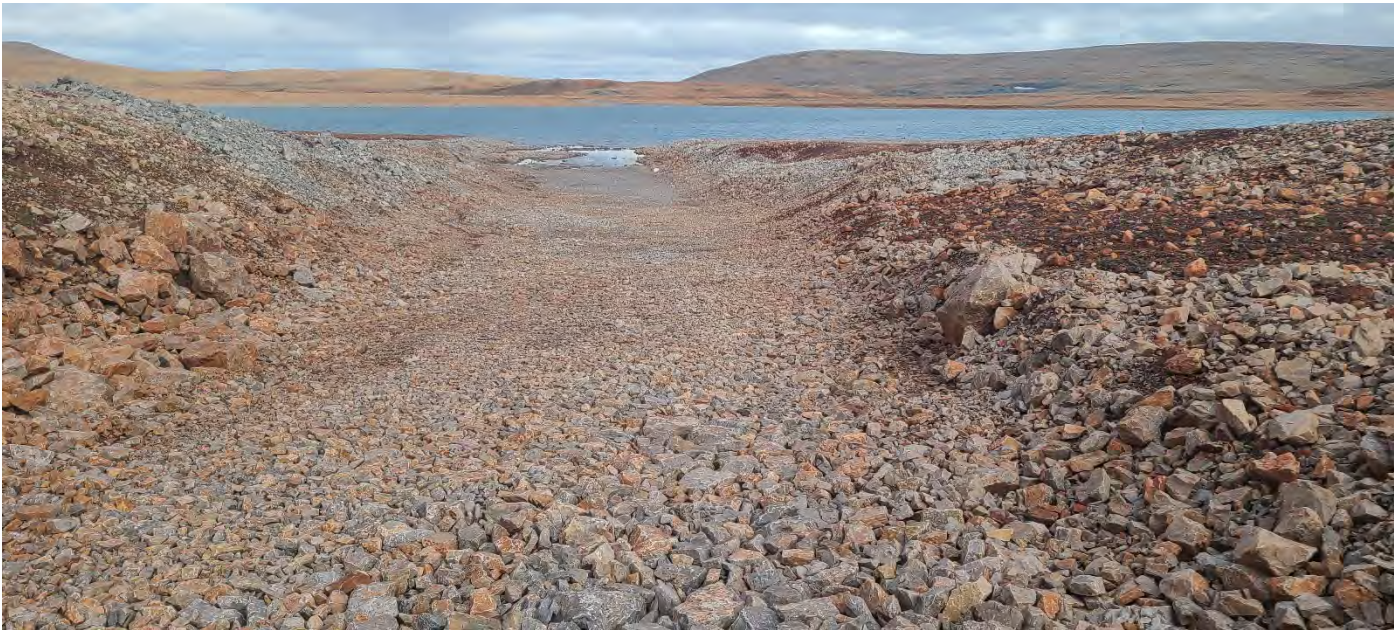
- During 2018 maintenance activities, transported armour material that was deposited at the base of the spillway was removed or compacted in-place. No new deposition of armour material in the base of the spillway was observed during the 2019 to 2022 inspections (Photo 8).

Photo 8. West Twin Dyke Spillway – Looking downstream at spillway outlet where 2018 maintenance was performed.

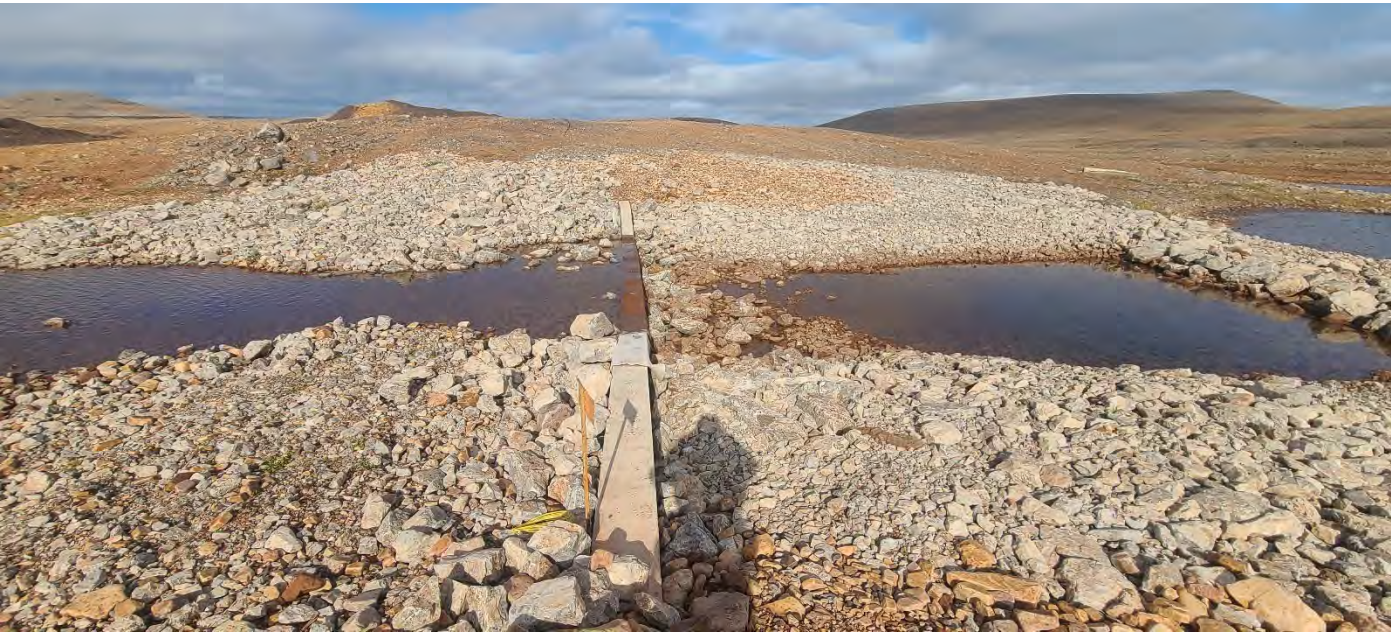
Photo 10. West Twin Outlet Wall – As seen from right bank.

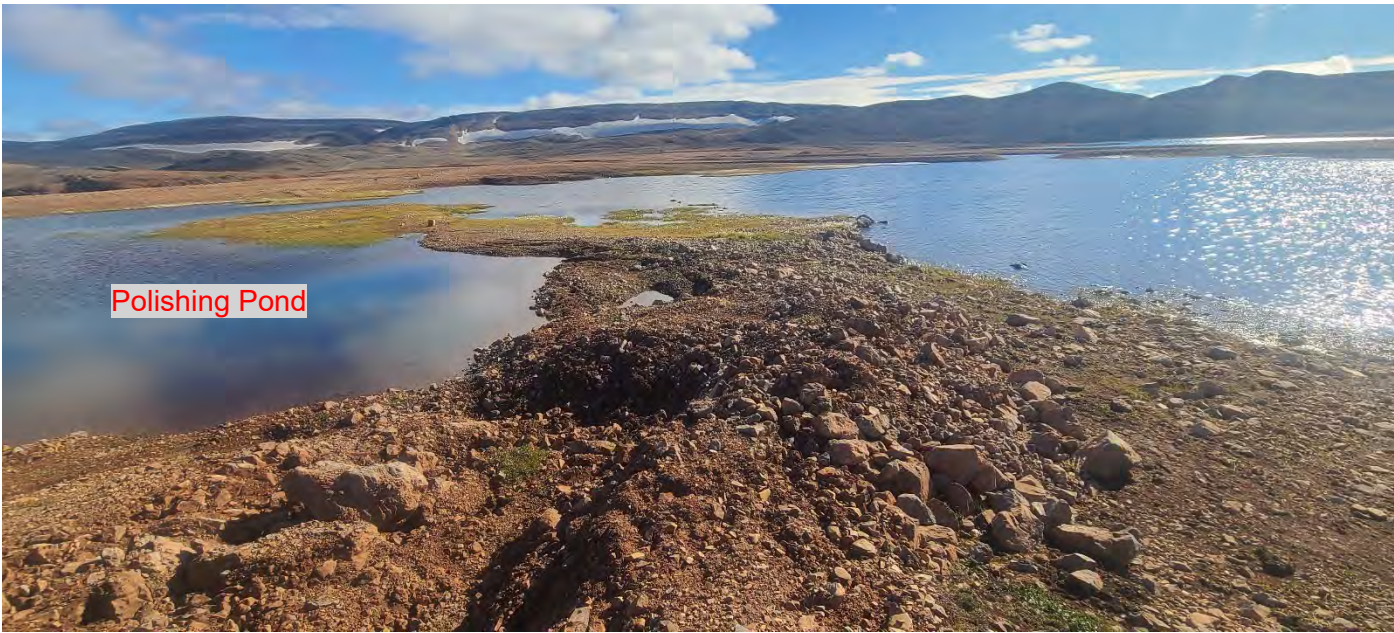
Photo 12. Polishing Pond – Thermokarsting around Polishing Pond, looking south.

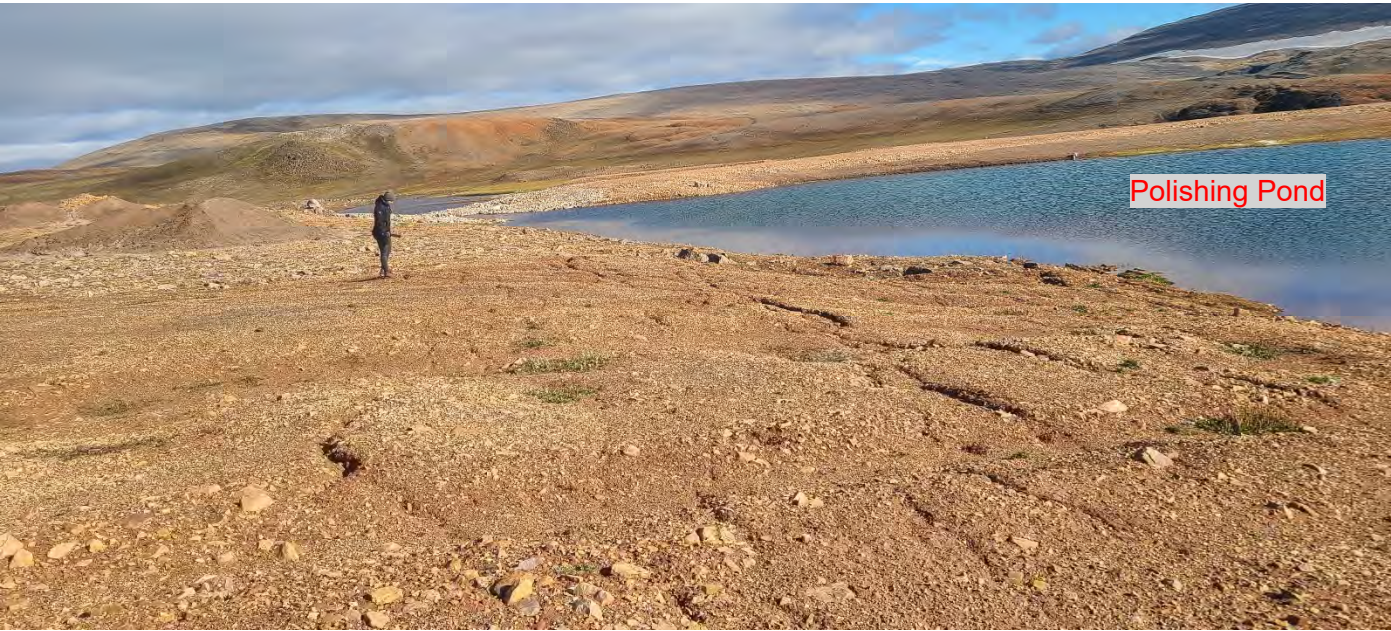
Photo 13. Polishing Pond – Thermokarst cracking along the north side of the Polishing Pond.

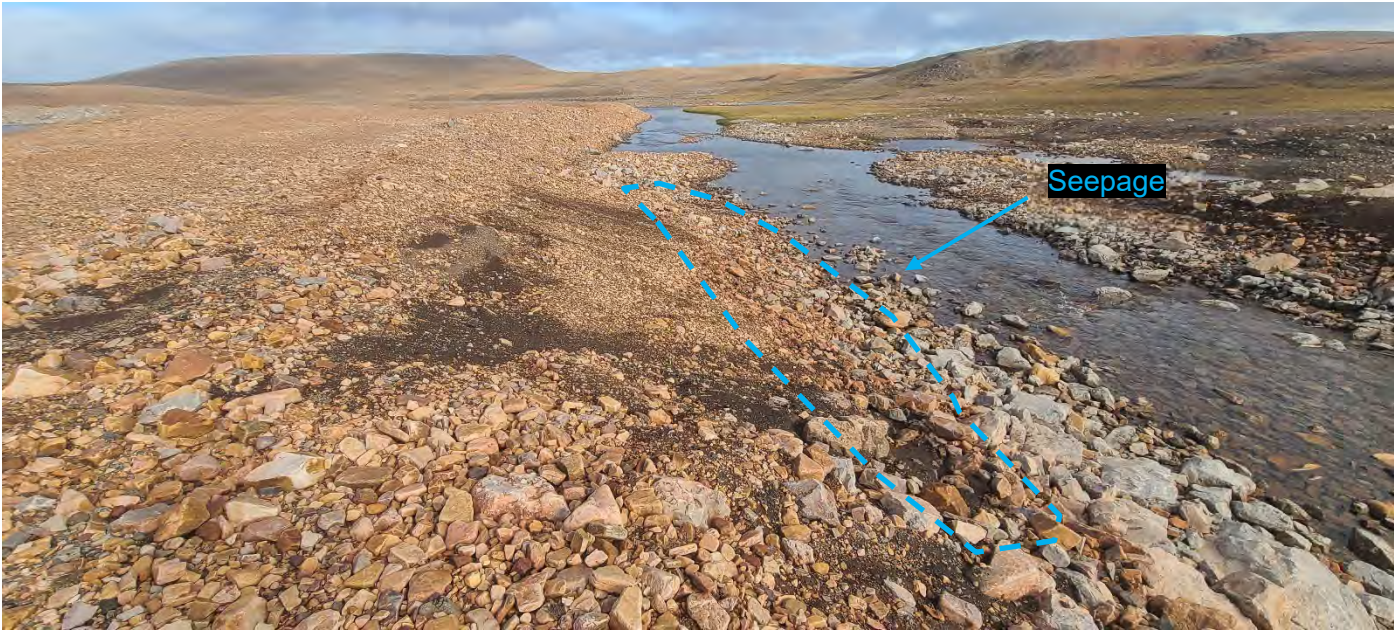
Photo 16. East Twin Creek Diversion – Looking downstream at area where 2018 left bank maintenance was performed.

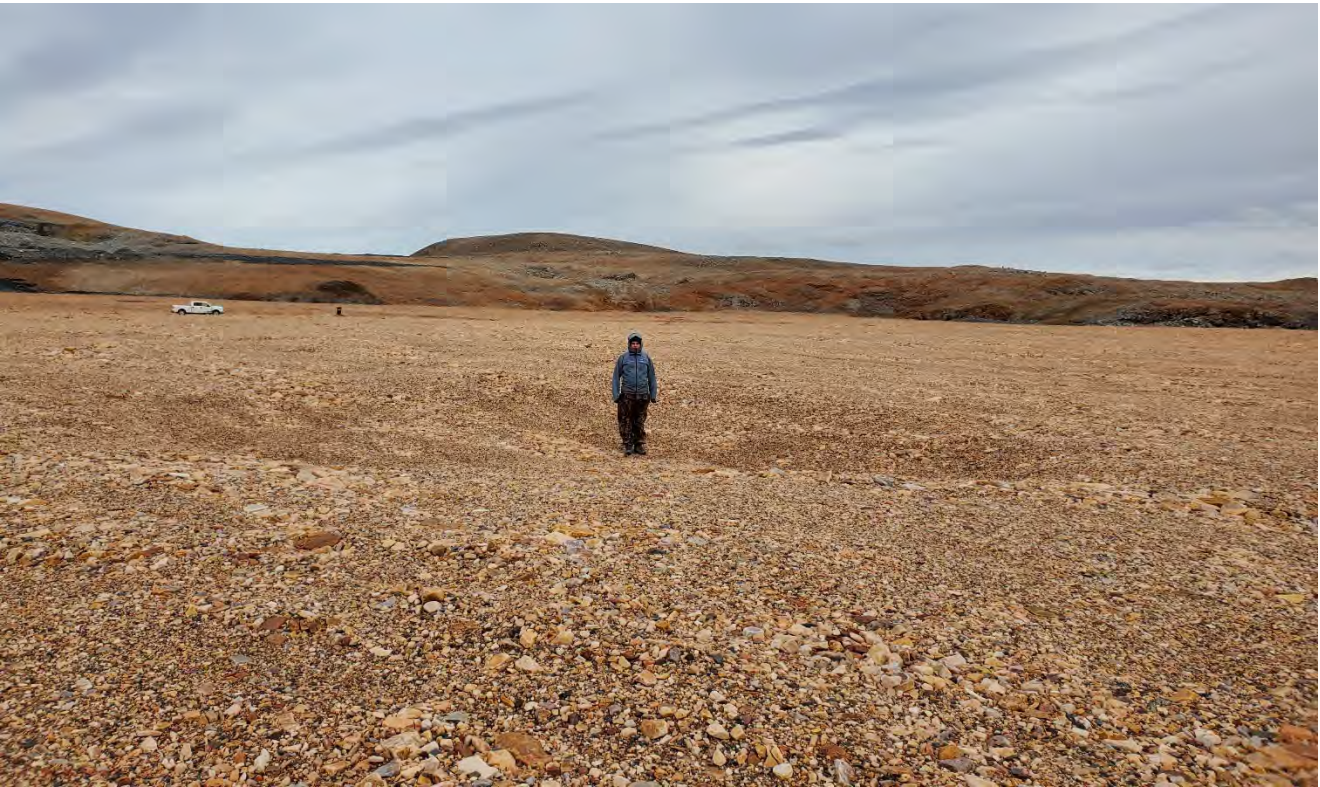
Photo 17. Surface Cell Cover System – Minor thermokarsting along main N-S drainage swale.

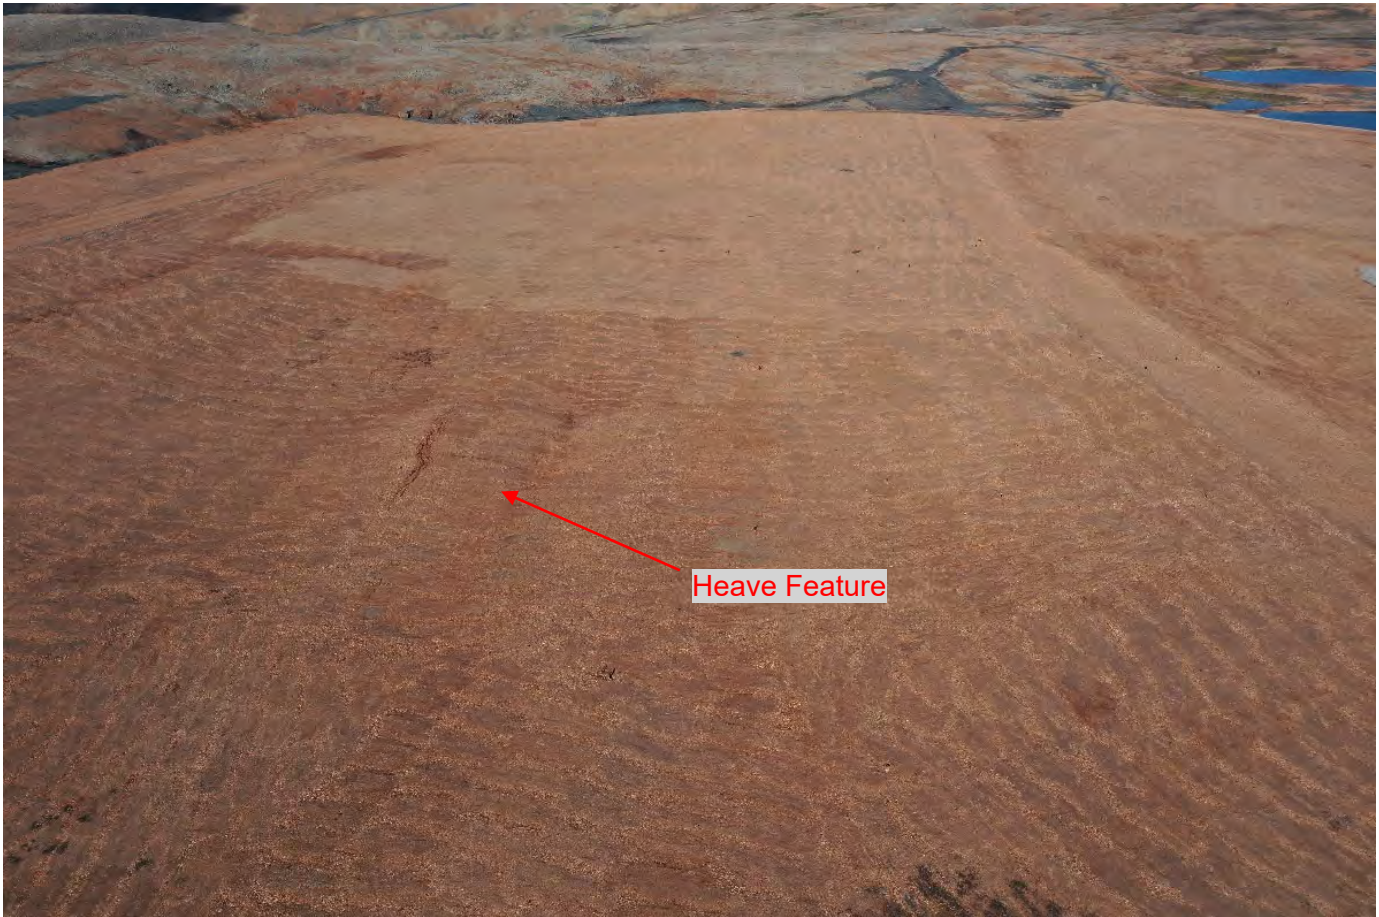
Photo 20. Surface Cell Cover System – Overview from UAV, looking Northeast. Note heave feature.

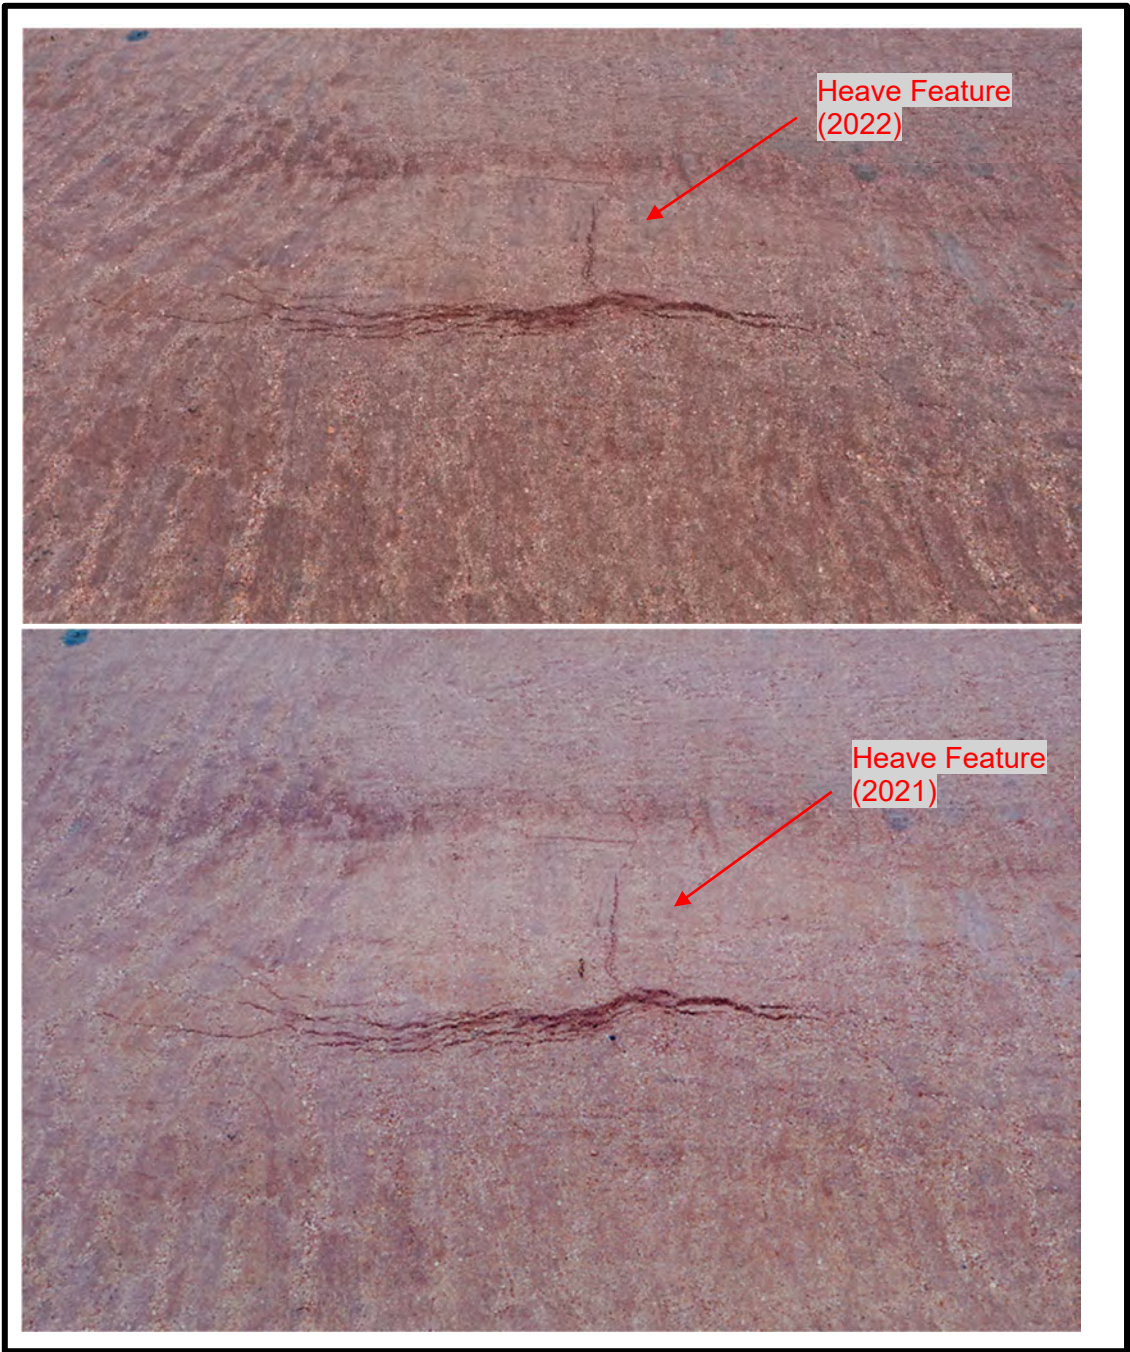
Photo 21. Surface Cell Cover System – Heave feature in 2022 (above) and 2021 (below), looking northeast.

Visual monitoring of the thermal covers is recommended to monitor for additional surface deformation and erosion, specifically the heave feature. Additionally, at the heave feature, measurements of the cracking (length, width, depth), and measurements of any exposed shale cover (length, depth), should be recorded and compared at each inspection. Localized regrading of the heave feature during an upcoming geotechnical inspection is recommended to limit snow accumulation and potentially to reduce the rate of growth of the heave.

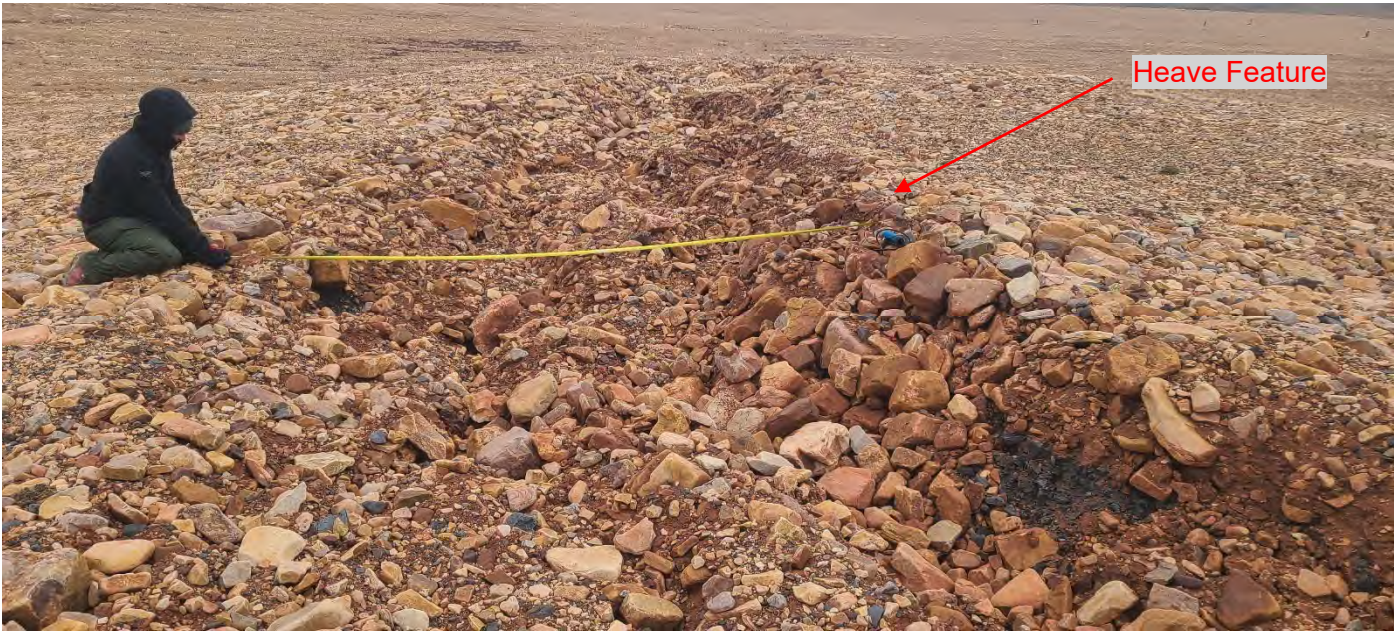
Photo 22. Surface Cell Cover System – Maximum crack width at the crest of the heave feature (2.8 m wide, 0.6 m deep).

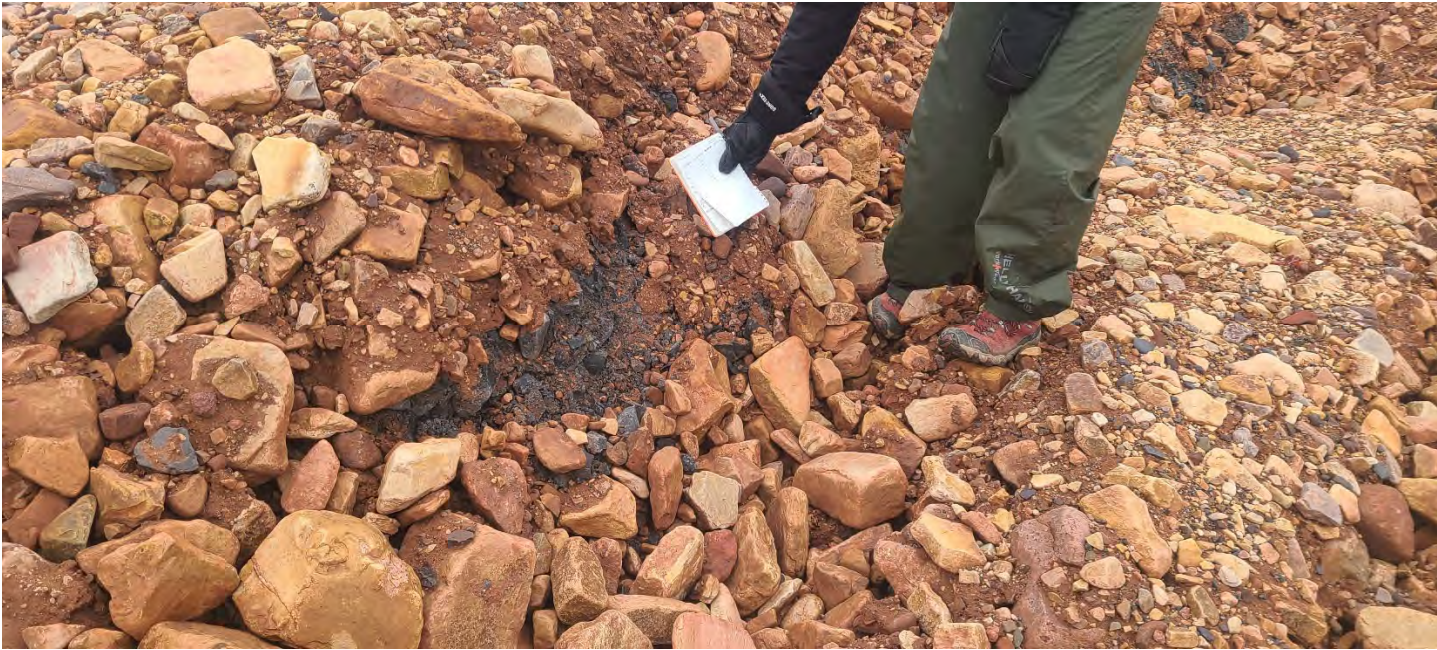
Photo 23. Surface Cell Cover System – Exposed shale within the cracking at the crest of the heave feature (0.3 m in thickness).

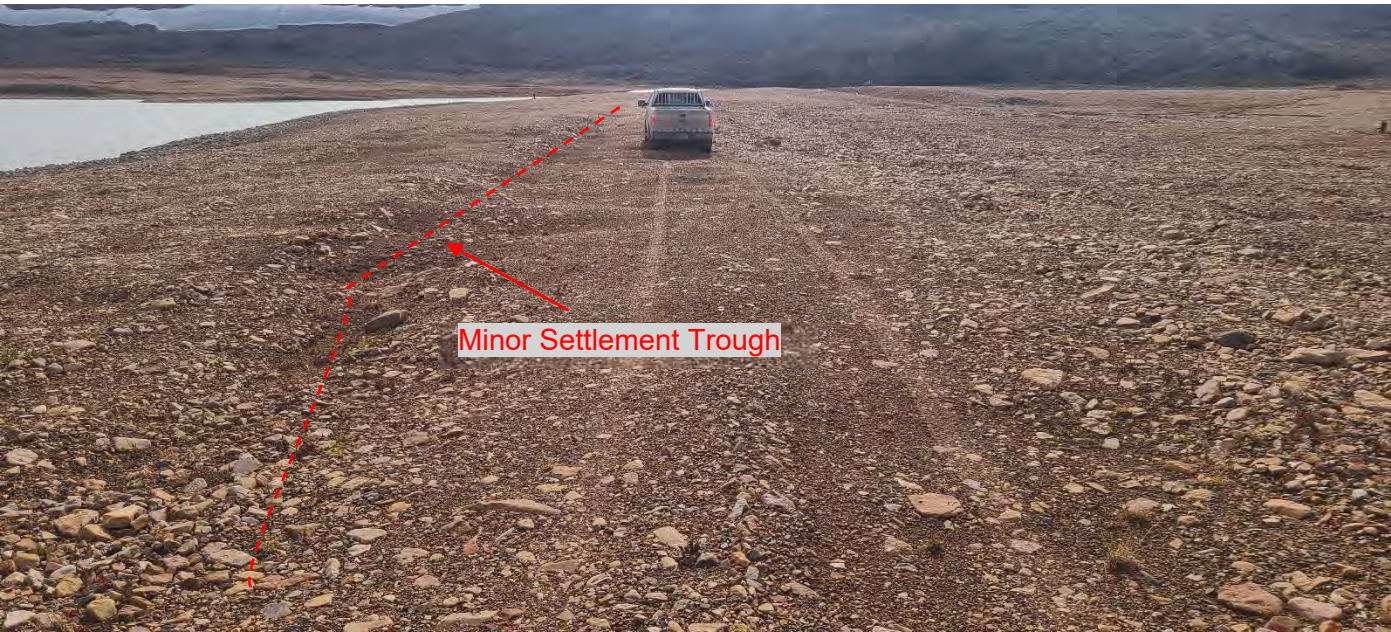
Photo 30. Test Cell Cover System – Minor settlement trough along N/S arm of Test Cell Dyke.

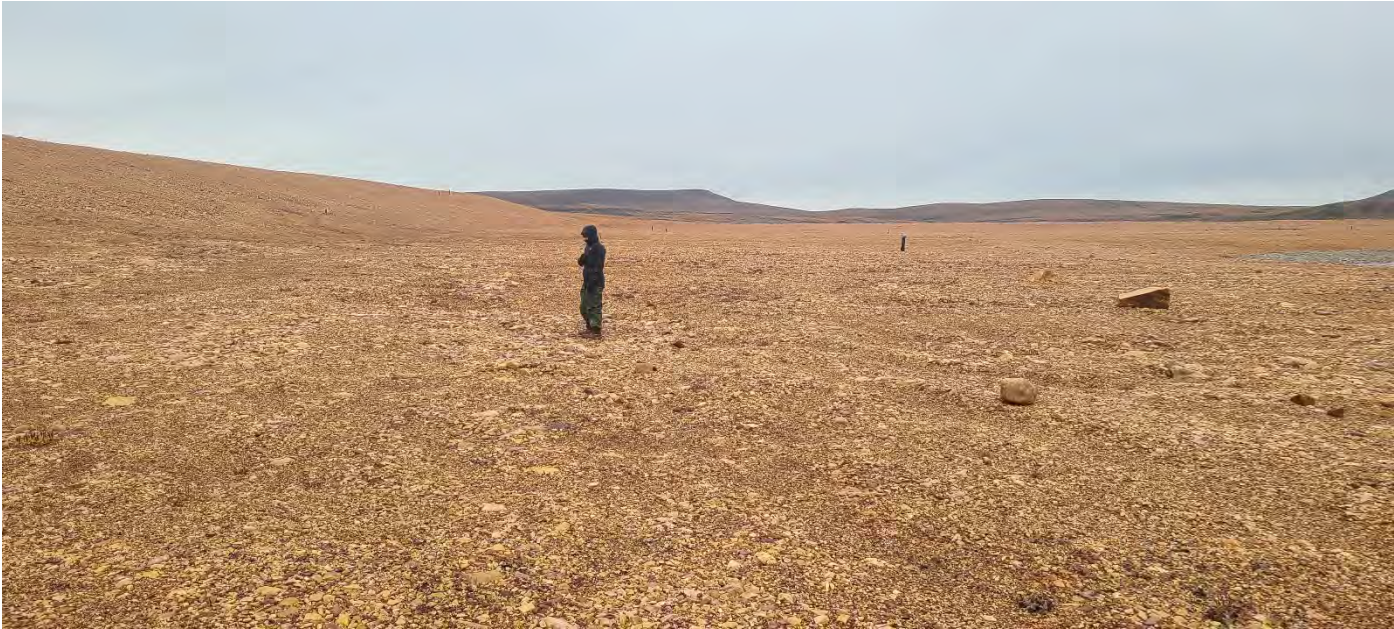
Photo 41. Toe of West Twin Dyke Tailings Cover – Note minor thermokarsting, looking North.

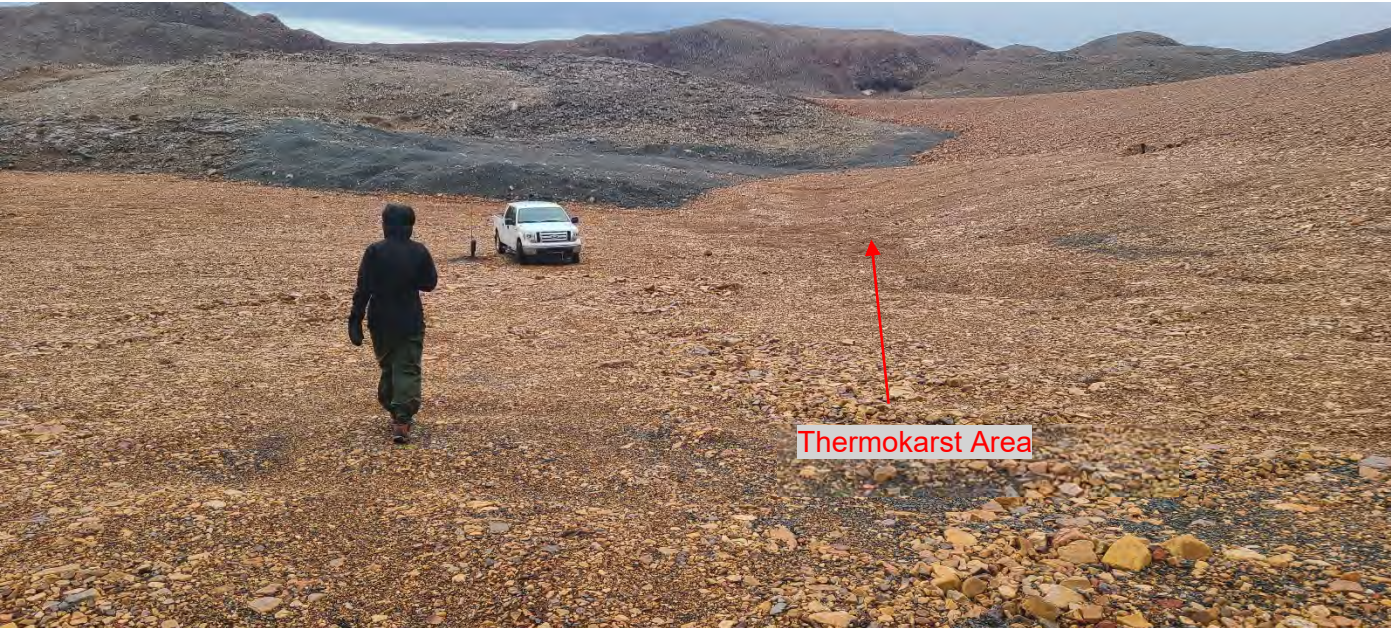
Photo 40. Toe of West Twin Dyke Tailings Cover – Note minor thermokarsting, looking south.

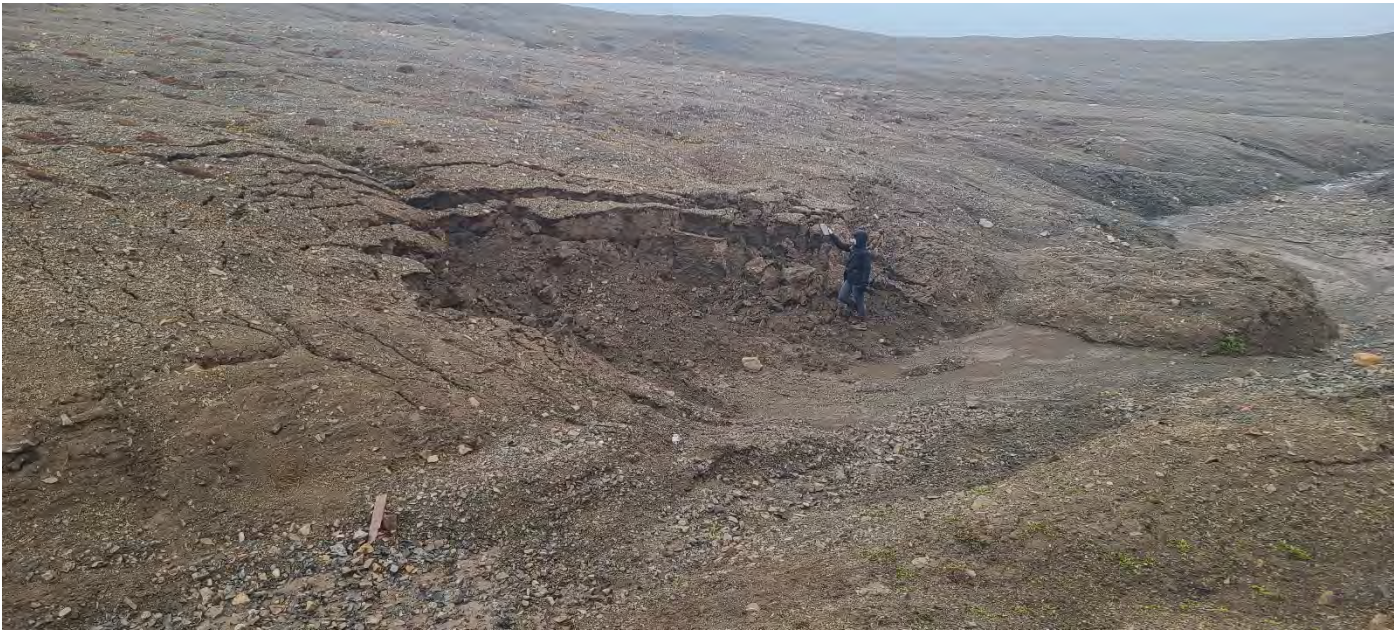
Photo 45. Landfill – Thermokarst along the diversion berm upslope of the landfill.

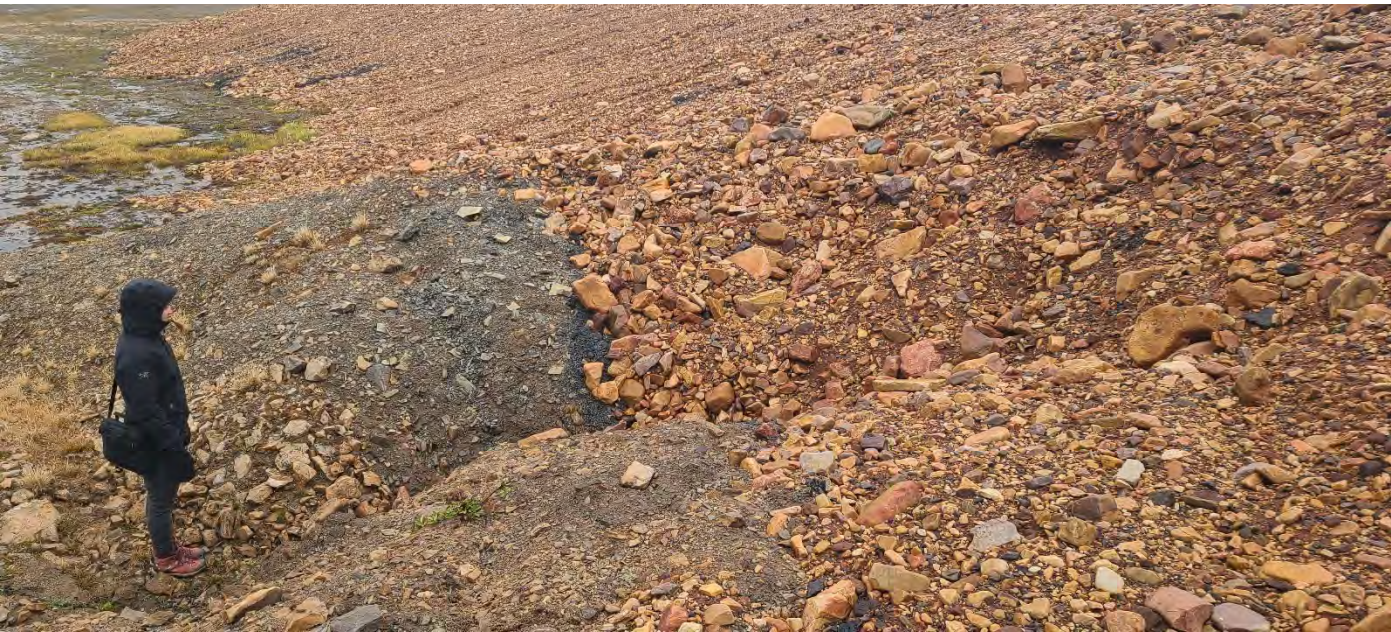
Photo 44. Landfill – Thermokarst encroaching on the southwest corner of the cover system. View looking north.

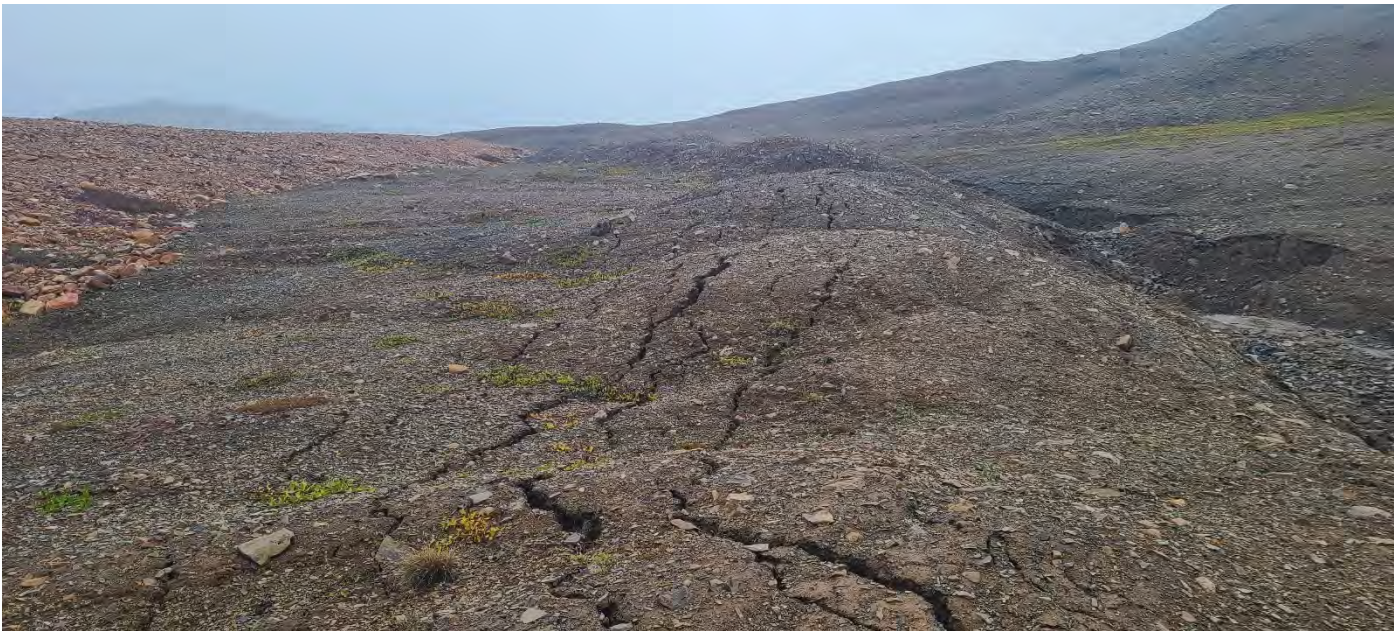
Photo 46. Landfill – Thermokarst cracking encroaching on the southwest corner of the cover system.

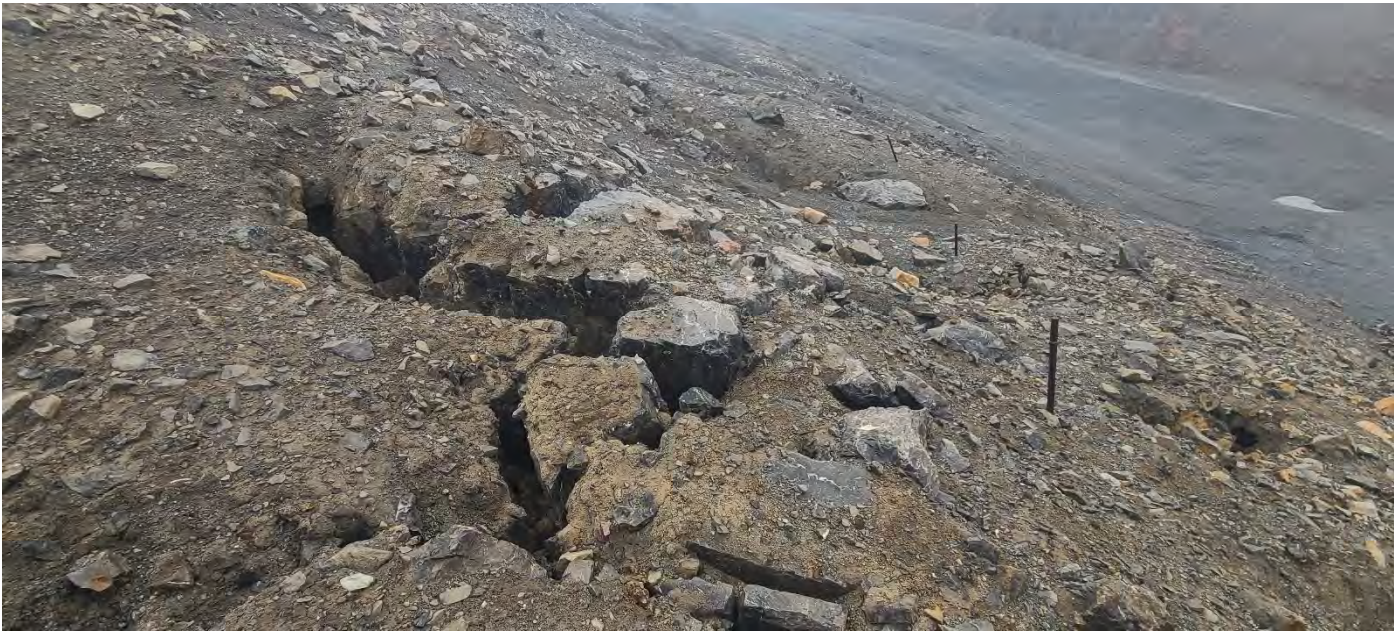
Photo 49. West Open Pit – Tension cracking and deformation adjacent to the east of the edge of the West Open Pit cover system.

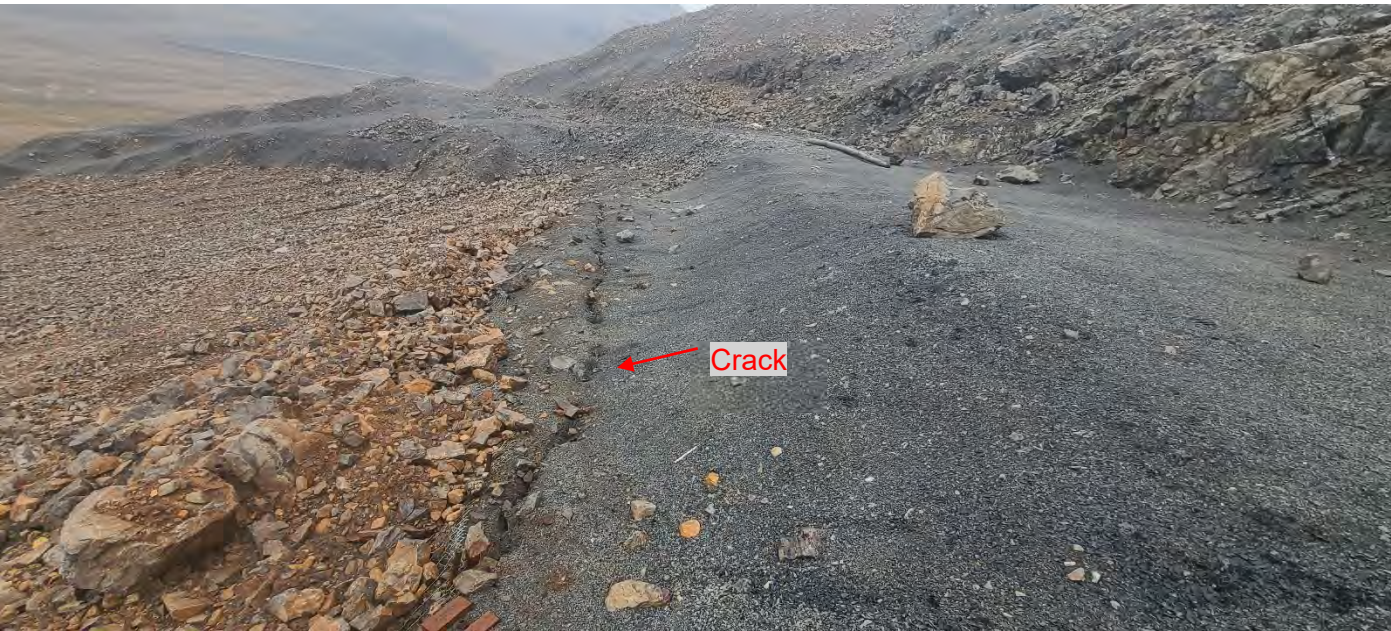
Photo 48. West Open Pit – Crack behind remnant highwall.

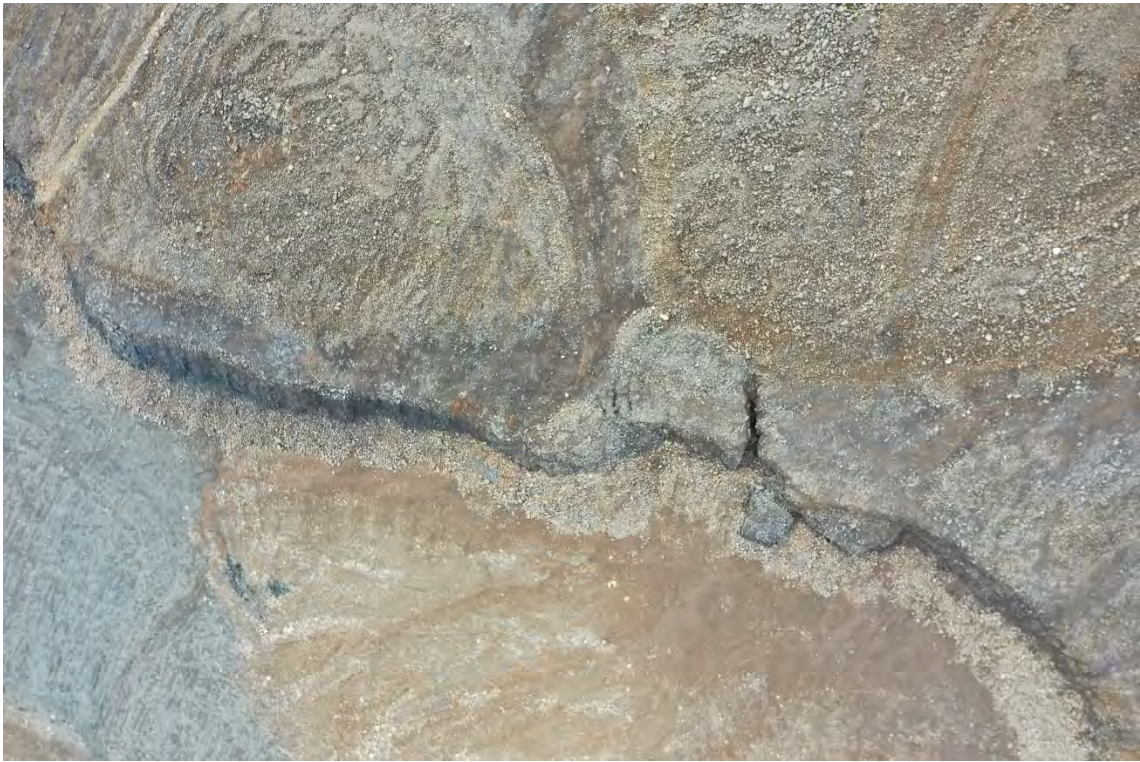
The covers constructed over the mine openings generally appear to be physically stable. Cracking at the East Open Pit crown pillar does not appear to have progressed in many years. No maintenance is recommended, but continued visual inspection is warranted.

Photo 53. East Open Pit - Cracking in crown pillar, as seen from UAV.

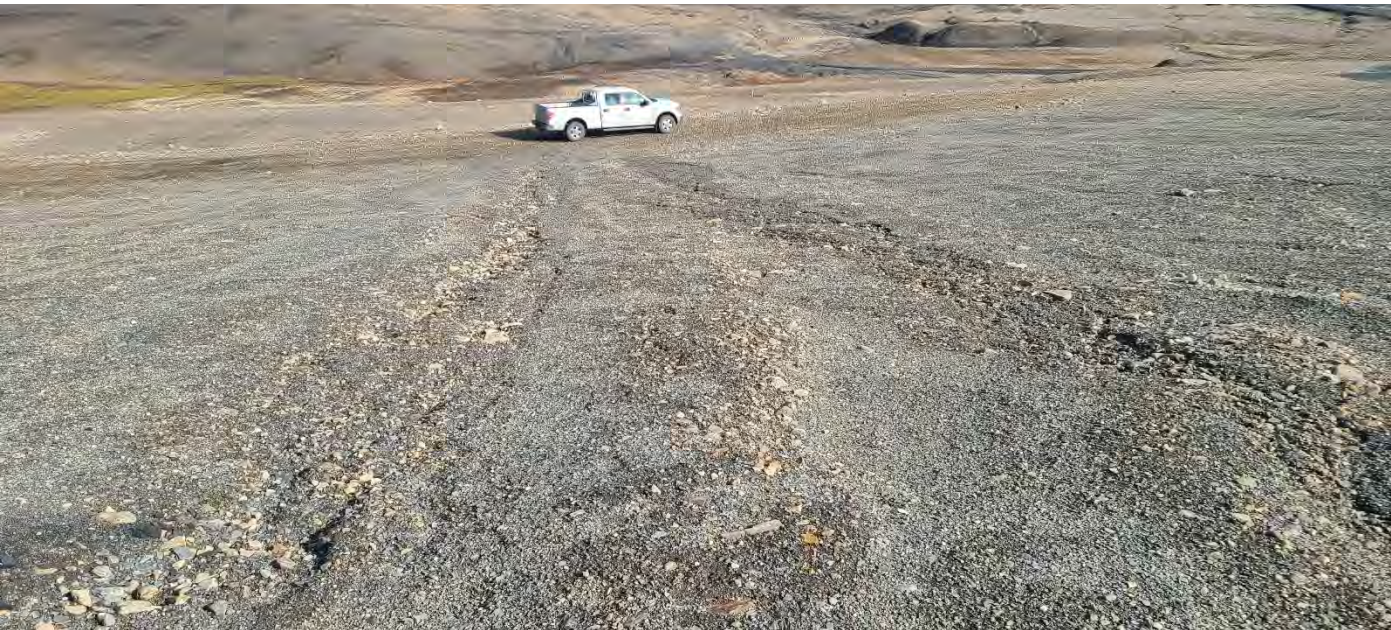
Photo 52. East Open Pit - Looking downslope at rilling on upper portion of cover. Note self-armouring.

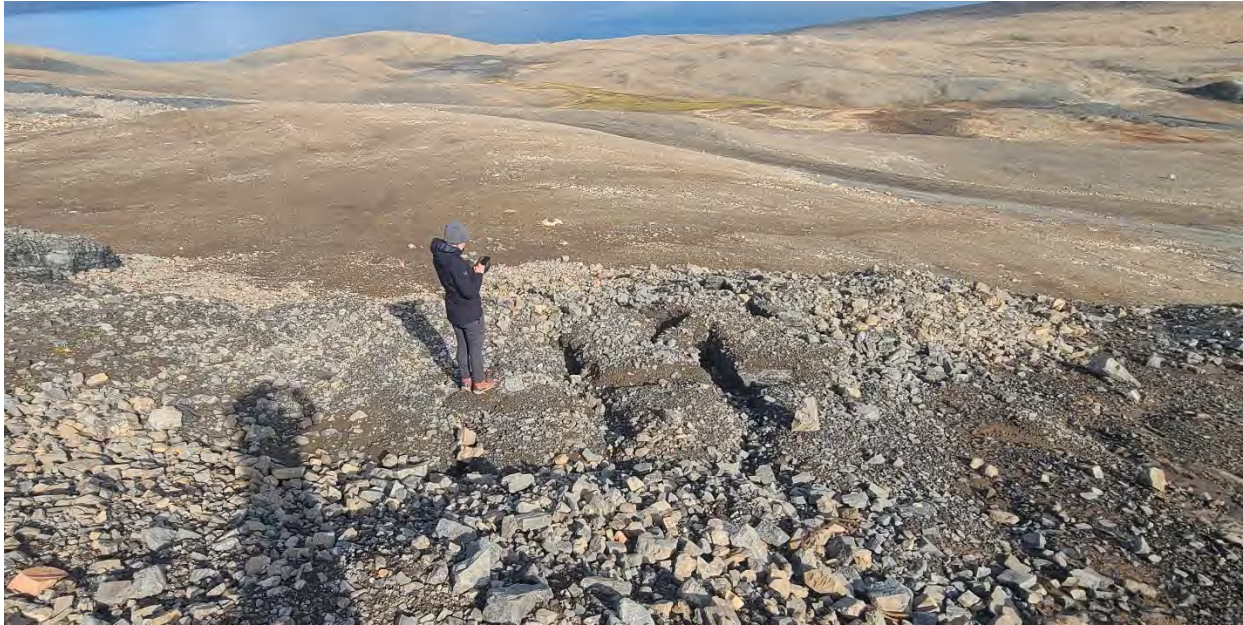
Photo 54. East Open Pit – Cracking in crown pillar.

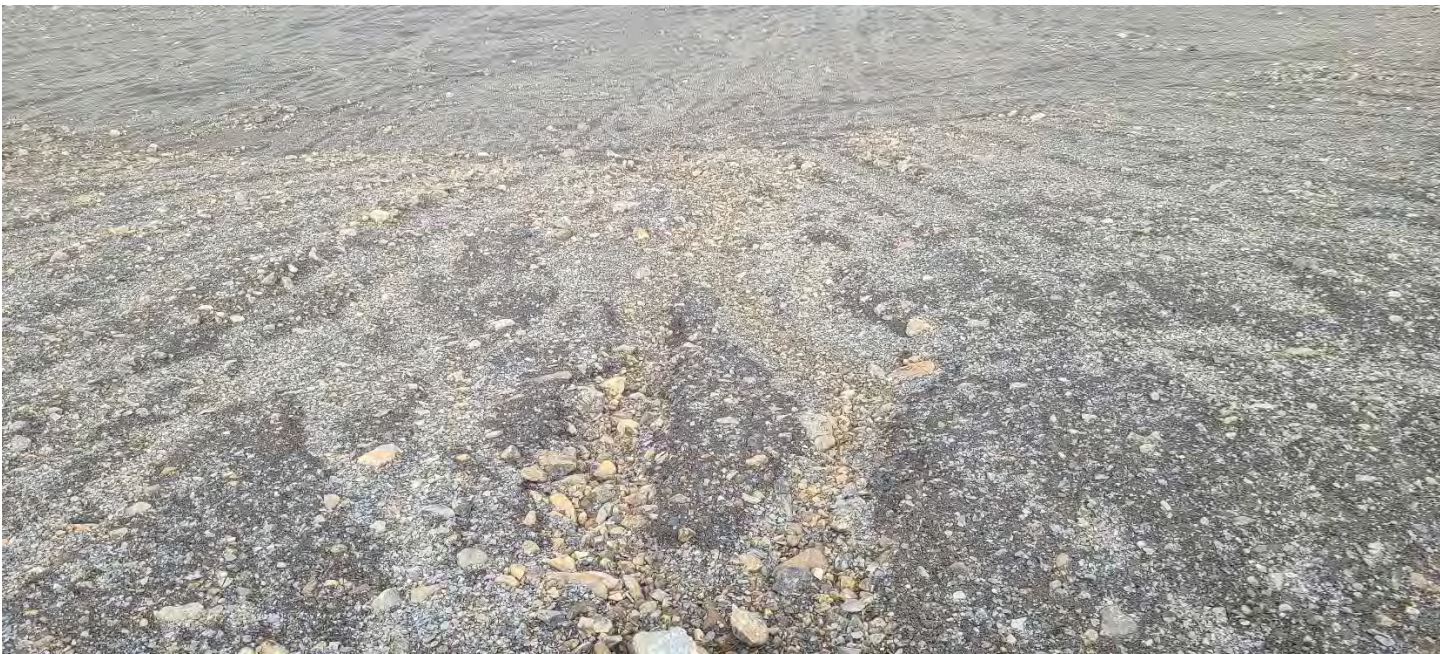
Photo 58. Oceanview Pit – Rilling on the south end of the cover system. Note self-armouring.

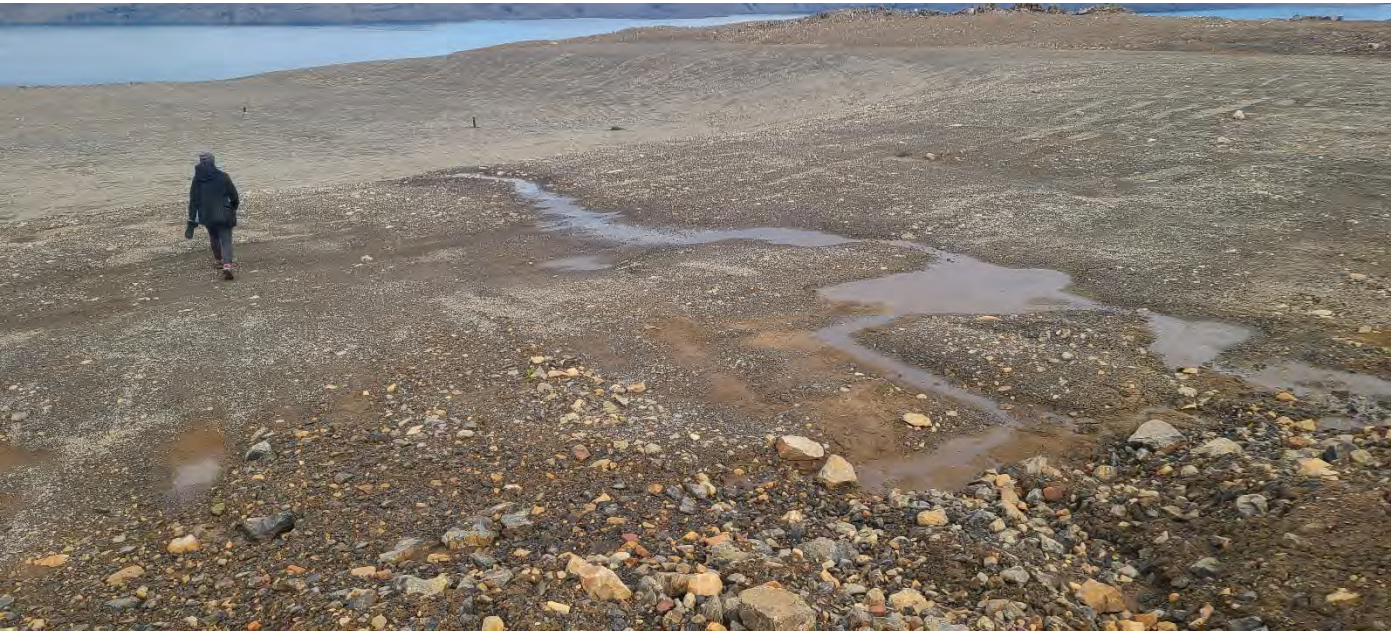
Photo 59. Oceanview Pit – Minor seepage flowing onto the cover system from upslope, as seen from the ground.

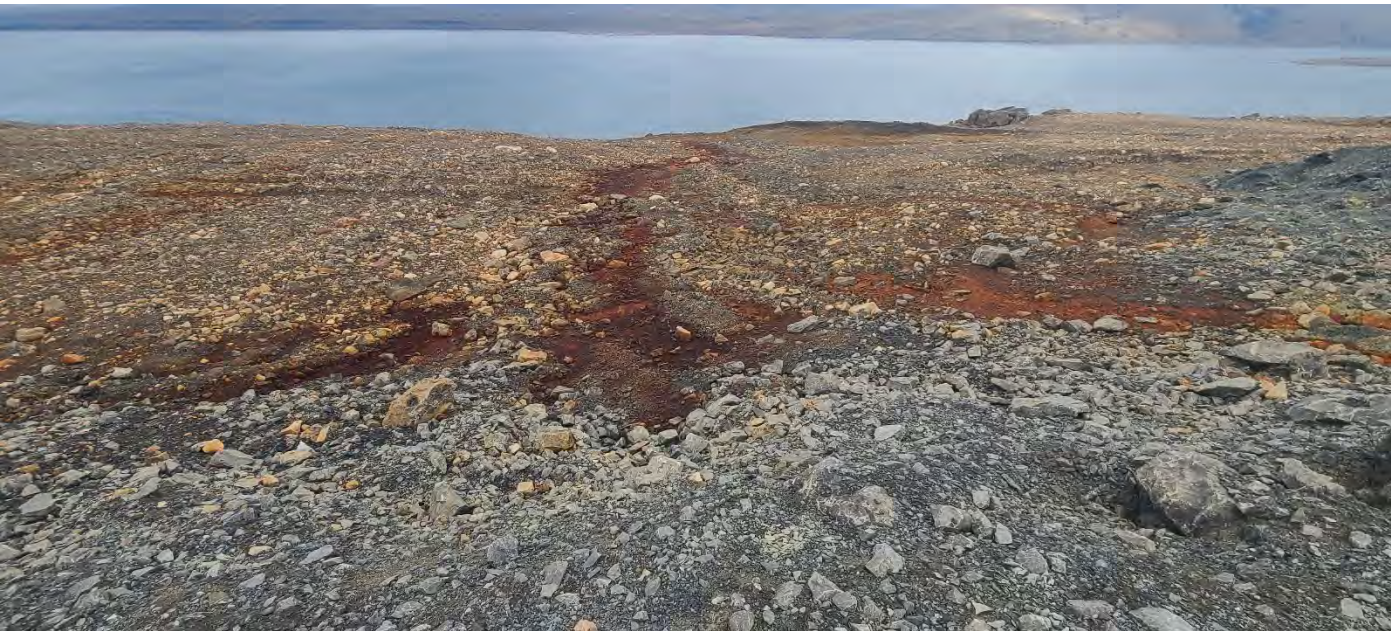
Photo 60. Oceanview Pit – Staining at toe of cover. No seepage was observed during the inspection.
