**Reclamation Activities Quarterly Report
(4th Quarter 2005)
(PER Water License NWBNAN0208)**

Submitted to:
The Nunavut Water Board

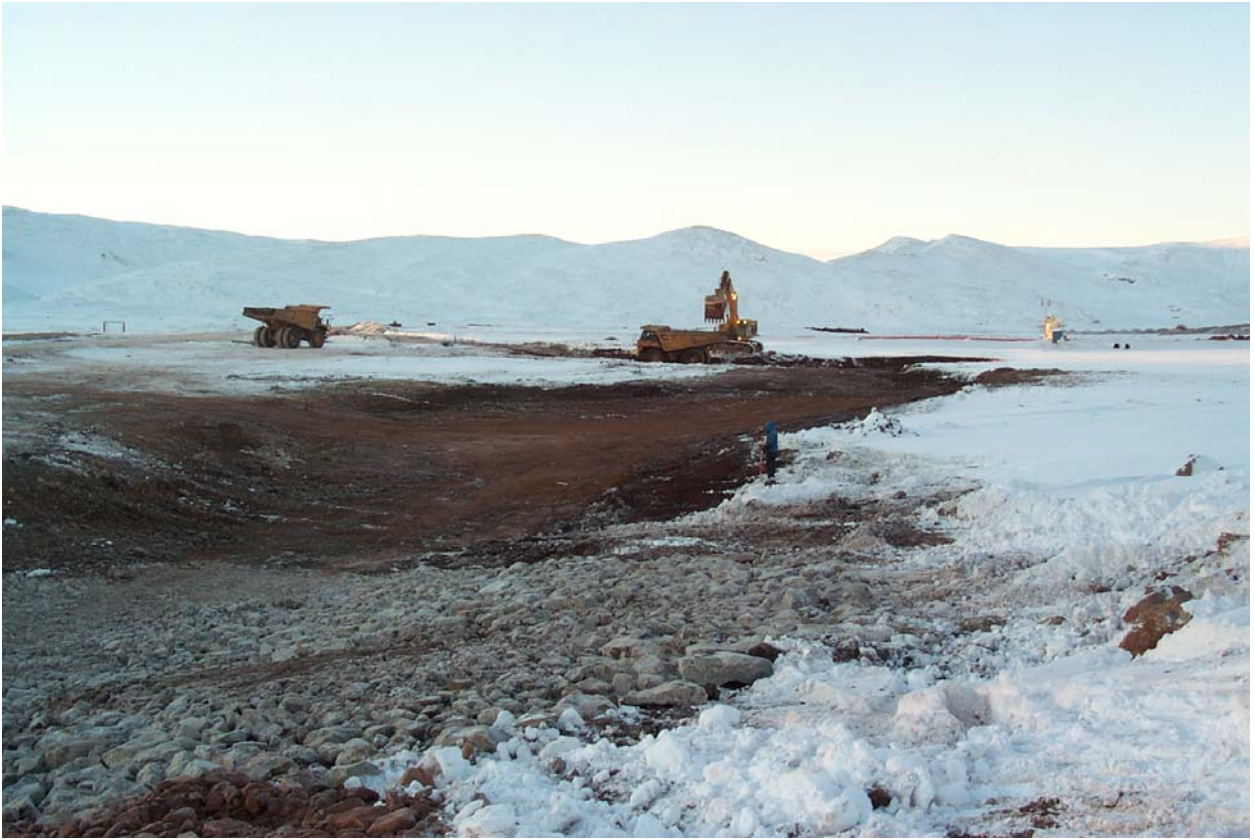
Shorelines: The sediments from the polishing pond were excavated during partially frozen conditions.

Excavation of sediments from the West Twin Lake Polishing Pond.

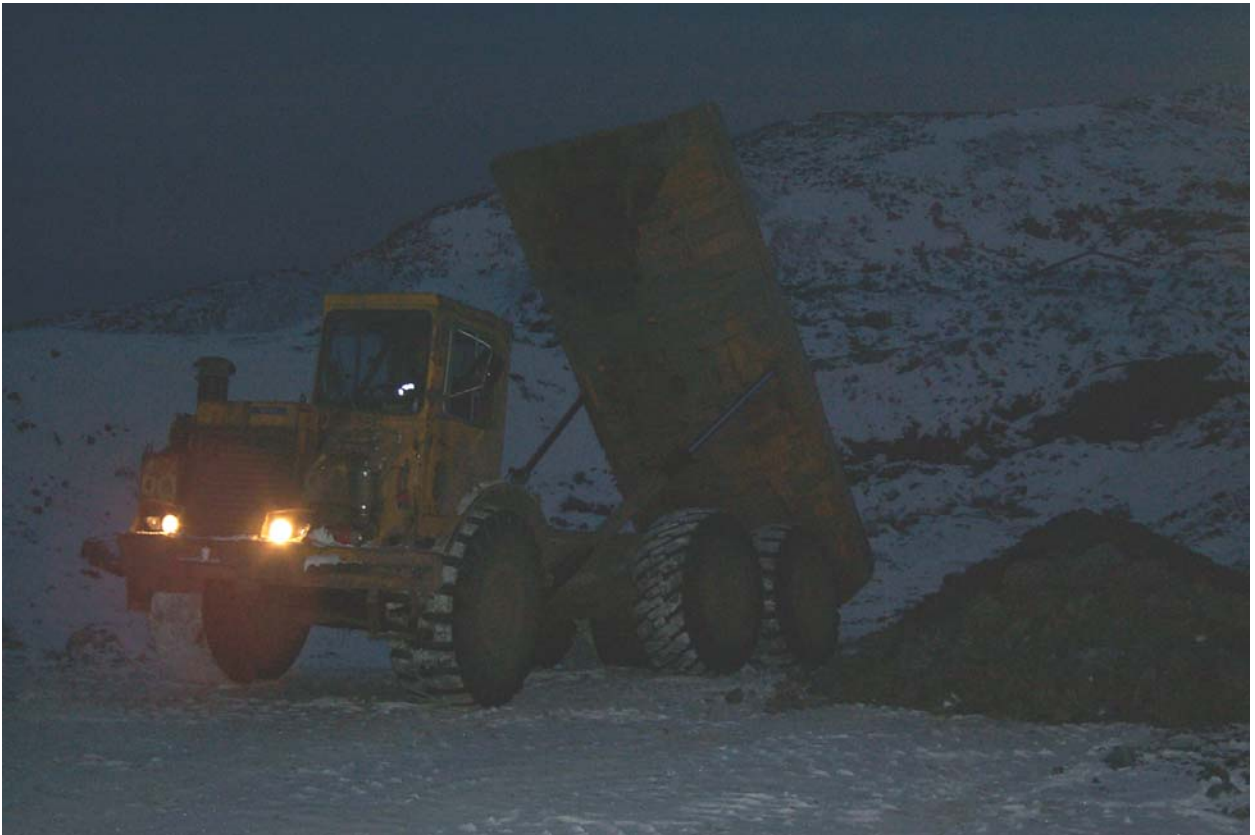
Shale placement on the recently backfilled West Open Pit commenced in October. Haulage operations were halted for the winter on the 18th of October. The remainder of the cover (including the armour rock) is scheduled for 2006.

Shale Placement in progress at the West Open Pit

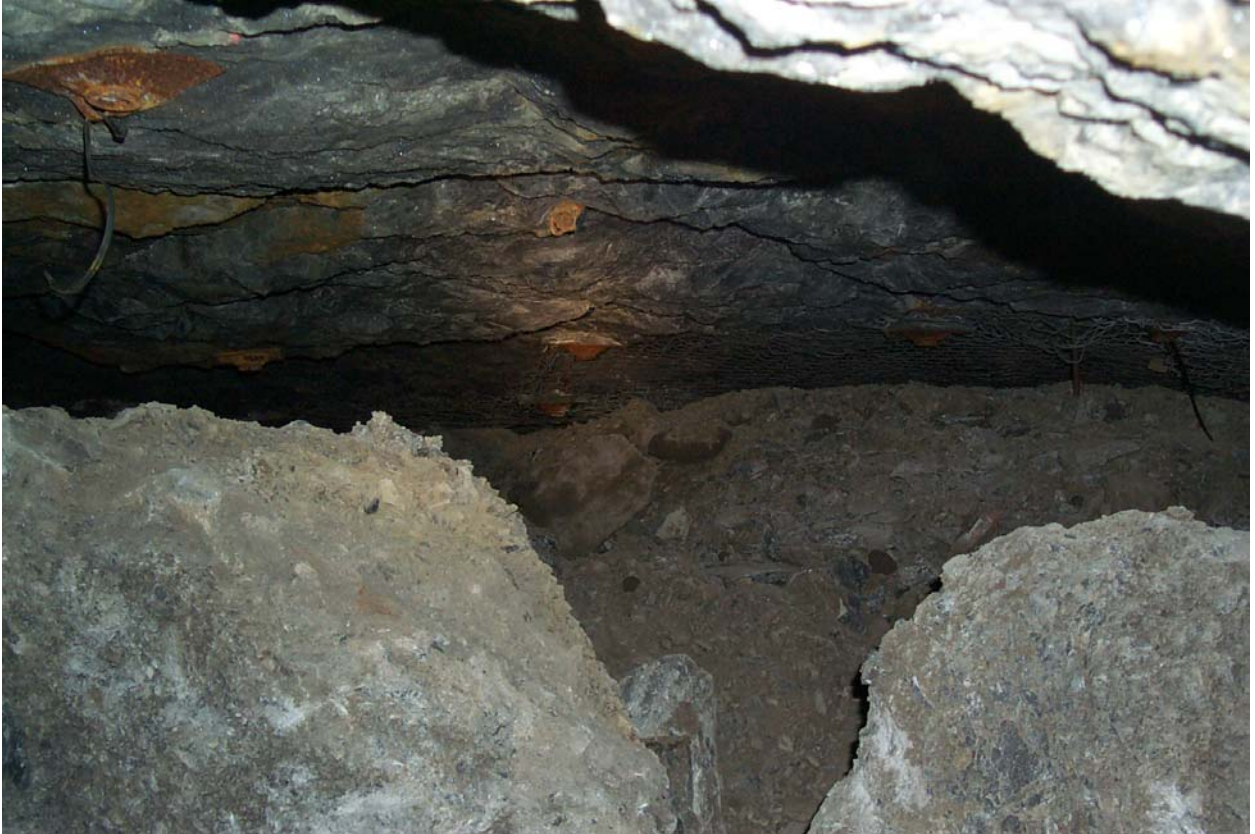
Backfill placed inside the mine opening adjacent to the West Open Pit

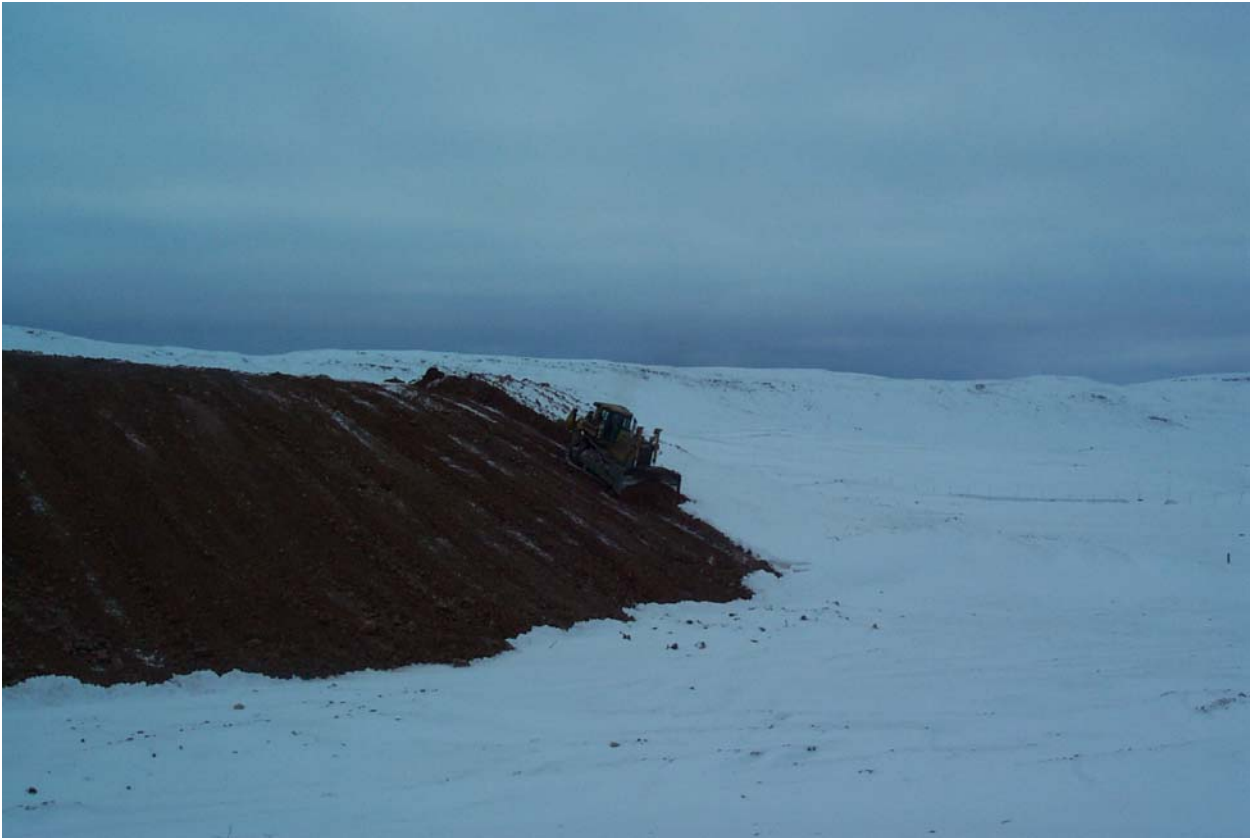
There were 900 cubic metres of Twin Lakes sand and gravel excavated and hauled to the landfill area. The final sloping of the sand and gravel armour material was finished early in the fourth quarter and the design cover is now complete.

Finishing touches on the sand and gravel armouring at the Landfill site

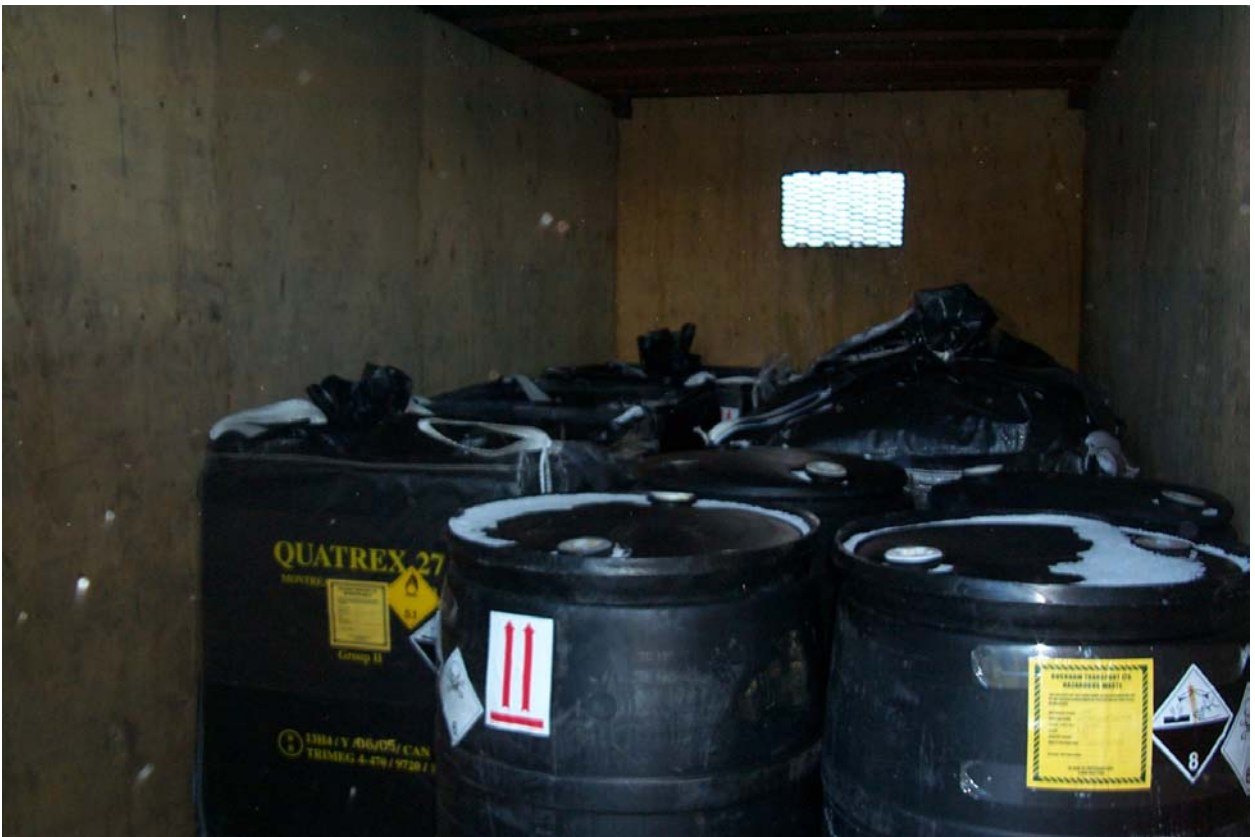
Hazardous materials packaged and ready for shipment to disposal facility

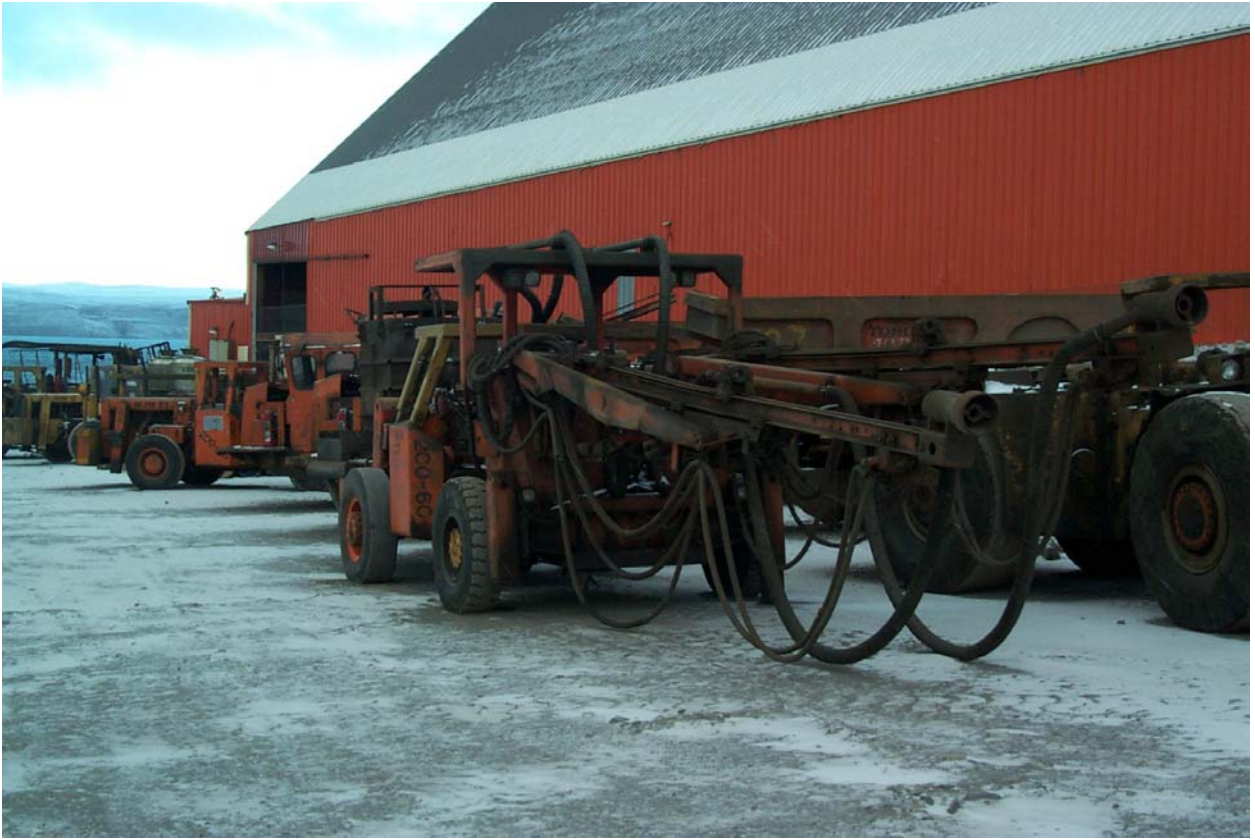
Mine Equipment awaiting the ship's arrival for deployment to other Breakwater operations

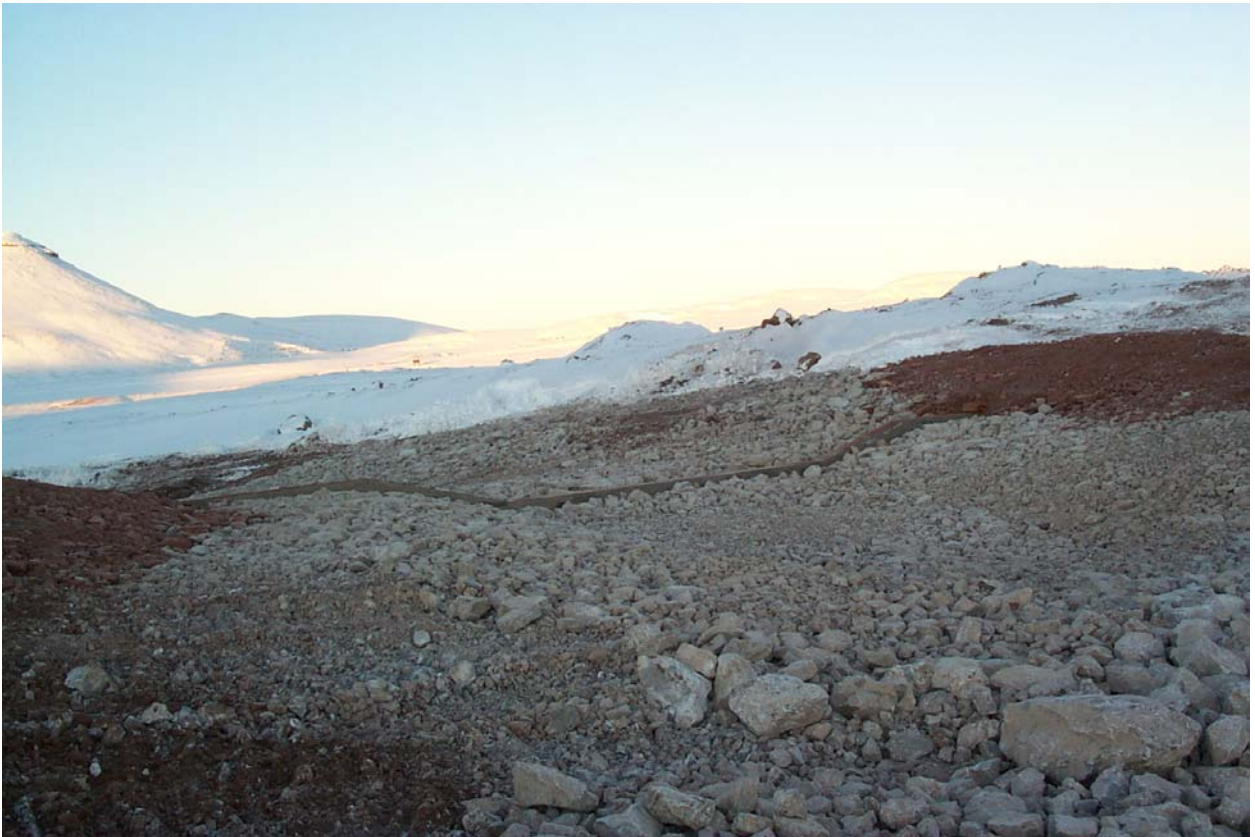
Final discharge Spillway outlet
