**NANISIVIK MINE** Phone: (867) 436 - 7544

August 31, 2006

The information contained herein is submitted as the Quarterly Report covering the months of April through June 2006. The reclamation activities at Nanisivik during this period included the following:

#### **7.0 PHOTOS:**

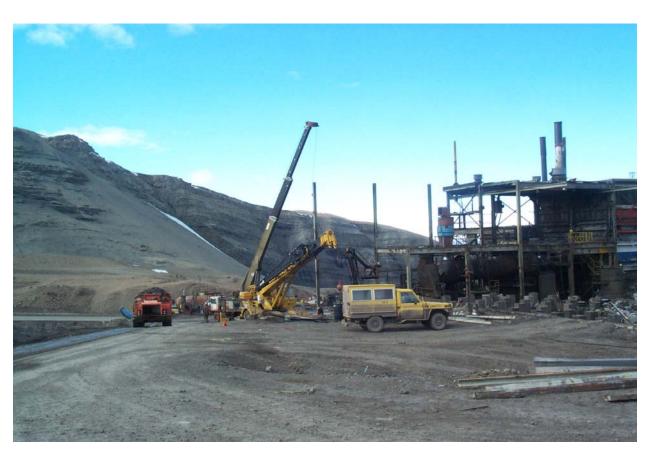
Dismantling Progress at the Industrial Complex

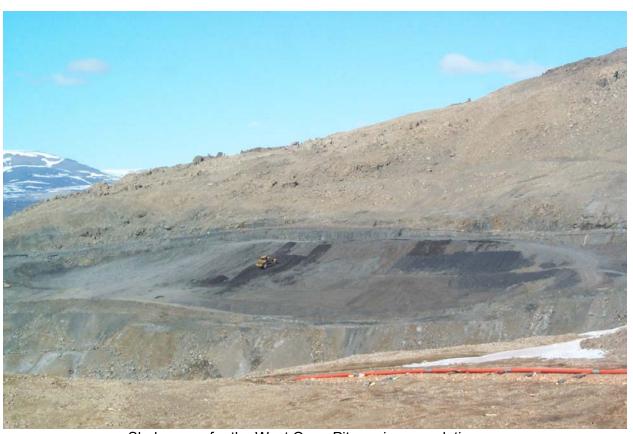
Shale cover for the West Open Pit nearing completion

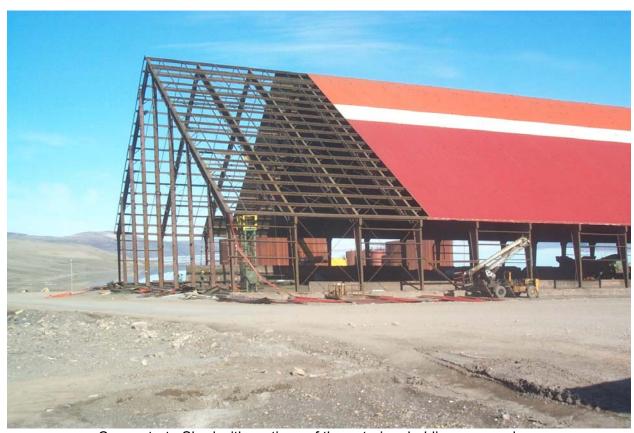
Concentrate Shed with portions of the exterior cladding removed
