# Nanisivik Mine Landfill Closure Construction Summary Report

CanZinco Mines Ltd.

SRK Consulting (Canada) Inc.  
1CB002.002  
October 2017

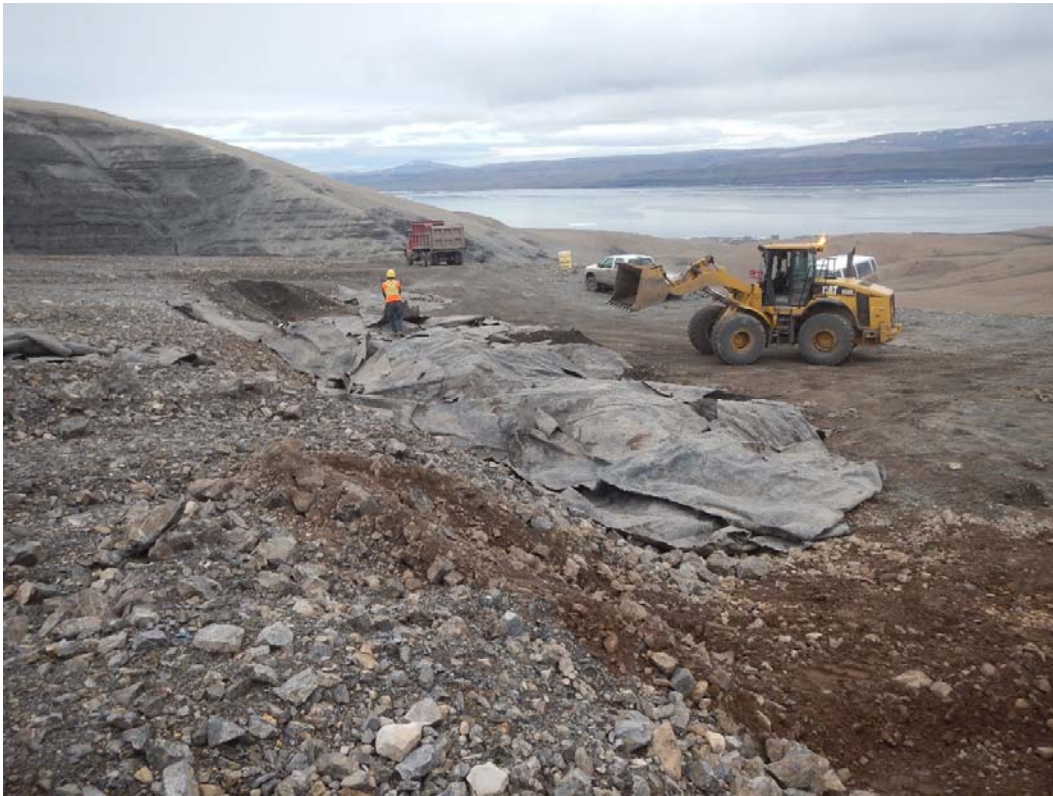
**Photo 1:** Large pieces of liner were stretched out over the waste in the landfill and the edges were backfilled with cover material to weigh them down. Photo looking north-west.

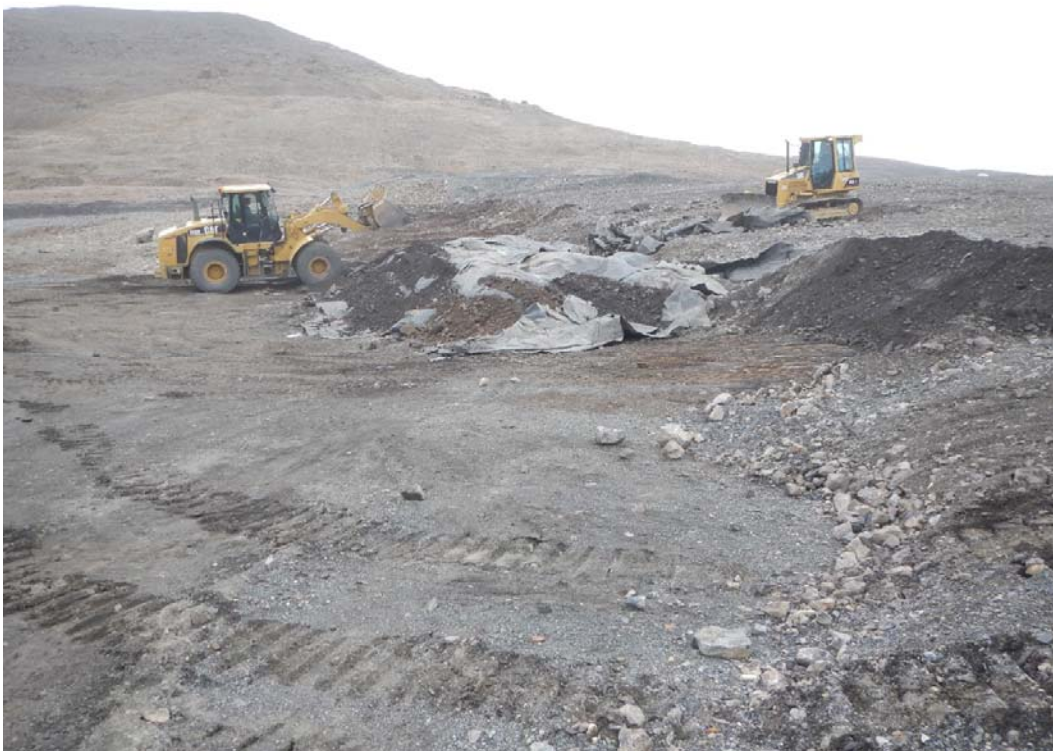
**Photo 2:** The outer slope of the landfill was covered with cover material relocated using the loader from the west edge of the landfill. Photo looking east.

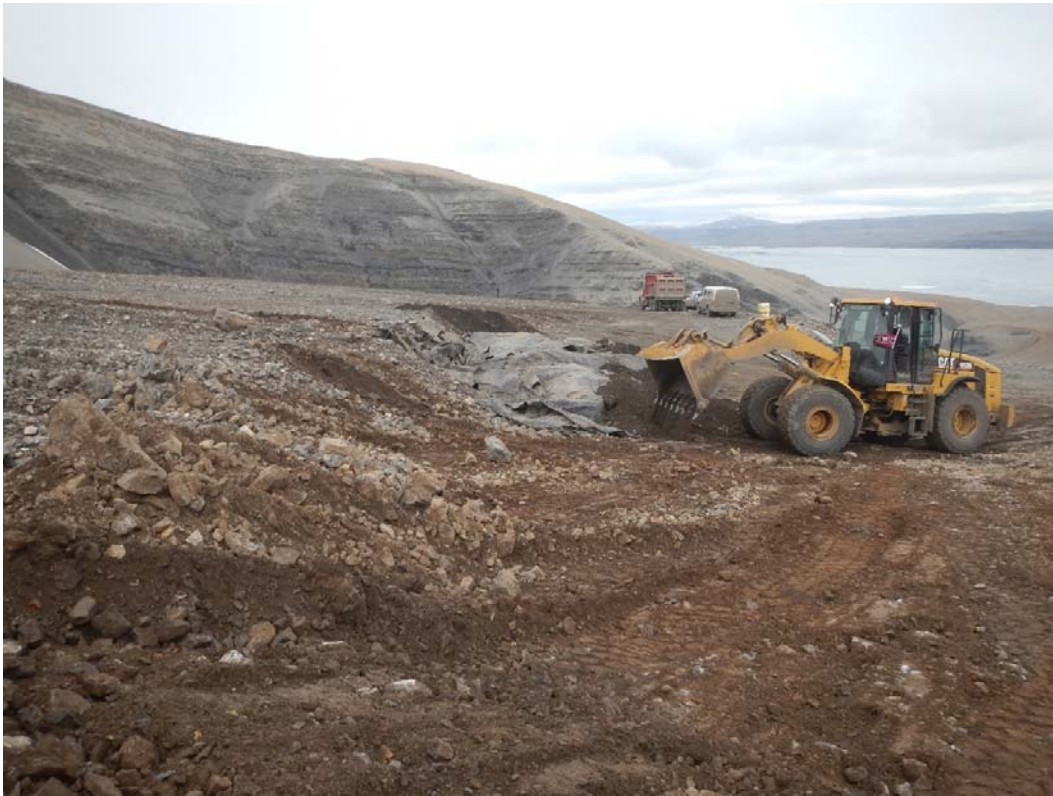
**Photo 3:** Landfill cover construction progressing from the middle toward the east. Photo looking north-west.

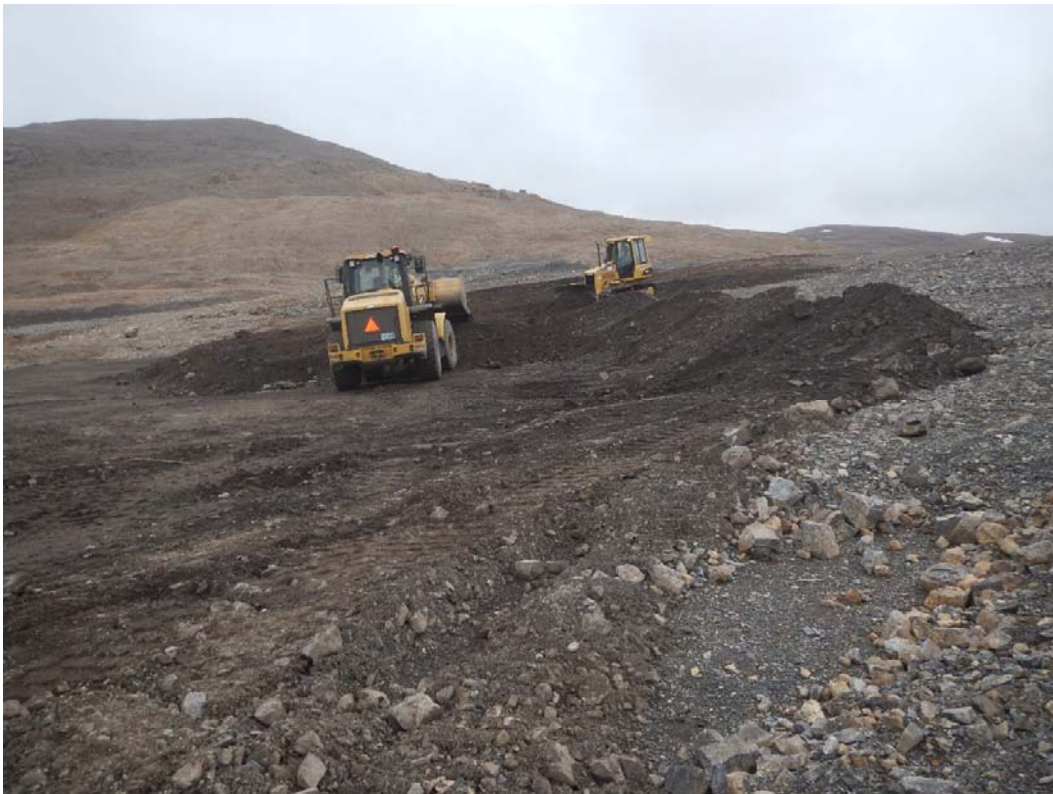
**Photo 4:** The upstream side of the landfill was covered by pushing the unconsolidated cover material with a dozer. Photo looking south-east.

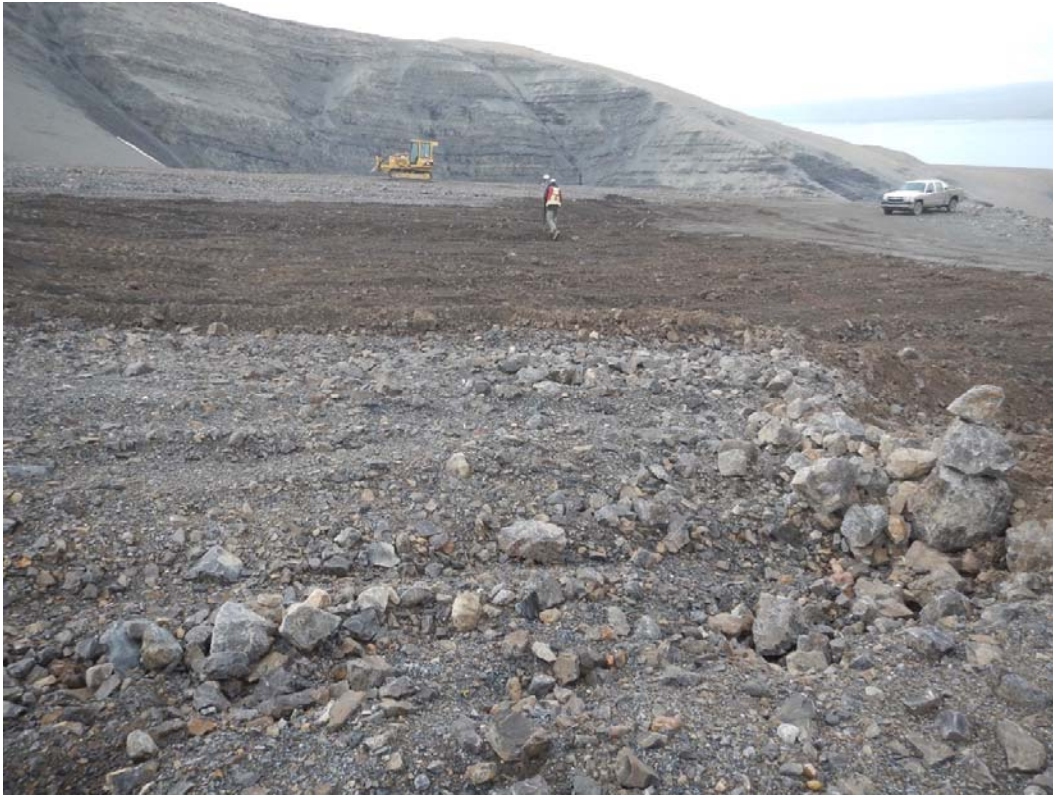
**Photo 5:** The covered landfill was surveyed immediately following completion. Photo looking north-west. The completed landfill cover shown in the right hand side of the photo.
