**Re: Water Licence 1AR-NAN2030 – 2022 Exceedance of Action Level for Zinc at Station 159-14**

## Project Memorandum

**To:** CanZinco  
**Attention:** Zied Tebaibi, P.Geo. **cc:** Johan Skoglund  
**From:** Scott Garrison, P.Eng., Sharon Blackmore, P.Geo. **Date:** October 4, 2022  
**Subject:** Zinc Action Level Exceedance at Station 159-14  
**Project No.:** 0255034

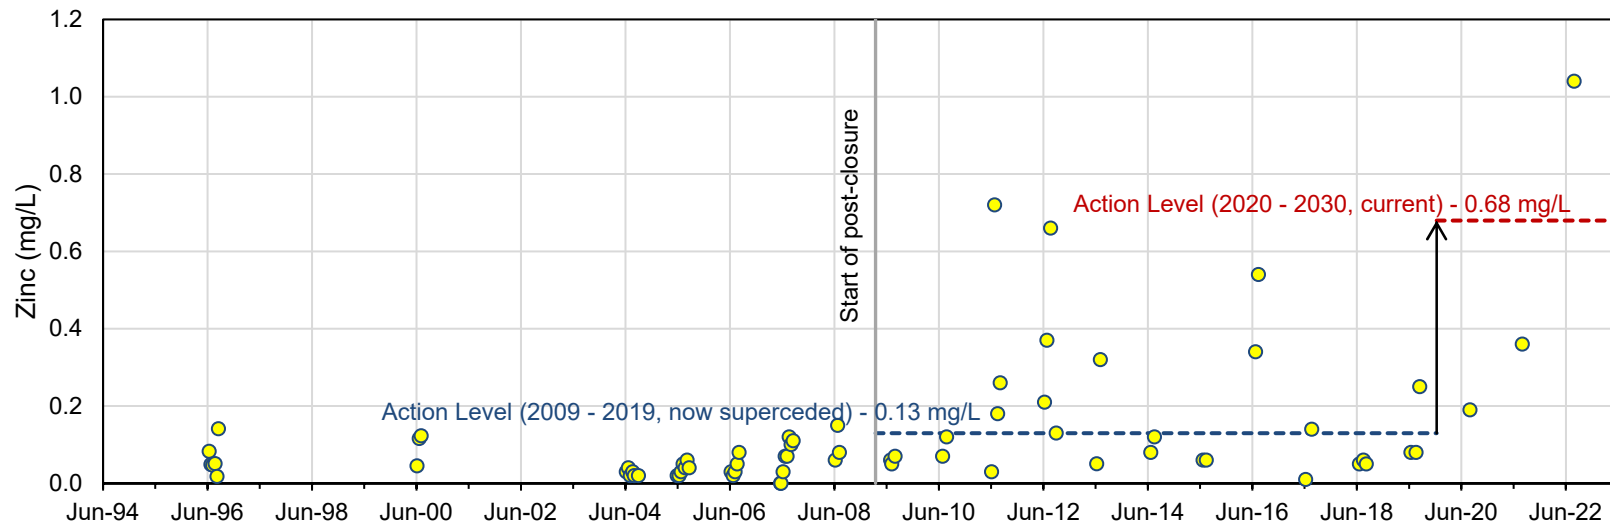
Figure 3-1. Station 159-14 zinc dataset.

The historical dataset of zinc concentrations at Station 159-14 is shown in Figure 3-1, which indicates there have been 10 other zinc Action Level exceedances (i.e., >0.13 mg/L) at Station 159-14 prior the most recent in 2022, as follows:

In 2022, a duplicate sample was collected at Station 159-14 (i.e., Sample ID: Field Duplicate 2). The measured zinc values provided by Eurofins on September 2, 2022 are shown in Table 3-1, and results at Station 159-14 reflect the highest zinc value measured to date at this station (i.e., 1.04 mg/L; refer to Figure 3-1). Upon review of these values and identification of the zinc Action Level exceedance, a re-analysis was requested by BGC (S. Blackmore, email communication, September 16, 2022) to Eurofins. The re-analyzed values were comparable to the original values (i.e.,  $\pm 4\%$ ), which is also shown in Table 3-1 and confirms the original measured zinc values. The comparability of the chemistry measured from Field Duplicate 2 and the labelled sample collected at Station 159-14 confirms consistent field sampling procedures were applied and the sample is considered representative of site conditions.

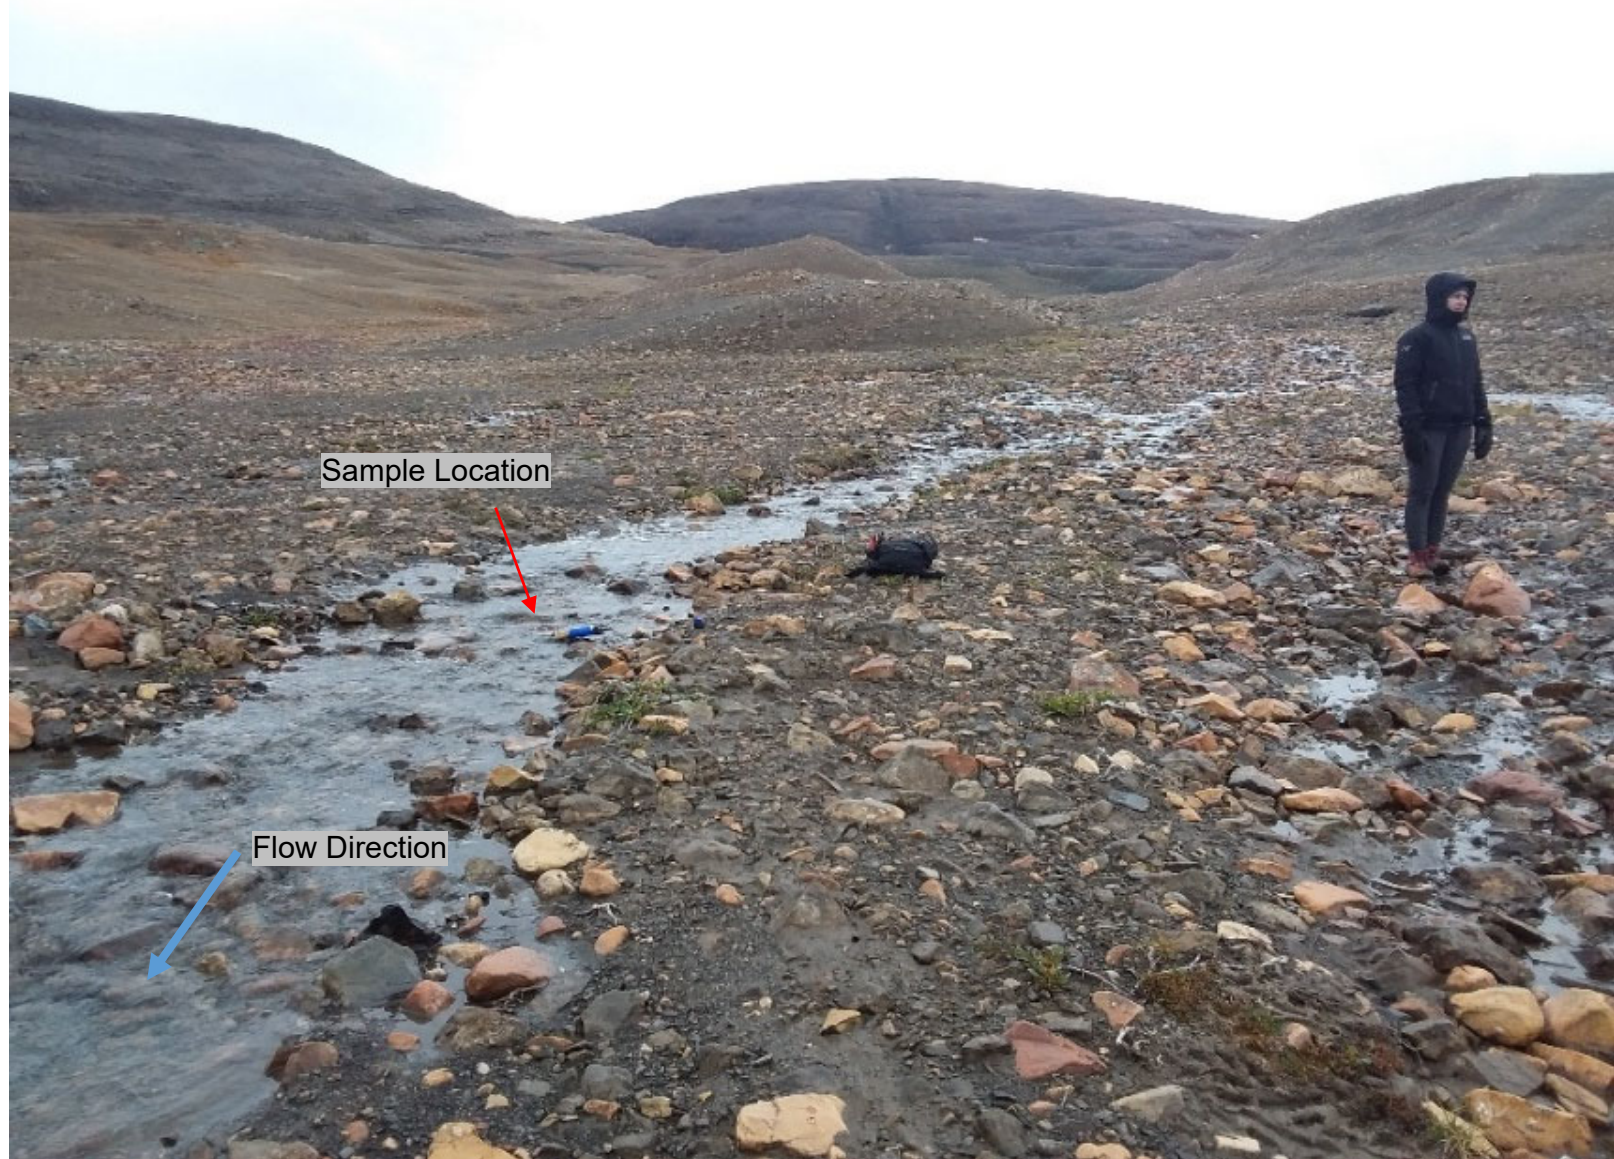
Mr. Scott Garrison, P.Eng. (NU), and Ms. Christy Rouault, P.Eng. (AB/BC), conducted the annual geotechnical site inspection and water quality monitoring at the Mine from August 18 to 23, 2022. Conditions during the visit were cloudy, cool (i.e., daytime maximum temperatures ranged from approximately 2 to 5 degrees Celsius) and no precipitation occurred. The station exhibiting the zinc Action Level exceedance, Station 159-14 (Figure 2-1), was sampled on August 20, 2022, and Photo 1 (appended at the end of this document) shows the field conditions at the time of sample collection.

Photo 1. Station 159-14, looking southeast (upstream).

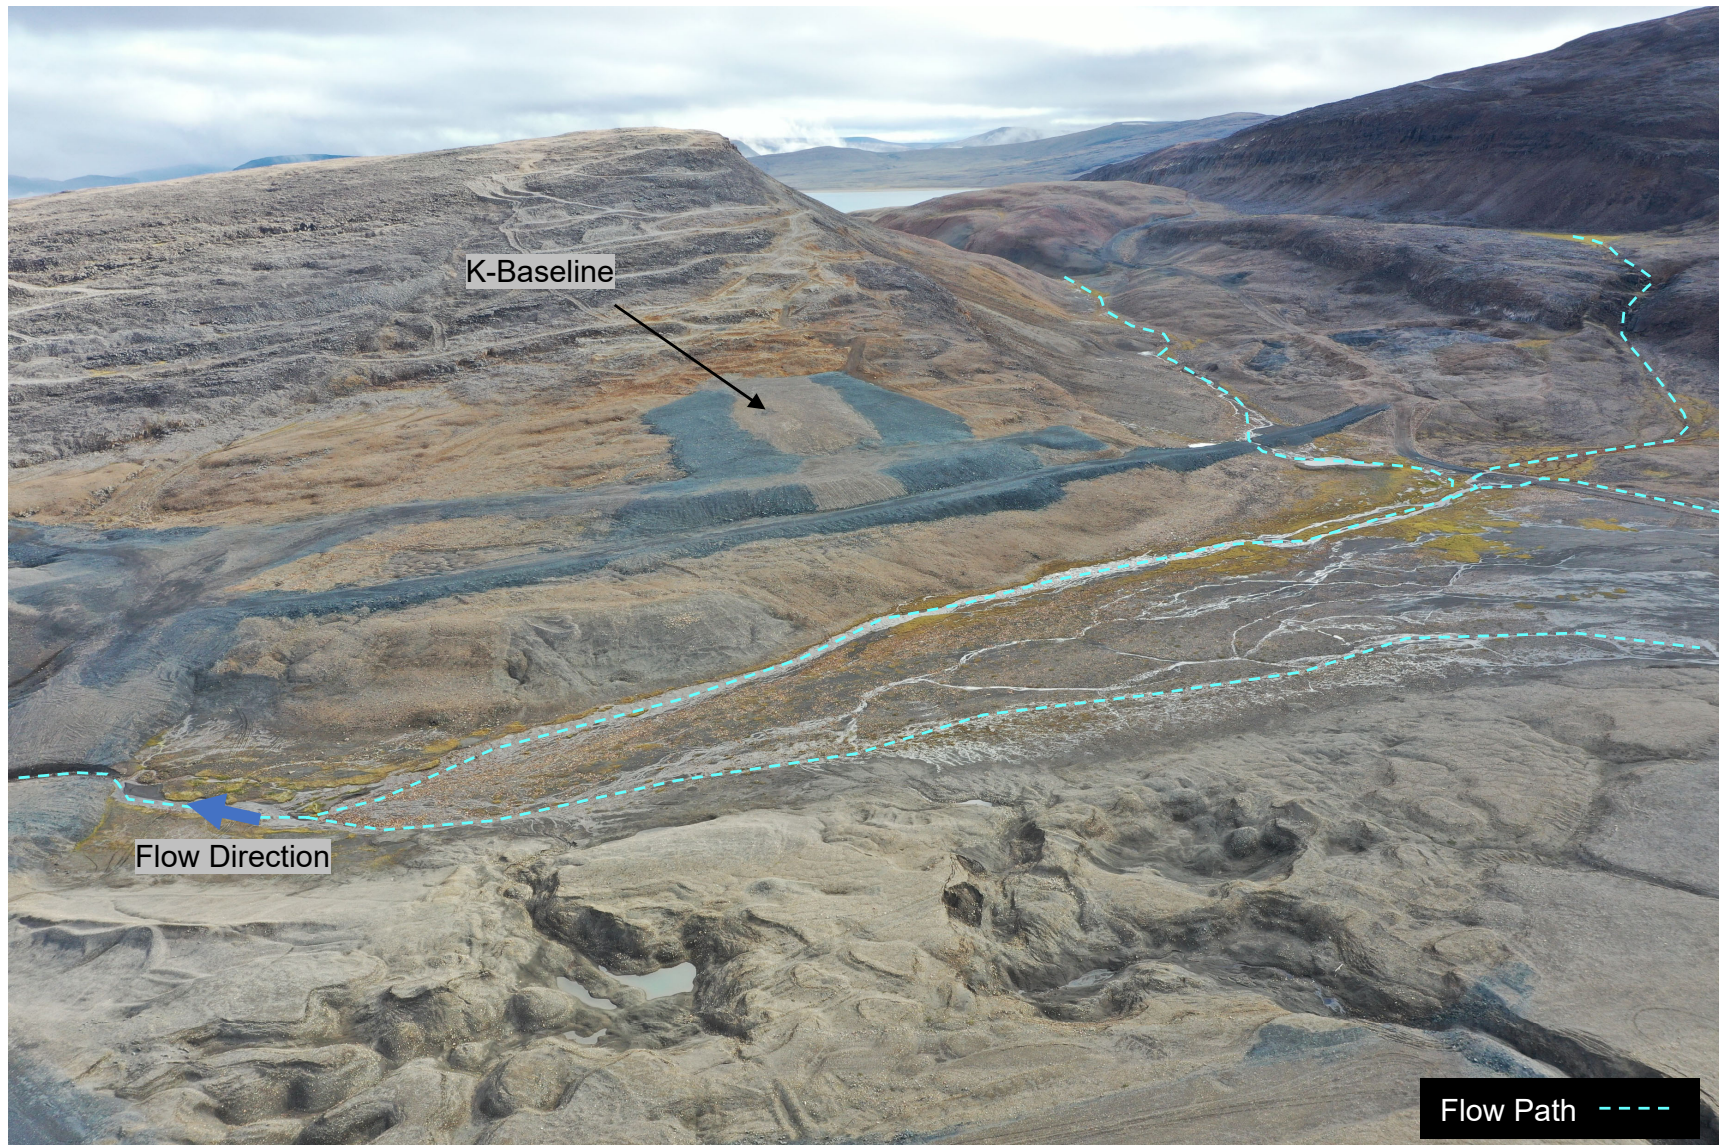
Station 159-14 is located within Chris Creek watershed, approximately 50 m upstream of where the main surface drainage or runoff from the East Open Pit area discharges to Chris Creek. The mine workings within the Chris Creek watershed and upstream of Station 159-14 include East Trench, Area 14 and K-baseline mine workings, which contain cover systems that were visually inspected in August 2022. Visual observations made by the field crew noted the covers to be physically stable, with no visual signs of deformation nor erosion, and seepage was not observed at the toes of these cover systems. Photo 2 presents an image taken by an unmanned aerial vehicle (UAV) during August 2022 of the K-baseline mine workings and cover.

**Photo 2. UAV image looking east-southeast toward an upper portion of the Chris Creek watershed, and the K-baseline cover system. Station 159-14 is located out of the frame to the left (north) of the photo.**

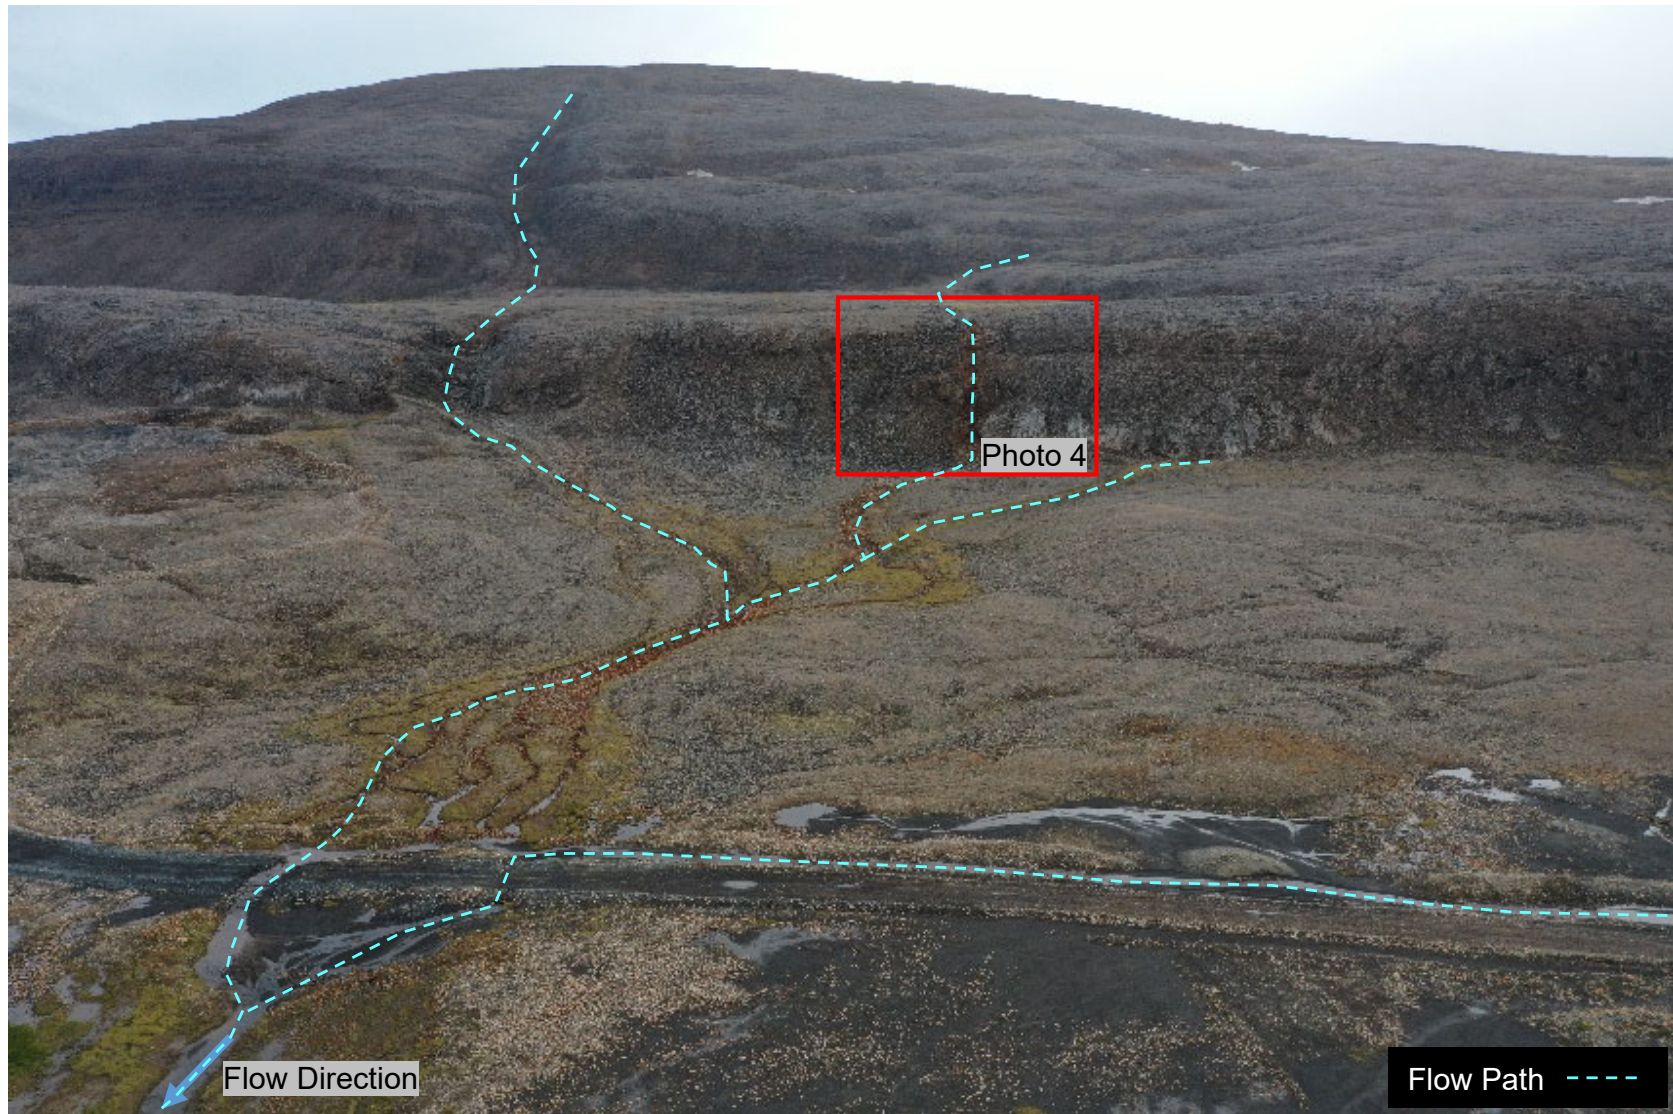
**Photo 3. UAV image (looking south) of upper reaches of the Chris Creek watershed. Station 159-14 is located outside of the image frame, to the bottom (north) of the photo. K-Baseline is to the left (northeast) of the photo frame.**

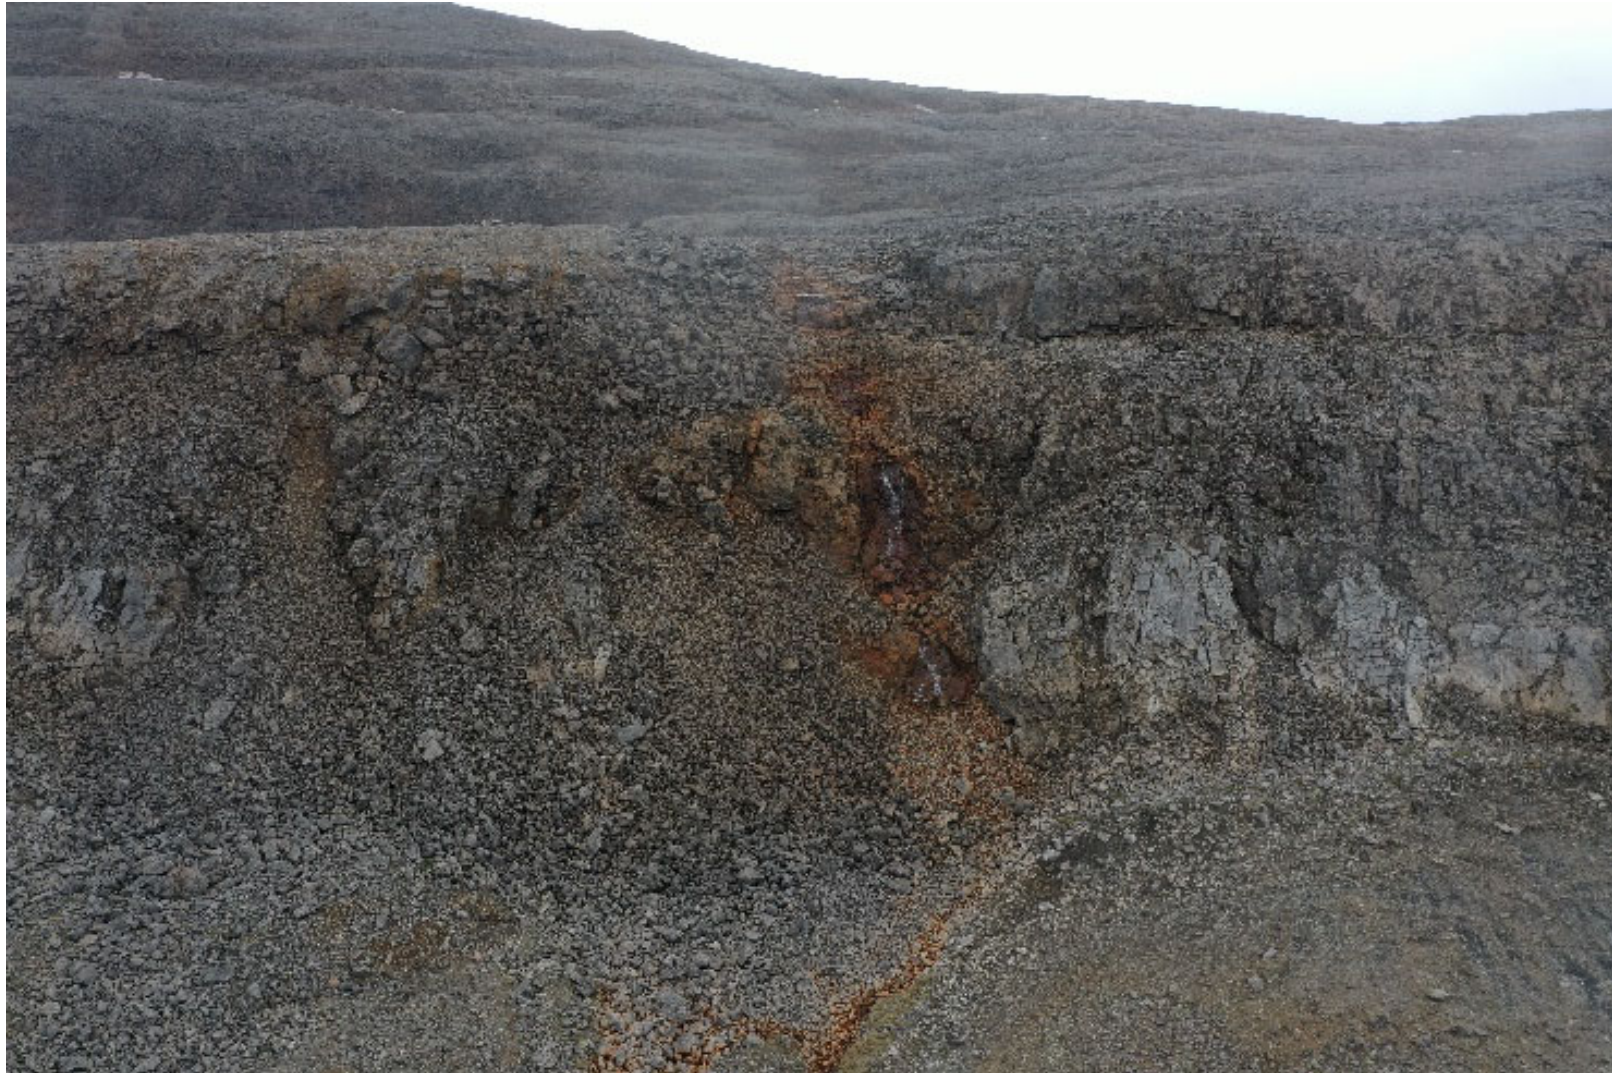
The Chris Creek watershed has several smaller tributaries discharging to Chris Creek (see Figure 2-1). Those tributaries located in the headwater region of the watershed have commonly presented visually observed evidence of oxidation and staining on surface, interpreted by BGC to be associated with zones of natural mineralization based on sulphide-bearing bedrock outcroppings in the area. Photos 3 and 4 were taken along the upper reaches of the Chris Creek watershed, and show one of the tributaries with noticeable oxidation/staining along the drainage channel, which is not associated with mine workings.

**Photo 4. UAV image (looking south) at a natural stream within the 159-14 watershed, upstream of Station 159-14. Visual observations of oxidation and iron-staining commonly noted.**

Based on field and laboratory results, the origin of the 2022 zinc Action Level exceedance at Station 159-14 is unclear, and the zinc concentrations measured in 2022 were the highest in the post-closure period. Therefore, BGC recommends a site investigation be undertaken at the Mine in 2023, to assess the potential source(s) and pathways that may have contributed to the elevated zinc value at Station 159-14 in 2022. Data from this investigation should also be used to perform a statistical assessment on the historical data, to assess for potential trends and/or correlation with other parameters.
