## **NANISIVIK MINE, A DIVISION OF CANZINCO LTD.**

### **2009 ANNUAL GEOTECHNICAL INSPECTION**

### **NANISIVIK MINE, NUNAVUT**

PROJECT NO.: 0255-019-03  
DATE: MARCH 26, 2010

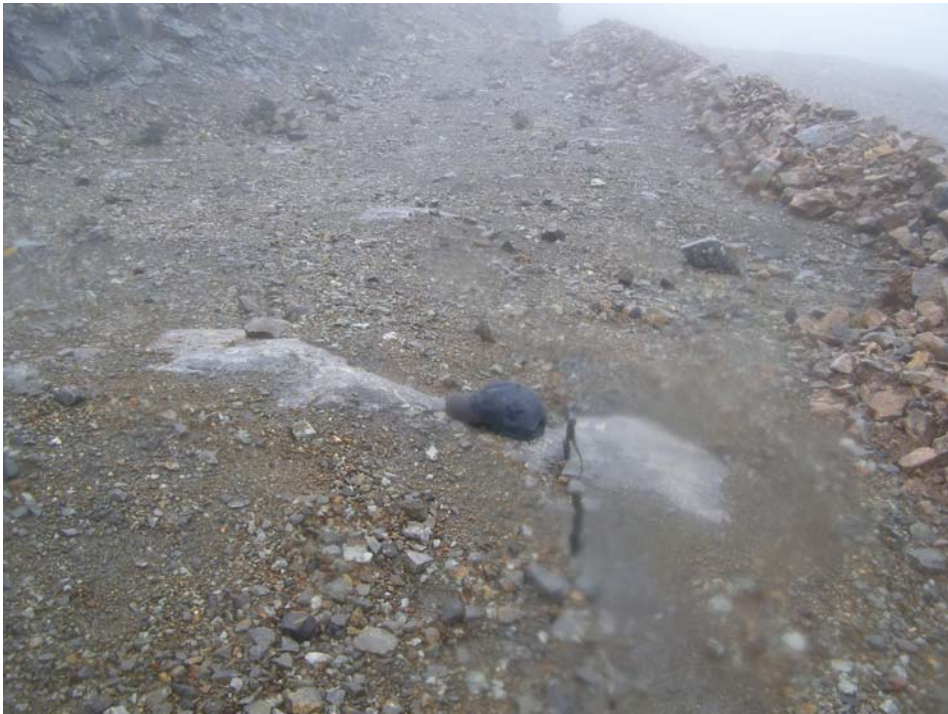
Photo 32 Crack in the West Open Pit crown pillar. Similar condition to what was observed in 2008.

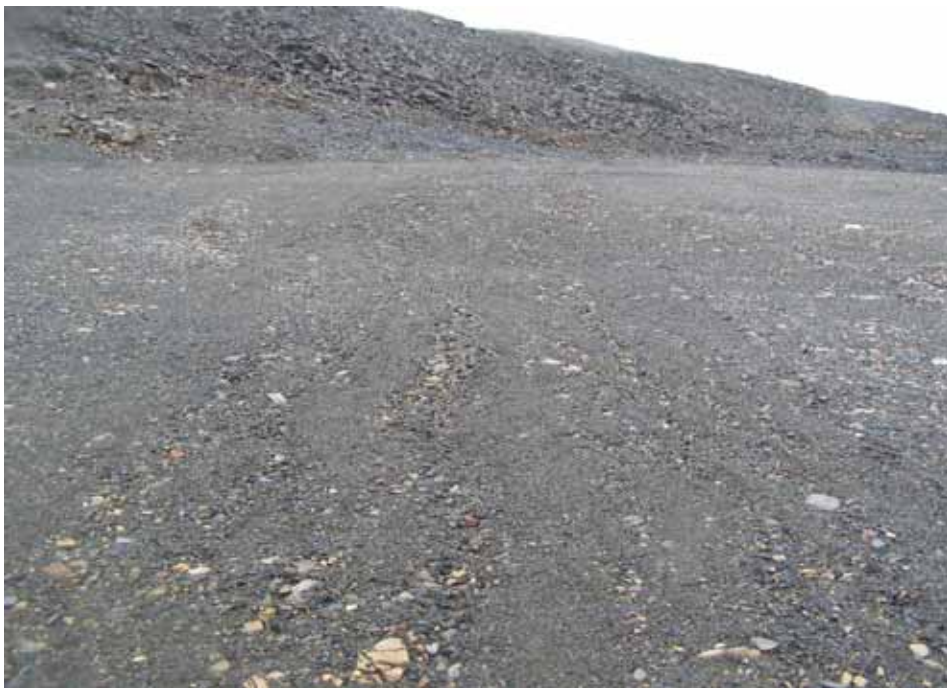
Photo 40 Very minor rill erosion attributed to constant seepage on surface of East Trench cover. Similar to what was observed in 2008.

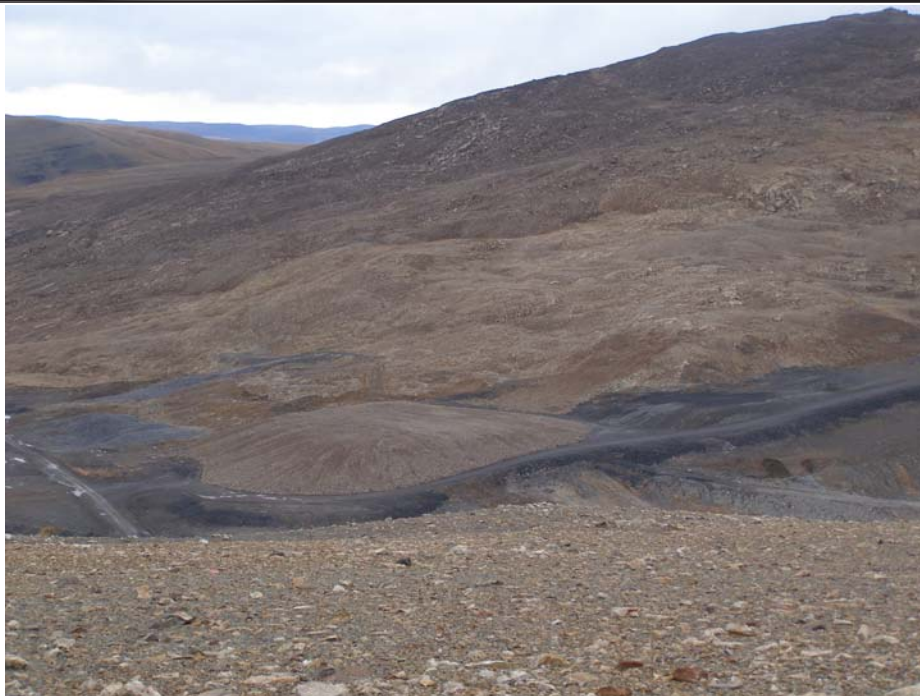
Photo 47 Industrial Complex cover as seen from Stol Port. Note that this cover was completed over metals contaminated soil and the original foundation during the summer of 2008.

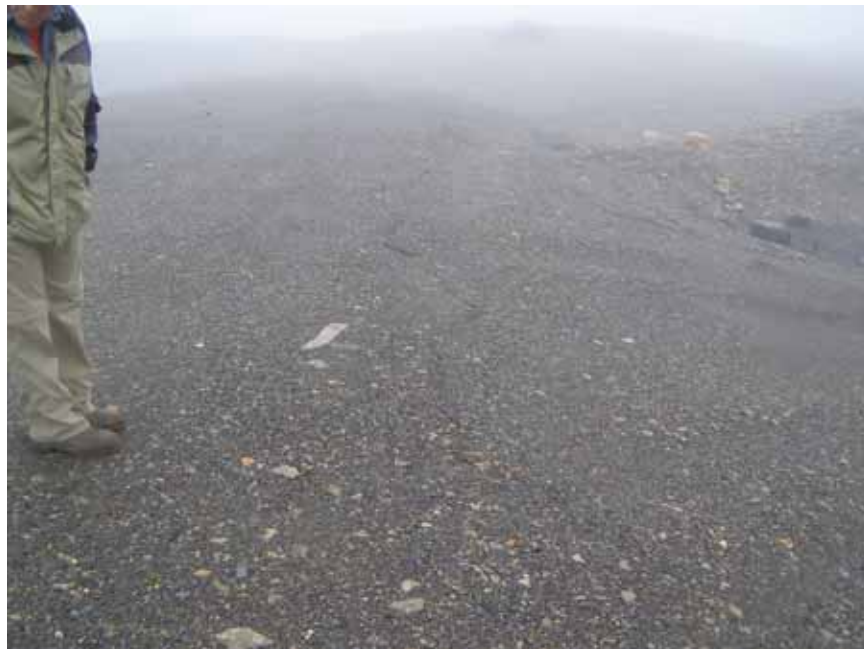
Photo 52 Oceanview Portal cover as seen from the upslope edge of the cover. Note minor cracking along the right (east) edge of the cover. No changes noted since 2008.
