NANISIVIK MINE, A DIVISION OF CANZINCO LTD.

2003 GEOTECHNICAL INSPECTION OF WASTE CONTAINMENT DIKES

NANISIVIK MINE, NUNAVUT

PROJECT NO.: 0255-008-05
DATE: OCTOBER 28, 2003

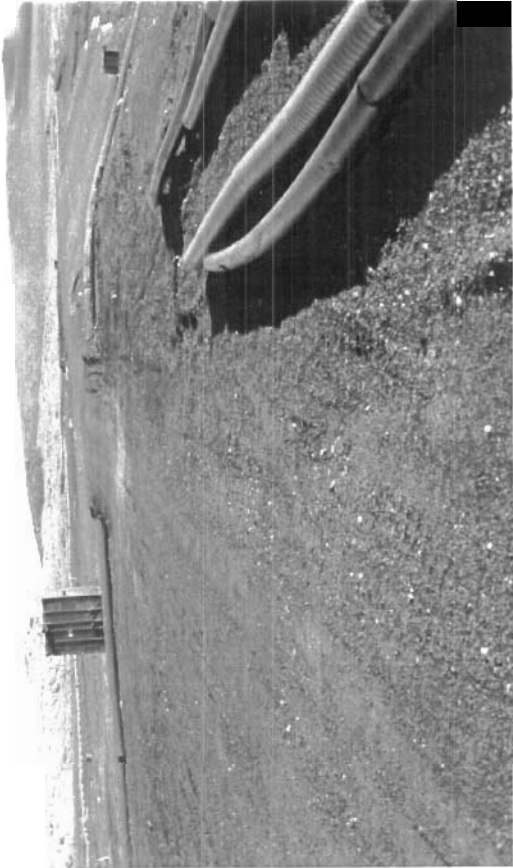
Photo 45 shows a view of the crest looking towards the north. Some minor pot holes are evident near the north limit of the spare pipes.

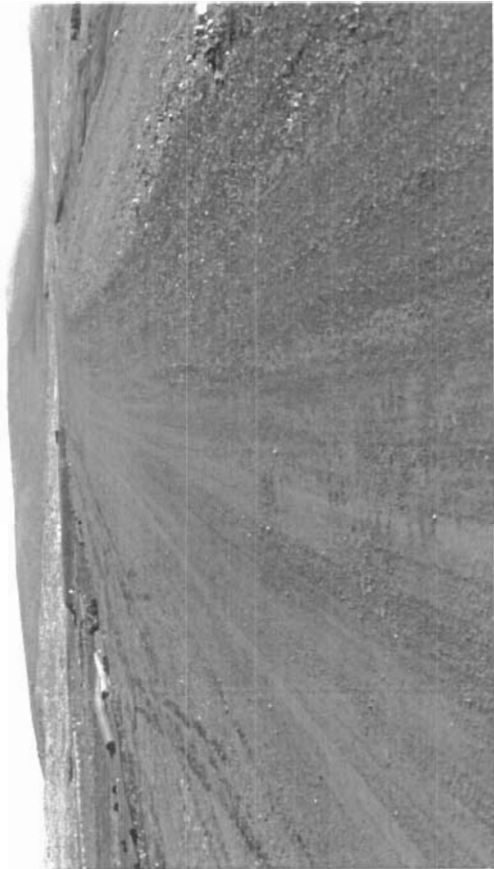
Photo 59 shows a view of the upstream crest looking towards the north abutment. No signs of significant settlement or deformation.

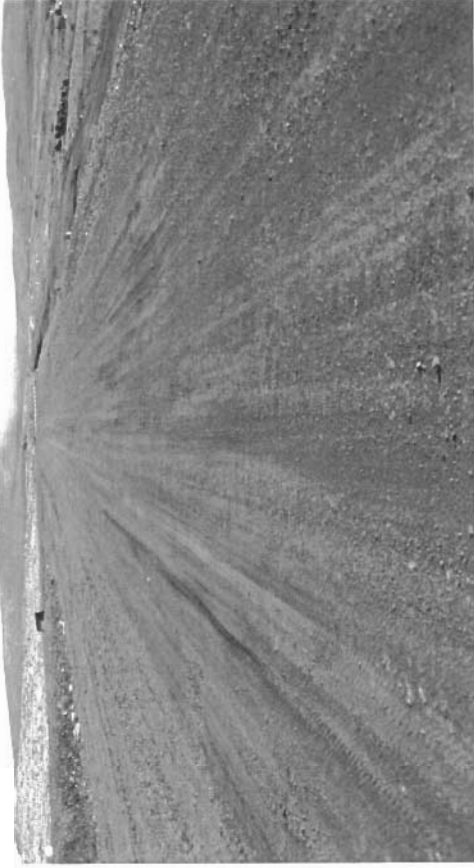
Photo 64 shows a view of the crest of the northern portion of this dike. In general, the surface is in good condition, although some minor pot holes are evident at this location.

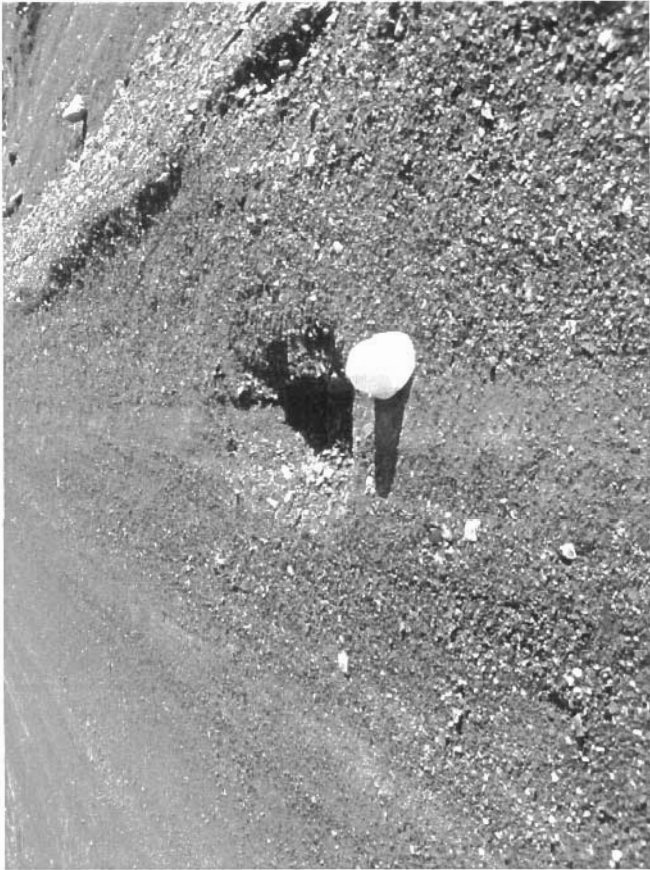
Photo 55 shows a sink hole located in the crest of the dike, above the portion of the dike that remains benched.

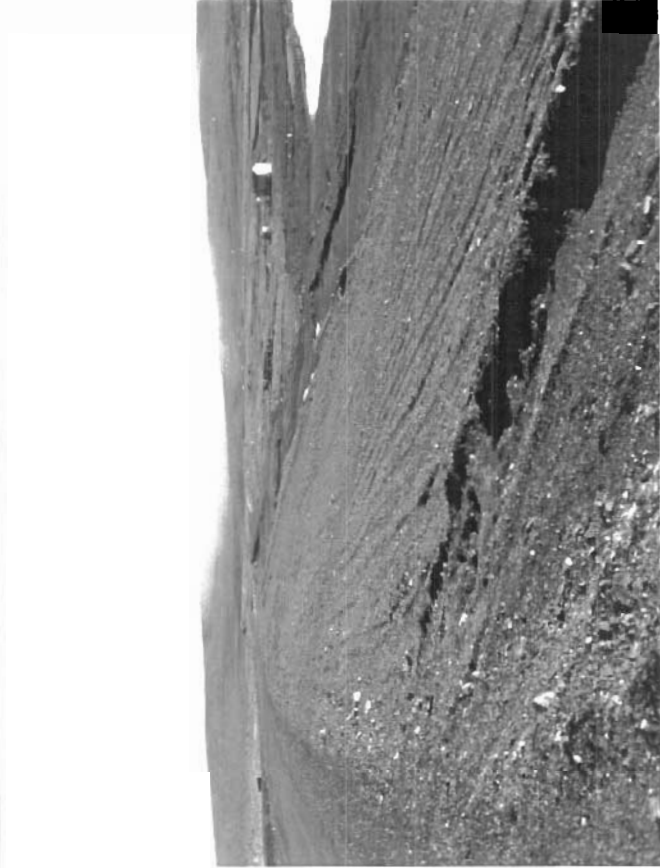
Photo 58 shows a view of the northern section of the downstream side of the dike. Note the smooth appearance of this slope face.

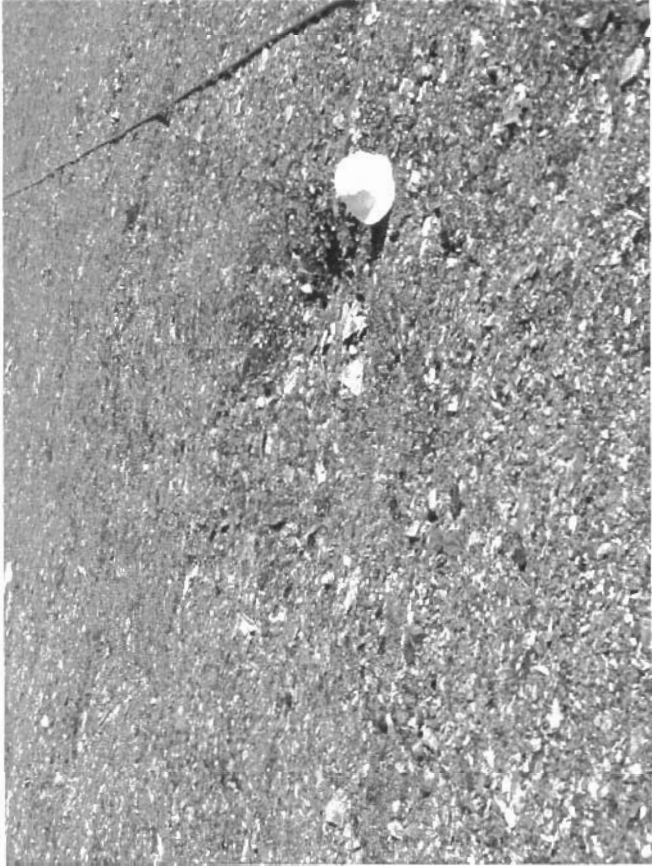
Photo 44 shows a view of some small settled areas just behind the hard hat. These are located some 3 metres down the downstream slope from the crest elevation. This photo was taken near the water discharge lines.

Grade over the settled areas and cracks on the downstream face of the dike and monitor. Backfill the small erosional gully located at the toe. Grade over and monitor the cracks in the crest near the north abutment dogleg and crest surface. Report any anomalous visual observations to BGC.

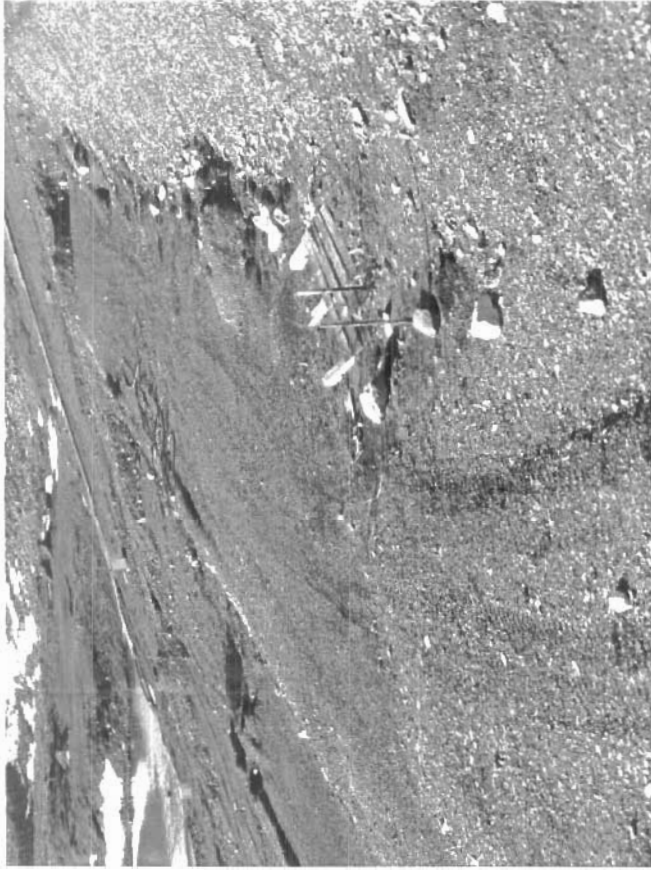
Photo 57 shows a view of the crest of two benches located just below the crest. On the level just below the crest, there is a subtle oblique crack running across the crest. On the second lower bench, there appears to be several transverse cracks.

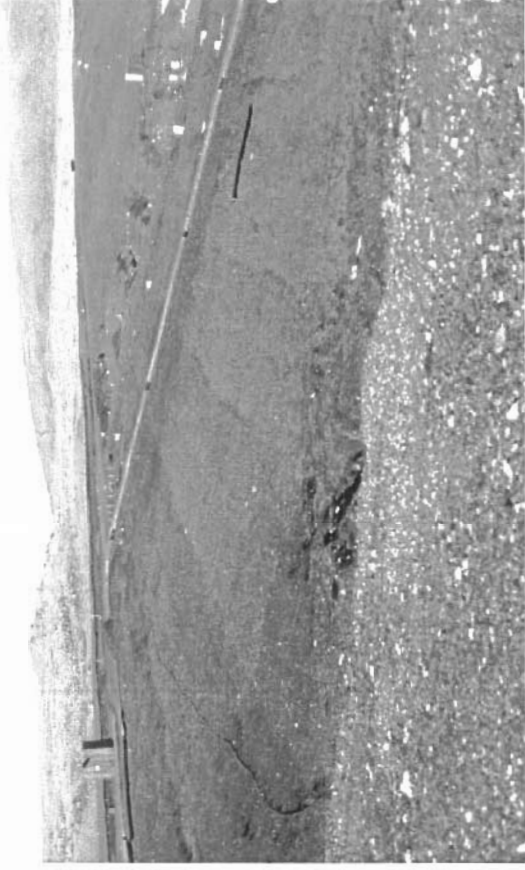
Photo 35 shows a view of the contact between the dike embankment fill and the native ground rising to the right at the south abutment. There are no wet spots or signs of seeping water. Note that some settlement of the fill has occurred where it was placed to smooth the benched appearance.

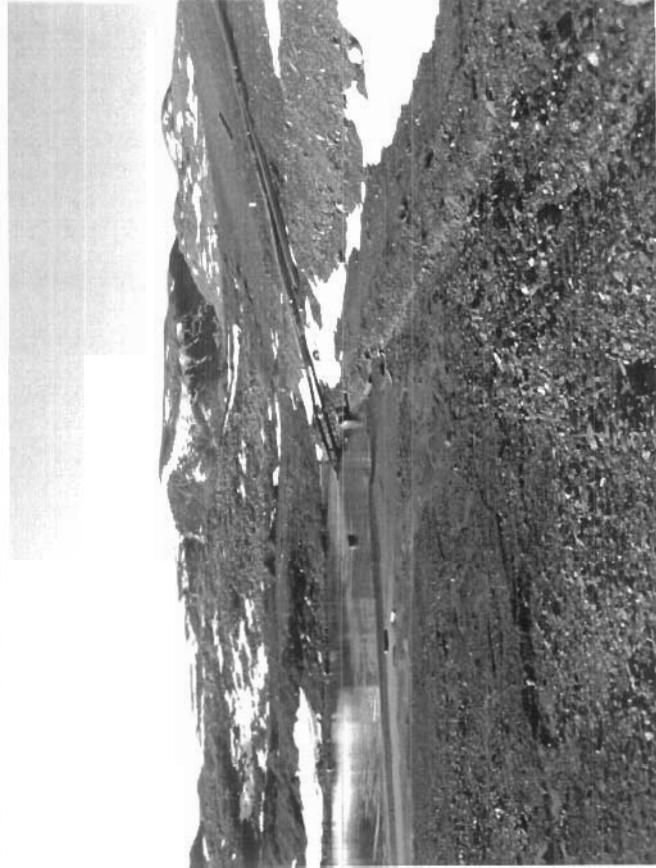
Photo 77 is a view along the toe. In the mid ground can be seen the lines which discharge water from the Surface Cell into the Reservoir. In addition, the initial placement of shale covering can also be seen over some tailings at the toe .

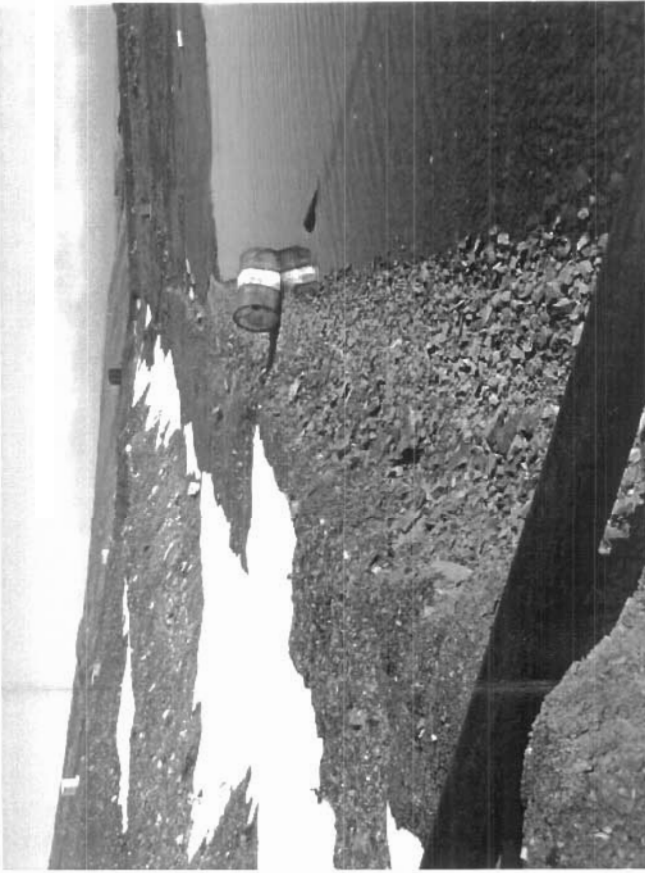
Photo 80 shows the minor erosion that is occurring at the toe of the dike. In the background of the photos some exposed tailings can be seen.

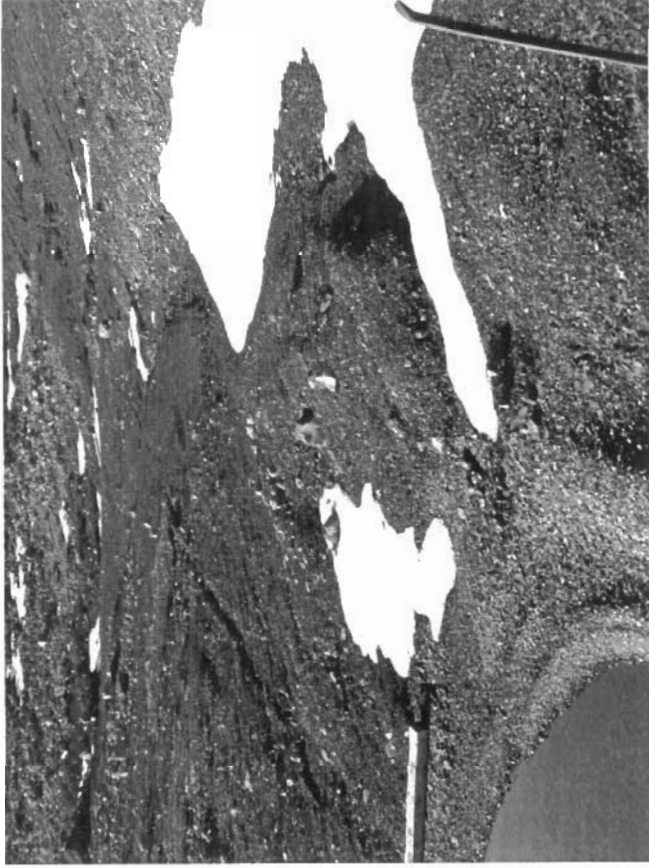
Photo 81 shows a minor erosional gully situated at the toe of the dike.

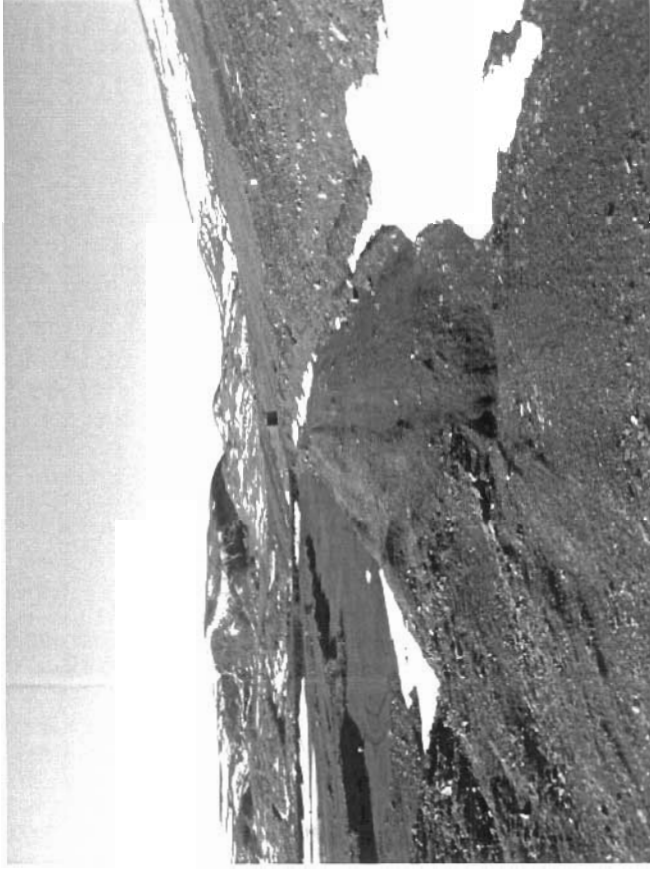
Photo 73 shows a view along the toe of the dike. There is no ponded water in this area and hence, no active erosion ongoing in this area.

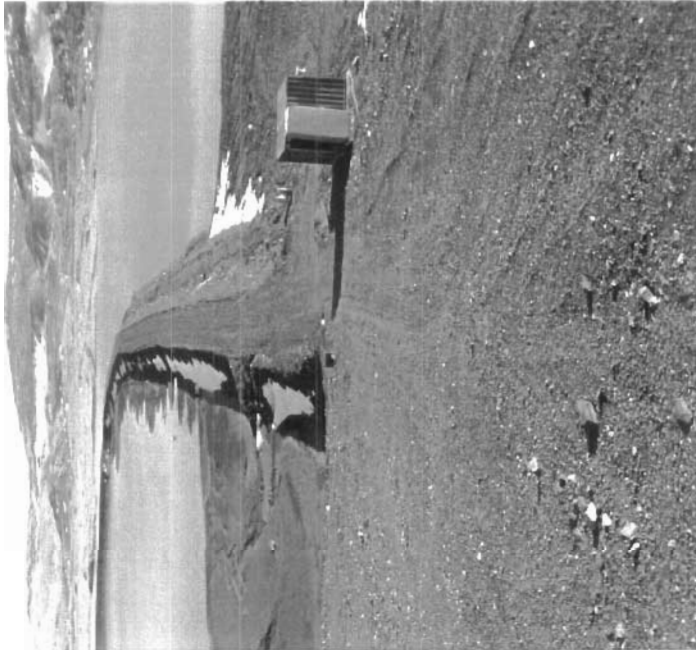
Photo 10 shows a view of the Test Cell Dike, which is situated in the middle of the toe of the West Twin Dike.

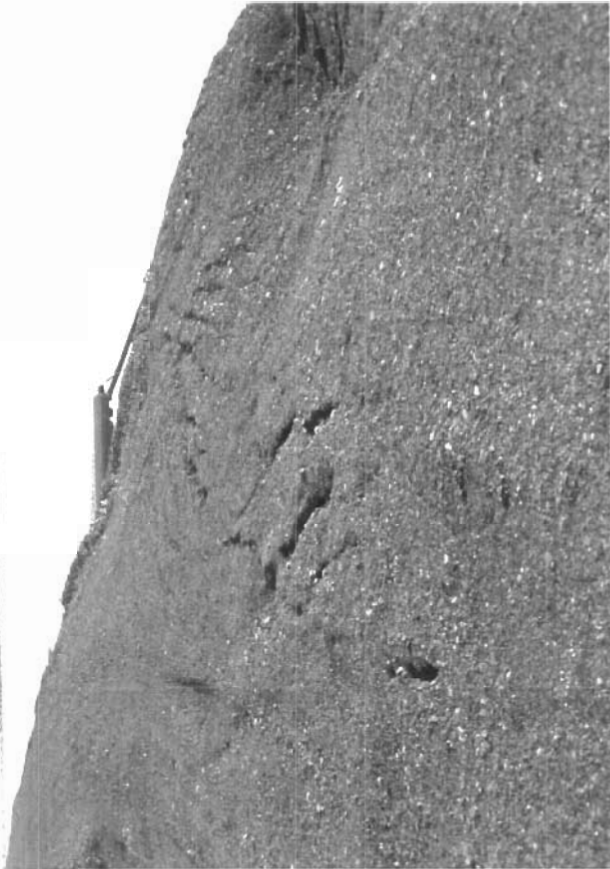
Photo 90 is a view of the outside face of this dike. Cracking, and settlement can be seen on this outside edge of the crest.

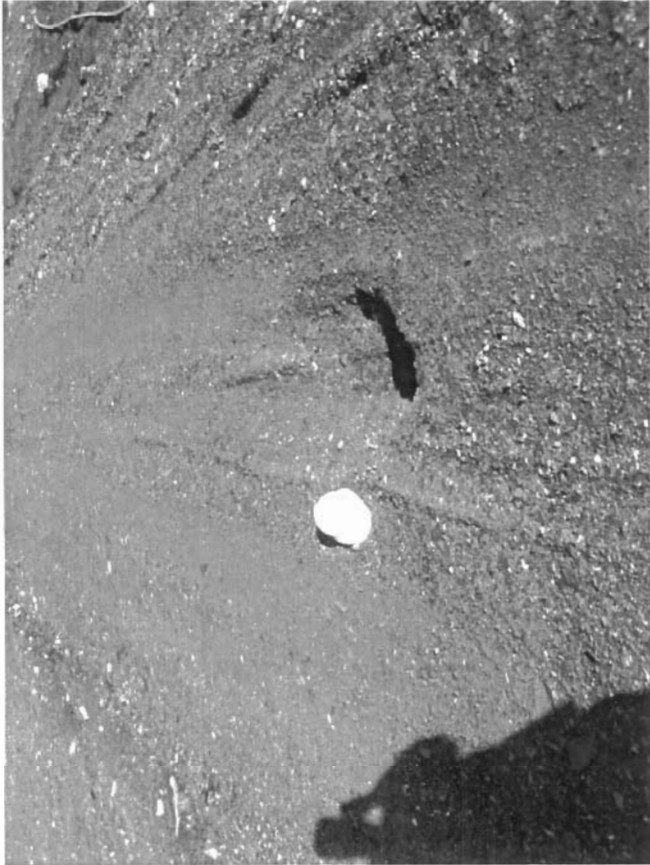
Photo 104 shows a view of a small sinkhole located in the crest of the Test Cell Dike.

INSTRUMENTATION:	Appendix 2 provides the results for TC36, BGC02-09 and BGC03-22 located in the Test Cell Dike. Temperatures warmer than zero occur at depths greater than 4 m.
MAINTENANCE RECOMMENDATIONS:	Grade over the two sinkholes on the crest and monitor for any additional settlement. Cracking on the crest of the dike should be graded to prevent inflow of water into the current cracks.
CONCLUSIONS:	The dike is in satisfactory condition.

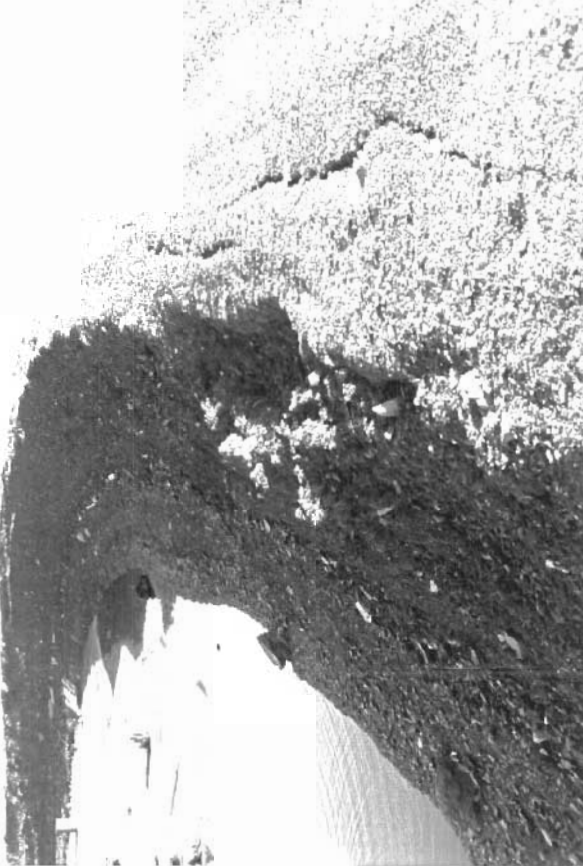
Photo 93 shows a view of the inside edge of the dike. This portion was the more recent fill placed to close the gap between the N-S and E-W portions of the Test Cell dikes. These cracks are the result of the oversteepened nature of the fill placed in this portion of the dike.

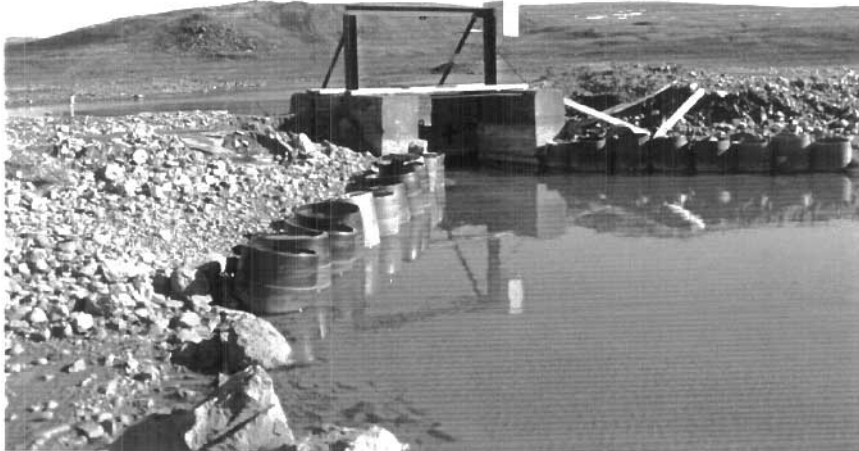
Photo 113 shows the decant spillway structure at the outlet of the polishing pond. There's a steel gate within five valves within the concrete structure that allows water to be decanted from the pond. This photo shows the erosion on the sides of wing walls of the concrete structure.

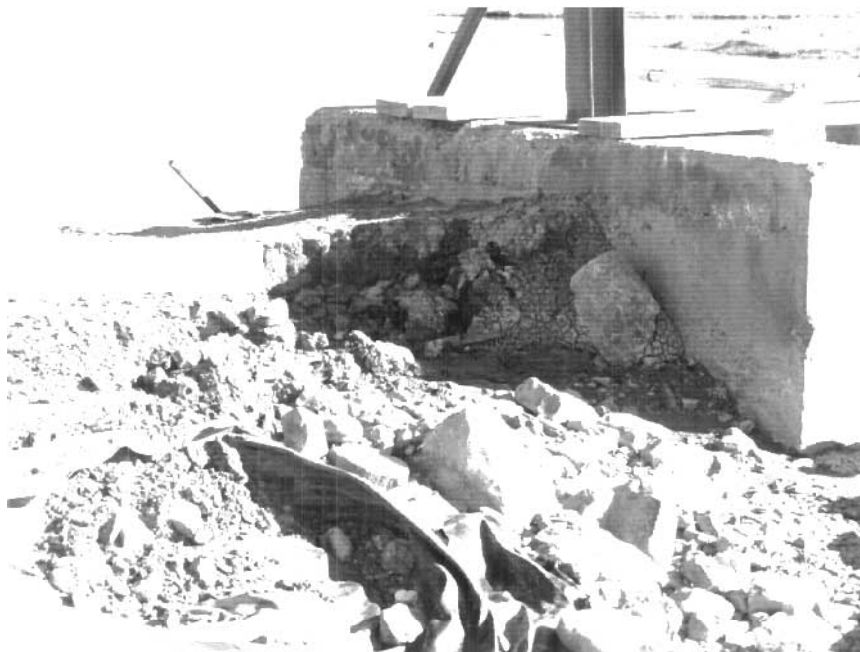
Substantial erosion has occurred in a portion of the retention dike, directly adjacent to the concrete walls of the decant structure. The dike structure must be properly repaired and appropriately sized rip rap should be placed to prevent any further erosion. In addition, the discharge capacity of the current valve arrangement should be reviewed in detail. It is felt that the discharge capacity from this system is too low with respect to the size of flood events that may occur in the WTDA area. Consideration should be given to removing the current steel gate/valve arrangement and returning to a stop-log system which would allow greater volumes of water to be moved (thus allowing for the management of flood events).

Photo 114 shows a close up view of the erosion that has occurred on the left wing wall. This needs to be repaired and then riprap should be placed on the upstream side to prevent future erosion.

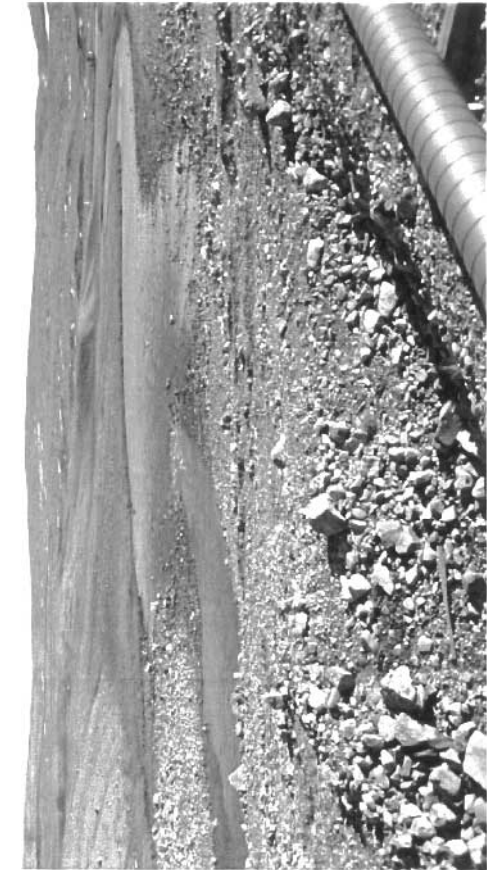
Photo 139 shows a view of the Dike and the start of the diverted portion of East Twin Lake Creeks.

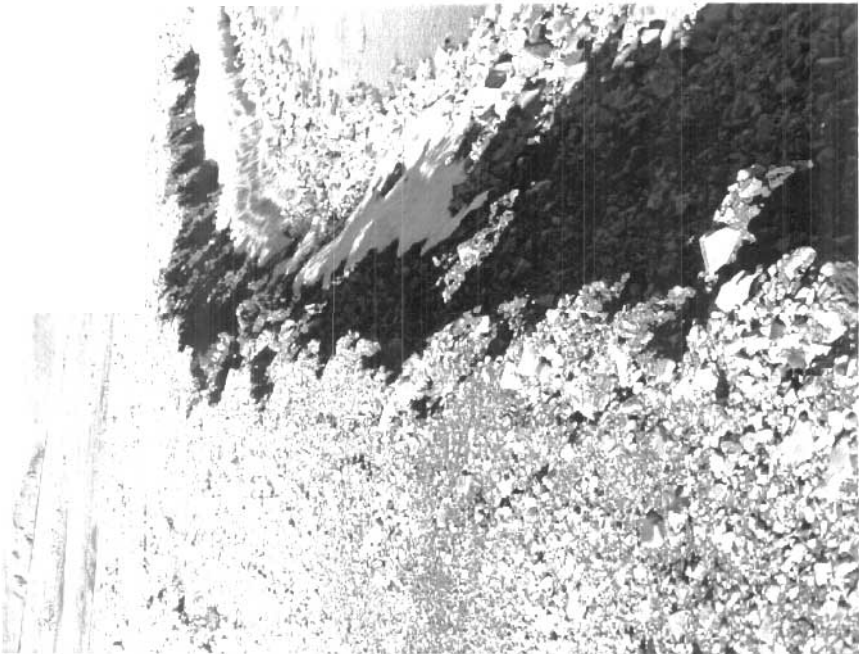
Photo 144 shows a close up view of the crest of the Diversion Dike. There is cracking occurring due to erosion on this side of the dike. Hence, some repairs and riprap will be required to prevent the erosion from getting worse.

MAINTENANCE RECOMMENDATIONS:	The erosion and the sloughing of both the channel and the dike should be repaired and some appropriately sized rip rap placed to prevent future erosion.
CONCLUSIONS:	Pending repair of the erosion and the cracking, the dike and diversion channel appear in satisfactory condition.

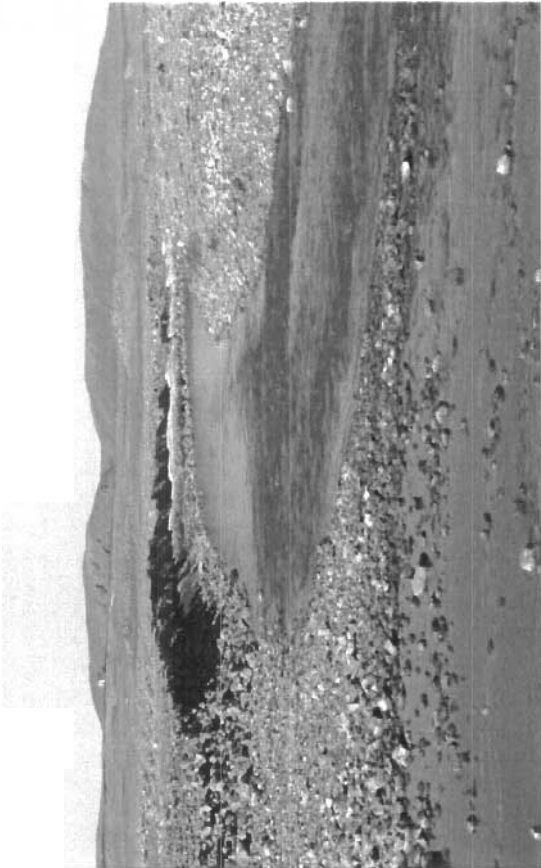
Photo 141 shows a view of the Diversion Canal. The slope on the left hand side is sitting at the angle of repose and some sloughing has occurred where the material has been slightly oversteepened due to erosion.

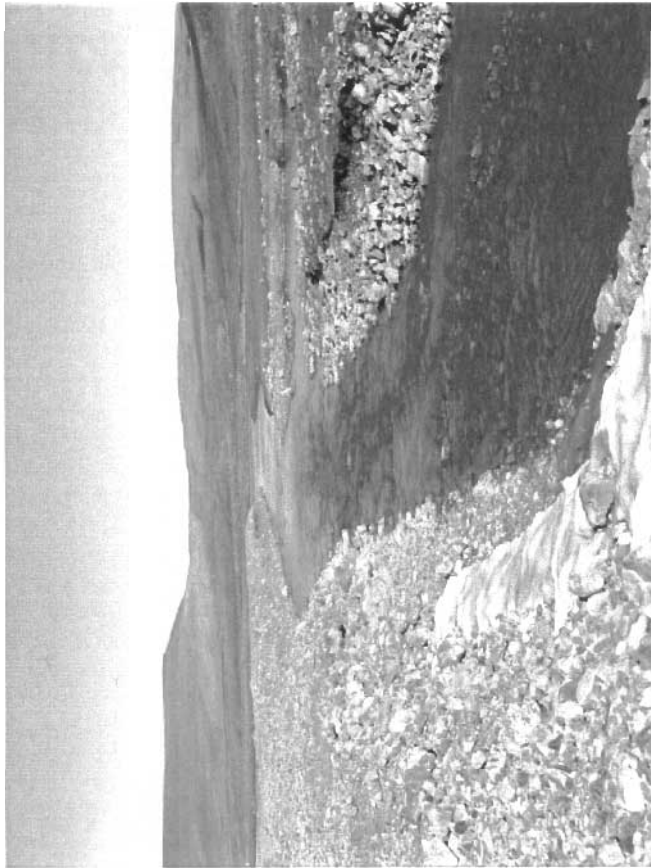
Photo 148 is a view in the downstream direction. On the left hand side of the photo can be seen some of the erosion which is sloughing the left hand slope.

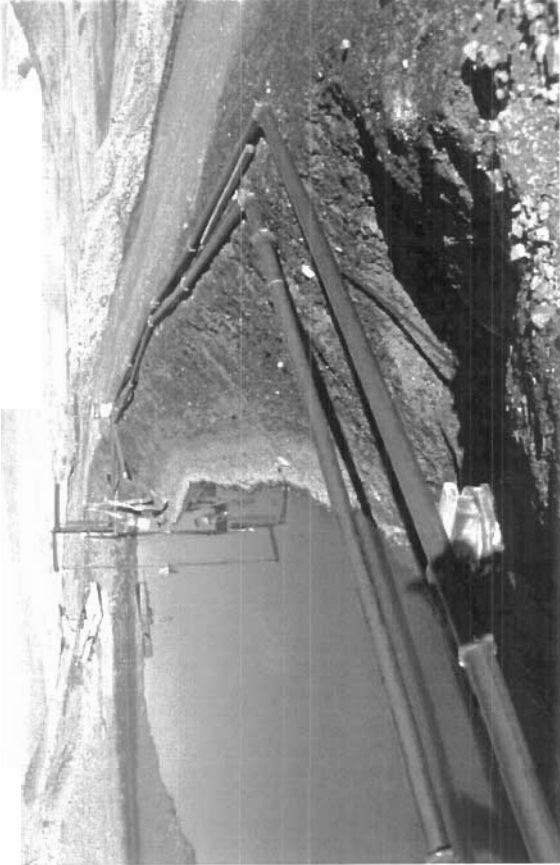
Photo 182 is a view of the crest of the Treatment Pond Dike. Pipeline used to pump water for lime treatment. Note the lighter coloured fill that has been recently placed on the crest.

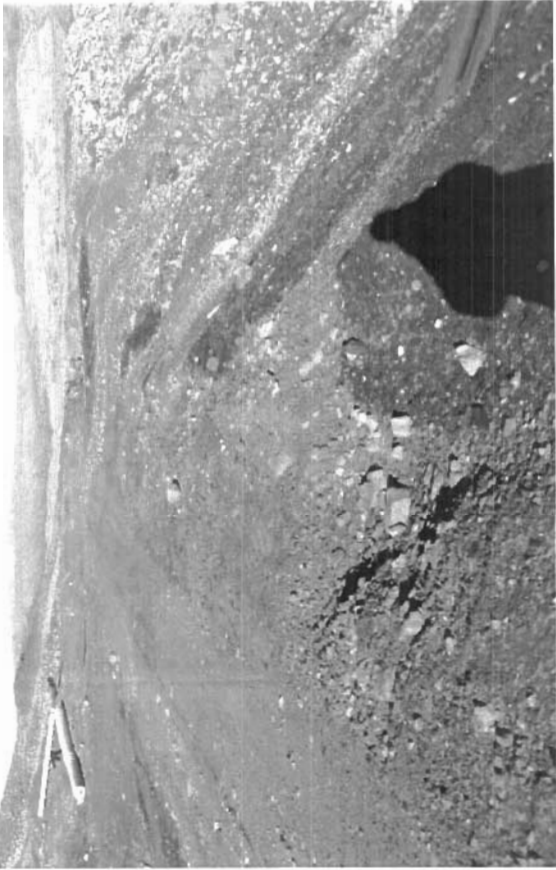
Photo 193 is a view of the fill placed at the north abutment as part of repairs taken following overtopping of this abutment.

should be performed at the north abutment to complete repairs following the overtopping. Provide a contingency plan regarding the prevention of crest overtopping due to extreme flood event. This could consist of upgrading the current spillway pipes to handle a greater volume of water or ensuring that the pumps operate to maintain a lower water level (such as having available a portable generator to run pumps if the electricity supply is interrupted).

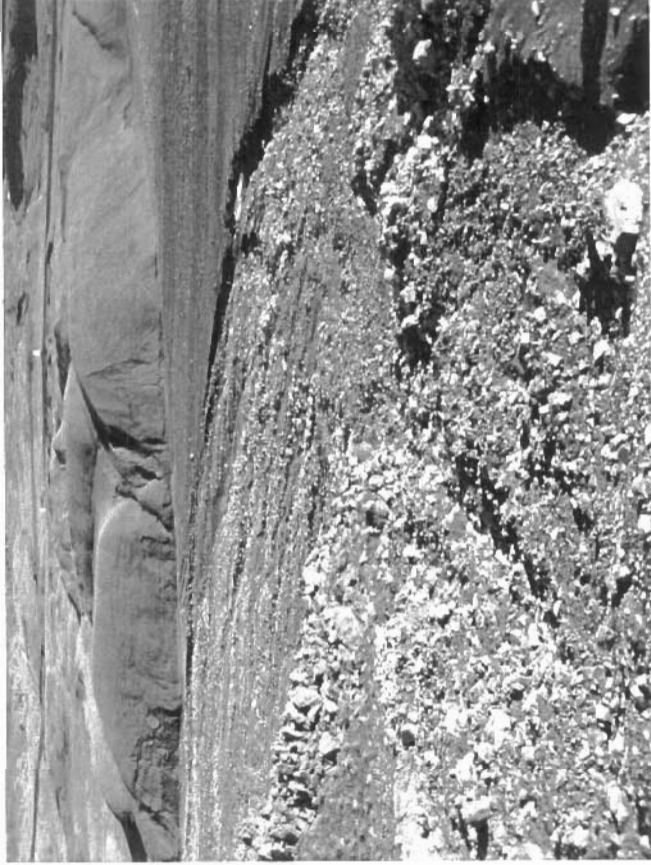
Photo 196 is a view of the erosion downstream from the overtopping at the north abutment.

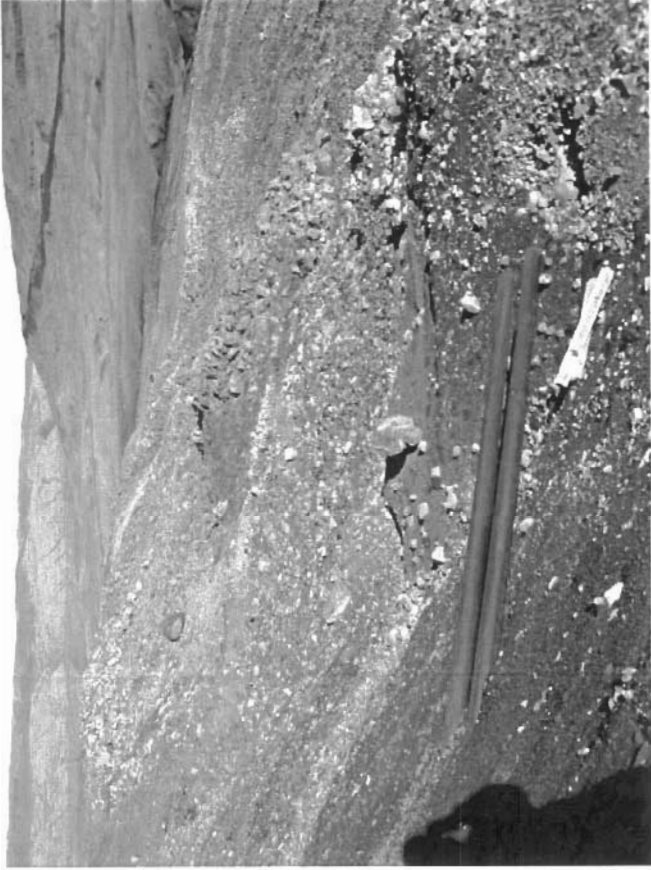
Photo 195 is a view of the discharge pipes passing through the crest of the dike.

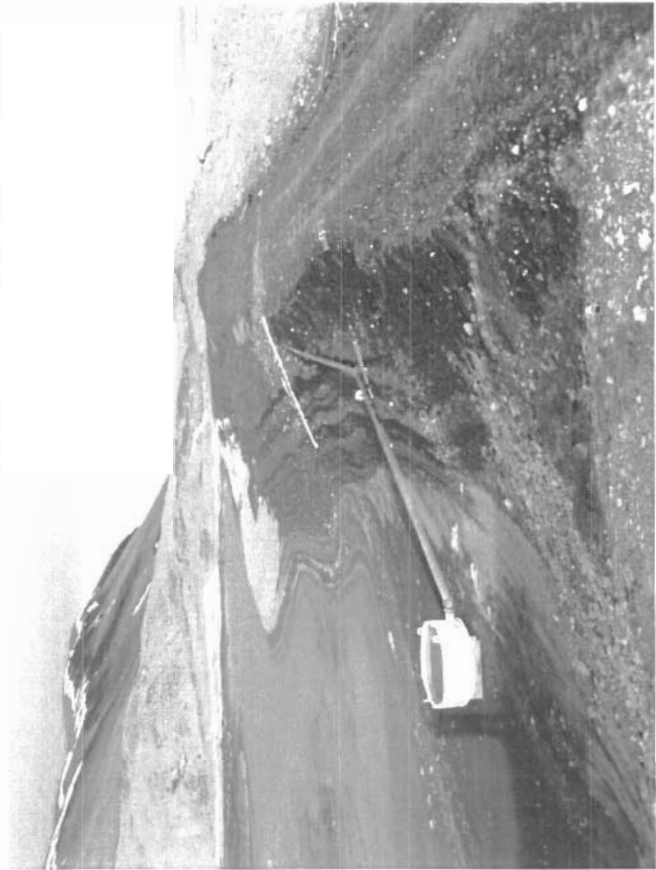
Photo 202 shows a view of the upstream side of the dike. Note the multiple beach lines and the appearance of the steepened upper section of the dike **face**.

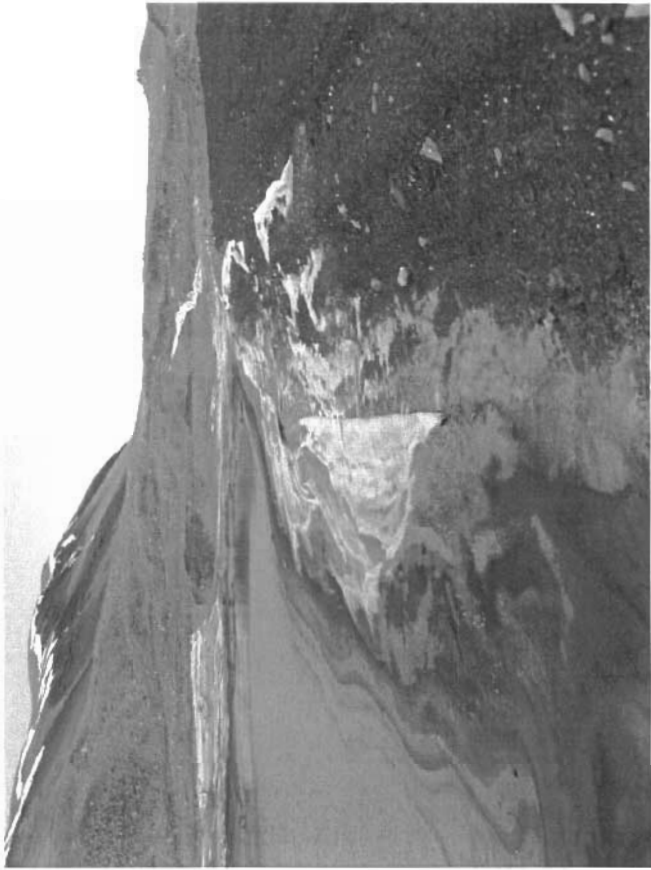
Photo 207 shows a view of the GCL which was previously placed on the upstream side of the dike. The top of the liner has dropped somewhat and needs to be re-installed. In the background of the photo can also be seen that some of the GCL has been caught by the wind and needs to be re-installed properly.

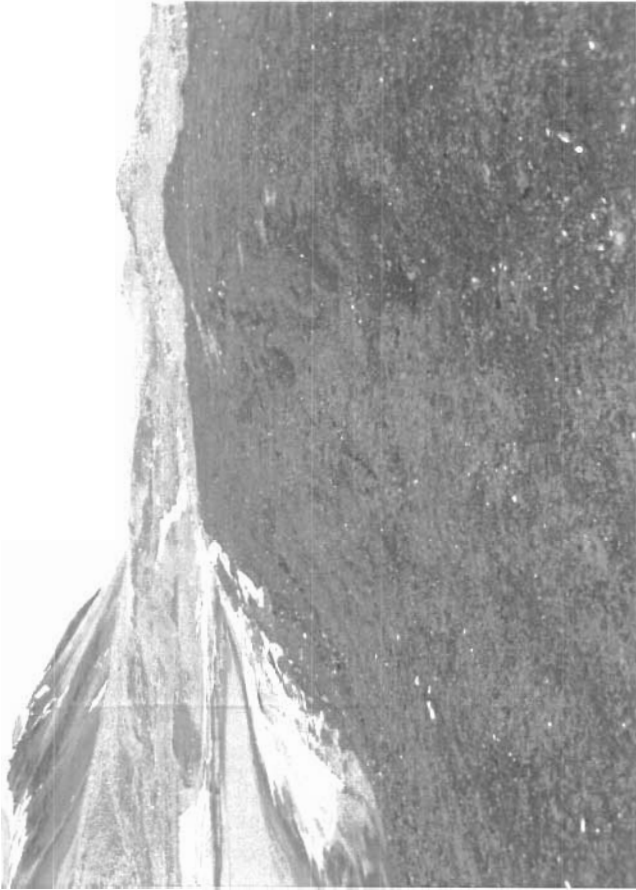
Photo 206 shows the undulating nature of the shale fill that was previously placed on the upstream face of the dike. Note the settlement troughs and cracking.

SEEPAGE:	No visual evidence of seepage at current time, but any potential seepage would likely disappear into the downstream talus slope.
WATER CONVEYANCE METHOD:	Gravity siphon decant pipe.
MAINTENANCE RECOMMENDATIONS:	Some grading of the cracks and settled areas on the upstream slope should be undertaken to establish positive drainage.

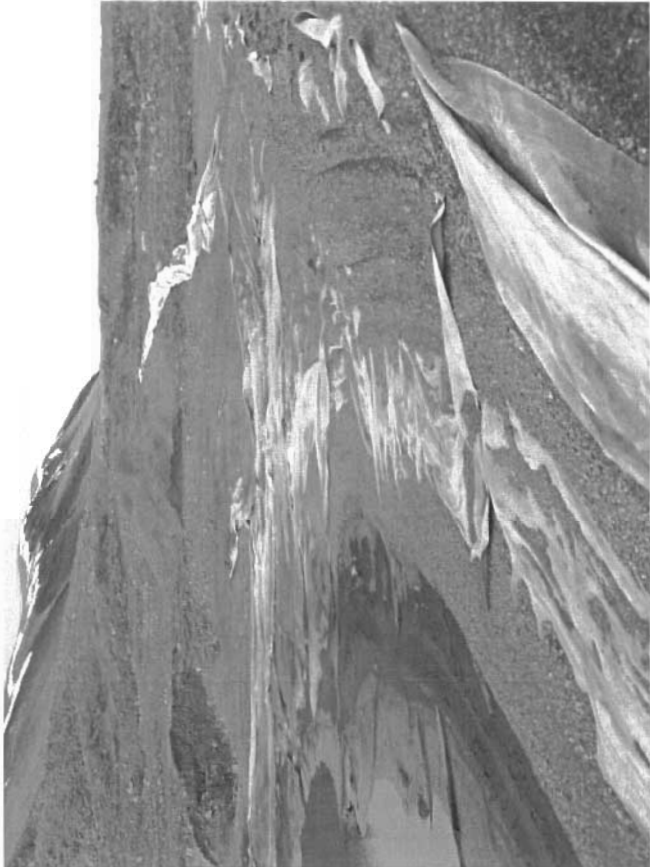
Photo 211 shows another view the disturbed liner on the southwest dogleg of the dike.

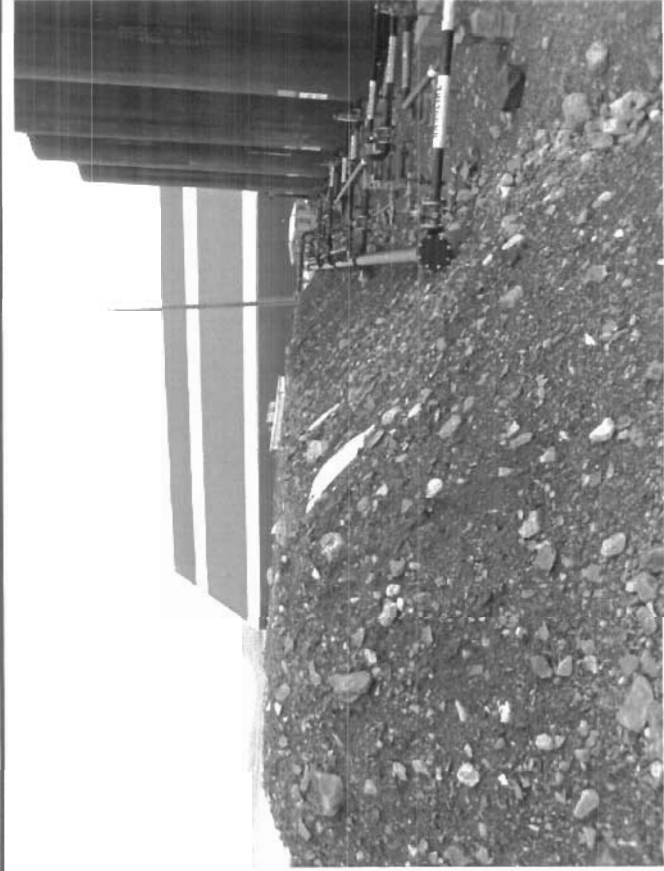
Photo 270 shows a new berm that was placed along a portion of the north berm. This new lift appears to be approximately 1.2 to 1.4 m high.

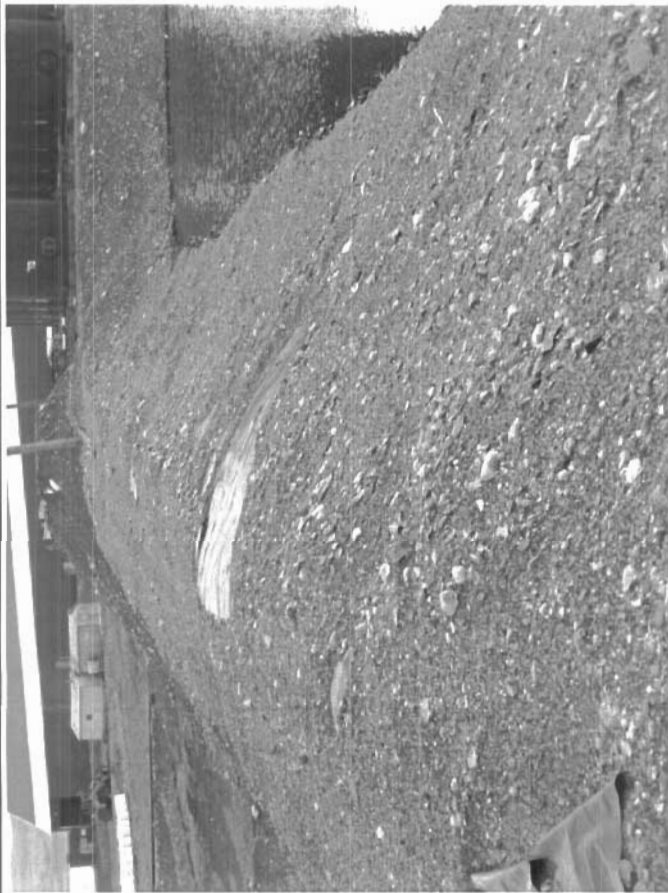
Photo 267 shows the crest of the north berm. There are several locations where the liner is exposed.

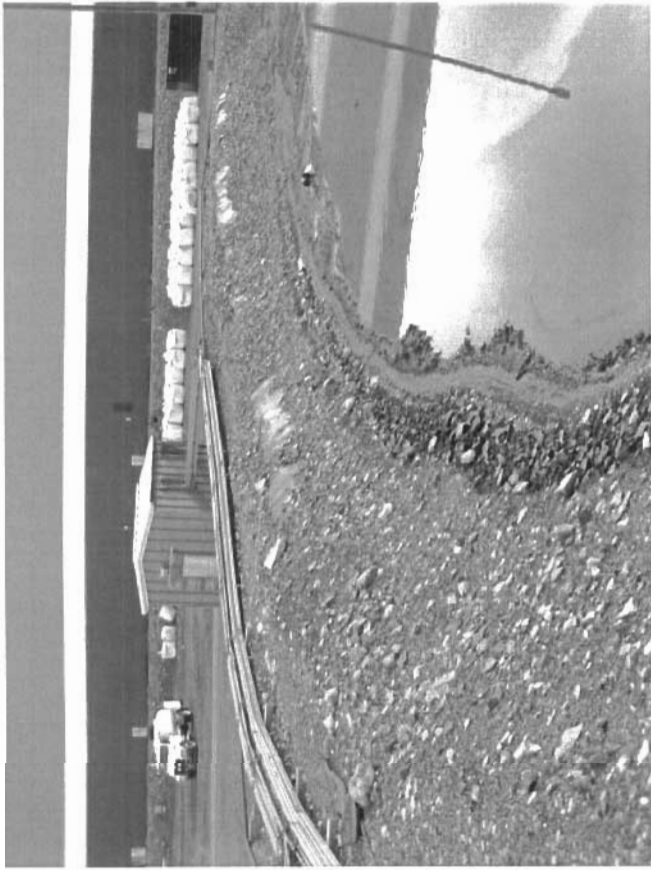
Photo 275 shows the dike crest, the retained pond and the exposed geomembrane liner (which does not appear to have any major cuts).

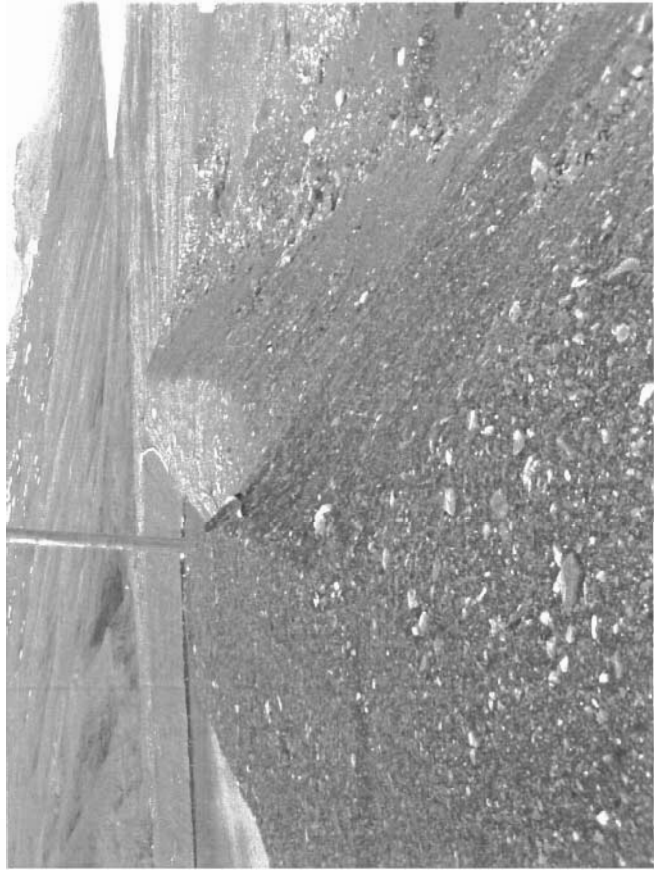
Photo 271 shows the sloughing of the face of the newly placed fill related to its marginal stability.

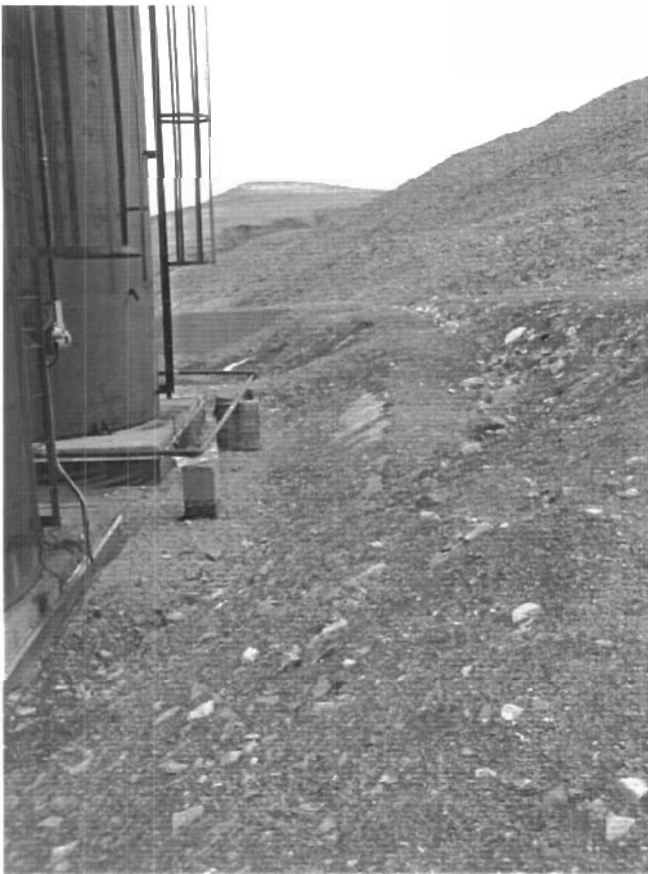
Photo 234 shows the east side berm. The liner is exposed in several places.

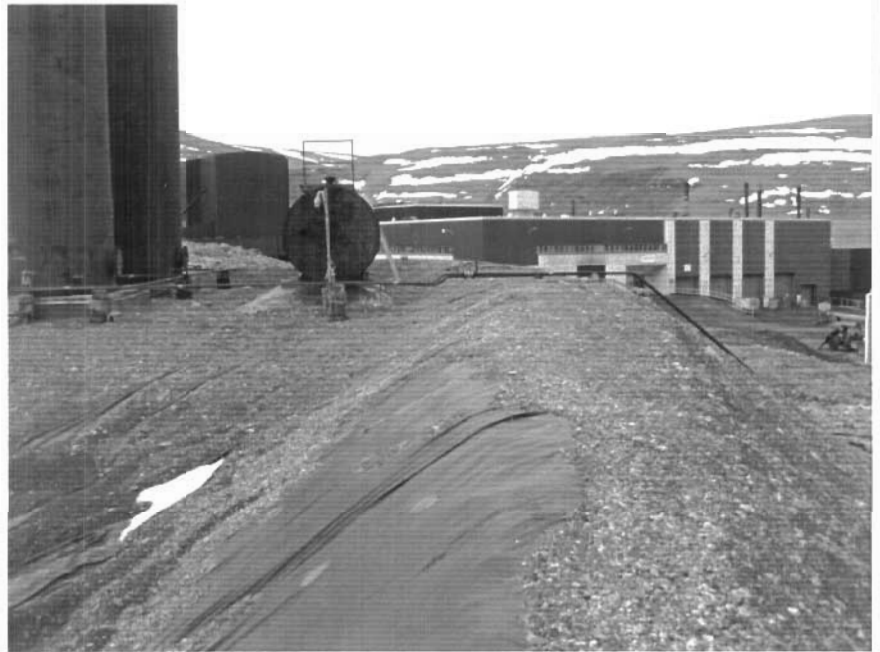
Photo 238 is a view of the exposed liner along the west berm. No cuts or tears were observed from this location.

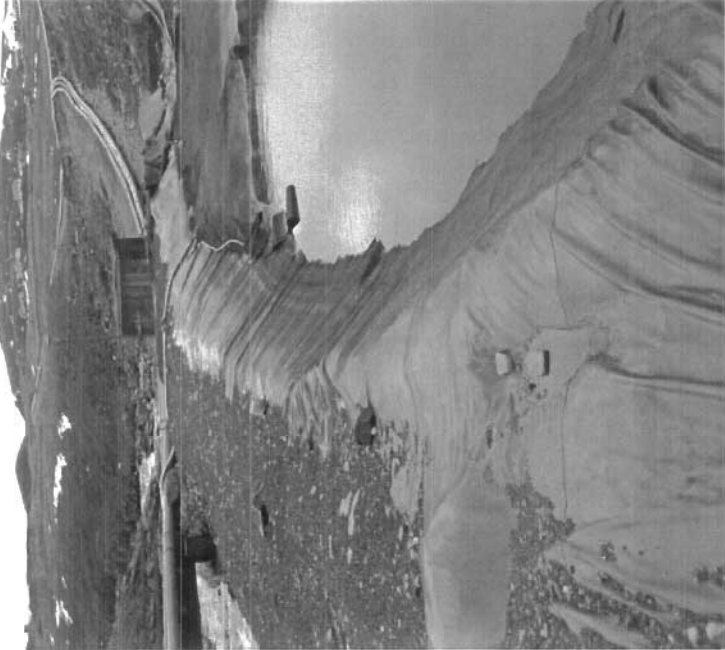
Photo 252 is a view looking towards the east or high end of the Dump Pond. The liner is wrinkled but appears to be uncut and is retaining water.

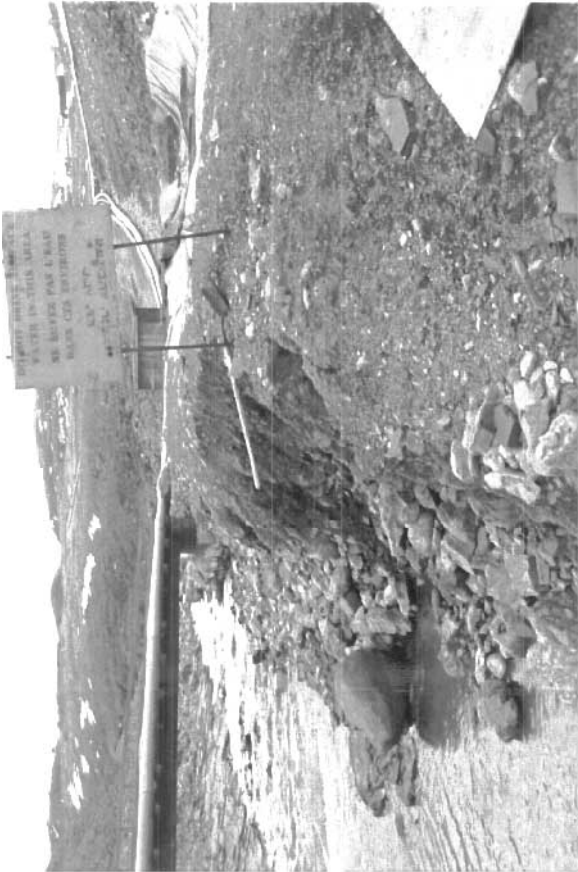
Photo 250 shows a view of the recent erosion of the bank of Twin Lake Creek. This erosion has undercut and oversteepened the embankment used to support the liner of the dump pond. This erosion needs to be repaired so that the liner maintains support.

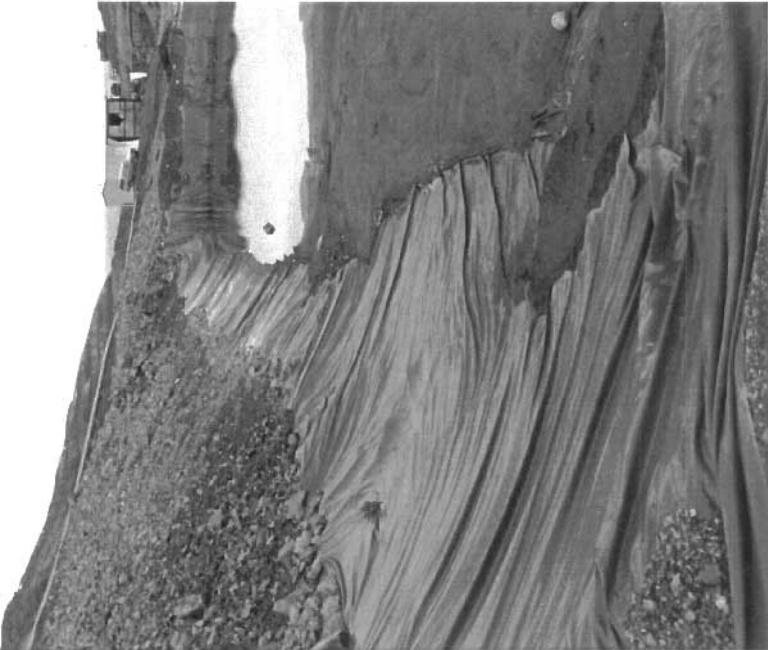
Photo 254 shows the retained pond within this Dump Pond. Two cuts in the top of the liner were observed at the crest edge.
