NANISIVIK MINE, A DIVISION OF CANZINCO LTD.

2003 GEOTECHNICAL INSPECTION OF WASTE CONTAINMENT DIKES

NANISIVIK MINE, NUNAVUT

PROJECT NO.: 0255-008-05
DATE: OCTOBER 28, 2003

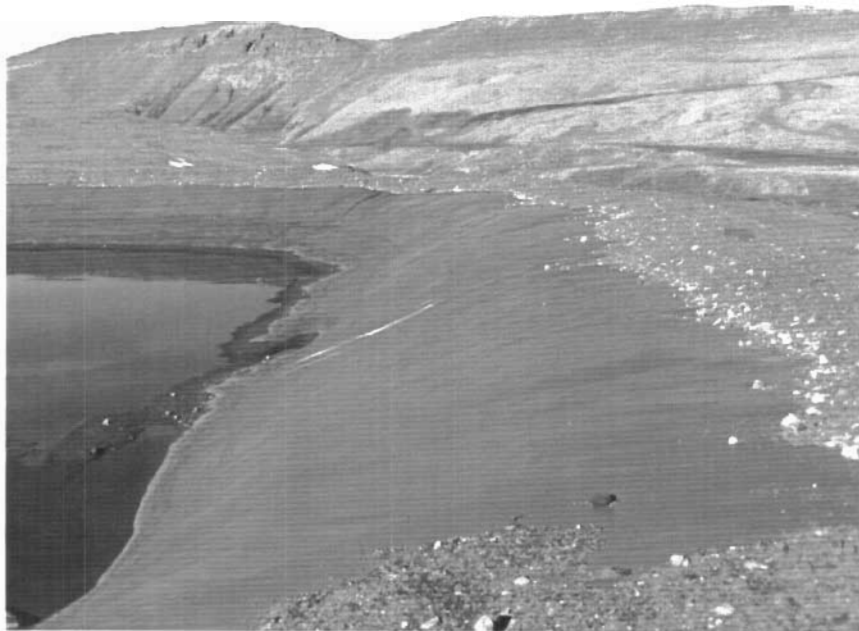
Photo 154 shows a view of the eastern berm of the Upper Dump Pond. The liner is quite wrinkled but some fill has been placed on top in an attempt to anchor the liner better.

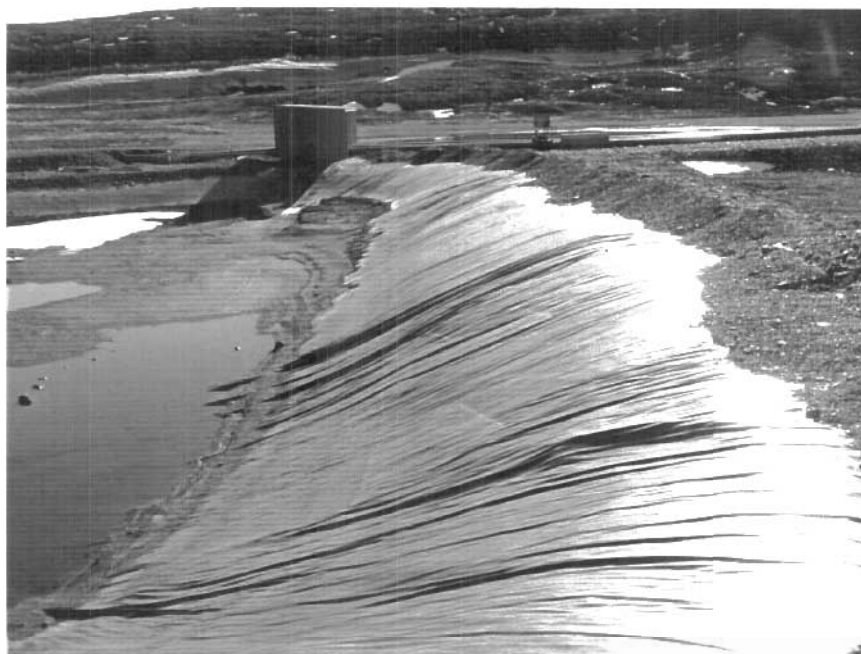
Photo 157 shows a view along the top of the western berm of this dump pond. No signs of cracking of the liner were noted. No signs of berm settlements or cracking or seepage at its downstream end have been noted either.
