### **INSPECTION MEMO OF SEPTEMBER 11, 2003**

## **PROJECT MEMORANDUM**

| <b>Subject:</b> | <b>Inspection Visit relative to Waste Containment Dikes and Berms<br/>Summary of Site Observations and Commentary</b> | | |

Nanisivik Mine - Annual Geotechnical Inspection of Dikes  
Nanisivik Mine, a division of Canzinc

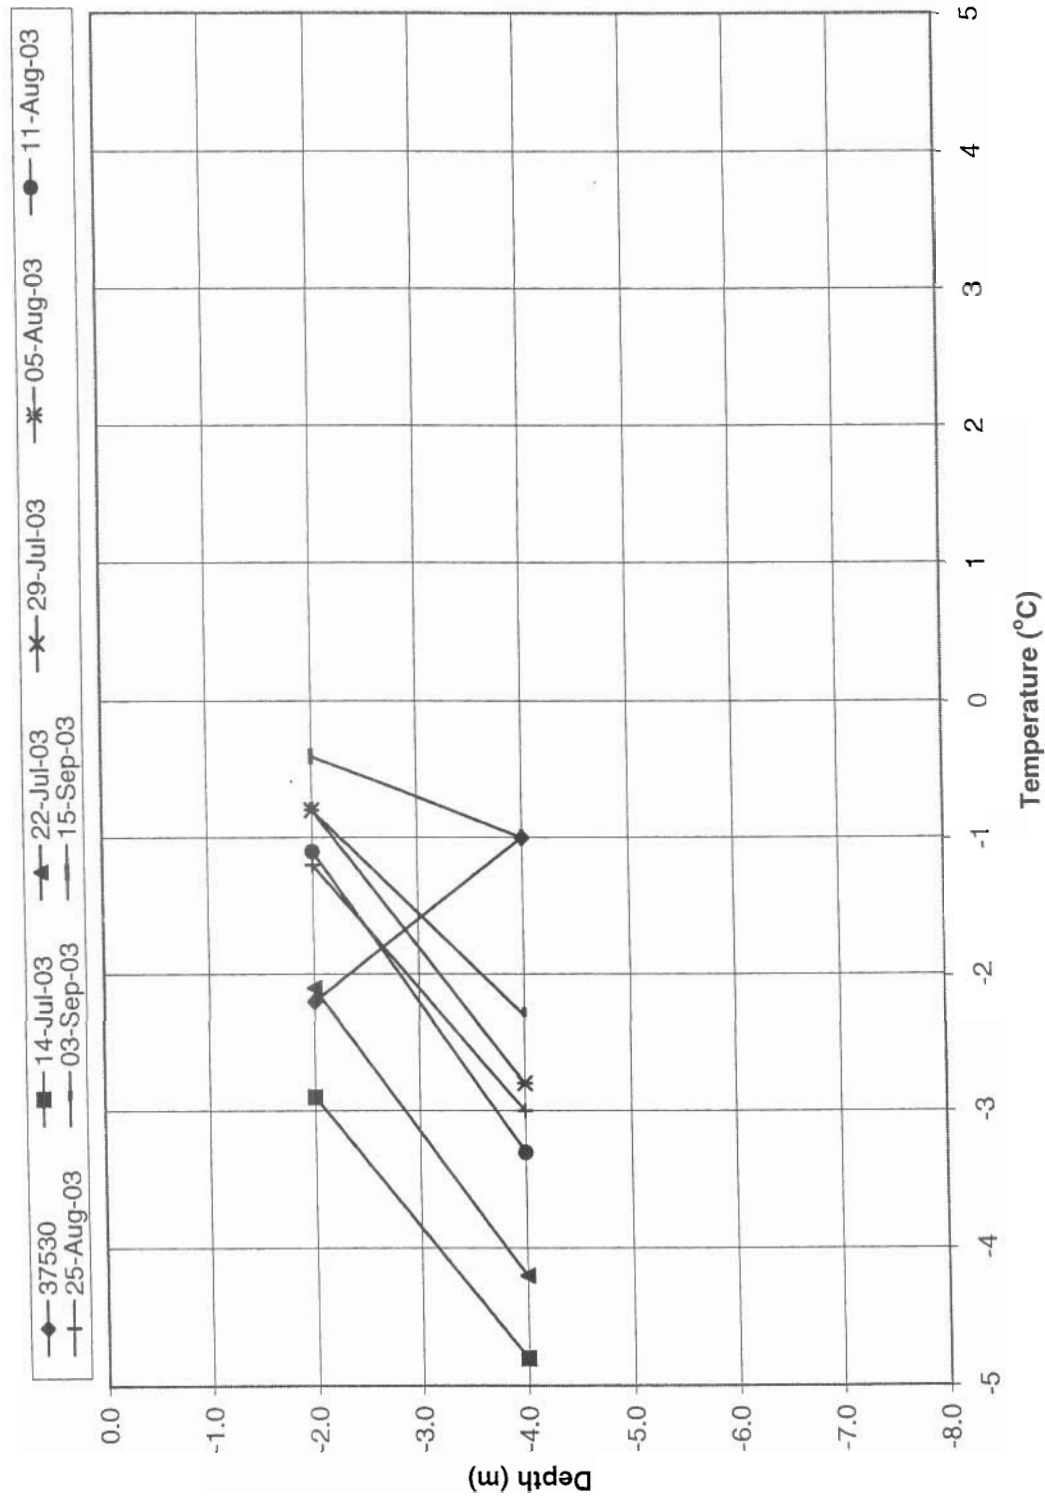
**Geothermal Monitoring**  
**South Toe of Dike**  
**Thermocouple BGC02-08**

| Instrument | Instrument type | Location | Station | Surface Elevation | Location of thawed ground (>-1°C) below active layer | Additional comments |
|---|---|---|---|---|---|---|
| BGC02-08 | T/C | Dike Toe | | 373 m | N/A | No warming trends, 8 readings in 2003 |

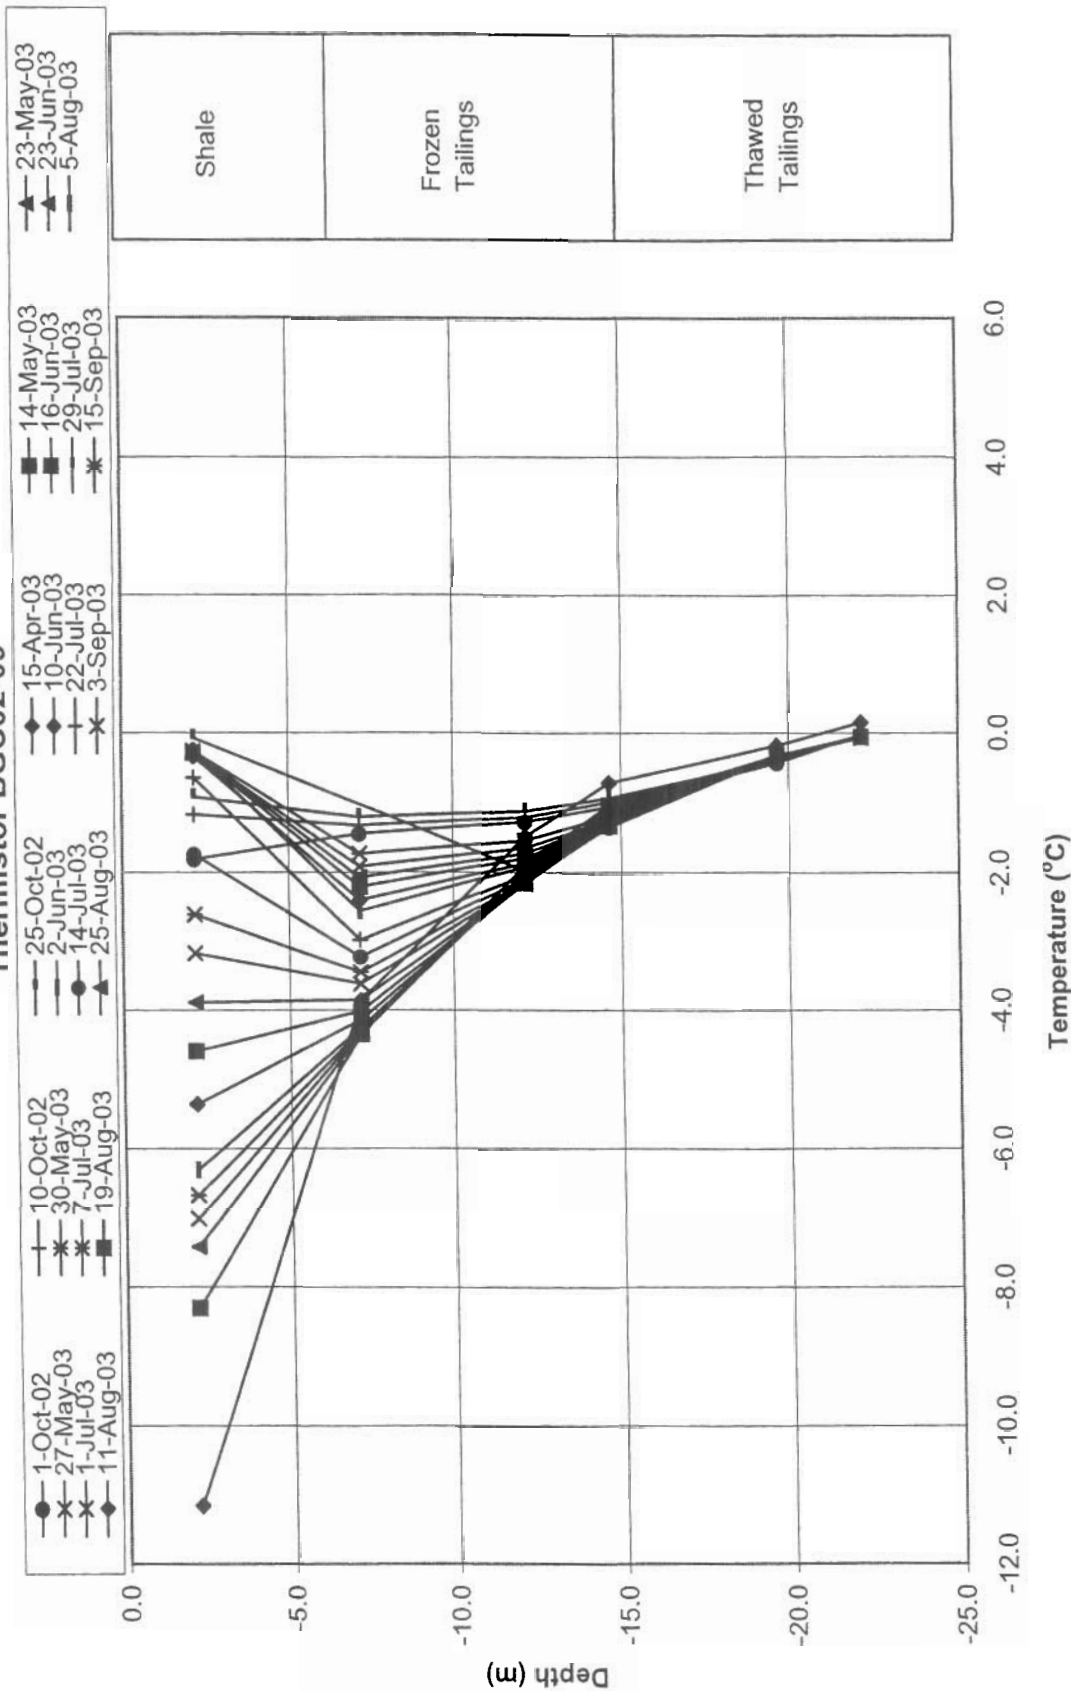
### Thermistor BGC02-09

| BGC02-09 | TM | Test Cell | | 377 m | 15 to 22 m | Thawed conditions below 15 m to the end of the hole. 20 readings in 2003. |

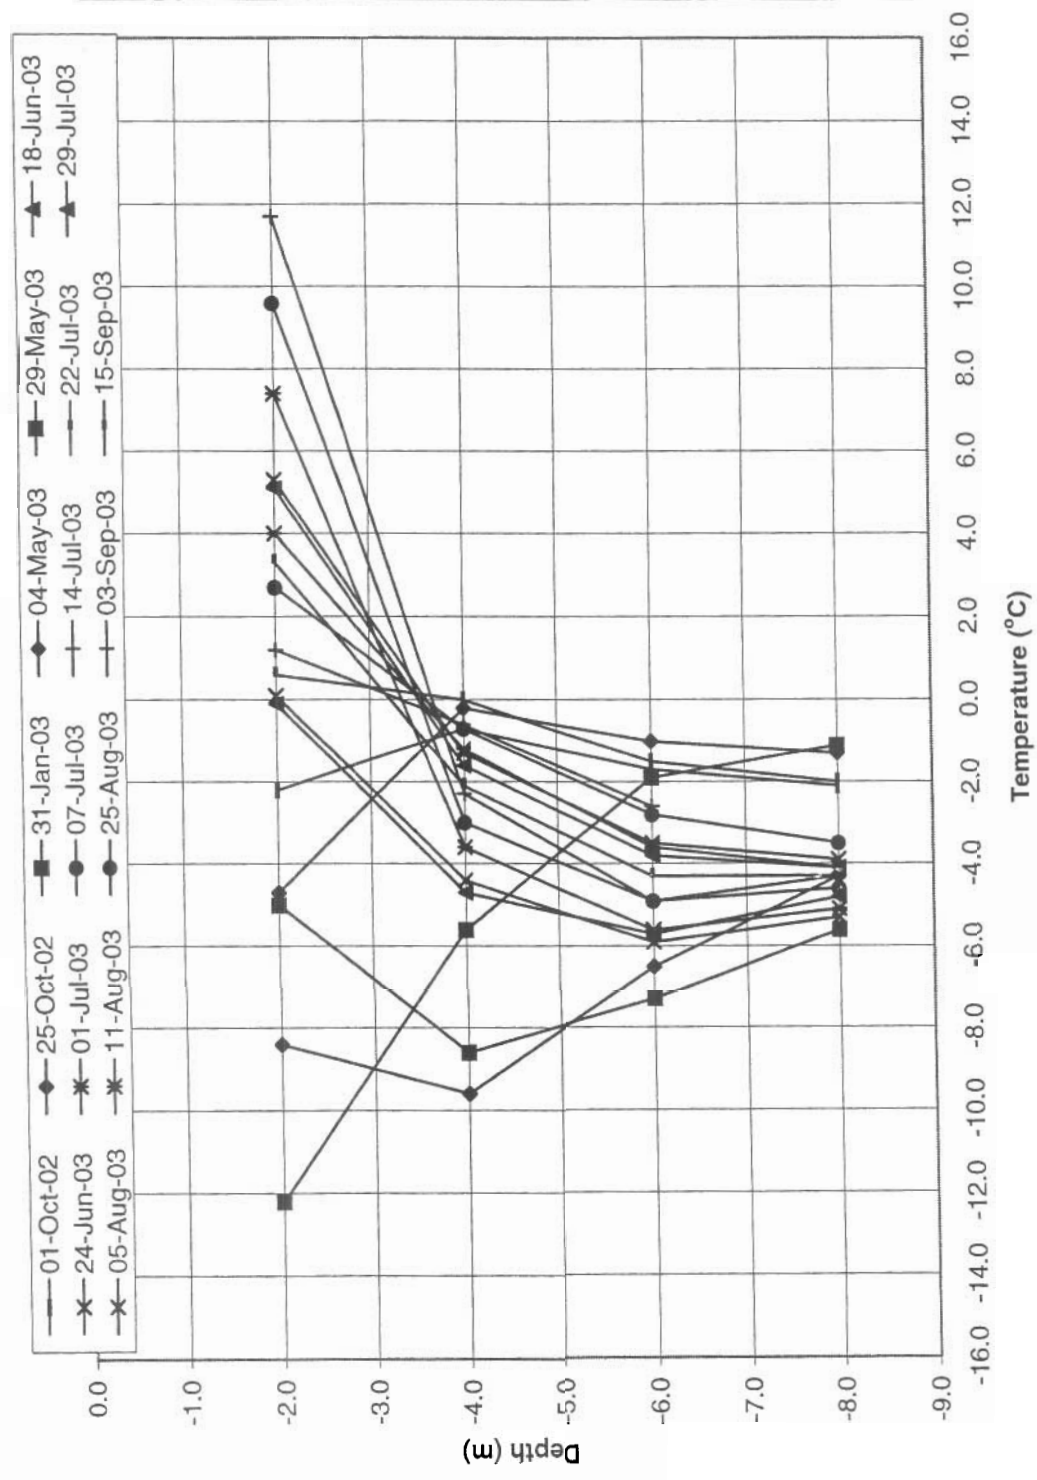
**Geothermal Monitoring**  
**Toe of WTD**  
**Thermocouple BGC02-10**

| Instrument | Instrument type | Location | Station | Surface Elevation | Location of thawed ground (>-1°C) below active layer | Additional comments |
|---|---|---|---|---|---|---|
| BGC02-10 | T/C | Dike Toe | | 373 m | N/A | No warming trends, 15 readings in 2003 |

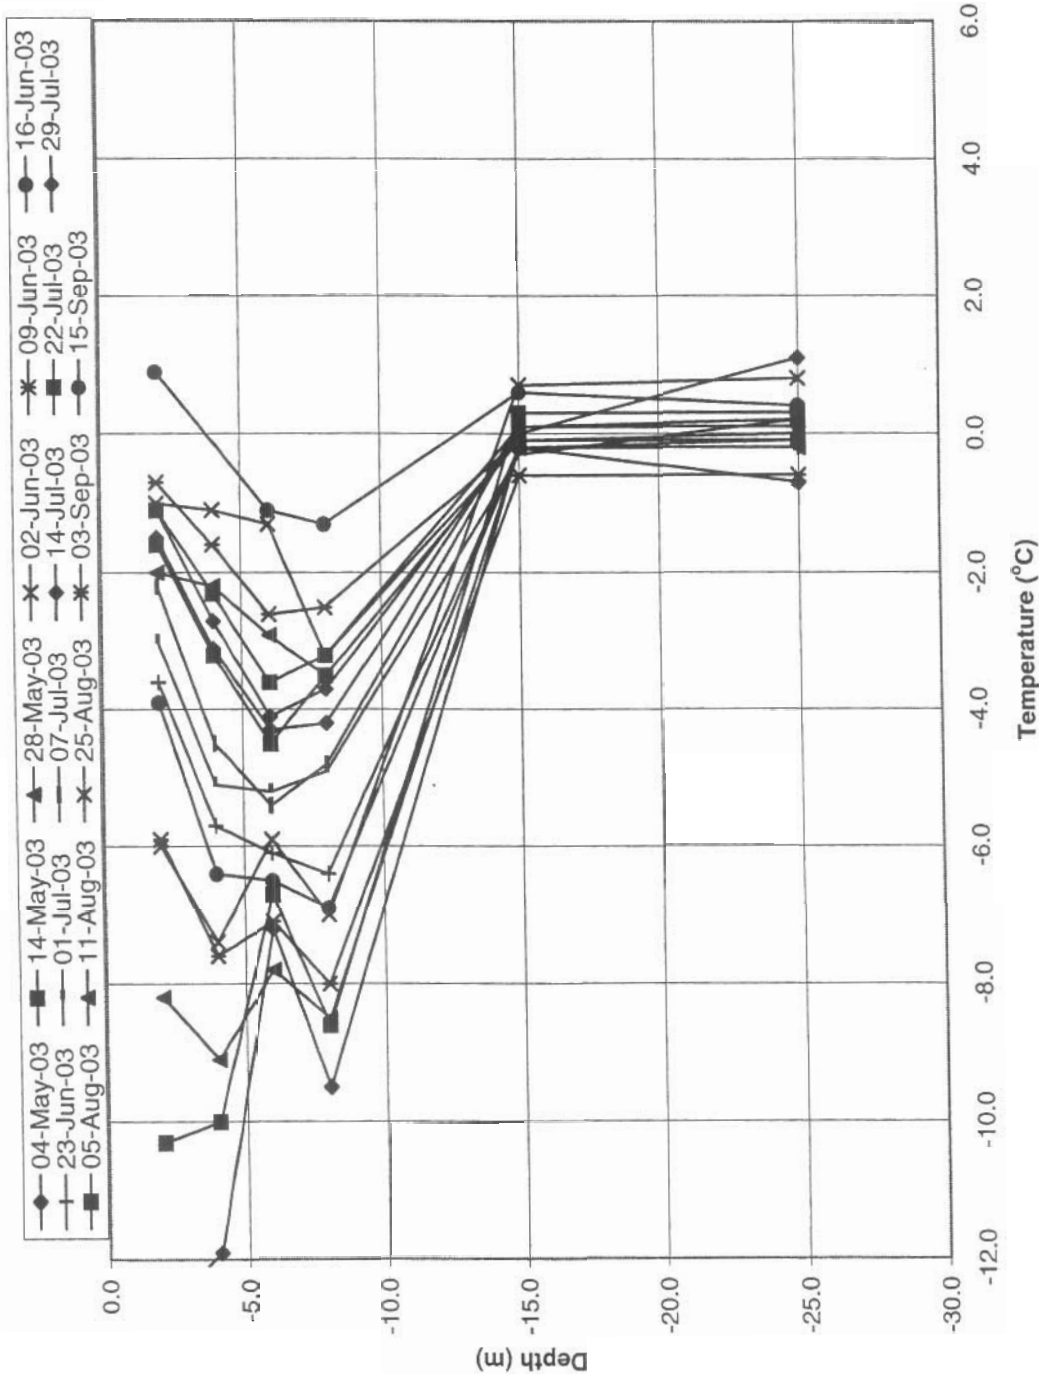
### Thermocouple BGC02-11

| Instrument | Instrument type | Location | Station | Surface Elevation | Location of thawed ground (>-1°C) below active layer | Additional comments |
|---|---|---|---|---|---|---|
| BGC02-11 | T/C | SC | | 387 m | 10 to 25 m | Thawed conditions below 10 m to the end of the hole. 19 readings in 2003 |

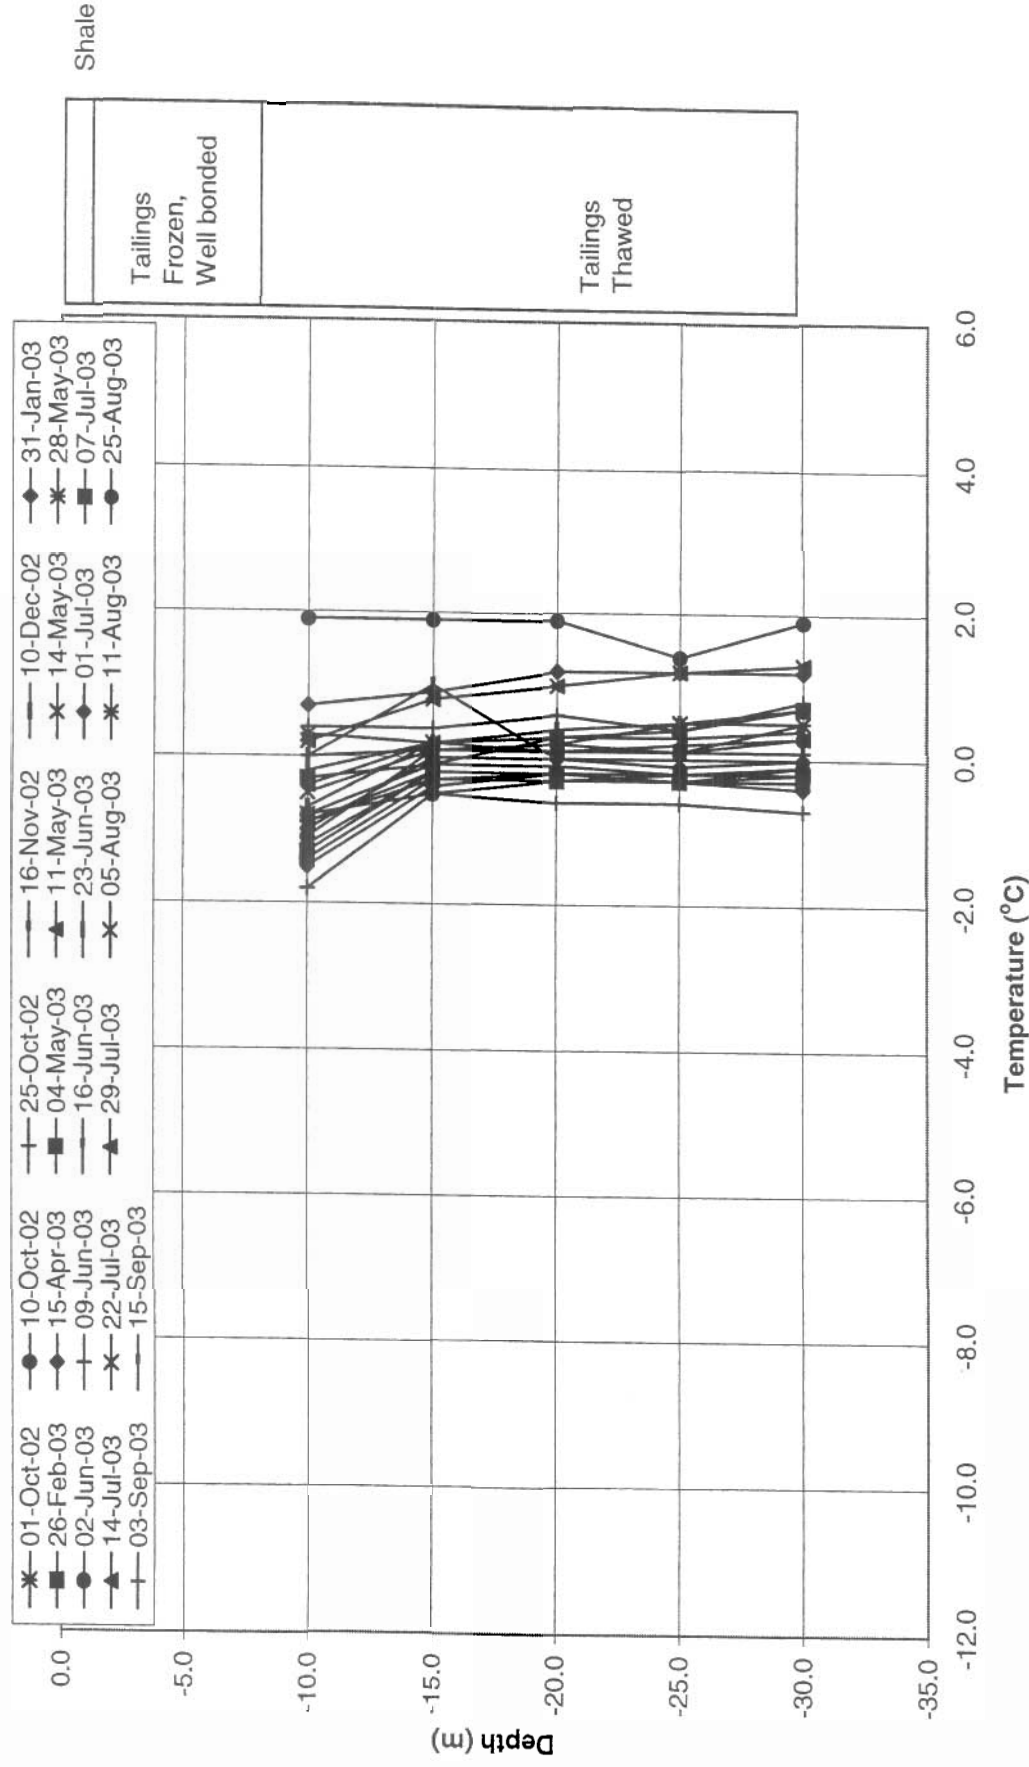
# Geothermal Monitoring Surface Cell Thermocouple BGC02-13

| Instrument | Instrument type | Location | Station | Surface Elevation | Location of thawed ground (>-1°C) below active layer | Additional comments |
|---|---|---|---|---|---|---|
| BGC02-13 | T/C | SC | | 387 m | 10 to 30 m | Thawed conditions below 10 m to the end of the hole. 21 readings in 2003 |

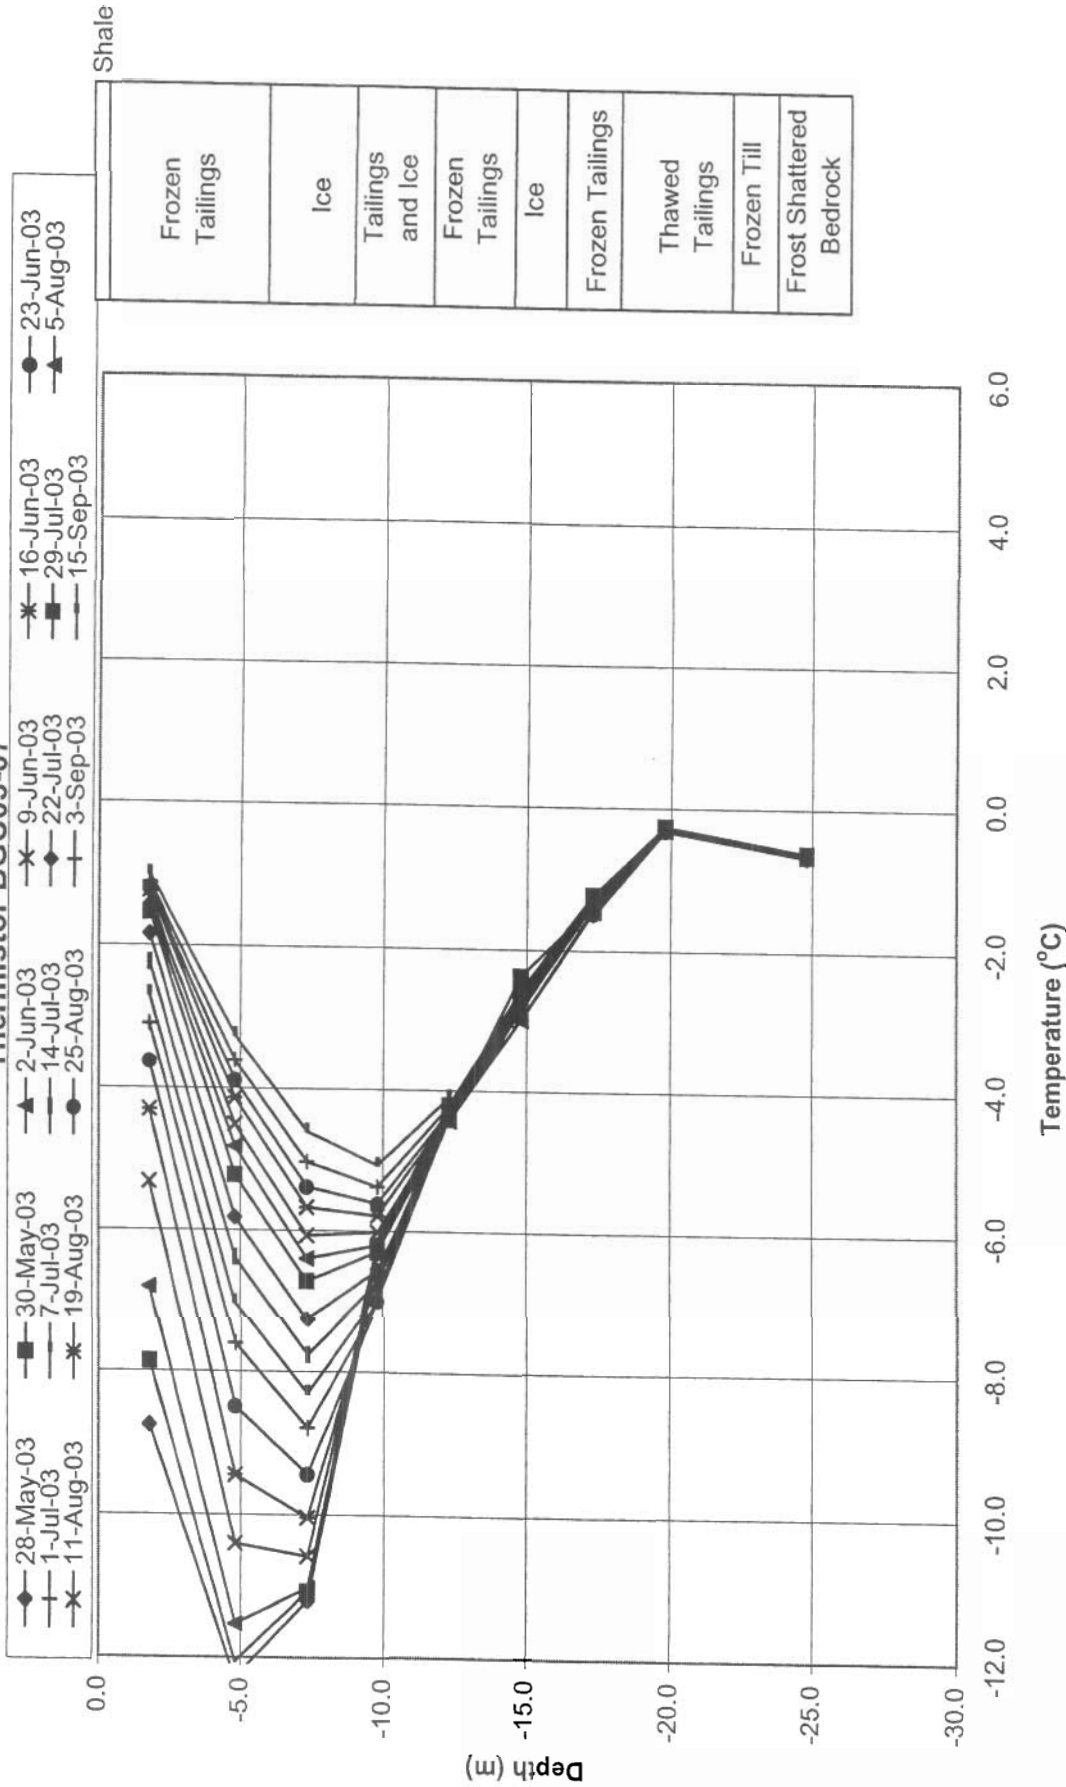
### Thermistor BGC03-07

| Instrument | Instrument type | Location | Station | Surface Elevation | Location of thawed ground (>-1°C) below active layer | Additional comments |
|---|---|---|---|---|---|---|
| BGC03-07 | TM | SC | | 387 m | 18 to 25 m | Thawed conditions below 18 m to the end of the hole. 17 readings in 2003 |

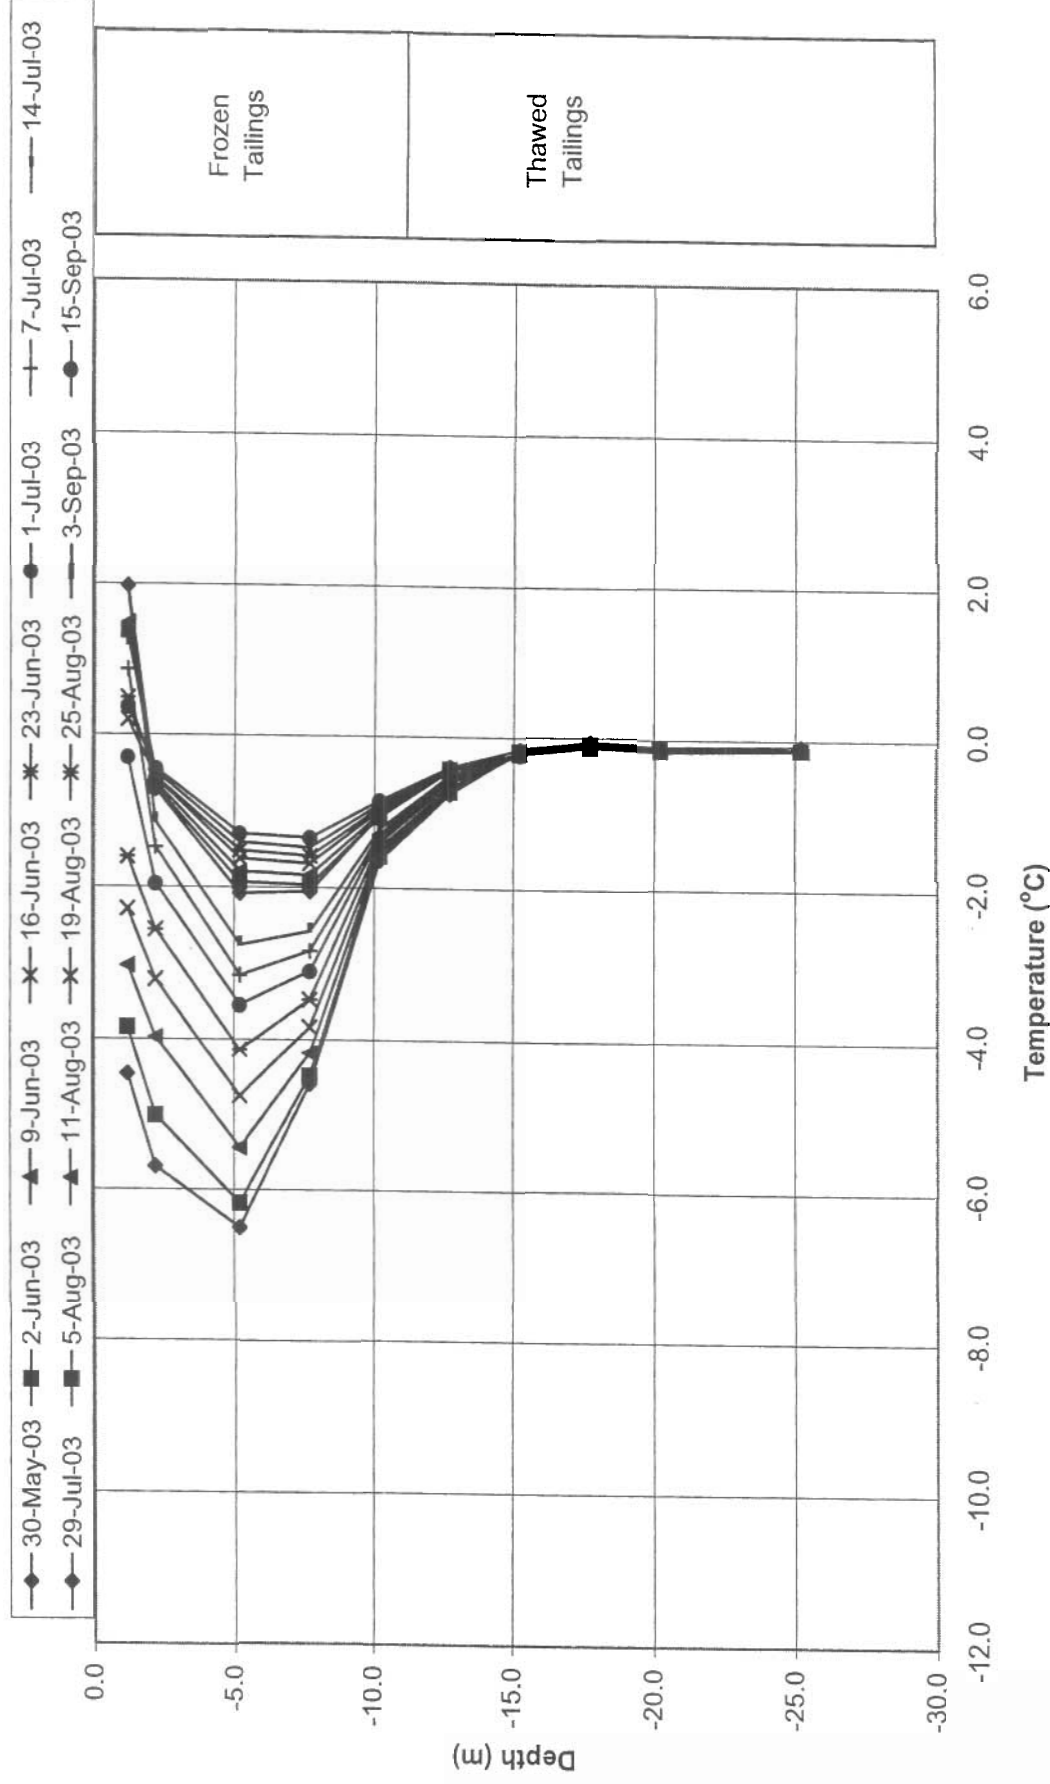
### Thermistor BGC03-09

| Instrument | Instrument type | Location | Station | Surface Elevation | Location of thawed ground (>-1°C) below active layer | Additional comments |
|---|---|---|---|---|---|---|
| BGC03-09 | TM | SC | | 387 m | 13 to 25 m | Thawed conditions below 13 m to the end of the hole. 15 readings in 2004 |

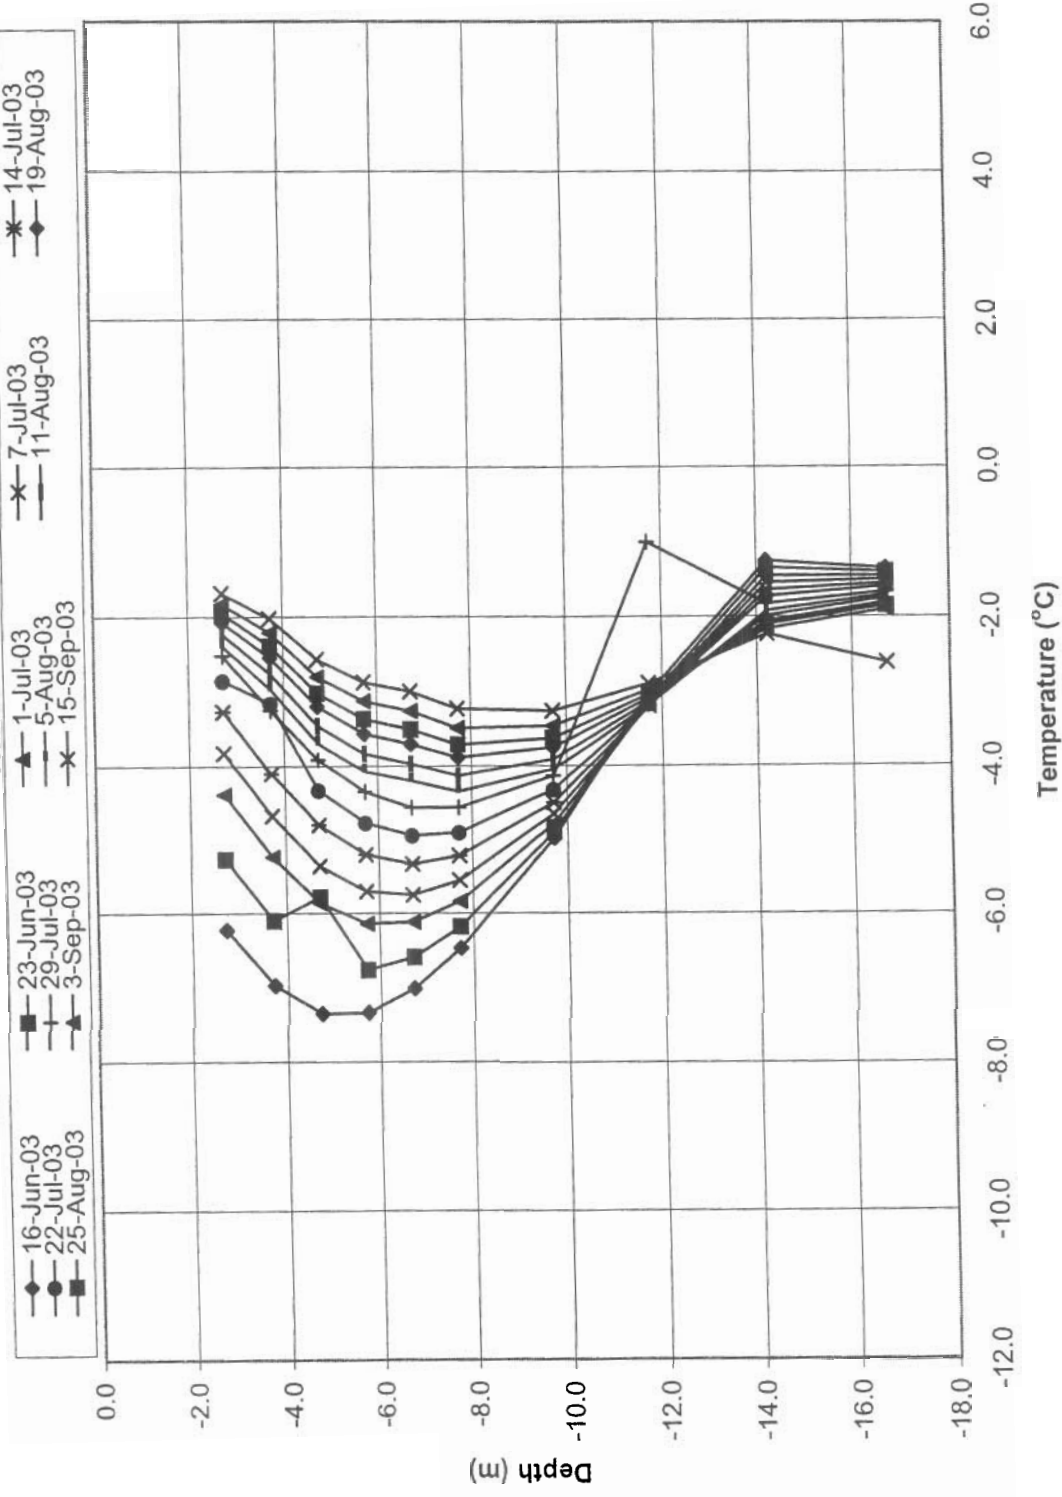
#### Thermistor BGC03-15

| BGC03-15 | TM | SC | | 387 m | 14 to 17 m | Thawed conditions between 13 and 17 m depth (temperature on the boundary of thawed/frozen). 13 readings in 2003. |

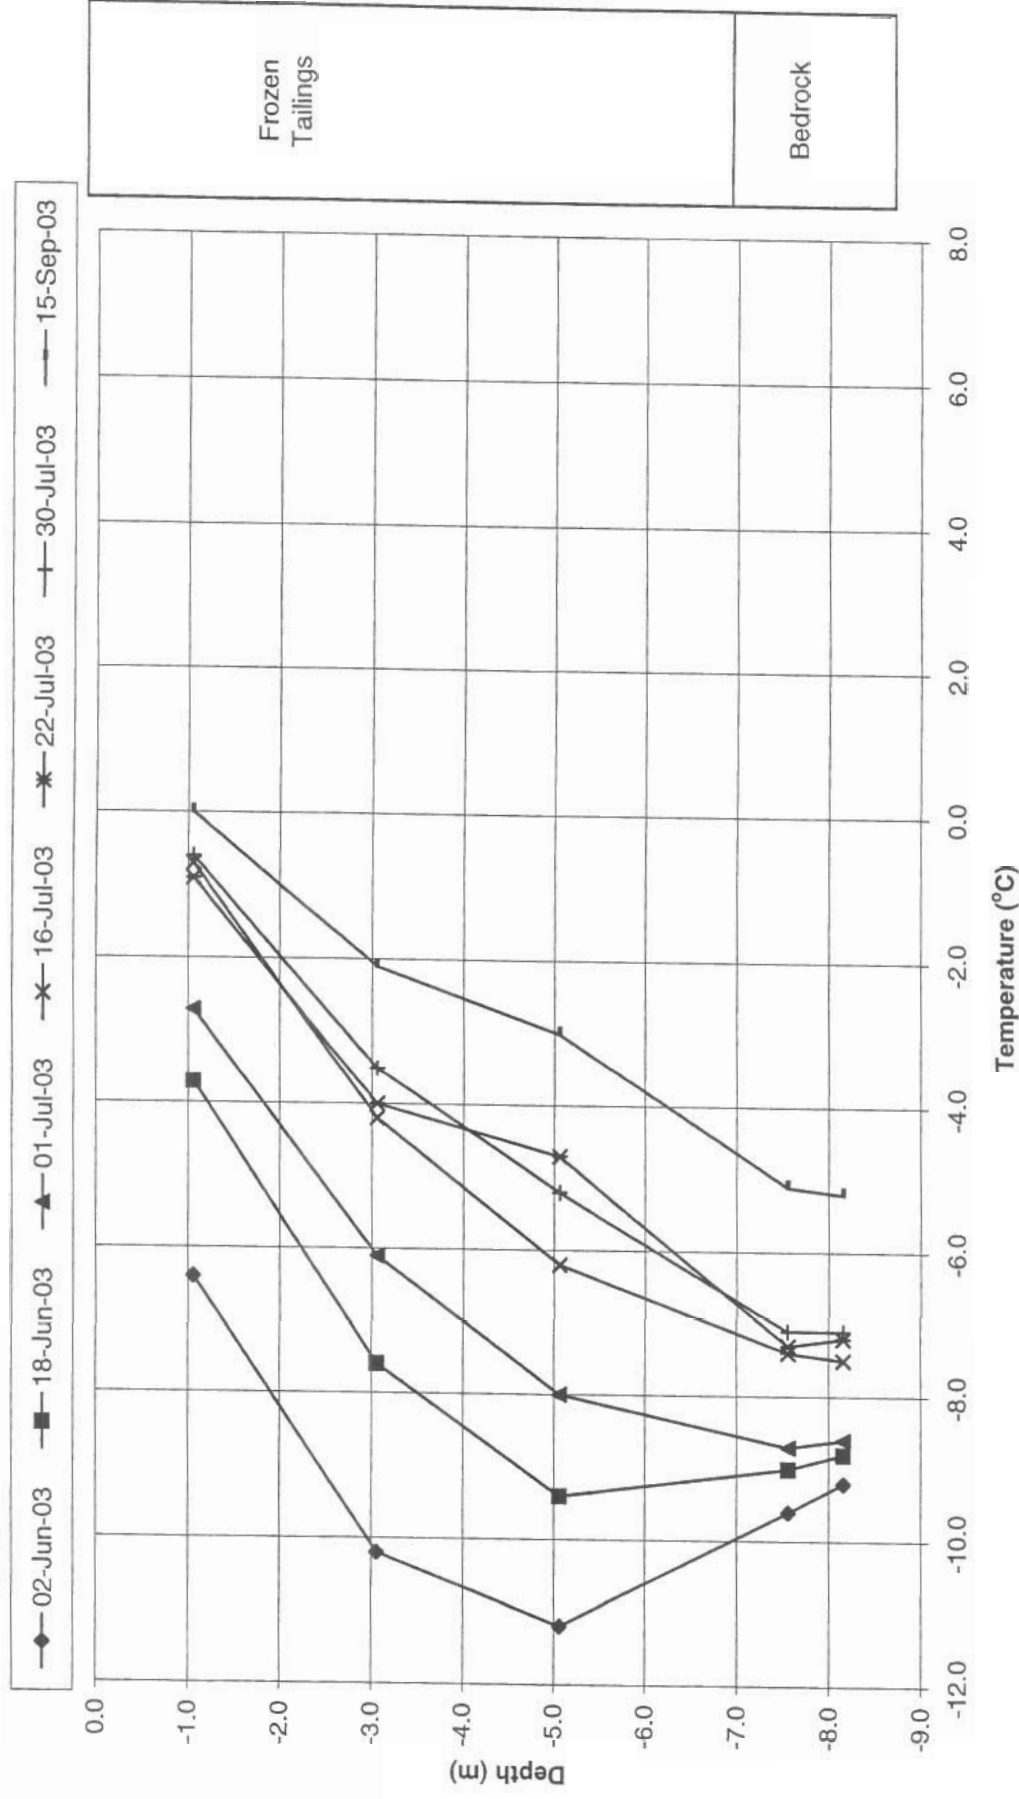
**Geothermal Monitoring  
Toe of WTL Dike  
Thermocouple BGC03-18**

| BGC03-18 | T/C | Dike Toe | | 374 m | N/A | No warming trends. 7 readings in 2003. |

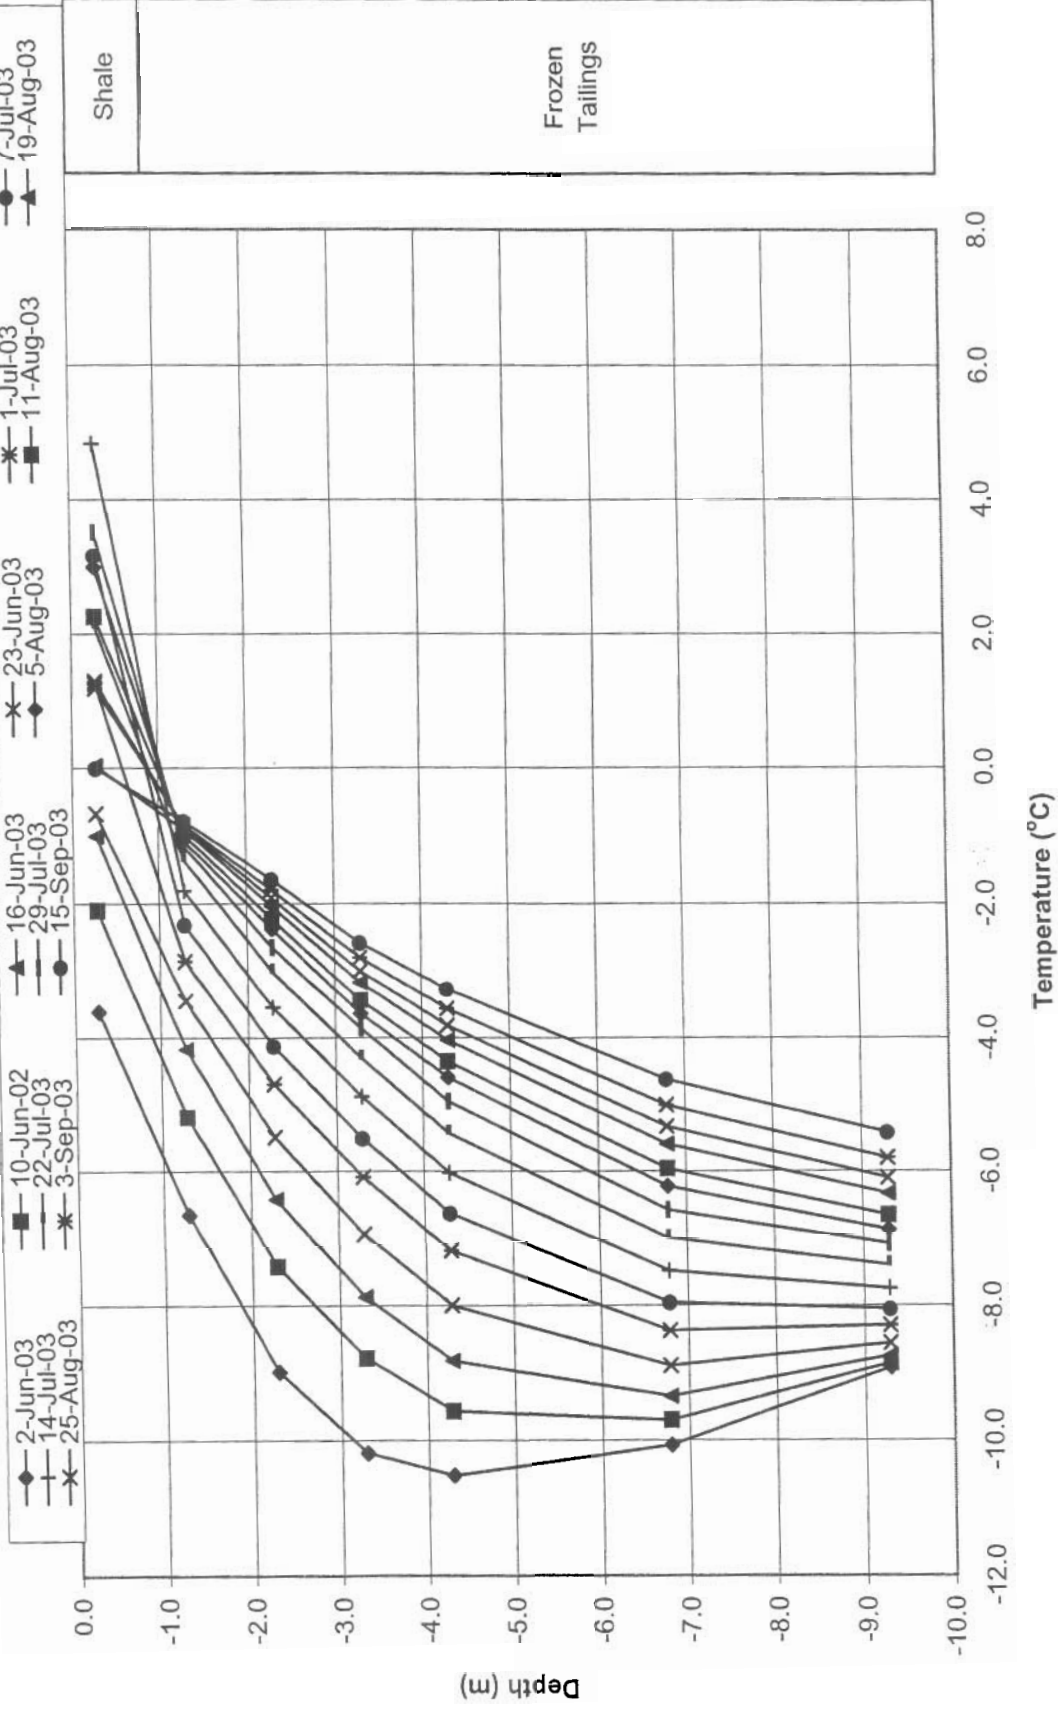
### Thermistor BGC03-19

| BGC03-19 | TM | Dike Toe | | 374 m | N/A | No warming trends. 15 readings in 2003. |

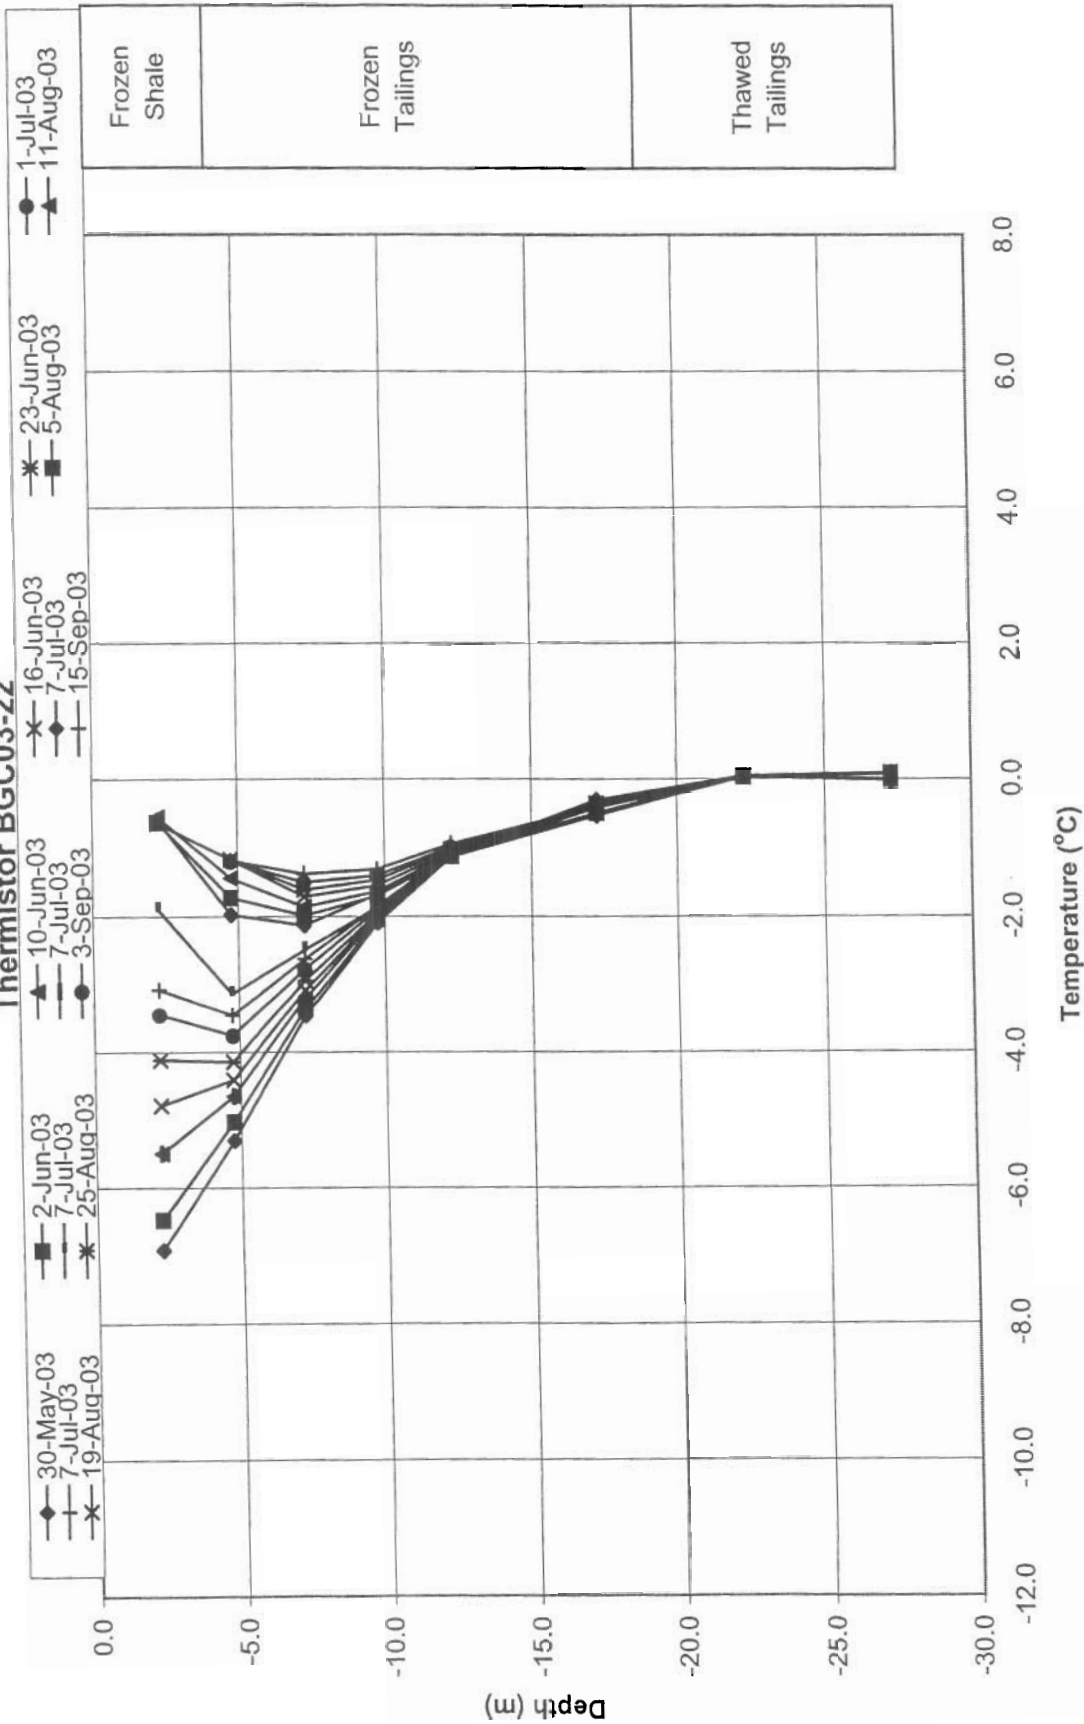
## Thermistor BGC03-22

| BGC03-22 | TM | Test Cell | | 378 m | 13 to 27 m | Thawed conditions below 13 m to the end of the hole. 16 readings in 2003. |

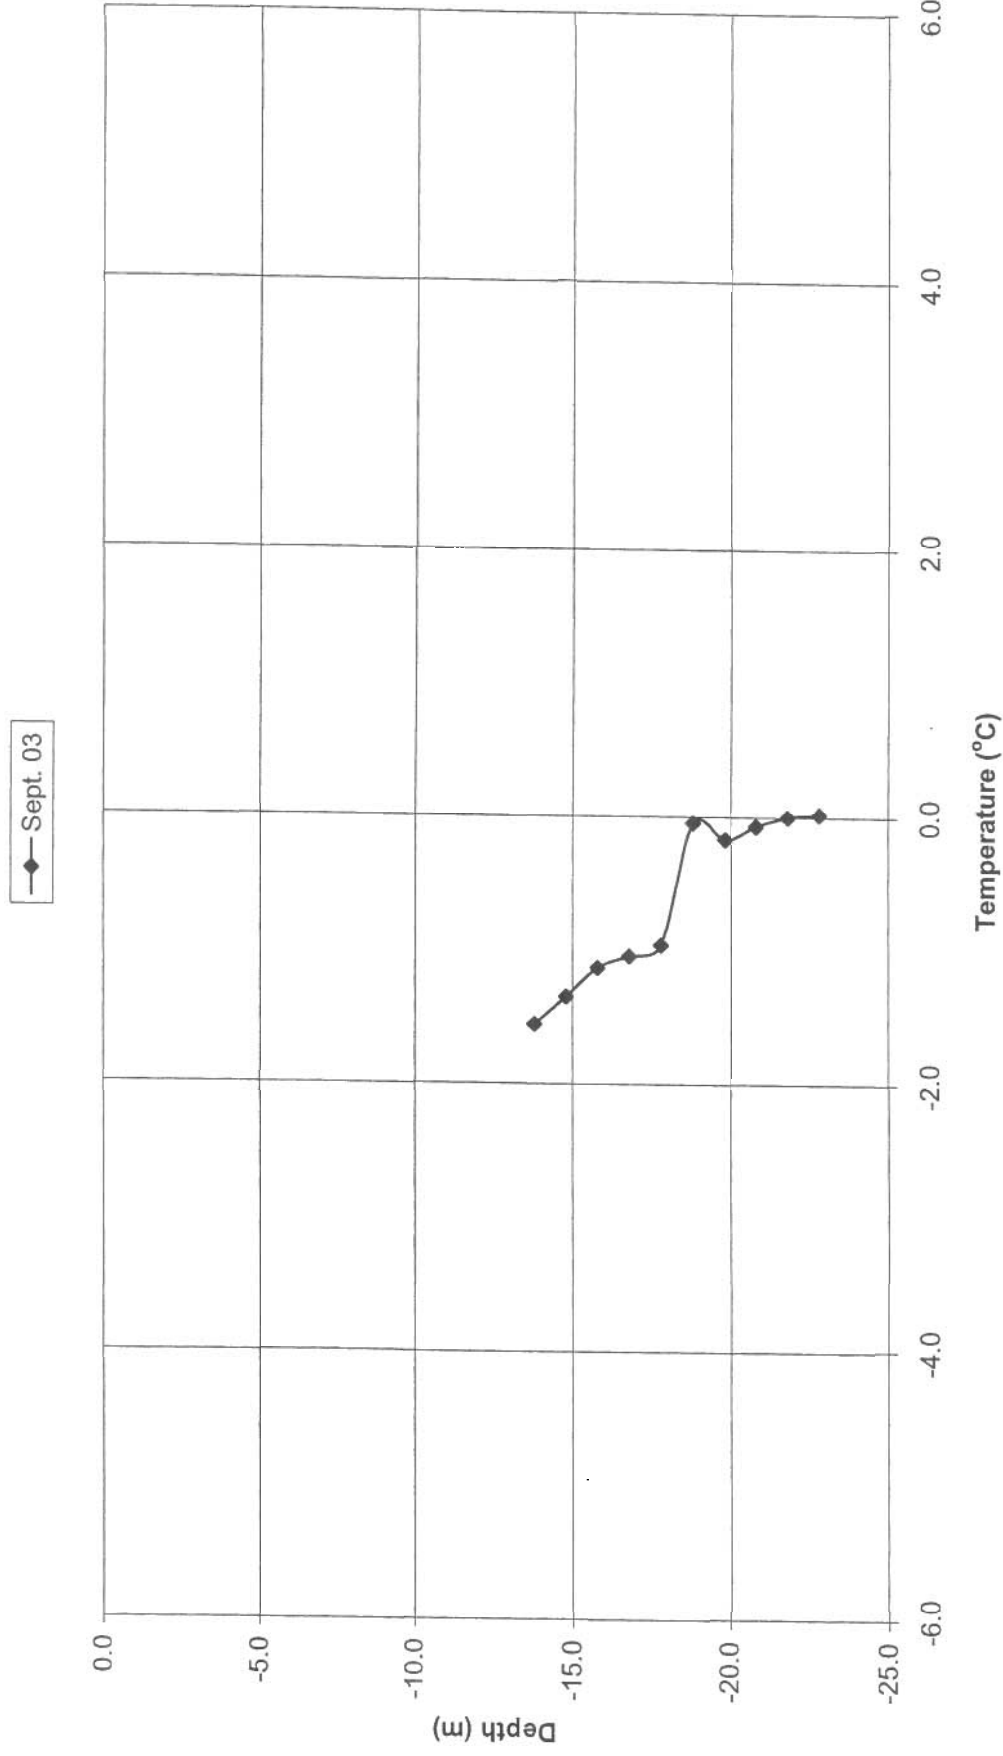
**Geothermal Monitoring  
Surface Cell  
Thermistor BGC03-33**

| BGC03-33 | TM | Dike Crest | | 388 m | 18 to 23 m | Thawed conditions below 18 m to the end of the hole. 1 reading in 2003. |
