### **INSPECTION MEMO OF SEPTEMBER 11, 2003**

## **PROJECT MEMORANDUM**

| <b>Subject:</b> | <b>Inspection Visit relative to Waste Containment Dikes and Berms<br/>Summary of Site Observations and Commentary</b> | | |

Nanisivik Mine - Annual Geotechnical Inspection of Dikes  
Nanisivik Mine, a division of Canzinc

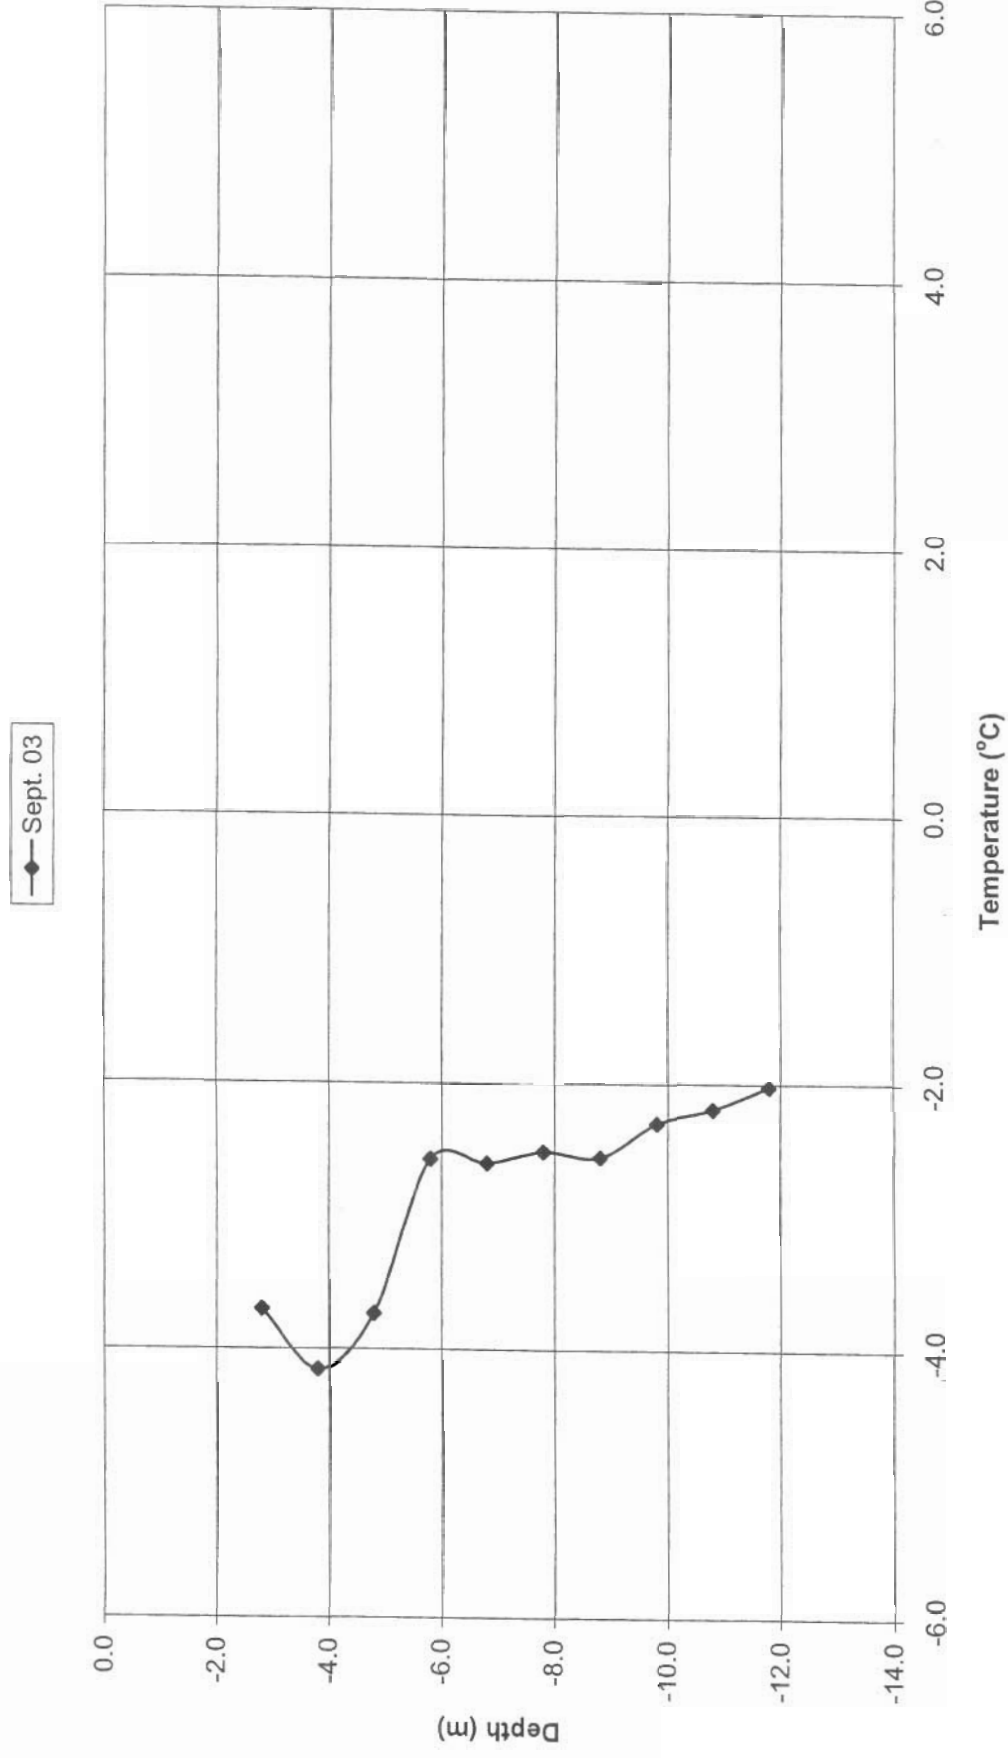
**Geothermal Monitoring  
Surface Cell  
Thermistor BGC03-34**

| BGC03-34 | TM | Dike Crest | | 388 m | N/A | BGC03-33 and BGC03-33 are adjacent to one another, measuring upper and lower zones, treat as one installation. |

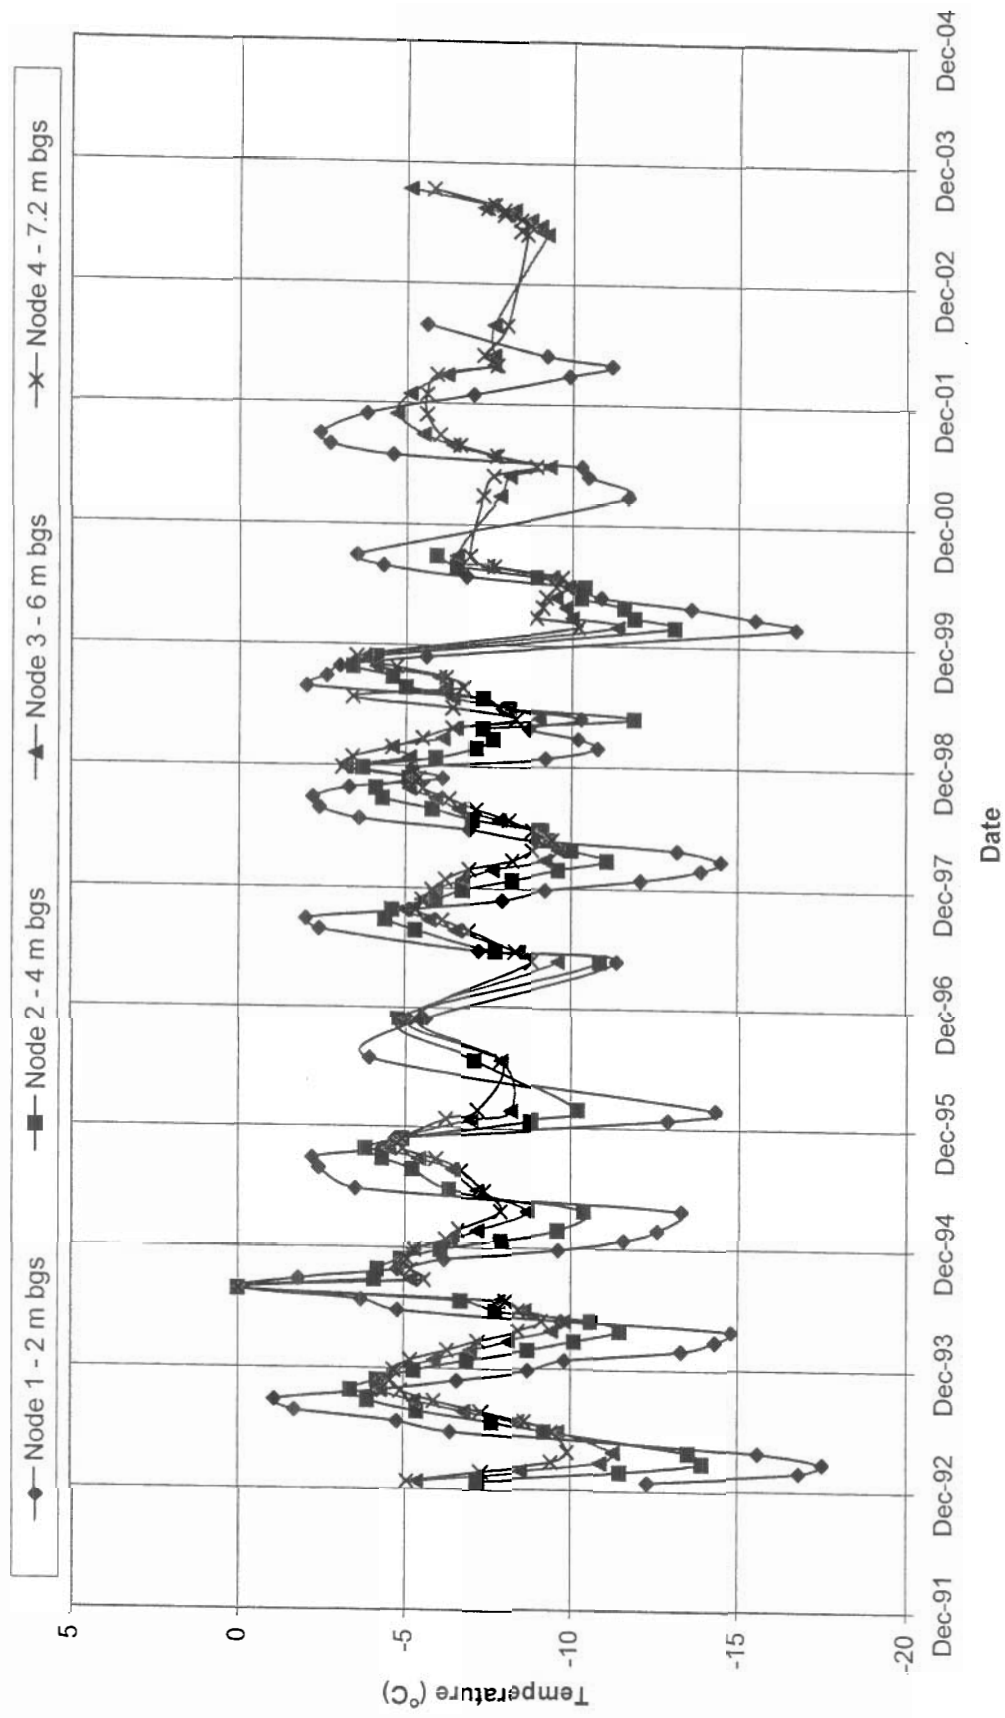
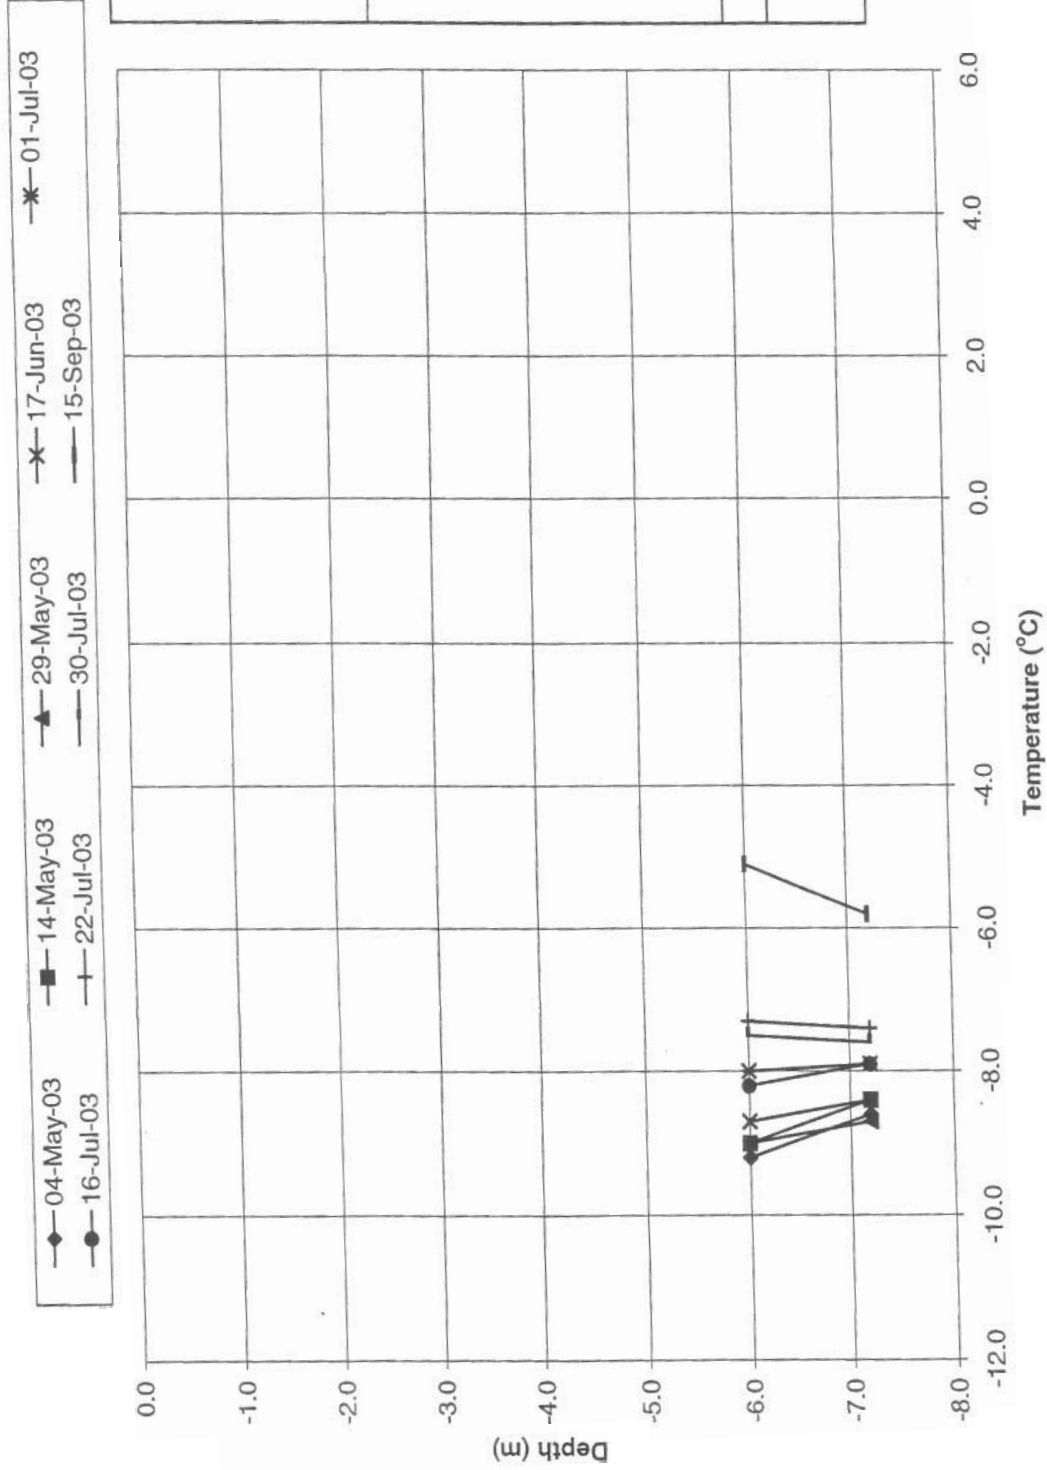
**Geothermal Monitoring  
West Twin Dike  
Thermocouple TC 1**

| Instrument | Instrument type | Location | Station | Surface Elevation | Location of thawed ground (>-1°C) below active layer | Additional comments |
|---|---|---|---|---|---|---|
| 1 | T/C | Dike face | 00+75 | 376 m | N/A | No warming trend. 9 readings in 2003. |

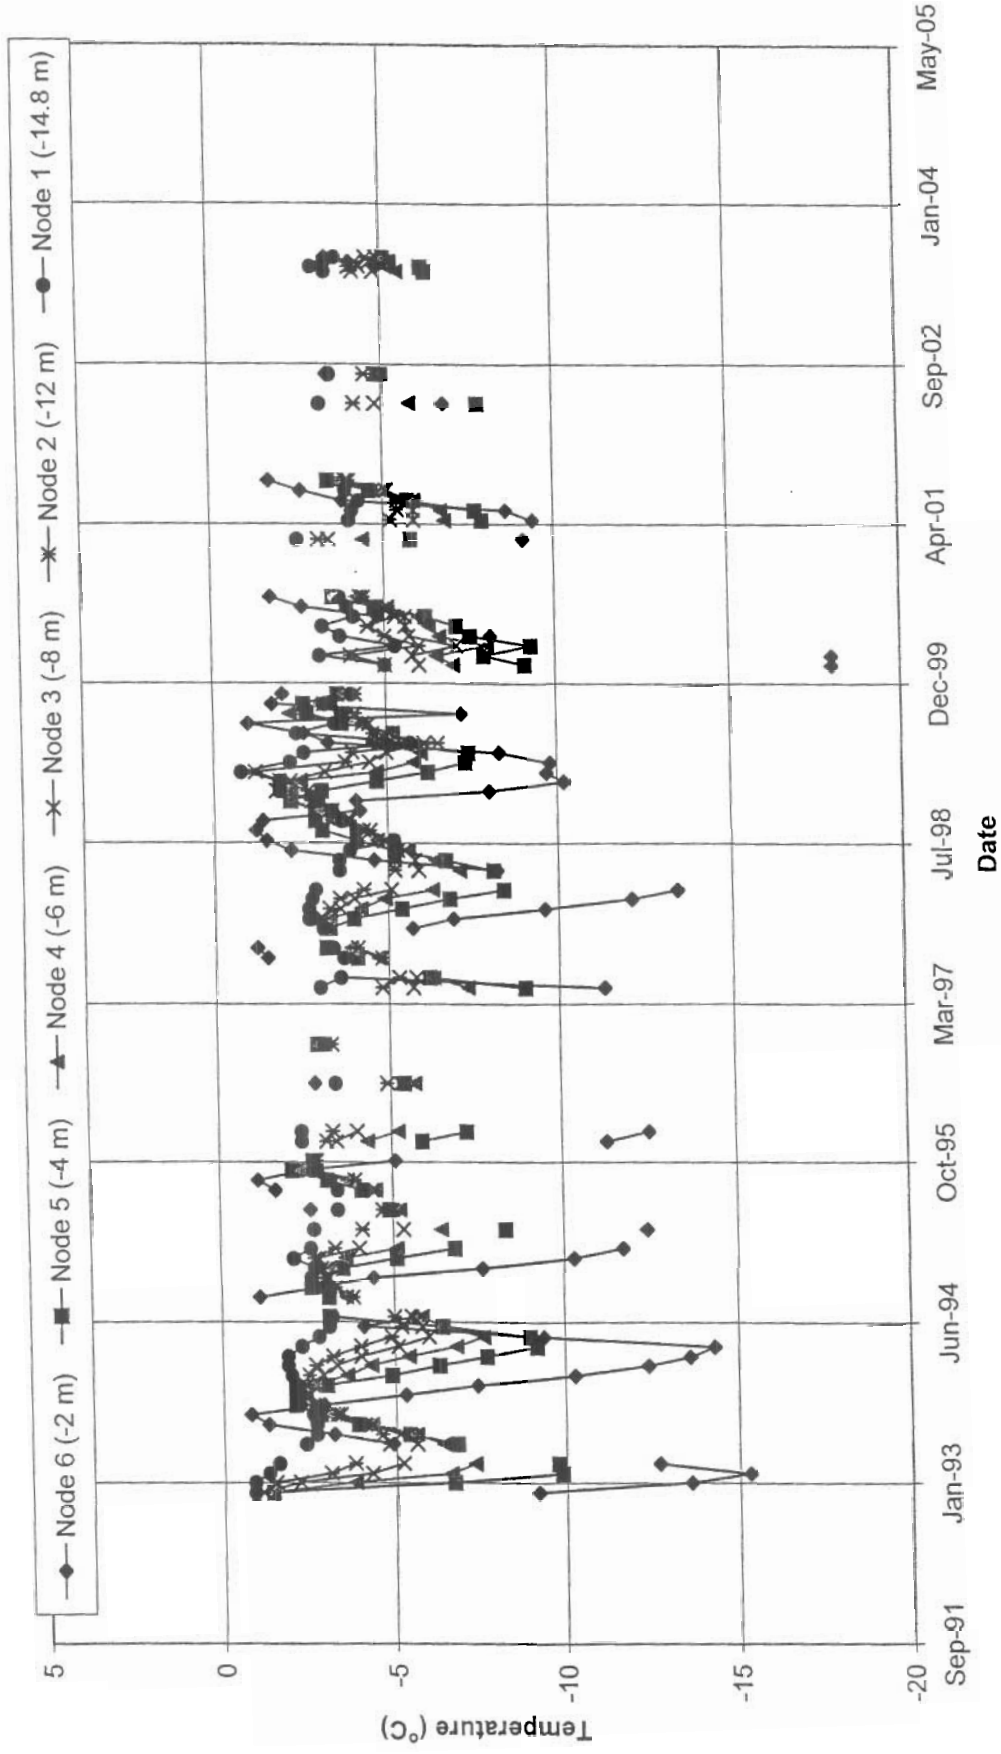
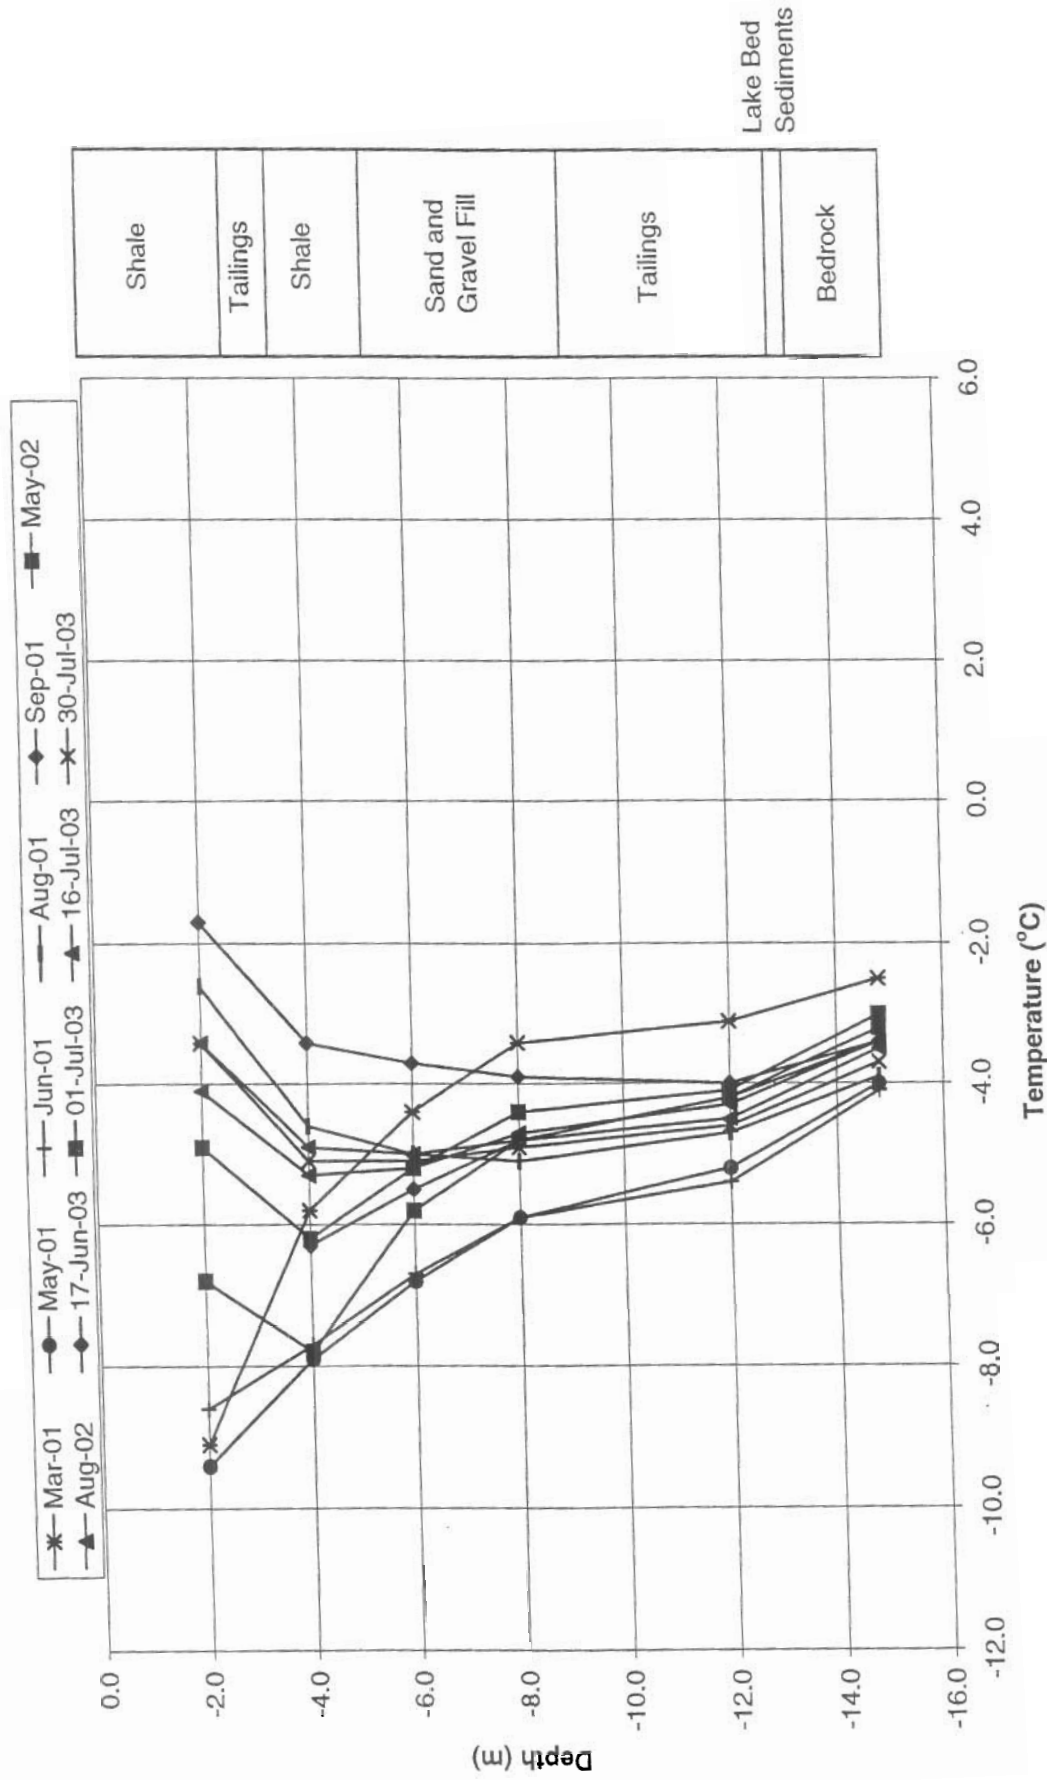
# Geothermal Monitoring West Twin Dike Thermocouple TC 2

| Instrument | Instrument type | Location | Station | Surface Elevation | Location of thawed ground (>-1°C) below active layer | Additional comments |
|---|---|---|---|---|---|---|
| 2 | T/C | Dike face | 3+25 | 376 m | N/A | Warming below 14 m, but not warm enough to indicate thawed conditions. 4 readings in 2003. |

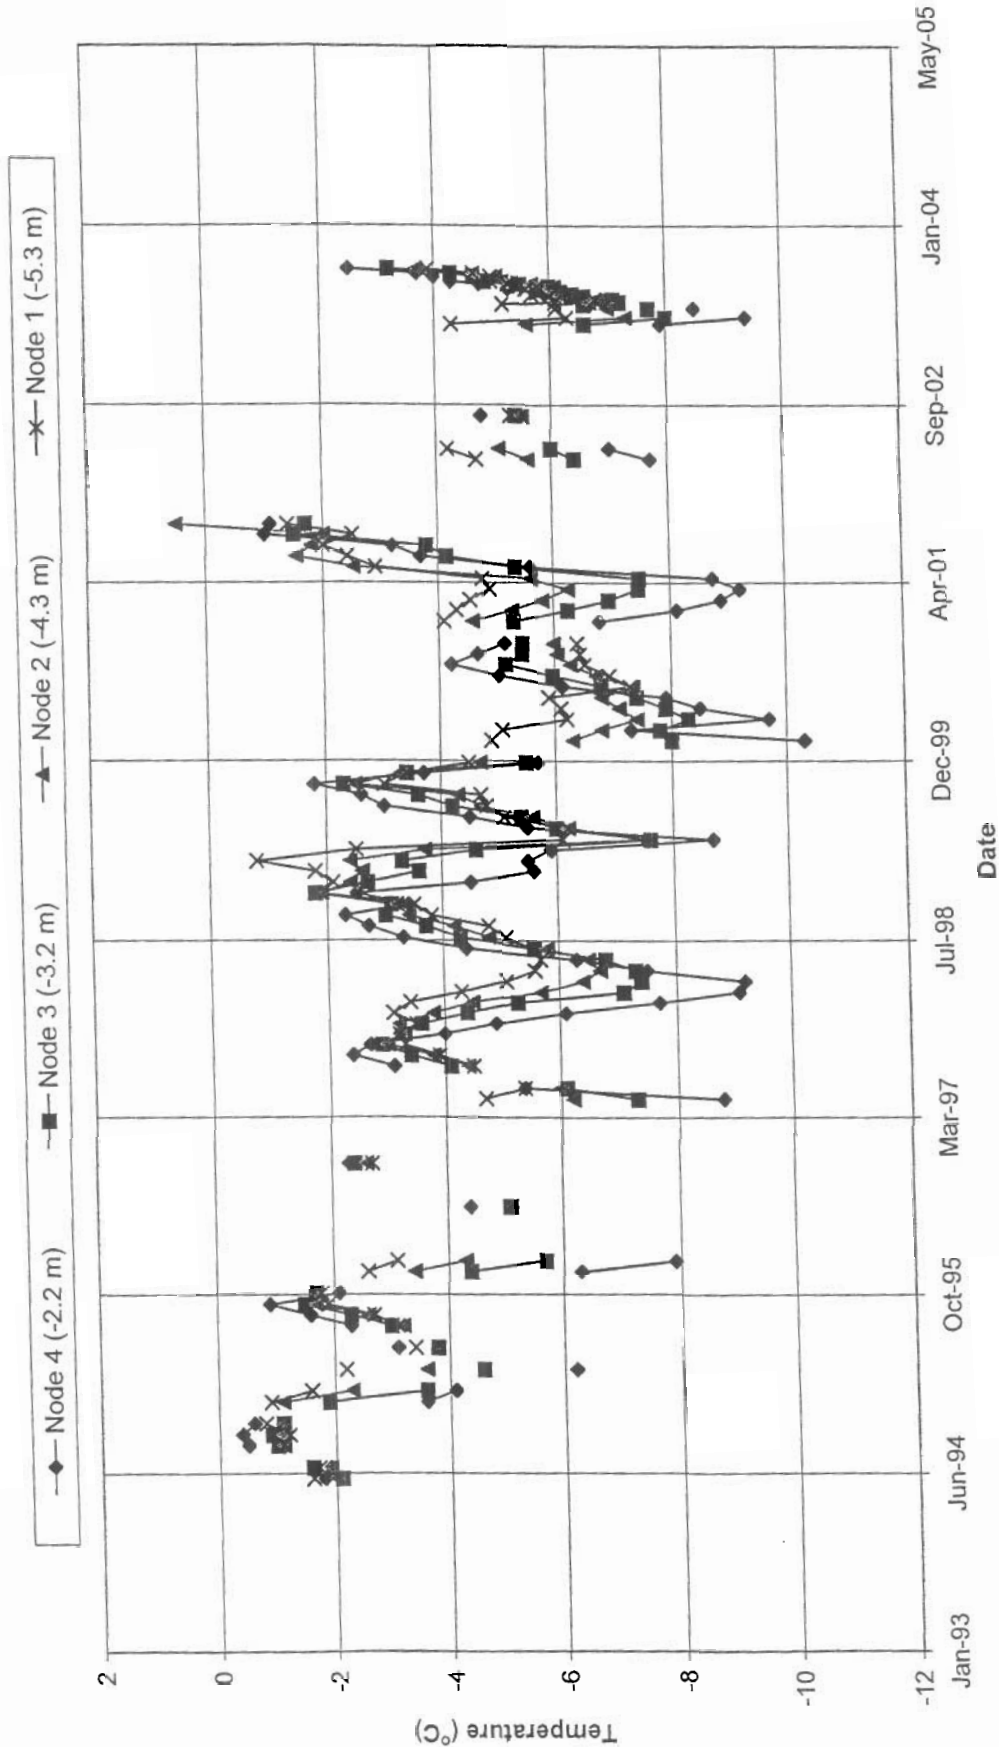
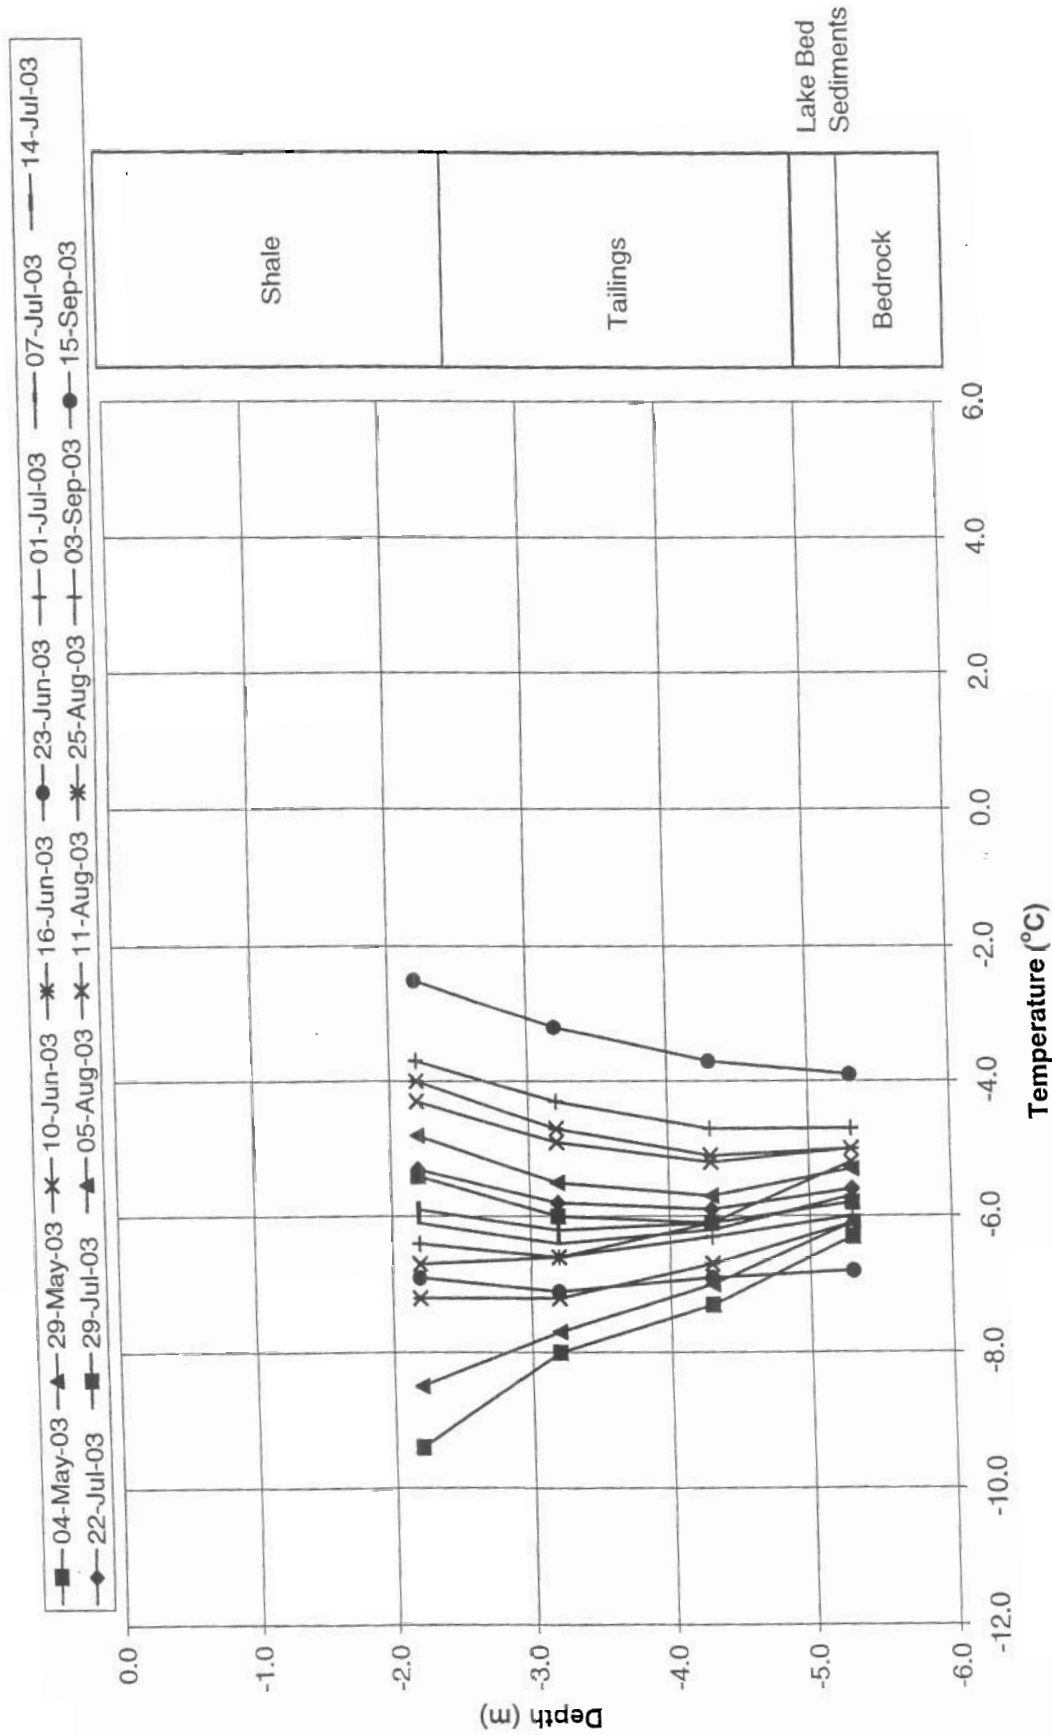
# Geothermal Monitoring West twin Dike Thermocouple TC 12

| Instrument | Instrument type | Location | Station | Surface Elevation | Location of thawed ground (>-1°C) below active layer | Additional comments |
|---|---|---|---|---|---|---|
| 12 | T/C | Dike face | 1+30 | 376 m | N/A | No warming trends. 15 readings in 2003. |

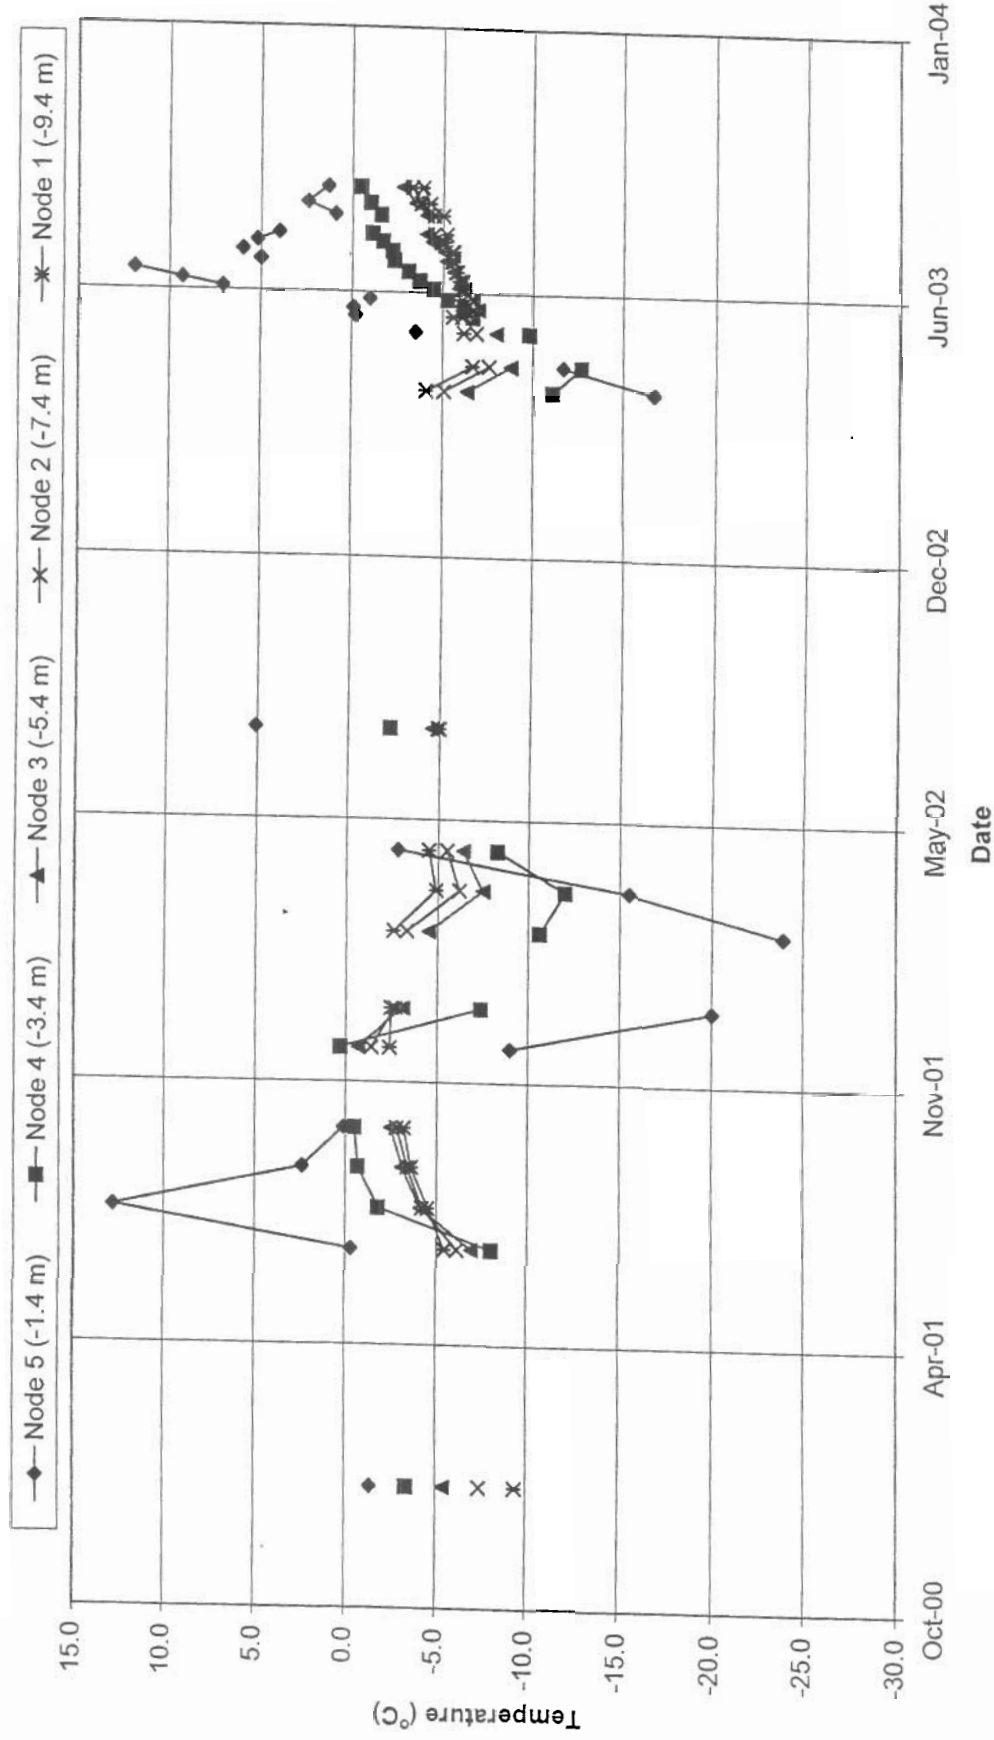
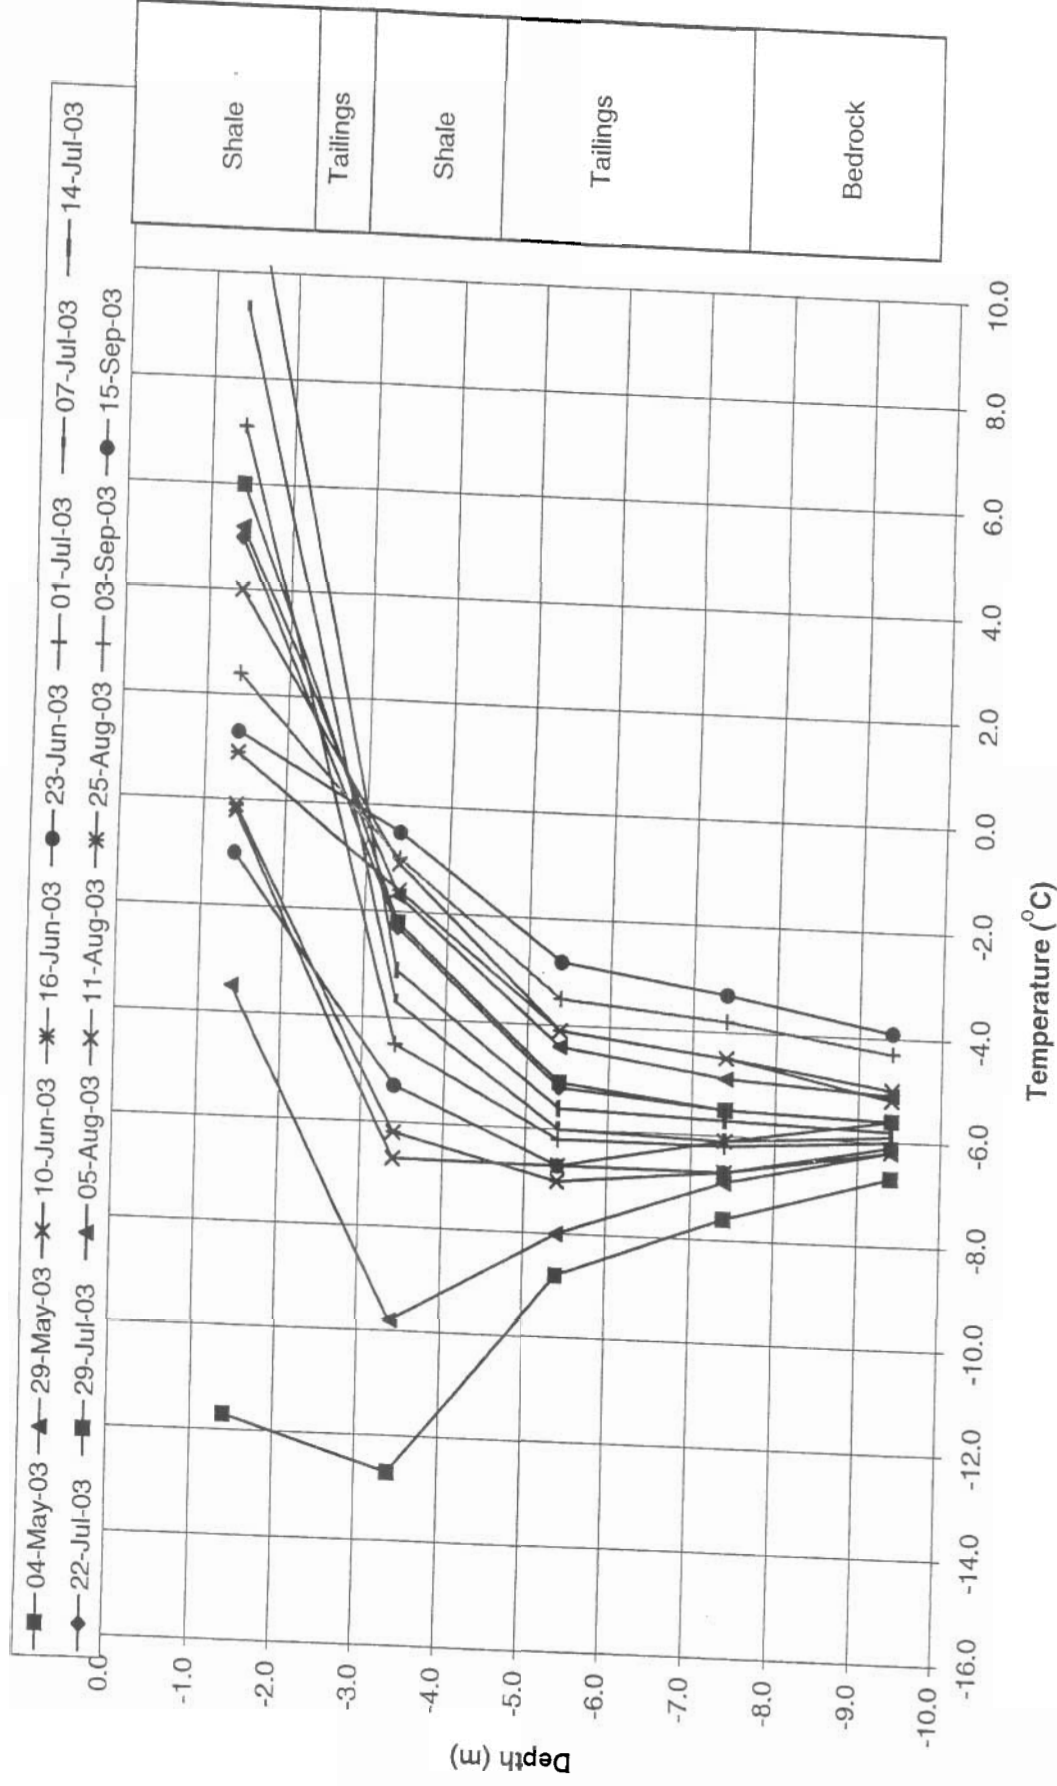
# Geothermal Monitoring West Twin Dike Thermocouple TC 13A

| Instrument | Instrument type | Location | Station | Surface Elevation | Location of thawed ground (>-1°C) below active layer | Additional comments |
|---|---|---|---|---|---|---|
| 13A | T/C | Dike face | 1+15 | 376 m | N/A | No warming trends. 15 readings in 2003. |

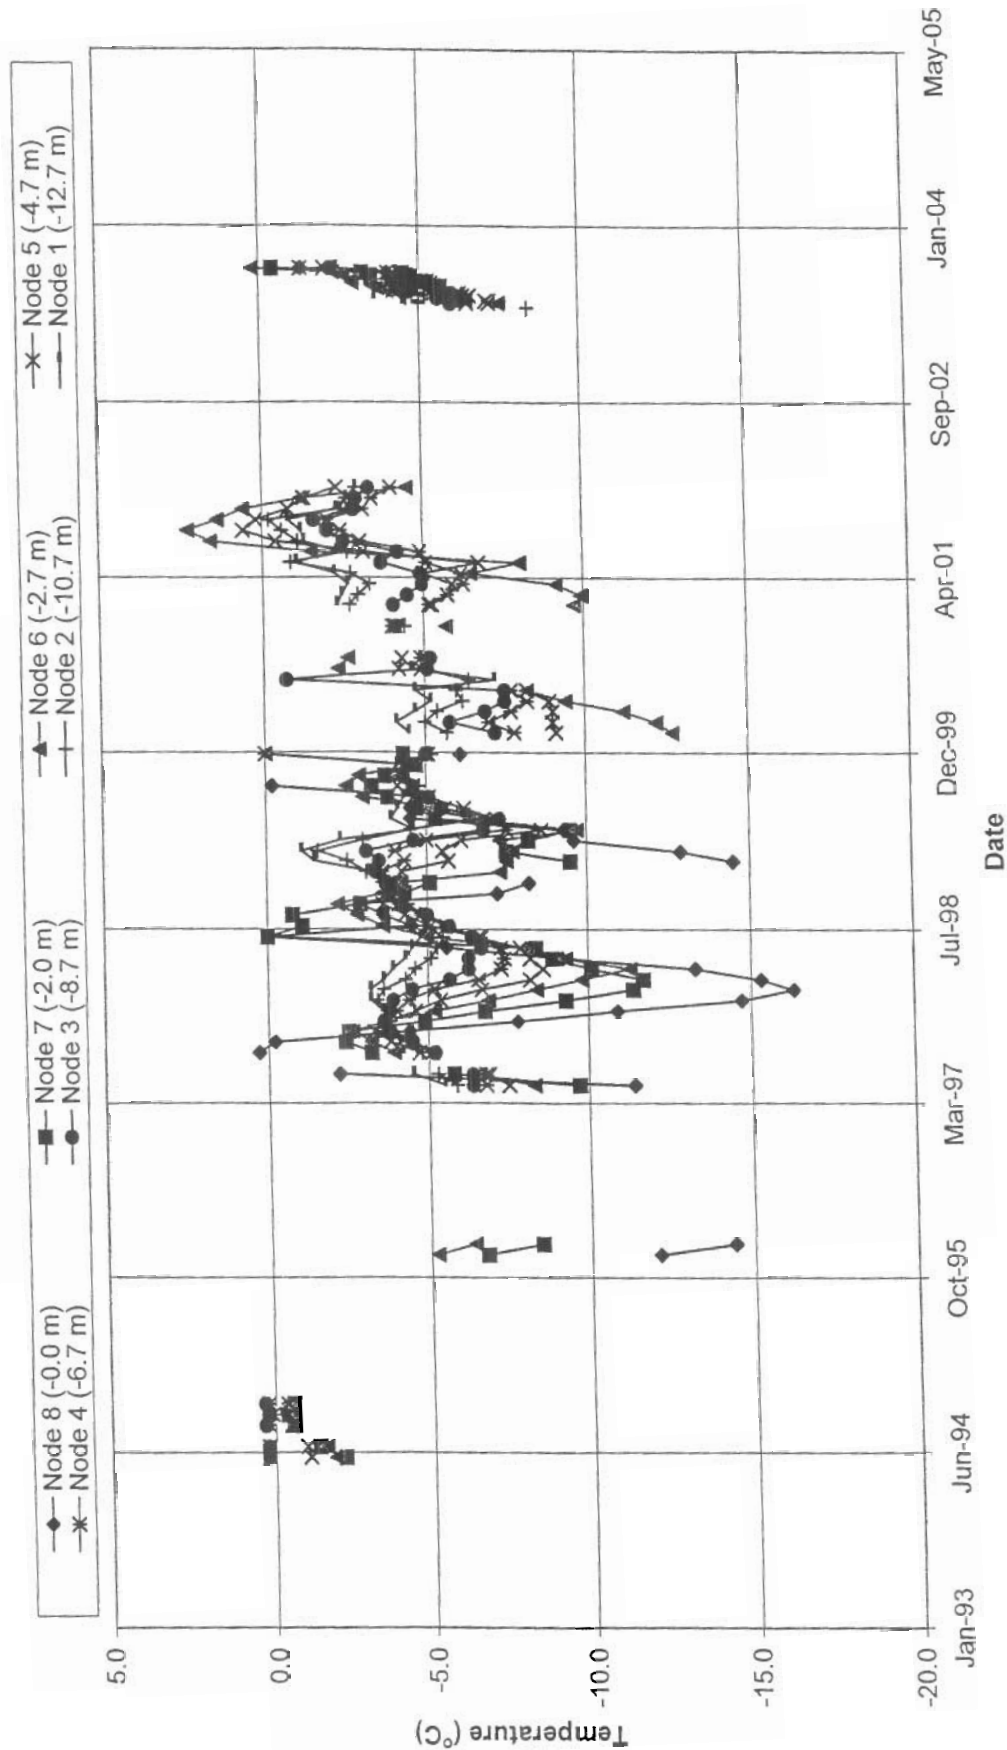
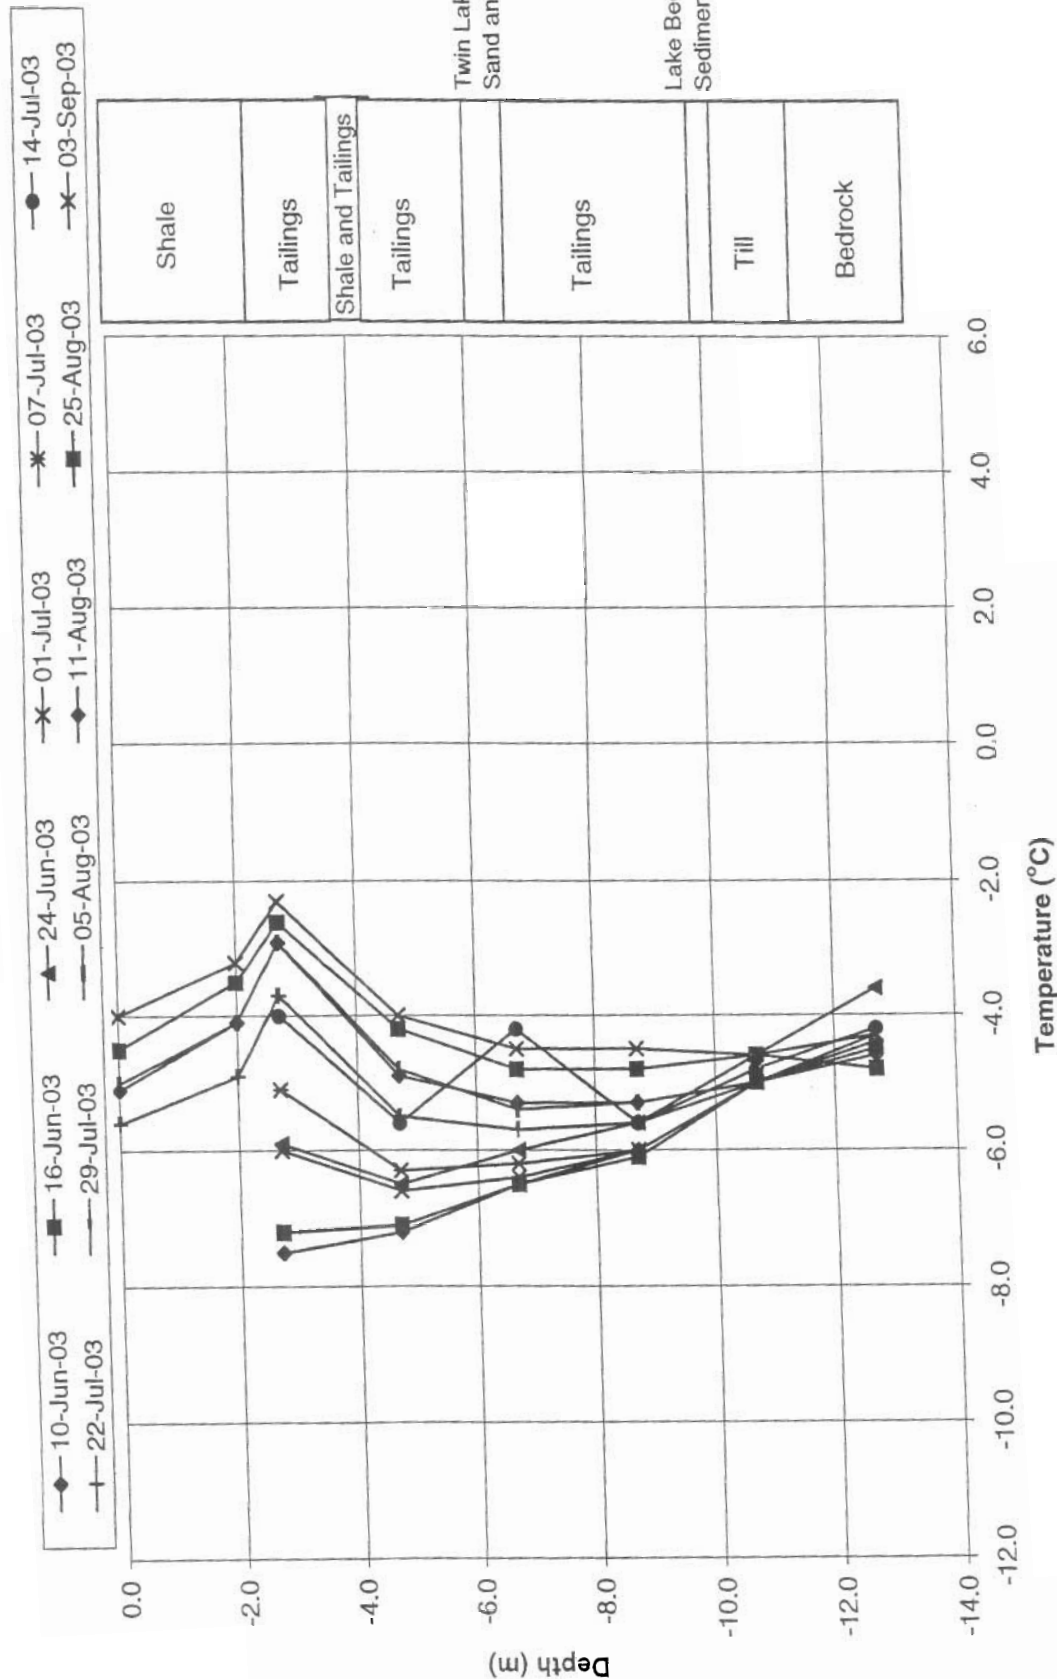
# Geothermal Monitoring West Twin Dike Thermocouple TC 14

| Instrument | Instrument type | Location | Station | Surface Elevation | Location of thawed ground (>-1°C) below active layer | Additional comments |
|---|---|---|---|---|---|---|
| 14 | T/C | Dike face | 2+25 | 376 m | N/A | No warming trends. 12 readings in 2003. |
