### **INSPECTION MEMO OF SEPTEMBER 11, 2003**

## **PROJECT MEMORANDUM**

| <b>Subject:</b> | <b>Inspection Visit relative to Waste Containment Dikes and Berms<br/>Summary of Site Observations and Commentary</b> | | |

Nanisivik Mine - Annual Geotechnical Inspection of Dikes  
Nanisivik Mine, a division of Canzinc

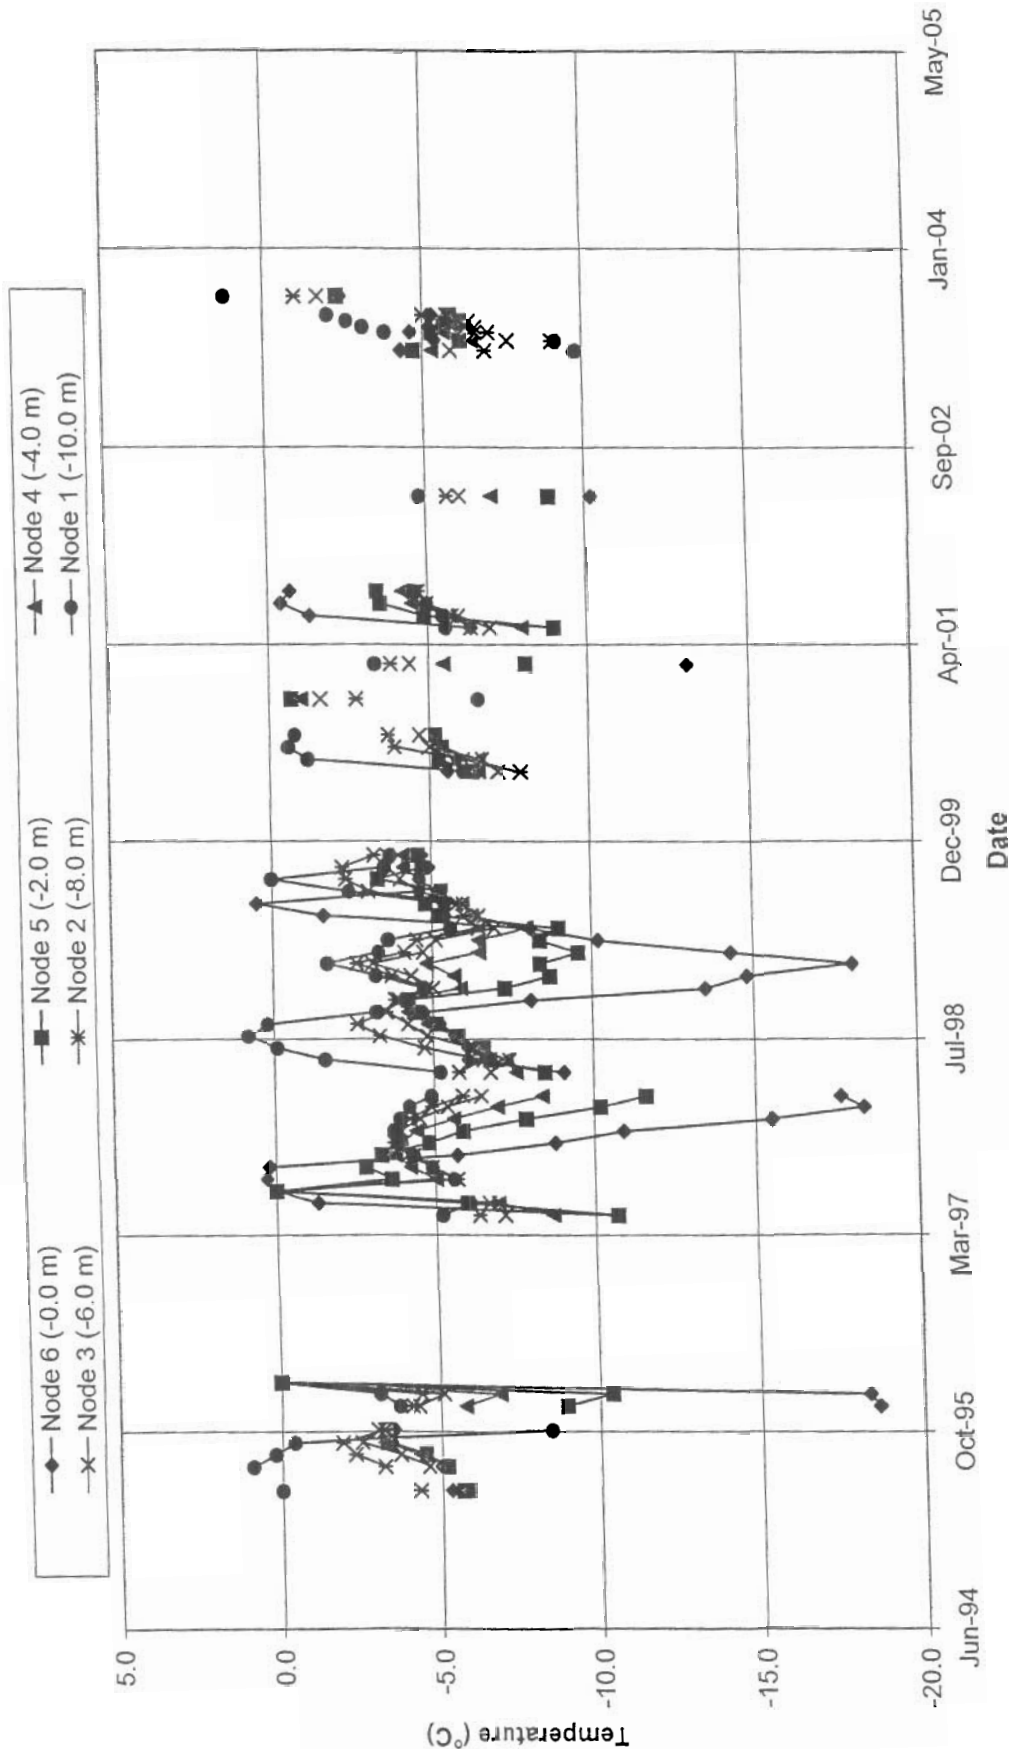
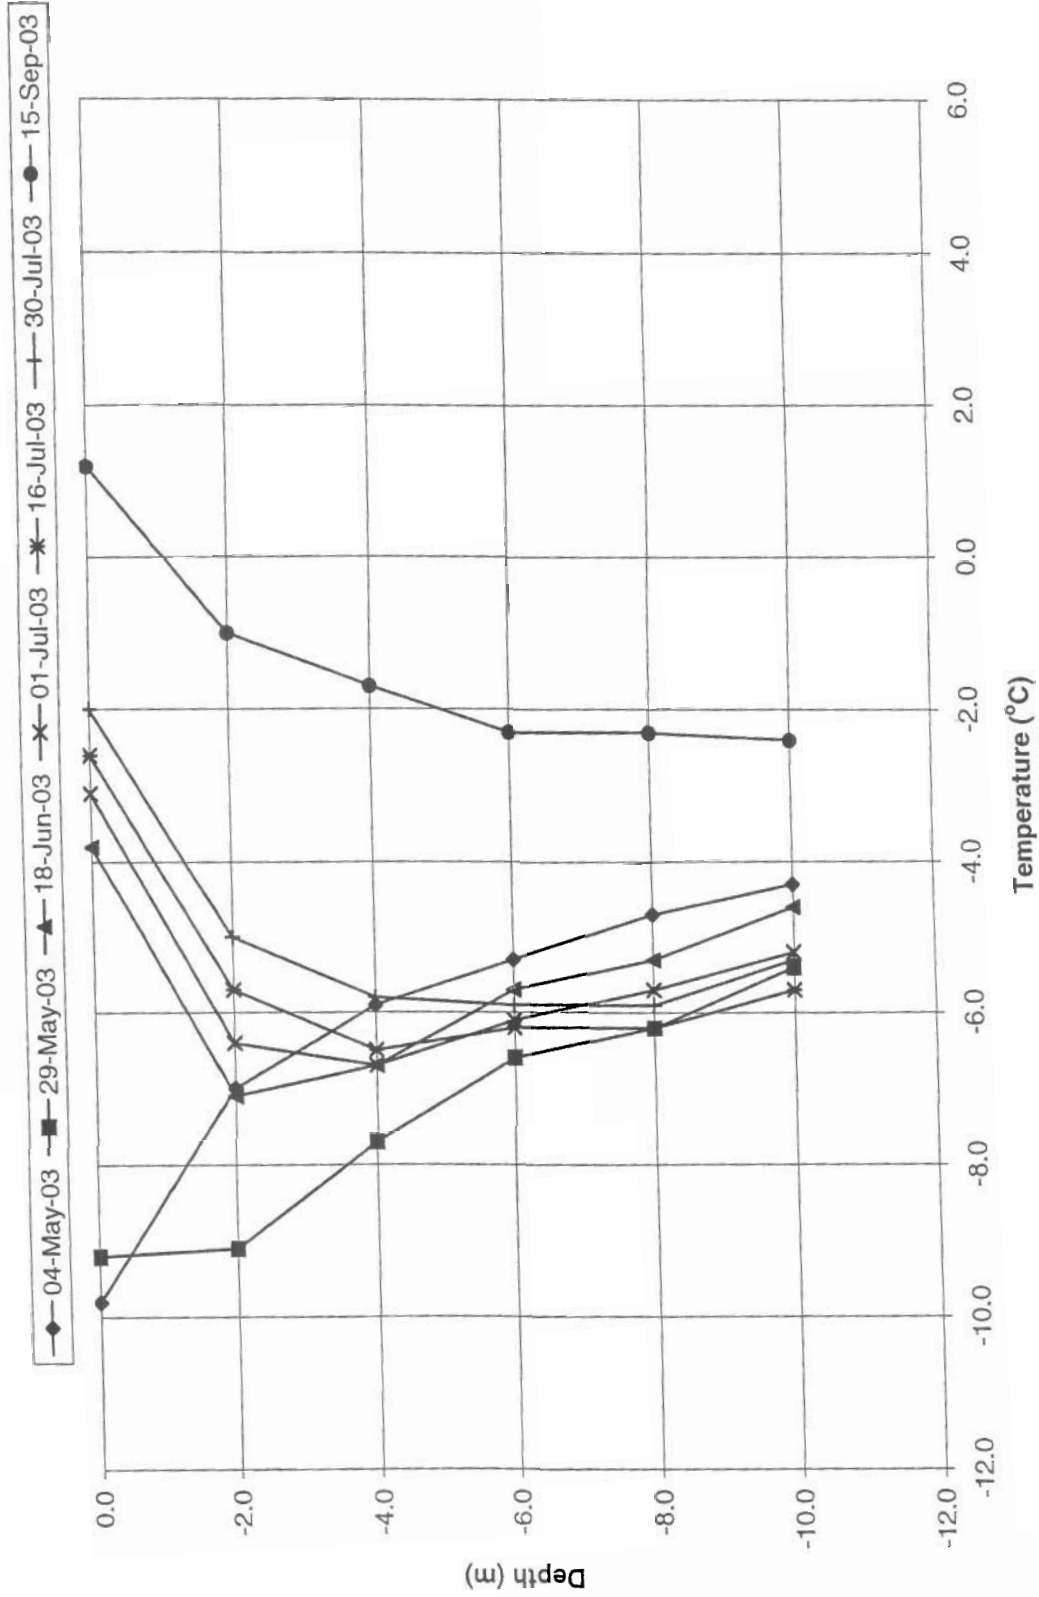
# Geothermal Monitoring West Twin Dike Thermocouple 15

| Instrument | Instrument type | Location | Station | Surface Elevation | Location of thawed ground (>-1°C) below active layer | Additional comments |
|---|---|---|---|---|---|---|
| 15 | T/C | Dike face | 2+88 | 376 m | N/A | No warming trends. 7 readings in 2003. |

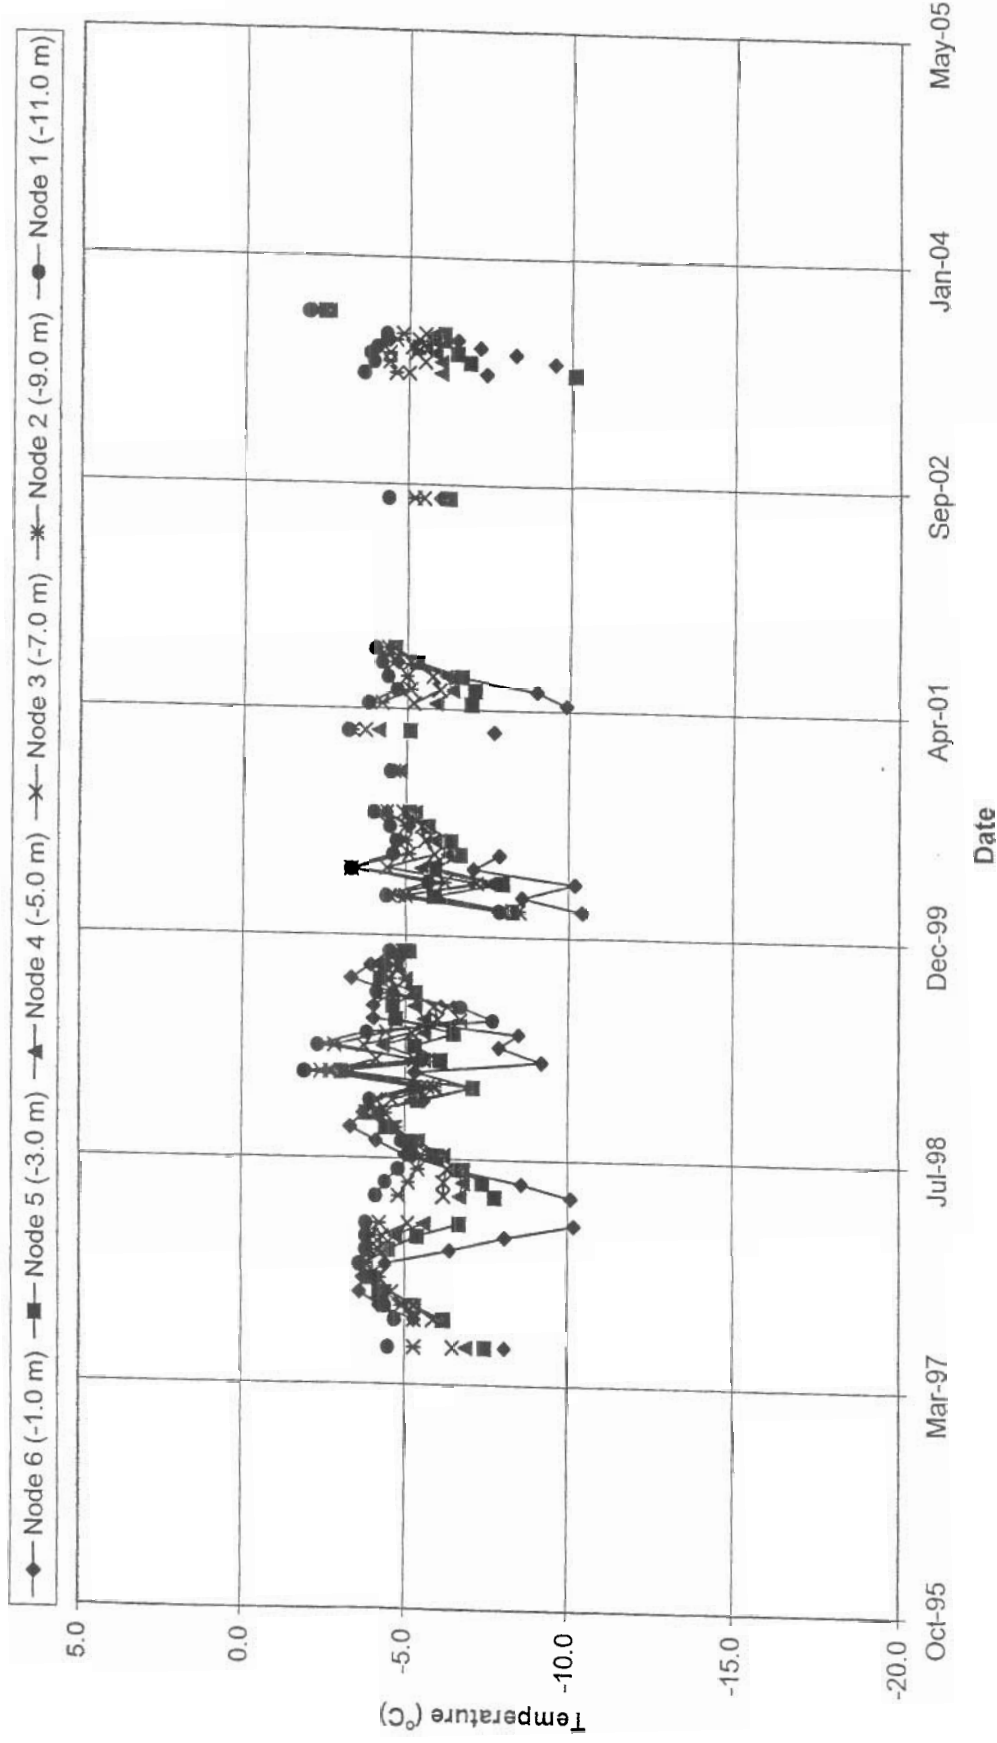
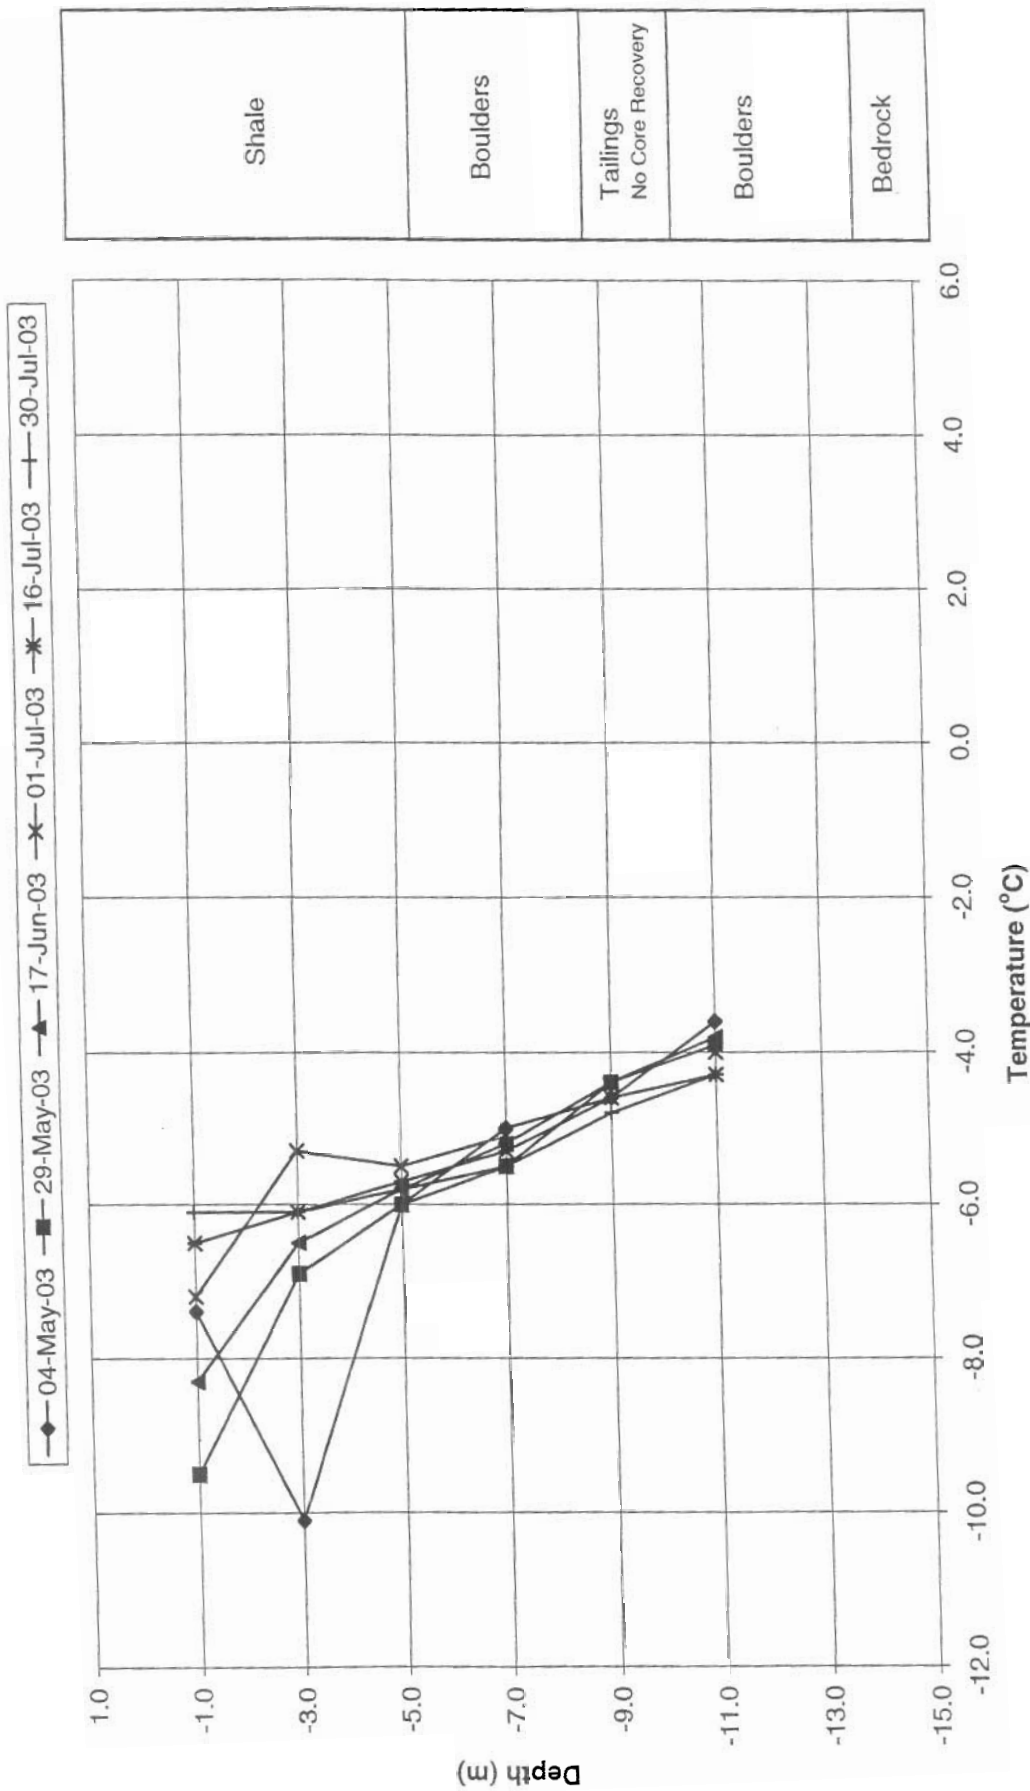
**Geothermal Monitoring  
West Twin Dike  
Thermocouple TC 15A**

| Instrument | Instrument type | Location | Station | Surface Elevation | Location of thawed ground (>-1°C) below active layer | Additional comments |
|---|---|---|---|---|---|---|
| 15A | T/C | Dike face | 3+00 | 377 m | N/A | No warming trends. 6 readings in 2003. |

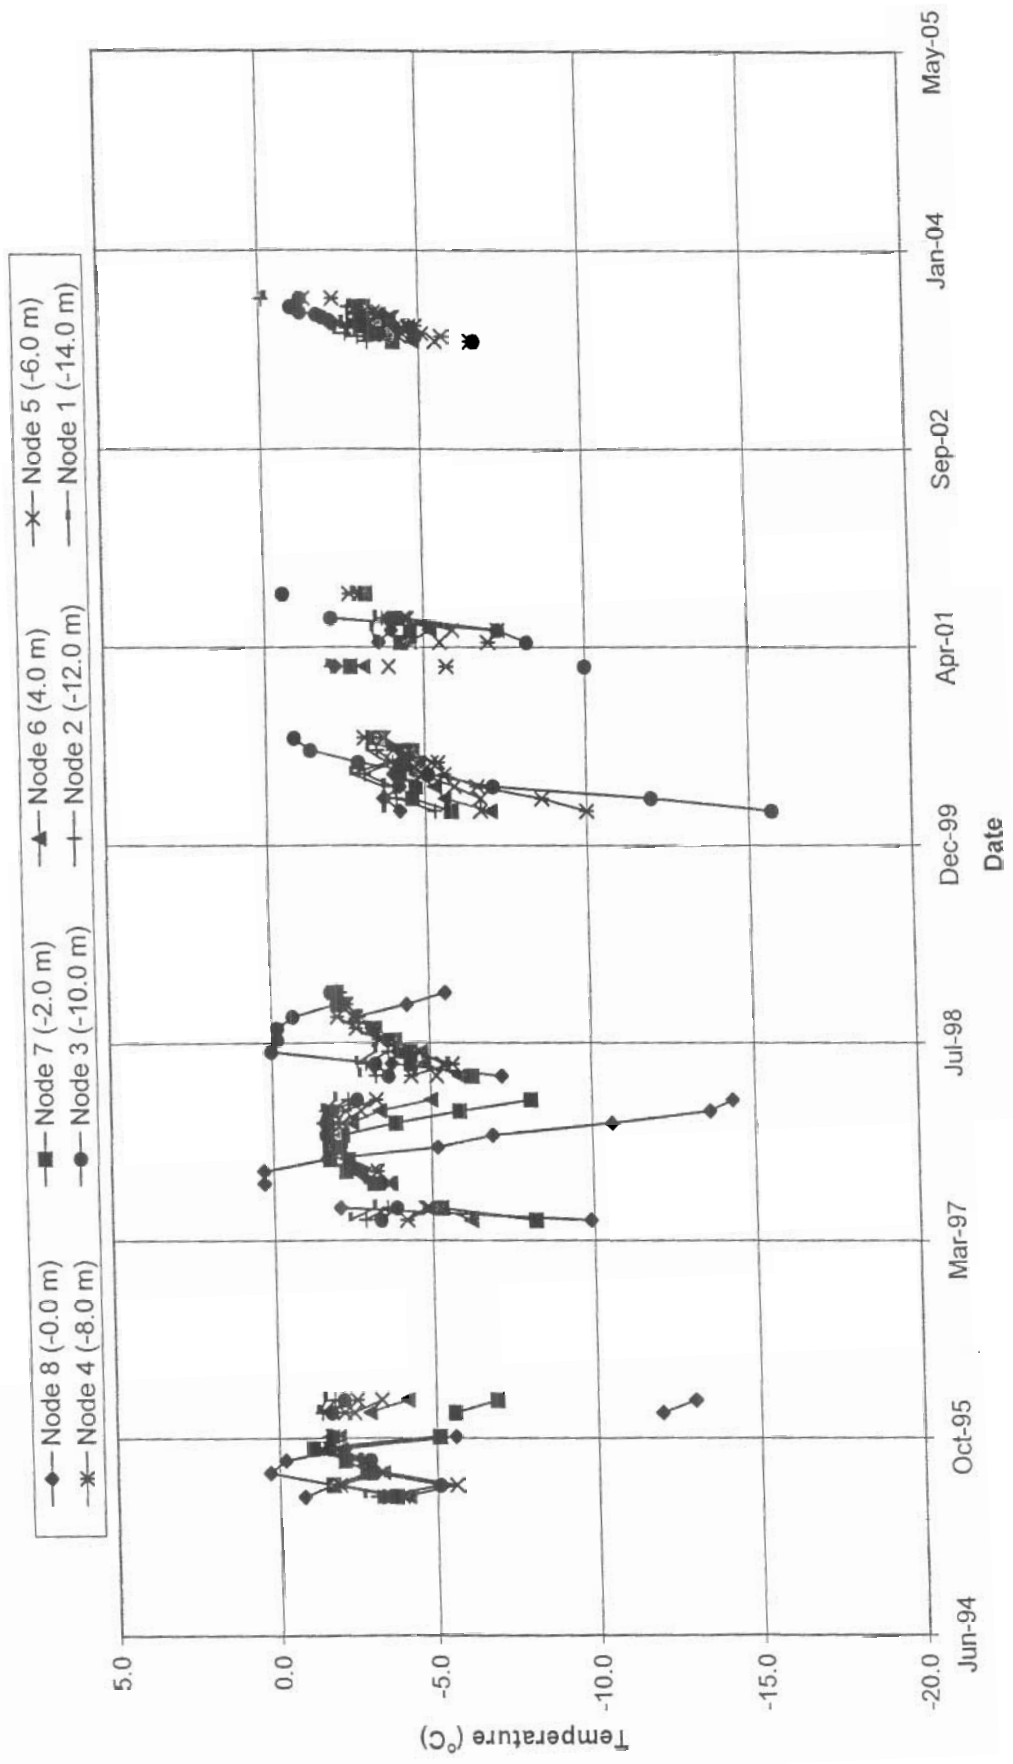
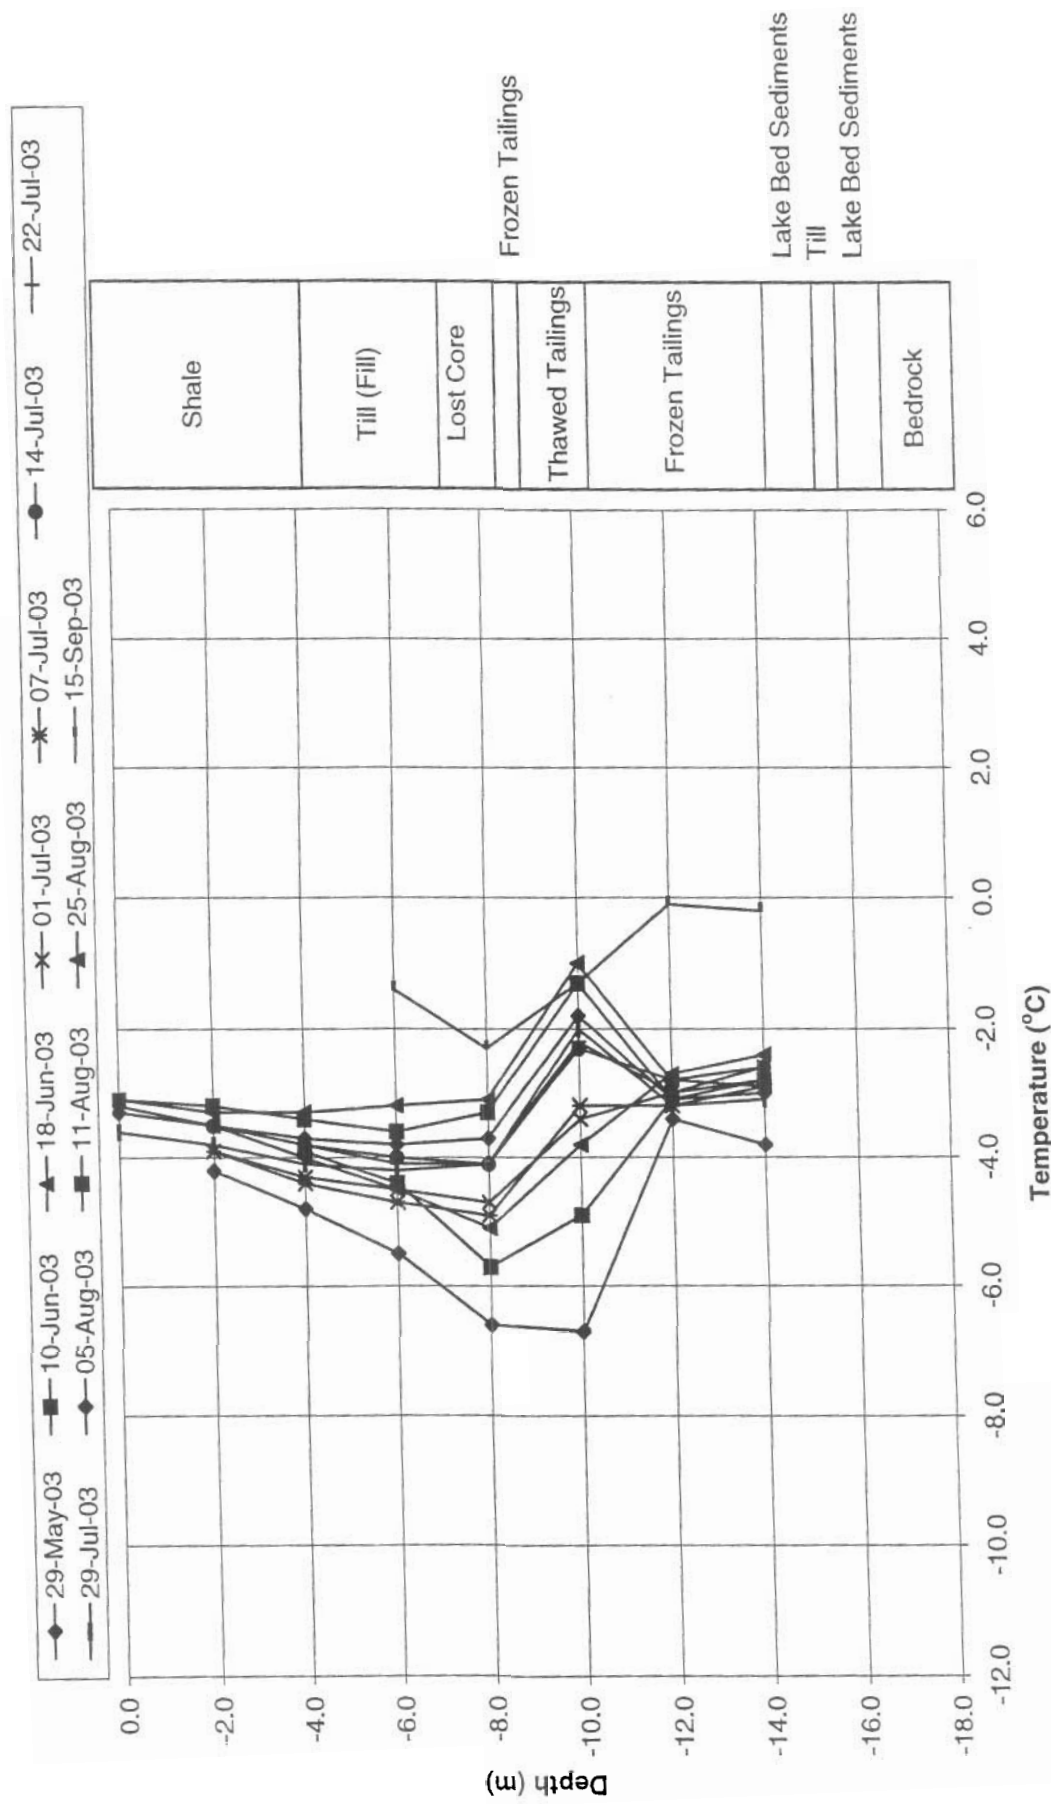
# Geothermal Monitoring West Twin Dike Thermocouple TC 16

| Instrument | Instrument type | Location | Station | Surface Elevation | Location of thawed ground (>-1°C) below active layer | Additional comments |
|---|---|---|---|---|---|---|
| 16 | T/C | Dike face | 3+75 | 376 m | 9 to 11 m | Measured temperature at 10 m depth rises to -1°C, other depths exhibit warming, but not to this high of temperature. 12 readings in 2003. |

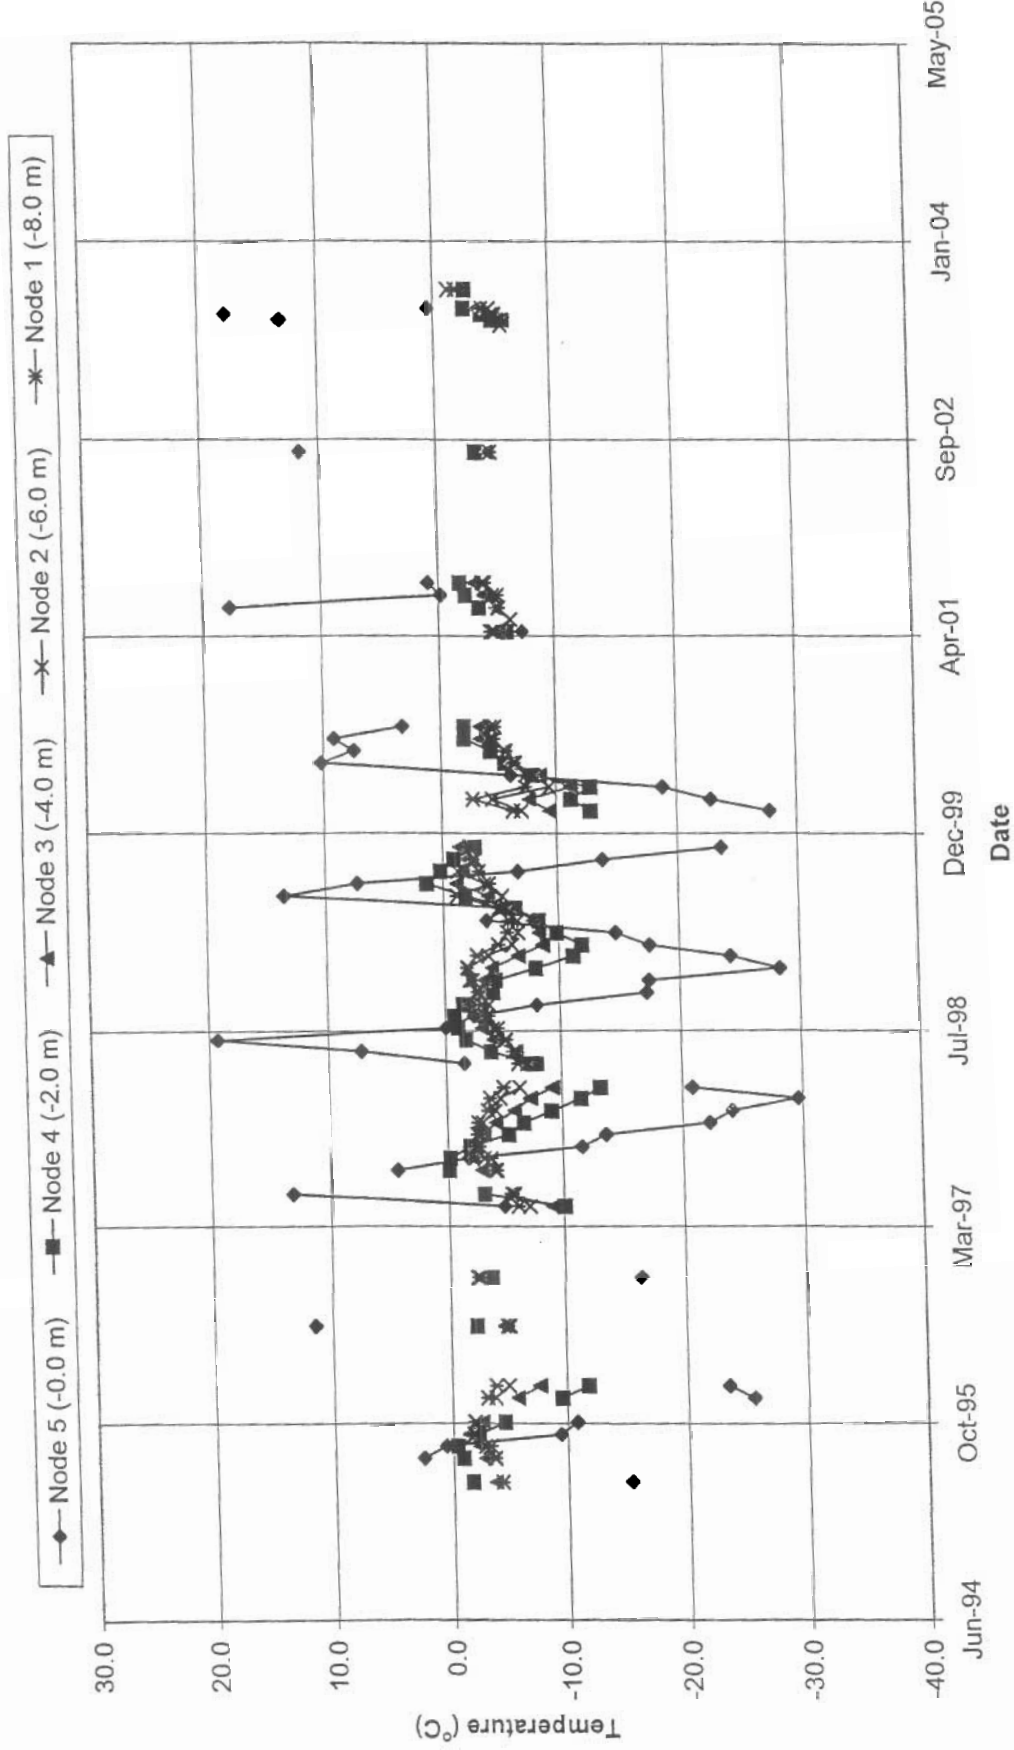
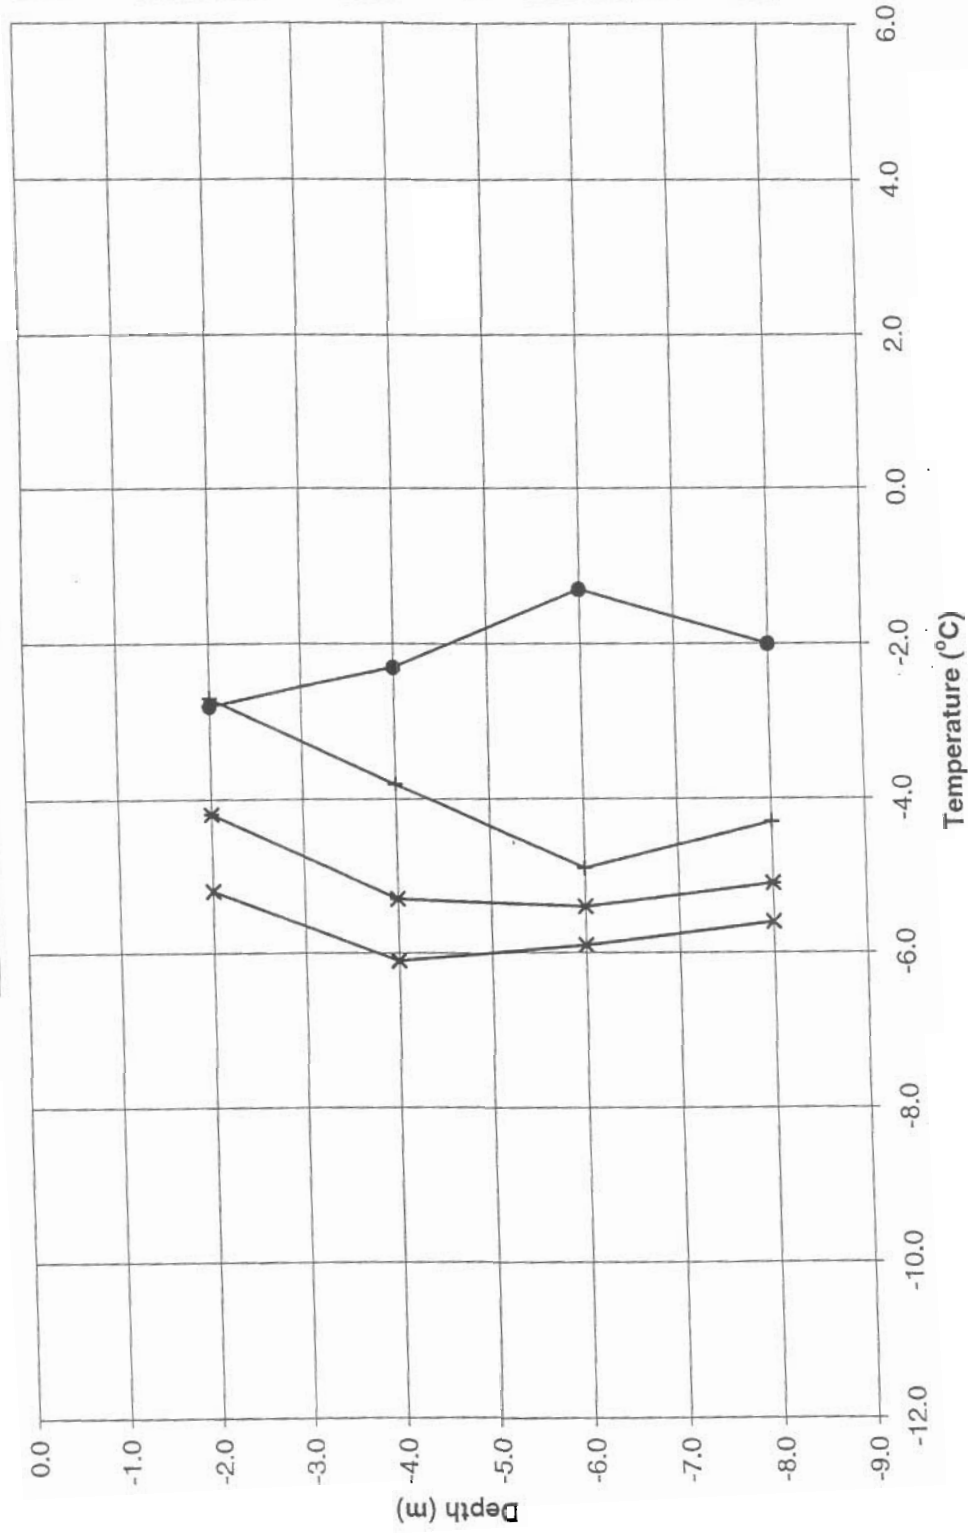
**Geothermal Monitoring  
 West Twin Dike  
 Thermocouple TC 17**

| Instrument | Instrument type | Location | Station | Surface Elevation | Location of thawed ground (>-1°C) below active layer | Additional comments |
|---|---|---|---|---|---|---|
| 17 | T/C | Dike face | 4+25 | 376 m | N/A | Potential warming trend at a depth of 6 m. 4 readings in 2003. |

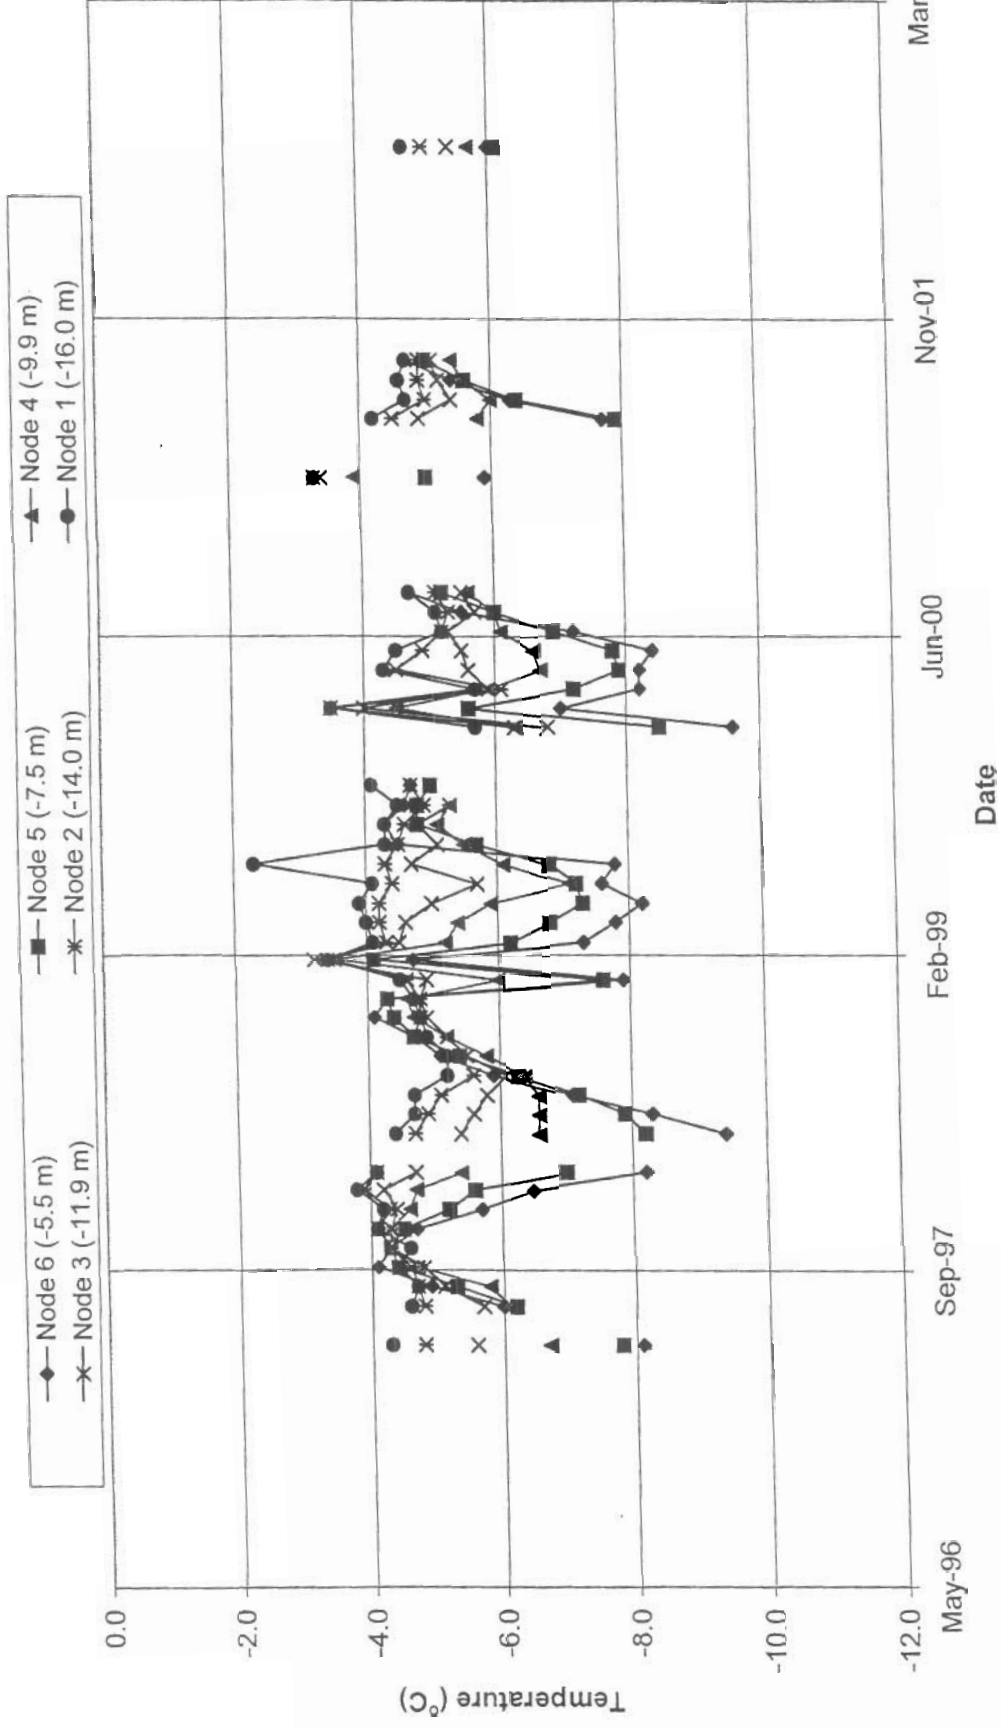
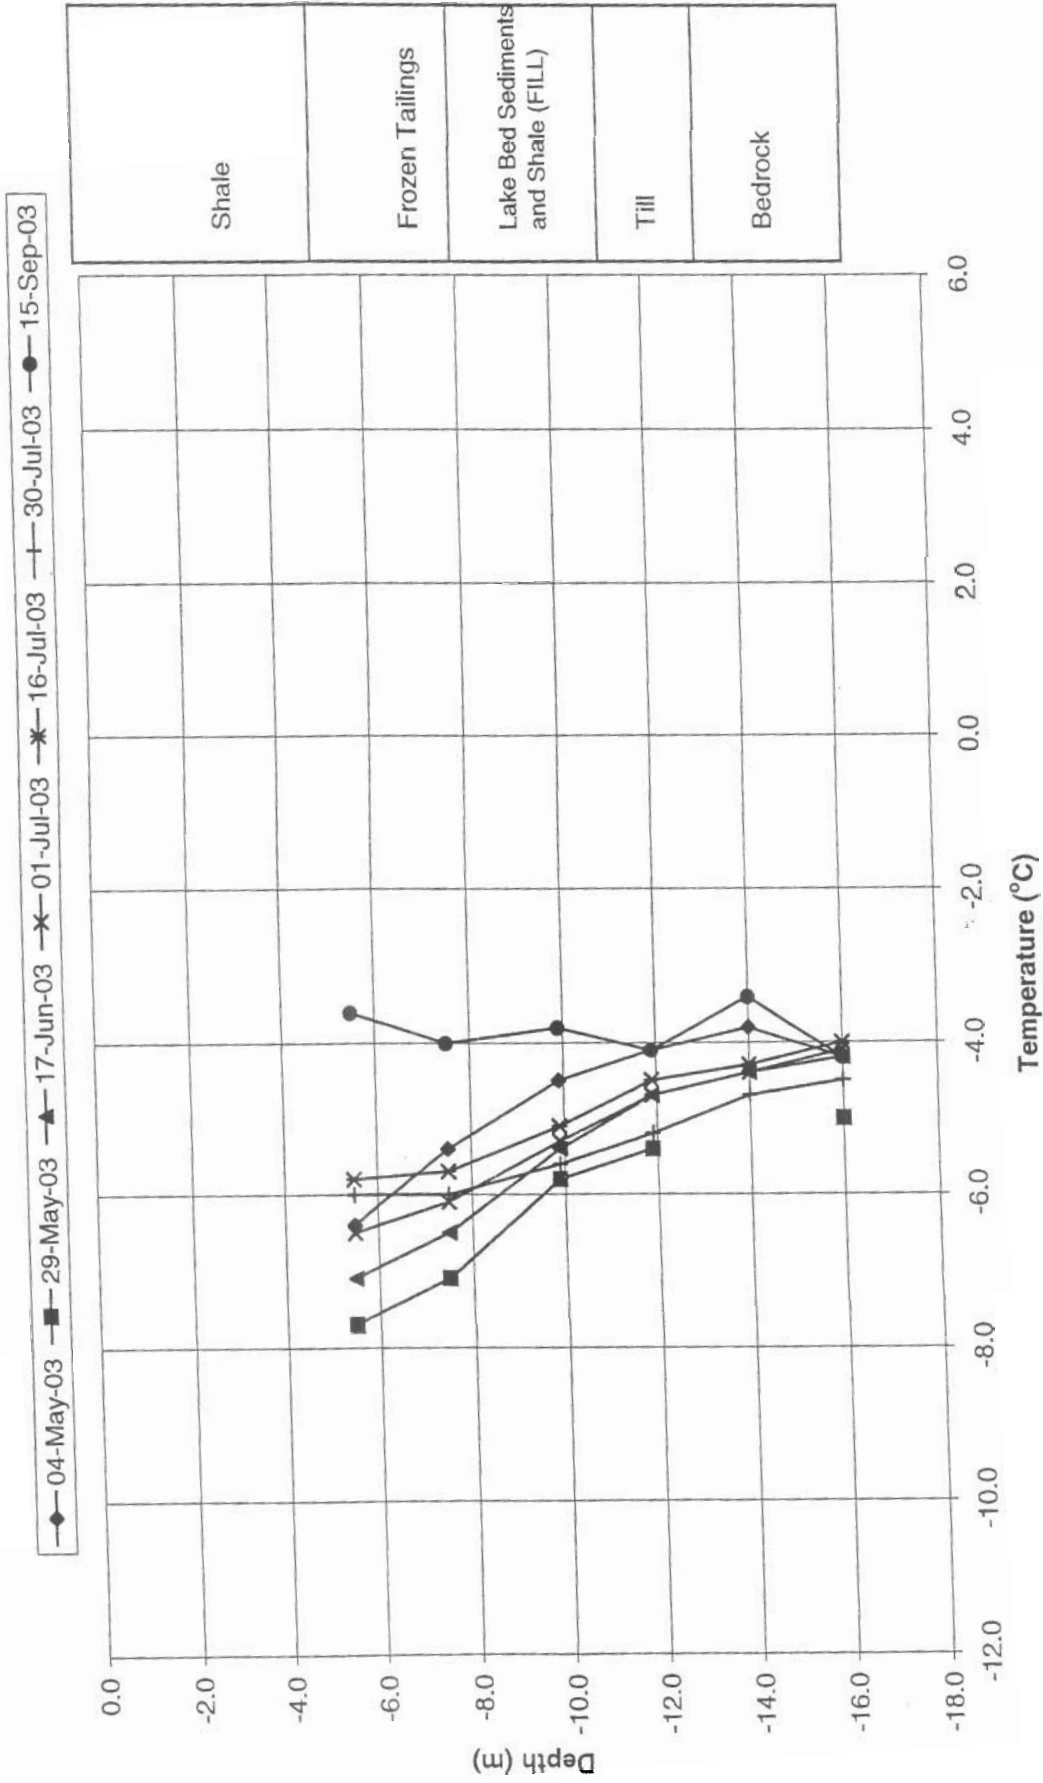
Geothermal Monitoring  
West Twin Dike  
Thermocouple TC 17A

| Instrument | Instrument type | Location | Station | Surface Elevation | Location of thawed ground (>-1°C) below active layer | Additional comments |
|---|---|---|---|---|---|---|
| 17A | T/C | Dike face | 4+50 | 376 m | N/A | No warming trends. 7 readings in 2003. |

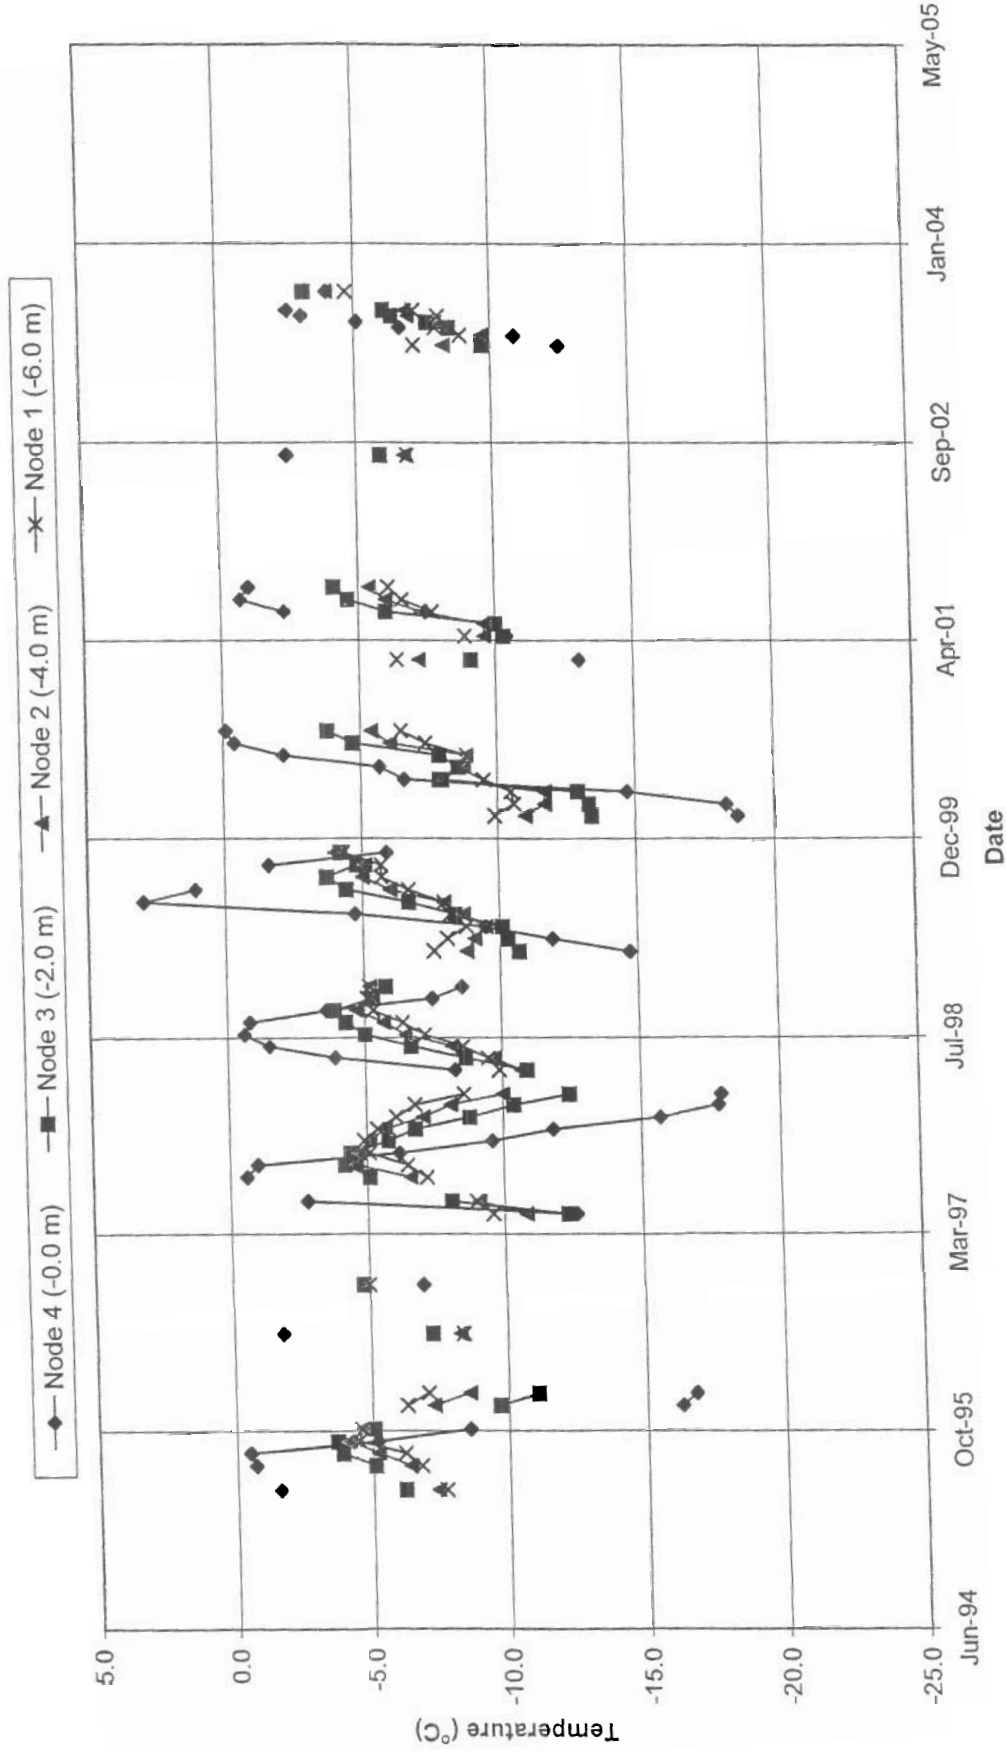
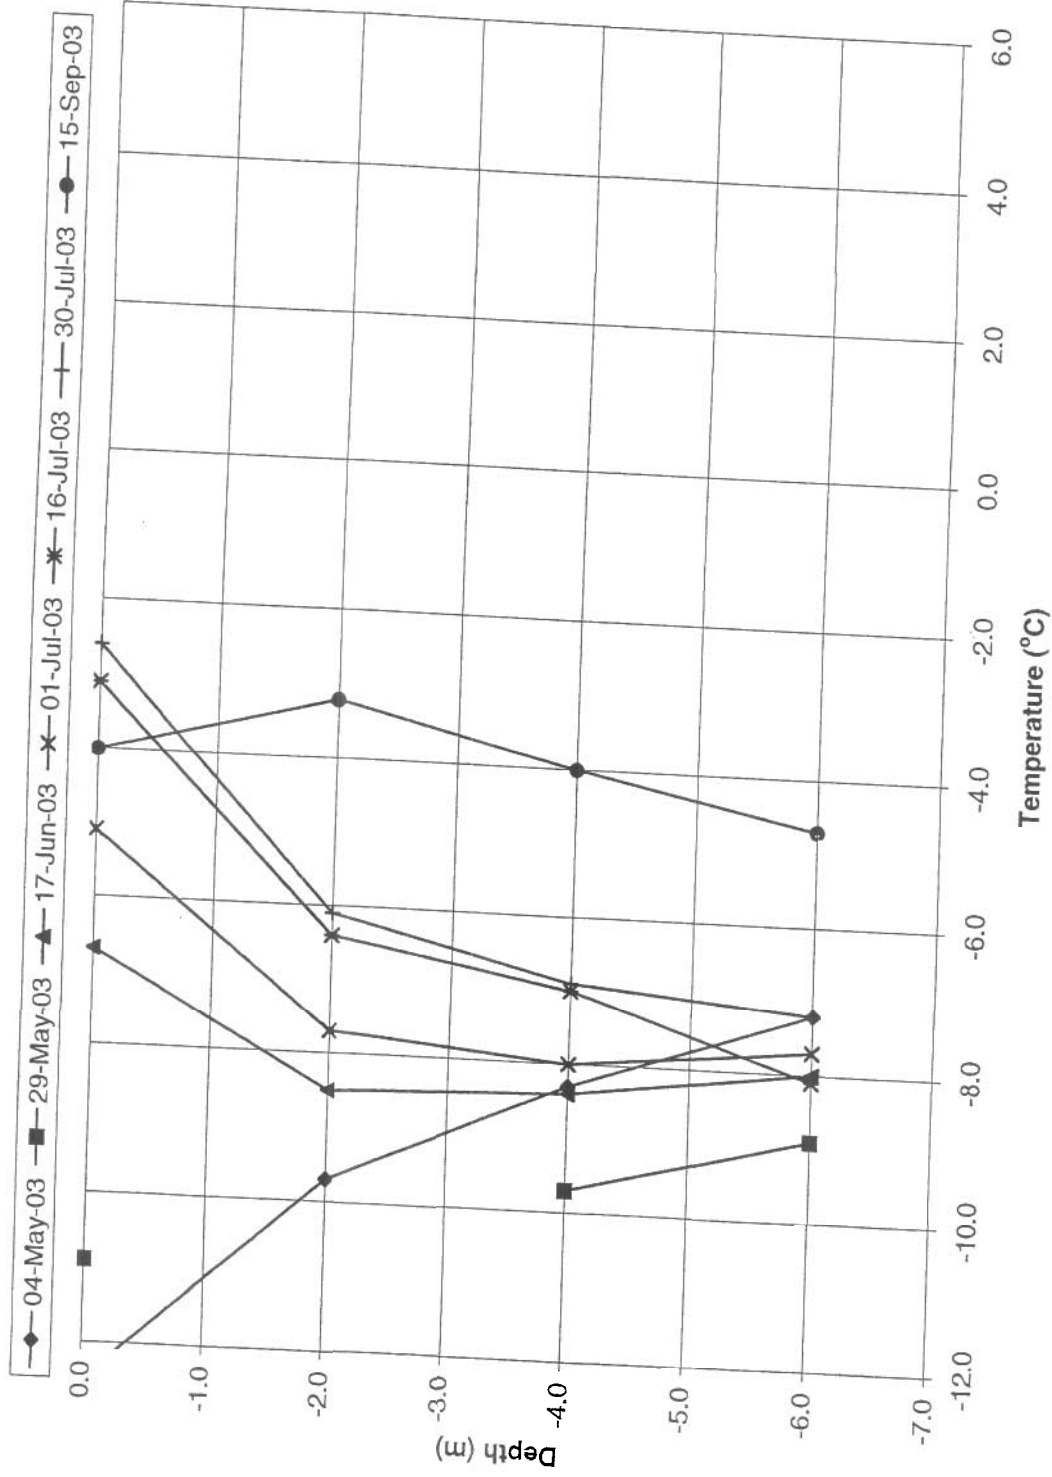
Geothermal Monitoring  
West Twin Dike  
Thermocouple TC 18

| Instrument | Instrument type | Location | Station | Surface Elevation | Location of thawed ground (>-1°C) below active layer | Additional comments |
|---|---|---|---|---|---|---|
| 18 | T/C | Dike face | 4+75 | 376 m | N/A | No warming trends. 7 readings in 2003. |
