### **INSPECTION MEMO OF SEPTEMBER 11, 2003**

## **PROJECT MEMORANDUM**

| <b>Subject:</b> | <b>Inspection Visit relative to Waste Containment Dikes and Berms<br/>Summary of Site Observations and Commentary</b> | | |

Nanisivik Mine - Annual Geotechnical Inspection of Dikes  
Nanisivik Mine, a division of Canzinc

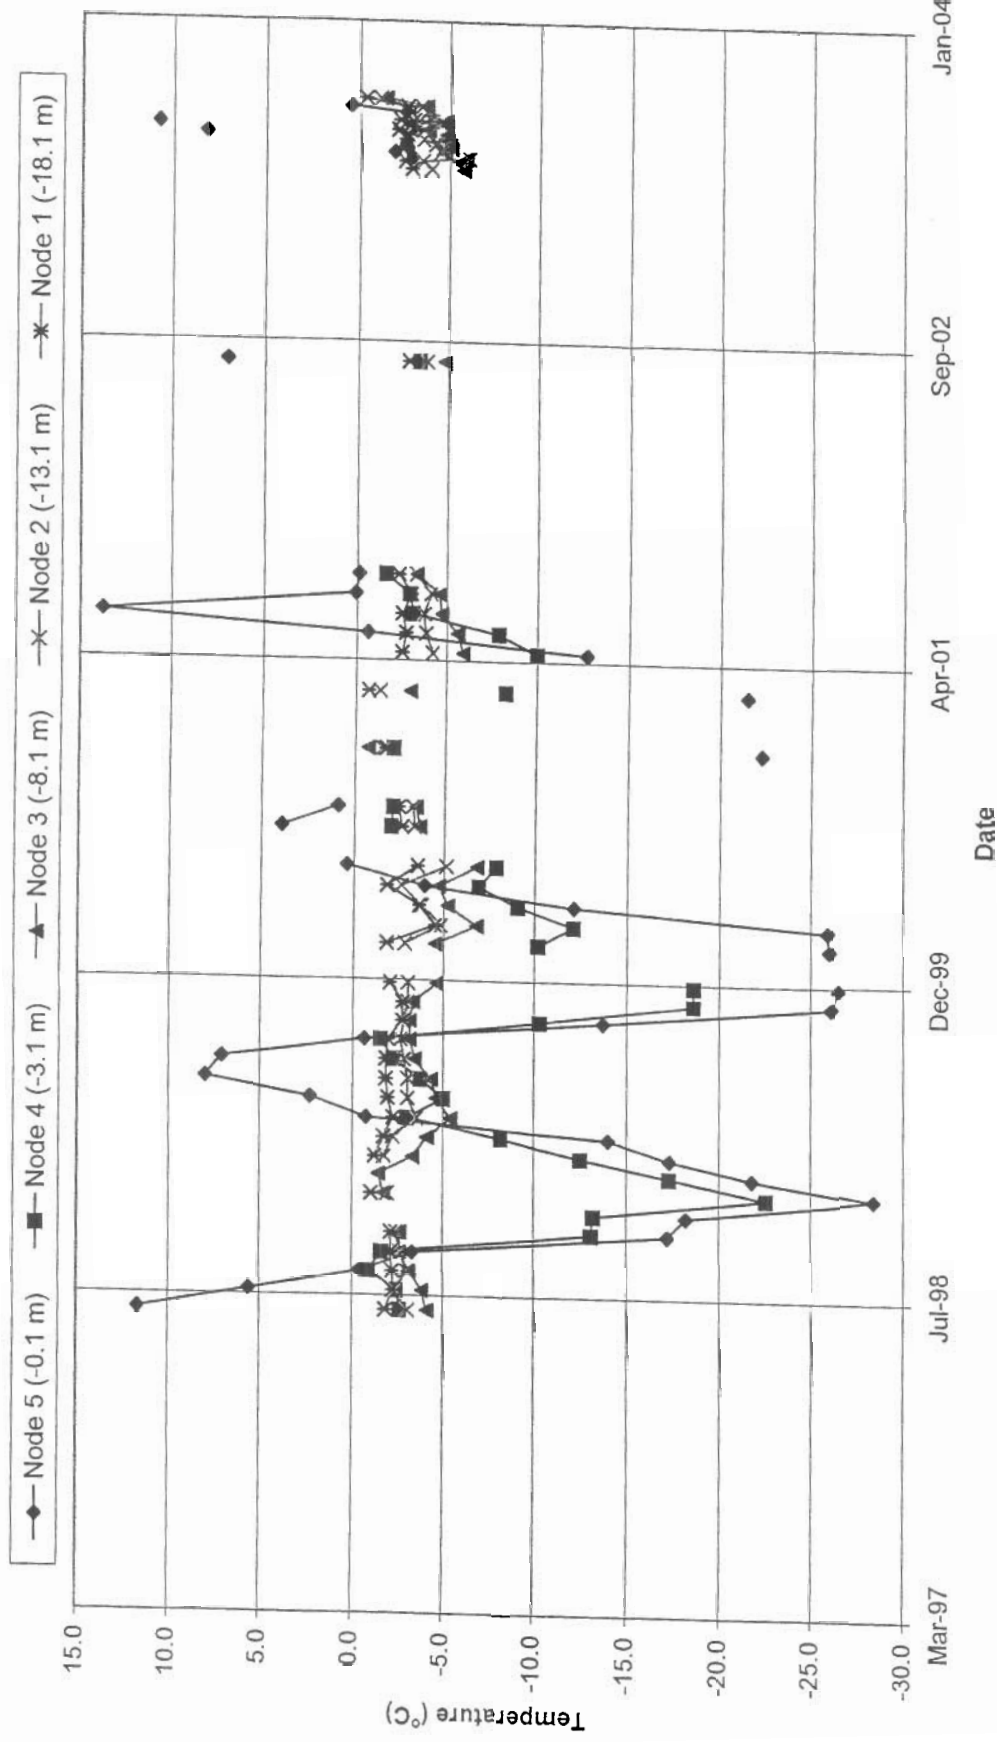
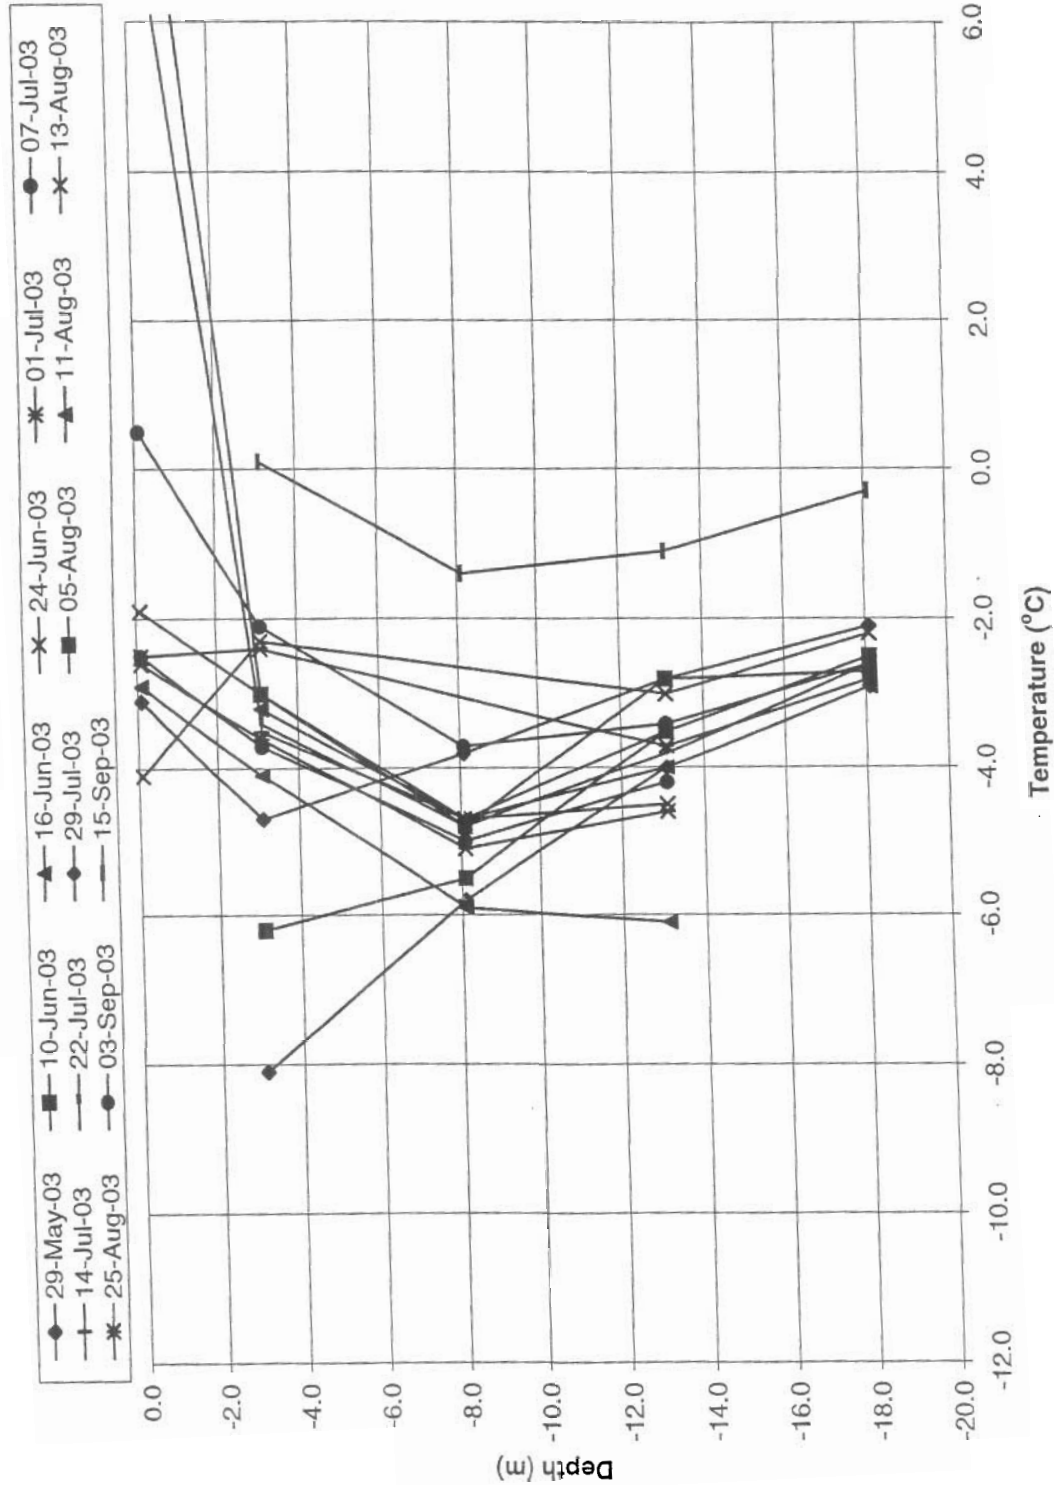
# Geothermal Monitoring West Twin Dike Thermocouple TC 28

| Instrument | Instrument type | Location | Station | Surface Elevation | Location of thawed ground (>-1°C) below active layer | Additional comments |
|---|---|---|---|---|---|---|
| 28 | T/C | Dike face | 2+25 | 384 m | N/A | No warming trends. 15 readings in 2003. |

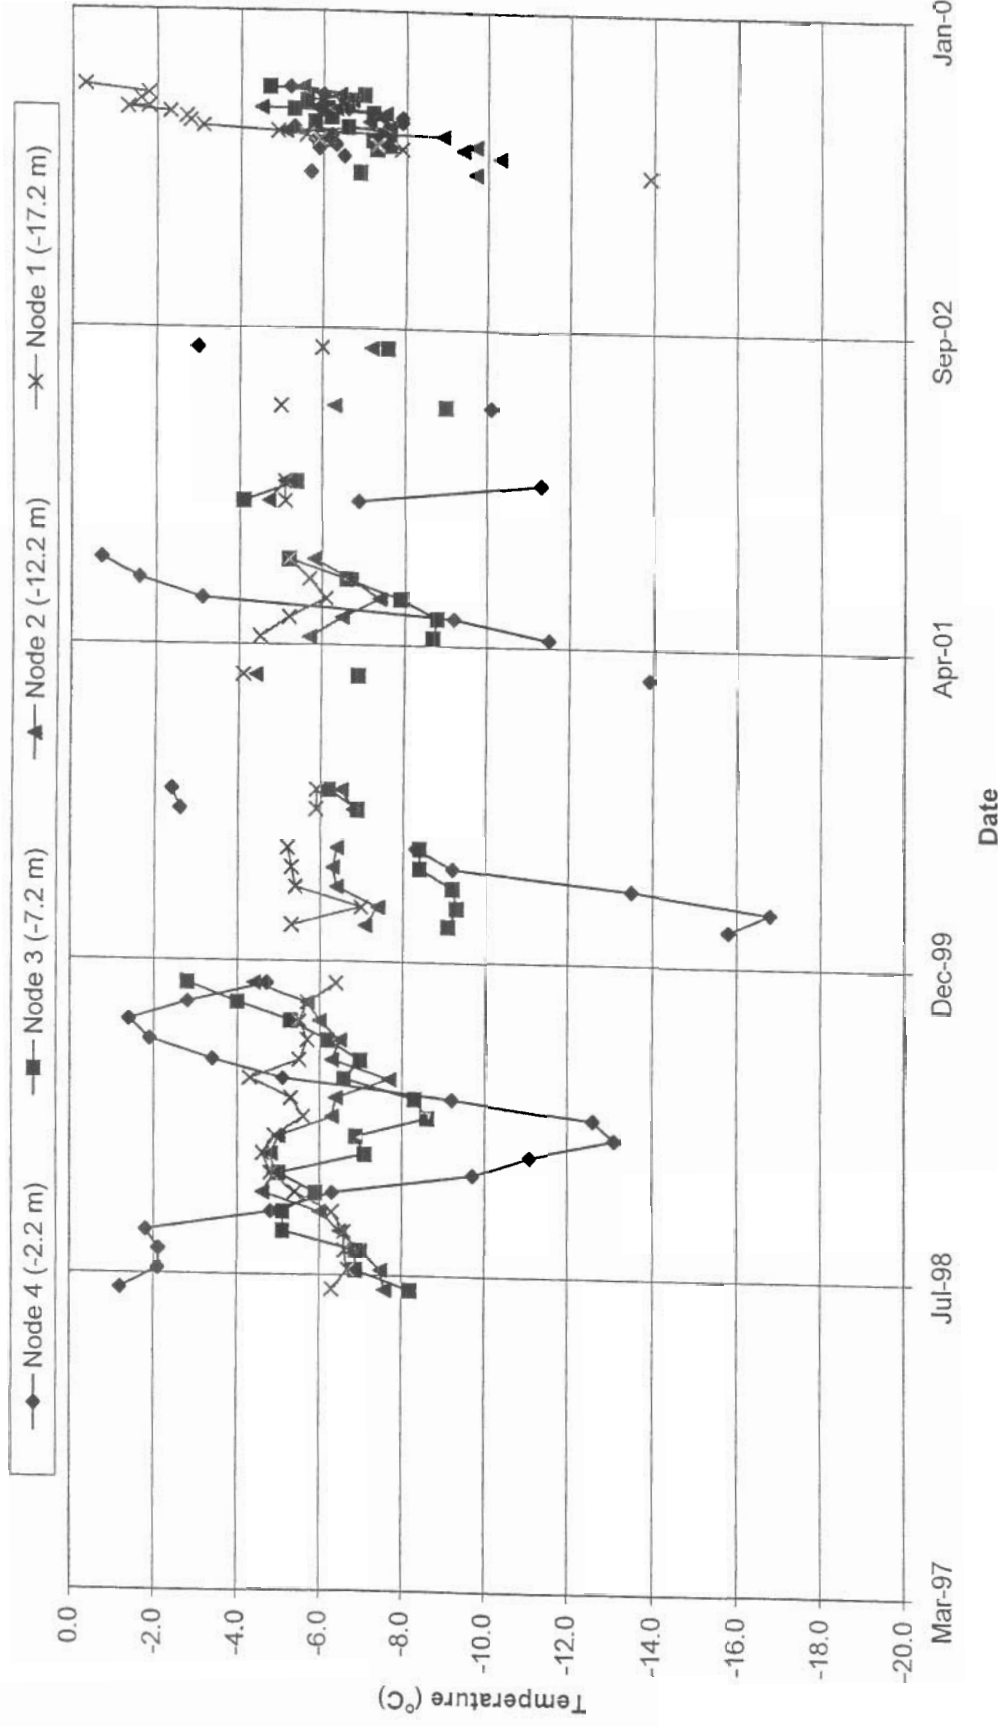
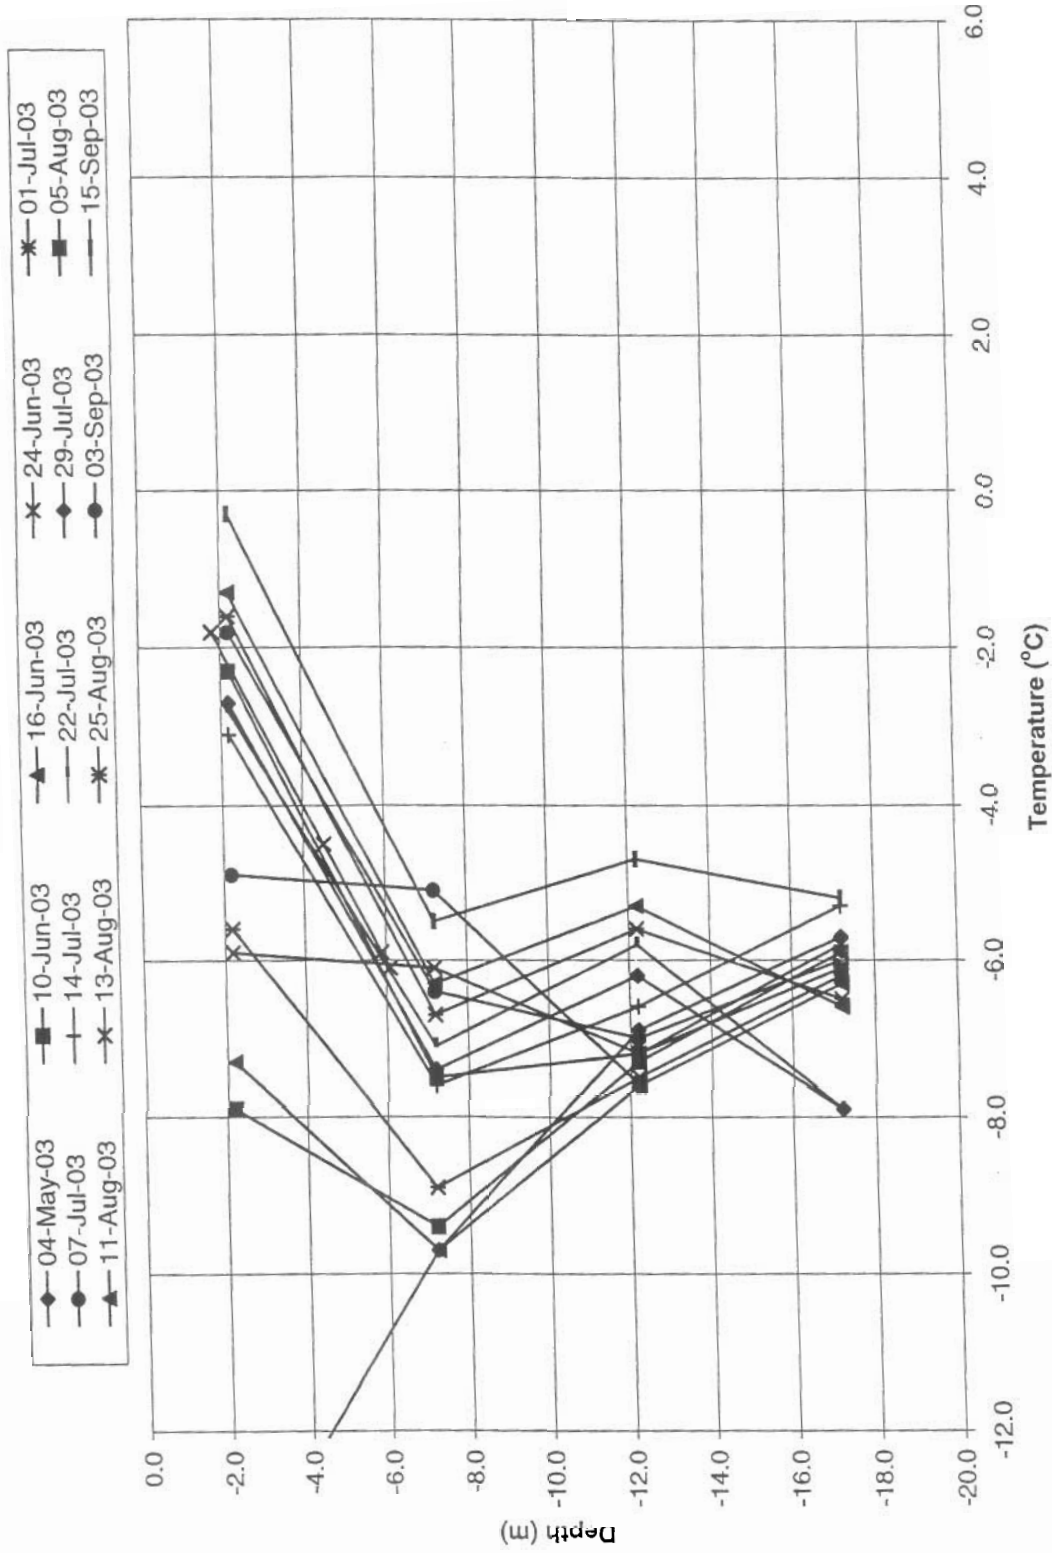
# Geothermal Monitoring West Twin Dike Thermocouple TC 29

| Instrument | Instrument type | Location | Station | Surface Elevation | Location of thawed ground (>-1°C) below active layer | Additional comments |
|---|---|---|---|---|---|---|
| 29 | T/C | Dike face | 4+50 | 385 m | N/A | No warming trends. 15 readings in 2003. |

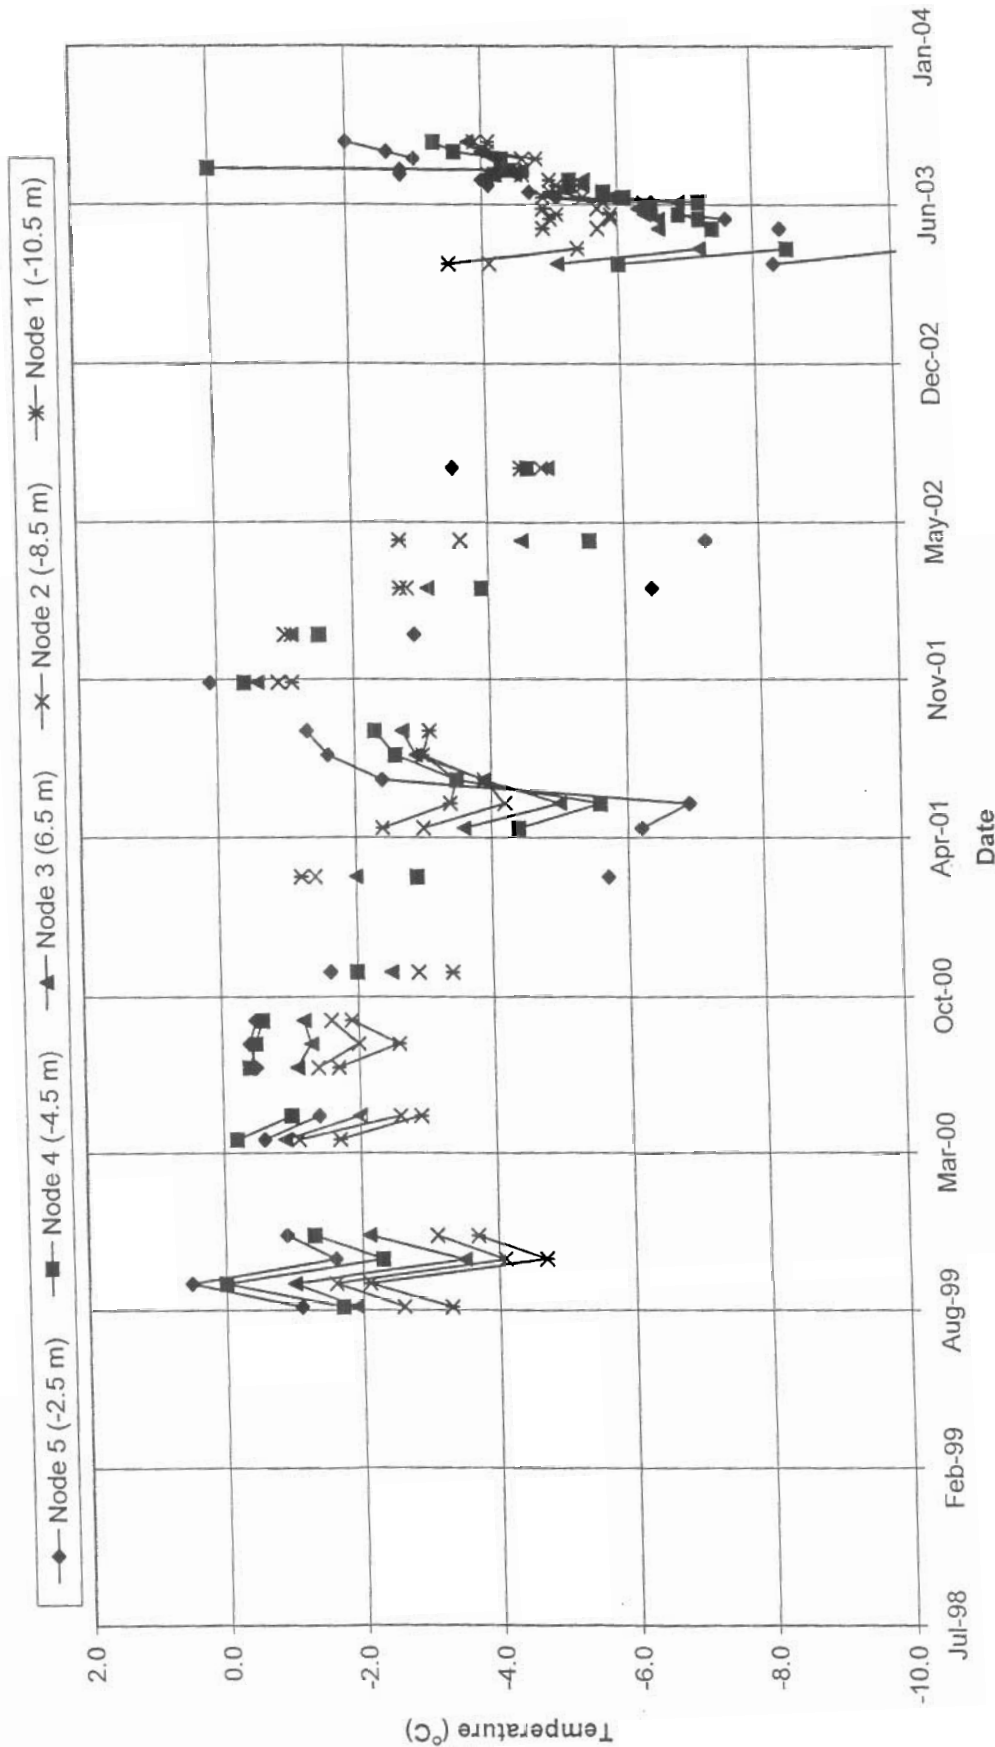
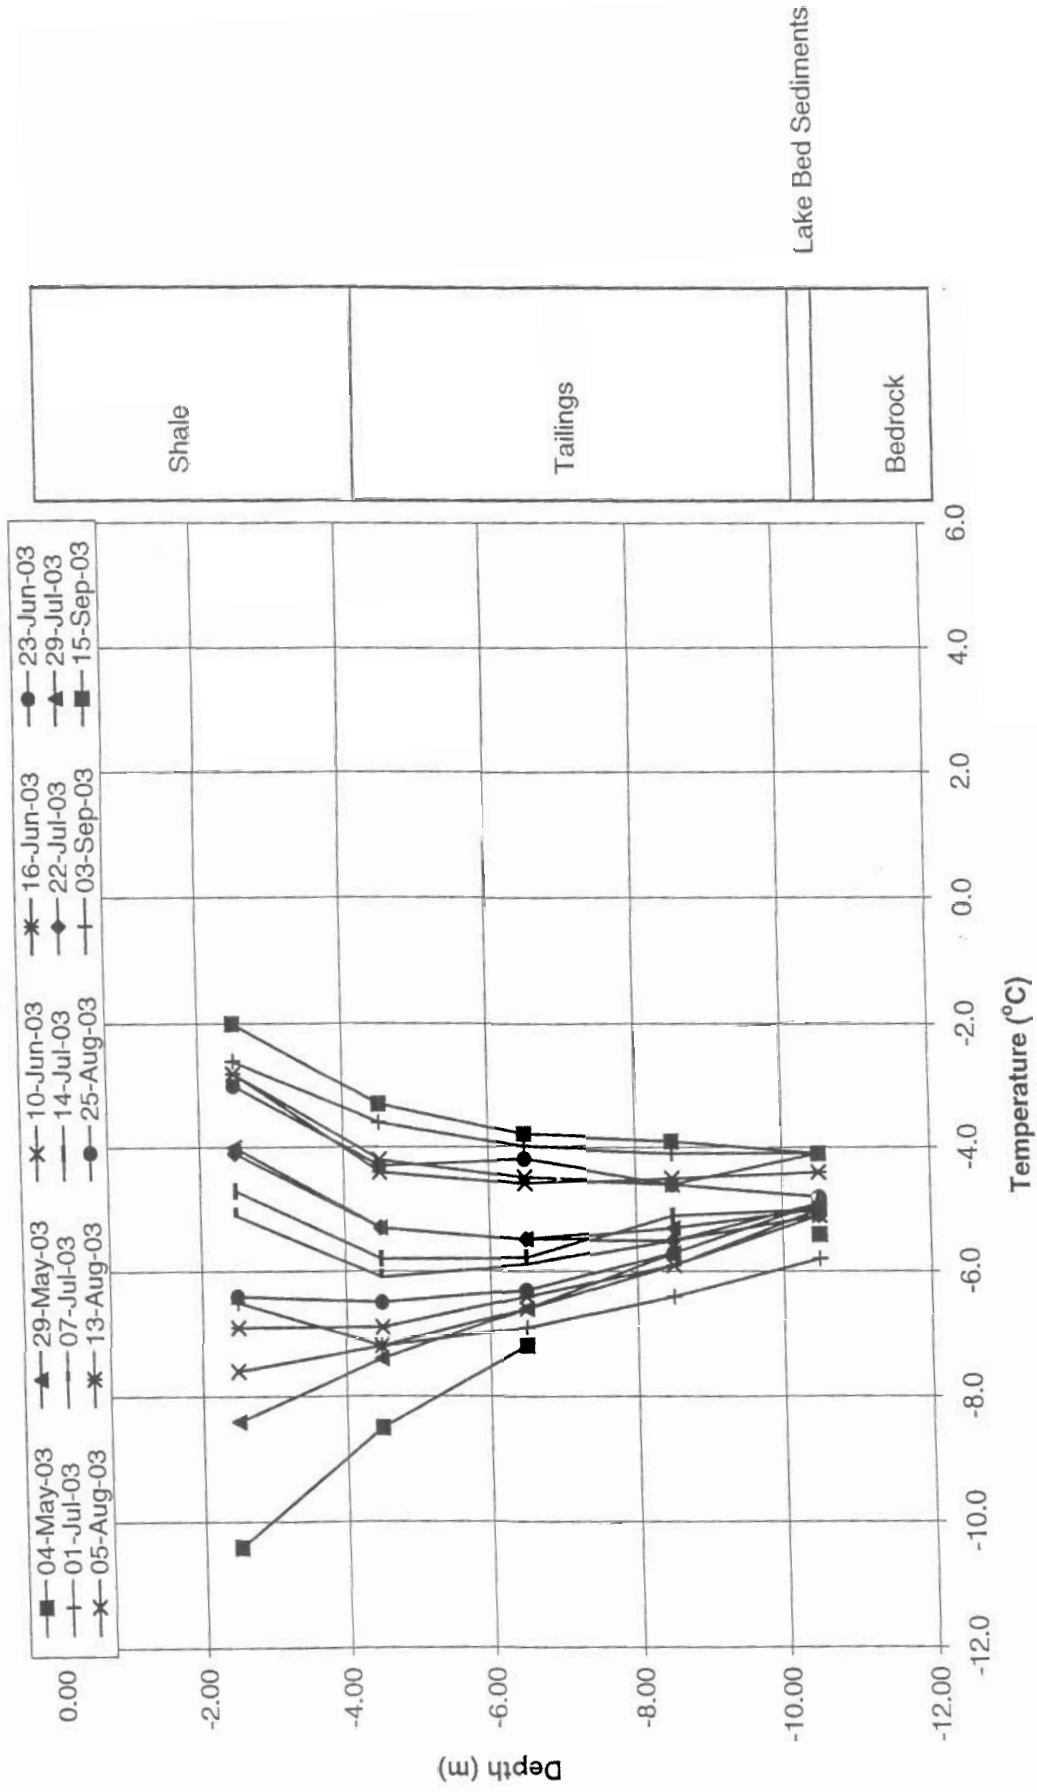
# Geothermal Monitoring West Twin Dike Thermocouple TC 31

| Instrument | Instrument type | Location | Station | Surface Elevation | Location of thawed ground (>-1°C) below active layer | Additional comments |
|---|---|---|---|---|---|---|
| 31 | T/C | Dike face | 1+50 | 378 m | N/A | No warming trends. 15 readings in 2003. |

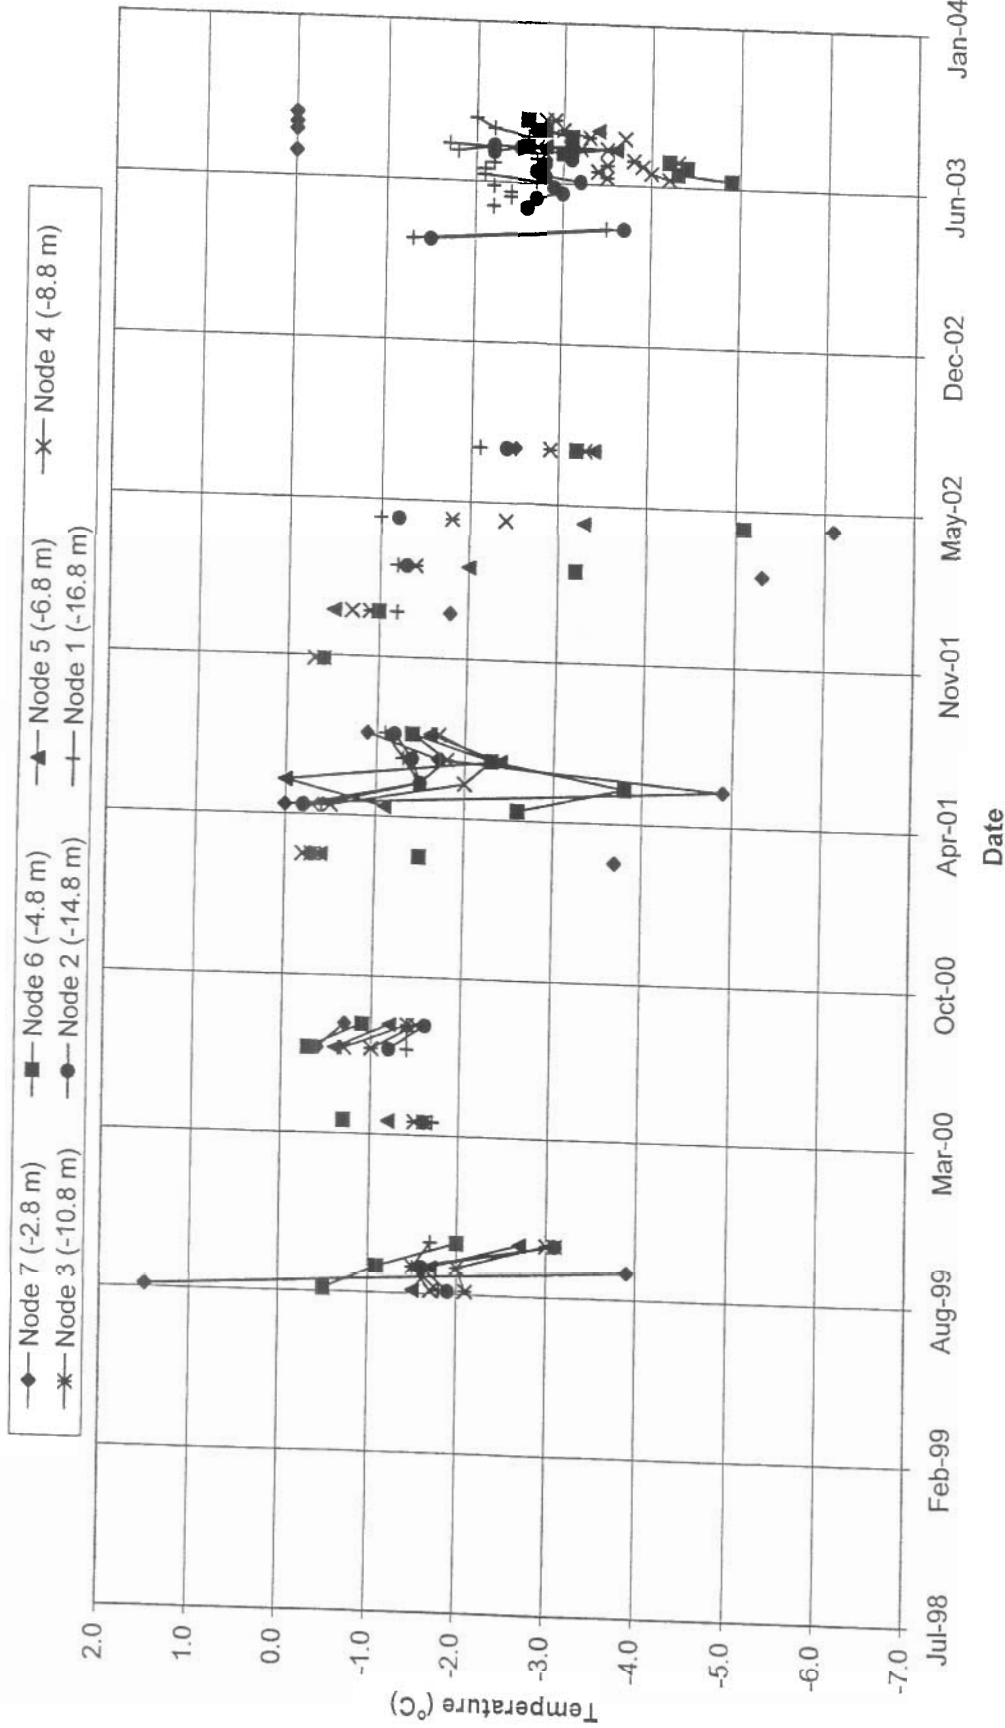
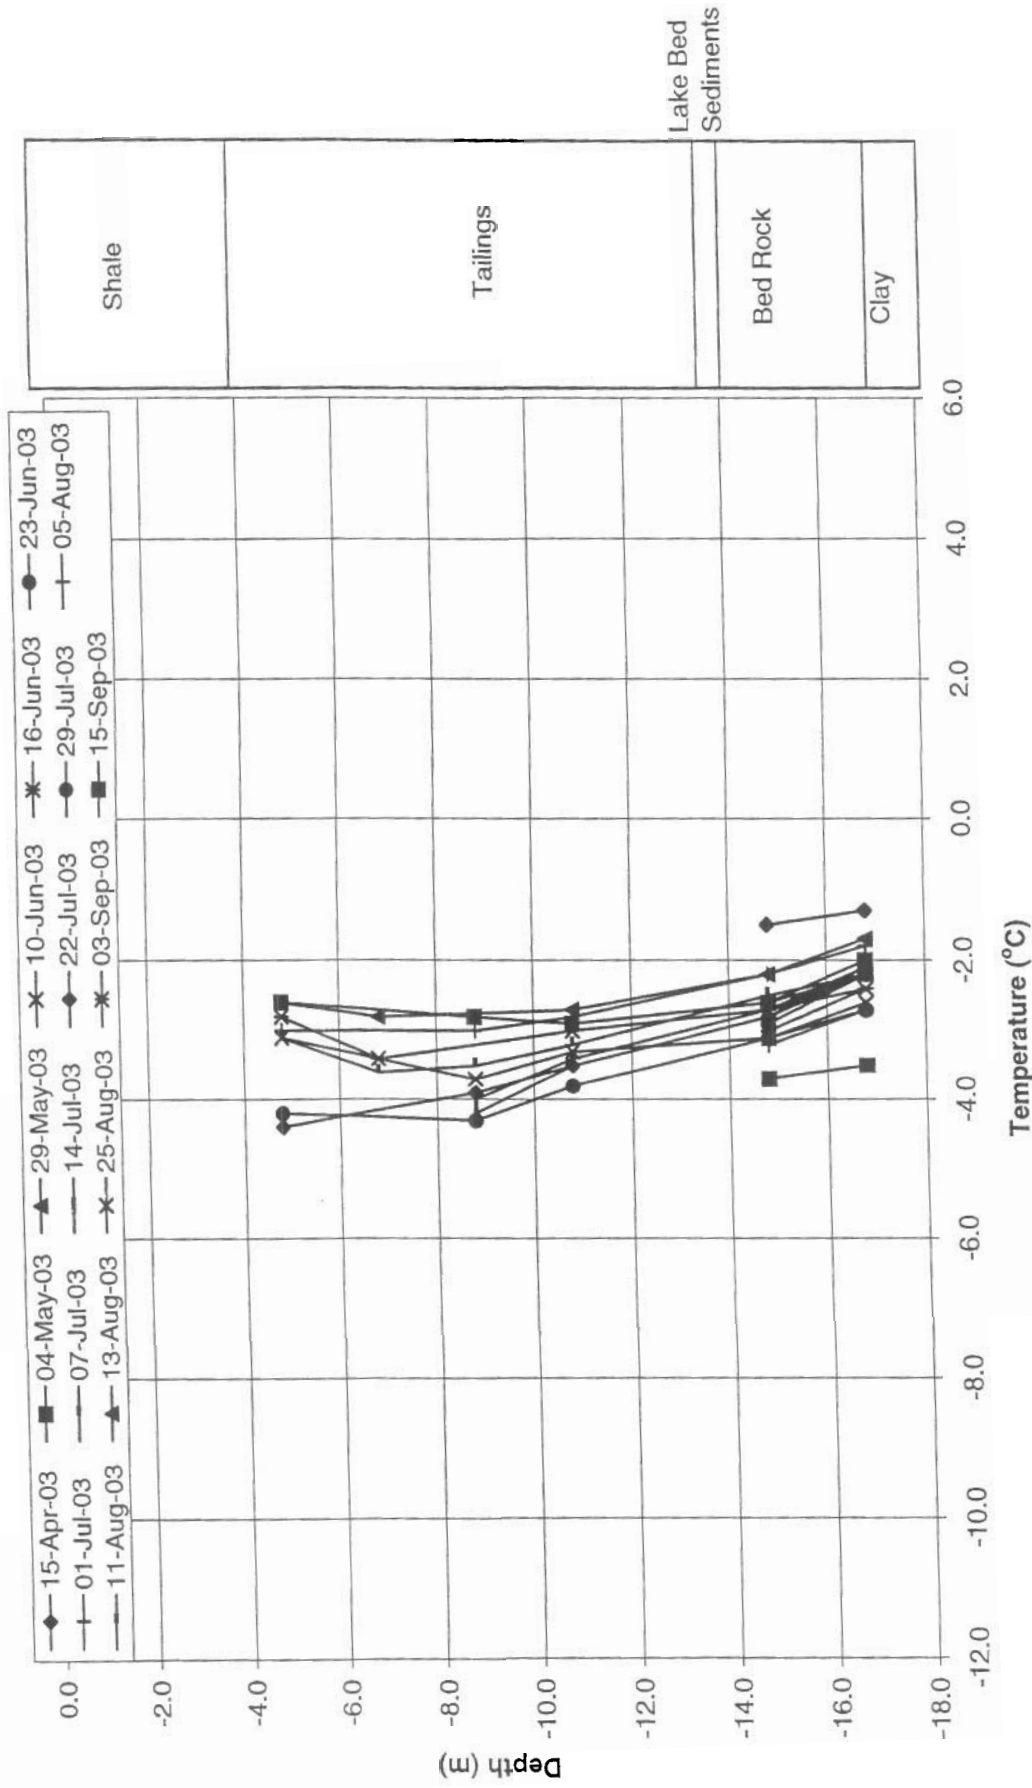
# Geothermal Monitoring West Twin Dike Thermocouple TC 32

| Instrument | Instrument type | Location | Station | Surface Elevation | Location of thawed ground (>-1°C) below active layer | Additional comments |
|---|---|---|---|---|---|---|
| 32 | T/C | Dike face | 1+50 | 382 m | N/A | Potential thawed zone at a depth of 16 m, within the bedrock. 17 readings in 2003. |

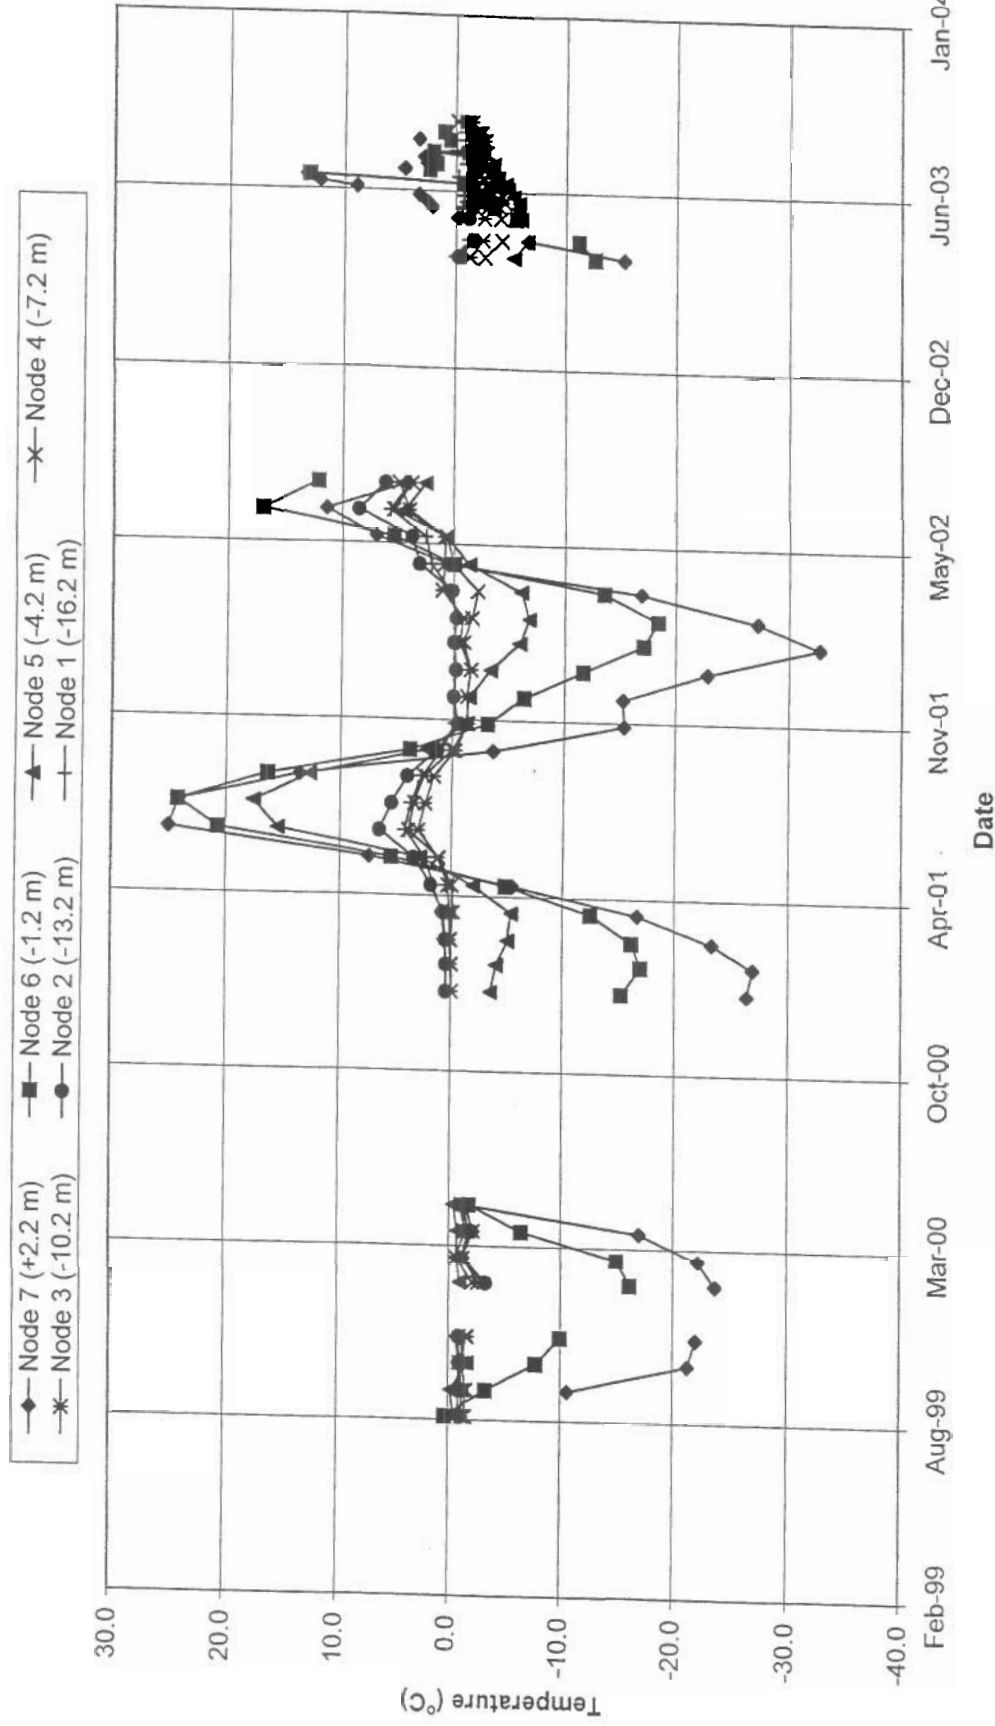
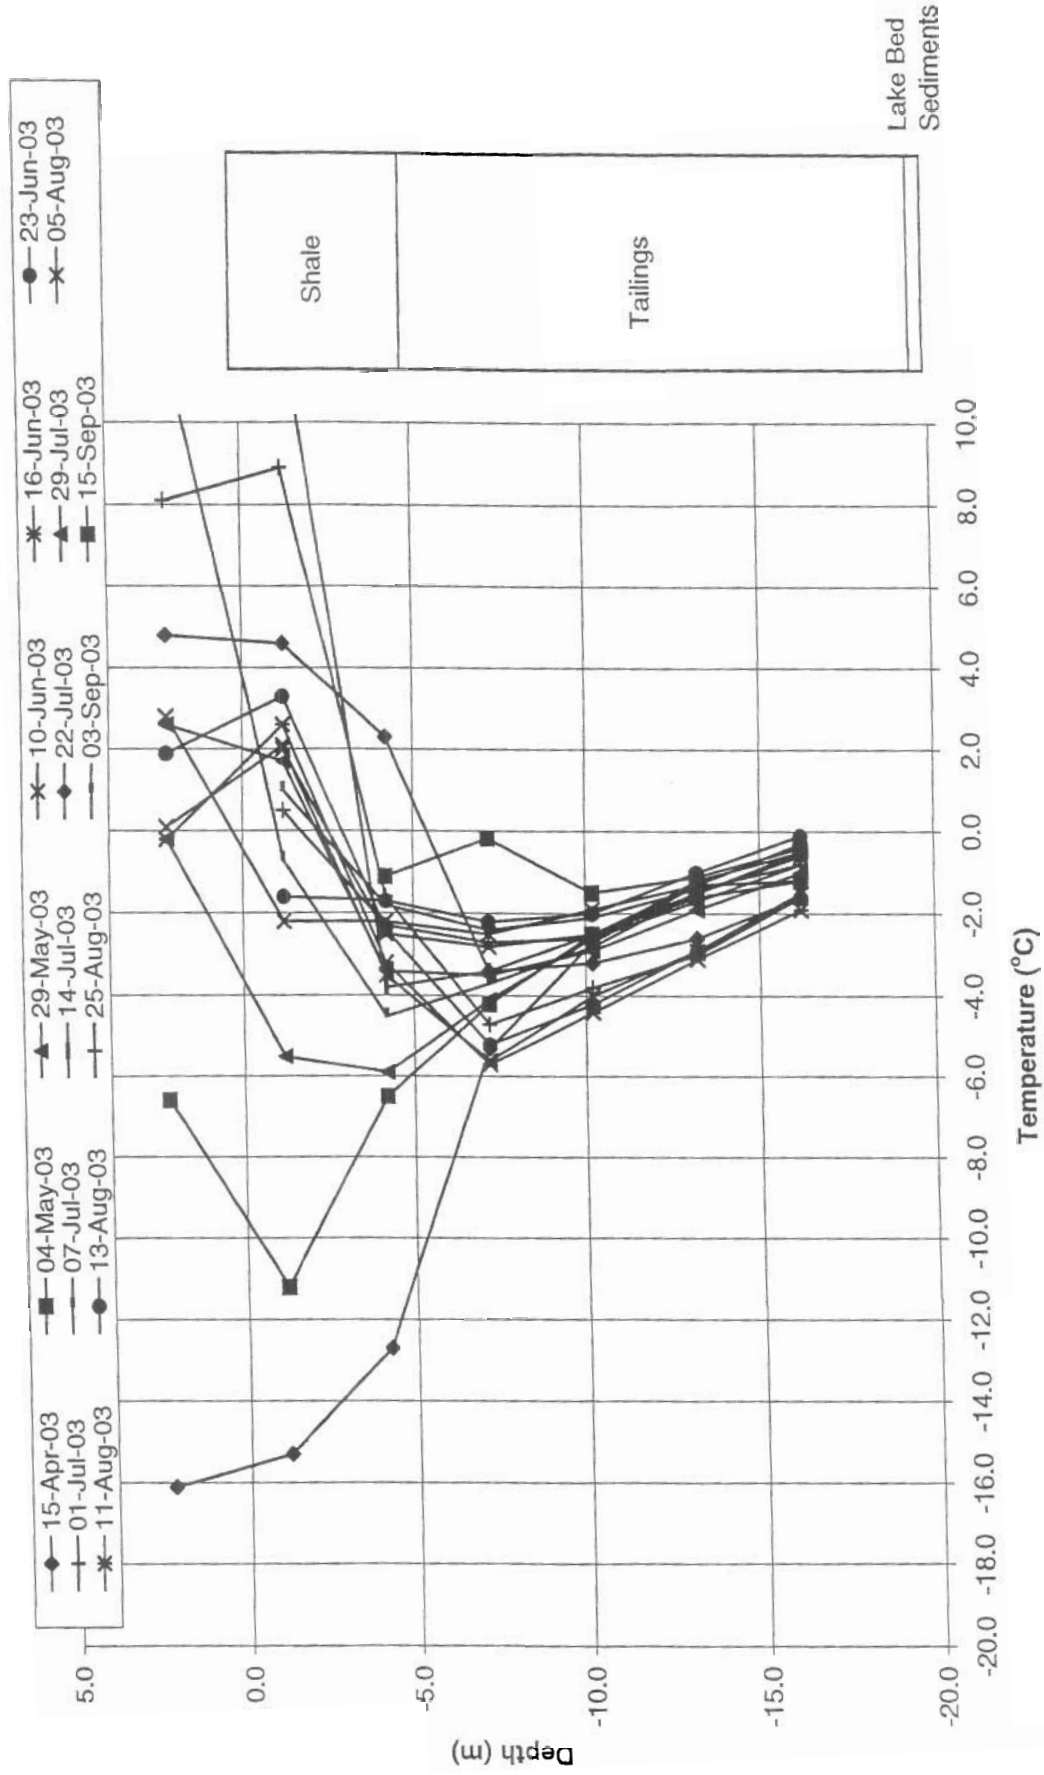
# Geothermal Monitoring West Twin Dike Thermocouple TC 33

| Instrument | Instrument type | Location | Station | Surface Elevation | Location of thawed ground (>-1°C) below active layer | Additional comments |
|---|---|---|---|---|---|---|
| 33 | T/C | Dike face | 1+50 | 386 m | 13 to 16 m. | Thawed conditions below a depth of 13 m. 17 readings in 2003. |

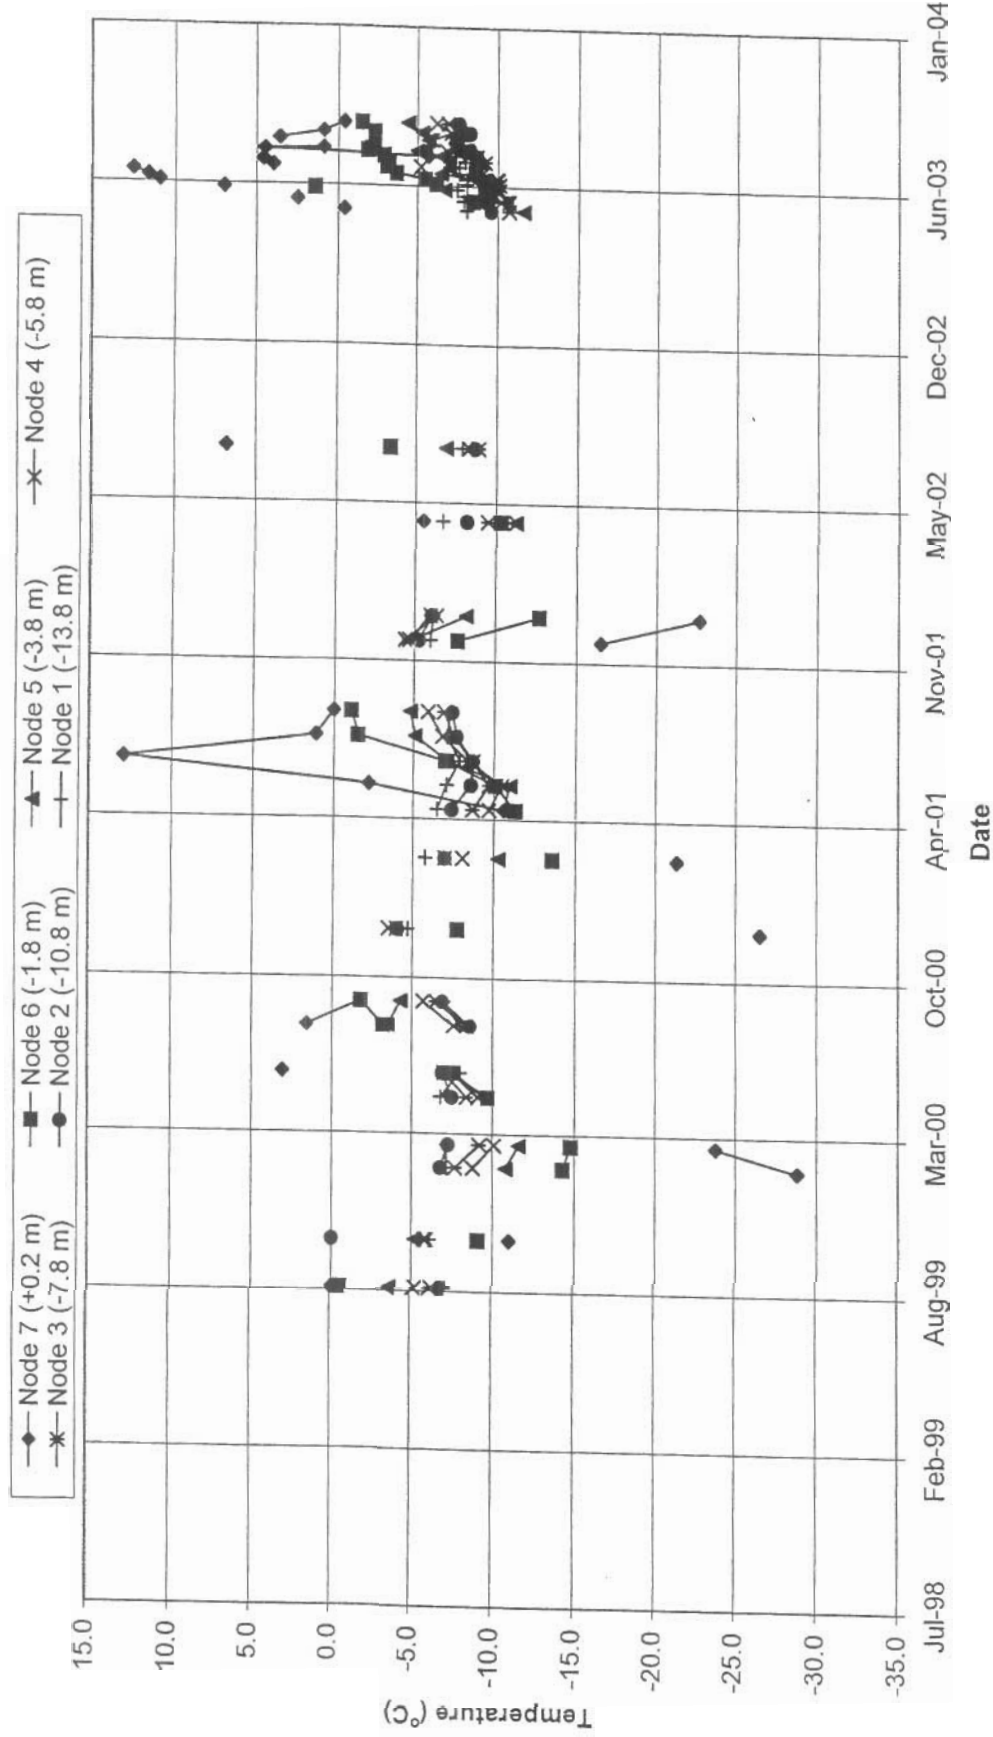
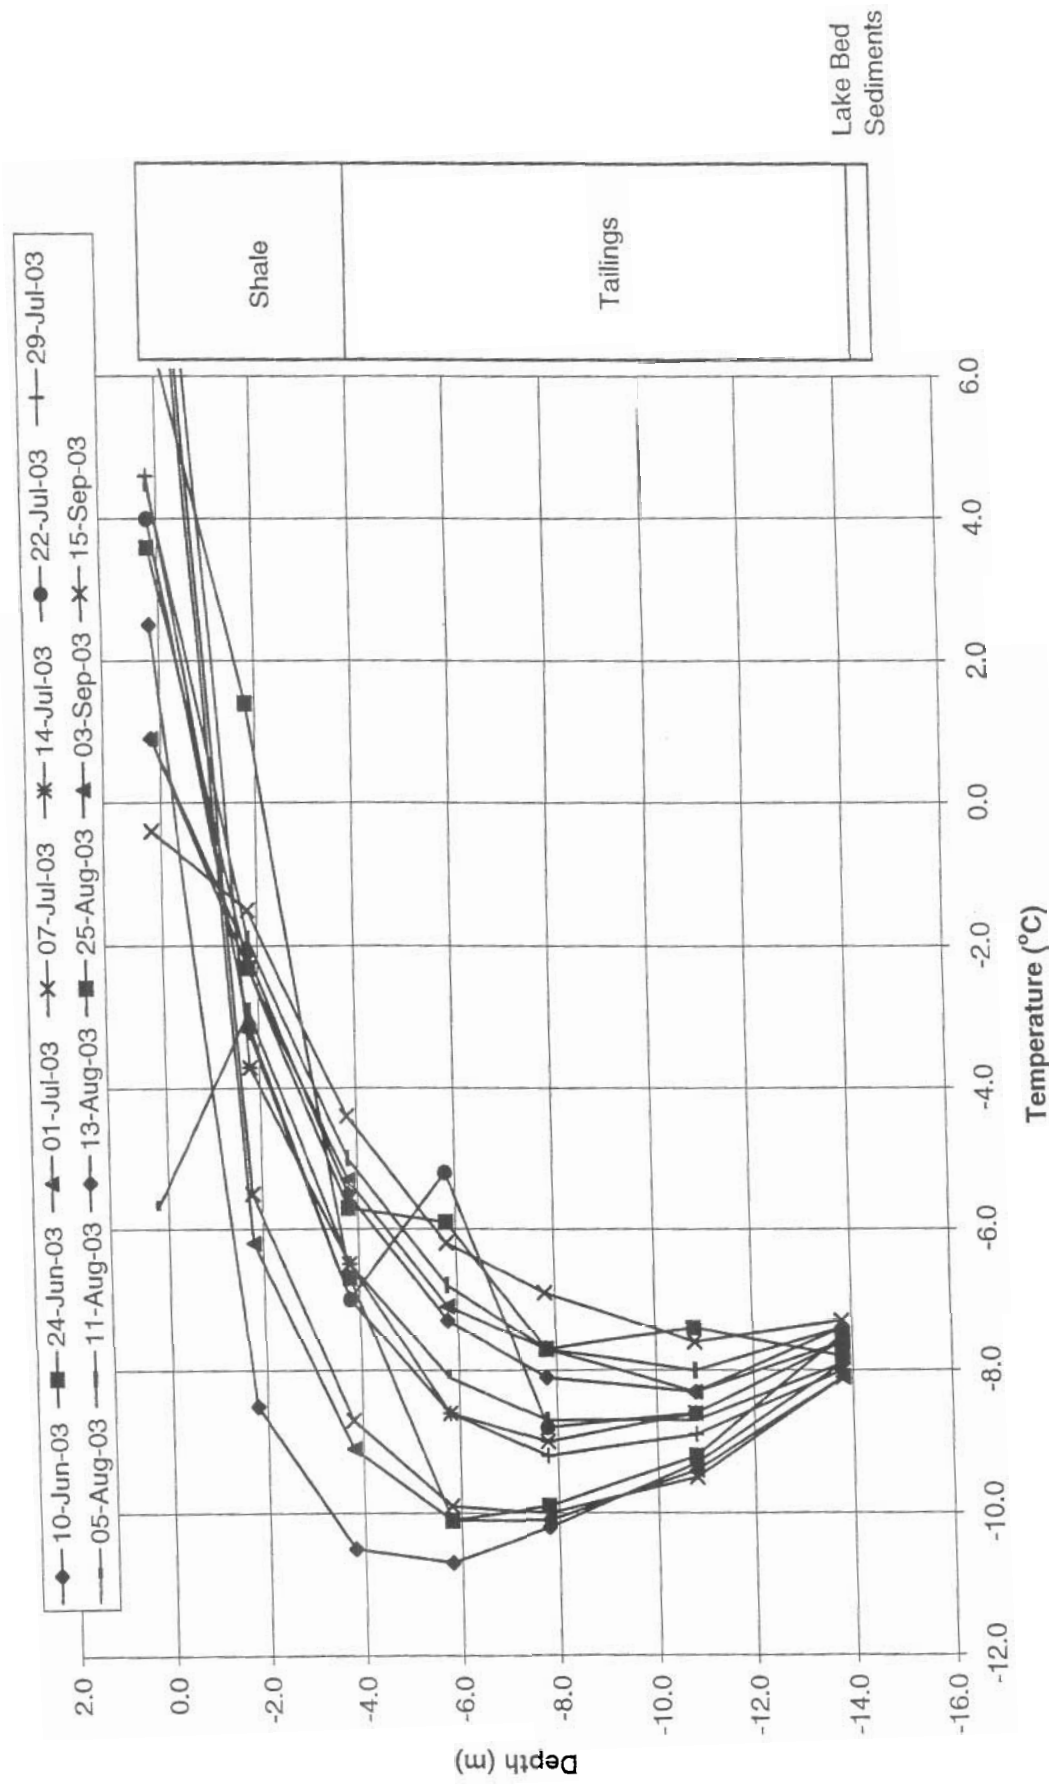
# Geothermal Monitoring West Twin Dike Thermocouple TC 34

| Instrument | Instrument type | Location | Station | Surface Elevation | Location of thawed ground (>-1°C) below active layer | Additional comments |
|---|---|---|---|---|---|---|
| 34 | T/C | Dike face | 4+75 | 385 m | N/A | No warming trends. 15 readings in 2003. |
