### **INSPECTION MEMO OF SEPTEMBER 11, 2003**

## **PROJECT MEMORANDUM**

| <b>Subject:</b> | <b>Inspection Visit relative to Waste Containment Dikes and Berms<br/>Summary of Site Observations and Commentary</b> | | |

Nanisivik Mine - Annual Geotechnical Inspection of Dikes  
Nanisivik Mine, a division of Canzinc

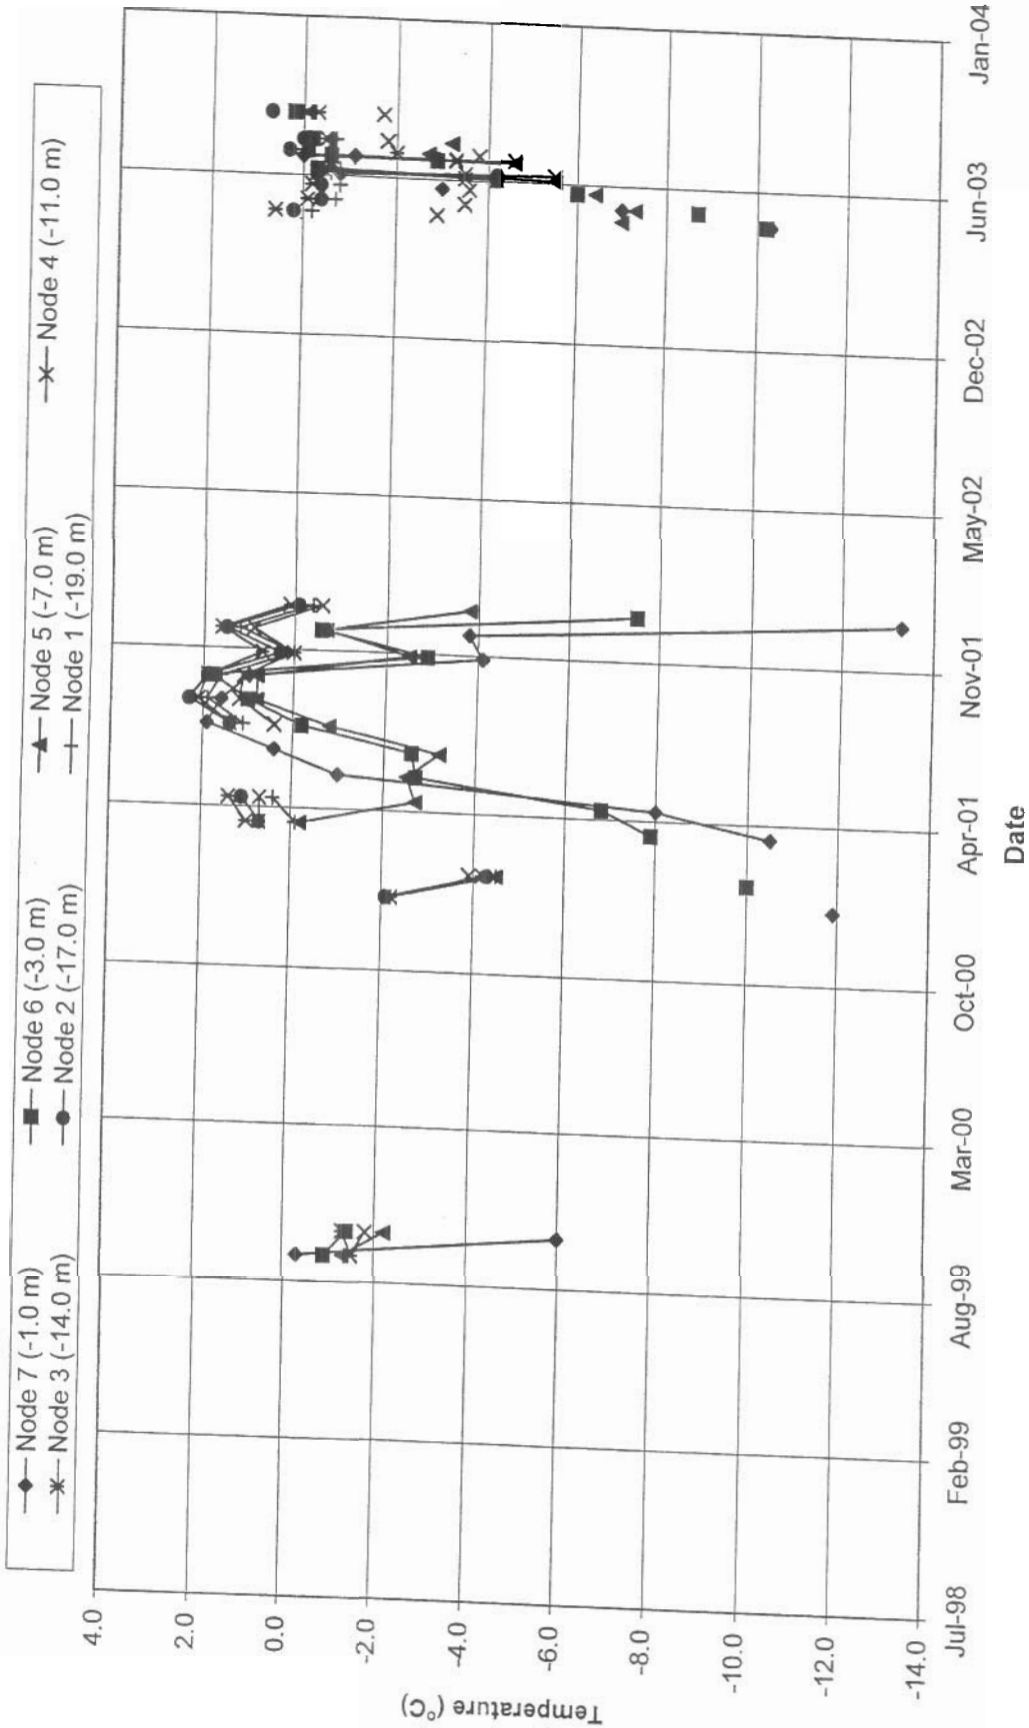
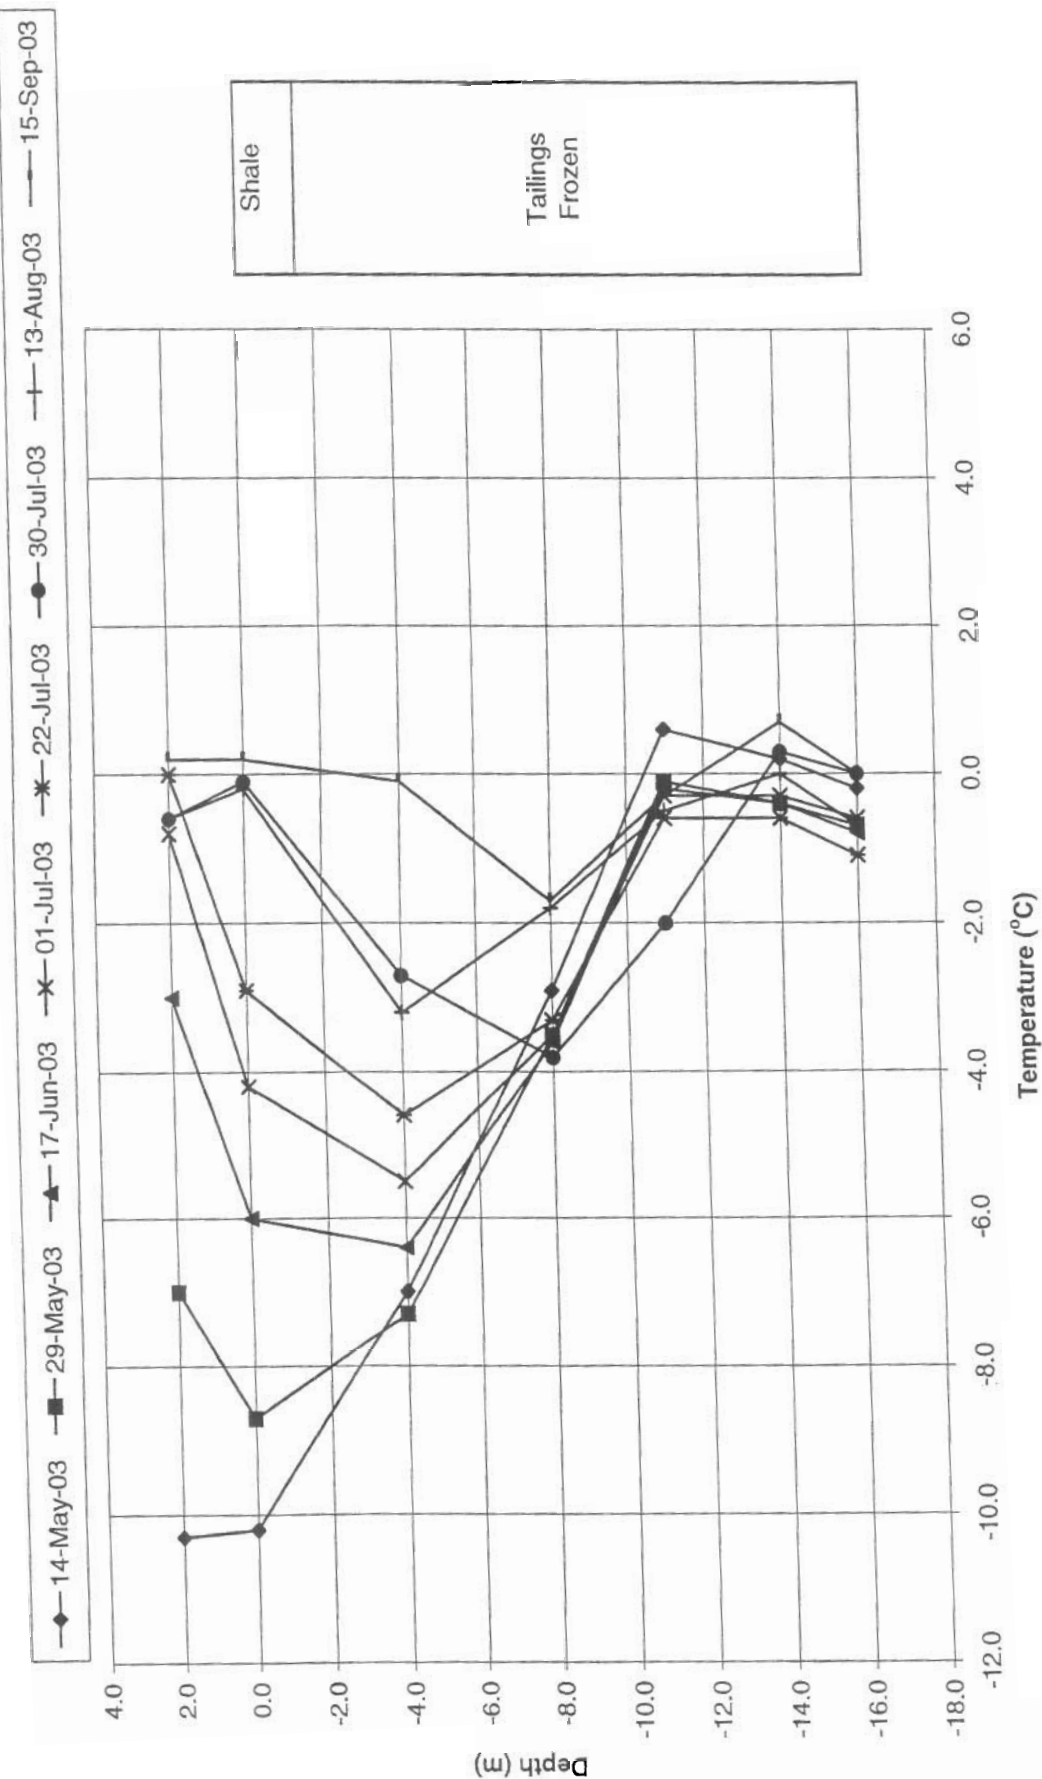
# Geothermal Monitoring West Twin Dike Thermocouple TC 35

| Instrument | Instrument type | Location | Station | Surface Elevation | Location of thawed ground (>-1°C) below active layer | Additional comments |
|---|---|---|---|---|---|---|
| 35 | T/C | Dike Crest | 00+75 | 388 m | 10 to 16 m. | Thawed conditions below a depth of 10 m. 8 readings in 2003. |

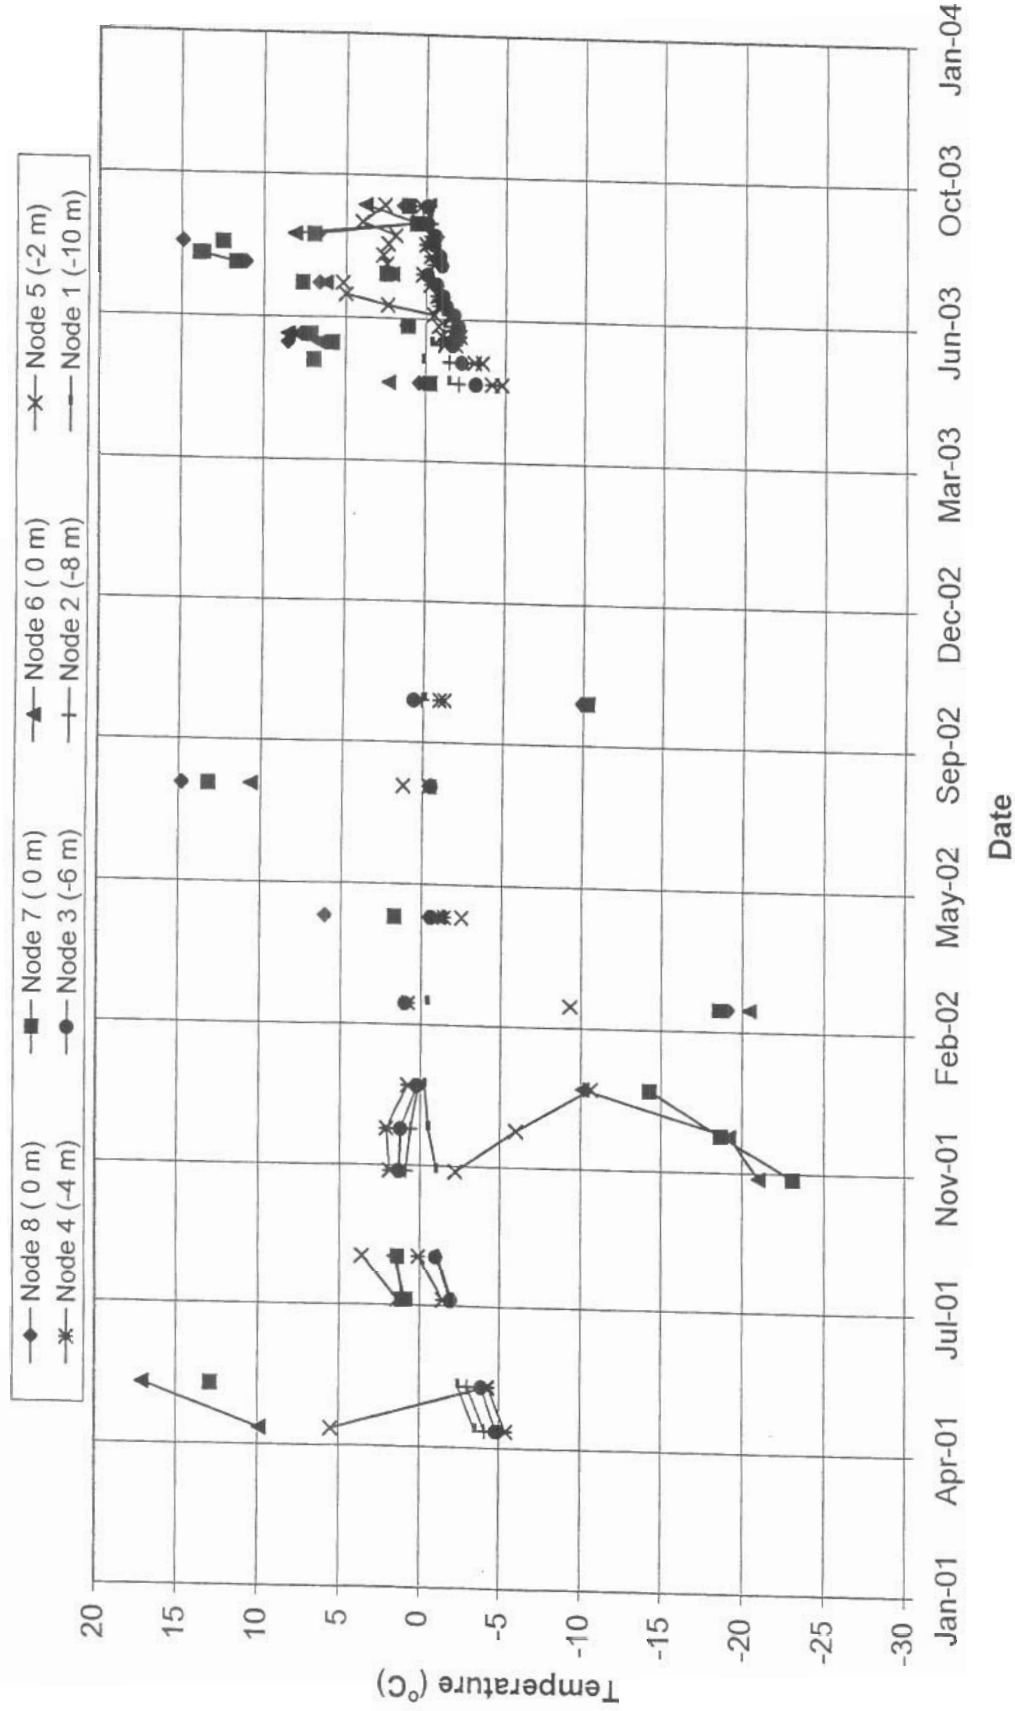
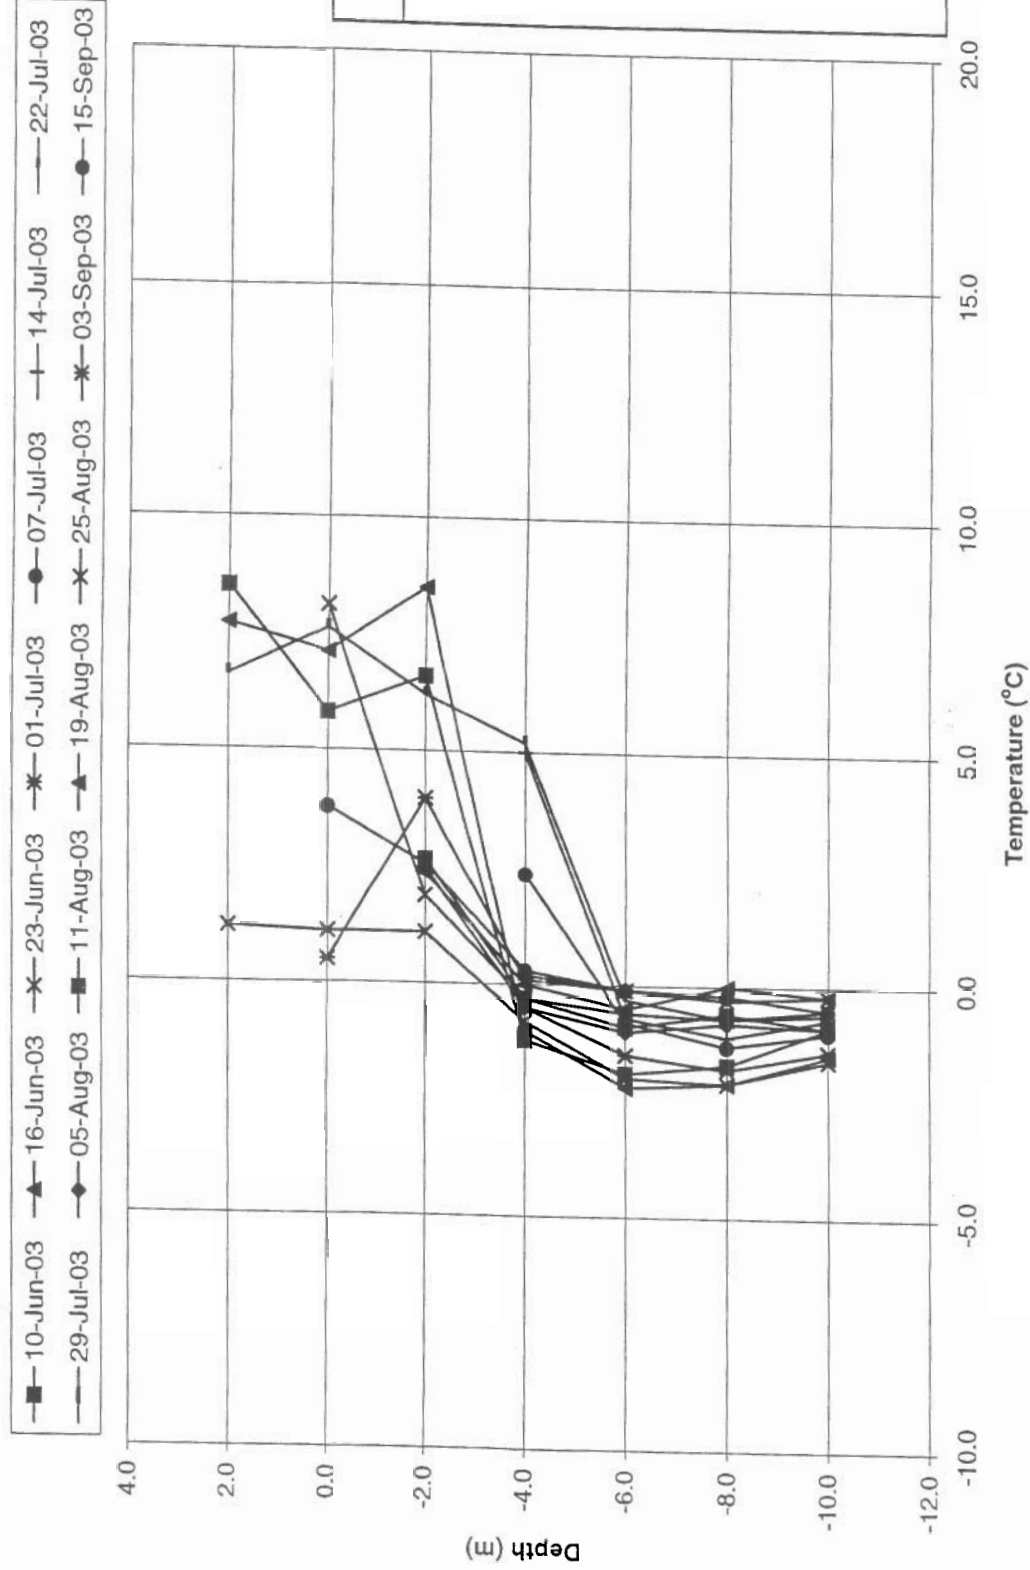
# Geothermal Monitoring Test Cell Dike Thermocouple TC 36

| 36 | T/C | Test Cell | | 376 m | 5 to 10 m | Thawed zone below a depth of 5 m to the end of the hole. 14 readings in 2003. |
