Nanisivik Mine, a Division  
of CanZinco Ltd.

| PROJECT | ANNUAL INSPECTION OF WASTE<br>CONTAINMENT DIKES | | | | |
| TITLE | WEST TWIN DIKE - TOE PHOTOS | | | | |

| <b>Subject:</b> | <b>Inspection Visit relative to Waste Containment Dikes and Berms<br/>Summary of Site Observations and Commentary</b> | | |

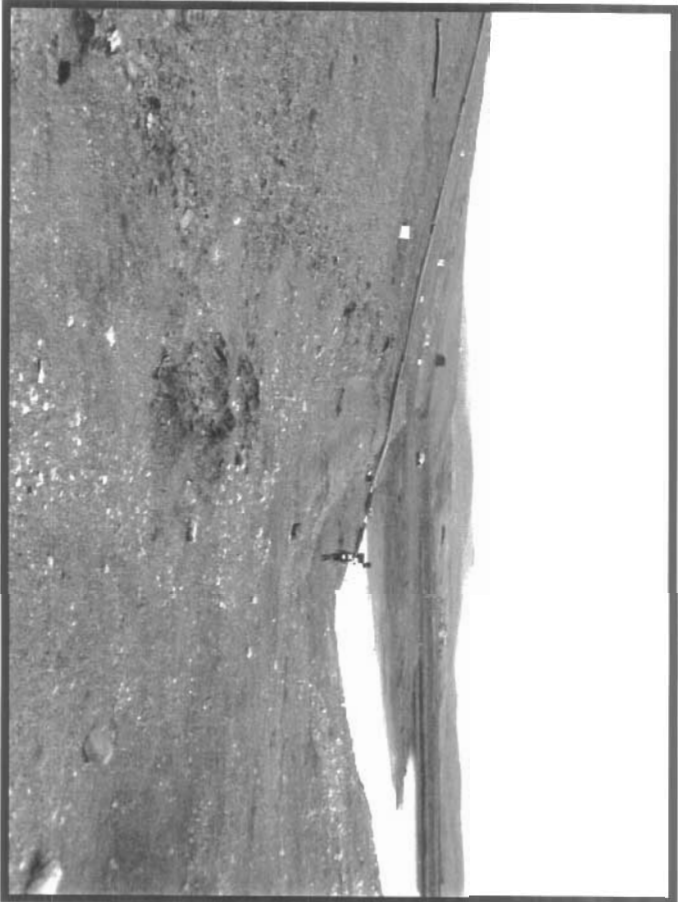
Photo 62 is taken at the toe of the West Twin Dike. The photo is taken from the south end of the dike looking north. Note frost mound features in the foreground.

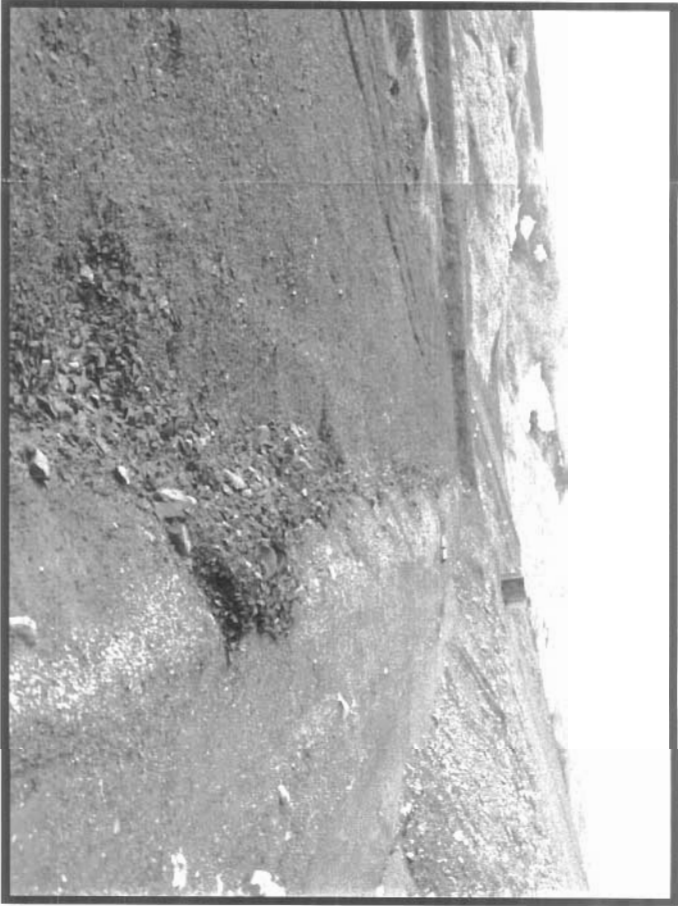
Photo 73 is taken along the toe of the dike looking towards the south. Note that this is probably mid-way down the 374 m bench. Additional tailings have been placed at the toe of the dike in this area and have increased the elevation of the "toe" of the dike.

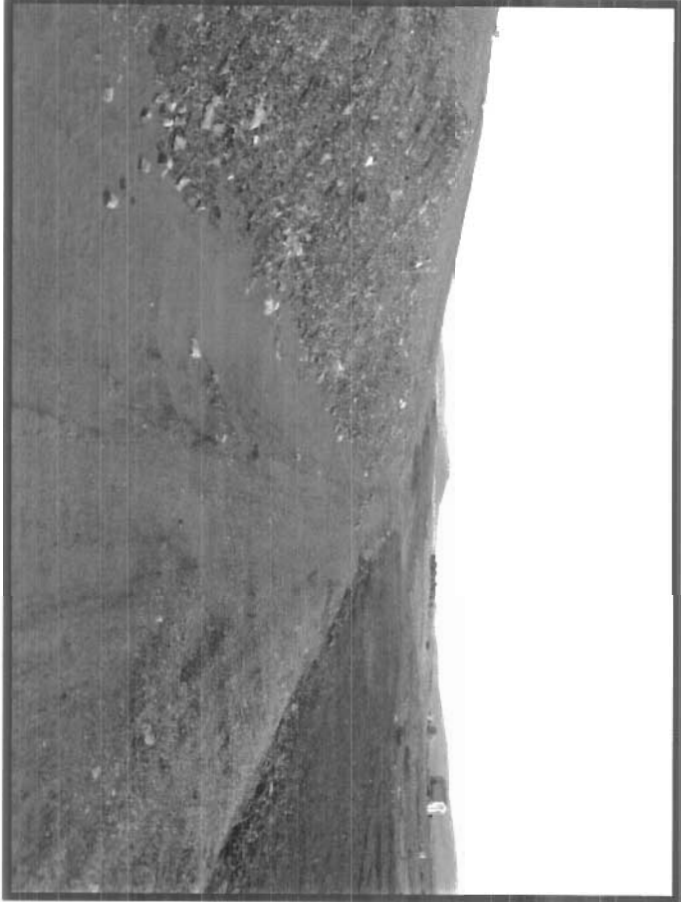
Photo 72 is taken at the toe of the West Twin Dike looking north taken on the north half of the dike. Note that there are tailings exposed at the surface here blended in with shale. The tailings were likely deposited here by wind transporting them from the Test Cell.

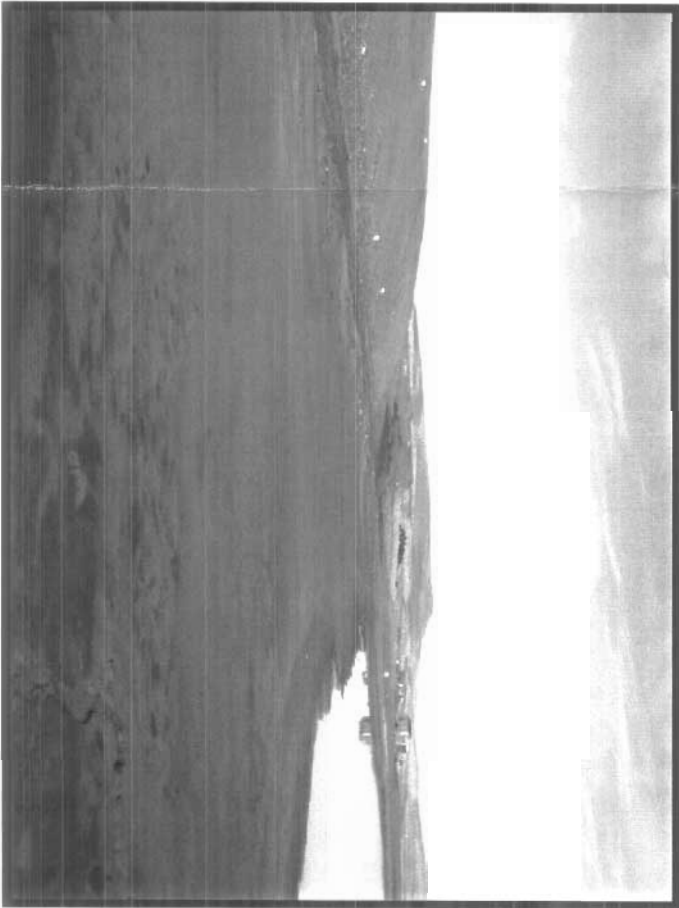
Photo 92 is of the tailings beach in the Test Cell proximal to the toe of the West Twin Dike. The view is looking north. Note that the water line is approximately 50 m from the toe of the West Twin Dike.

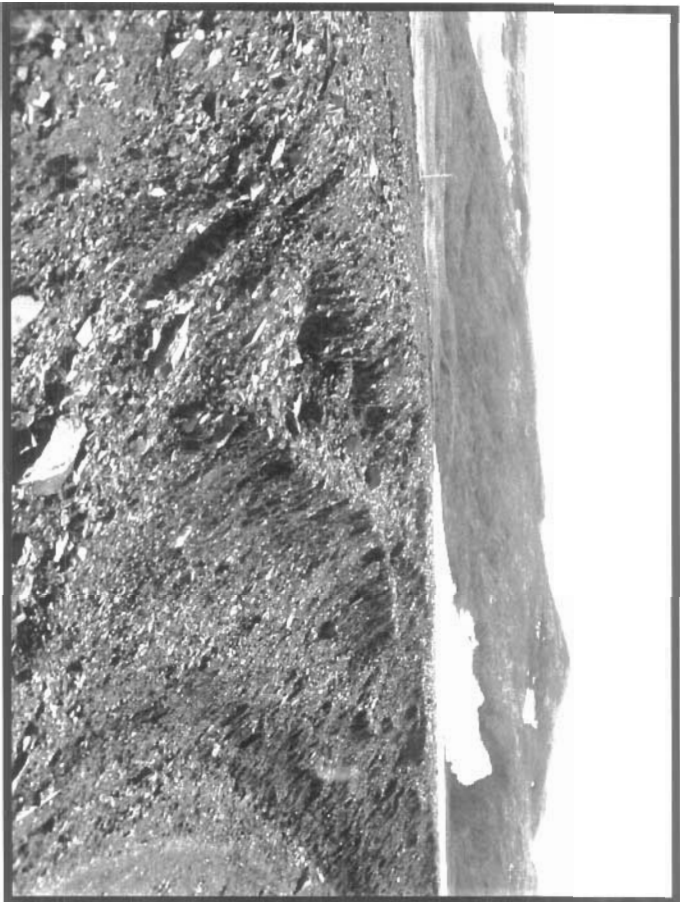
Photo 86 shows some surficial sloughing of the Test Cell side face of the dike.

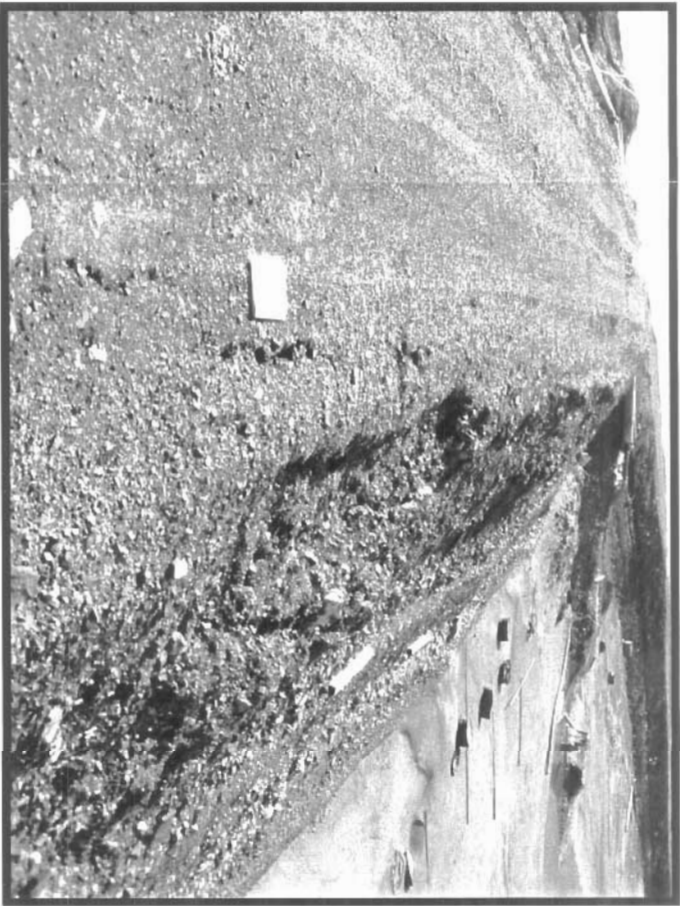
Photo 88 shows some cracking along the crest in the area where the sloughing is occurring on the Test Cell side of the dike.

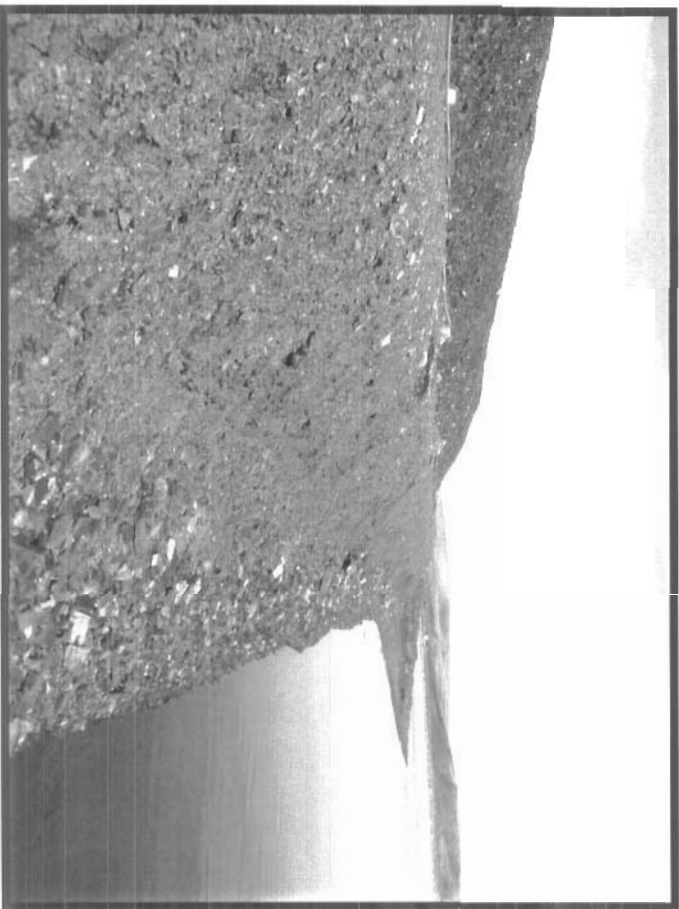
Photo 100 shows the toe of the Test Cell Dike where the EMW arm and the N/S arm meet.

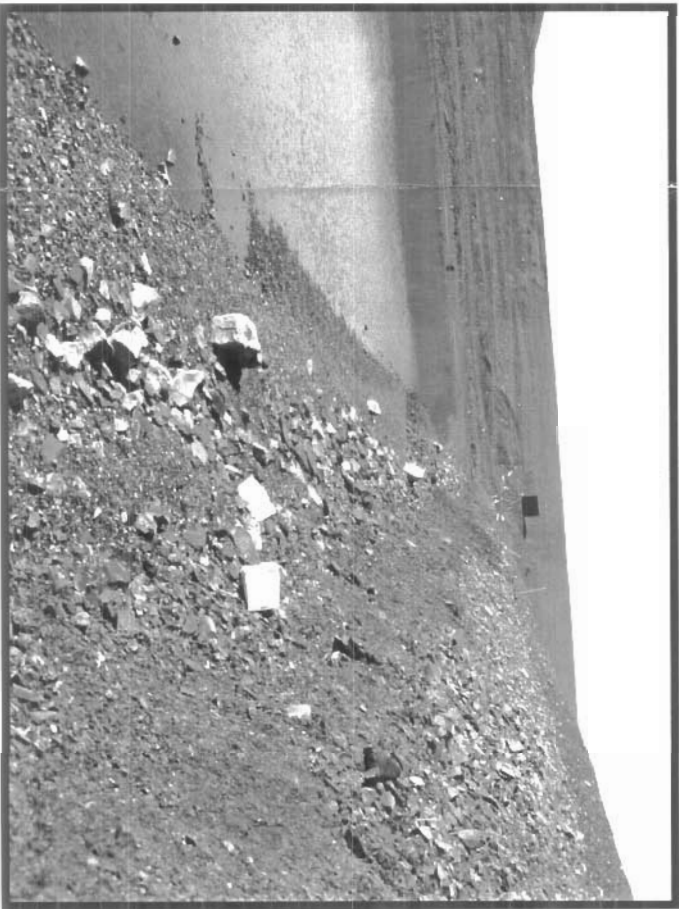
Photo 96 is of the toe of the Test Cell Dike taken looking towards the west. Note the file folder in the photo for scale. Note the surficial sloughing of the dike at this location that has occurred. The sloughing is possibly related to undercutting erosion from wave action when the reservoir is at a high water level.

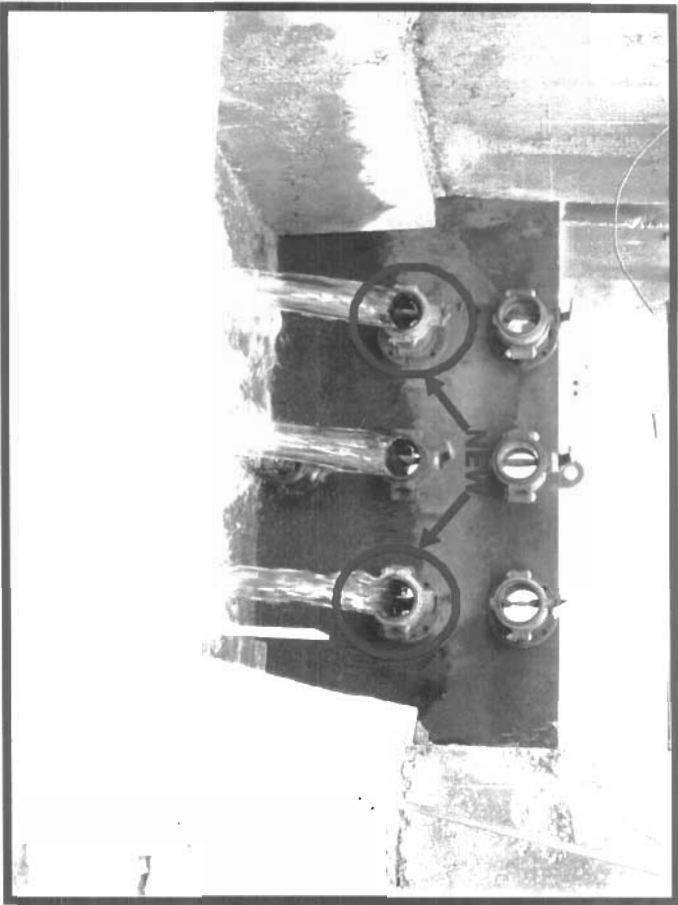
Photo 8 is a view of the outlet valves. Note the additional valves installed since last year.

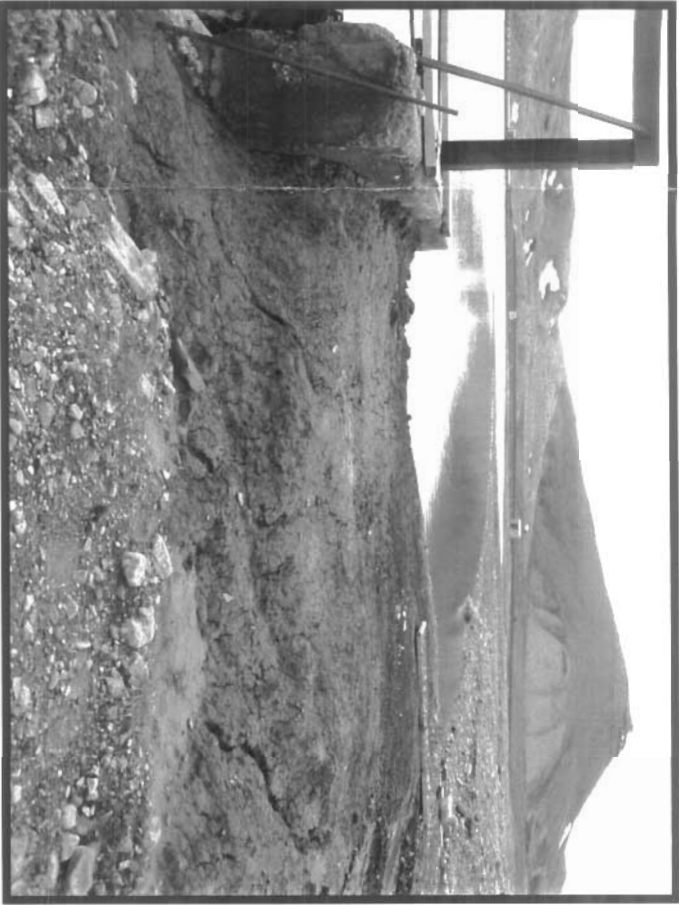
Photo 118 is of the north side of the of Polishing Pond Outlet structure. Note the erosion around the concrete observed last year has been repaired by placing additional marine silt and clay.

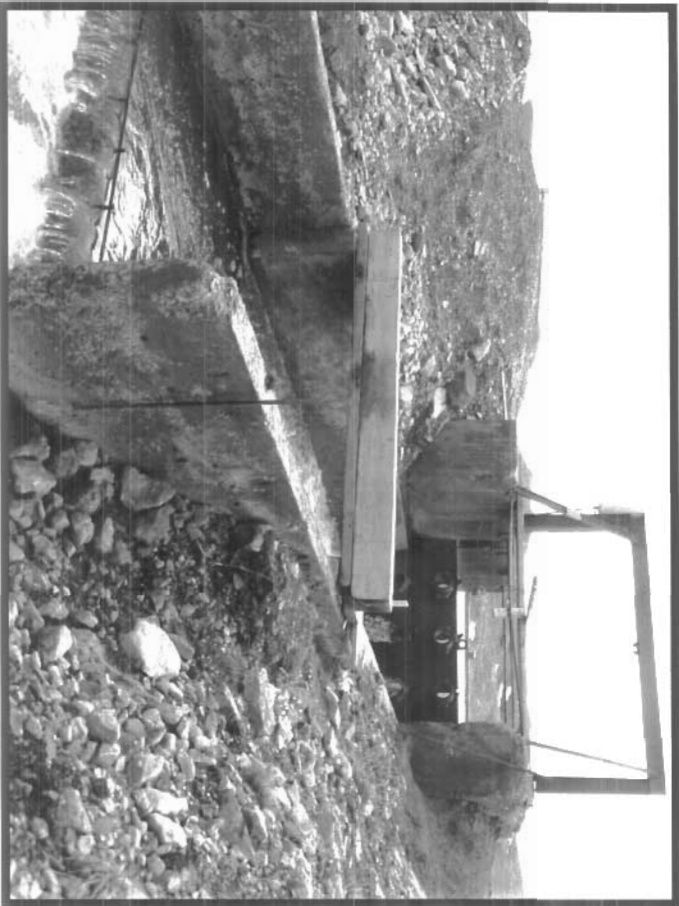
Photo 116 is of the Polishing Pond Outlet structure. Note the flow is only occurring from the middle and bottom valves.

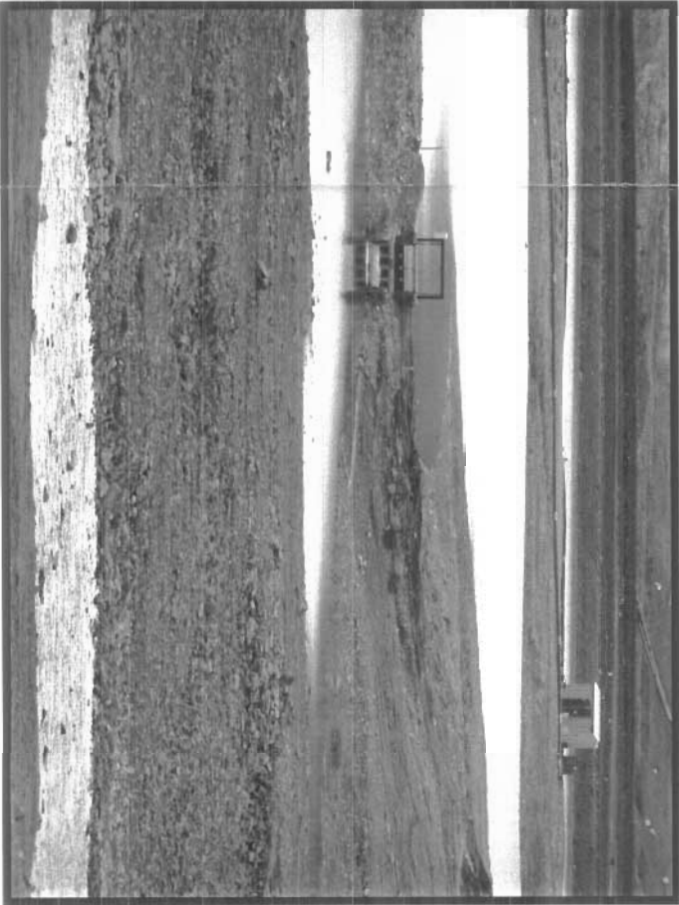
Photo 124 is of the Polishing Pond Outlet area taken from a high point east of the area.

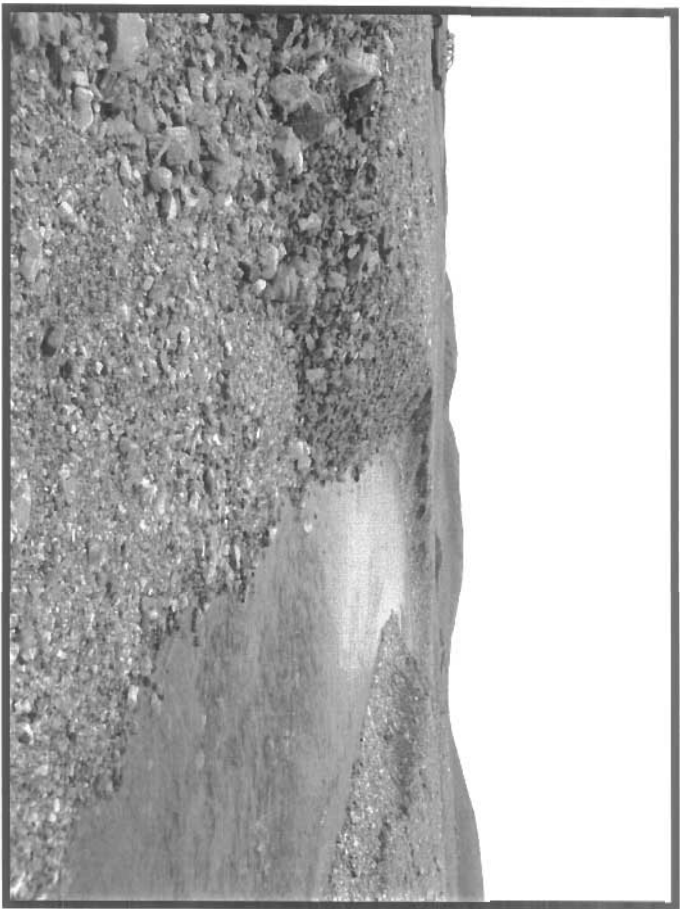
Photo 111 is taken from the south end of the Diversion Berm looking north.

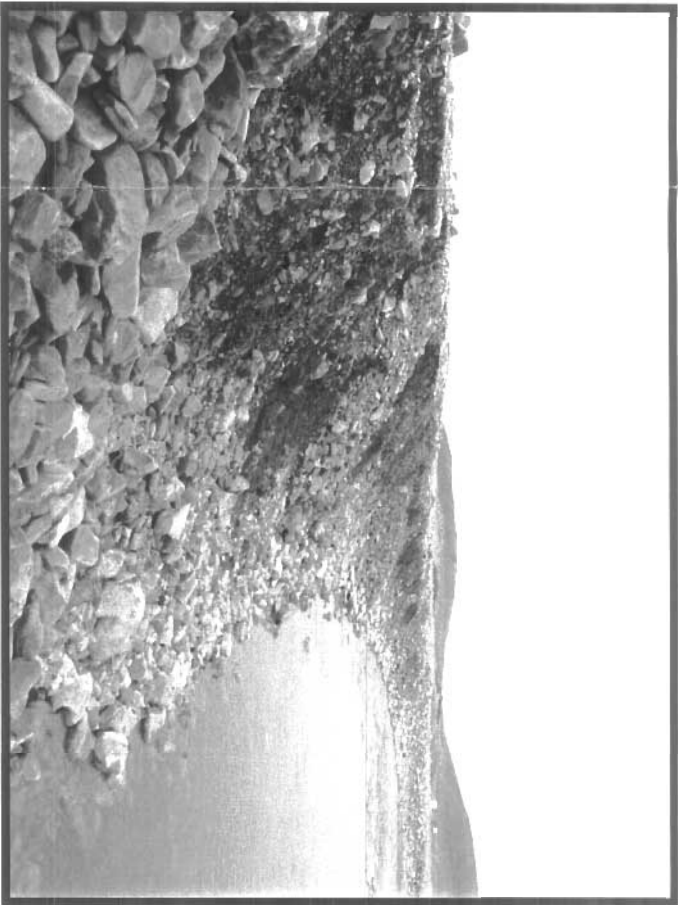
Photo 112 is taken where a bit of erosion of the bank has occurred due to undercutting by the stream.

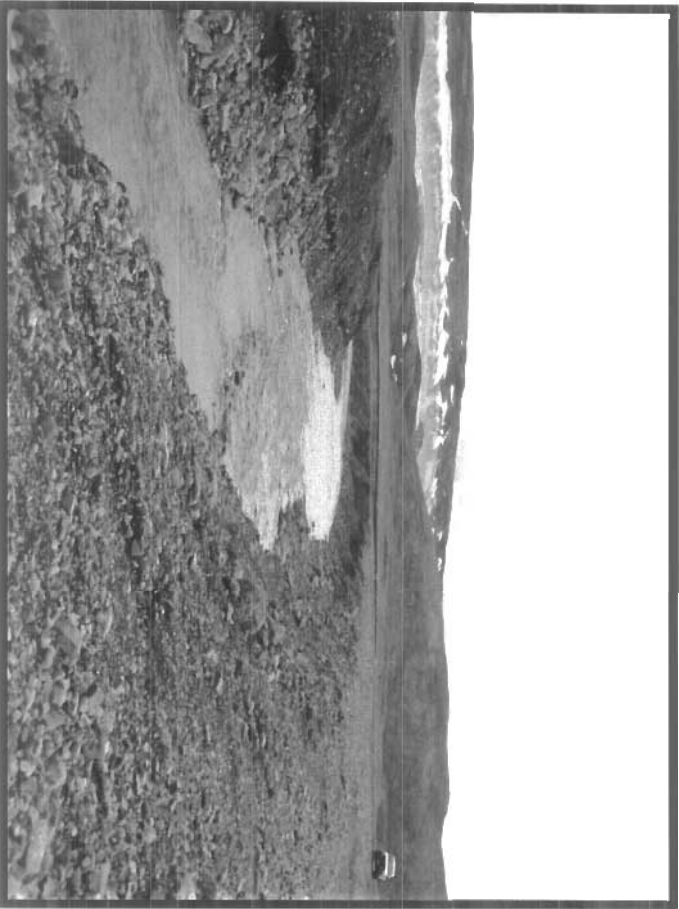
Photo 115 shows the diversion area looking south.

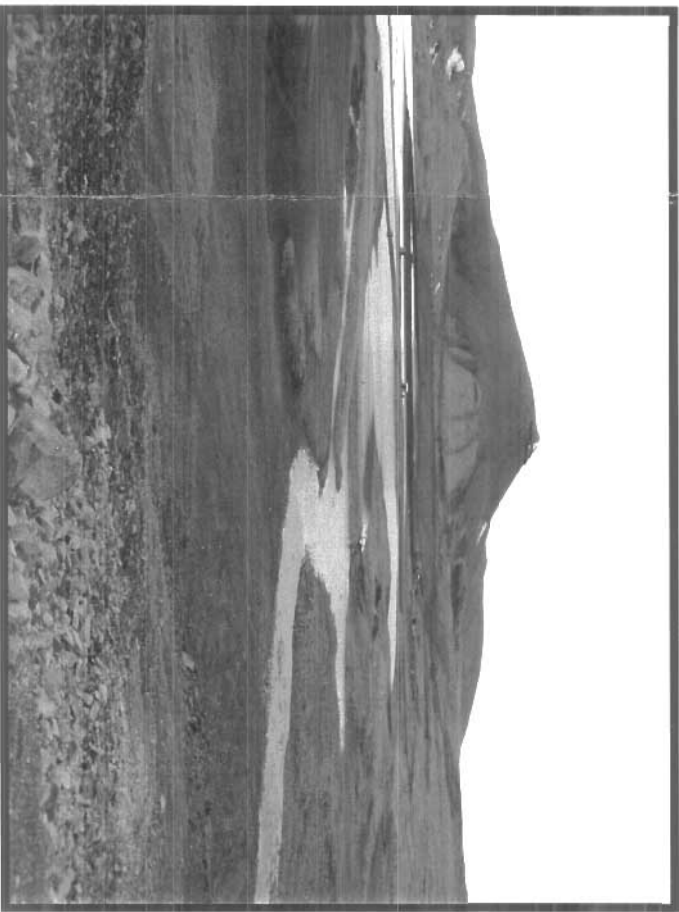
Photo 119 is of the Polishing Pond Outlet area taken from a high point east of the area.

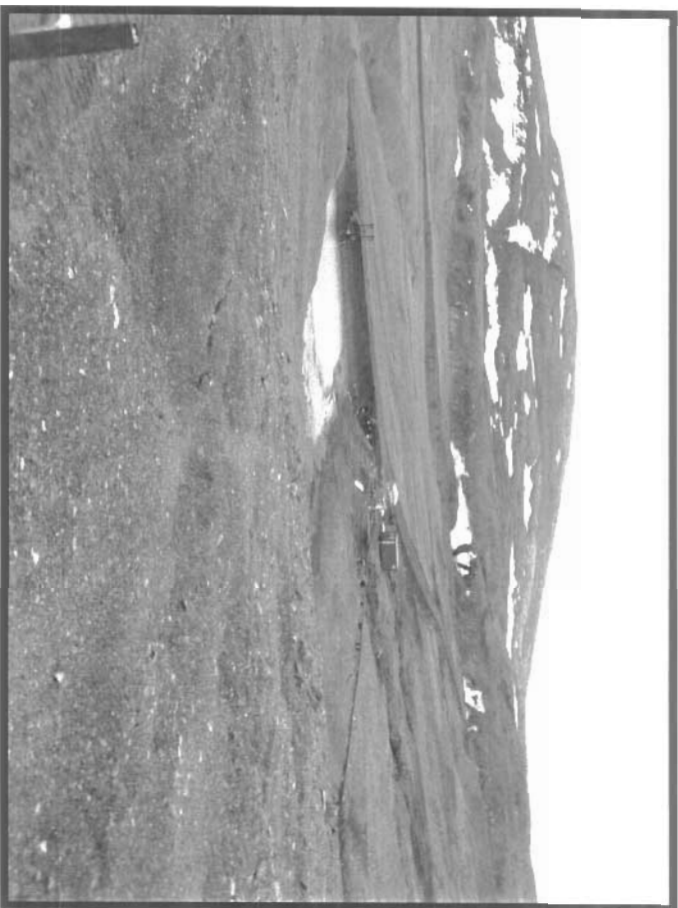
Photo 142 is an oblique aerial view of the treatment pond.

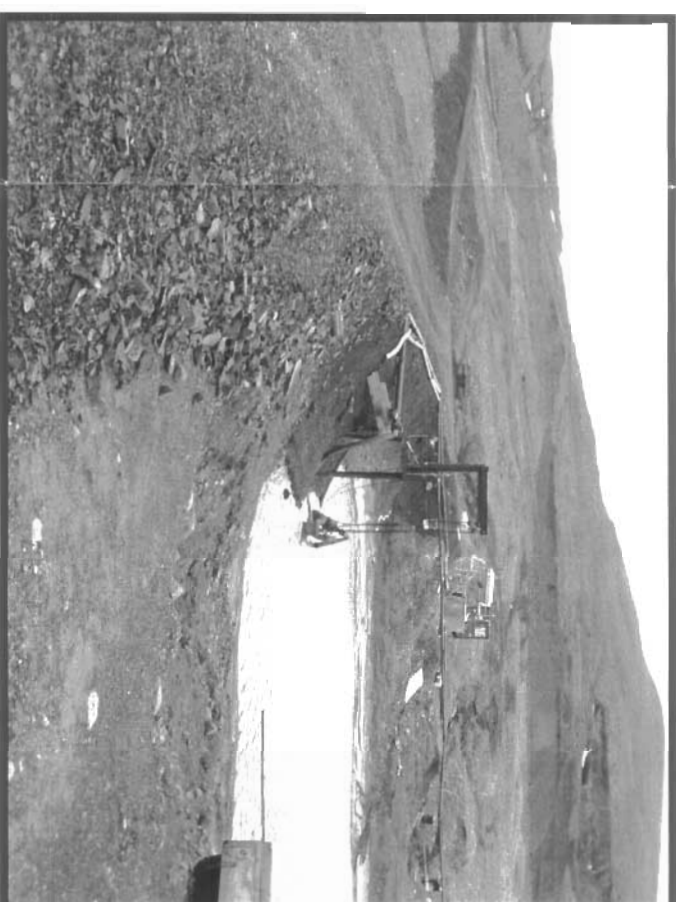
Photo 143 is a view of the upstream face of the treatment pond dike. The view is looking south from the north end of the dike.

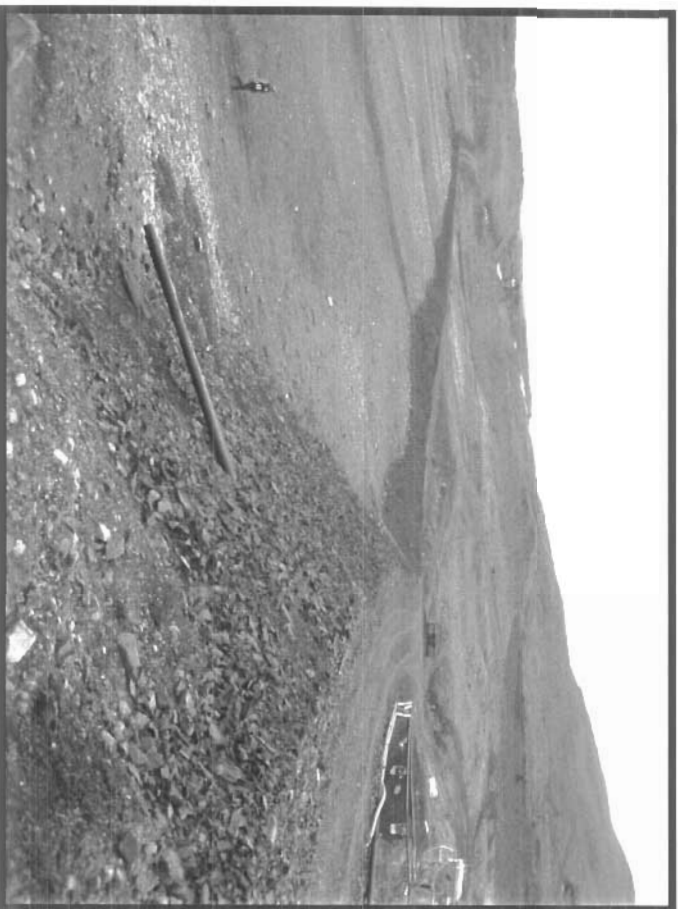
Photo 146 is a view of the downstream face of the dike from the north end of the dike.

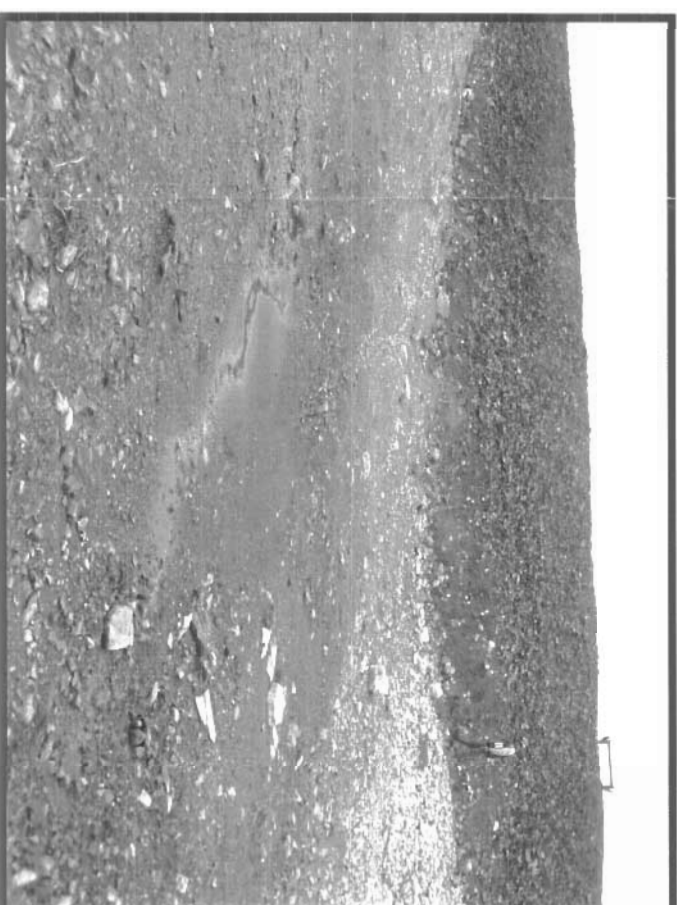
Photo 148 is a view of a wet area approximately 10 m downstream of the centre portion of the treatment pond dike.

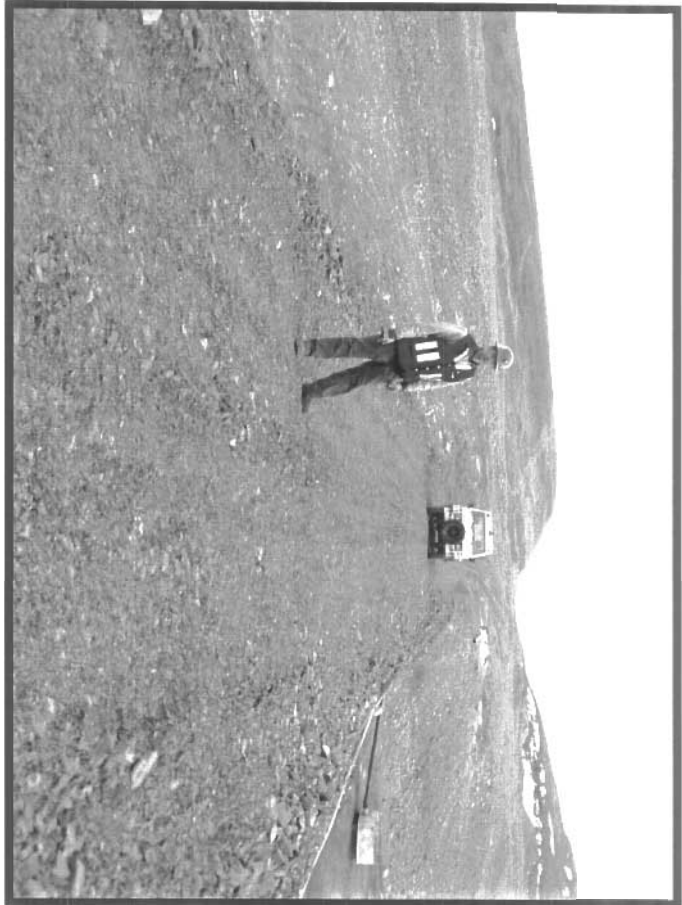
Photo 138 is a view of the crest of the retention pond dike. View is taken from the centre of the dike looking east.

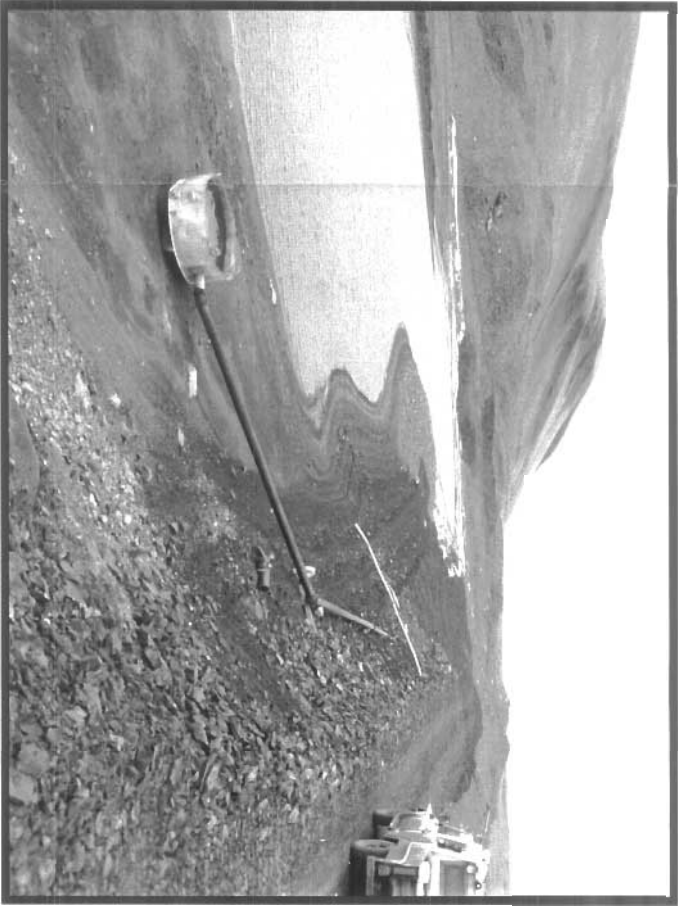
Photo 131 is a view of the upstream toe of retention pond dike from crest of dike. View is from east end of the dike looking west.

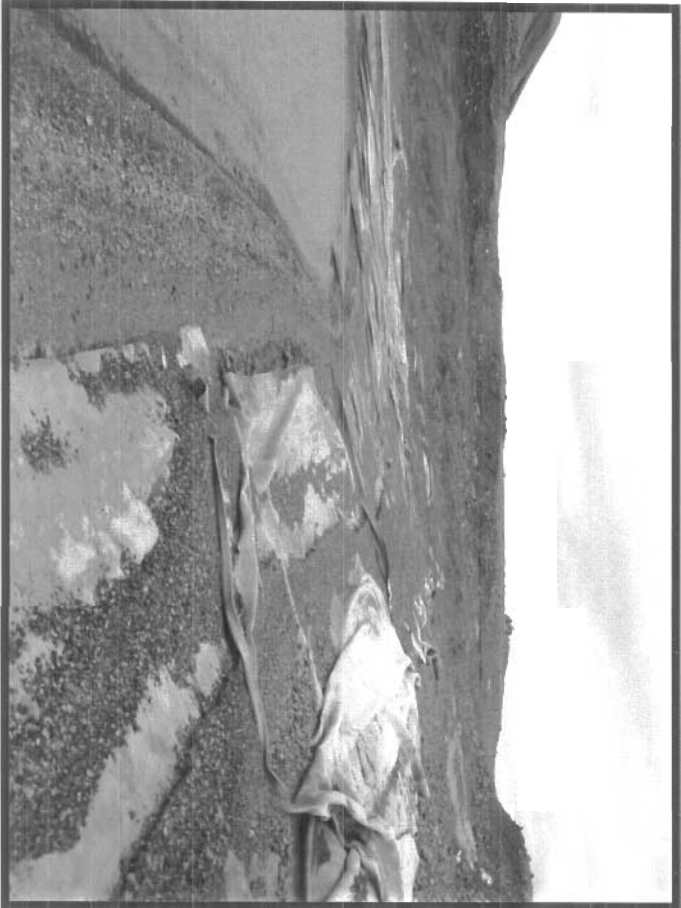
Photo 136 is a view of the northwest corner of the treatment pond. Note the ruffled nature of the liner.

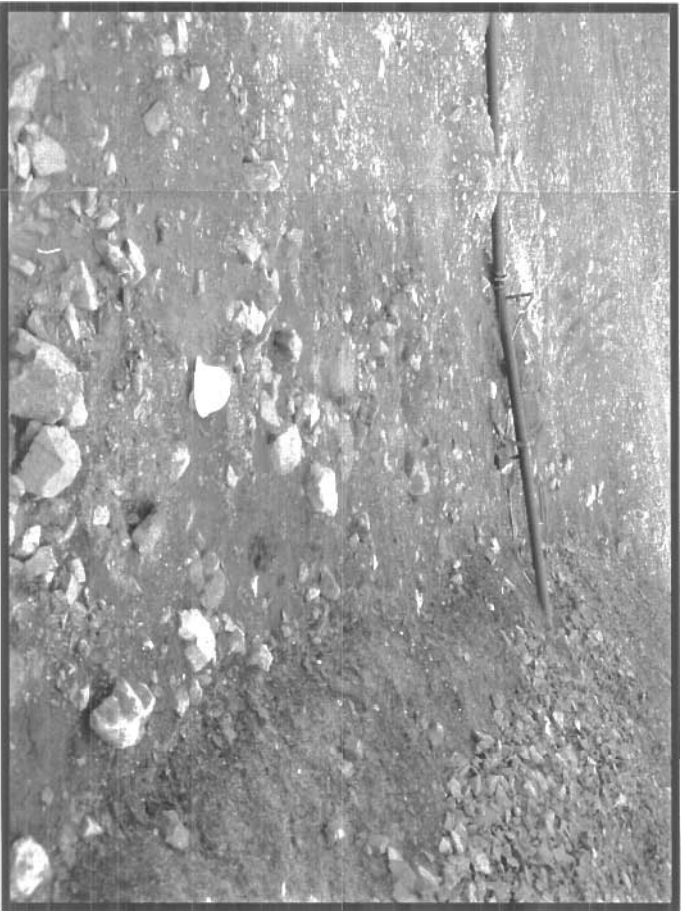
Photo 140 is a view of the downstream face of the dike at the centre of the dike. Note the wet area near the toe of the dike (by the hardhat). This may indicate seepage beneath the dike at this location.

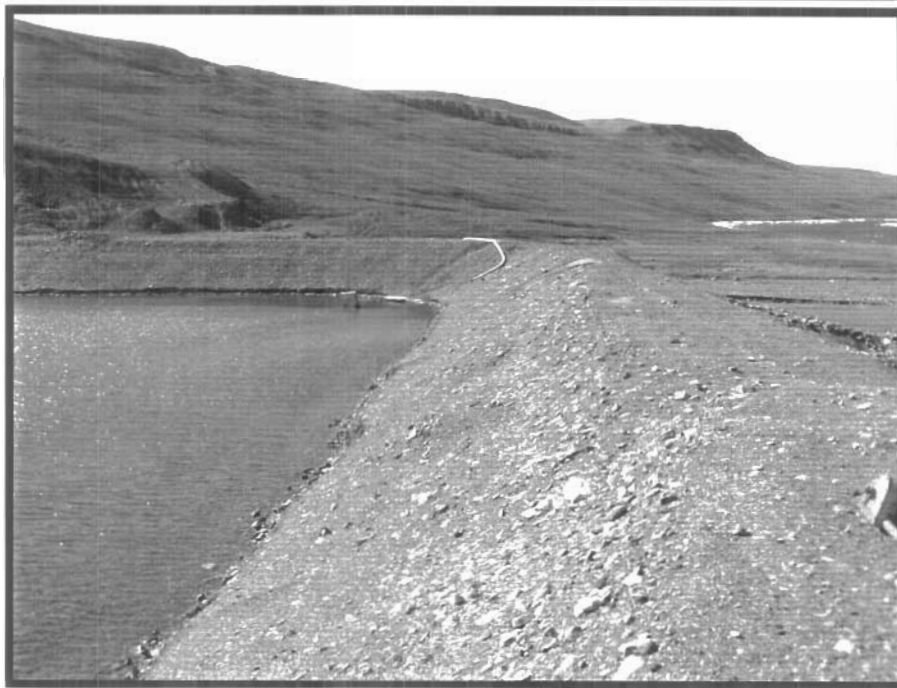
Photo 51 is taken along the north edge of the berm looking west. Note the water collected in the berm.

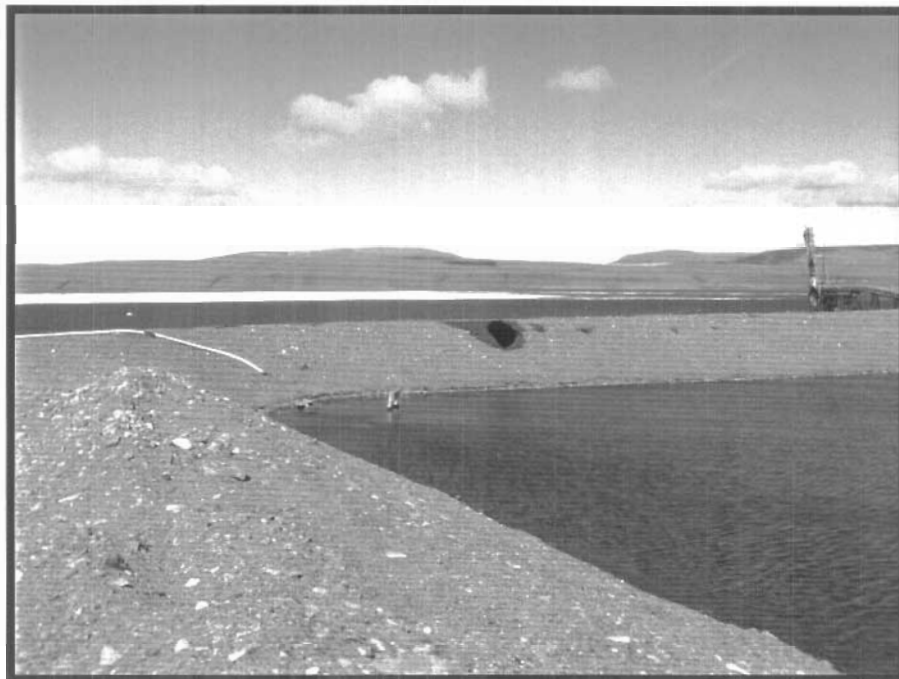
Photo 52 is taken looking towards the northwest corner of the containment berm. It is an area where the liner is exposed. As can be seen it has been repaired at some point in the past. The depth of water within the pond is approximately 50 cm.

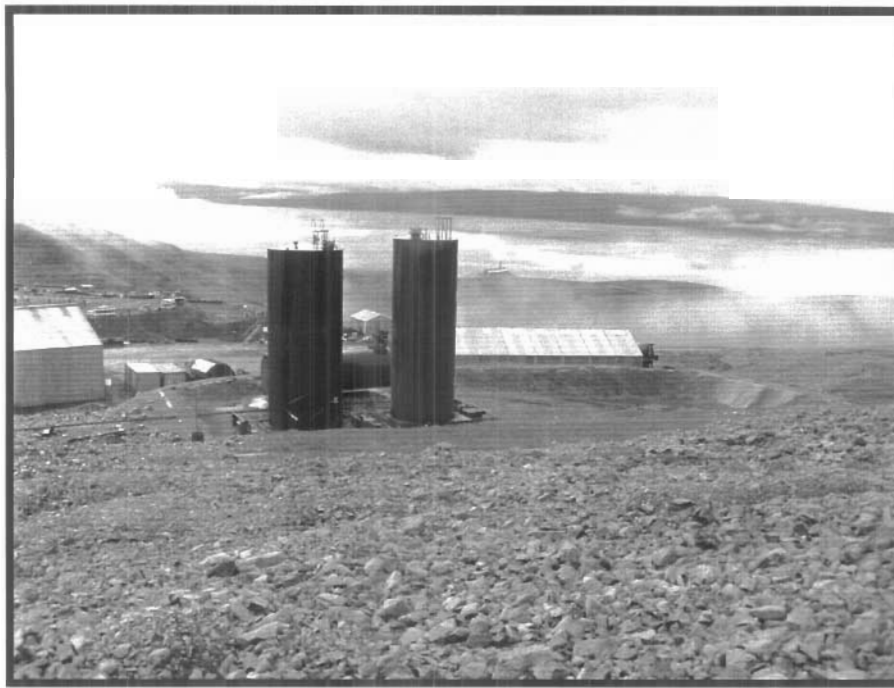
Photo 8 at the Day Tank Farm is taken from upslope of the Tank Farm. The photo is taken looking to the west.

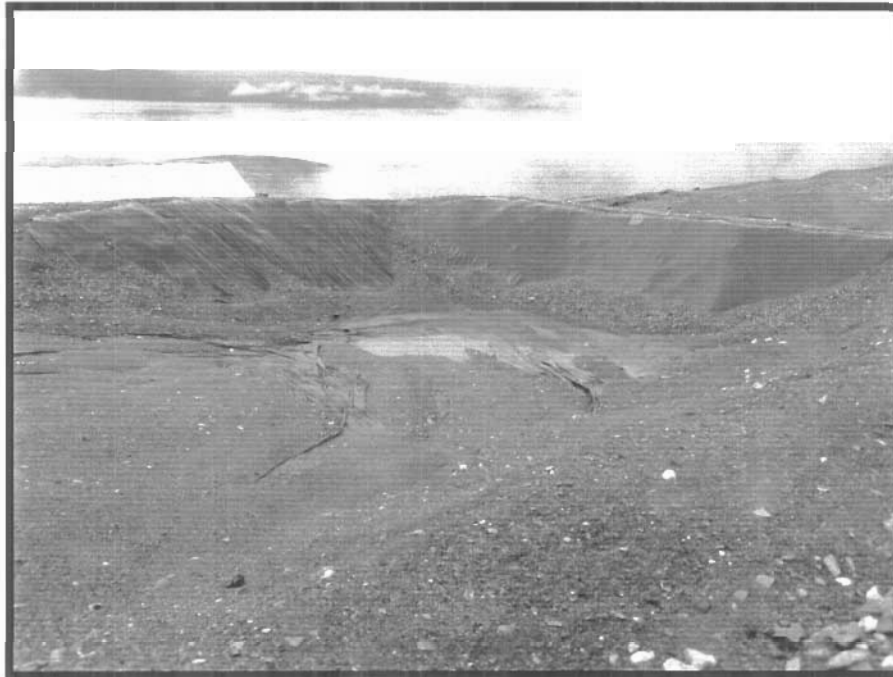
Photo 10 is taken towards the north end of the Tank Farm in the water collection pit. Note that there is currently approximately 50 centimeters of water in the deepest spot collected in the bottom of this pit.

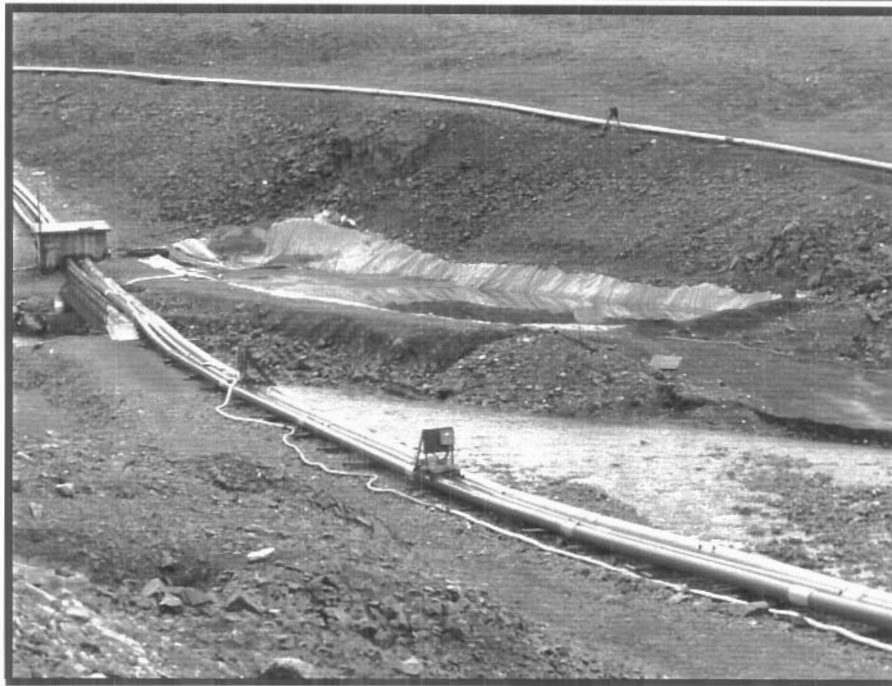
Photo 14 taken at the Mill Dump Pond is an oblique aerial shot from the top of the slope near the mill.

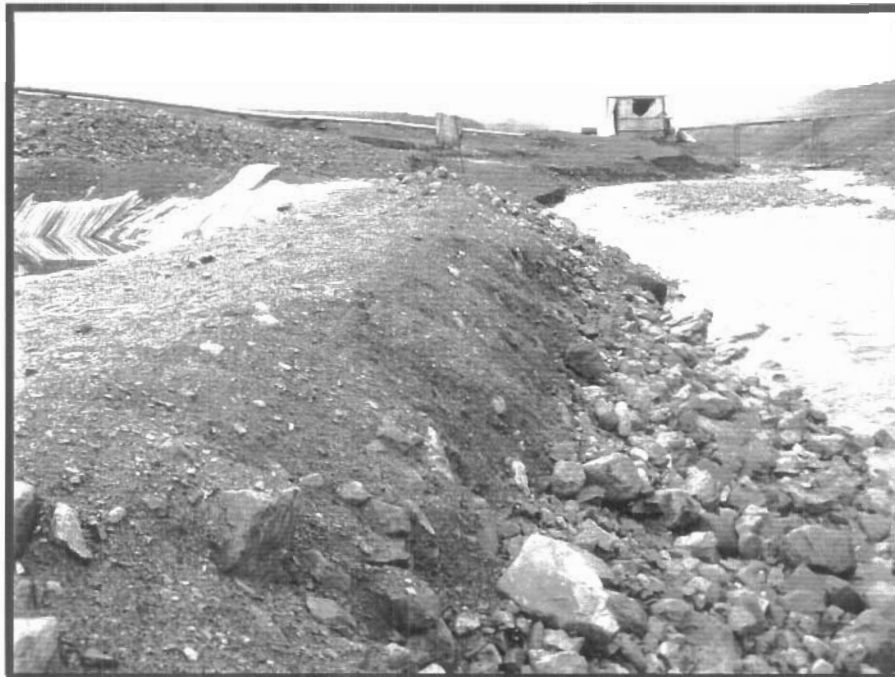
Photo 18 is taken along the outside toe of the berm proximal to Twin Lakes Creek. The erosion of the toe of the berm does not appear to have increased since the 2003 inspection. The main erosion area near the west limit of the berm was repaired by adding rockfill to the berm at this location.

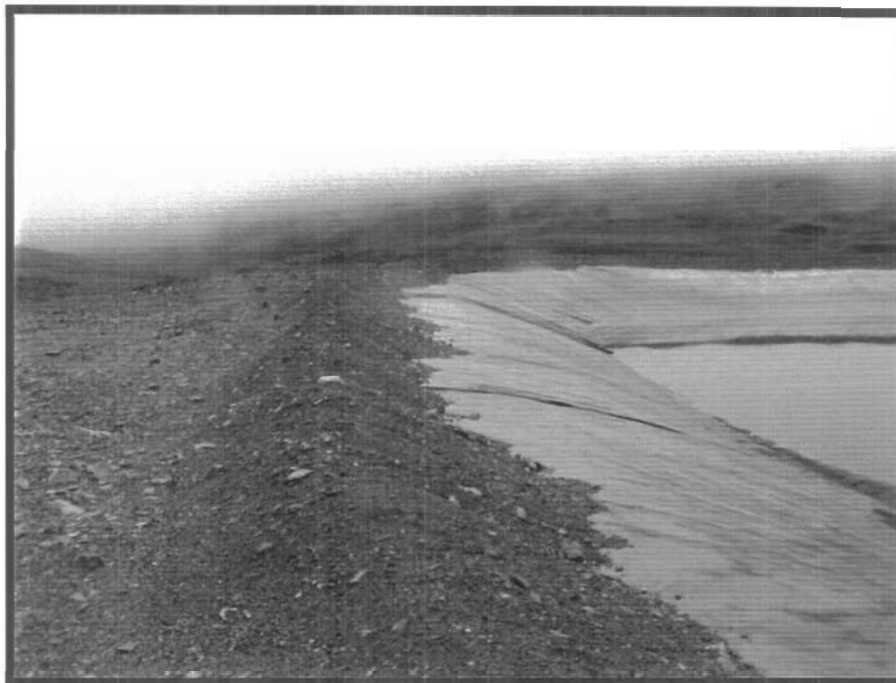
Photo 31 is of the shale and native ground material holding down the liner.

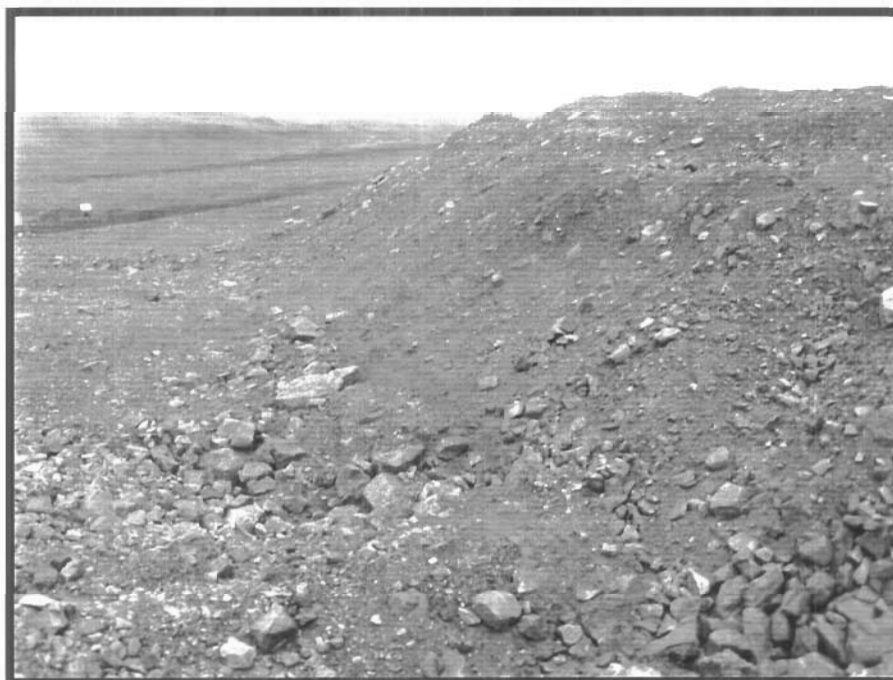
Photo 33 is of the outside face of the berm near the north west corner of the dump pond.
