BGC Project Memorandum

To: Murray Markle – Nanisivik Mine
Subject: Summary of Annual Inspection Visit

Date: July 30, 2004
Proj. No: 0255-009-06

PROJECT	ANNUAL INSPECTION OF WASTE CONTAINMENT DIKES
TITLE	WEST TWIN DISPOSAL AREA
PROJECT No.	0265-009-06
DWG	FIGURE A2-1
REV.	0

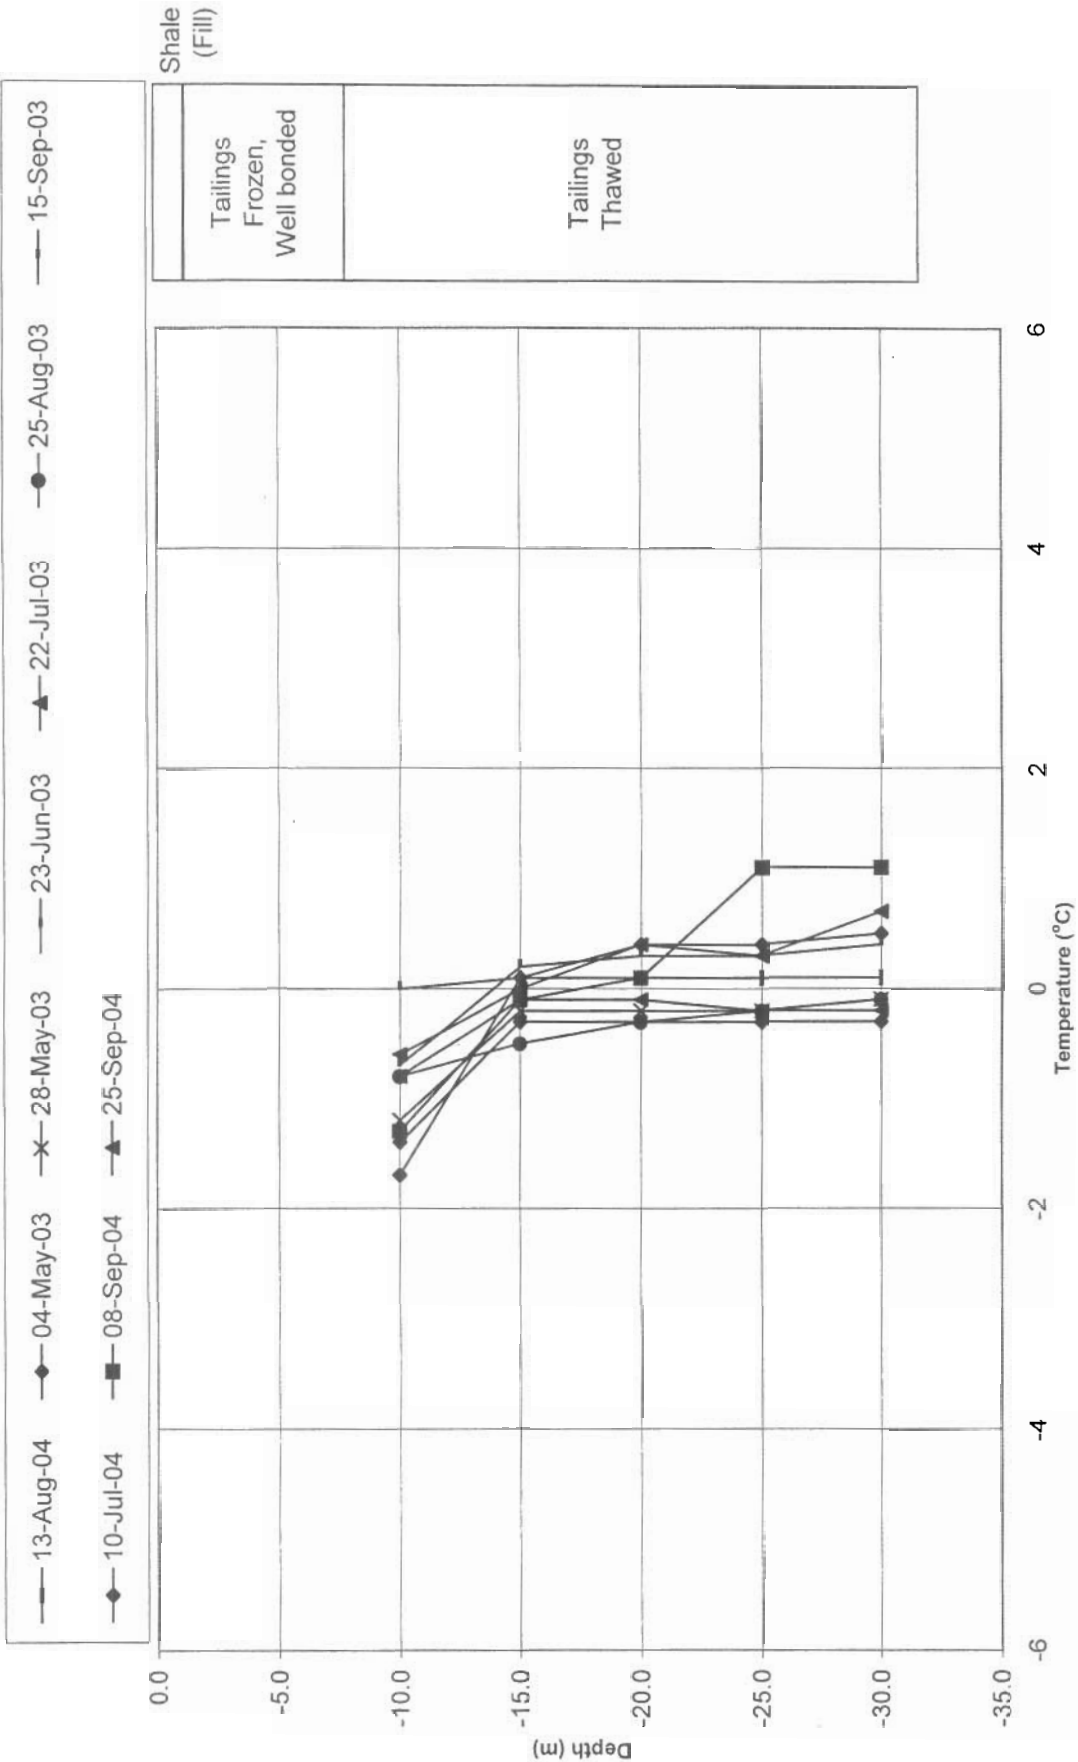
Geothermal Monitoring
Surface Cell
Thermocouple BGC02-13

BGC02-13	T/C	SC		387	10 to 30 m	No warming or cooling trends noted in data. Data quality erratic during periods of cold climatic conditions.	Stop Monitoring
BGC03-03	T/C	SC		387	N/A	Frozen ground conditions below 4 m throughout entire year.	Stop Monitoring
BGC03-07	TM	SC		387	18 to 25 m	Cooling of ground temperatures observed where thawed tailings were previously encountered (18-25 m).	Monthly
BGC03-09	TM	SC		387	13 to 25 m	Cooling of ground temperatures observed where thawed tailings were previously encountered (10-15 m).	Monthly
BGC03-10	TM	SC		387	7 to 27 m	Cooling of ground temperatures observed at top of thawed zone (7 m depth).	Monthly
BGC03-11	TM	SC		387	7 to 25 m	Minimal cooling of ground temperatures observed.	Monthly
BGC03-12	VW	SC		387		Increase in pore pressures observed during winter months.	Monthly
BGC03-13	TM	SC		387	13 to 16 m	Cooling of ground temperatures between 10 and 12 m observed.	Monthly
