NANISIVIK MINE, A DIVISION OF CANZINCO LTD.

2006 ANNUAL GEOTECHNICAL INSPECTION

NANISIVIK MINE, NUNAVUT

PROJECT NO.: 0255-013-08
DATE: JANUARY 10, 2007

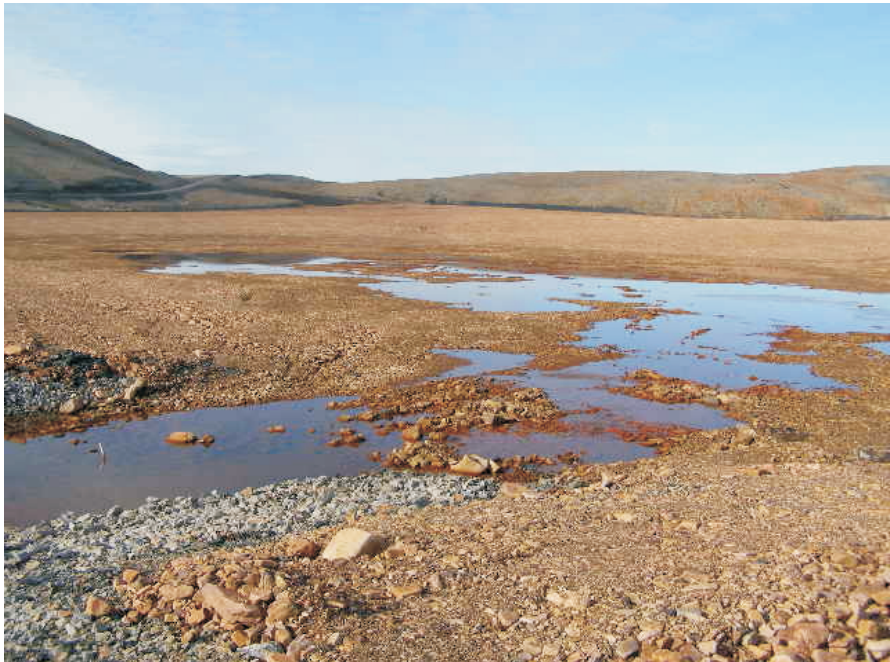
- Some cracking and minor settlement of the cover was observed in the east/west drainage swale.
- A small head pond was present at the spillway inlet (approximately 30 cm deep).
- No erosion of the cover was observed.

Photo 22
East/West drainage swale at Surface Cell. Note cracking along slopes.

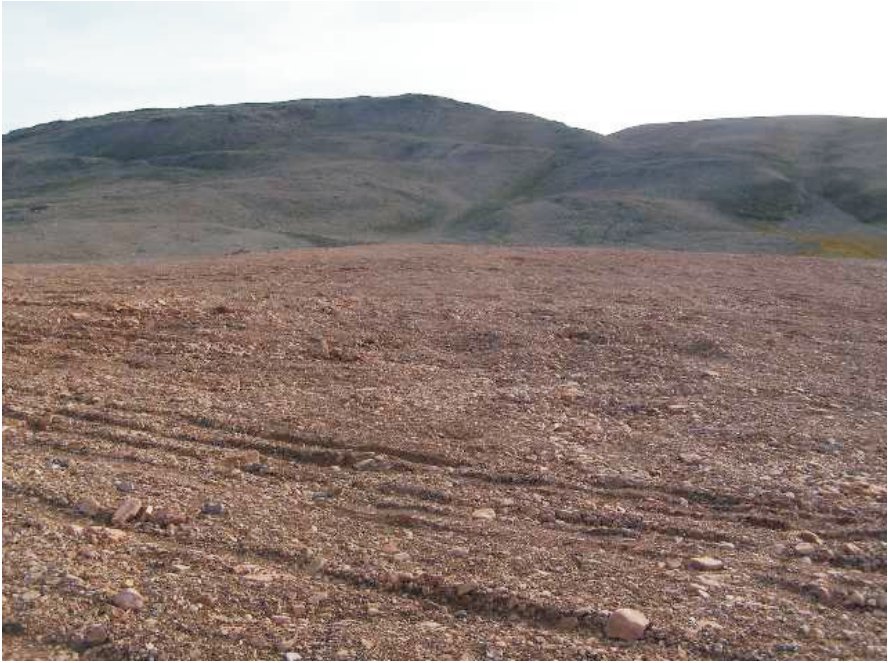
Photo 37
Toe of Landfill cover on west face. Note uncovered shale at toe.

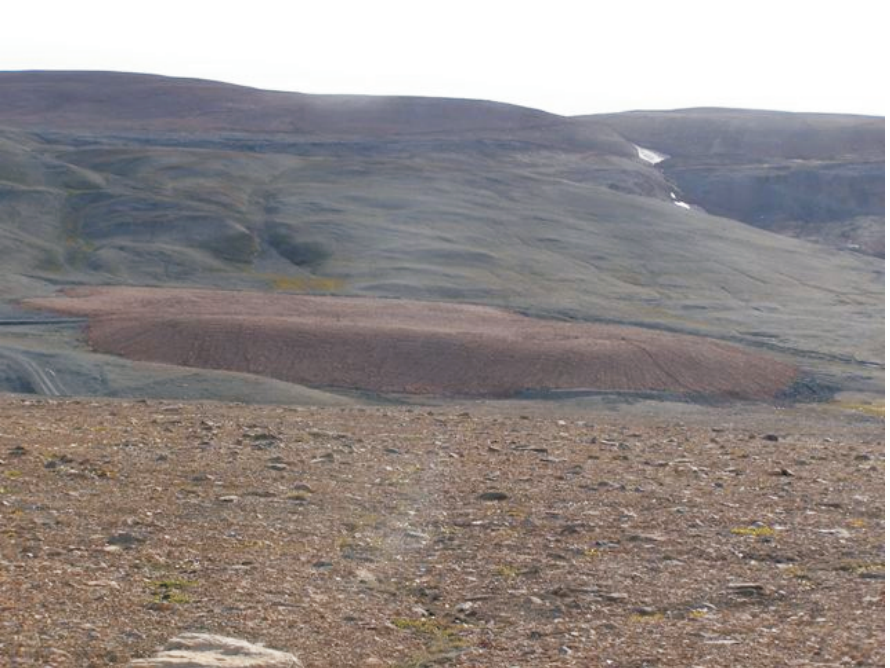
Photo 38
Surface of Landfill cover. Note undulations and loose surface.

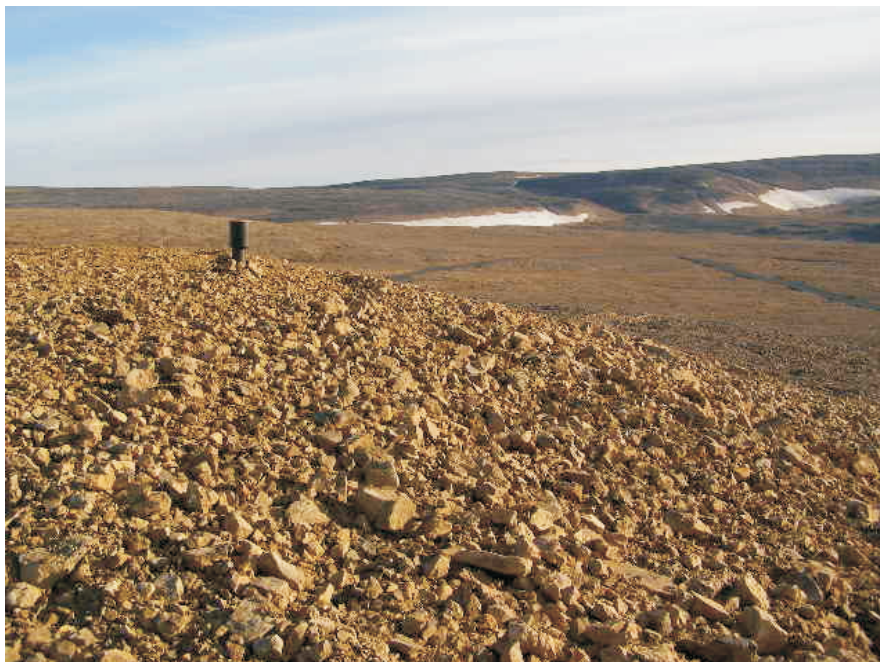
Photo 55
Area 14 waste rock cover.

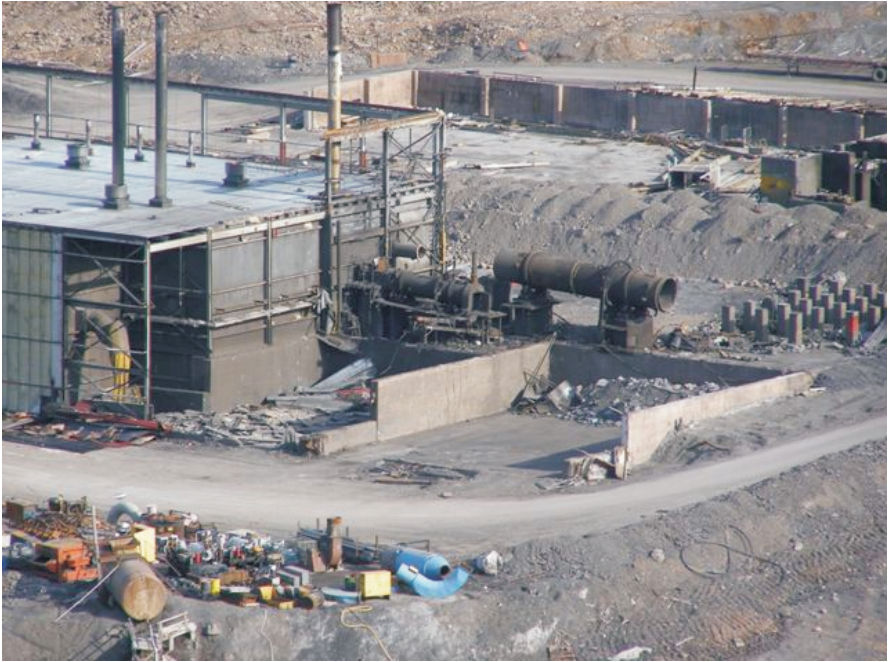
Photo 78
Mill foundation. Note soil backfill being placed.

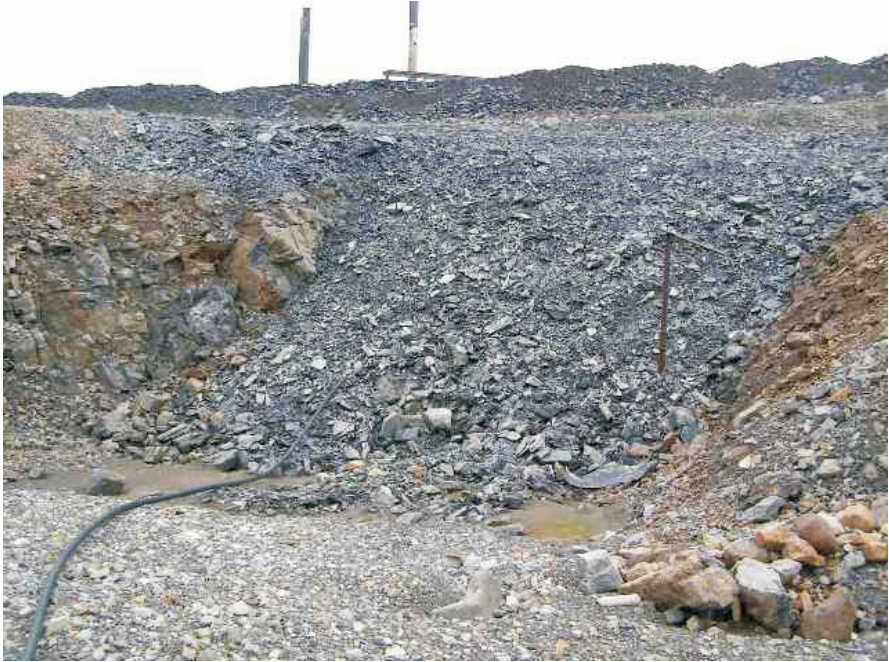
Photo 80
Plug for portal beneath Mill.
