NANISIVIK MINE, NUNAVUT

2013 ANNUAL GEOTECHNICAL INSPECTION

PROJECT NO.: 0255-023
DATE: February 27, 2014
DOCUMENT NO.:

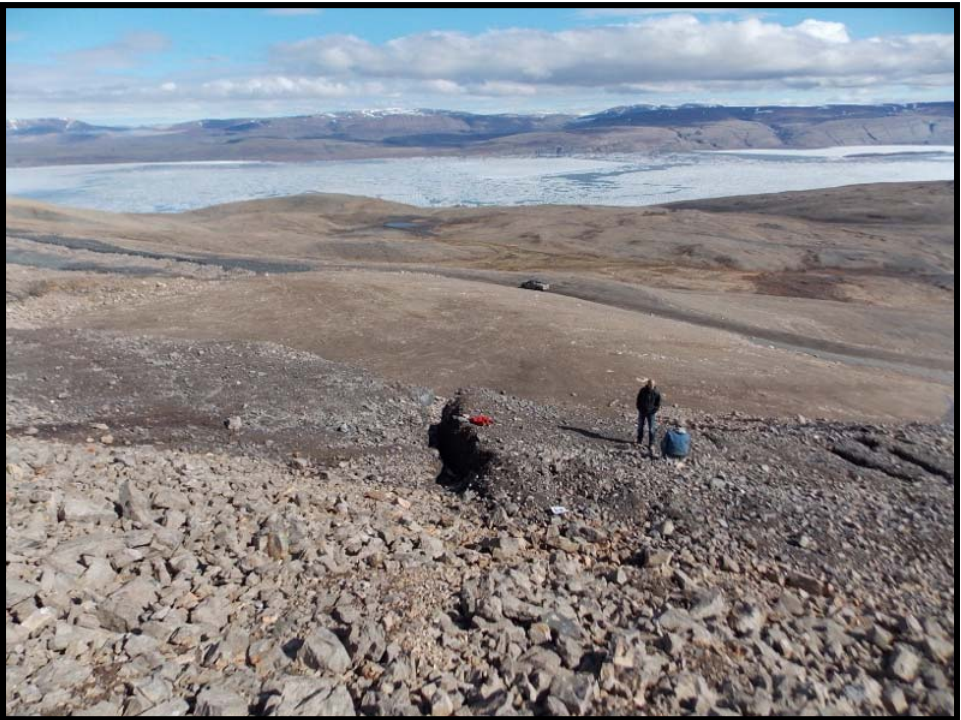
The covers constructed over the mine openings generally appear to be physically stable. Cracking at the East Open Pit crown pillar does not appear to have progressed since 2011. No maintenance is recommended, but continued visual inspection is warranted.

Photo 40. East Open Pit—Cracking in crown pillar. Similar condition to 2012.
