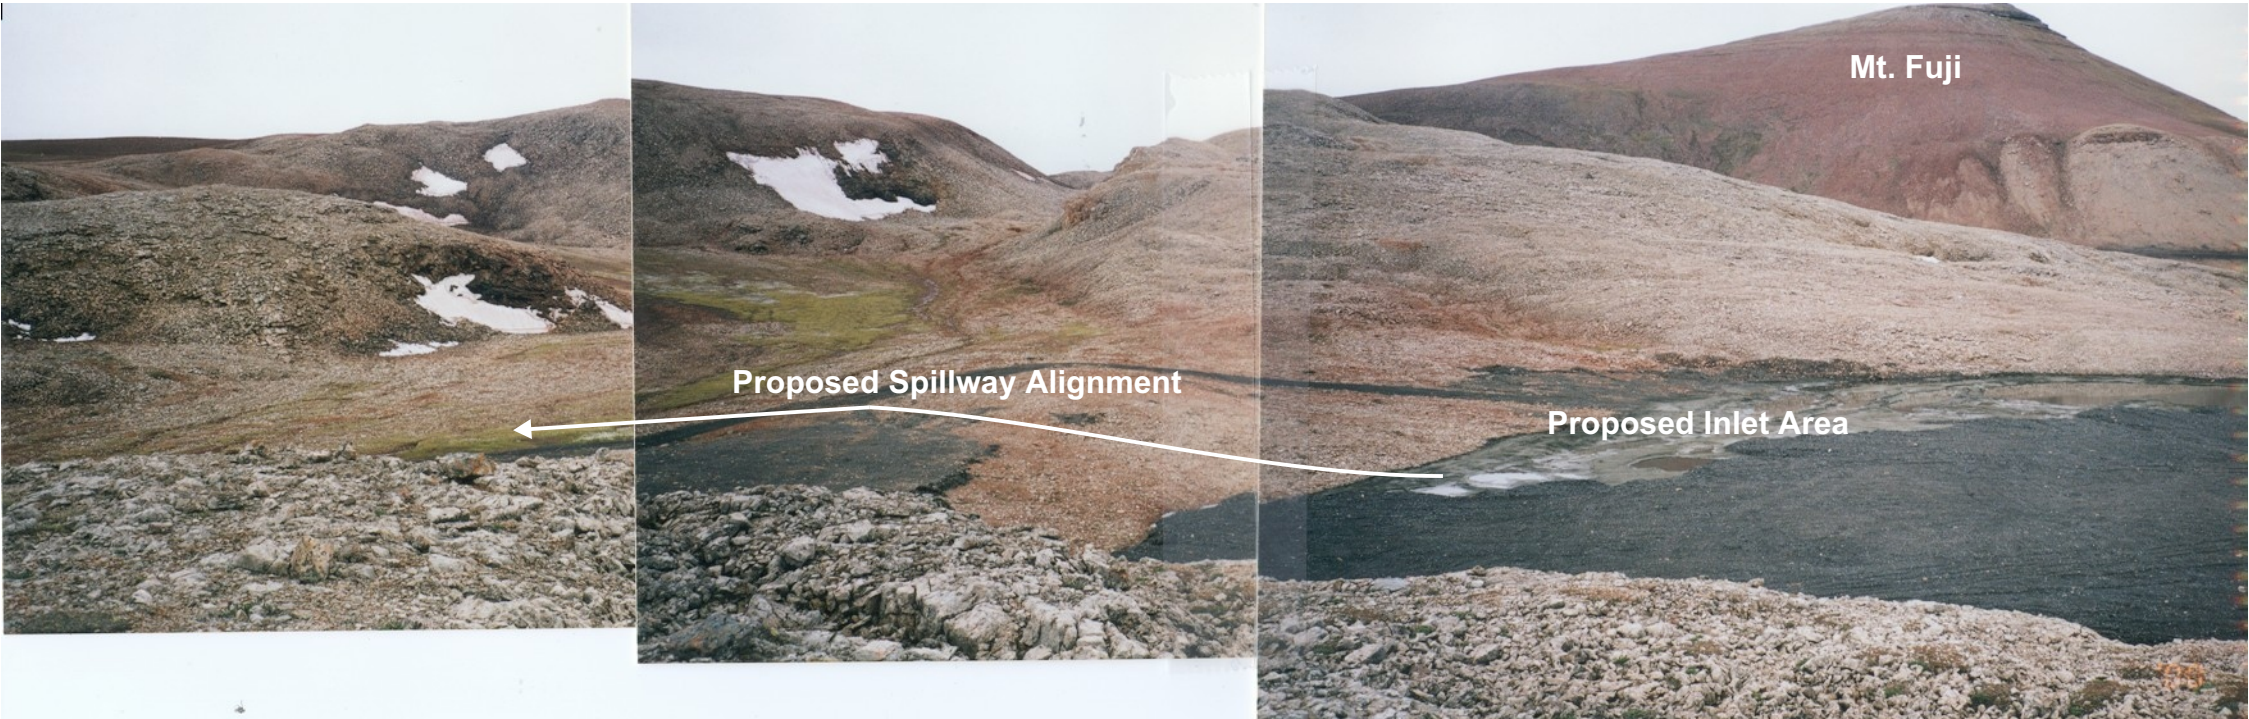
**Photo #4 (left)**  
View of inlet area from dolostone bedrock outcrop at the south abutment. Note that drainage also occurs from higher up.

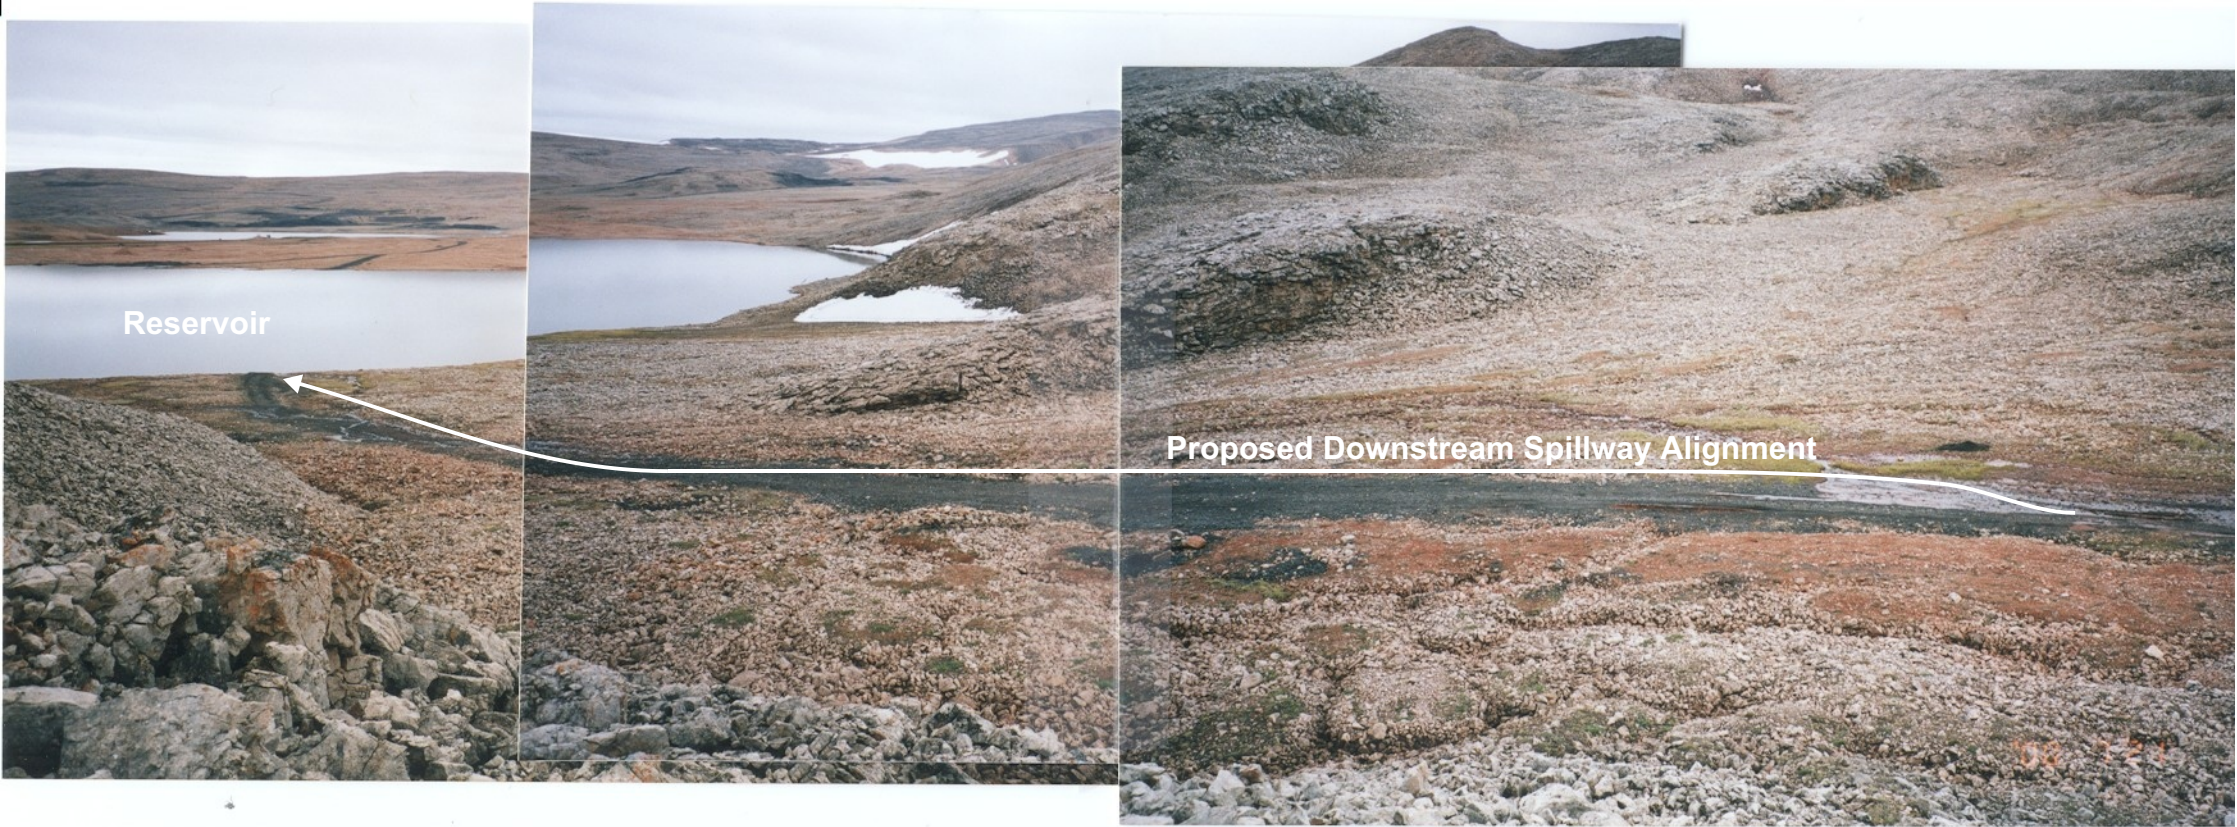
**Photo #5 (left)**  
View of downstream portion of proposed spillway alignment from the top of dolostone bedrock outcrop at the south abutment.
