WEST ADIT AREA RECLAMATION REQUIREMENTS

BGC ENGINEERING INC.

0255-009-10.03

NANISIVIK MINE, A DIVISION OF CANZINCO LTD.

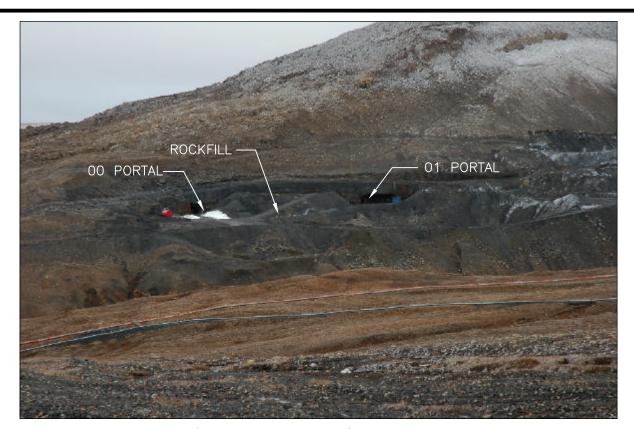
PHOTO 1 — JULY 2004 (VIEW LOOKING NORTH) GENERAL VIEW OF WEST OPEN PIT AREA. NOTE LOCATIONS OF 00 AND 01 PORTALS.

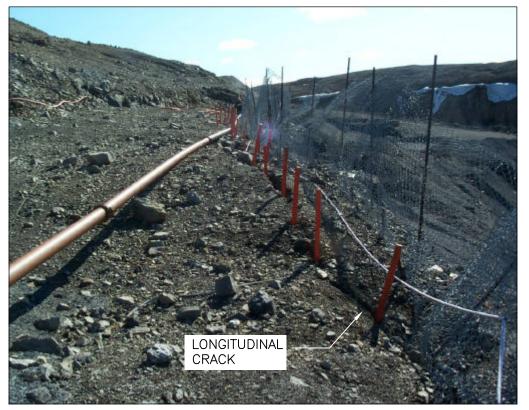
PHOTO 2 — JULY 2004 (VIEW LOOKING EAST)
BENCH ABOVE WEST OPEN PIT HIGHWALL.
NOTE THE LONGITUDINAL CRACK RUNNING PARALLEL TO THE HIGHWALL
MARKED OUT BY ORANGE STAKES.

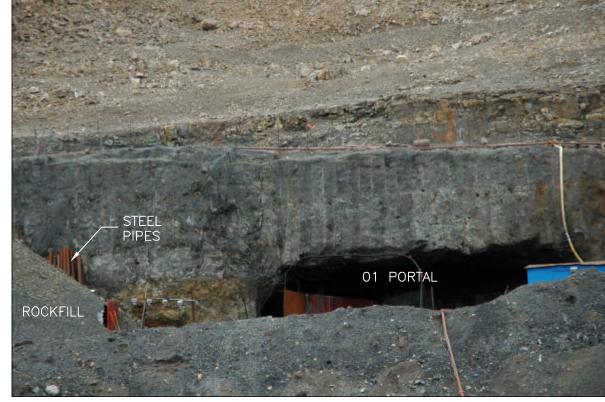
PHOTO 3 — JULY 2004 (VIEW LOOKING NORTH)
ROCKFILL PLACED AGAINST STEEL PIPES LAID AGAINST THE
OUTSIDE OF WEST OPEN PIT HIGHWALL ADJACENT TO 01 PORTAL.

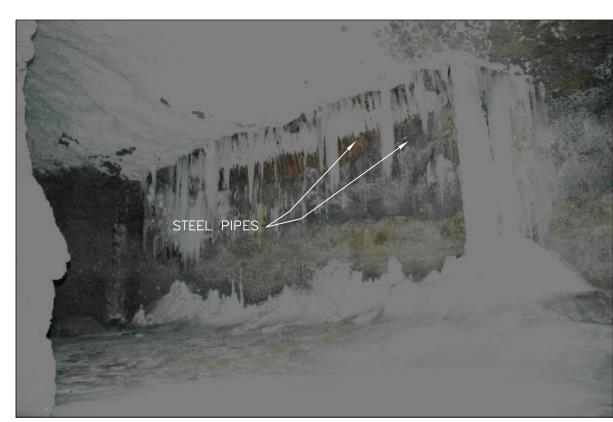
PHOTO 4 — SEPTEMBER 2004 (VIEW LOOKING SOUTH)
VIEW OF REMOVED PORTION OF RIB PILLAR FROM UNDERGROUND.
NOTE THE STEEL PIPES VISIBLE BY THE FROST COVER ON THE PIPES NEAR THE
TOP OF THE EXCAVATION. THE PIPES RETAIN THE ROCKFILL PLACED AGAINST THE
OUTSIDE FACE OF THE HIGHWALL.
