ZOSTRICH GEOTECHNICAL

RE: REVIEW OF NANISIVIK MINE OPENINGS CLOSURE PLAN (JANUARY 27, 2005)

PROJECT: NANISIVIK ROCK MECHANICS REVIEW - III

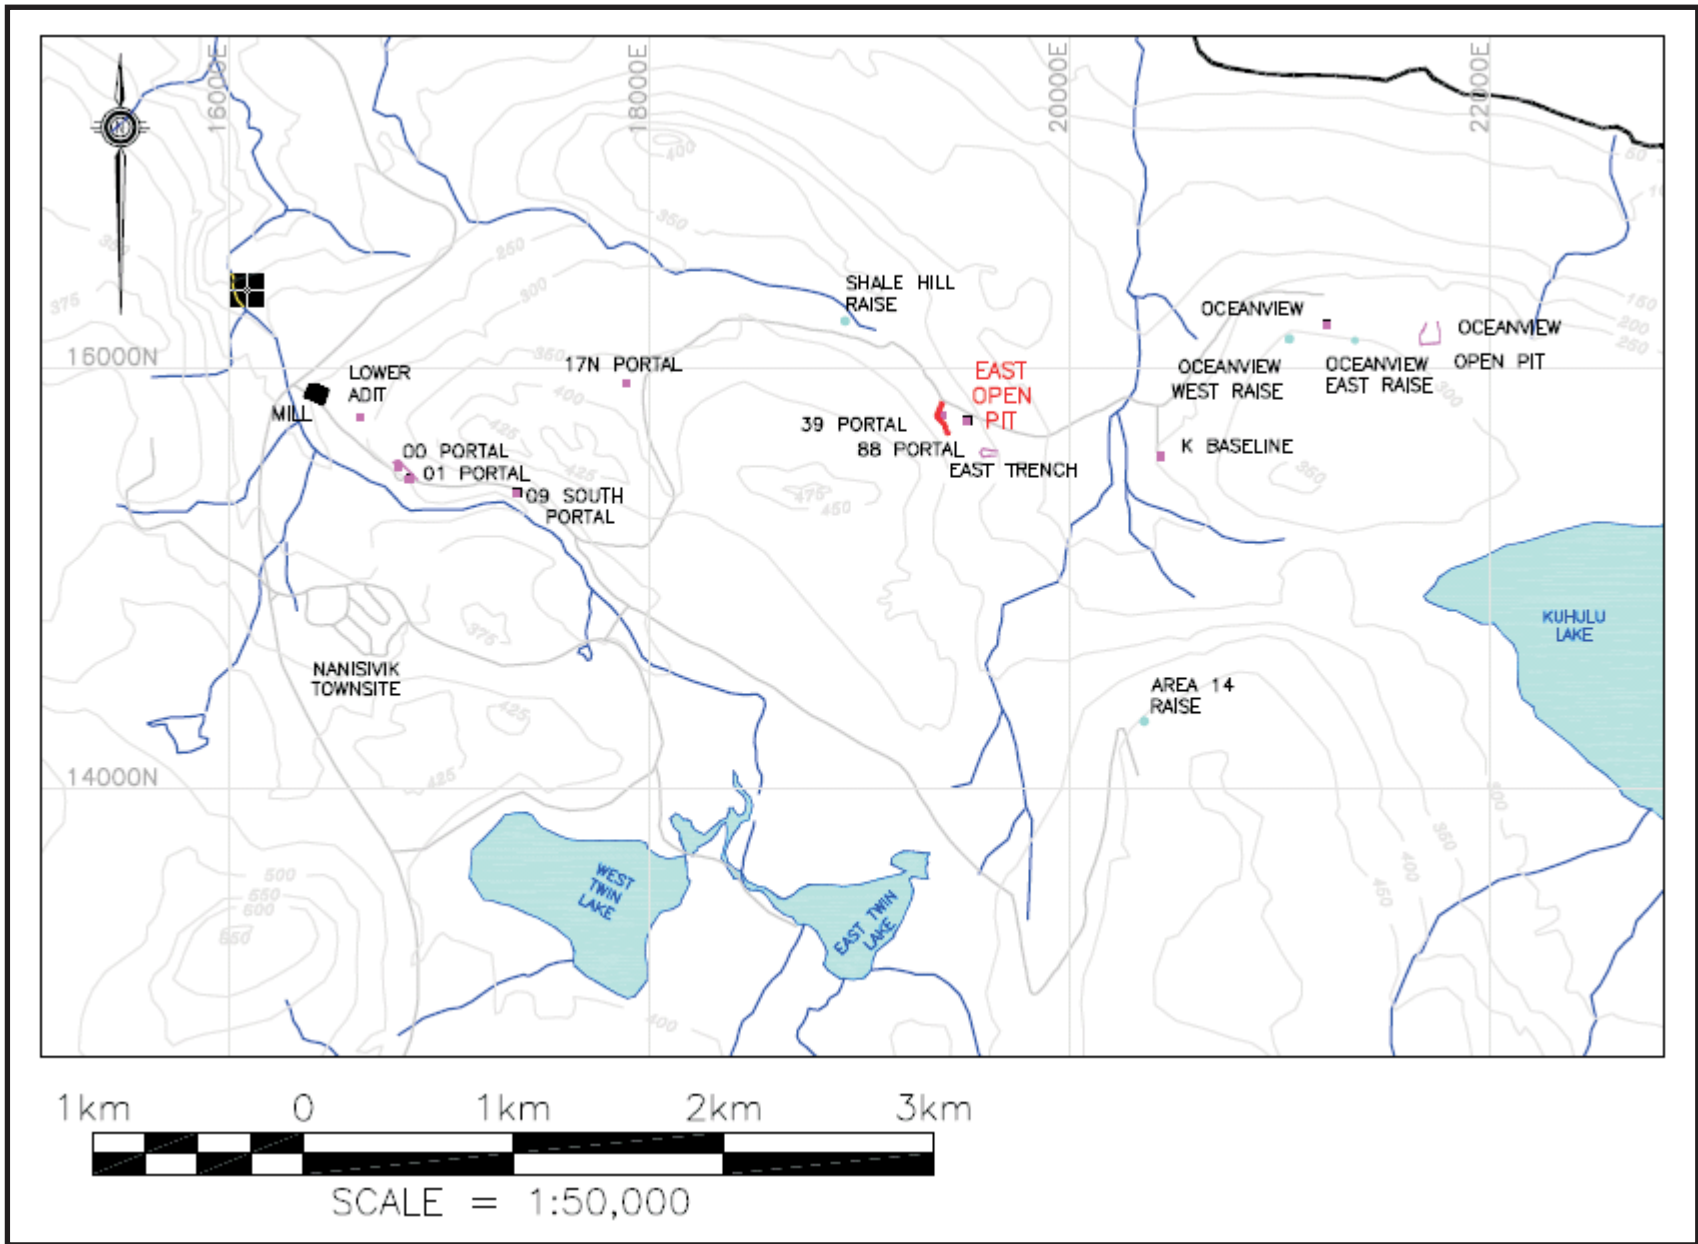
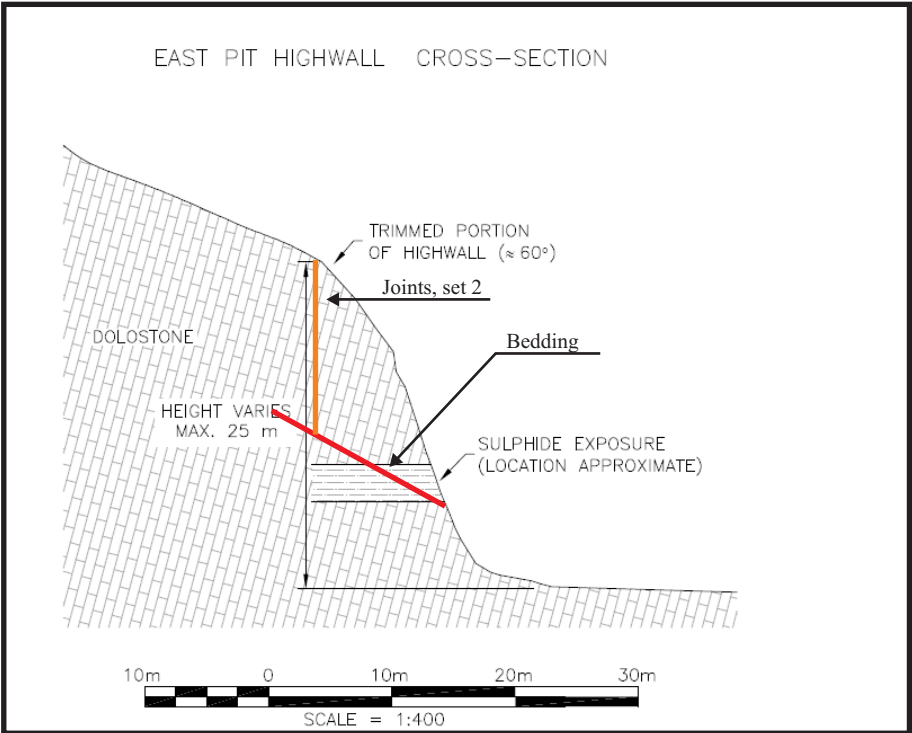
From Figure 22, East pit highwall

Here, a 25m high wall, apparently excavated as a single bench, is shown in section. This apparently faces somewhat to the northeast. If so, and if the structural mapping as obtained from Figure 28 is correct, then the bedding will be dipping out of the face in plane shear mode. Sub-vertical jointing would function as side and back releases for a kinematically viable failure. However, this is nowhere noted in the report nor addressed for closure. Does this jointing exist in this area? If so, does the sulphide zone shown on the highwall parallel bedding? What will occur if and when the sulphide decomposes, or will it? Will a step path be created by bedding in combination with the sub-vertical joints working back up the slope, driven by frost and water action? What engineering has been conducted to reach the design presented?

East pit area:
Have the joints in the bench shown on the schematic section been mapped? If the joint pattern follows that obtained from the West pit area, then bedding joints may create a potential long term failure geometry (frost action driven) as shown. Has this been analyzed and taken into account?

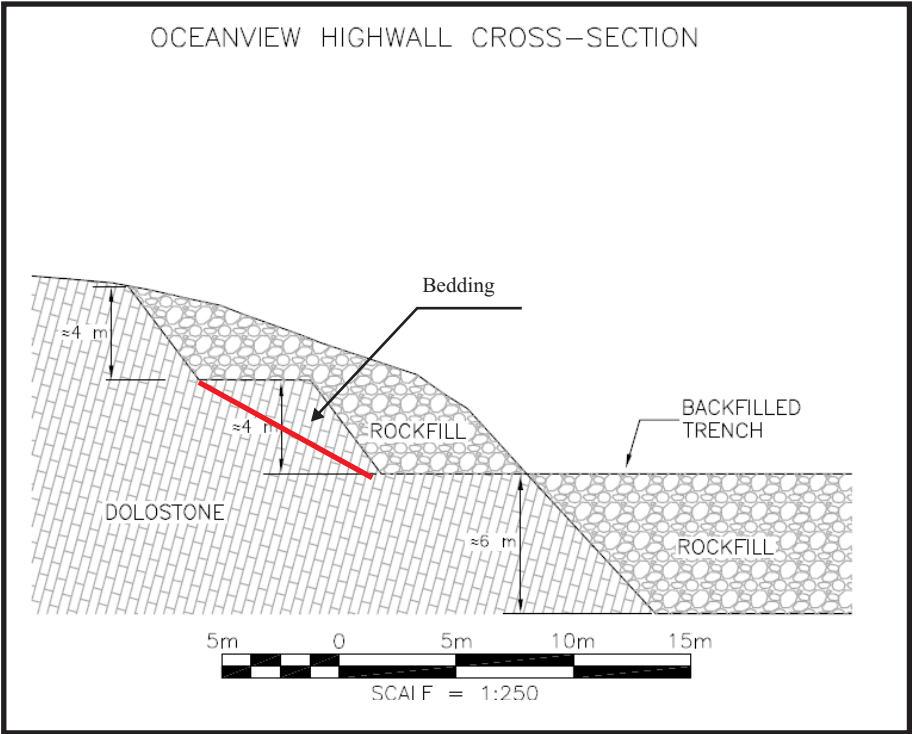
From Figure 24, Oceanview pit highwall

While this is a very shallow pit, as can be seen in Figure A, a potential structural failure geometry may exist in the benches. In addition, there is a lack of stability analyses addressing the stability of these slopes, including pore water pressure, ice, etc. This is a very minor wall. However, for completeness sake, the work should be conducted in a proper engineering manner. In other words: material properties should be listed for design purposes, design assumptions listed (including failure modes), and analytical methods and any computer codes utilized for analysis should be denoted.

Oceanview:
Has the stability of the rock fil, given the shown profile, been analyzed, including pore pressure conditions present during melt. Has the potential complex failure geometry of bedding joints combined with a circular type failure been analyzed?

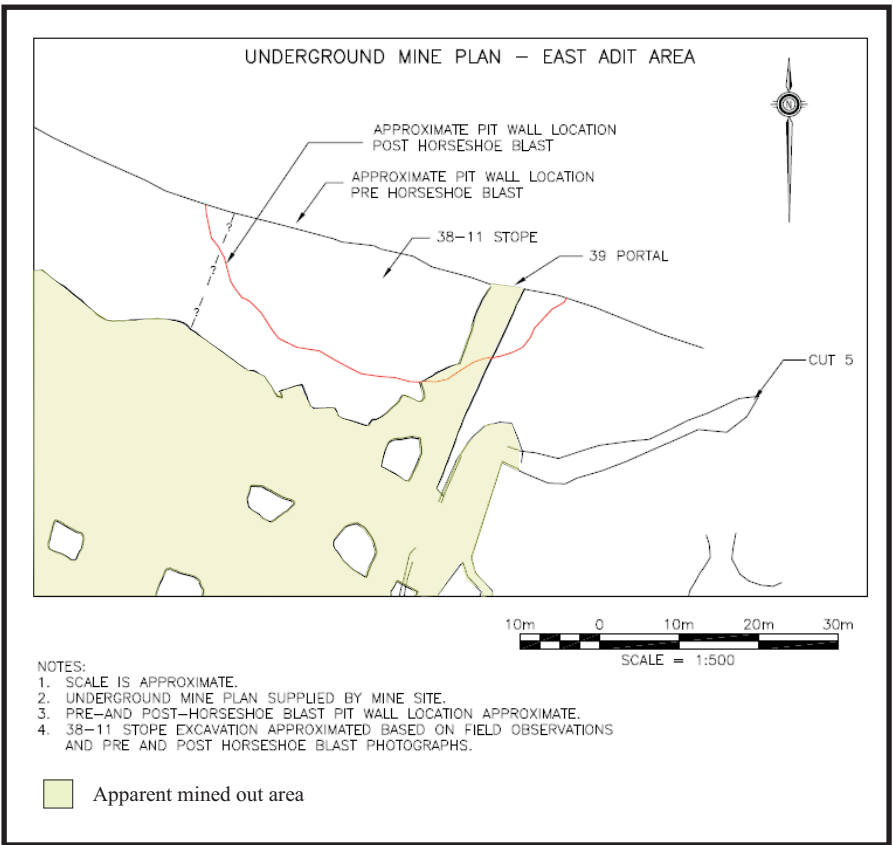
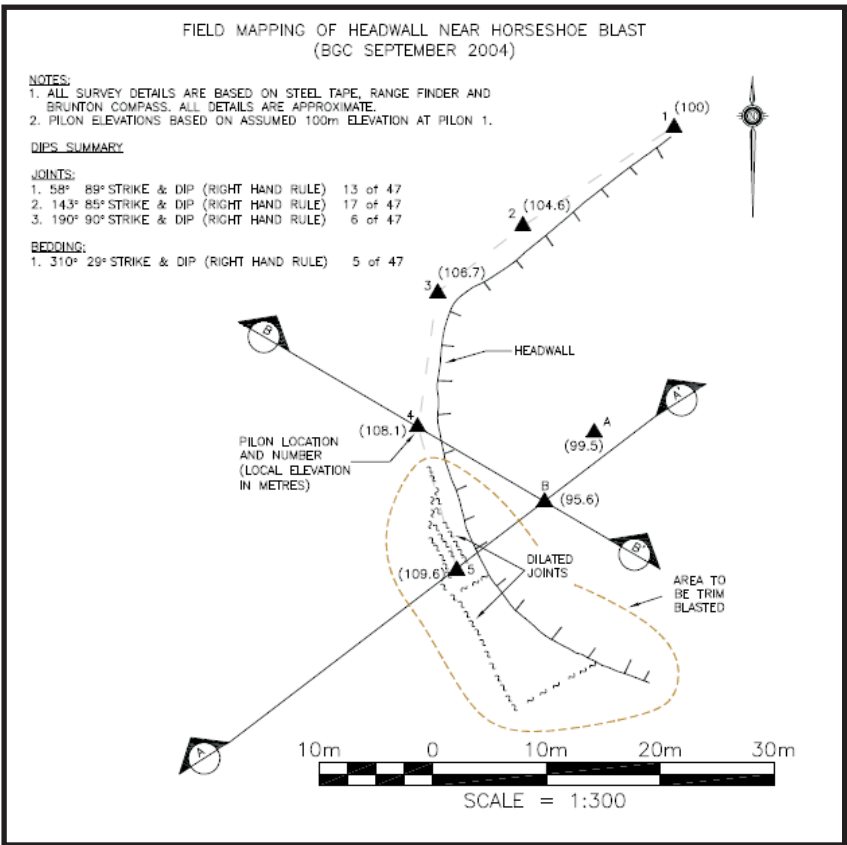
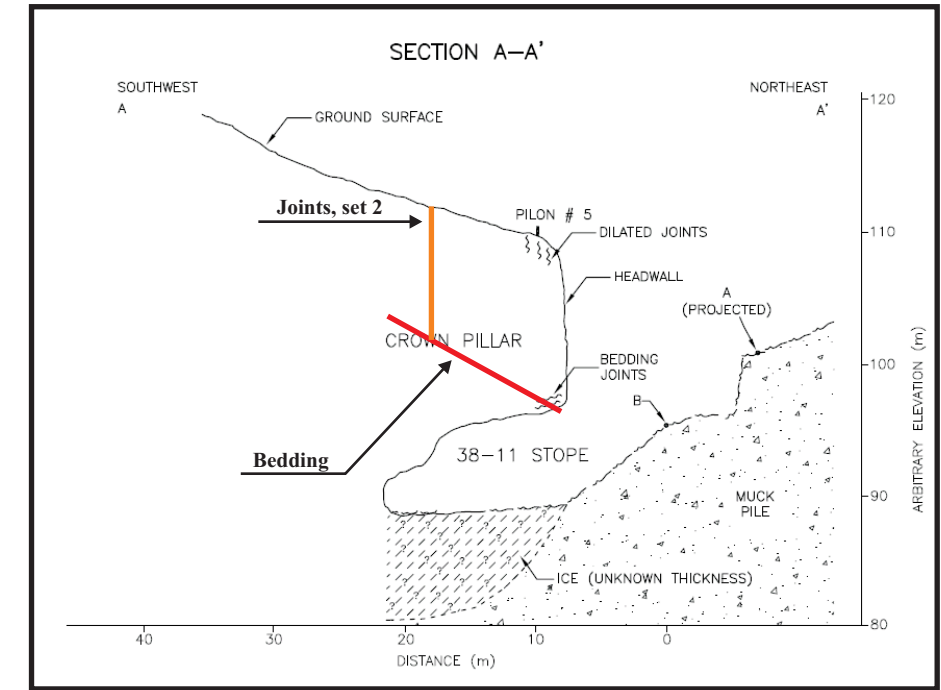
From Figure 29, Plan detail of Horseshoe blast area

As can be seen in Figure B, the underground workings have apparently been daylighted under the highwall of the East pit (?). The exact geometry of the situation is difficult to discern from the mine plan (Figure B) and the limited number of sections provided. In fact, if one interprets the mine plan as shown on the upper center diagram, Figure B, then the Horseshoe blast did not even daylight the mined out area. However, photographs and descriptions elsewhere indicate that the underground workings were daylighted. Thus, a key question remaining is what is the exact geometry of the situation, including the remaining cover, included rock support, and geologic structure, both major and minor, in the area?

First, in the center diagram above, the mined out area does not appear to daylight in the pit. Yet, the photos and sections clearly show a daylighting stope.

A detailed map is necessary, showing the amount of cantilevered, undercut rock remaining, as well as multiple sections through the area. No stability analysis has been conducted. This is required.

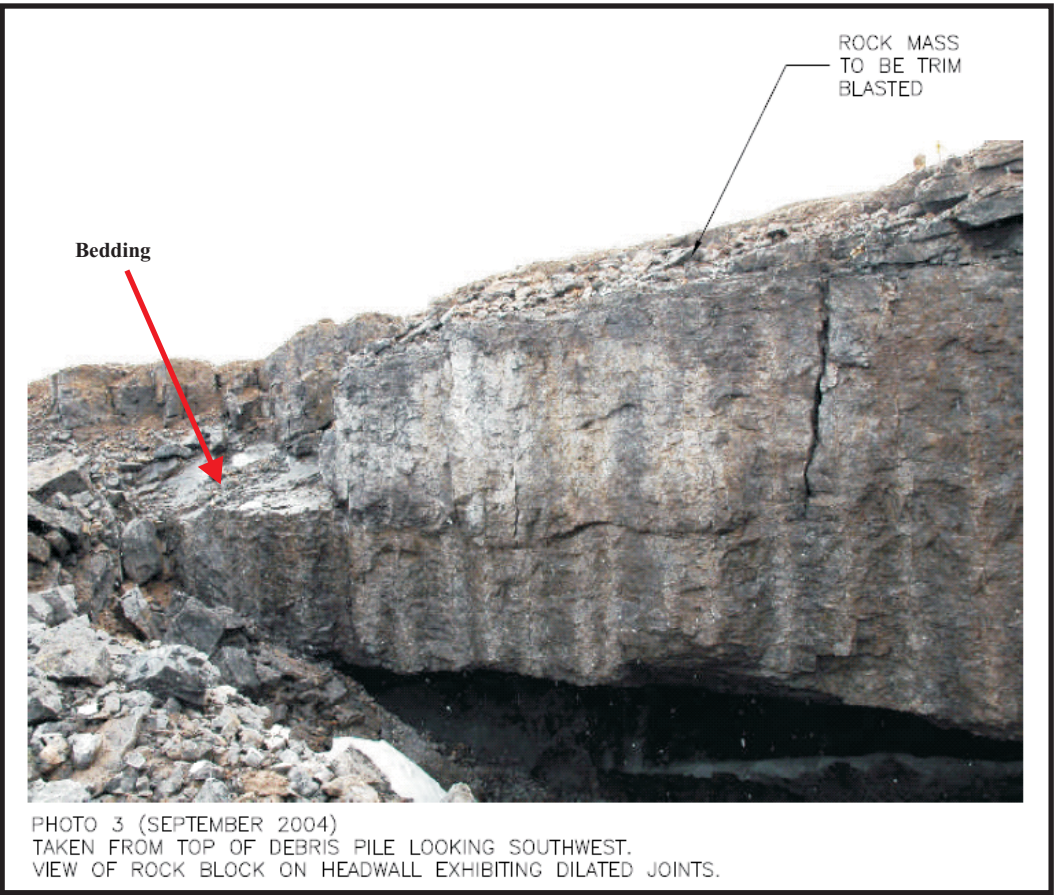
From Figure 29, Photo of failure area

In addition, as is obvious from the photographs, a portion of the face is in plane shear on bedding joints. Whether this is blast related is irrelevant at this point, as the geometry obviously exists. How has this been addressed for closure design?

The visible failure mode in the photograph appears to be a plane shear on bedding with a side and back releases by the cross joint sets (see joint attitudes numerically in upper right, sectionally to left). This is also consistent with the area in failure shown in the upper left detail map. The northernmost section of the failure area has limited freedom of motion, potentially restricting failure of this sort.

A complete engineering analysis is required here prior to determining remediation measures. This has not been conducted. As such, any remedial works proposed at this stage are premature and not verifiable.

In a situation such as this, with overhanging rock, viable kinematic failure mechanisms, frost and water action potentially driving such mechanisms, blast damage, etc, a detailed engineering stability analysis is warranted, as is a specific detailed monitoring plan. Visual assessment is insufficient.

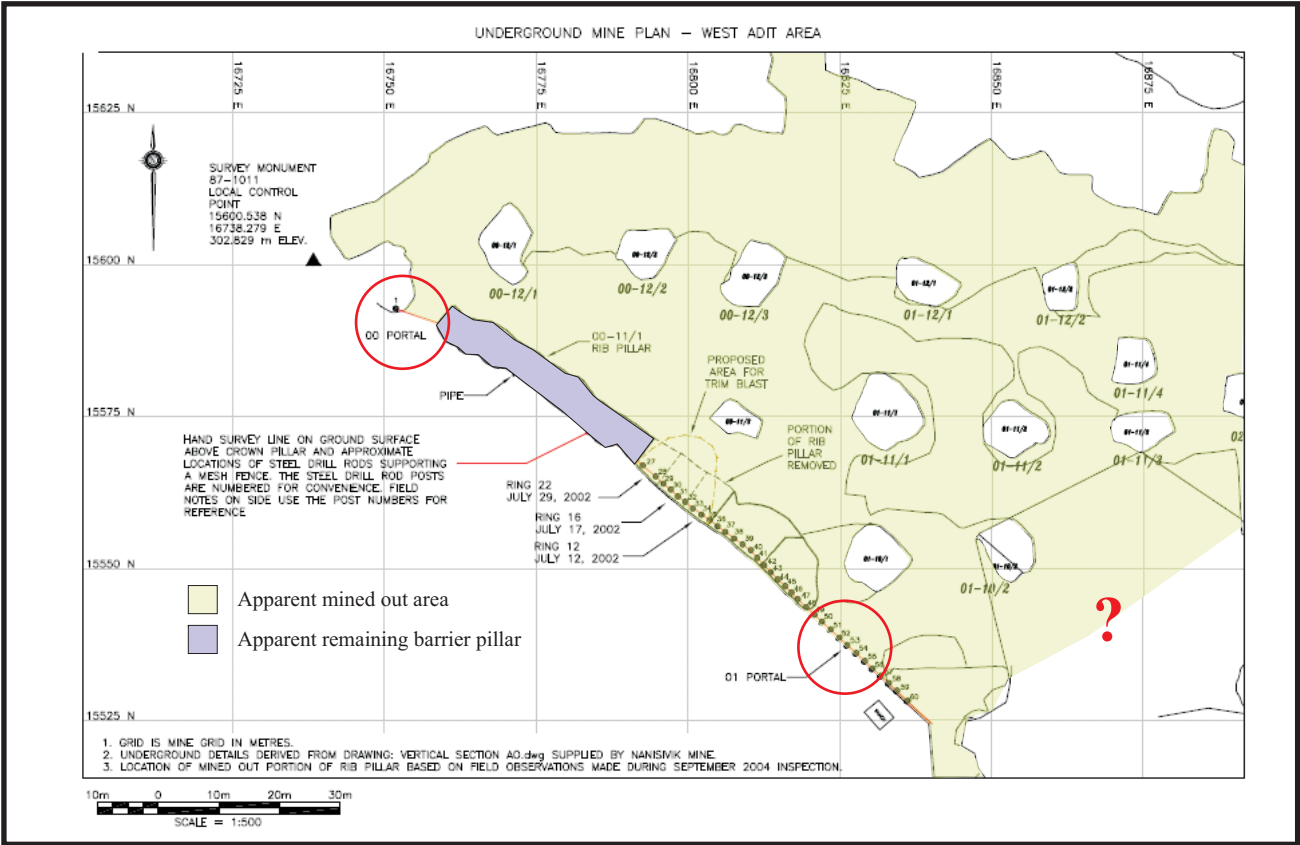
From Figure 28, Underground mine plan

As for the East pit, one cannot discern the geometry from the shown mine plan (Figure C). A detailed mine plan is required, including elevations as well as opening heights. Such has not been presented. This pit/underground interaction area is complex as well. In this case, a rib pillar against the West pit highwall was apparently blasted out. How much is unknown. A failure now exists paralleling the highwall. This has been attributed to toppling. Remedial work has been proposed in the form of blasting down the highwall in a specific area, then pushing muck underneath the daylighted brow for a very limited distance.

First, in the upper right diagram above, it is unclear what is mined, what remains, where the pillars are located, what portion of the barrier pillar has been mined, etc. This is insufficient. Neither planning and analysis, nor review, can be conducted on drawings of this nature.

A detailed engineering analysis is required for this area. This will require that the geologic structure, mine openings, and surface topography of the entire area be accurately known and provided to the designer. In addition, the designer should expend more time and effort in understanding the failure mechanisms in play, as well as the effect of frost action, water, and present rock support degradation.

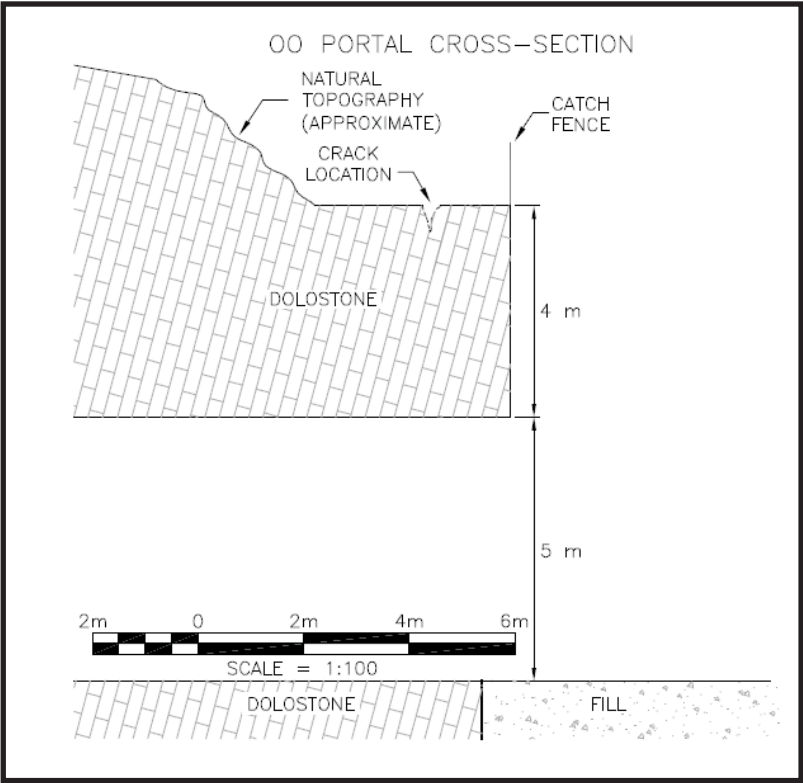
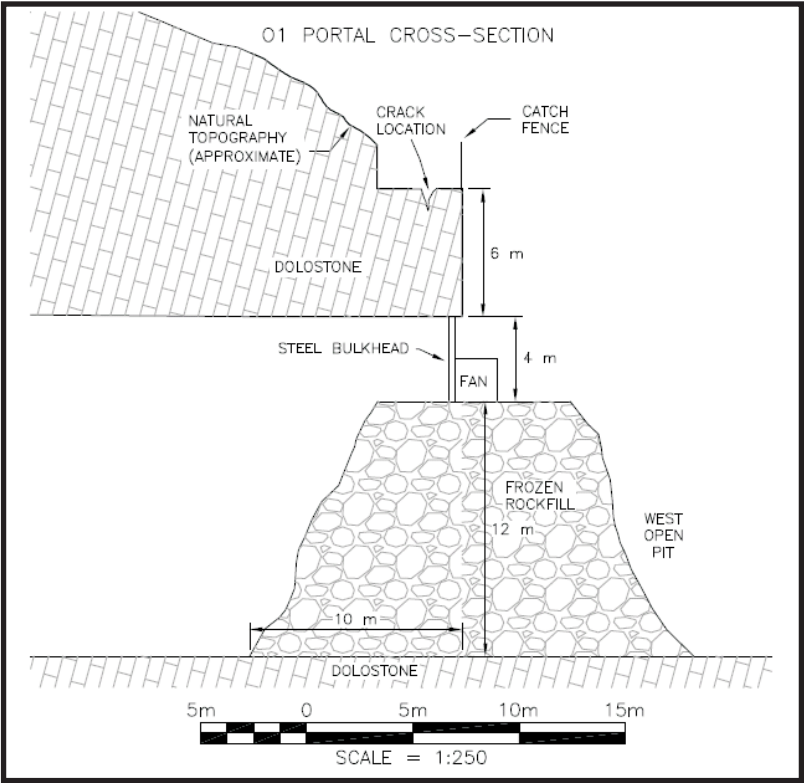
What has been presented is explained insufficiently and does not appear to be founded on a detailed engineering study of the situation. The present evaluation (Lauzier, 2002), indicating that if a 5m “brow” remains between surface and the opening, it will be stable is obviously in error as the brow is failing here at a 5m thickness or greater.

Sections are shown to the left indicating the apparent dimensions, failure mechanisms, etc. of the area. These, too, are incomplete in terms of present rock support, expectations of failure progression, engineering analysis, and final remediation.

In a situation such as this, with overhanging rock, viable kinematic failure mechanisms, frost and water action potentially driving such mechanisms, blast damage, etc, a detailed engineering stability analysis is warranted, as is a specific detailed monitoring plan. Visual assessment is insufficient.

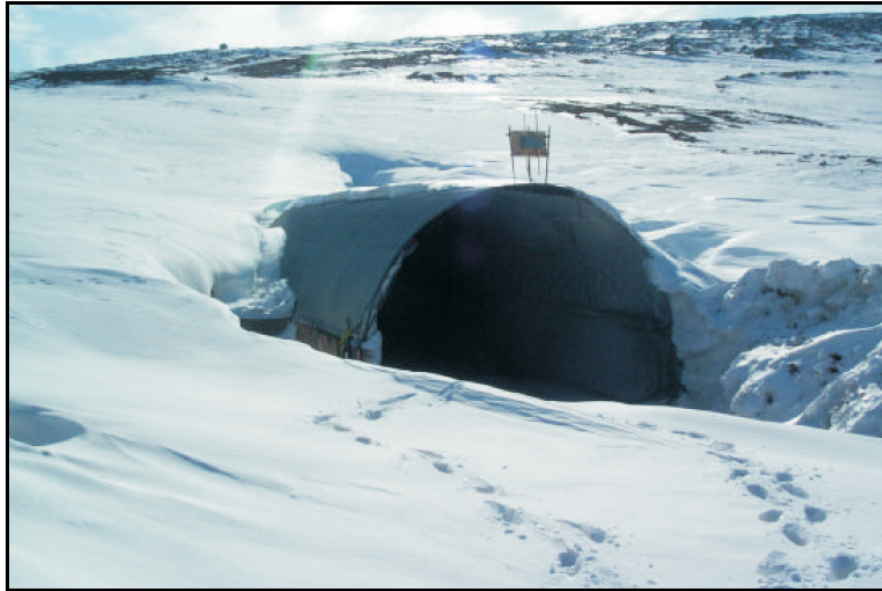
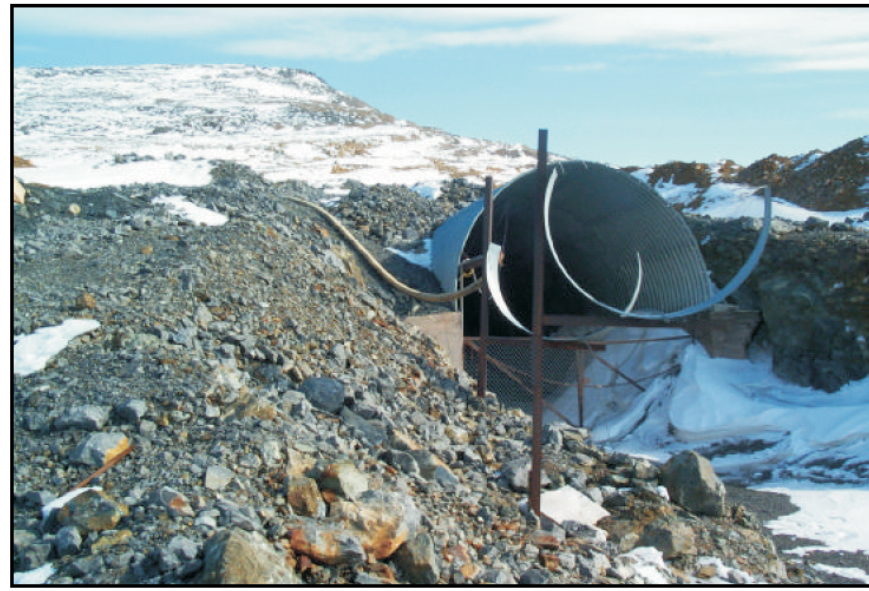
These designs are insufficient as they do not quantify the cover, potential failure modes/geometries, and the degradation of presently installed rock support.

As can be seen in Figure D, these portals are located in areas of low relief. They obviously have some cover, but the liners (“culvert”) would not have been utilized if adequate cover could have been quickly attained when driving the openings.

VIEW OF 17 NORTH PORTAL (SEPTEMBER 2002).

VIEW OF K BASELINE PORTAL (SEPTEMBER 2002).

First, all of the shown portals appear to have relatively shallow cover (from photographs) for quite some depth into the rock mass. This lack of cover is not shown in the provided sections, nor are the geologic structure and associated failure modes shown.

Detailed analysis is required. In addition, ice is not considered adequate backfill material. Rockfill, if utilized, must be jammed to the back in the areas where subsidence could occur, as identified by the aforementioned analysis.

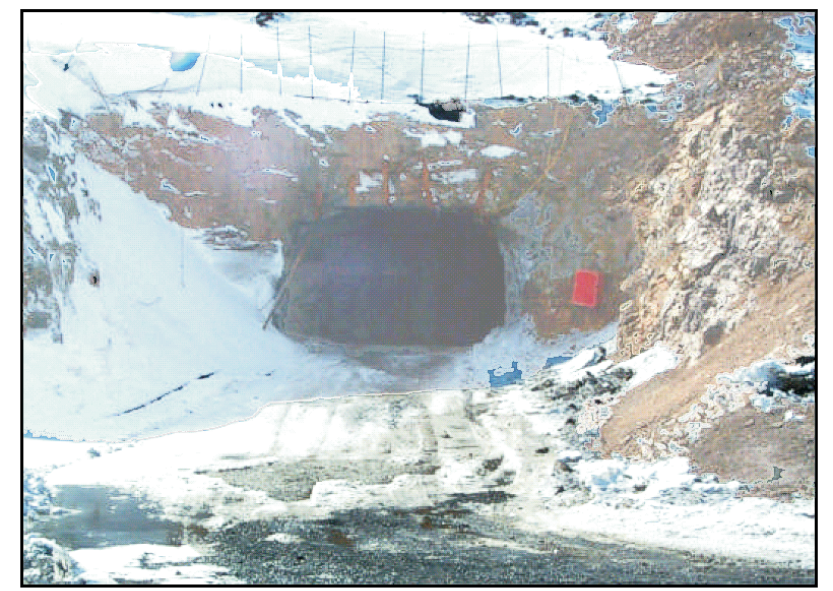
From Figure 14, 88 portal

The topography and geologic structure for this area are uncertain. However, it is noted that strap (“steel belts”, Figure D) has been utilized to wrap the brow (photo, Figure D). This is normally done when it appears that rock blocks can fall from the brow.

VIEW OF 88 PORTAL (SEPTEMBER 2002).

Therefore, a detailed engineering analysis is required, showing the geologic structure, accurate topography, and an accurate depiction of the portal face and alignment to some depth at which failure is shown to be improbable. The reasons for the straps, and the effect of the degradation of the presently installed rock support should be included in this analysis as well.

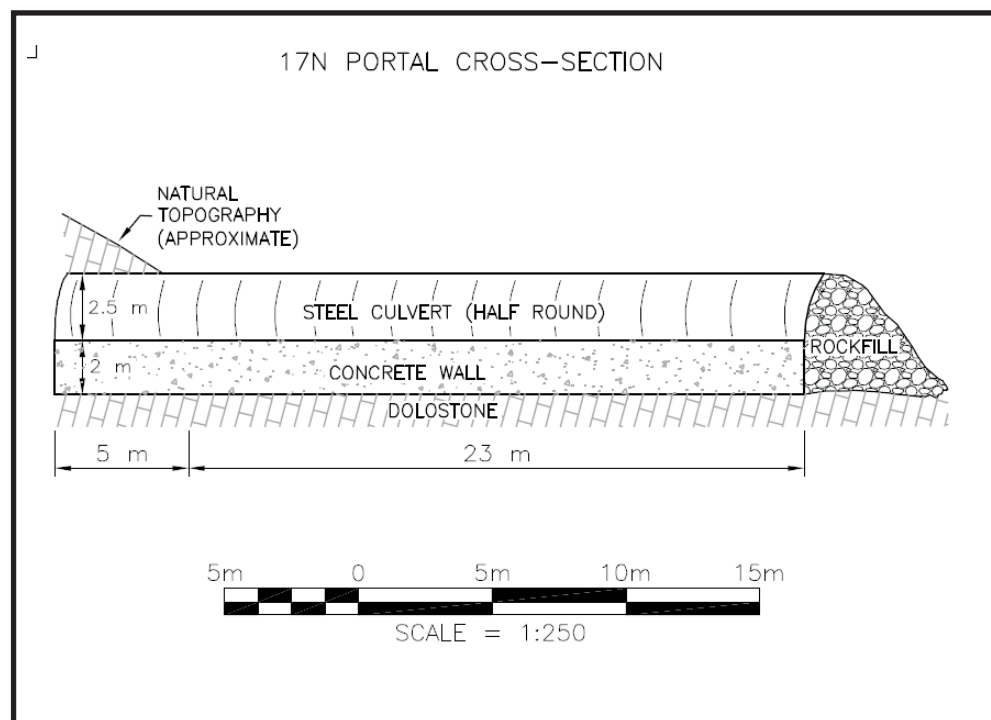
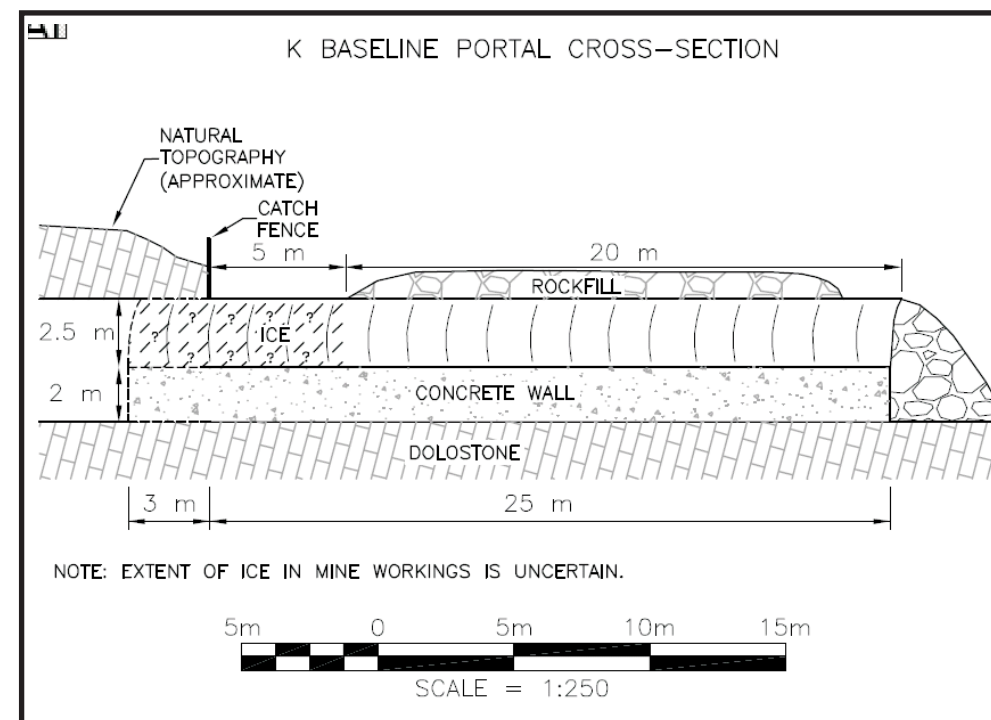
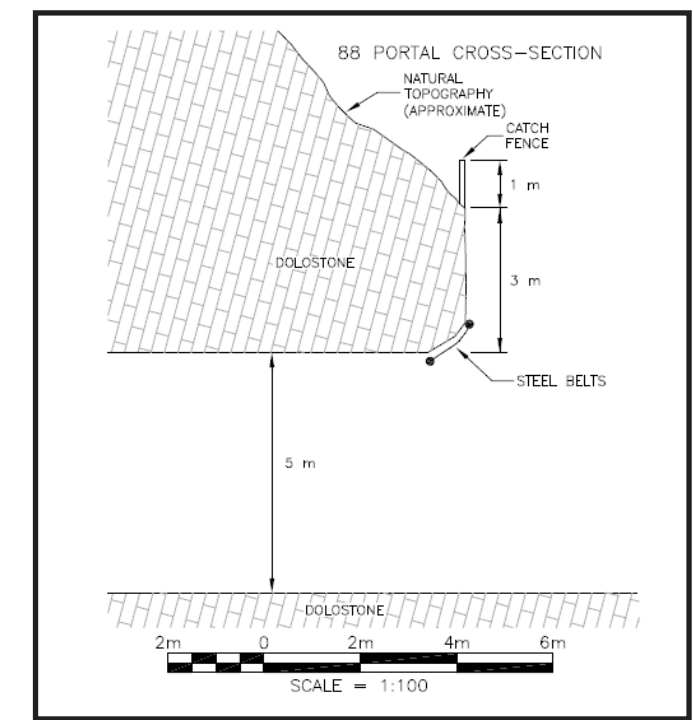
In addition, ice is not generally approved as a permanent backfill material.

In general, detailed engineering design, including adequate geologic sections, failure modes, and provided permanent rock support has not been provided.

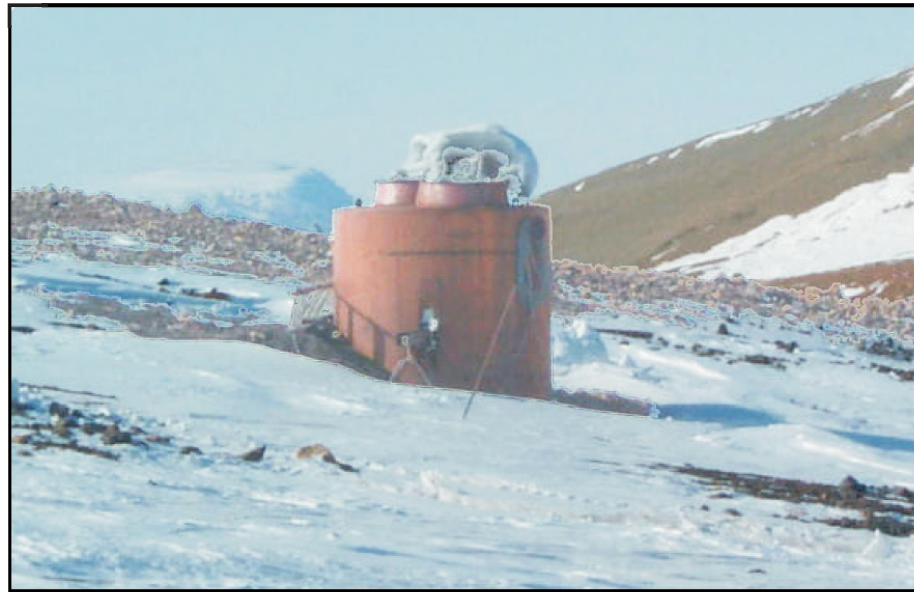
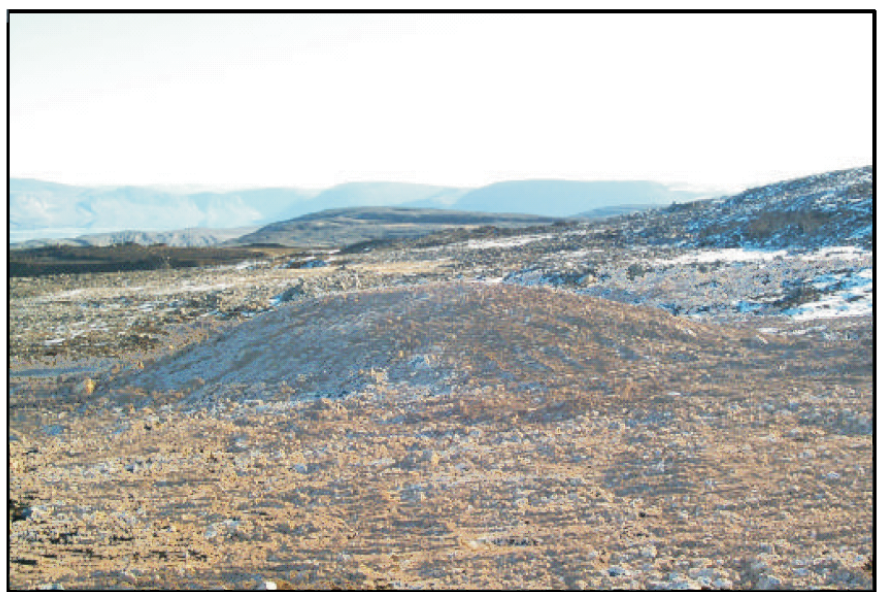
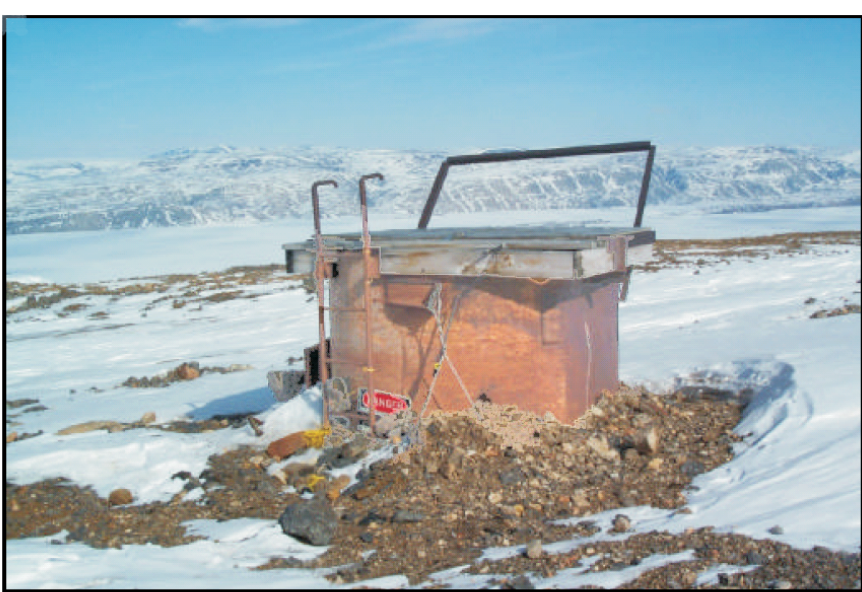
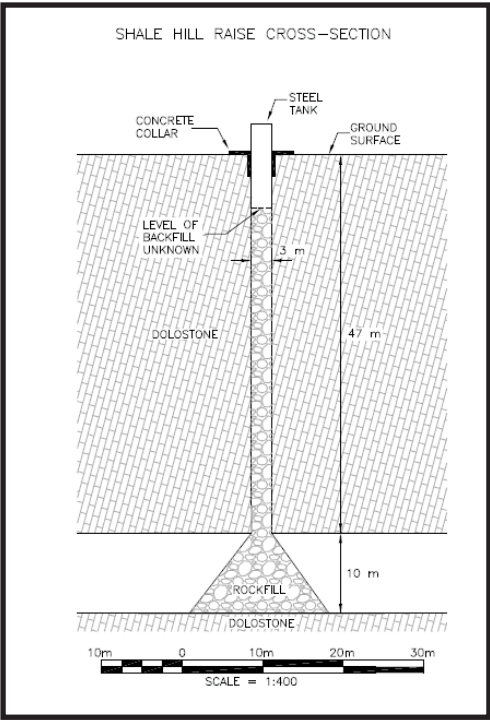
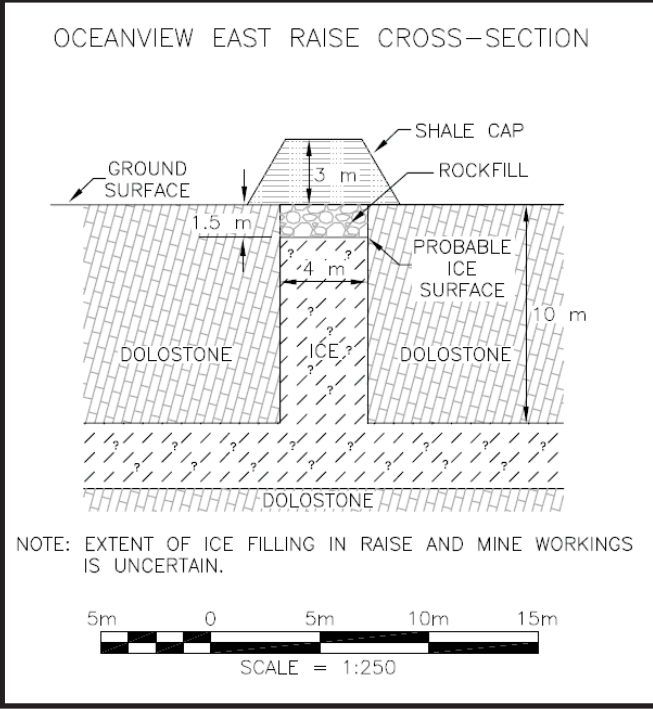
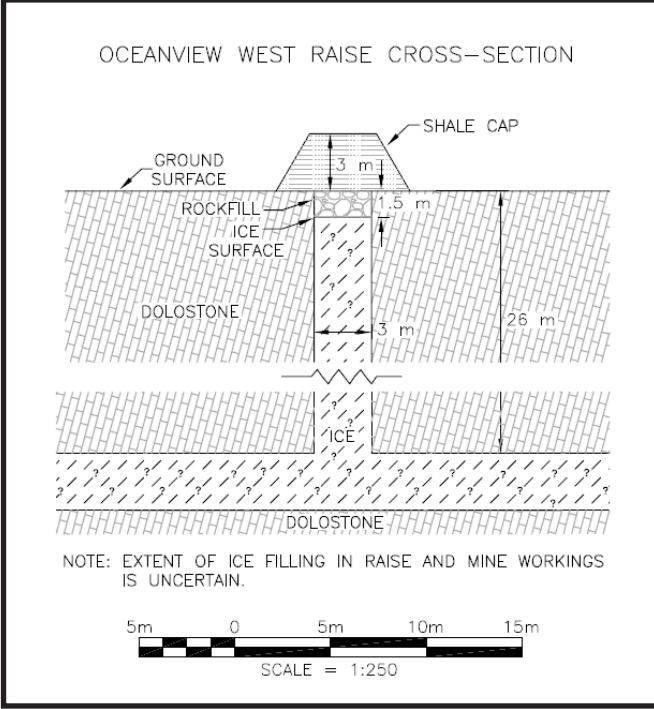
In many cases, as is demonstrated in Figure E, the raises are presently blocked with ice. While backfill may have been placed in these raises, it is uncertain what depth the rock fill has attained.

Backfilling on top of these ice blockages, especially when they are close to the collar (surface) is inappropriate. Ice can settle and creep or the ice bridge may be narrow and fail resulting in surface subsidence and/or an open hole.

First, it is apparent from all the shown sections that the raises are blocked with ice. Even if rock fill has been placed in the raise, it is uncertain to what depth the fill is found.

This is inadequate as Ice is not generally approved as a permanent backfill material.

The raises should be sealed with an engineered concrete plug or the ice removed and the rock fill verified for the depth of the raise. Alternatively, other potential engineered alternatives may exist.

In this case, if the depth to the rock fill is unknown, then a permanent concrete plug should be placed at the raise collar. The thickness of this plug is the responsibility of the design engineer.

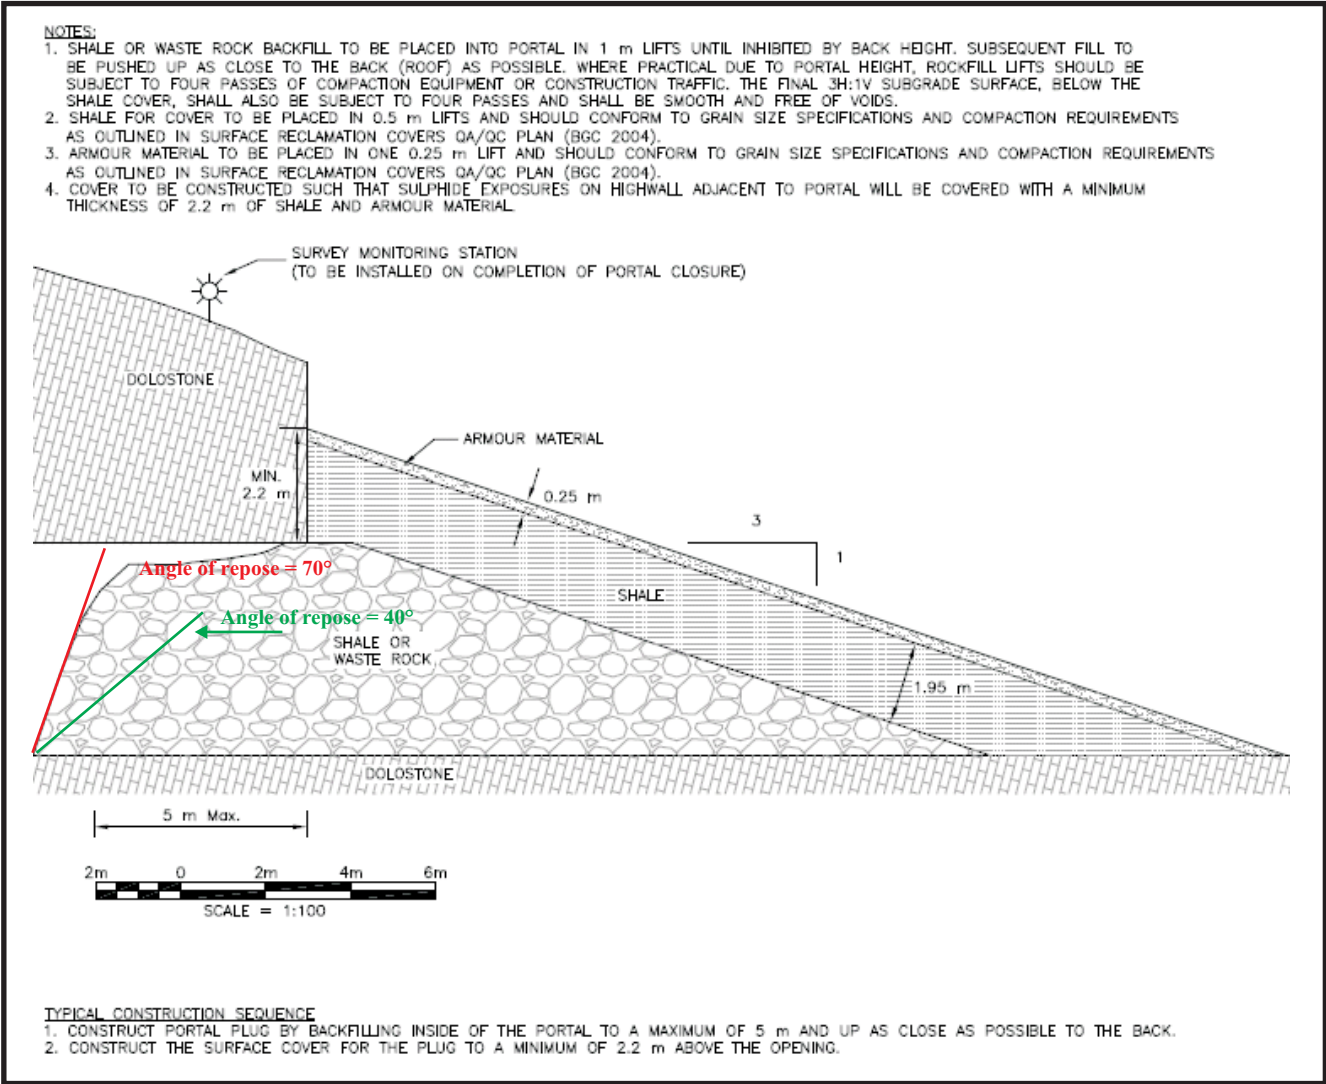
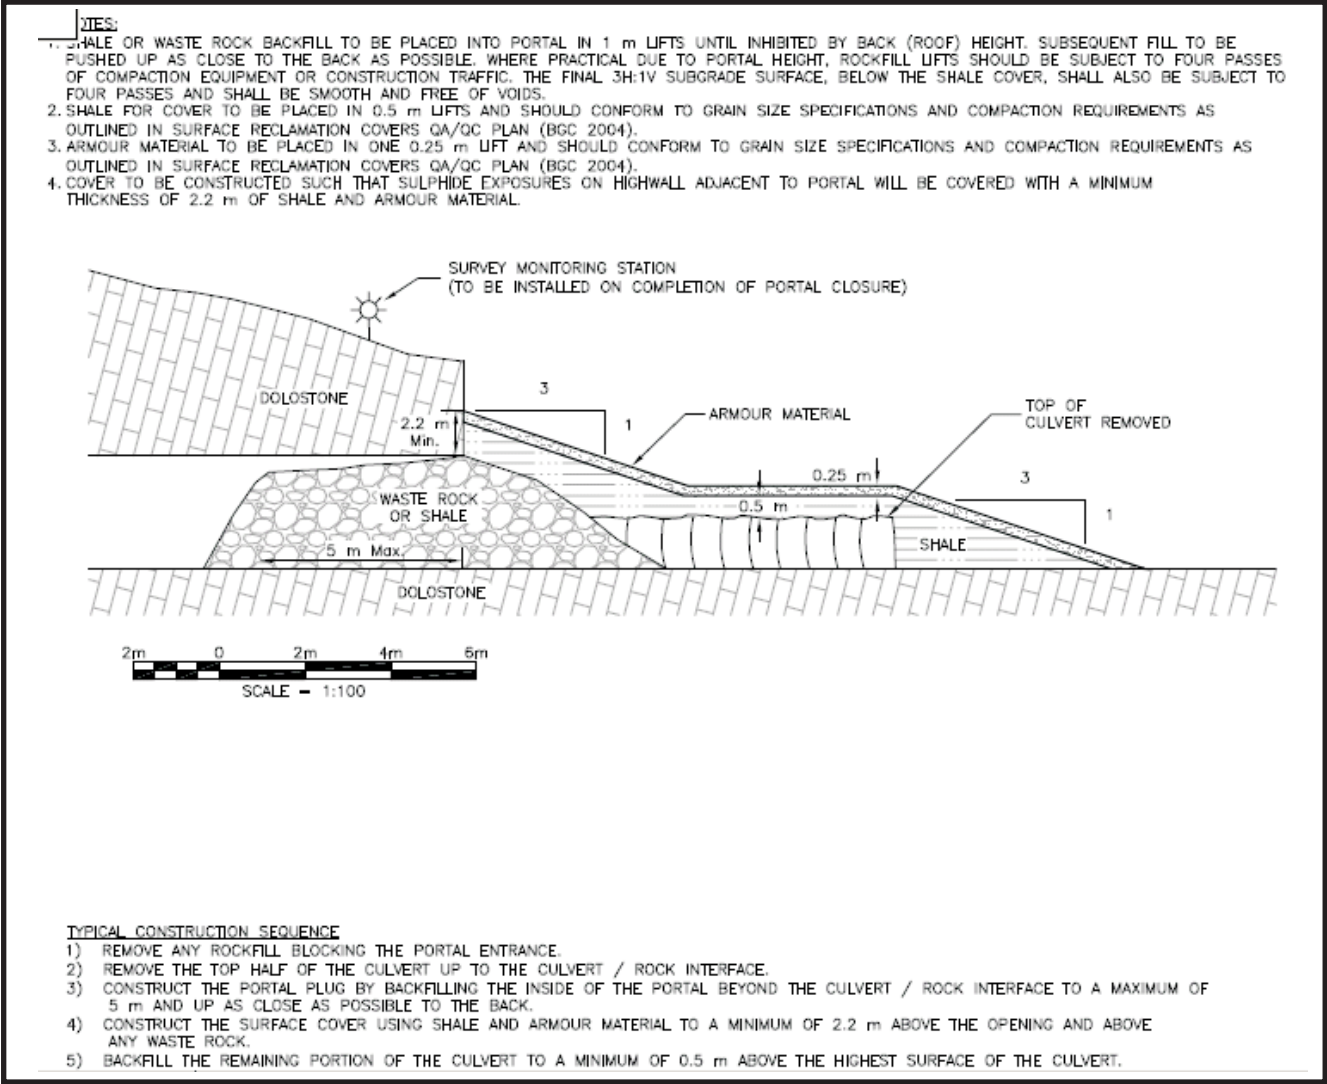
The portal reclamation schemes are generally found to be inadequate.

The backfill of the portal is incomplete. While the stated purpose of the backfill is to provide some support of the back, this is unlikely. As the fill is to be pushed into the portal a maximum of 5m, and not placed tight against the back, this will provide no, or at the very best, very limited support to the immediate portal area. Note that the angle of repose of blasted muck rarely exceeds 40°.

The rock capping the portal cap is insufficiently supported by adjacent fill or by underlying fill (or concrete) to be considered to be permanently remediated.

More detailed engineering work is required. This should include detailed sections of the portal, including specific structures as well as general rock fabric information, true ground profiles to such depth as failure is unlikely to breach surface, realistic engineered backfill options that demonstrably insure rock support to a depth where rock failure can be demonstrated to be unlikely to occur, and the effect of the present portal rock support (bolts, strap, etc.) degrading and being rendered ineffective over time.

Monitoring should be specifically designed for each portal such that it will take into account all of the above noted details. It should also be verified to function of the time period required for the aforementioned failure modes to manifest.
