# **GEOTECHNICAL INSPECTION OF GARROW LAKE DAM**

November 5, 2003

**Subject: Garrow Lake Dam  
2003 Annual Assessment  
Polaris, Nunavut**

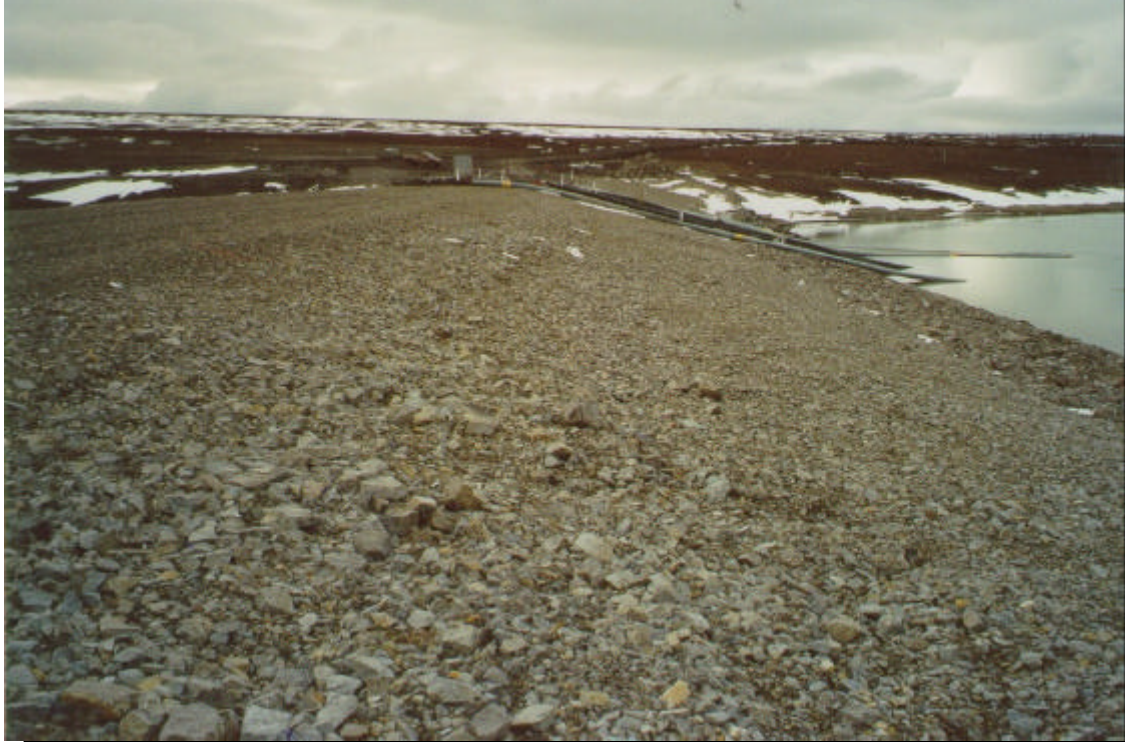
**Photo 1**  
Upstream slope - looking west.

The upstream and downstream dam slopes of Garrow Lake Dam have remained stable and there is negligible erosion on the slopes (Photos 1 and 2).

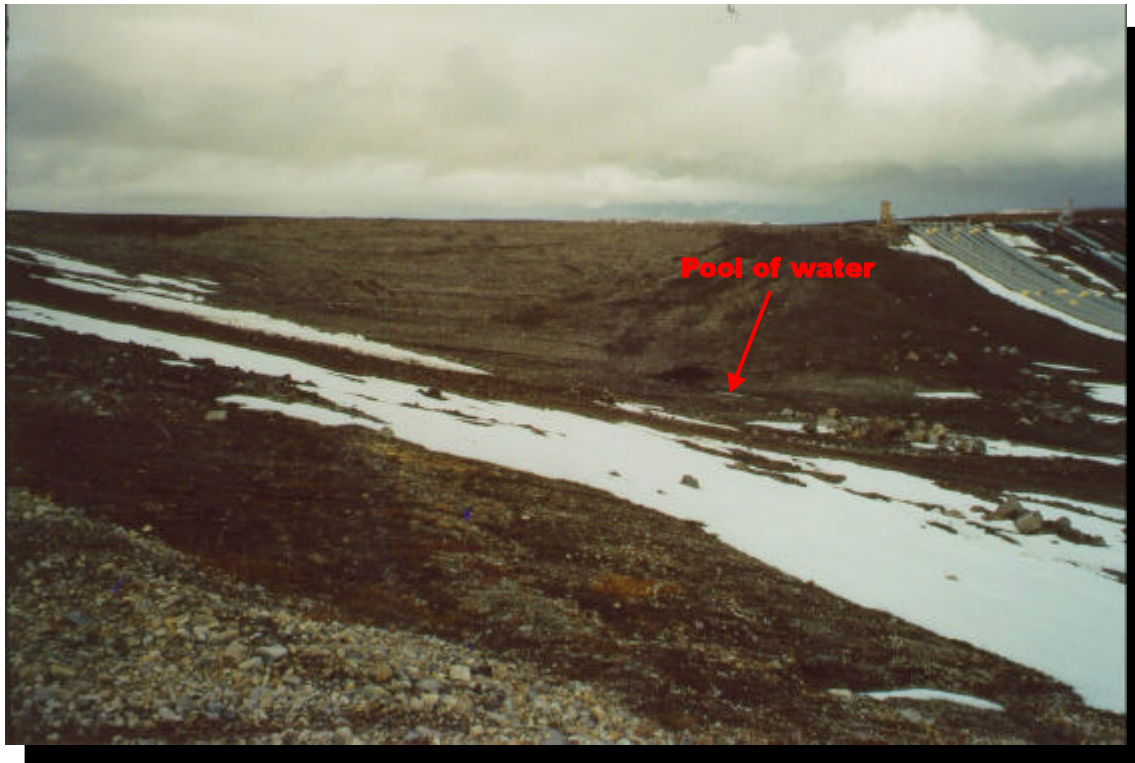
**Photo 3**

A very small pool of water is ponded just past the downstream toe of the west abutment. Runoff from the approach road to the dam has a direct path to this location. Standing water was observed in this area by EBA in 1996, 1998, 2000 and 2002. The area has always been slightly depressed and likely has collected runoff from the surrounding area.

Downstream slope - looking east.  
Very little ponded water at toe of dam.

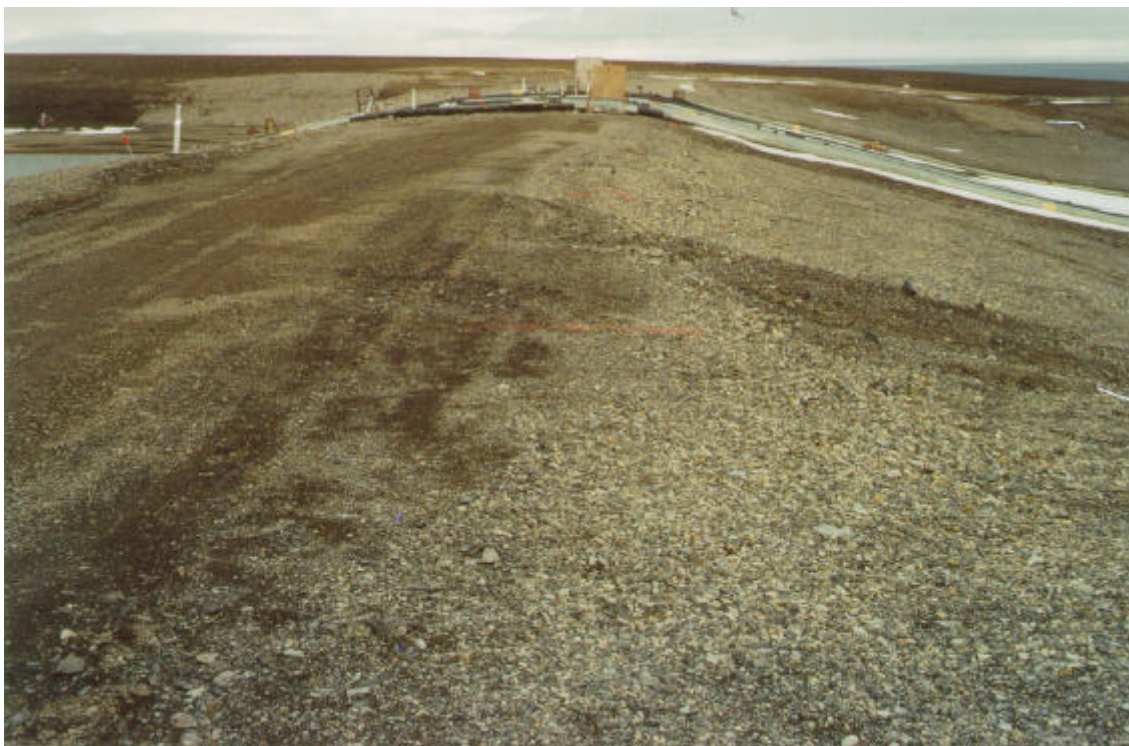
**Photo 4**

There has been a considerable amount of vehicle traffic on the west half of the dam since EBA's 2002 site visit. This traffic has occurred while adding and maintaining siphon lines. A modest curb of granular ridge has developed on the upstream crest shoulder from material displaced by rubber tired vehicle traffic. On the downstream side the ridge is absent, however, some areas of disturbance and subsequent redressing are apparent (Photos 3 and 4). A shallow dish shaped depression that was about 1.5m diameter remained on August 20, that was free of any water (Photo 4).

Dam crest - looking east.

These areas do not present any influence on the short-term dam performance and can be addressed at the time of decommissioning of the dam.

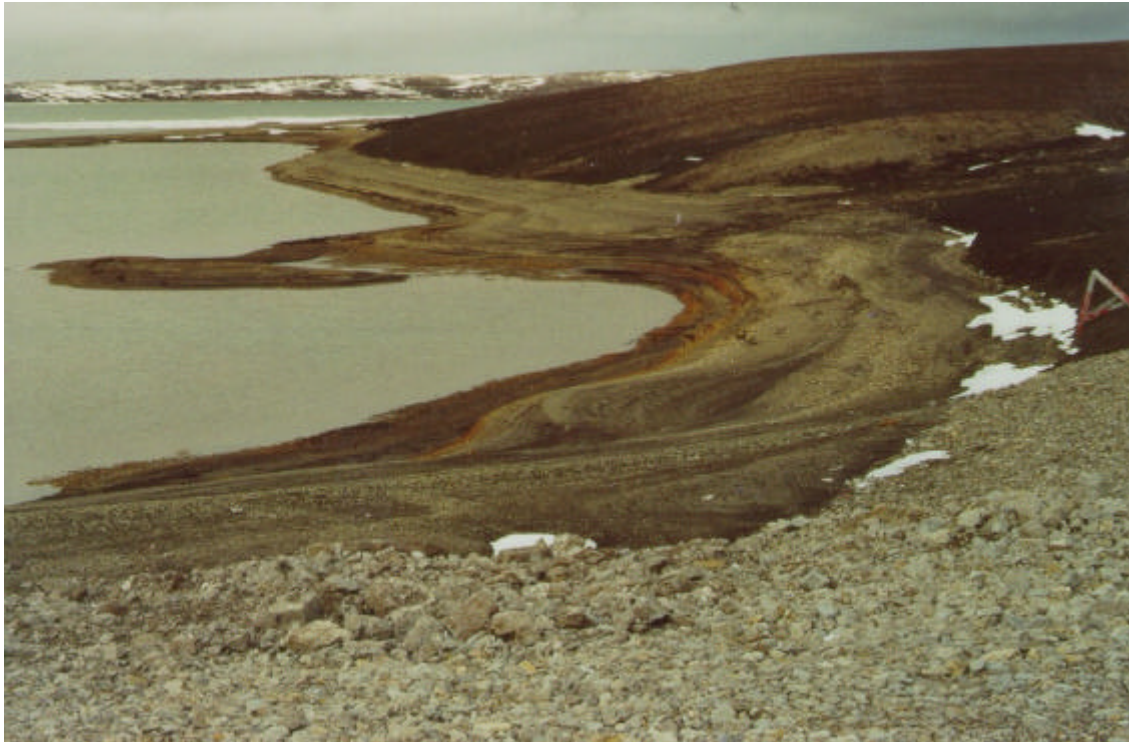
**Photo 5**

The lowering of the water level has exposed more beach (Photo 5). Upslope of the beach, the sides of the reservoir remain stable with no evidence of any new erosion or instability.

East abutment - beach condition after lowering reservoir.

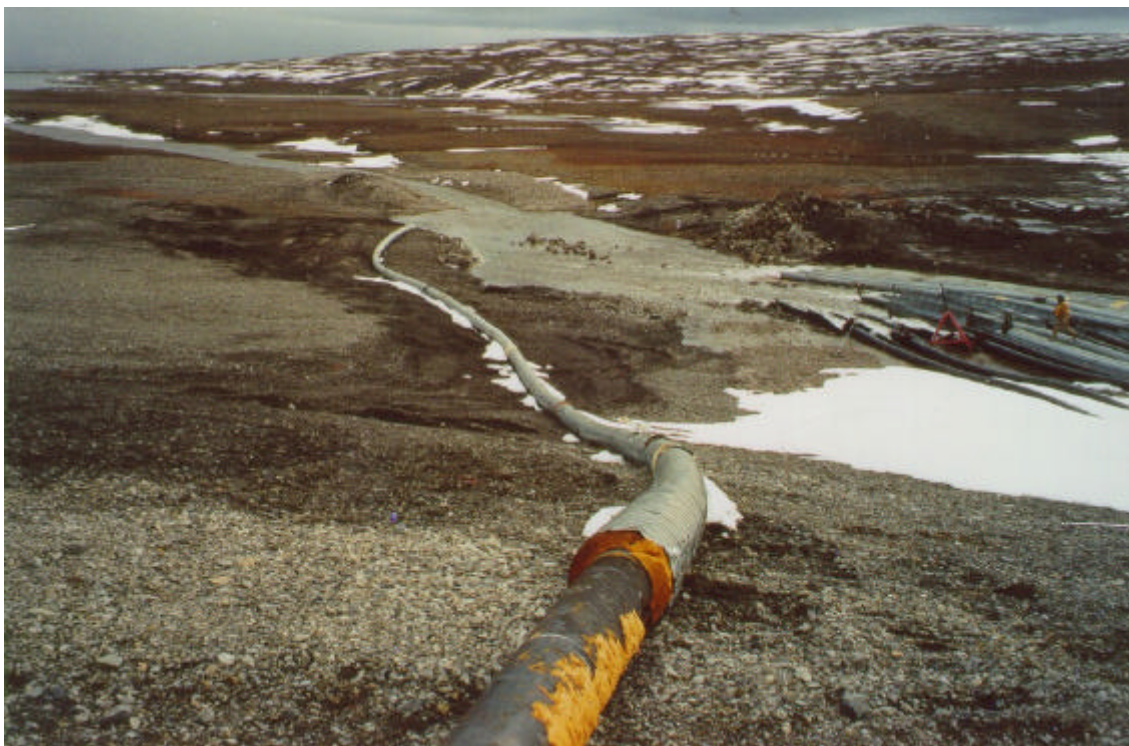
**Photo 6**

Siphon discharge observed during the 2003 site visit is shown in Photo 6.

Siphon discharge into Garrow Lake.  
Single line in foreground was inactive.

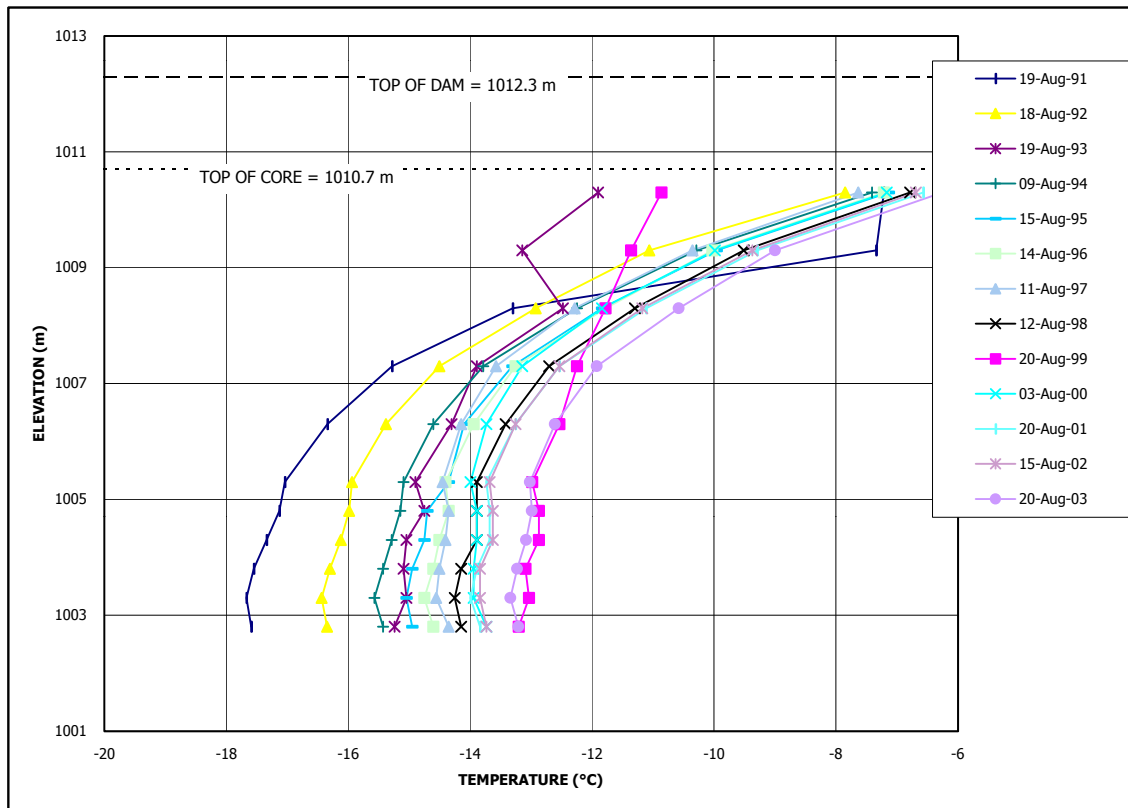
FIGURE 1: NORTH THERMISTOR - TEMPERATURE PROFILE

Ground temperature measurements were recorded on a monthly basis in 2002/03 by Teck Cominco's mine site personnel. Ground temperature profiles are shown in Figures 1, 3 and 5, and temperature variation over time is shown in Figures 2, 4, and 6. The ground temperatures have been relatively stable over the years with the exception of 1999 when ground temperatures warmed in response to unusually warm weather experienced at the Polaris Mine.

The general trend in the collected data since dam construction has historically been one of slight warming; however, the 2001 and 2002 data collected indicated that this trend attenuated. In 2003, the trend observed was that of slight warming of 0.1 to 0.2 C°. The temperatures remain consistently lower than predicted by the thermal analysis used to support the dam design.

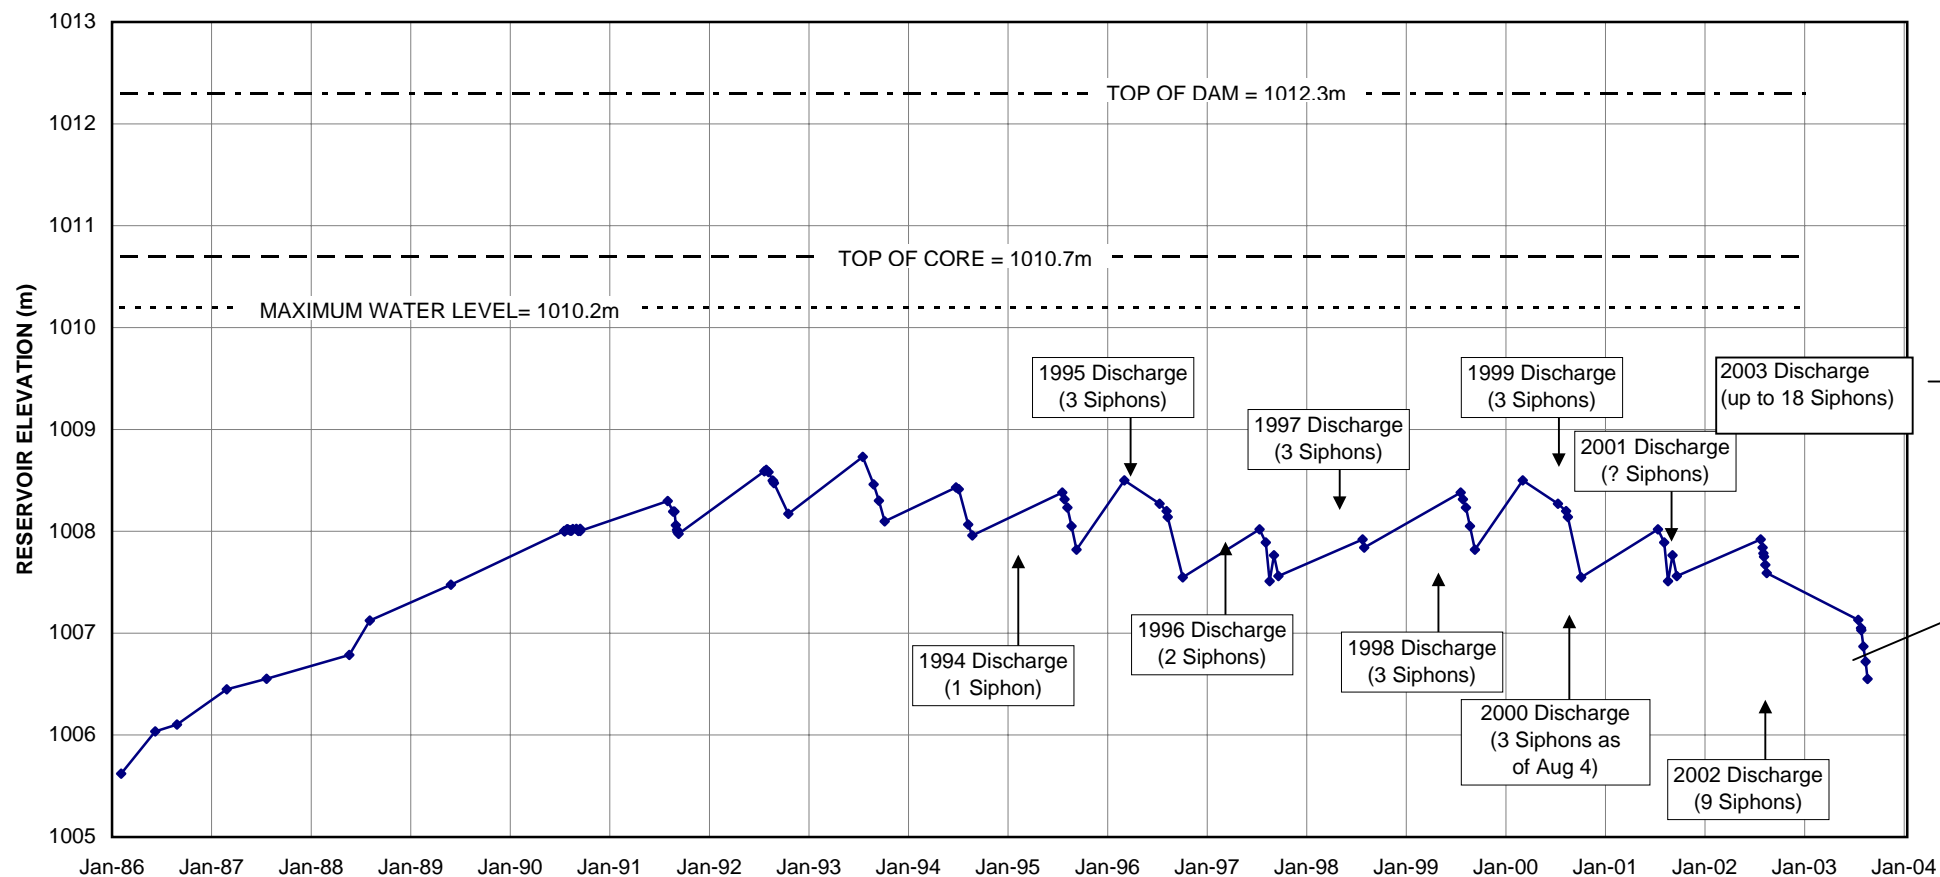
FIGURE 7: GARROW LAKE - RESERVOIR LEVEL

The reservoir elevation was 1006.55 m on August 20, 2003. This is approximately 0.85 m higher than the lake elevation before impoundment, approximately 3.65 m below the maximum design water level and 1.3 m lower than when the dam was last inspected in 2002. The lake level history is shown in Figure 7.
