GEOTECHNICAL REVIEW OF THE RECLAMATION LANDFILL SUBSIDENCE AREA

POLARIS MINE

RESPONSE TO REGULATORS QUESTIONS REGARDING

September 30, 2003

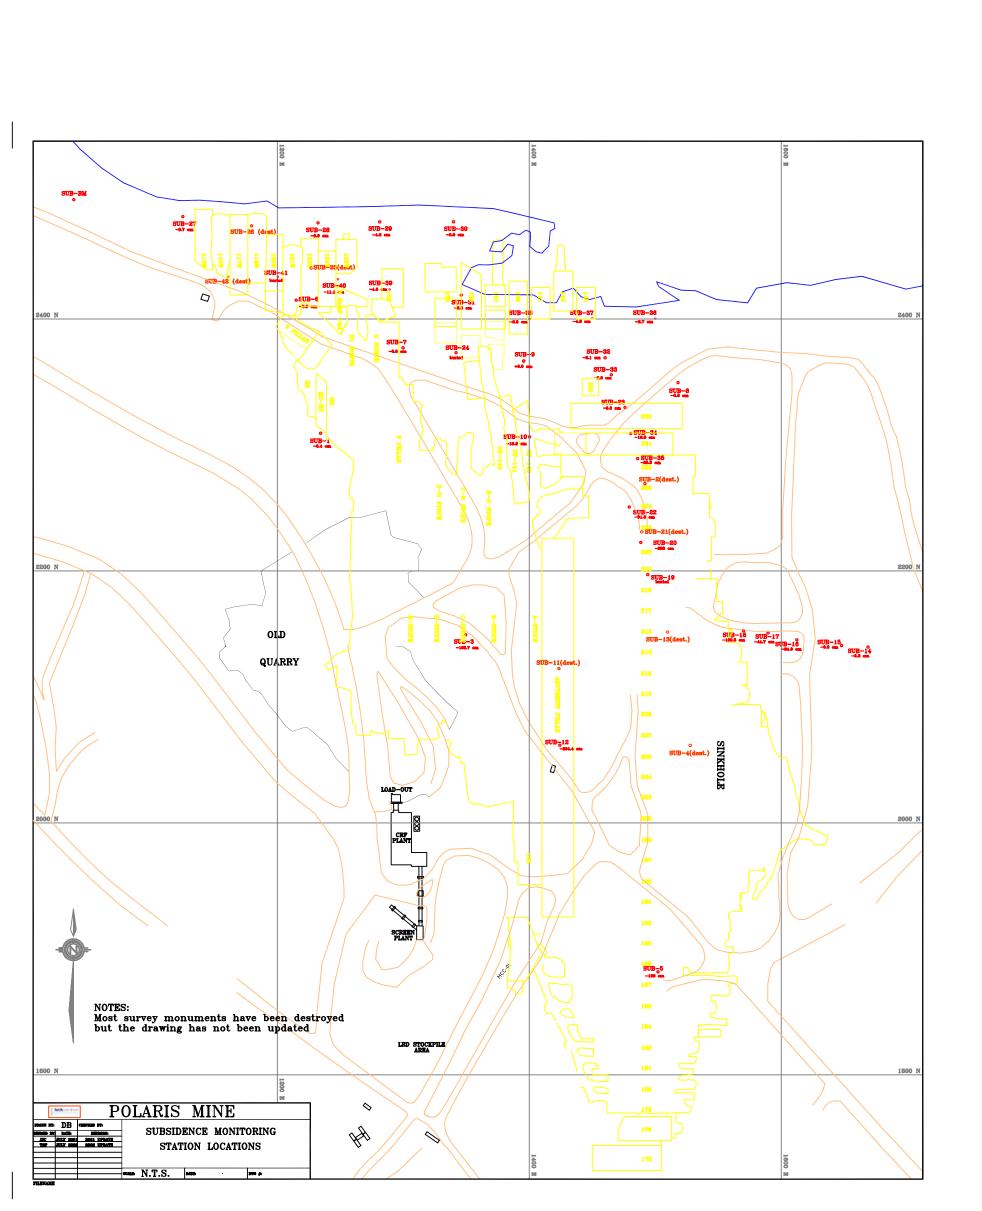
SUBSIDENCE DISPLACEMENT NORTH - SOUTH THROUGH SINKHOLE AREA AT 1500 E SECTION

The caving of the overlying strata into the 202 Stage III stope has resulted in substantial localized subsidence ('sinkhole') that is atypical of subsidence being experienced elsewhere at Polaris. Monitoring of subsidence at Polaris indicates that subsidence over the majority of the mine is not a concern in either the short or long term. However, in the area of 202 Stope, substantial subsidence has been occurring since 1999 as evidenced by the precise subsidence monitoring conducted while the mine was operating. The last precise subsidence survey was conducted in 2002 and the sinkhole area was still actively subsiding at that time.

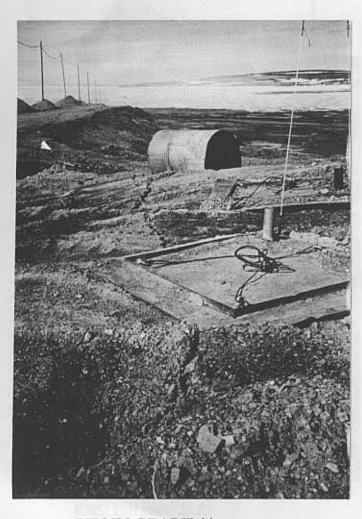
PHOTOGRAPH 44
Surface subsidence cracks.

• Subsidence induced cracks have appeared on surface (see Photographs 44 to 48).

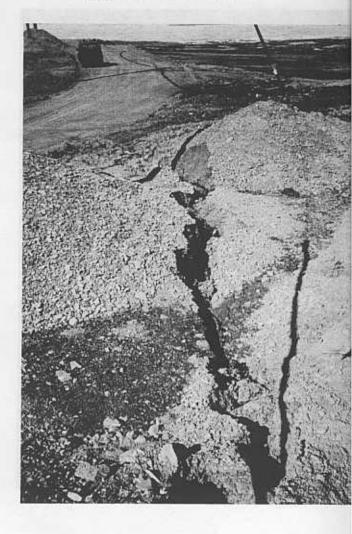
PHOTOGRAPH 43

Surface subsidence cracks.

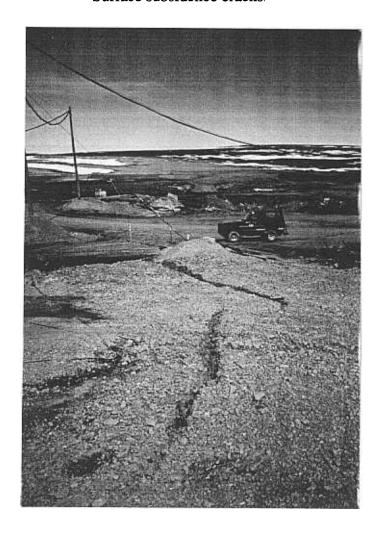
PHOTOGRAPH 46

Surface subsidence cracks.

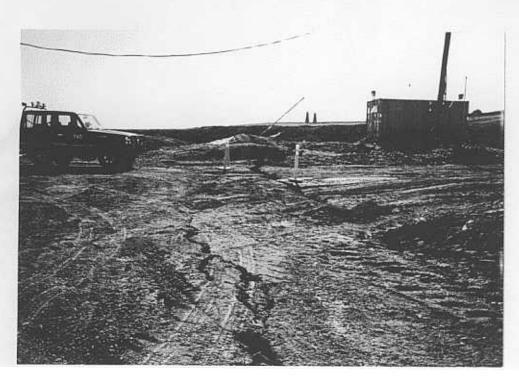
PHOTOGRAPH 47

Surface subsidence cracks.

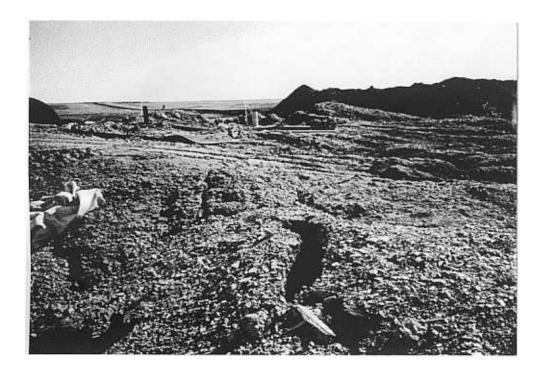
PHOTOGRAPH 48

Surface subsidence cracks.
