Report on Post-closure Geotechnical Inspection for Polaris Mine Site in 2005

Reference: **GLL 50508**

December 15, 2005

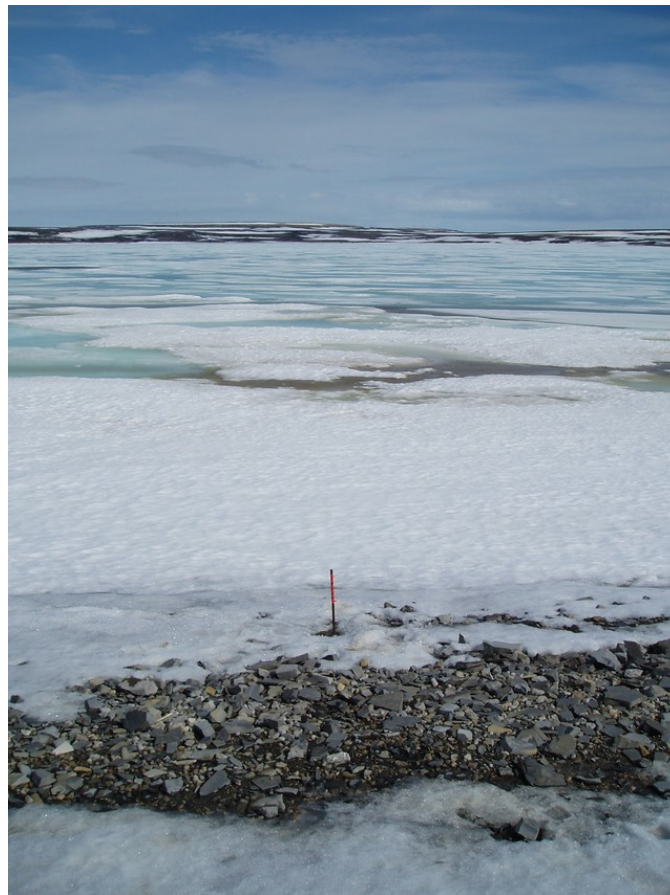
West Quadrant Pin at Station 11 – no measurement is available and the remainder of the shoreline remained snow or ice covered.

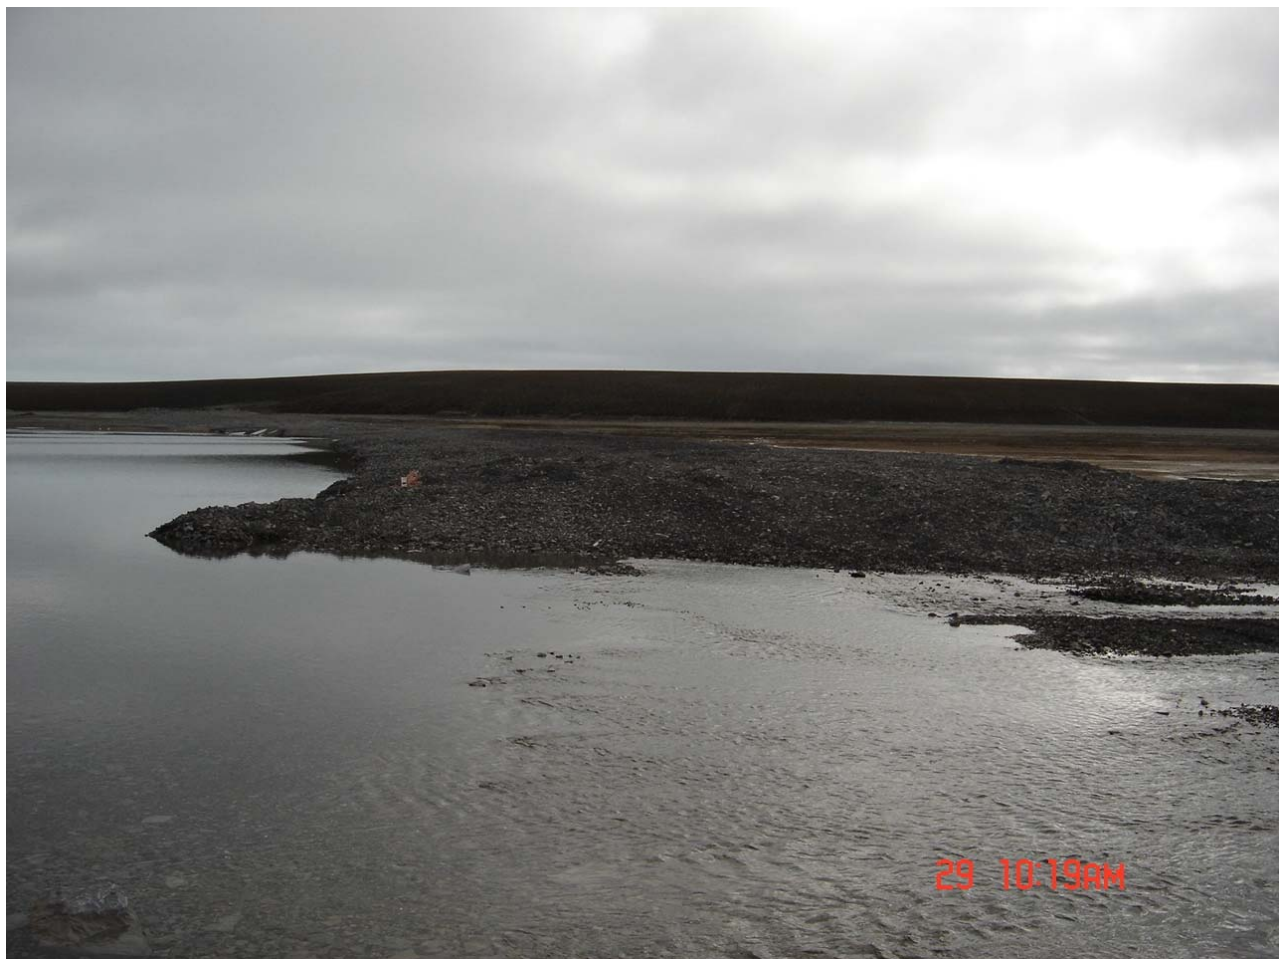
View from waypoint GLWB2a looks eastward across outlet channel illustrating uniform flow.

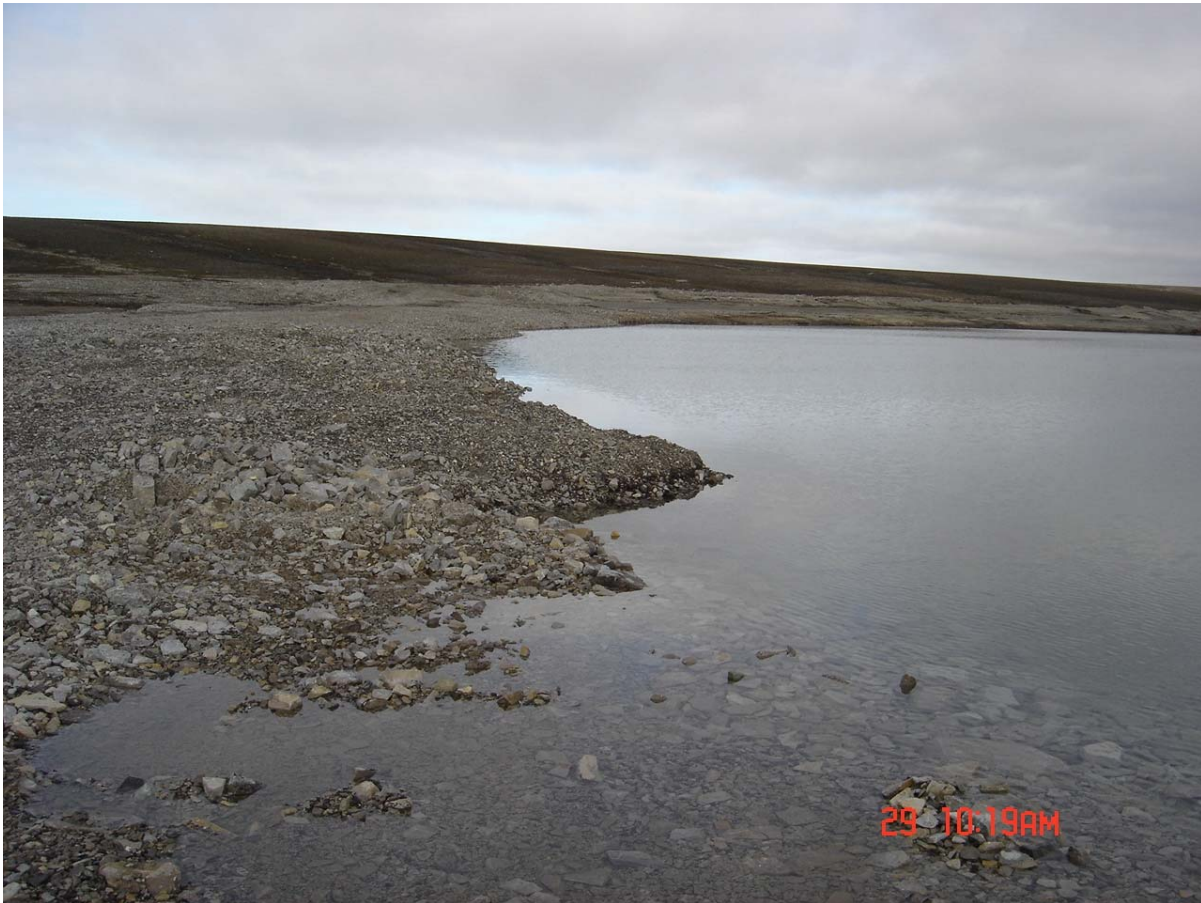
View from waypoint GLWB2a looking west along shoreline, with short remnant section of wavebreak structure in the foreground. Note coarse rock fragments in channel and clarity of shallow flowing water.

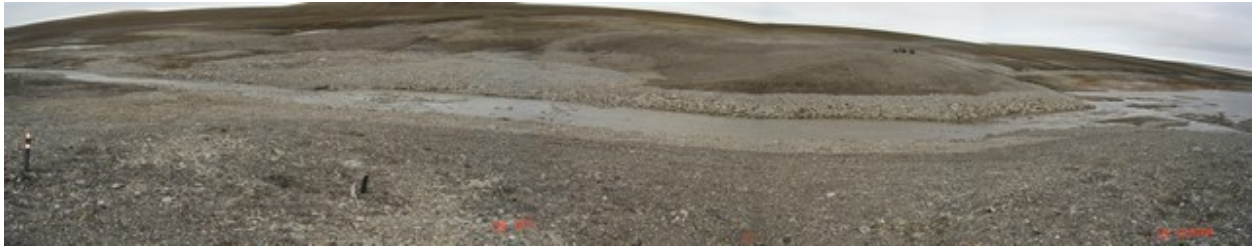
View of the west side of the dam breach from east abutment from waypoint GLD2, showing inlet at right, and rip-rapped channel which is generally in good condition. Opposite side slope, inclined at approximately 12 degrees, appears stable. A minor crack and slight slumping was observed at the left (southern) end of the side slope, about 4 m from the top of the rip-rap, over a length of about 10 m horizontally, and should be watched in subsequent inspections.

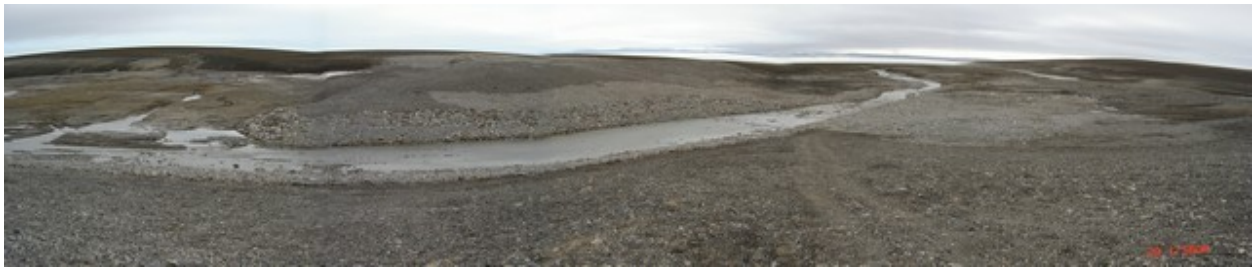
View of east side of dam breach from west abutment from waypoint GLD1. Both breach side slopes are inclined at approximately 12 degrees and are generally in good condition.

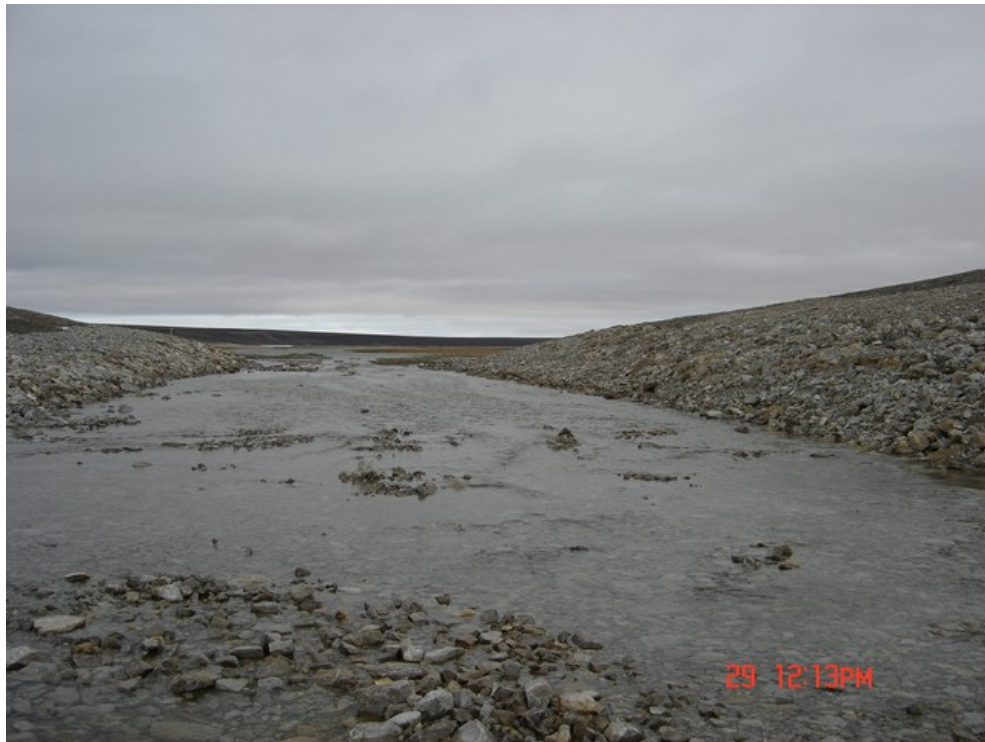
View northwards at waypoint GLD3, looking upstream along creek channel, showing rip-rap lining, which is in good condition. Flow is moderately uniform across channel, with high clarity.

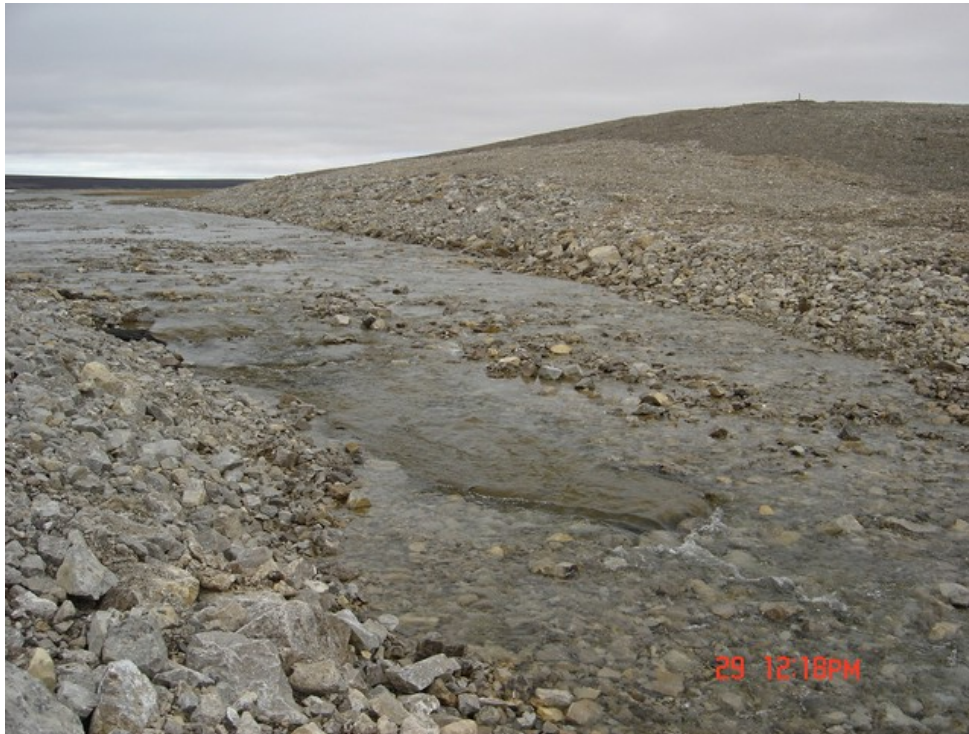
View from 30 m downstream of waypoint GLD3 at a point where channel gradient increases. Filter fabric underlying the rip-rap material has been exposed over a width of 3 to 4 m and over a length of about 10m. Remedial action to replace rip-rap is recommended. The integrity of surrounding rip-rap does not appear to have been affected.

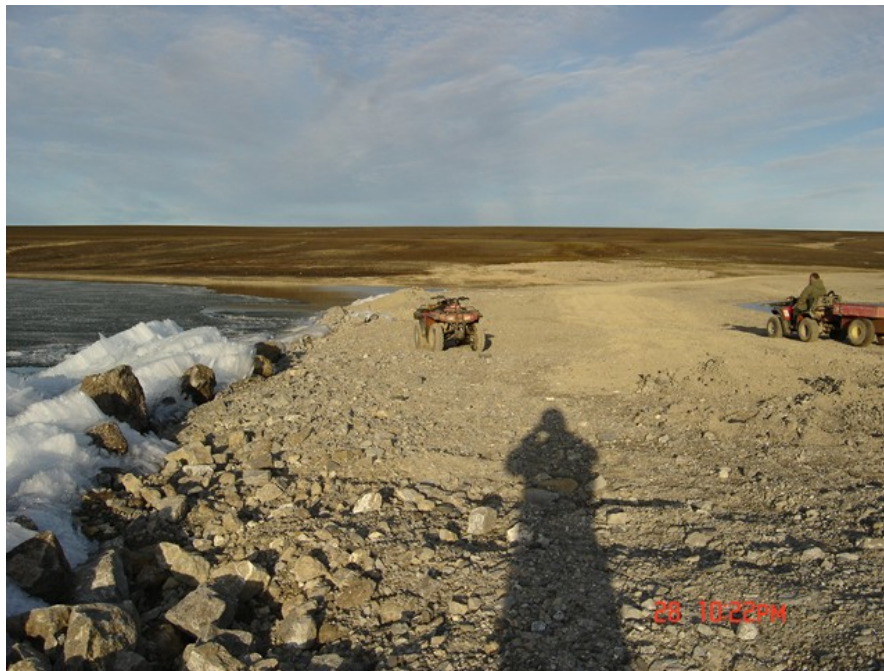
View from waypoint FL1 looking towards shoreline – note slight subsidence in foreground.

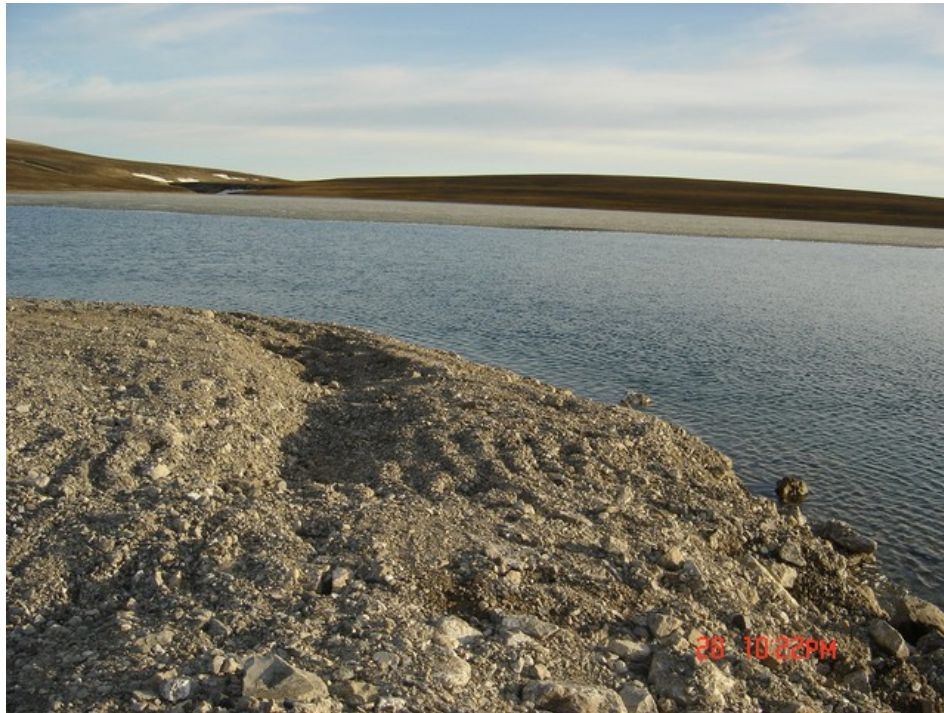
View from waypoint FL1 looking across end of causeway – note slight subsidence in foreground.

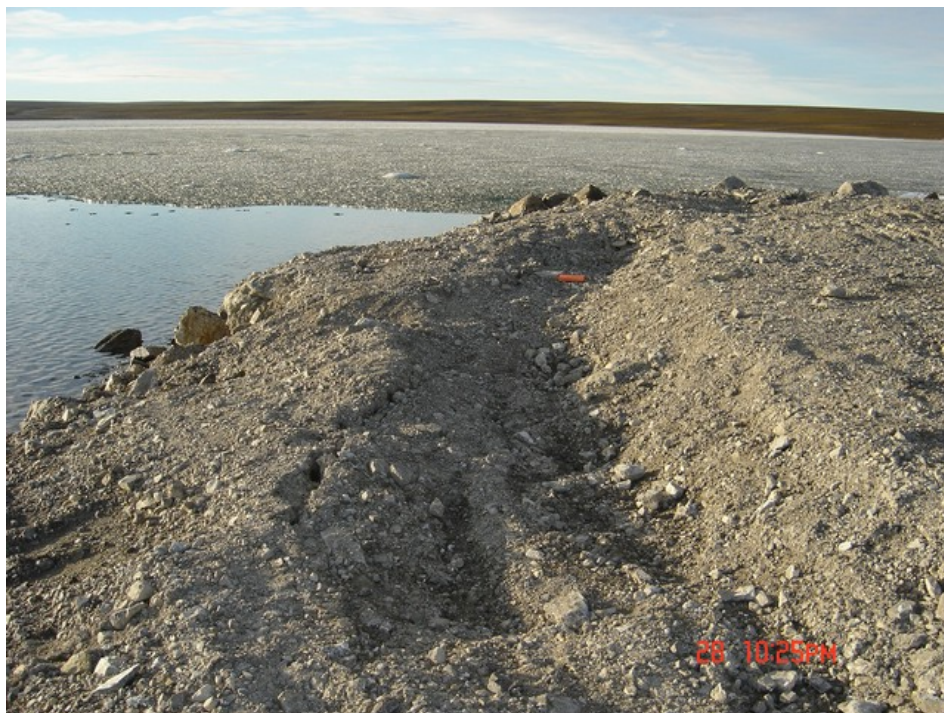
View from waypoint FL2 looking across northern end of causeway – note slight subsidence in foreground, with vertical separation of about 0.3 m over a width of 2 m possibly from melting of snow/ice buried within the fill.

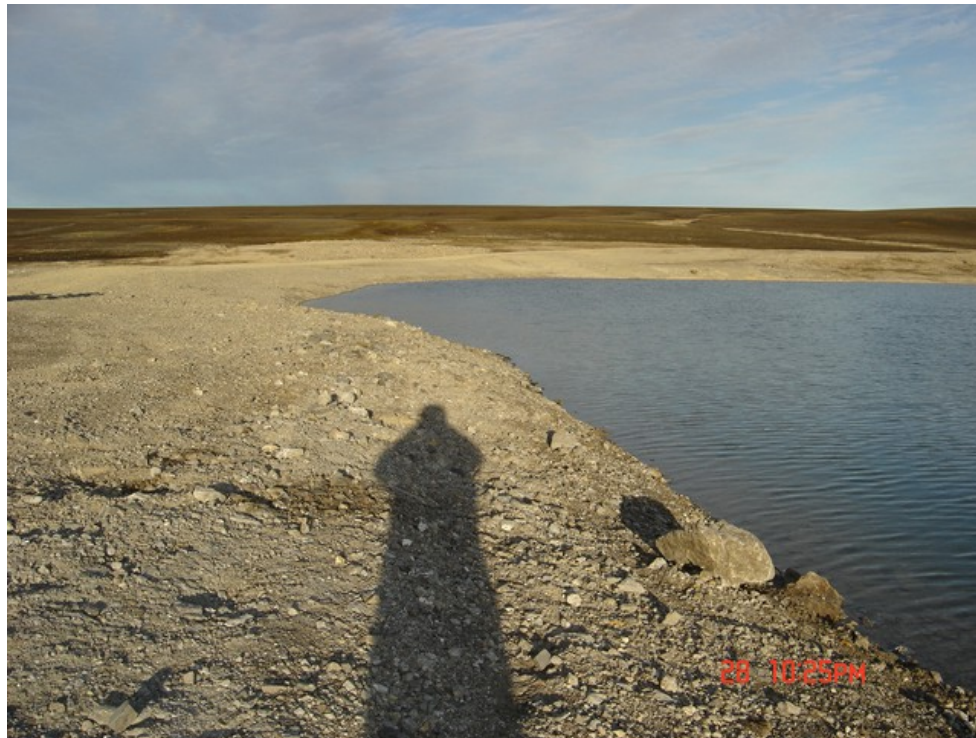
View from waypoint FL2 looking towards shoreline along west side of causeway. No sign of deformation observed along this side.

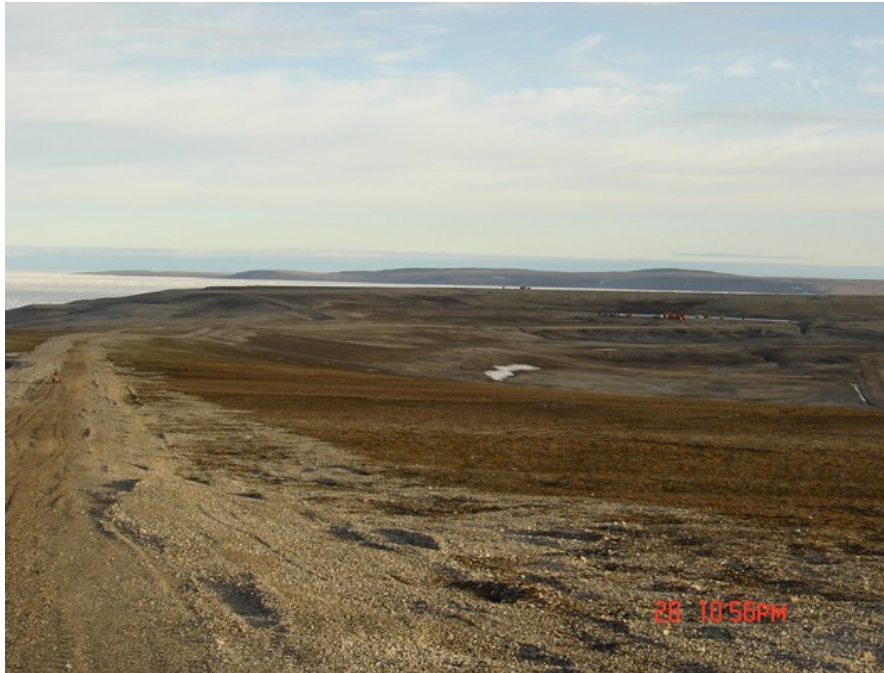
View of segment of road to Frustration Lake looking southwest towards mine site from the highest point of topography. Roadway and sideslope are in good condition, free of significant erosion features.

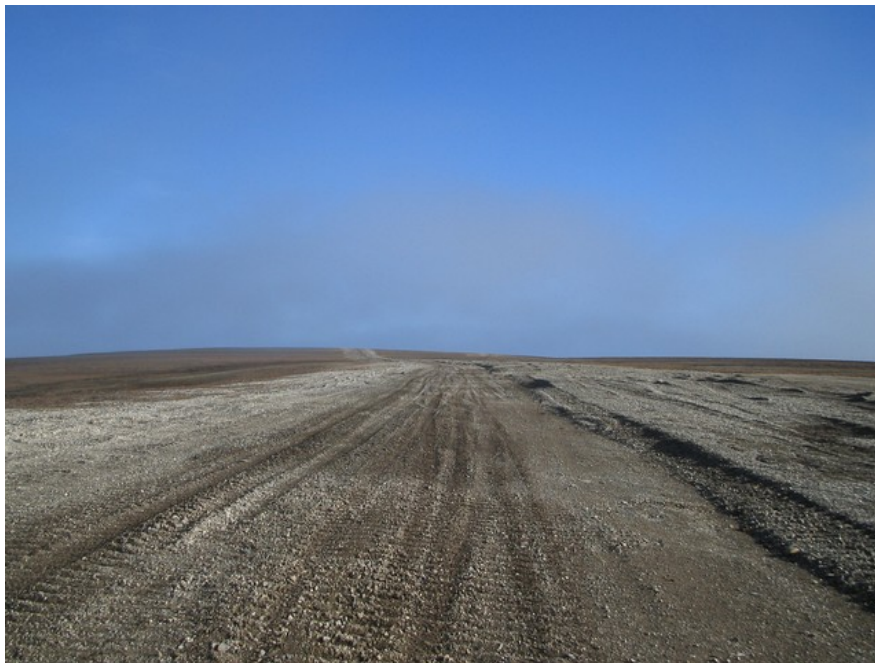
View to the southwest looking towards topographic high point showing approximately the middle one-third of the access road to Frustration Lake. This section is in good condition.

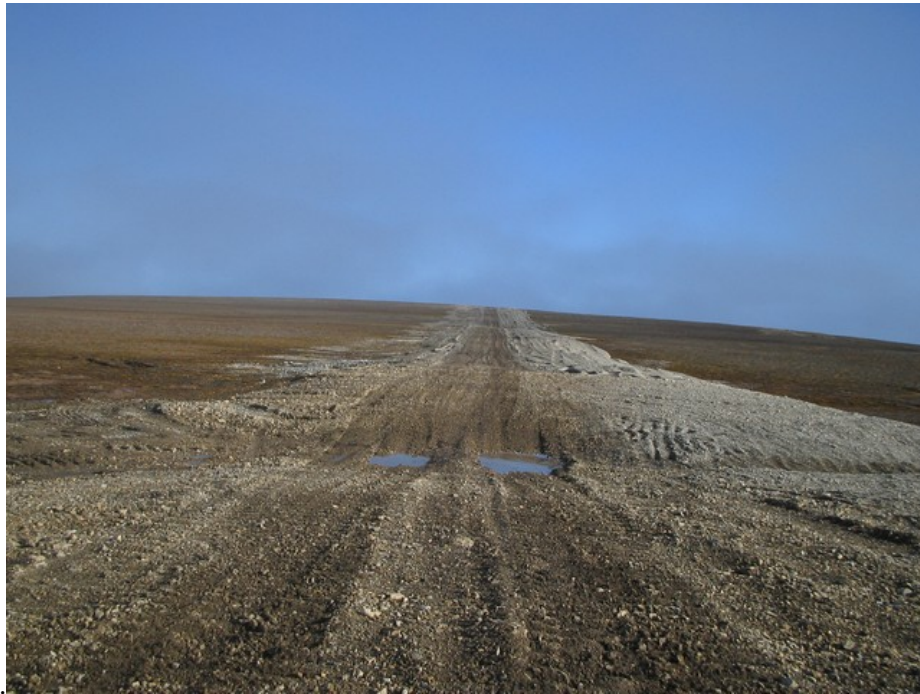
View to southwest looking up gently sloping section approximately 800 m from the water intake causeway. Roadway is in good condition, with only minor erosion of loose material at drainage crossing.

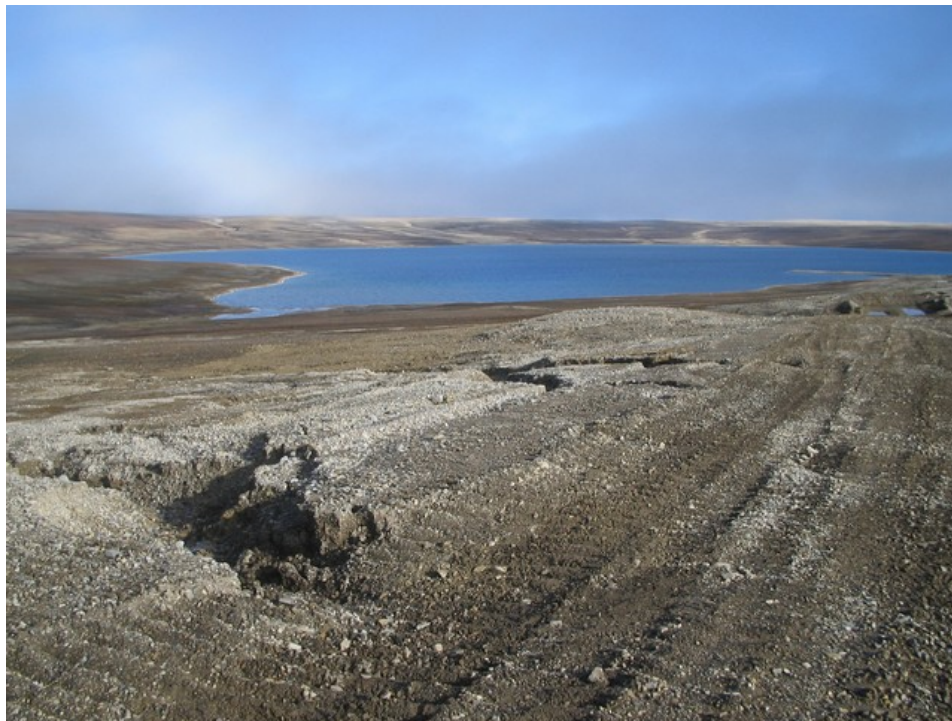
Closer view of minor erosion gully at a point approximately 600 m distant from causeway. There appears to be sufficient coarse fraction so that self-armouring will occur in due course.

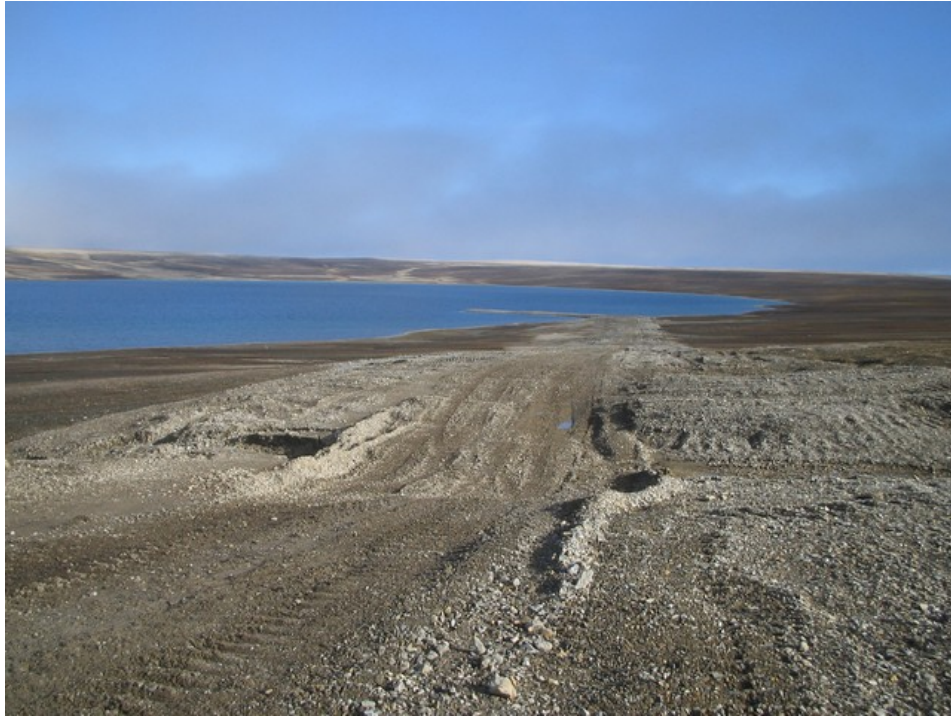
A drainage swale at about 500 m distance from intake causeway is in good condition.

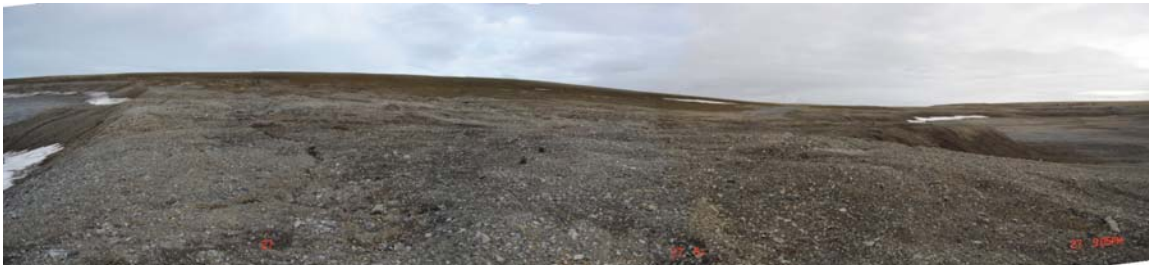
View looking up west sideslope of New Quarry Extension, where stripped organic surficial soil has been spread. Occasional cracks but no signs of mass movement presenting any hazard to humans or wildlife.

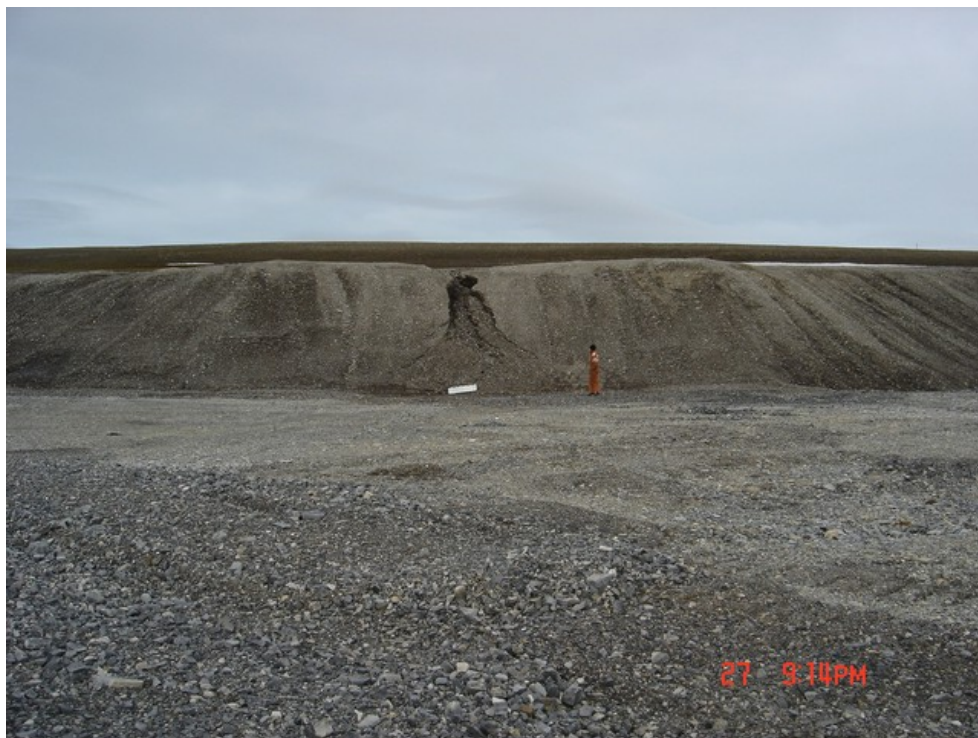
Isolated erosion gully at waypoint NQ2 PH1.

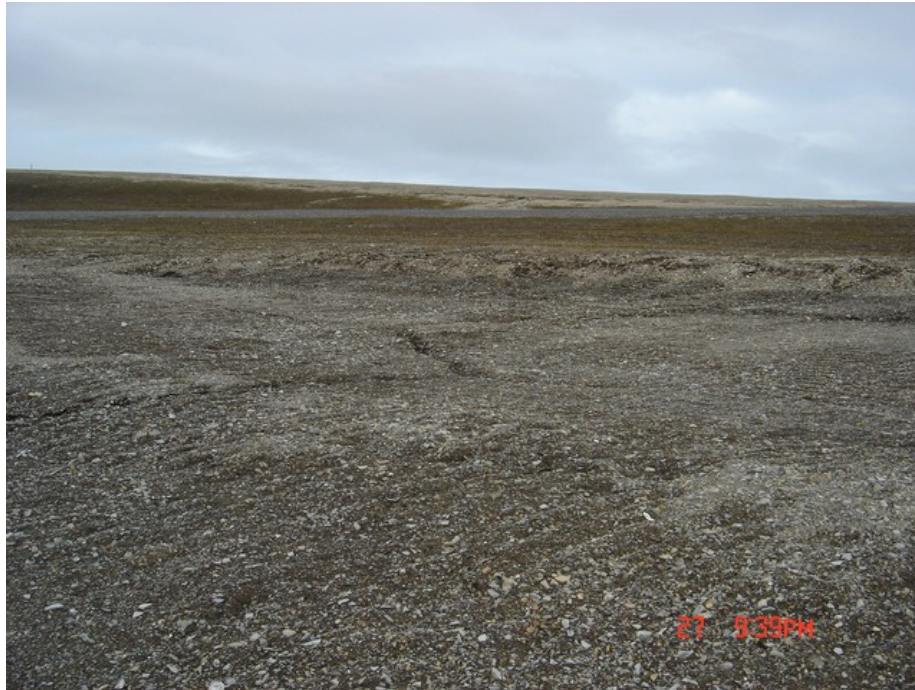
Area above waypoint NQ5 view looking northeast across area of disturbed surficial soil bordering edge of quarry sideslope. Illustrates typical pattern of surficial deformation caused by seasonal thaw of disturbed surficial soils. This poses no threat to humans or wildlife.

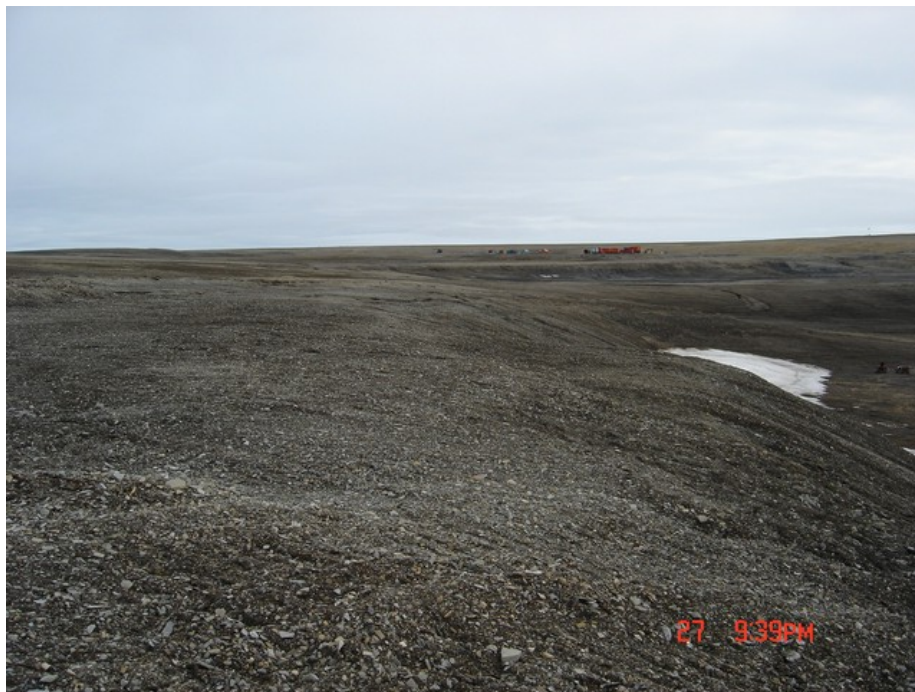
From waypoint NQ5 view west showing stable erosion free nature of surficial soils draped over the top edge of the new Quarry perimeter.

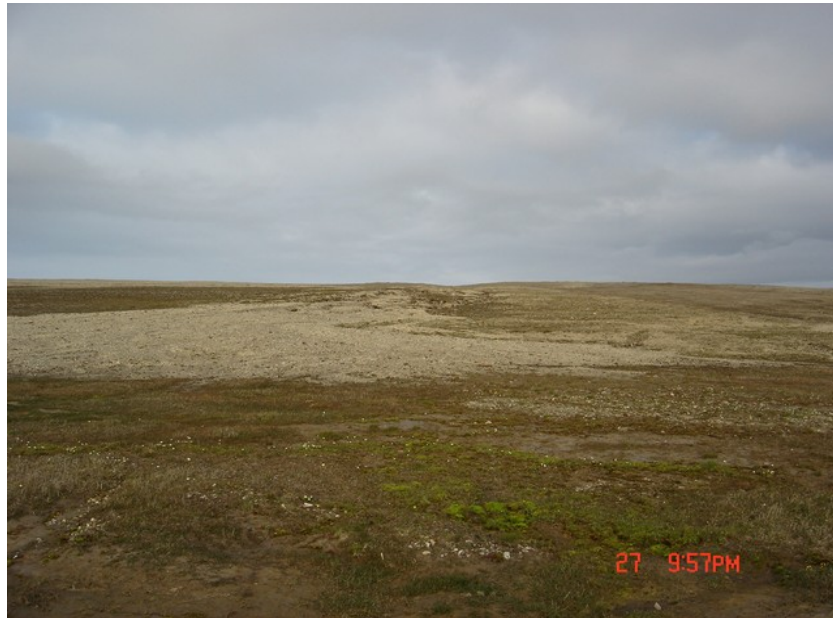
View at waypoint NQ 6 northeast across natural slopes to west of new Quarry area. Thawing and erosive processes have during the life of the project appear to have resulted in two parallel gullies and erosion of surficial weathered rock which has formed a fan as shown. The following photographs show more details of gully that has been eroded in the loosened disturbed materials deposited around the perimeter of the quarry area.

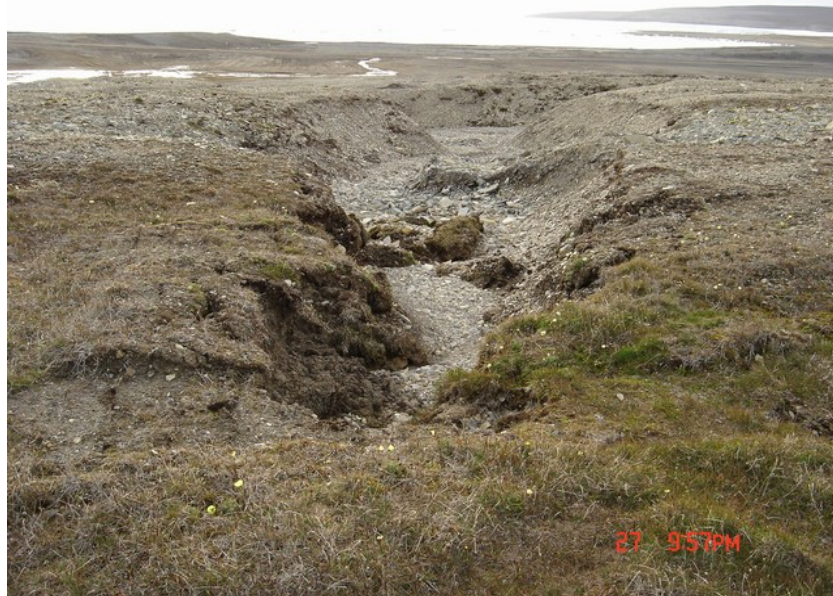
View northwest looking down gully at waypoint NQ6. This appears to be a gradual yet active erosive process, possibly as a result of intermittent storm runoff transporting coarse material from fan upslope, shown in photograph above. This area should continue to be monitored. See measurements of gully size noted in following photographs at known GPS locations to facilitate future comparison of rate of erosion. Localised erosion control measures, likely best implemented by manual labour, to protect surrounding tundra, should be planned for implemented as soon as is practical in 2006.

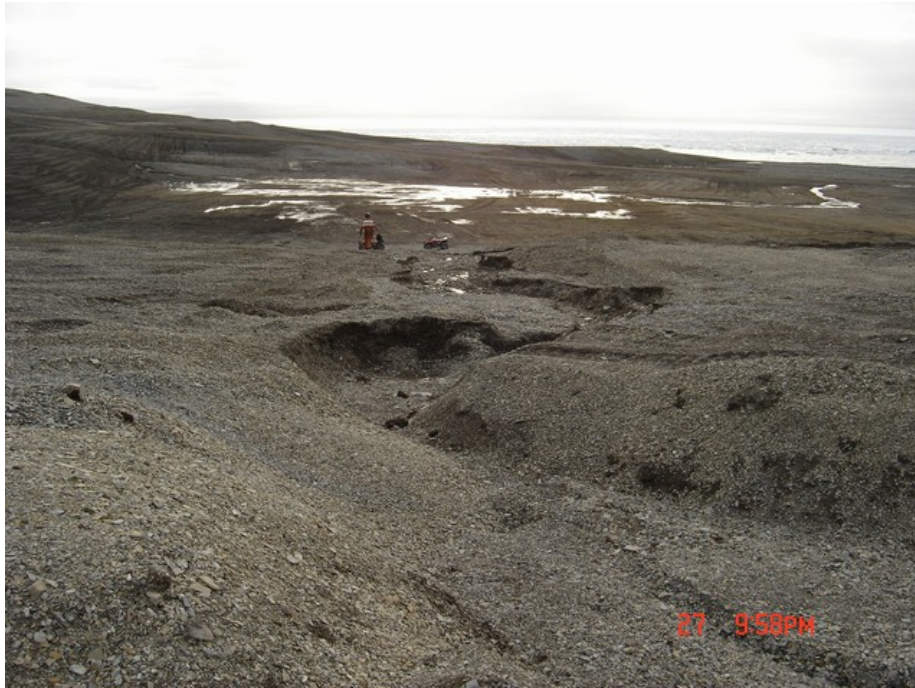
Photo shows gully through loosened materials around edge of new Quarry, down slope of waypoint NQ6. Following show more detailed measurements and photographs in the vicinity of waypoint NQ6, but labeled at NQG1.

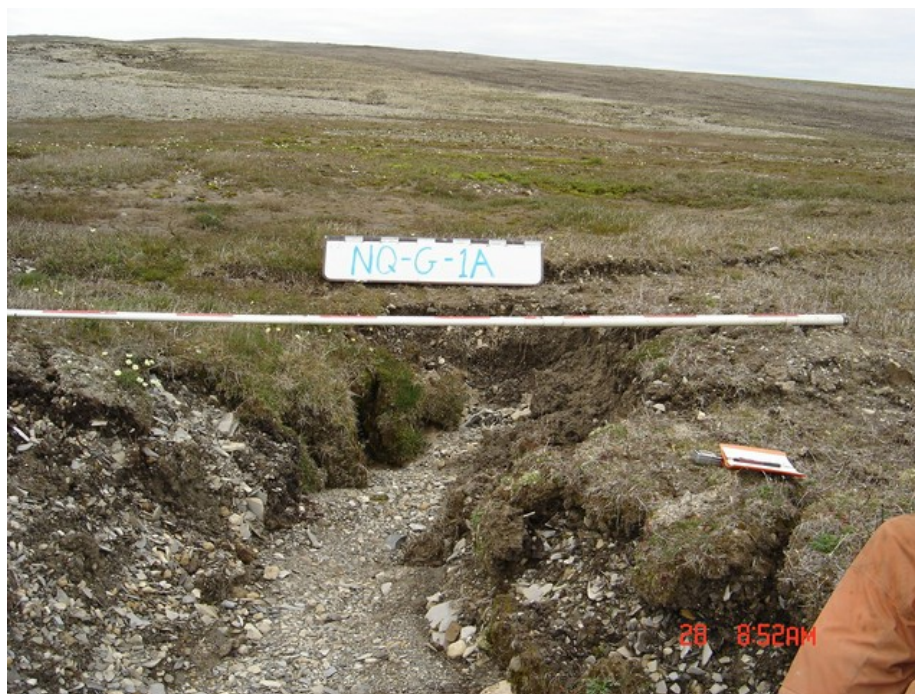
At waypoint NQG1A depth of erosion gully is 72 cm. Signboard has top bars at 10 cm intervals.

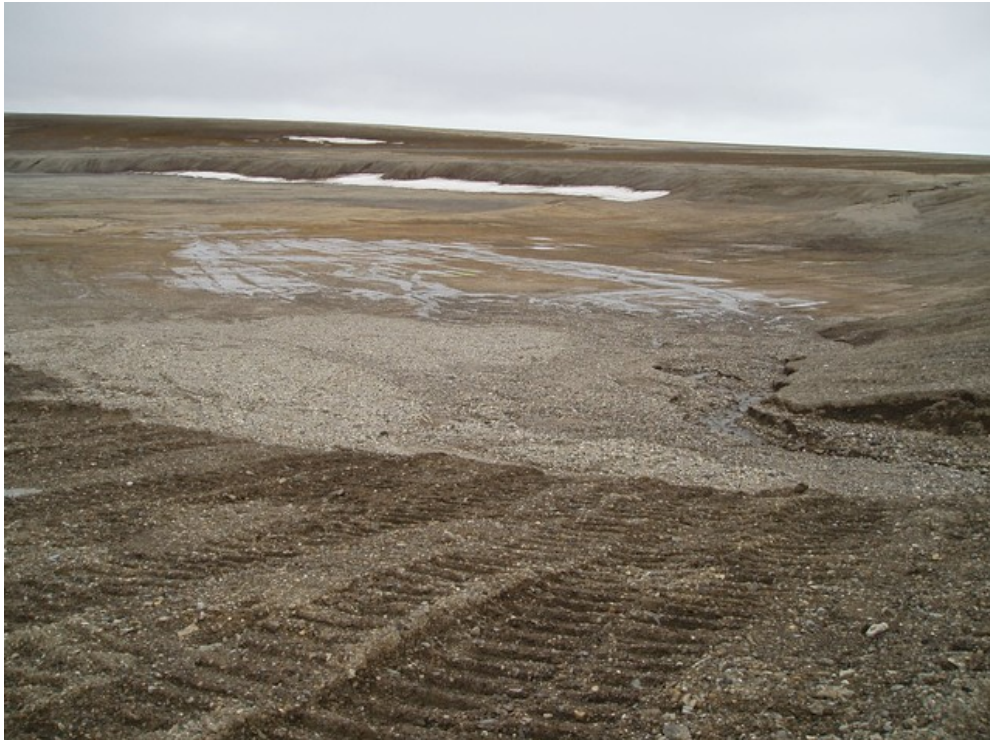
Debris fanning across floor of New Quarry.

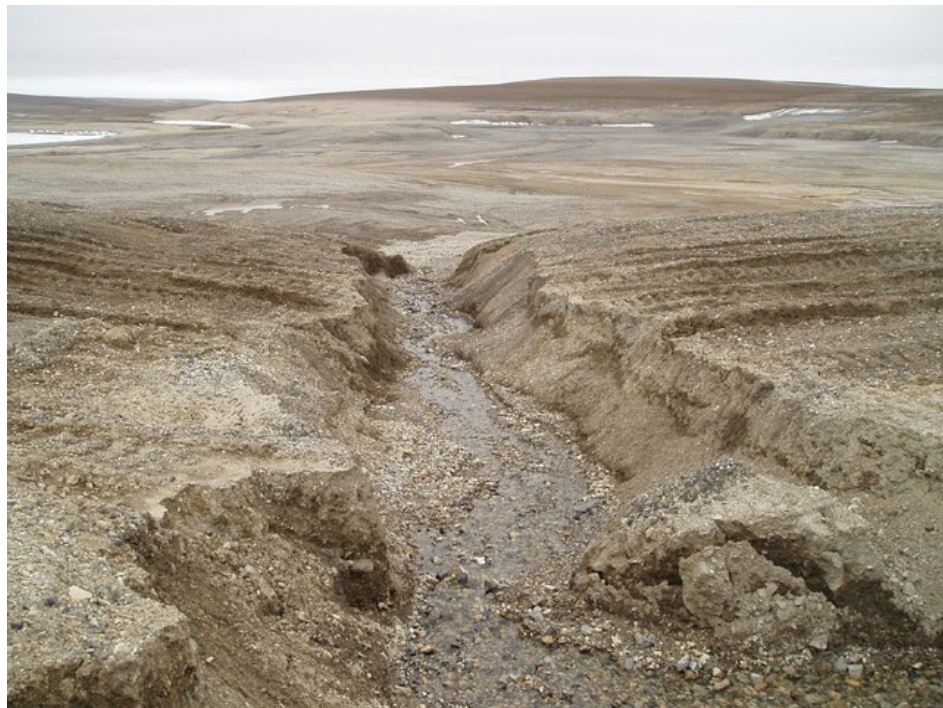
View upstream of view above. Erosional down cutting of loose silty sand and gravel can be expected to continue if coarse material is not placed here.

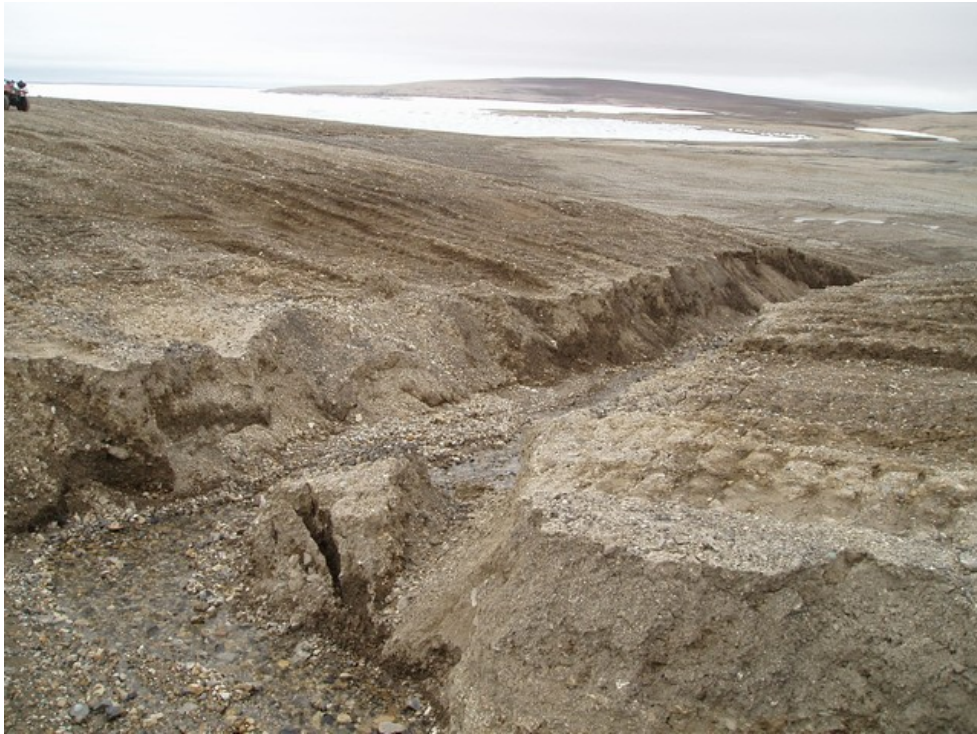
View further upstream of above view, at point where drainage channel changes direction and becomes steeper and more active erosion is occurring.

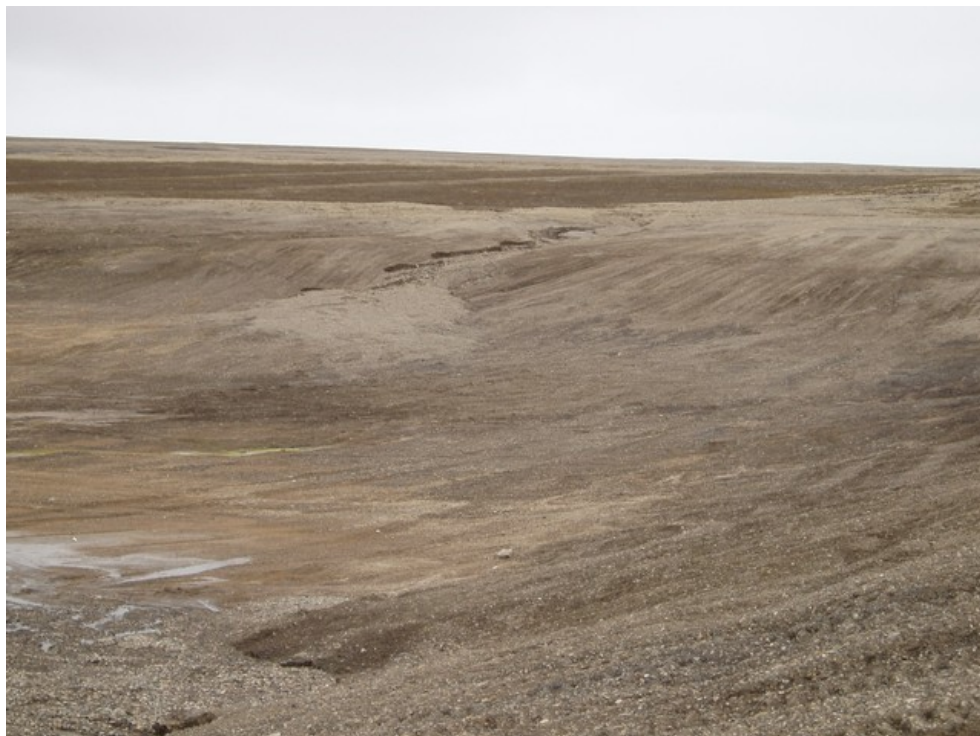
View eastwards from waypoint NQLOONCK of erosion gully at waypoint NQ6.

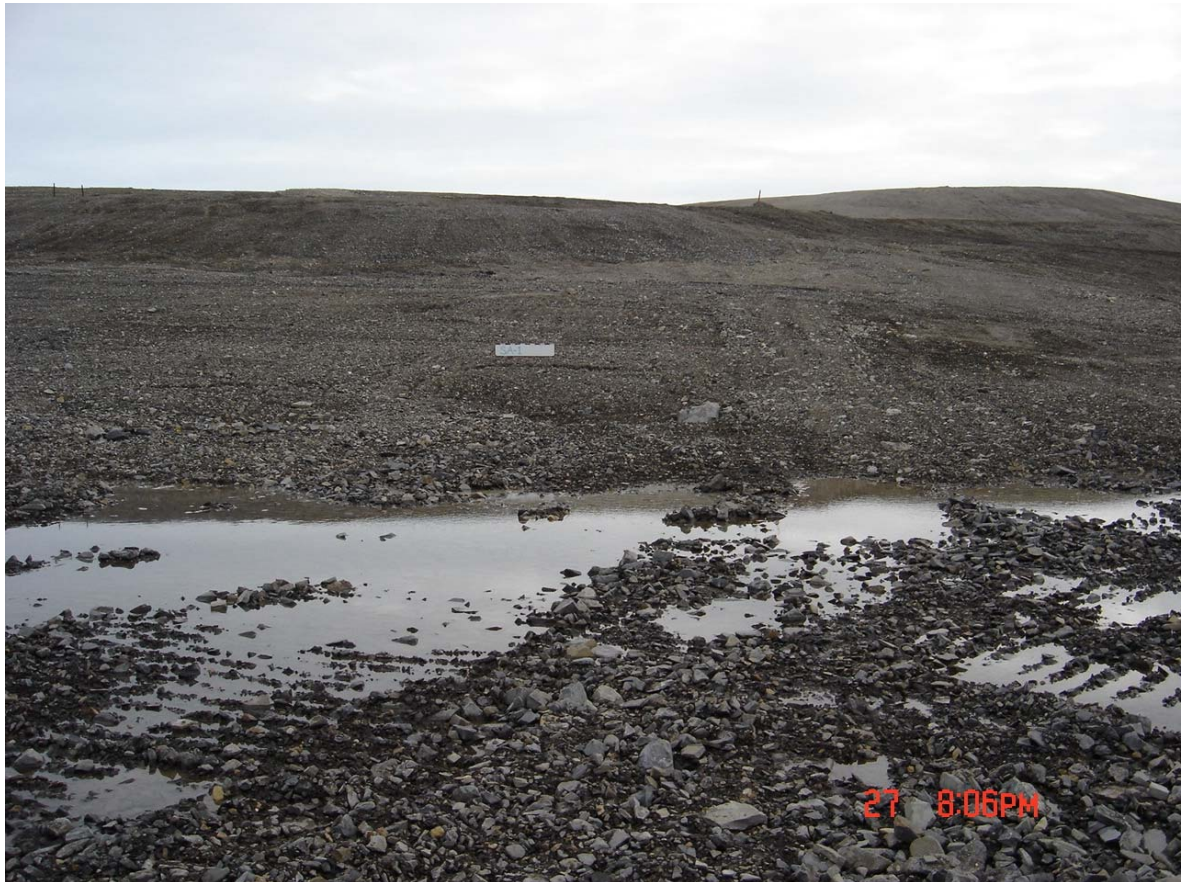
Photo of location SA1 at waypoint SA PH 1, with view looking west. The marker board is positioned adjacent to a tension crack. Other than the ponding in the foreground, this crack is the only distinct feature visible across the entire subsidence area.

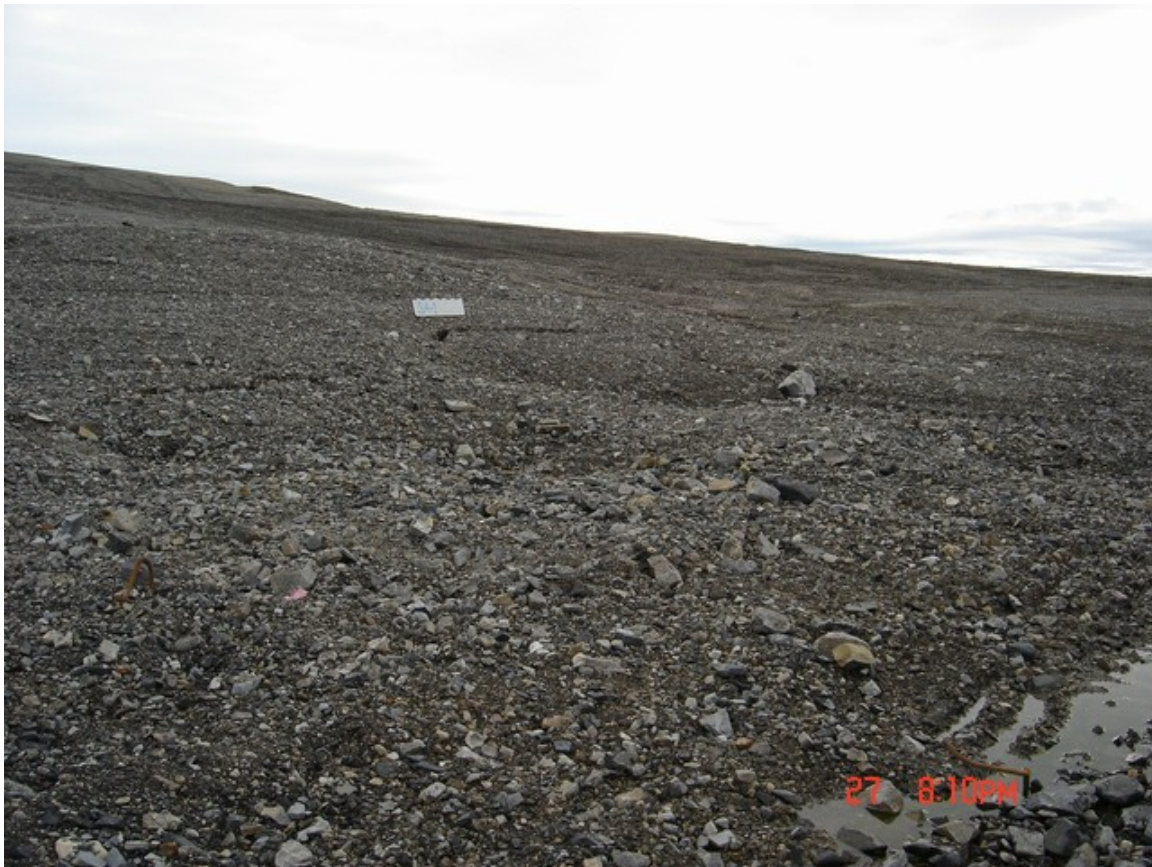
Photo of location SA1 from waypoint SA1 PH2, looking northwest, showing a crack, which is some 30m in length, several cm in width, and no differential displacement. This terrain does not present a hazard to humans or wildlife.

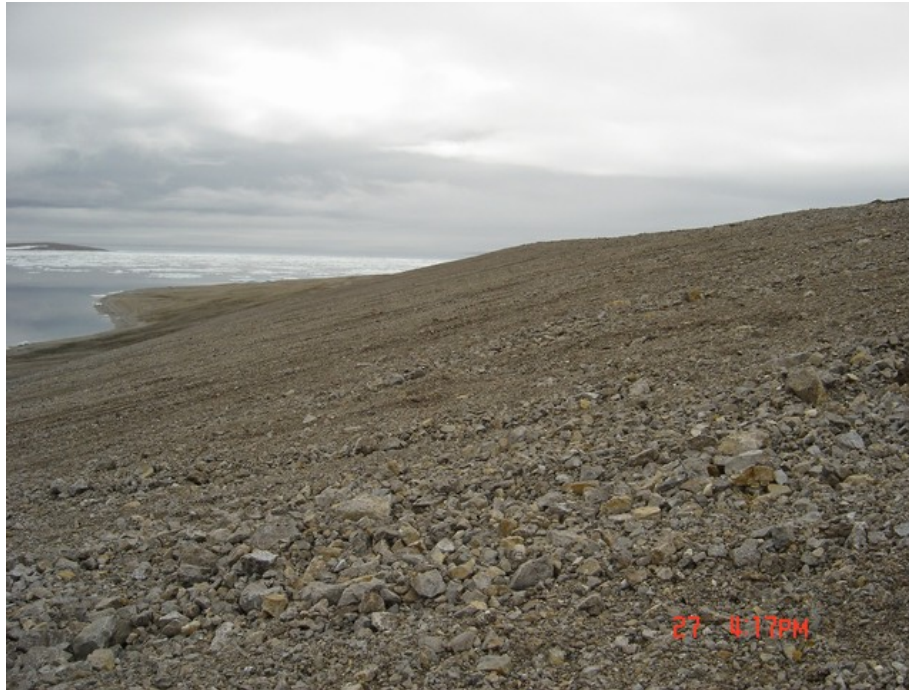
View southwest along main sideslope of the Operational Landfill from waypoint OLF3, again showing slopes in good condition, free of any erosion or deformation.
