Report on Post-closure Geotechnical Inspection for Polaris Mine Site in 2005

Reference: **GLL 50508**

December 15, 2005

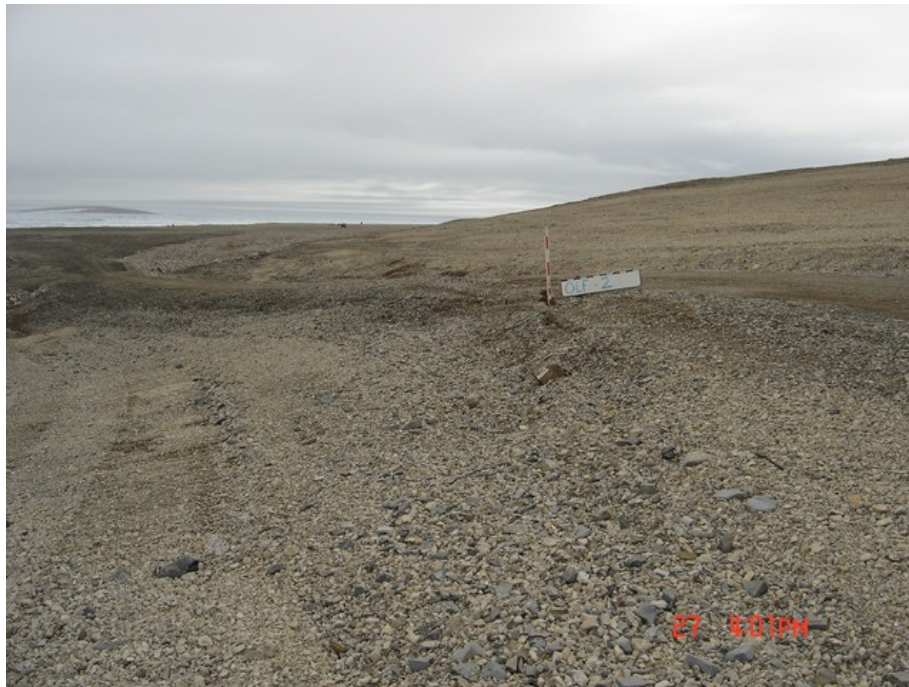
Minor almost imperceptible crack at edge of approach road to northeast end of the operational landfill, viewed from waypoint OLFPH 2. This is not associated with any other signs of settlement of instability in the slope above or below, and poses no hazard to human health or wildlife.

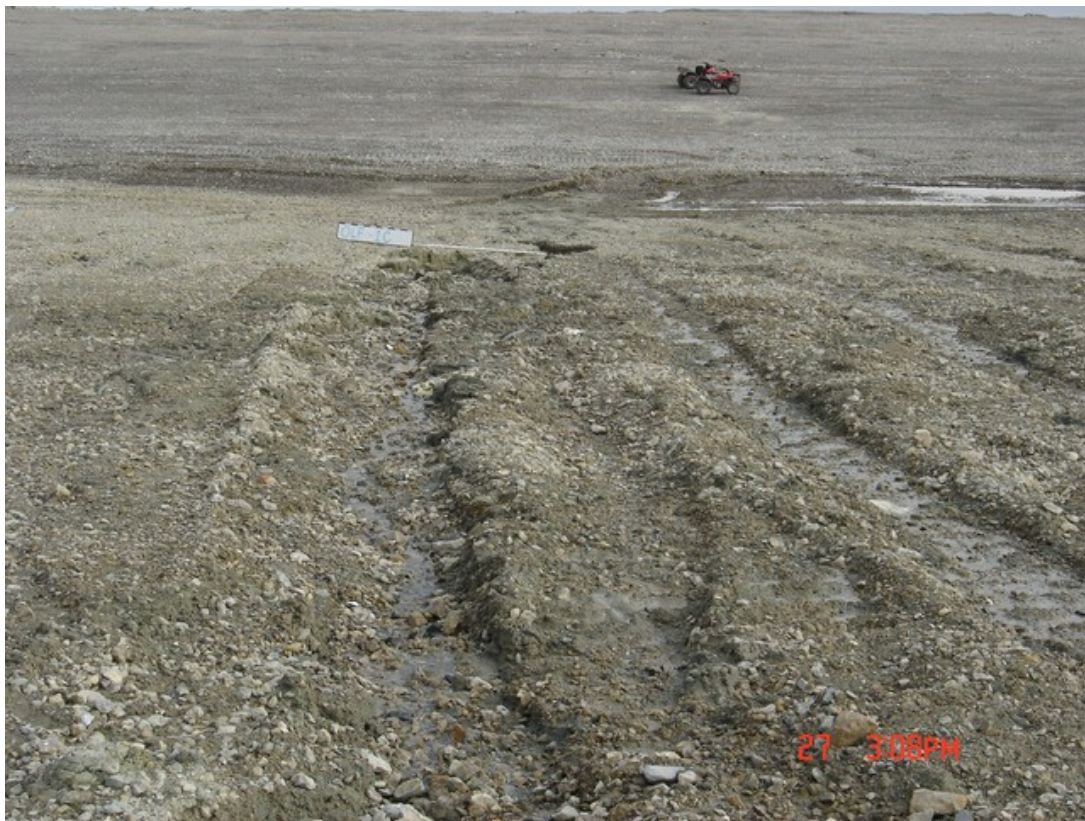
View downslope from waypoint LO SPR TOP. The degree of erosion is not serious and appears to be gradually self-armouring.

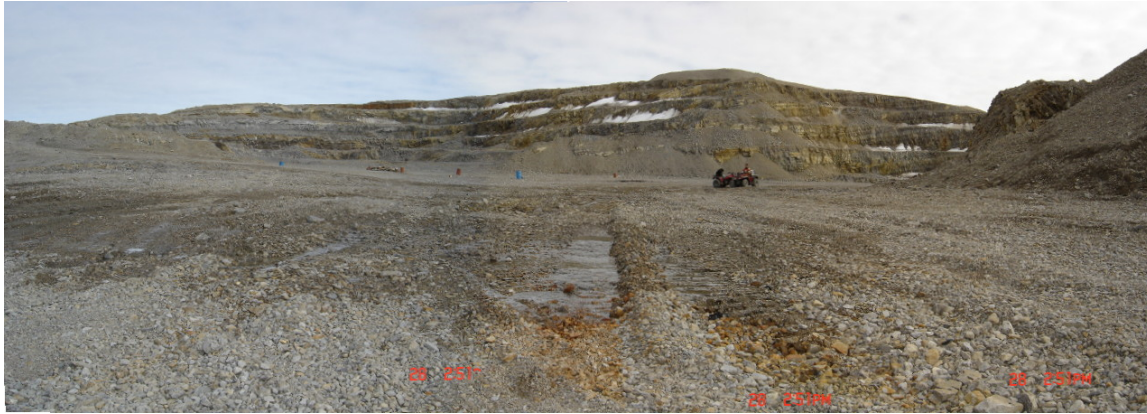
View approximately eastwards through the topographic “notch” in the perimeter of the LRD quarry, from waypoint LRD5, where seepage through surficial gravel and rockfill daylights over a distance of some 10m before re-infiltrating. This flow was sampled and was estimate at 1 to 2 litres/sec, exhibiting little to no turbidity. No erosion or instability was observed in the slopes below the notch of the LRD quarry.

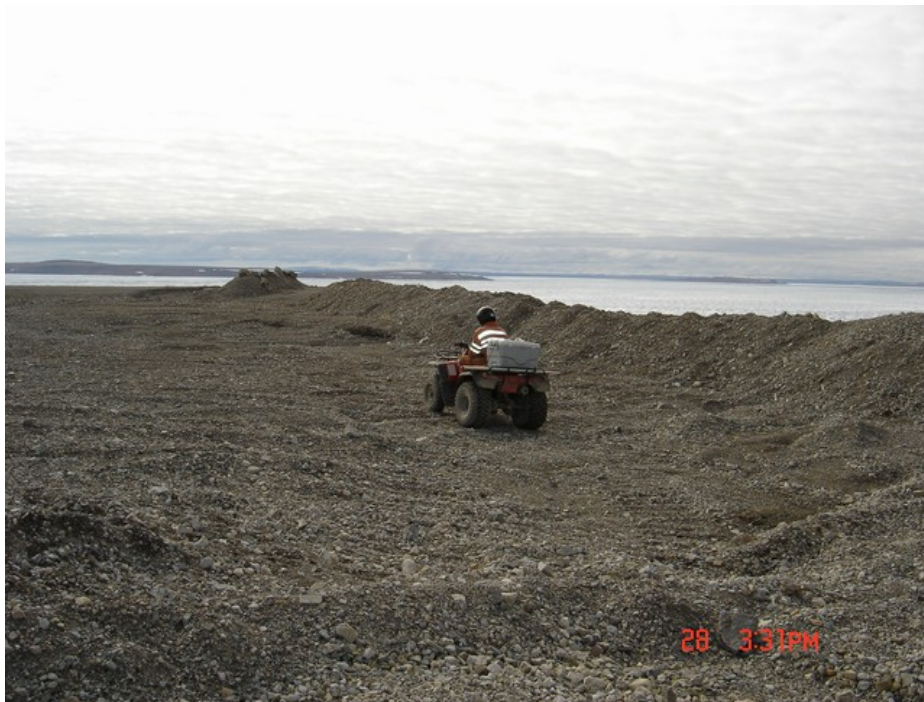
View of the terrain adjacent to the north end of the airstrip, and of the safety berm around the upper edge of the LRD quarry slopes. The berms are in good condition.

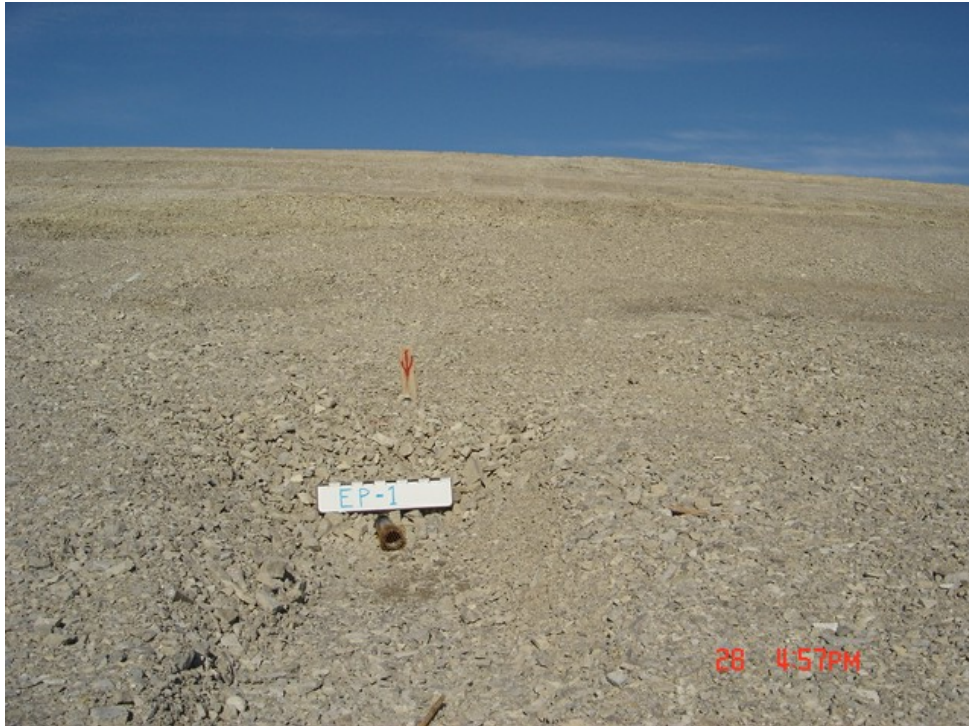
View from waypoint EP1, with no drainage or signs of discharge from vent pipe. Overall slope is approximately 10 degrees and covered in coarse gravel sized rockfill. No signs of instability or hazard to humans or wildlife.

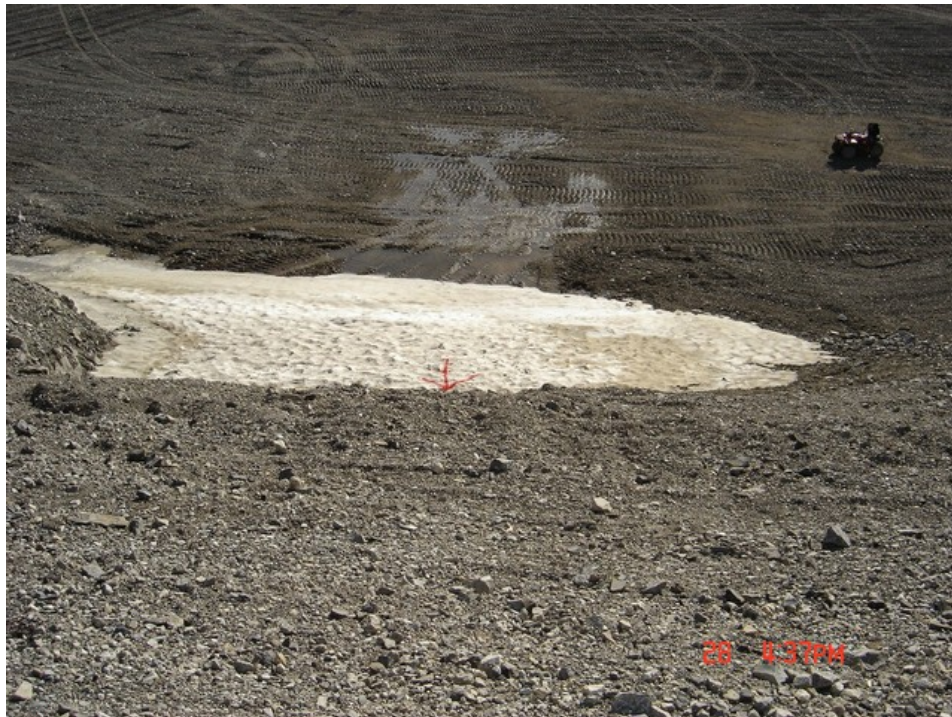
**Slope above Main Portal area is inclined at about 26 degrees, locally steepening to 35 degrees.
Minor slumping was observed, but not considered to present hazard to humans or wildlife.**

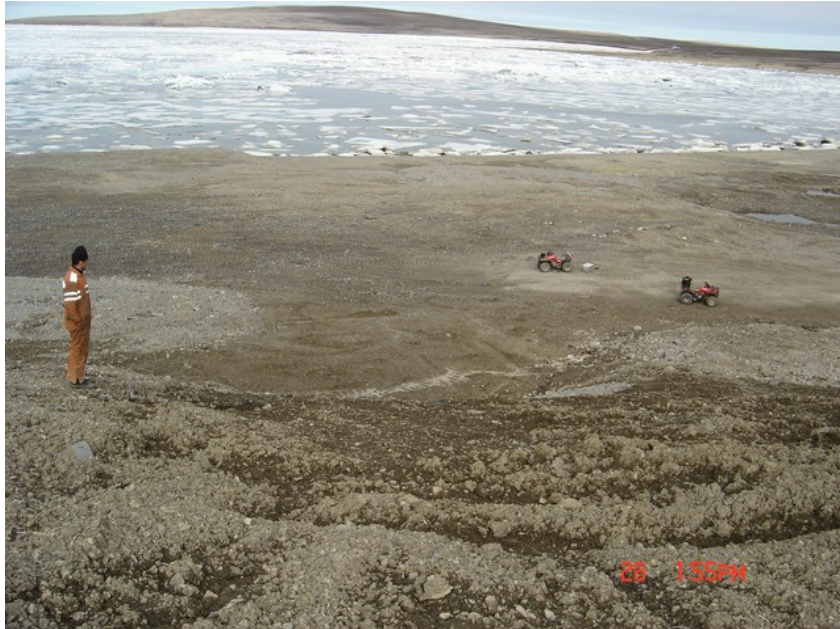
North Portal from slope above, which shows no sign of cracks or distress.

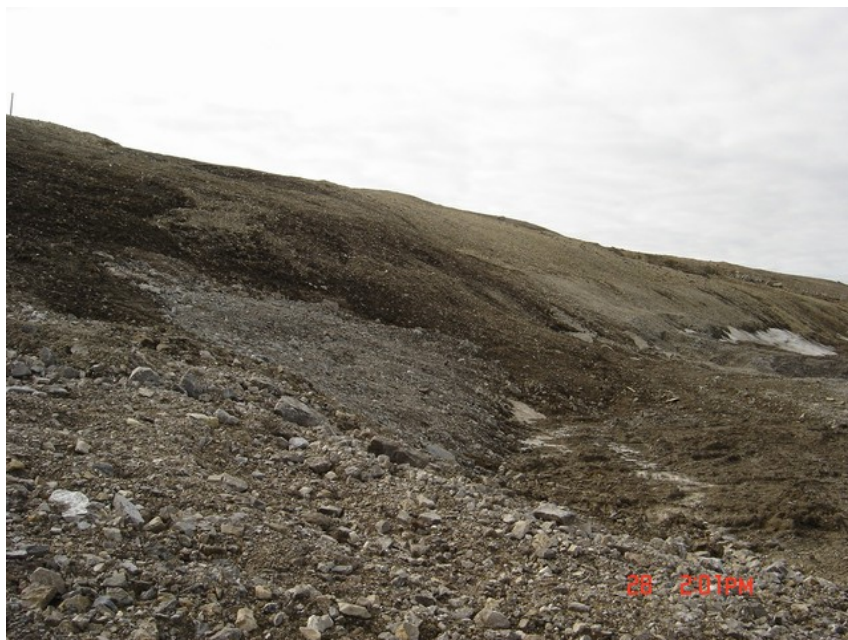
North Portal looking west across backfill. This portal accessed a decline and was frozen prior to being backfilled. Thus, the minor drainage along the toe of the cap is considered to be of a surficial nature only.
