# **Report on Post-Closure Geotechnical Inspection of Polaris Mine Site in 2007**

Prepared for  
**TeckCominco Metals Ltd.**

Submitted by  
**Gartner Lee Limited**

**October, 2007**

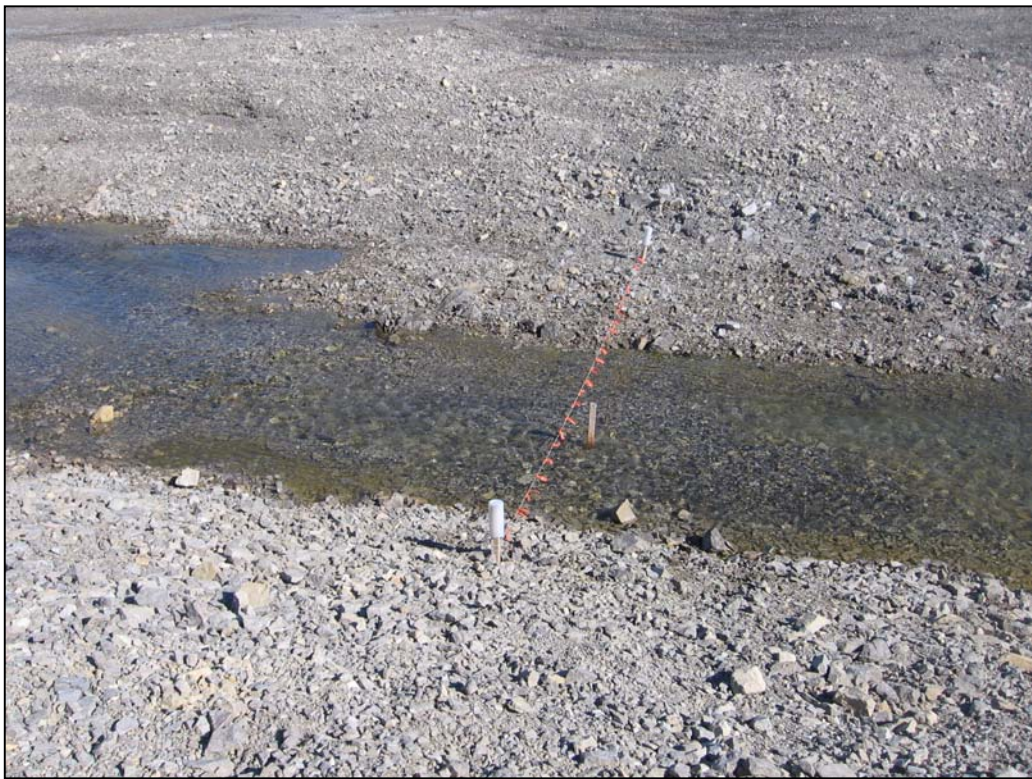
The Garrow Creek surface water sampling station is downstream of the dam (Photograph 1 in Appendix A). Two erosion gullies were observed downstream of the sampling station (Photographs 2 and 3 in Appendix A). These erosion gullies appear to be self-armouring and are an example of natural or normal erosion processes in the area. Maximum erosion gully depth is approximately 0.5 m.

Photo 1 - Northing: 8366835 Easting: 561659 Elevation: 7 m.  
Garrow Creek Sampling Station

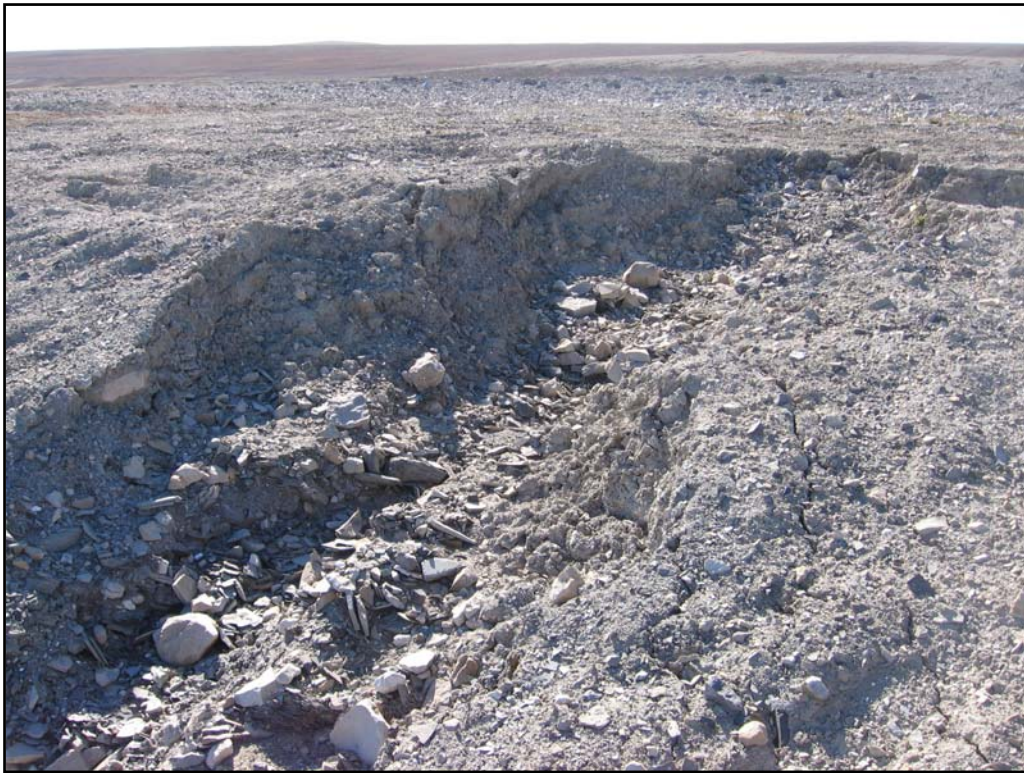
Photo 3 - Northing: 8366835 Easting: 561659 Elevation: 7 m.  
Second erosion gully south of the sampling location

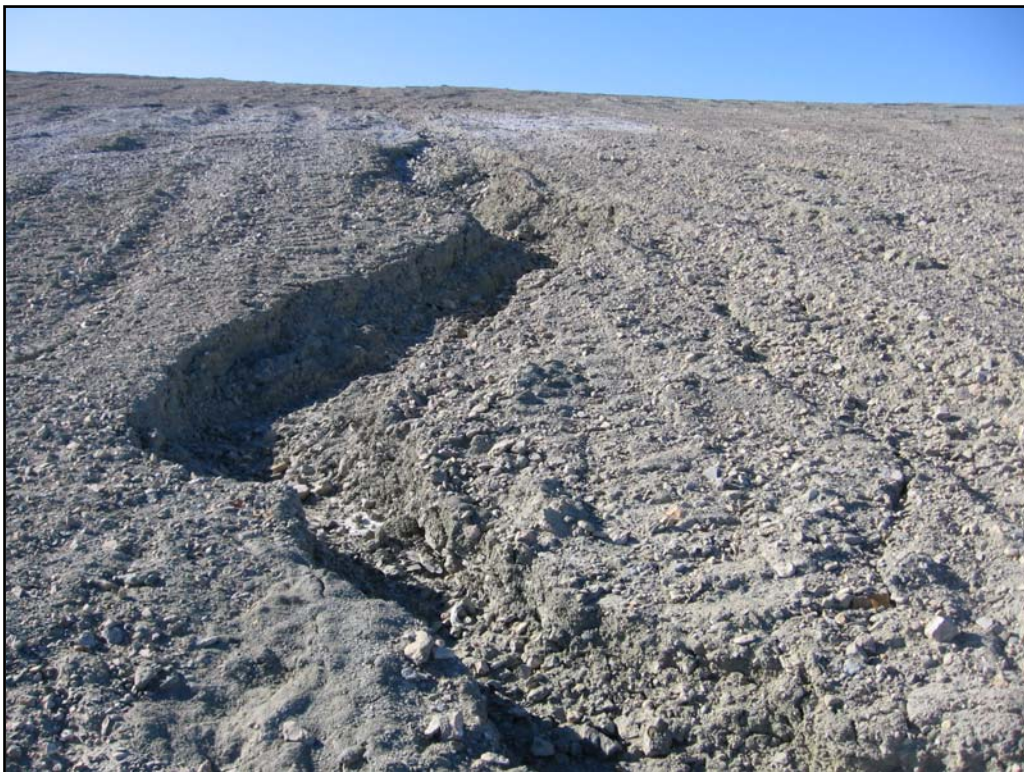
No indications of slope instability were observed at the Operational Landfill during the July 2007 inspection. Indications of slumping or creep were not observed on the landfill slope (Photographs 90 and 91 in Appendix A). No tension cracks or settlement depressions were observed on the landfill crest (Photographs 4 and 5 in Appendix A). Erosion gullies on the slope above the Operational Landfill observed during previous inspections appear to be unchanged and self-armouring. The previously photographed erosion gully at OLF GUL2 (above the landfill) was photographed in July 2007 (Photographs 6 and 7 in Appendix A) and appears to be unchanged with a maximum depth of 0.5 m.

Photo 6 - Northing: 8367615 Easting: 558780 Elevation: 33 m.  
Operational landfill; View of erosion gully on slope above the landfill

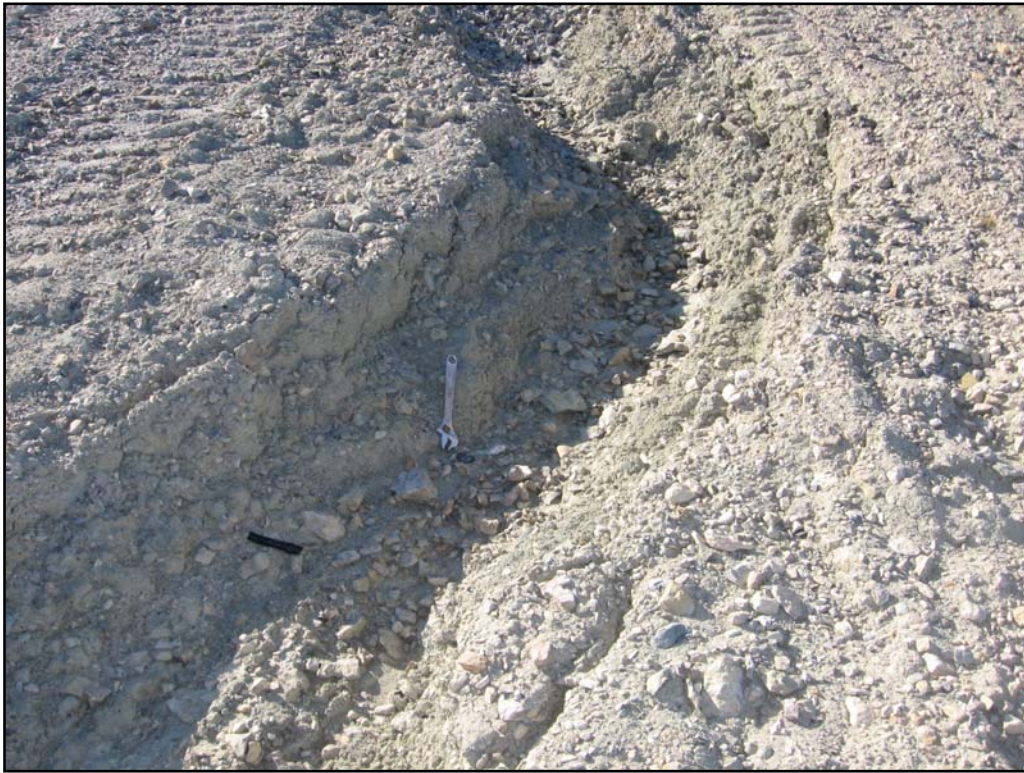
Photo 7 - Northing: 8367615 Easting: 558780 Elevation: 33 m.  
Operational landfill; View of erosion gully on slope above the landfill  
(Scale: Wrench is 0.3 m)

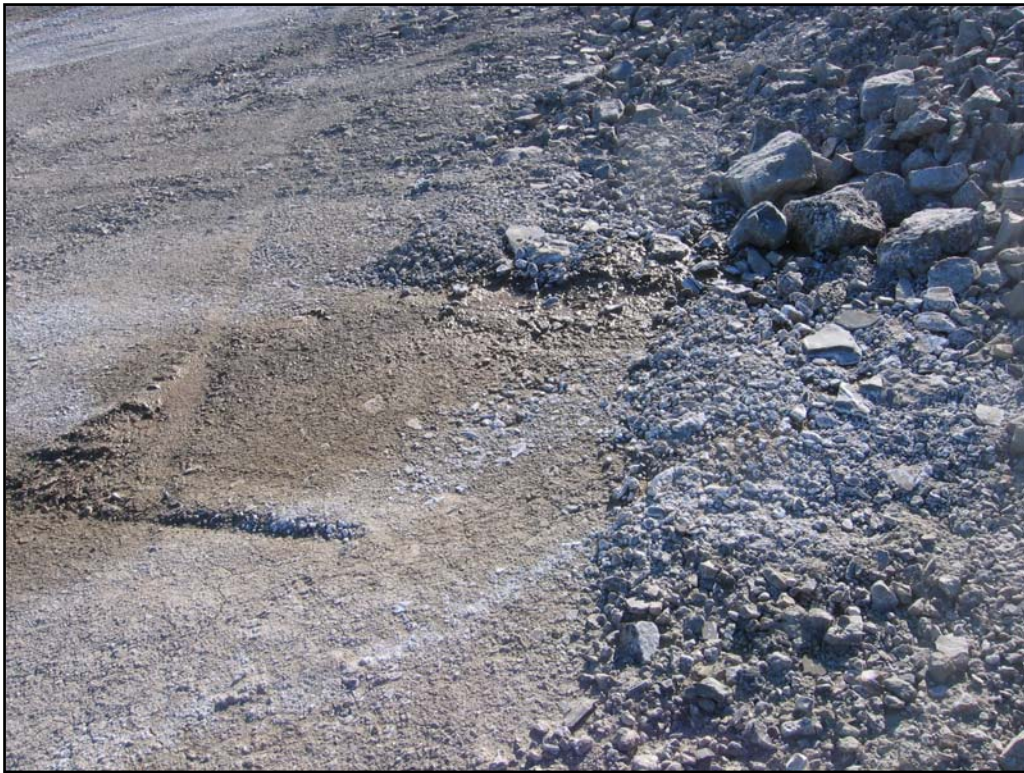
Some minor seepage from the toe of the landfill and associated white precipitate was observed during the July 2007 inspection (Photographs 8 through 10 in Appendix A).

Photo 9 - Northing: 8367408 Easting: 558917 Elevation: 9 m.  
Operational landfill; Seepage from toe and white precipitate

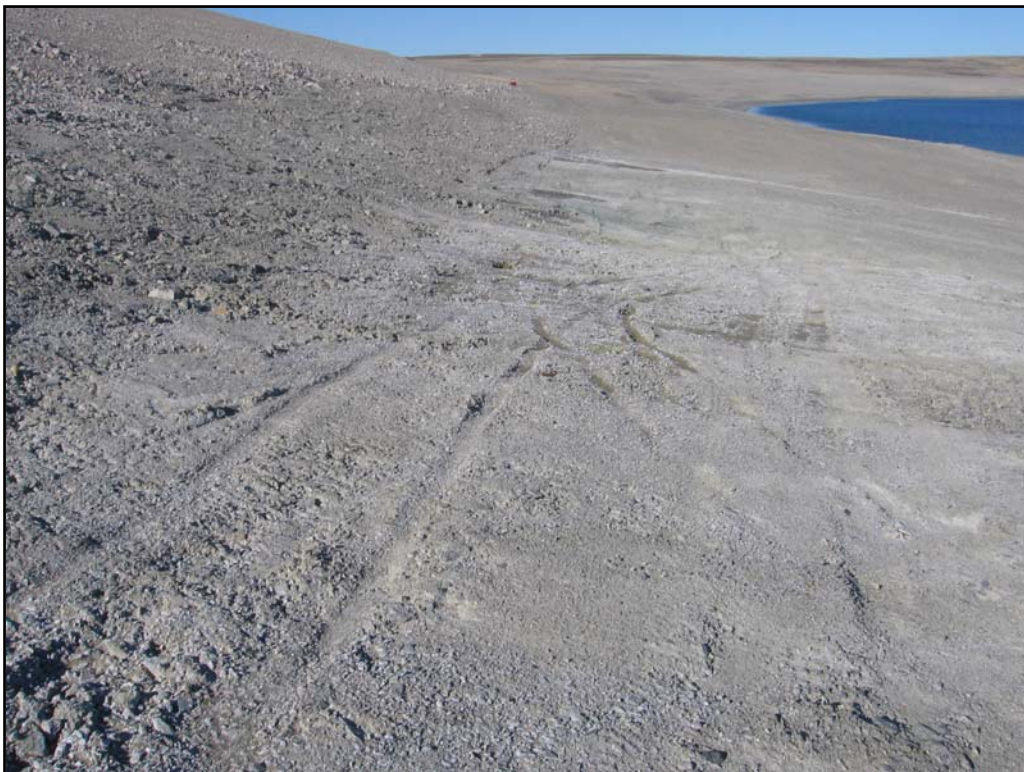
Photo 10 - Northing: 8367408 Easting: 558917 Elevation: 9 m.  
Operational landfill; Seepage from toe and white precipitate

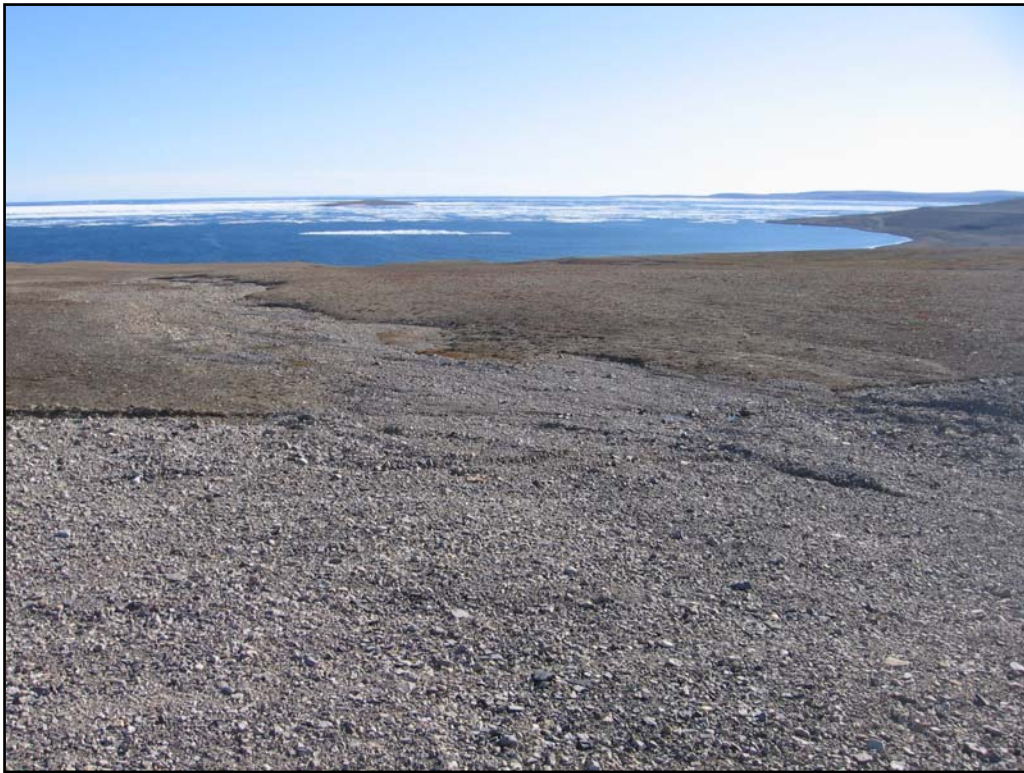
Photo 13 - Northing: 8368786 Easting: 559998 Elevation: 49 m.  
Drainage crossing through road with downstream erosion

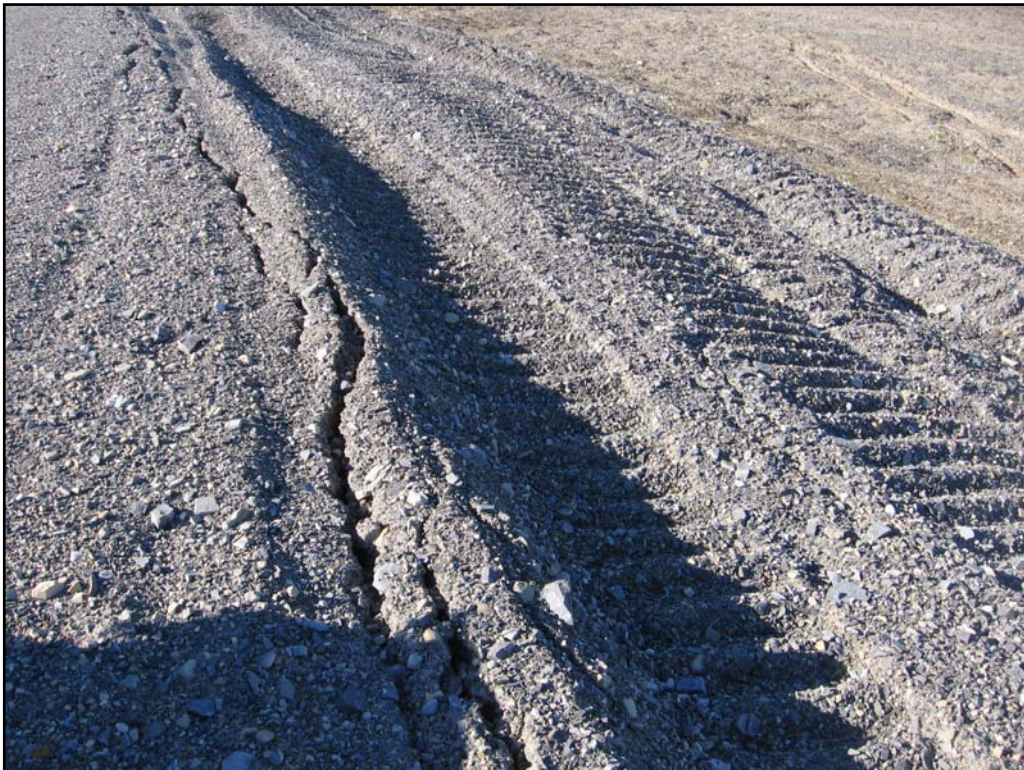
Photo 14 - Northing: 8367721 Easting: 560837 Elevation: 57 m.  
Tension crack along road

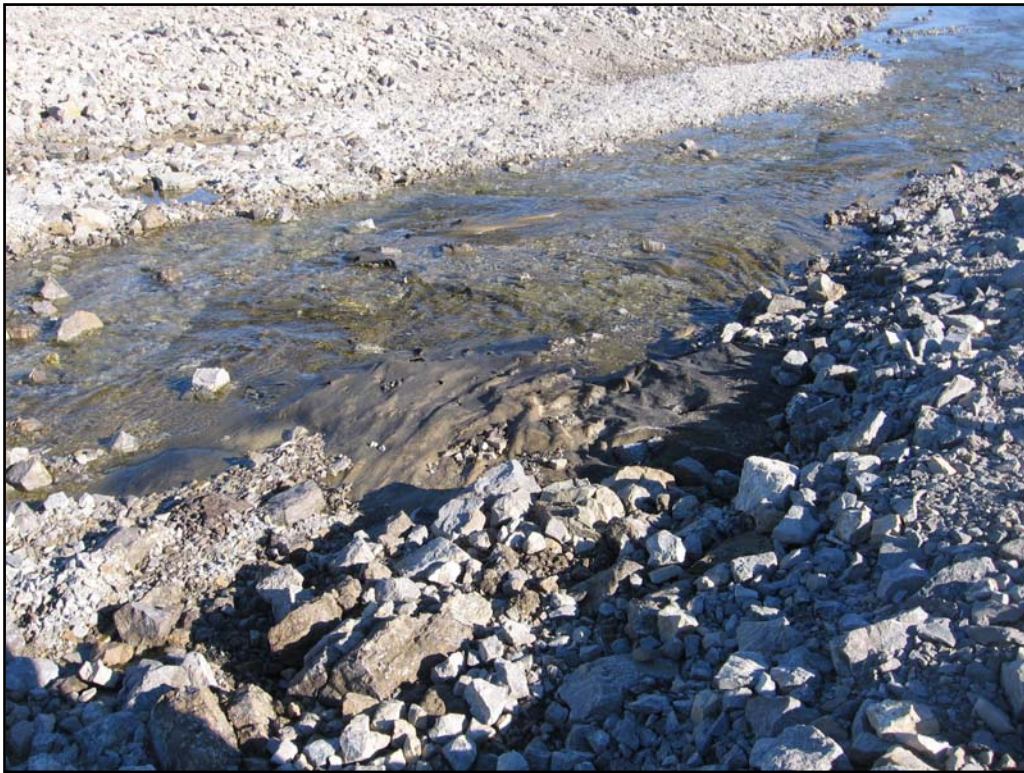
The sideslopes of the breach excavated through the main dam structure are in good condition, free of erosion or signs of major instability. Minor localised slumping observed in 2005 and 2006 appears unchanged. The condition of the dam breach slopes during the July 2007 inspection is documented in Photographs 20 through 25 (Appendix A). A localised section of the invert of the breach channel has a section of exposed geotextile that was observed in 2005 and 2006. The

condition of the exposed geotextile during the July 2007 inspection is documented in Photographs 18 and 19 (Appendix A). It is recommended that the exposed geotextile be covered with rip-rap.

Photo 19- Northing: 8366909 Easting: 561646 Elevation: 15 m.  
Garrow dam; exposed geotextile

No immediate action or repairs are required based on conditions observed at the time of the July 2007 inspection. An area of exposed geotextile downstream of Garrow Lake dam should be covered with rip-rap as soon as practicable, however the exposed geotextile does not present an immediate risk to Garrow Creek water quality. An unfilled gap along the northeast wall of LRD quarry should be filled to grade with rockfill when the debris pile is being buried beneath a layer of rockfill. We understand that TCL intends to bury the collected debris pile prior to final abandonment of the site.

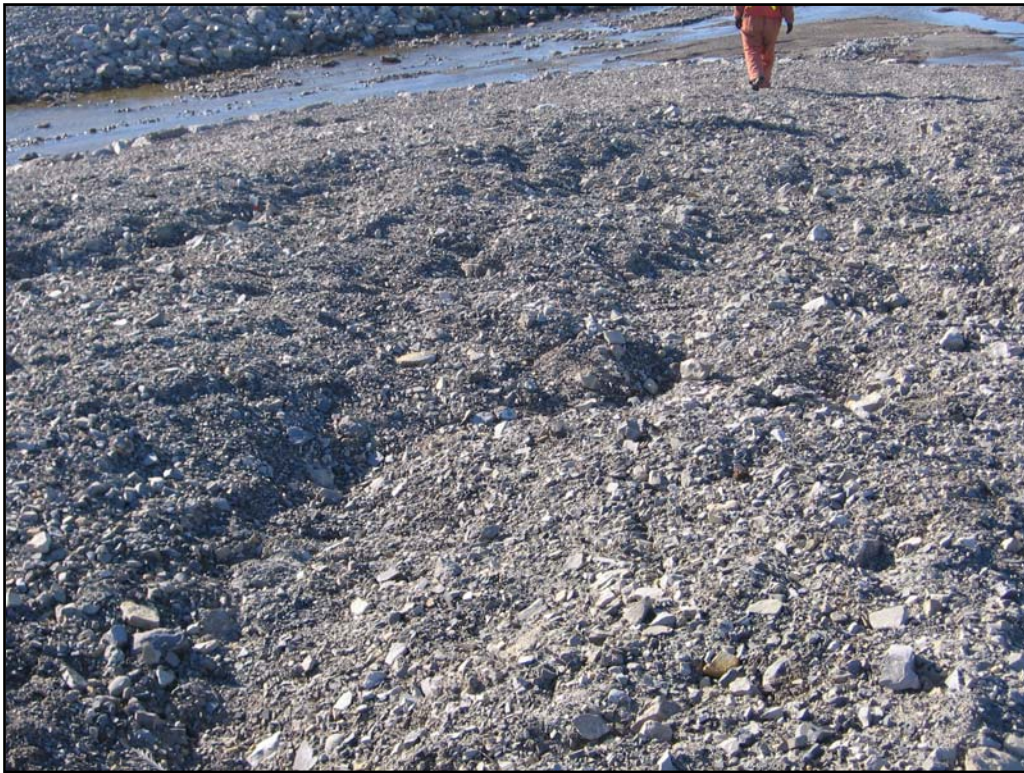
Photo 23- Northing: 8366999 Easting: 561646 Elevation: 15 m.  
Garrow dam; hummocky / bumpy crest of Southeast abutment

It is recommended that TCL commence annual topographic surveys of the Garrow Lake dam breach abutments and wave break structure to monitor any slope movement and material deposition, respectively.

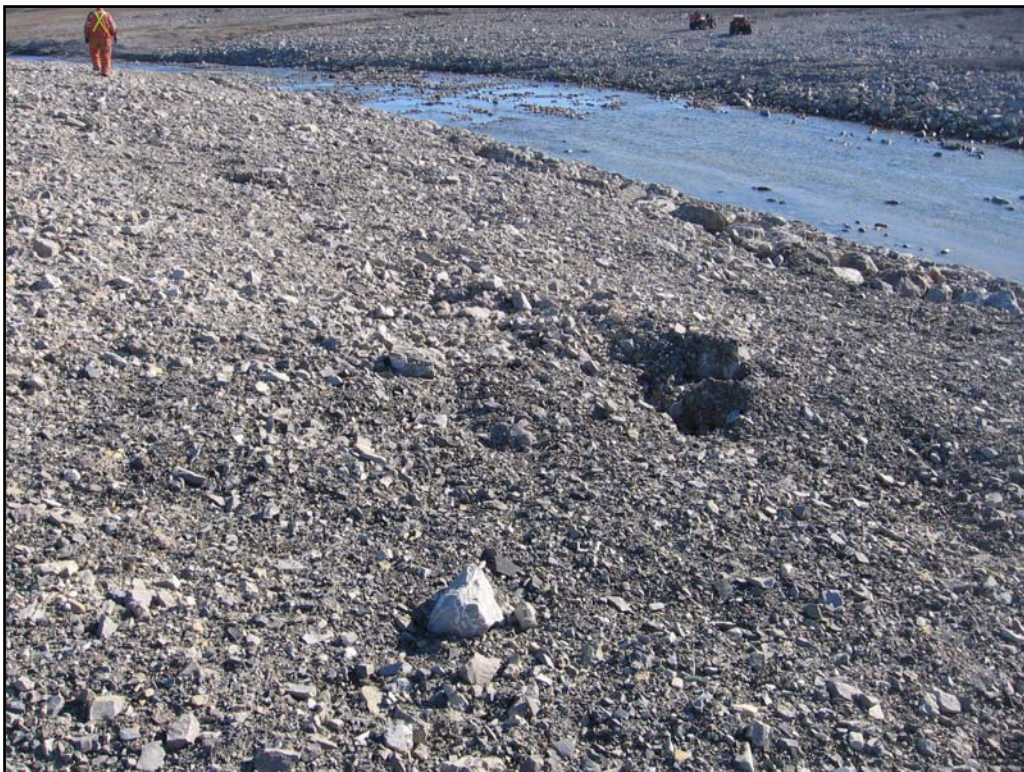
Photo 24- Northing: 8366999 Easting: 561646 Elevation: 15 m.  
Garrow dam; loose evidence of settling / movement on Southeast abutment above rip-rap

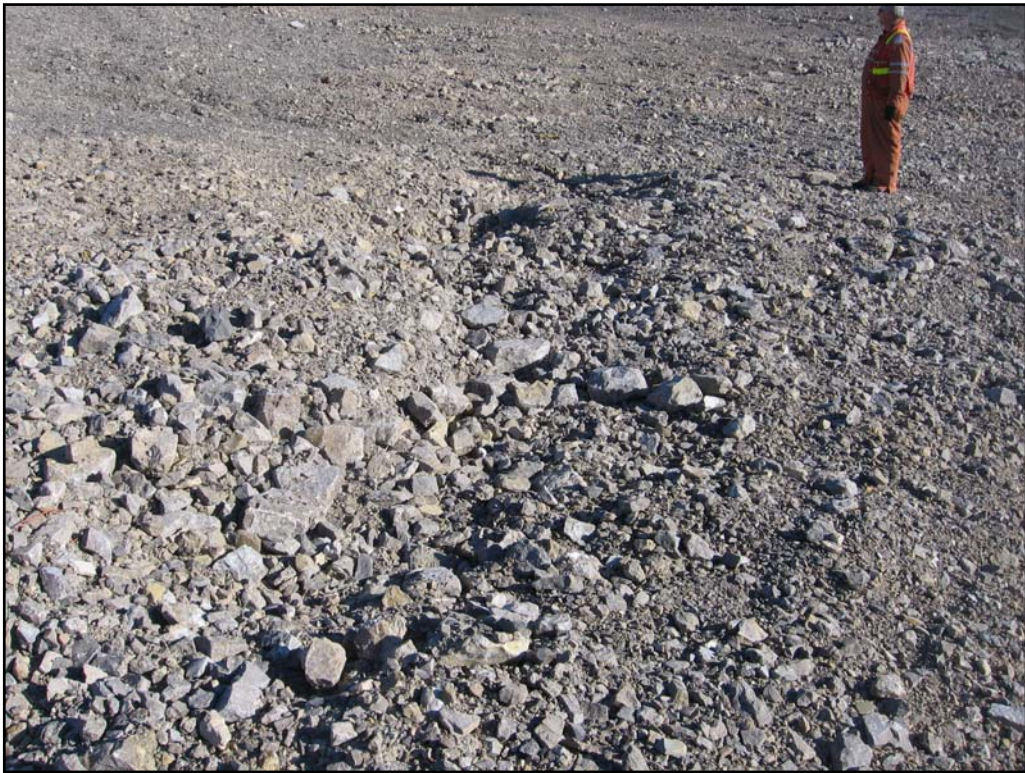
Photo 25- Northing: 8366999 Easting: 561646 Elevation: 15 m.  
Garrow dam; lower bumpy slope from snow / ice fill or slope movement

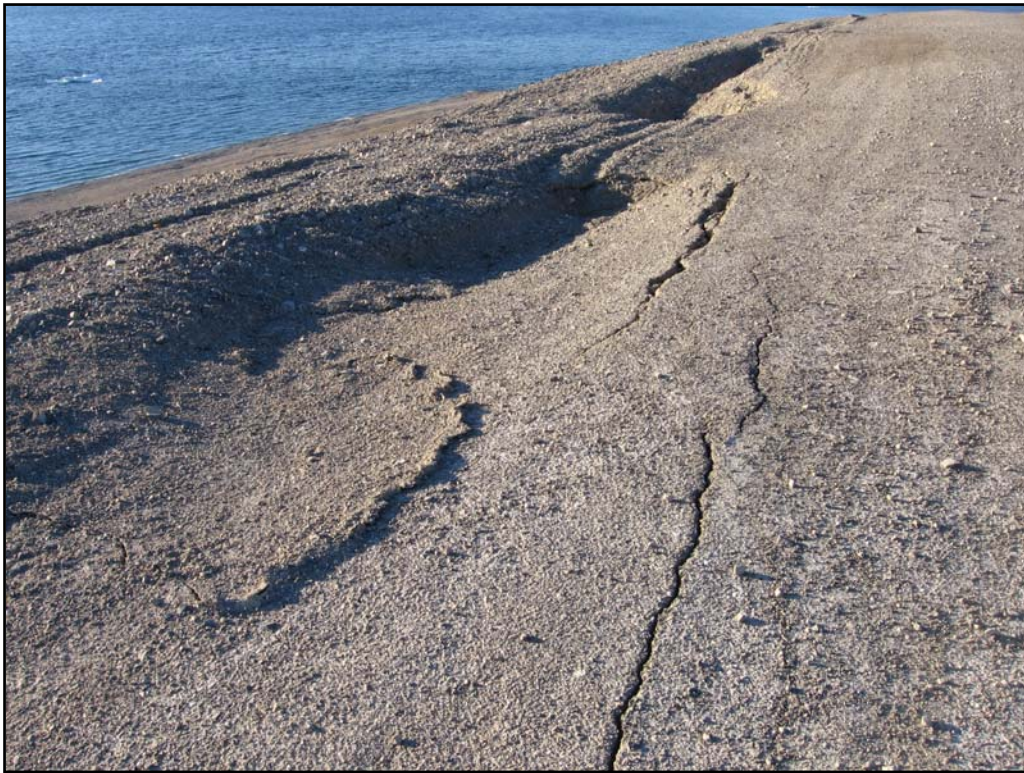
Photo 29- Northing: 8368863 Easting: 557713 Elevation: 38 m.  
Subsidence/slumping along road to Little Red Dog Quarry

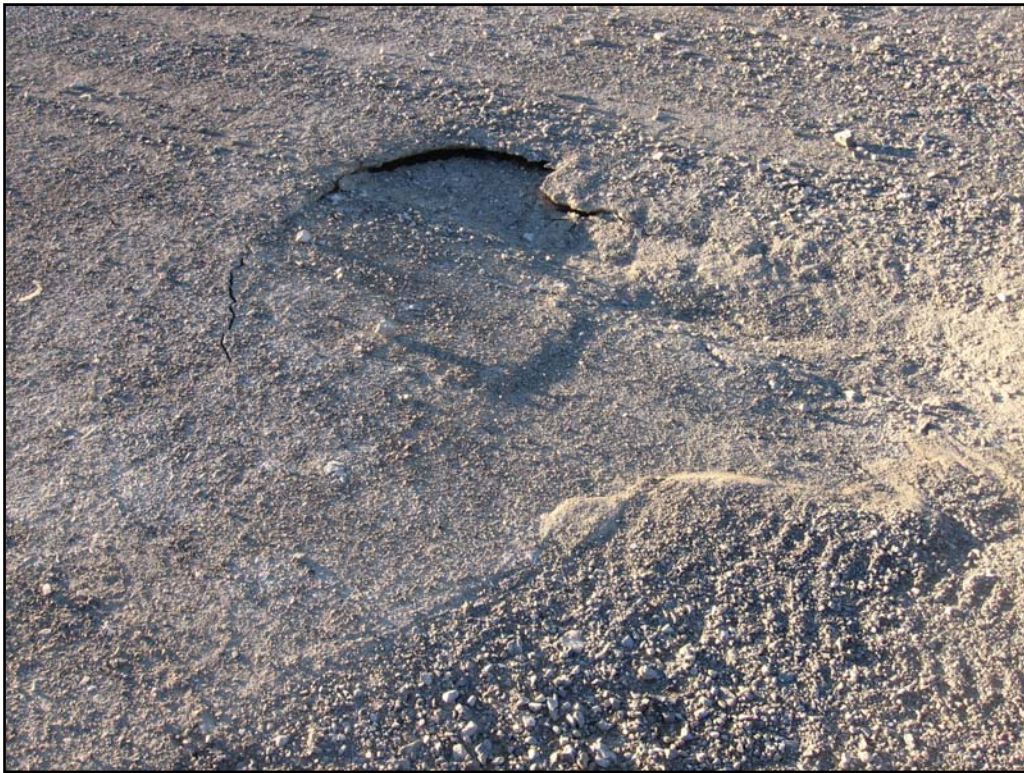
Photo 35- Northing: 8368499 Easting: 558491 Elevation: 49 m.  
Crack / settlement in middle of road likely from melting of entrained snow or ice

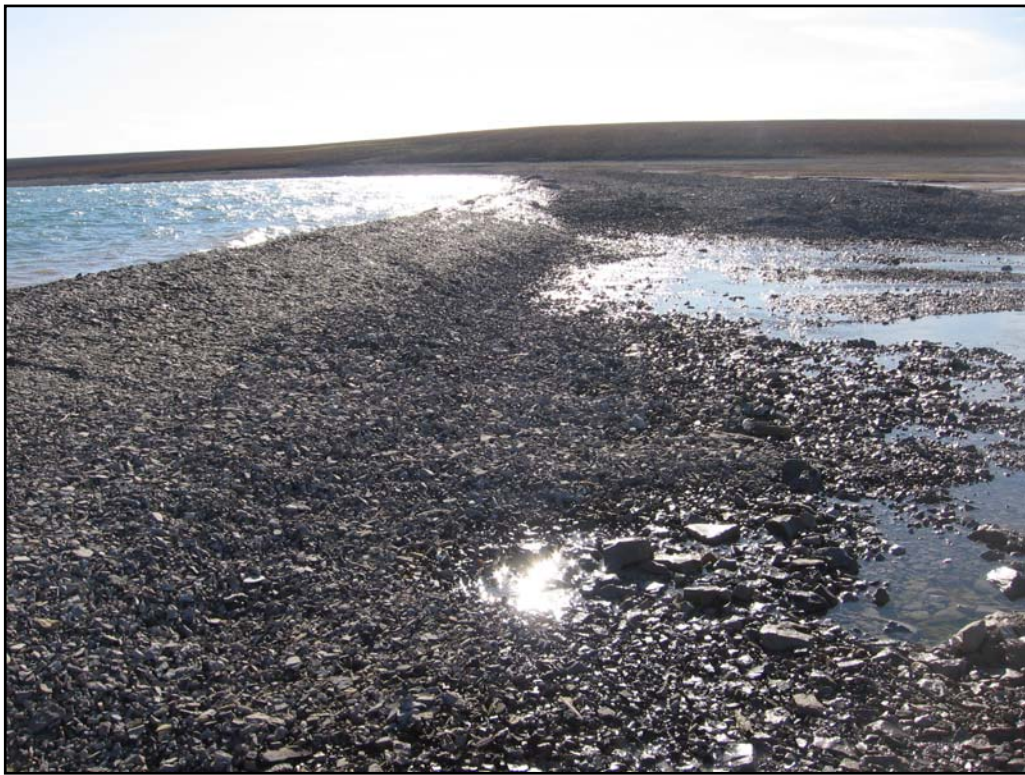
A ridge of gravel deposited across the breached outlet channel was initially observed during the 2006 inspection. The ridge or berm of gravel across the lake outlet appears to have grown since the 2006 inspection. Photographs 38 to 43 in Appendix A document the size and height of the gravel berm at the time of the July 2007 inspection. The mechanism creating the ridge of gravel is likely ice action. It is assumed that ice on the lake is pushed by the wind towards the south shoreline and outlet of the lake relocating gravel from the lake bottom to form a ridge or berm. The relatively coarse nature of the gravel permits a steady flow of water through the gravel ridge from the lake into the creek channel during the summer. However, the gravel ridge appears to be retaining some water and may be influencing the lake water level. As the ridge grows higher and wider, the lake outlet may naturally relocate towards the east end of the wave break structure. The growth of the berm and lake outlet location should continue to be monitored, however this appears to be a natural process that likely also occurred prior to development at the site.

Photo 43- Northing: 8367425 Easting: 561582 Elevation: 11 m.  
Wave break structure; west end at former lake outlet

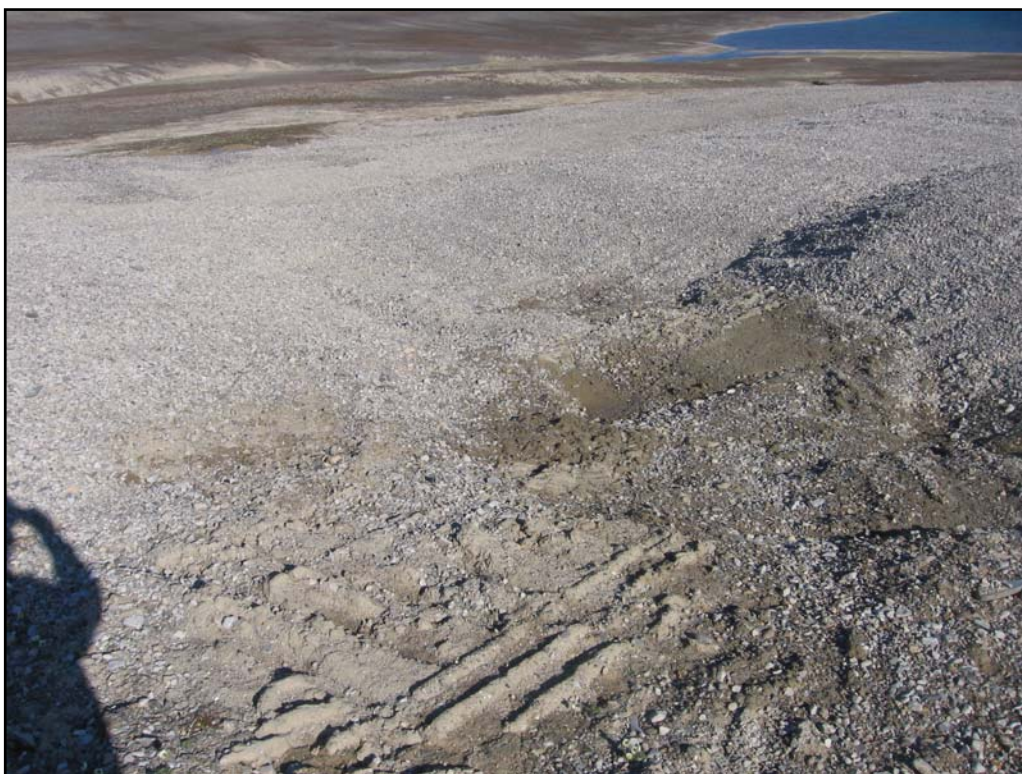
The access road is generally in good condition, with some localised erosion at drainage crossings (Photograph 52 and 53 in Appendix A). Significant erosion gullies identified during previous inspections were repaired in July 2006. Remedial work included regrading slopes, placement of gravel/rip-rap and construction of water bars. The repaired areas appear to be performing well (Photographs 54 through 58 in Appendix A).

Photo 54- Northing: 8371151 Easting: 560166 Elevation: 52 m.  
Frustration Lake access road; repaired erosion gully

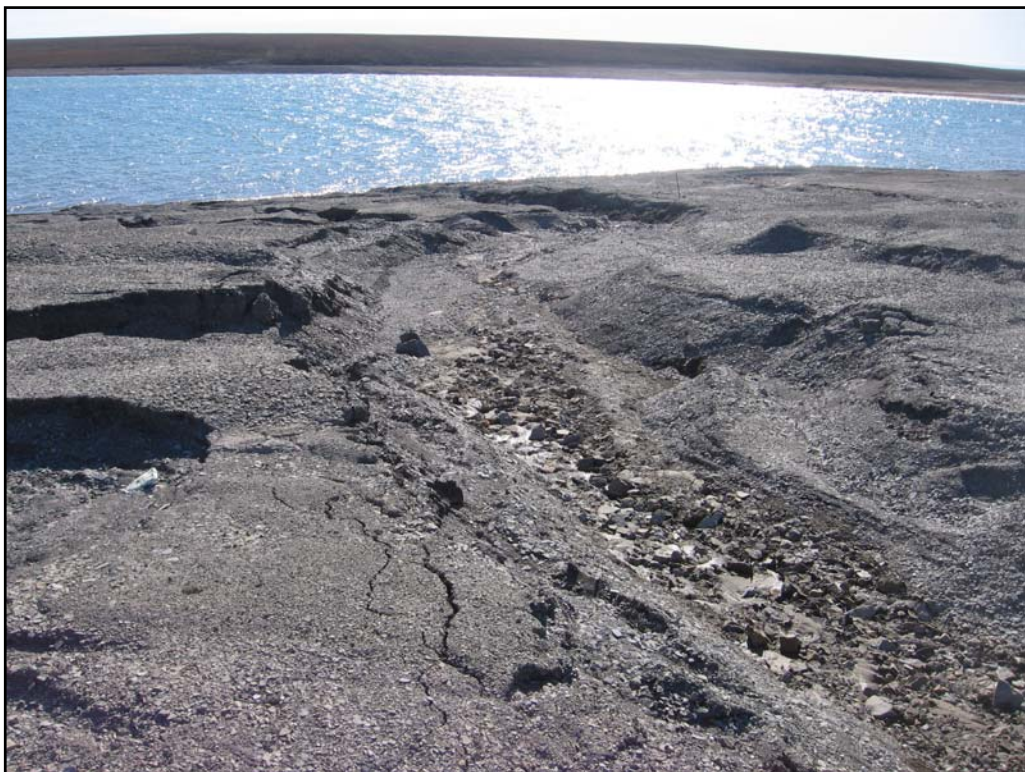
Photo 60- Northing: 8367677 Easting: 561474 Elevation: 15 m.  
Garrows Lake perimeter; erosion gullies

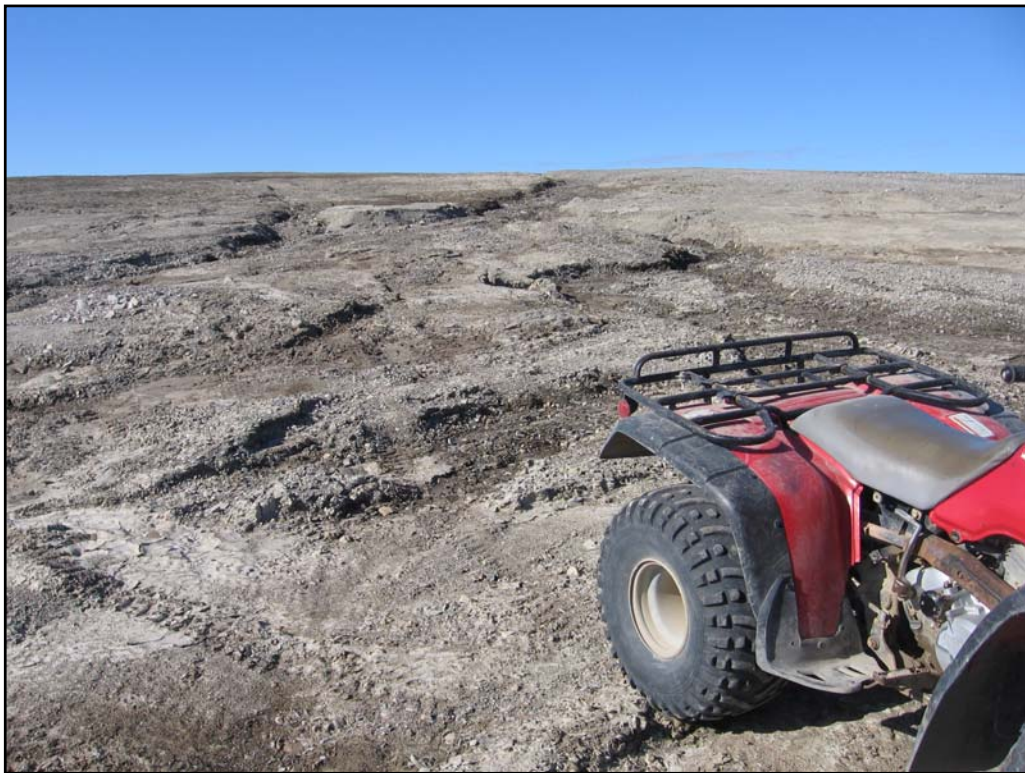
Photo 63- Northing: 8368908 Easting: 561101 Elevation: 10 m.  
Garrow Lake perimeter; erosion near boat launch

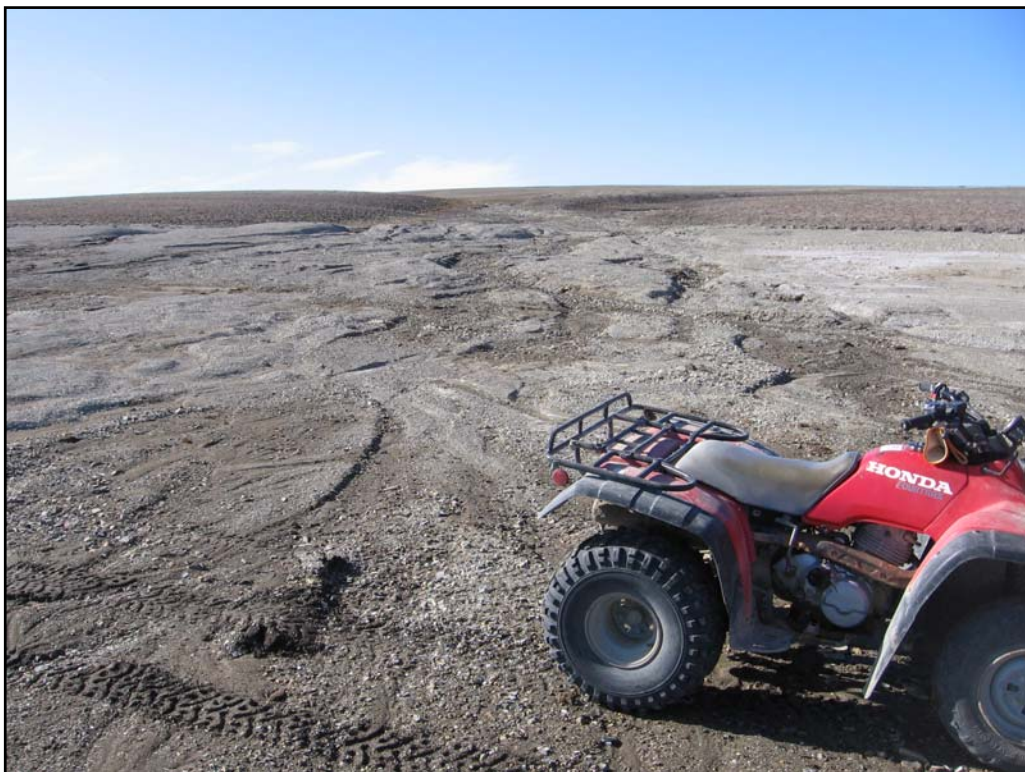
Photo 64- Northing: 8369180 Easting: 560963 Elevation: 8 m.  
Garrow Lake perimeter, erosion channels

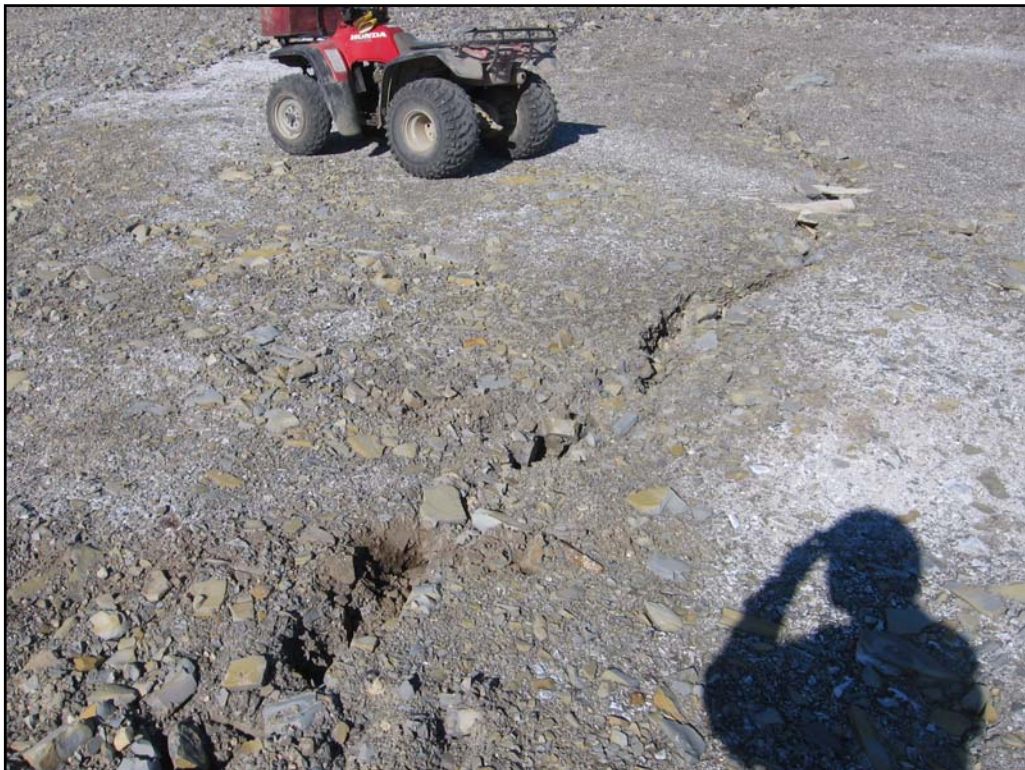
Photographs 72 and 74 (Appendix A) document previously observed settlement tension cracks with maximum depth and width of about 0.15 m.

Photo 72- Northing: 8368922 Easting: 558543 Elevation: 25 m.  
Subsidence area; previously observed tension crack (no change)

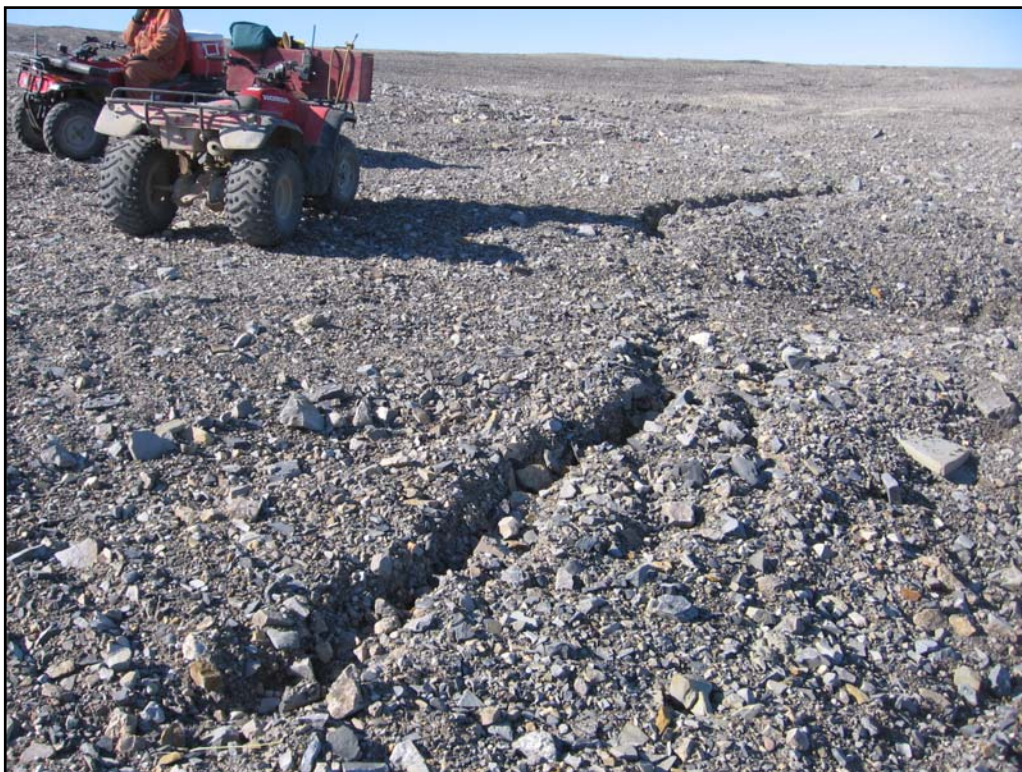
Photo 74- Northing: 8368977 Easting: 558445 Elevation: 18 m.  
Subsidence area; previously observed tension crack (no change)

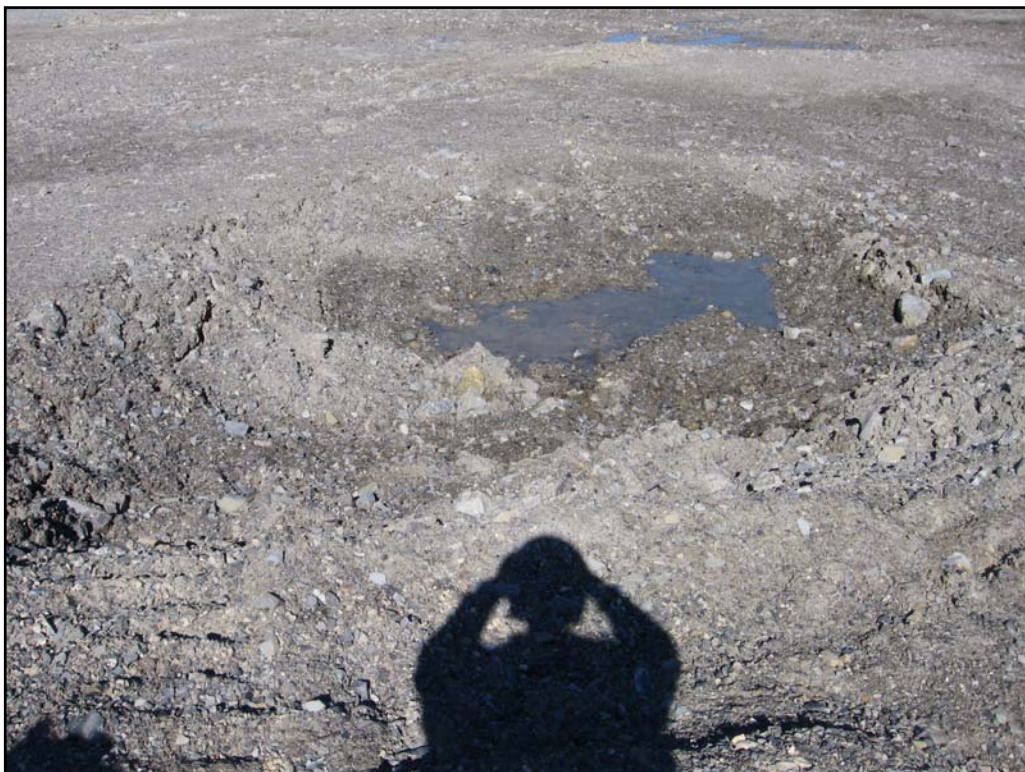
Photograph 76 (Appendix A) is an observed settlement area surrounded by minor tension cracks that is approximately 5 m by 5 m in size.

Photo 76- Northing: 8369058 Easting: 558442 Elevation: 18 m.  
Subsidence area; previously observed settlement area (no change)

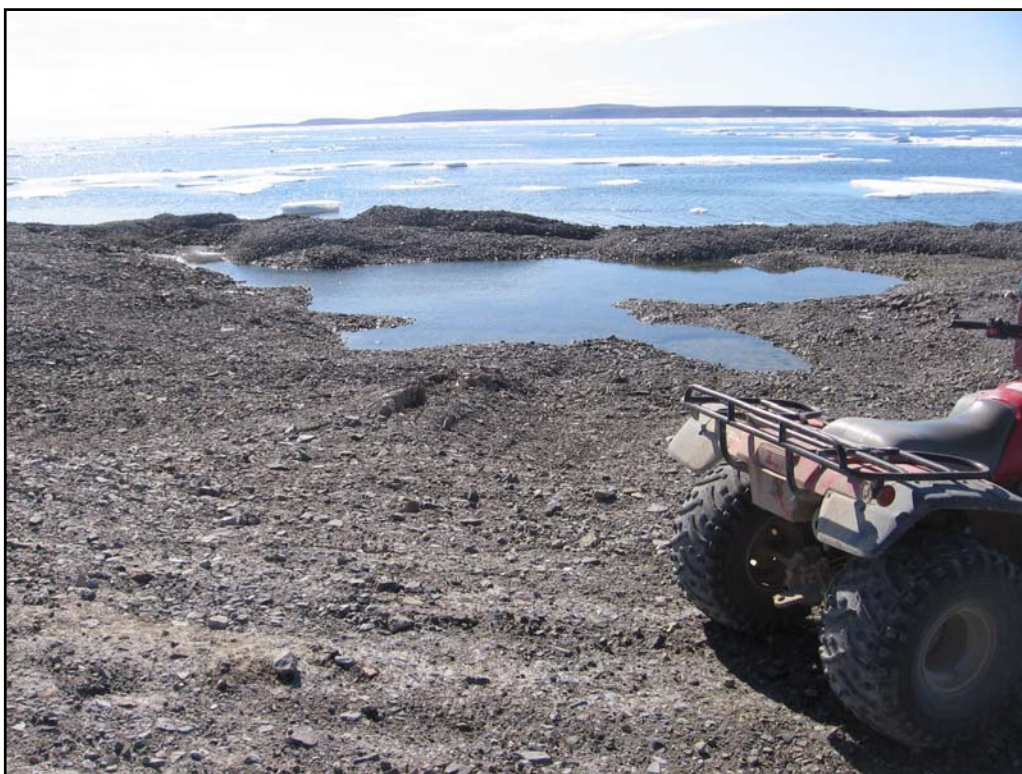
Photo 82- Northing: 8367758 Easting: 557943 Elevation: 6 m.  
Foreshore; ice thaw settlement
