## **APPENDIX 9**

### **Annual Geotechnical Inspection Report**

## Report on Post-Closure Geotechnical Inspection of Polaris Mine Site in 2008

Date: November 11, 2008

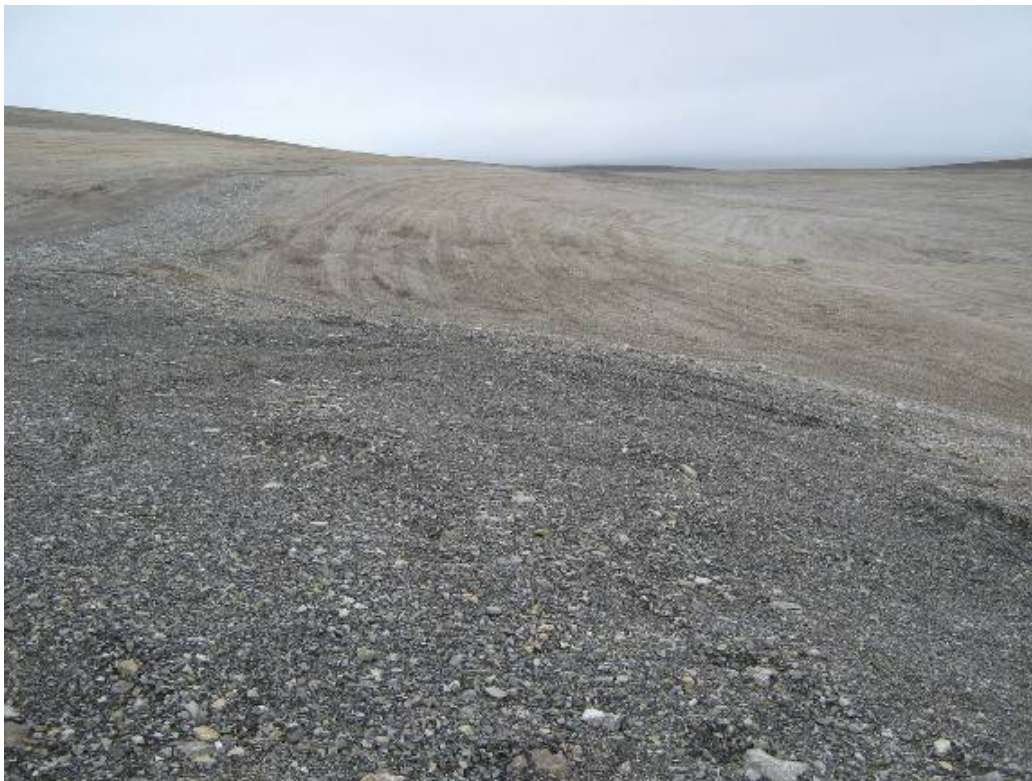
Photo 1- Northing 558920 Easting 8367713 Elevation 37 m  
Operational landfill: looking north along crest

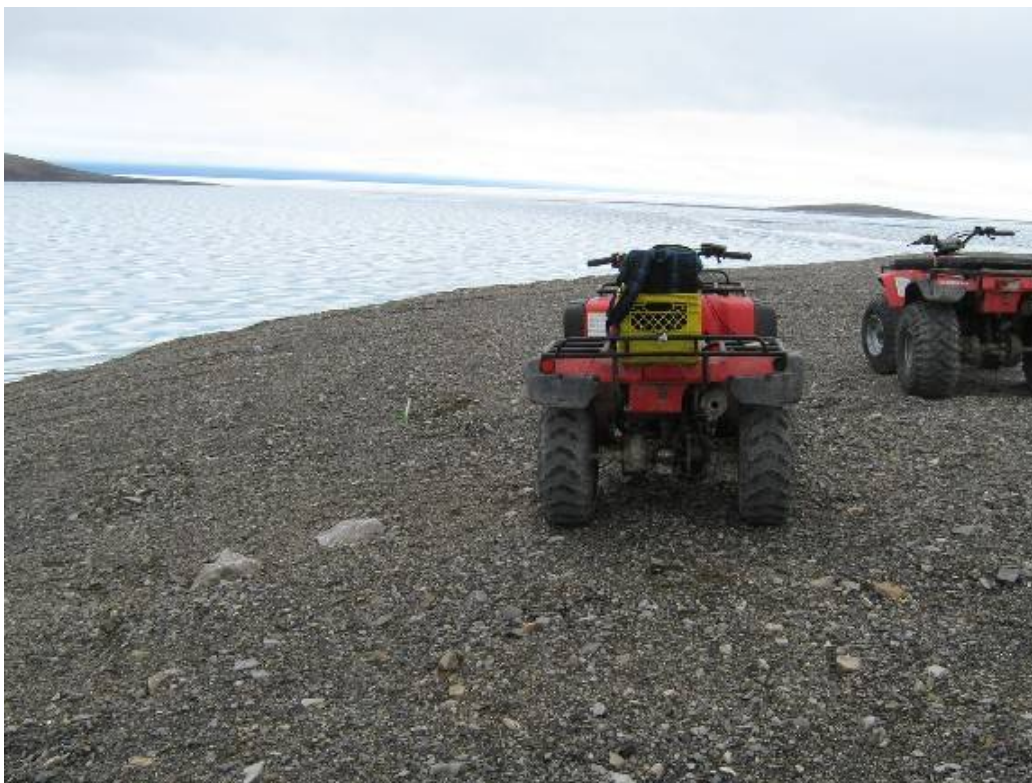
Photo 2- Northing: 558920 Easting 8367713 Elevation 37 m  
Operational landfill: looking south along crest

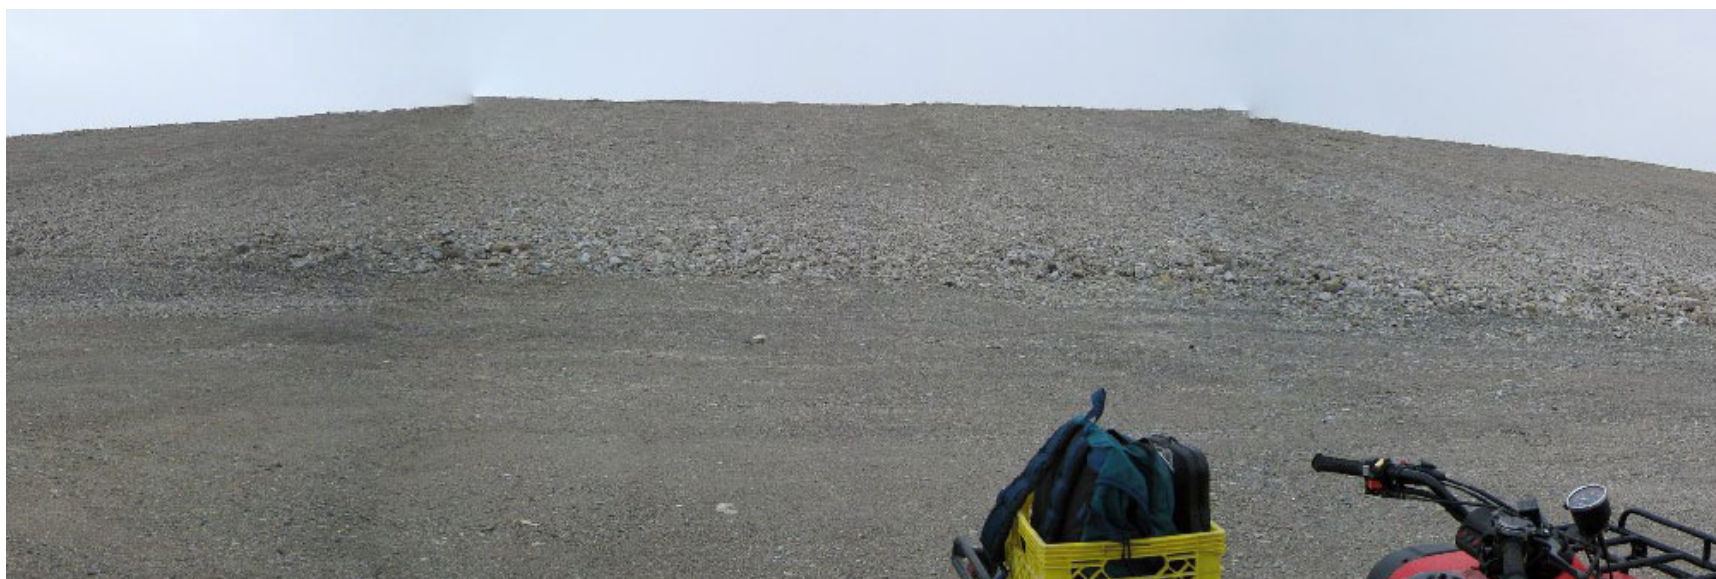
Some minor seepage and associated orange staining was observed along the south toe of the landfill during the July 2008 inspection (Panoramic of Photographs 9 through 11 in Appendix A). A minor erosion gully about 0.5 m wide and 0.3 m deep was observed directly upslope of Waypoint #6 (Panoramic of Photographs 12, 13 and 14 in Appendix A).

Panoramic (Photos 12,13,14)  
Northing 558968 Easting 8367484 Elevation 15 m  
Operational landfill: central, along toe

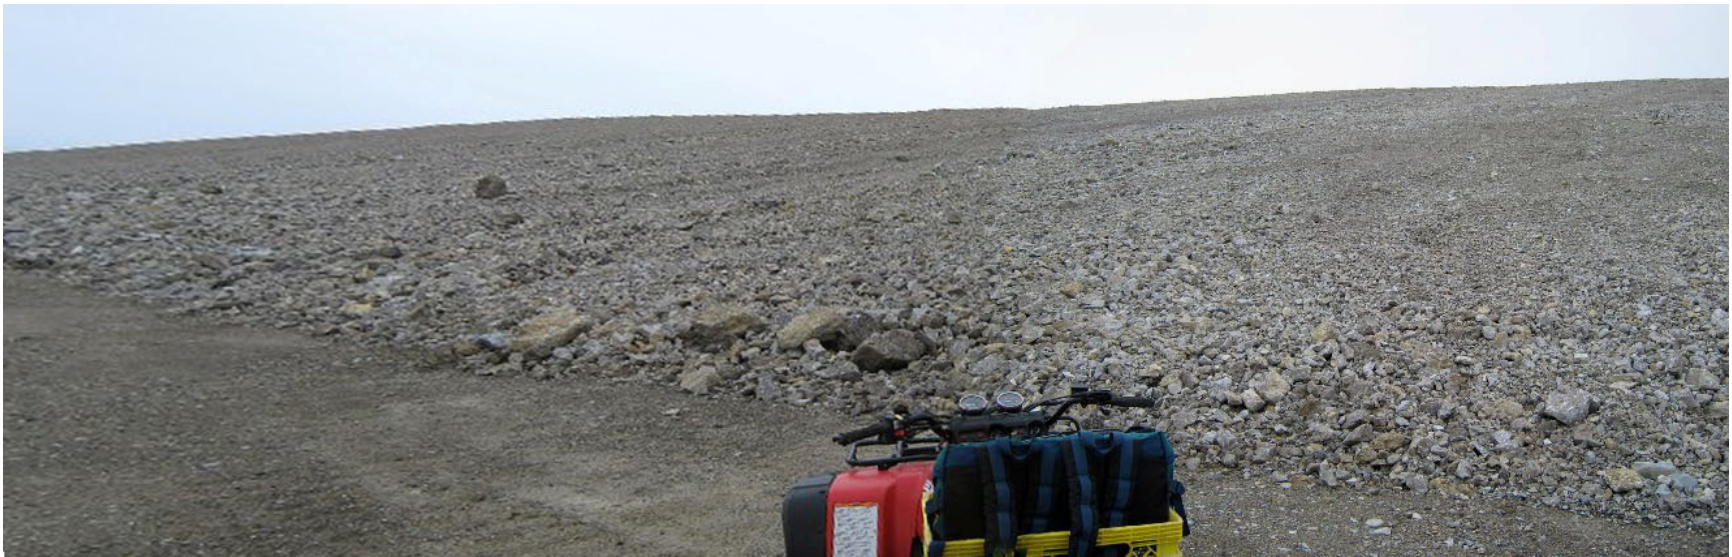
Panoramic (Photos 15&16)  
Northing 558995 Easting 8367621 Elevation 12 m  
Operational landfill: north toe of slope to crest

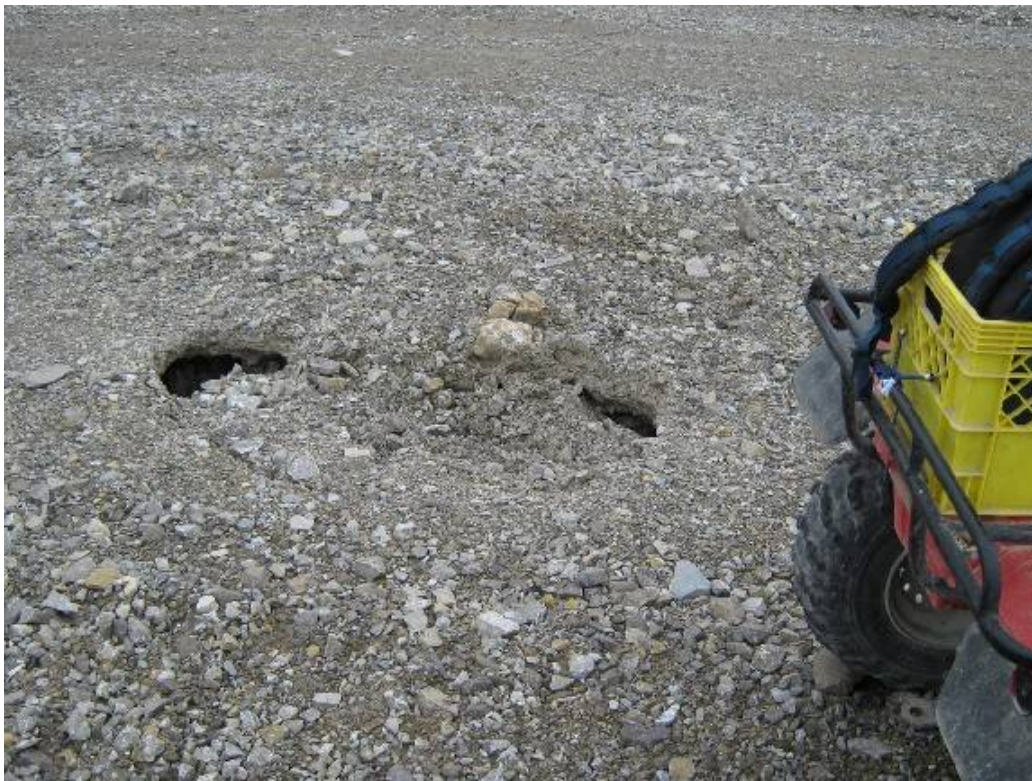
Photo 25- Northing 557983 Easting 8367710 Elevation 8 m  
Foreshore: 1 m diameter thaw sinkhole about 40 m from shoreline

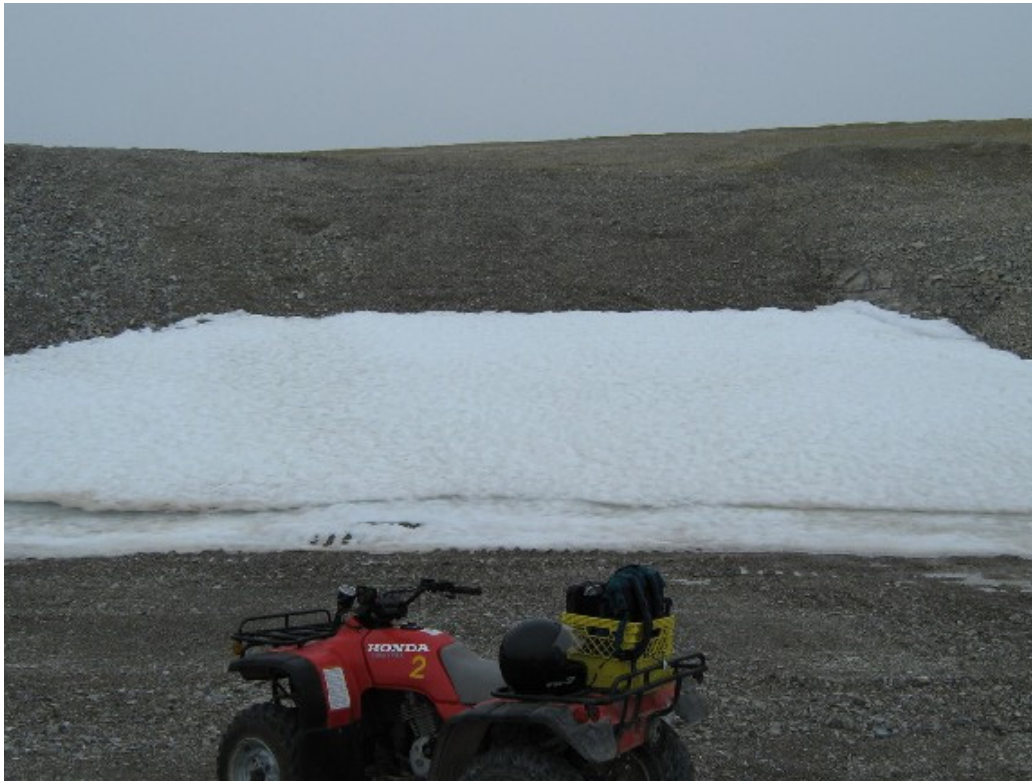
Photo 31- Northing 557860 Easting 8368041 Elevation 7 m  
Main portal: snow-covered slope

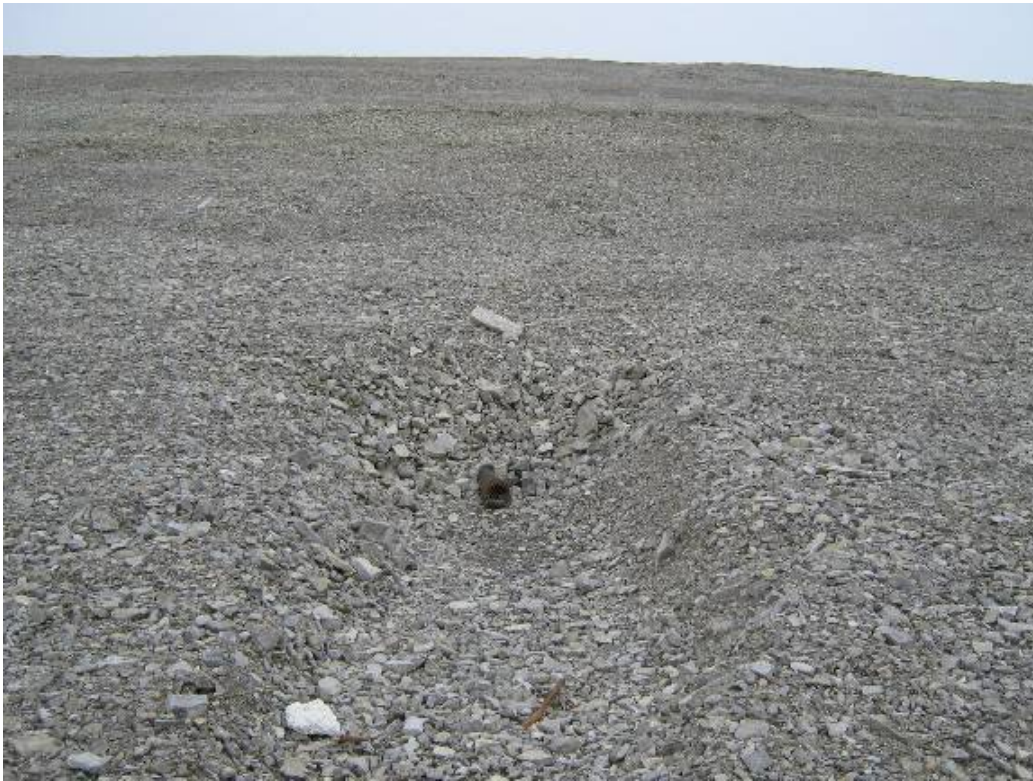
Photo 34- Northing 557829 Easting 8368182 Elevation 23 m  
Exploration portal: black hole pipe drain covered with wire mesh

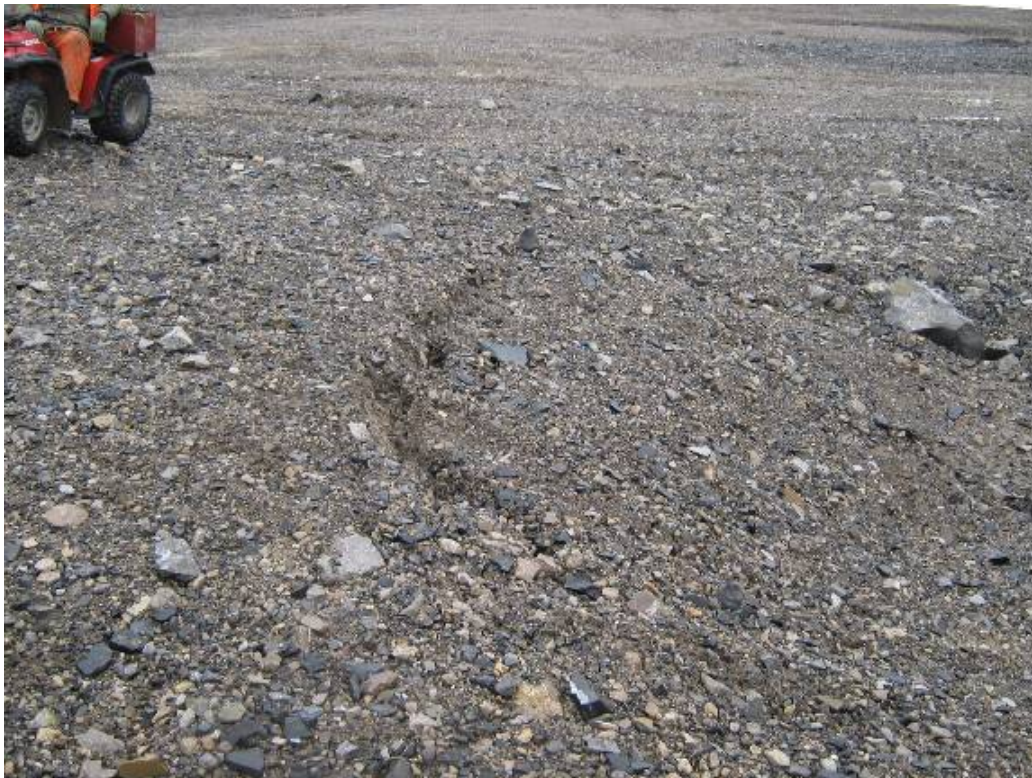
Photo 48- Northing 558447 Easting 8368972 Elevation 13 m  
Subsidence Area: view of tension crack

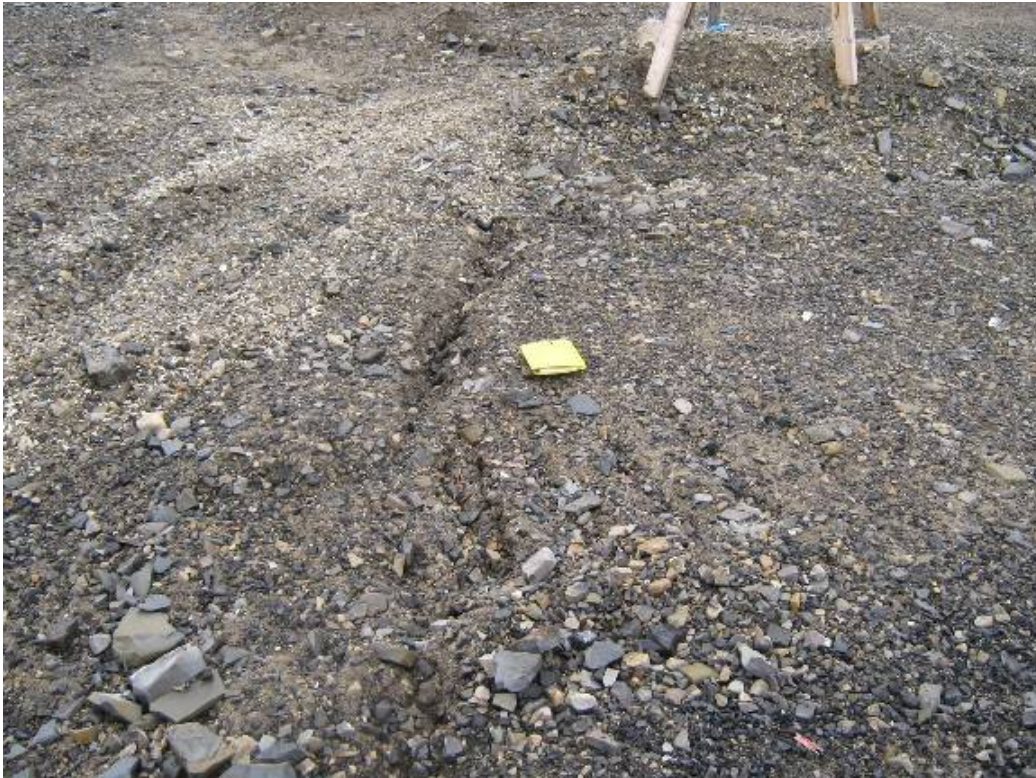
Photo 50- Northing 558515 Easting 8368992 Elevation 17 m  
Subsidence Area: view of tension crack near bench mark

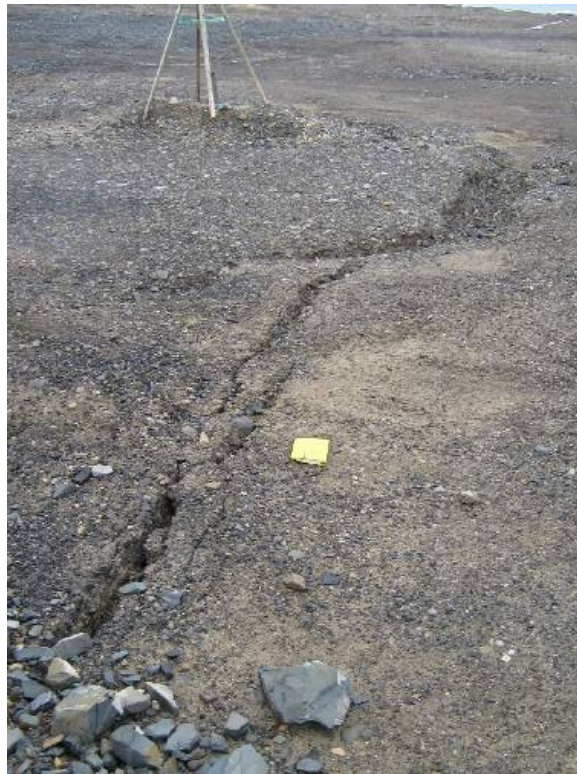
Photo 51- Northing 558515 Easting 8368992 Elevation 17 m  
Subsidence Area: view of another tension crack near bench mark

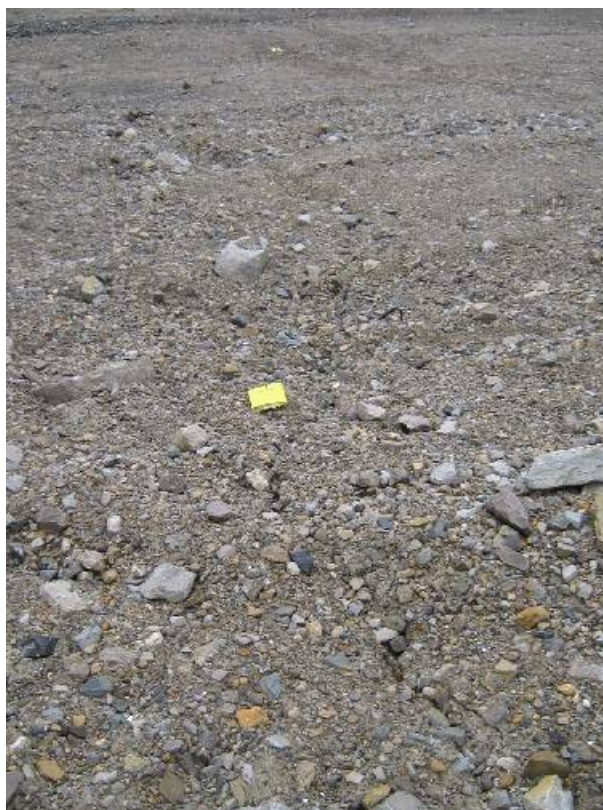
Photo 53- Northing 558576 Easting 8368837 Elevation 28 m  
View of tension crack upslope of subsidence area

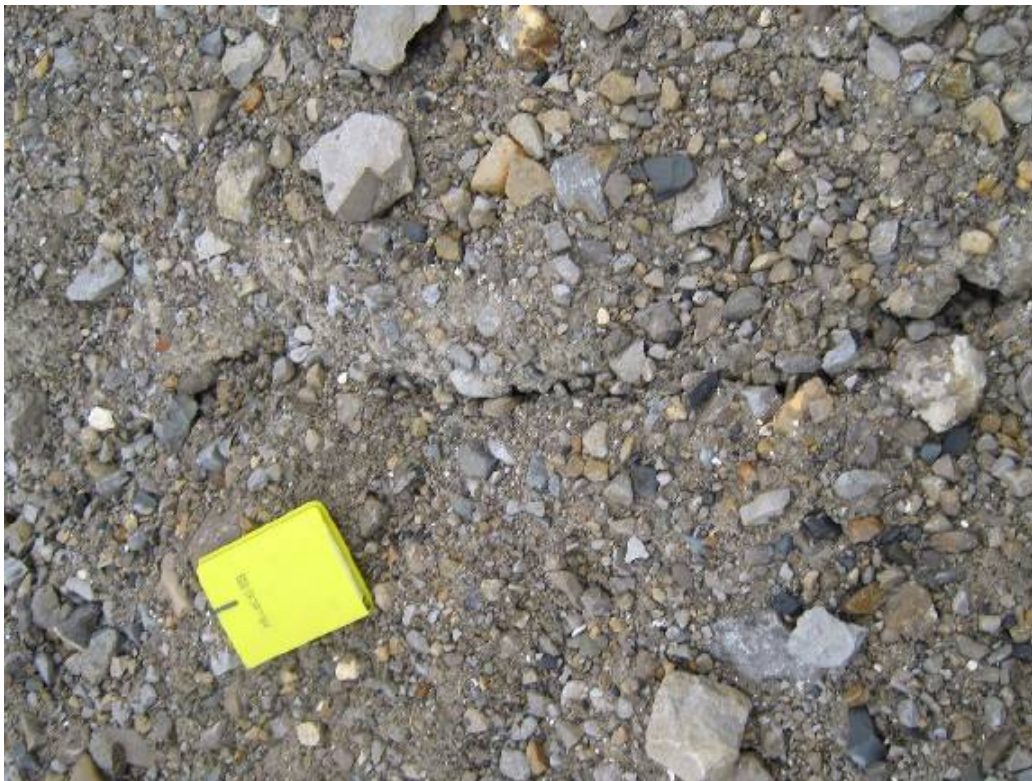
Photo 54- Northing 558576 Easting 8368837 Elevation 28 m  
Close up of tension crack upslope of subsidence area

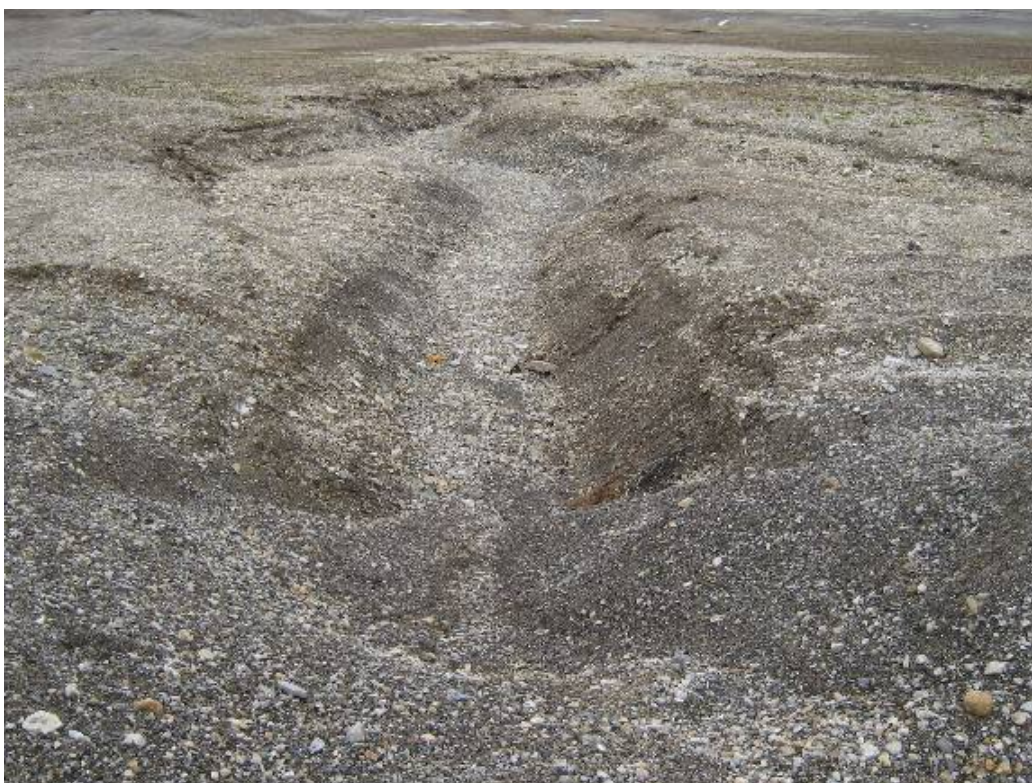
Photo 59- Northing 559090 Easting 8368552 Elevation 34 m  
View of the gully downstream in the third ditch

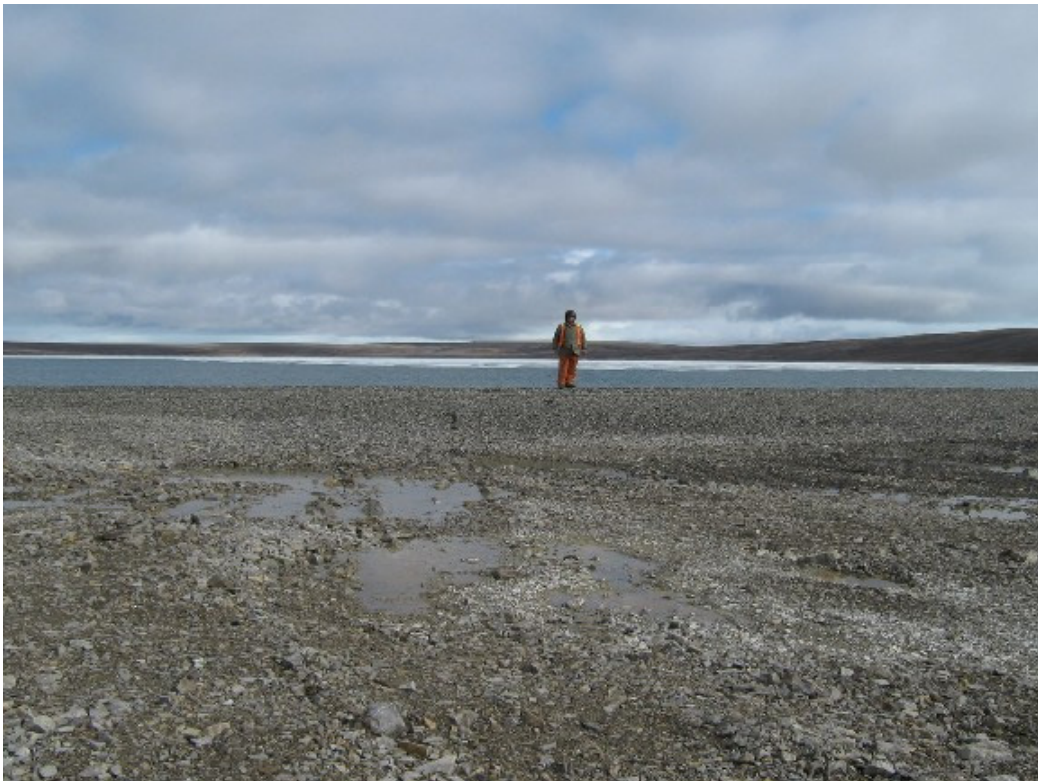
A ridge of gravel deposited across the breached outlet channel was initially observed during the 2006 inspection. The ridge or berm of gravel across the lake outlet appears to be increasing in size each year as a result of additional gravel accumulation. Photographs 78 to 82 in Appendix A document the size and height of the gravel berm at the time of the July 2008 inspection. The mechanism creating the ridge of gravel is likely ice and wave action. It is assumed that ice on the lake is pushed by the wind towards the south shoreline and outlet of the lake relocating gravel from the lake bottom to form a ridge or berm. The relatively coarse nature of the gravel permits a steady flow of water through the gravel ridge from the lake into the creek channel during the summer. However, the gravel ridge appears to be retaining some water and may be influencing the lake water level. Photograph 82 (Appendix A) illustrates a location where seepage through the gravel berm has caused some settlement from piping of the underlying soils. As the gravel berm grows higher and wider, the lake outlet may naturally relocate (e.g., move towards the east end of the wave break structure). The growth of the berm and lake outlet location should continue to be monitored, however this appears to be a natural process that likely also occurred prior to development at the site.

Photo 79- Northing 561569 Easting 8367440 Elevation 8 m  
Deposited gravel berm at breached outlet of wave break structure

Previously observed exposed geotextile downstream of Garrow Lake dam was removed in 2008. The ridge of gravel being deposited across the wave break outlet appears to be increasing in size each year as a result of additional gravel accumulation. It is recommended that Teck carry out annual topographic surveys of the wave break structure to monitor material deposition and lake water levels.

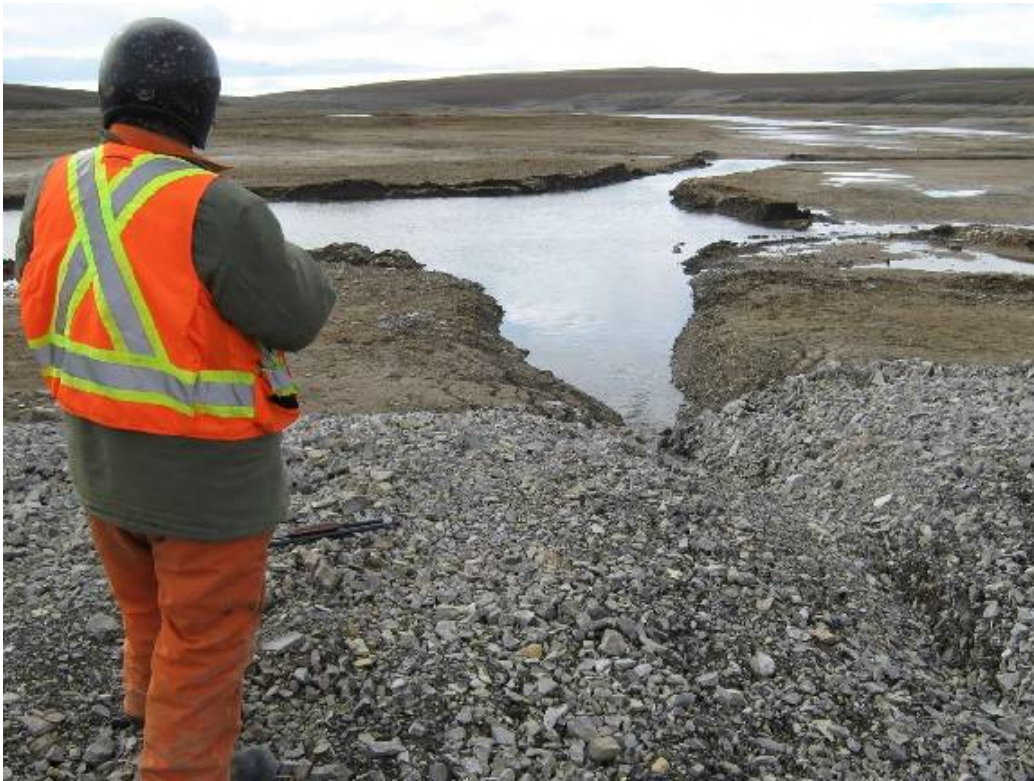
Photo 82- Northing 561569 Easting 8367440 Elevation 8 m  
Seepage through wave break structure causing some settlement from piping

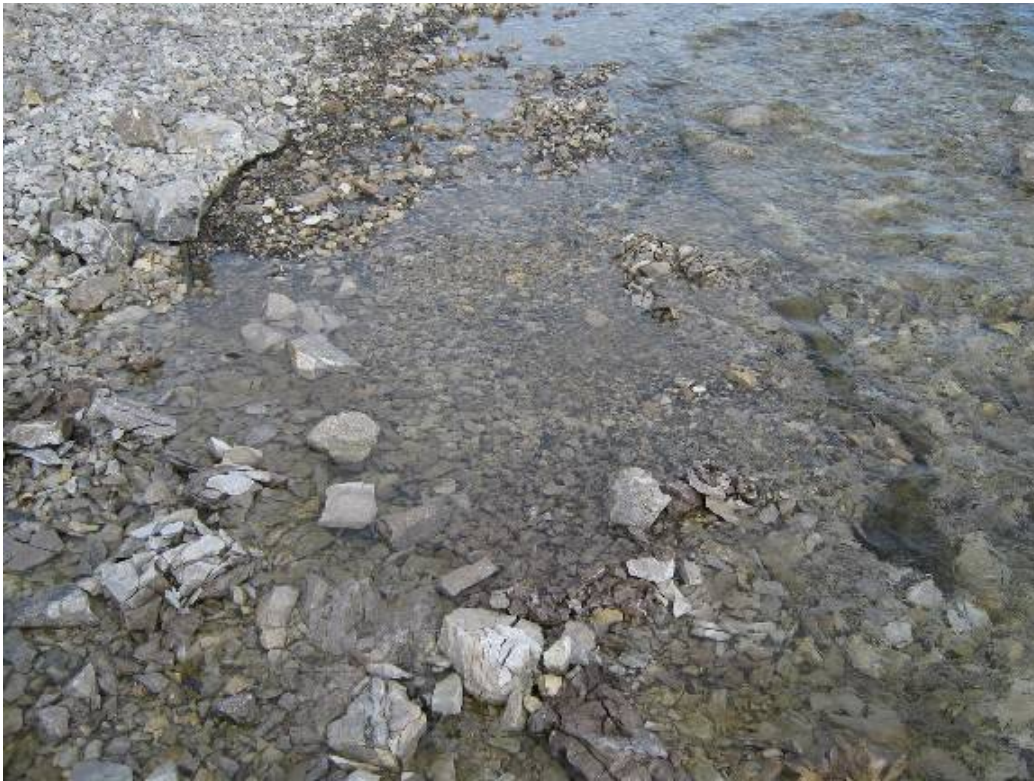
The sideslopes of the breach excavated through the main dam structure are in good condition, free of erosion or signs of major instability. Minor localised slumping observed in 2005 and 2006 appears unchanged. The condition of the dam breach slopes during the July 2008 inspection is documented in Photographs 83 through 87 (Appendix A). A localised section of the invert of the breach channel had a piece of exposed geotextile that was first observed in 2005. The exposed geotextile was cut away and removed in 2008. Photograph 86 (Appendix A) documents the current conditions where the exposed geotextile was removed.

Photo 86- Northing 561646 Easting 8366909 Elevation 15 m  
Garrow Creek: area of previously exposed geotextile

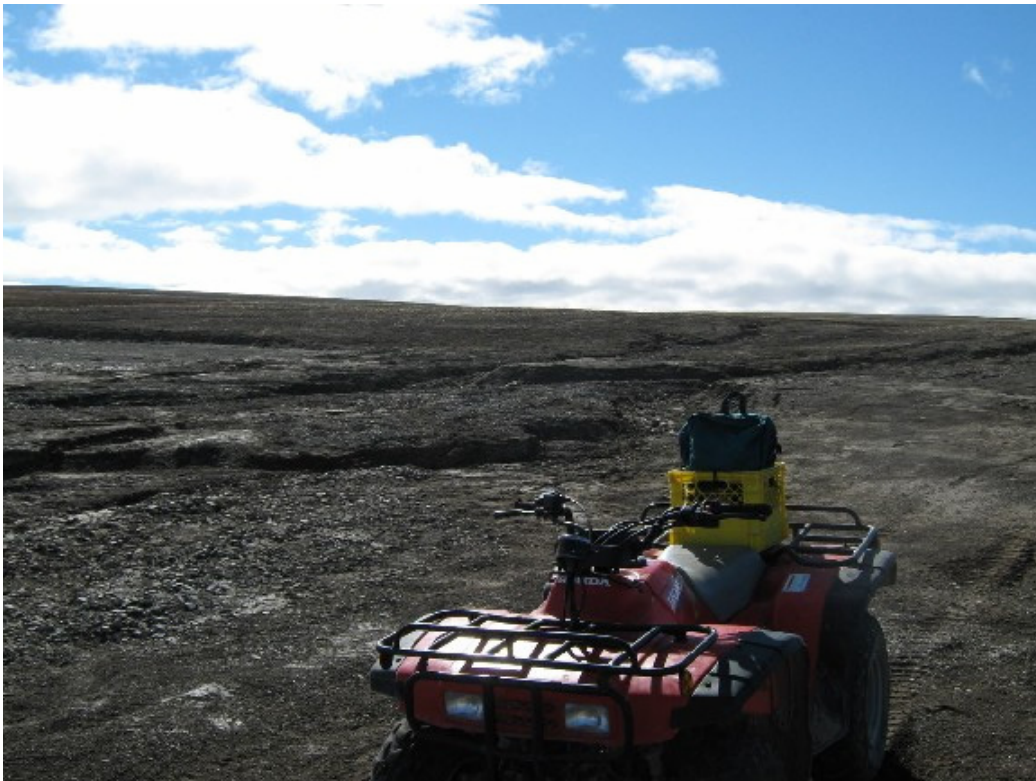
Photo 92- Northing 561088 Easting 8368913 Elevation 13 m  
Garrow Lake perimeter, erosion gullies near boat launch

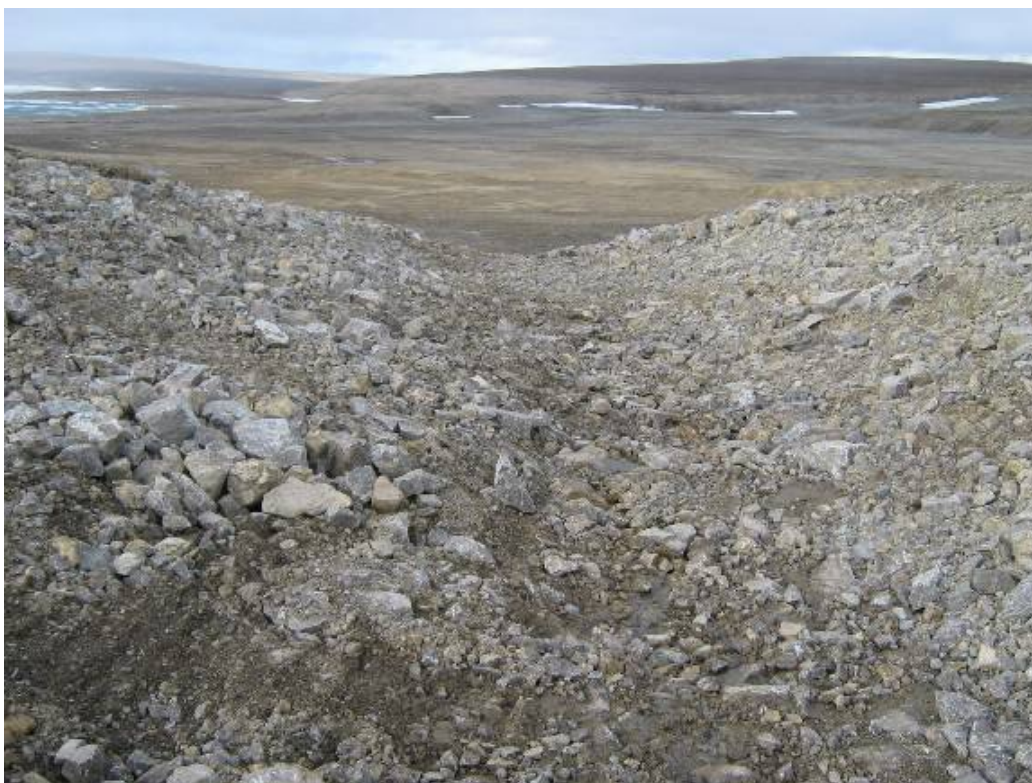
Photo 106- Northing 558815 Easting 8368653 Elevation 29 m  
New quarry area: repaired drainage ditch

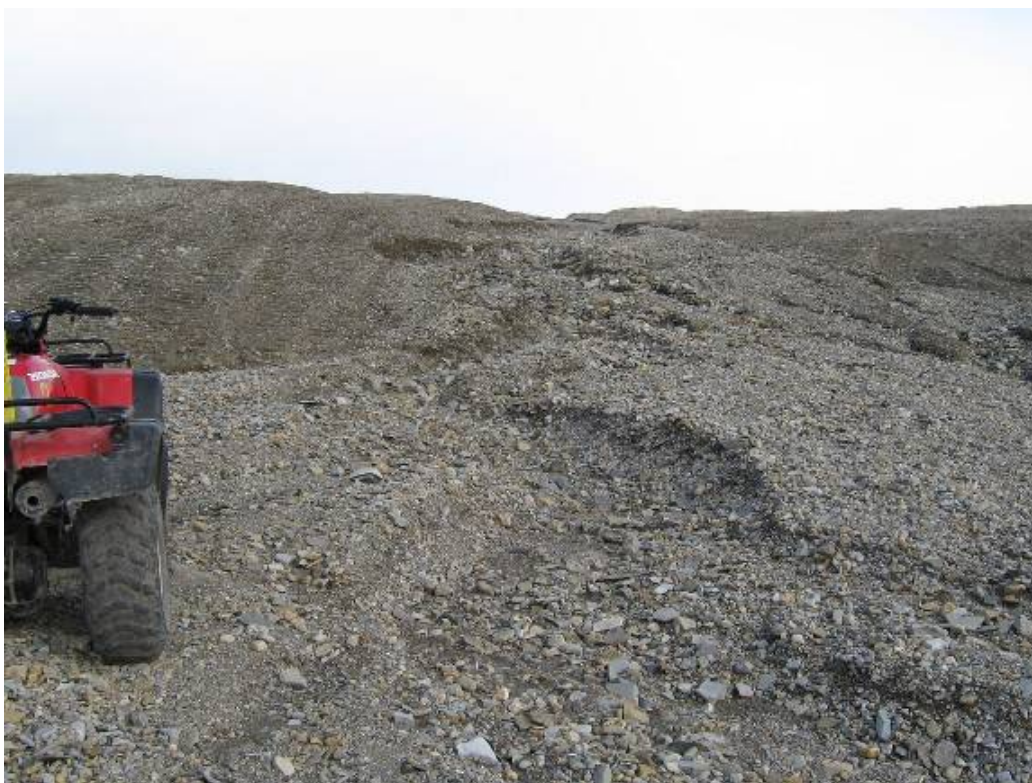
Photo 108- Northing 558880 Easting 8368714 Elevation 25 m  
New quarry area: self-armoured erosion gully

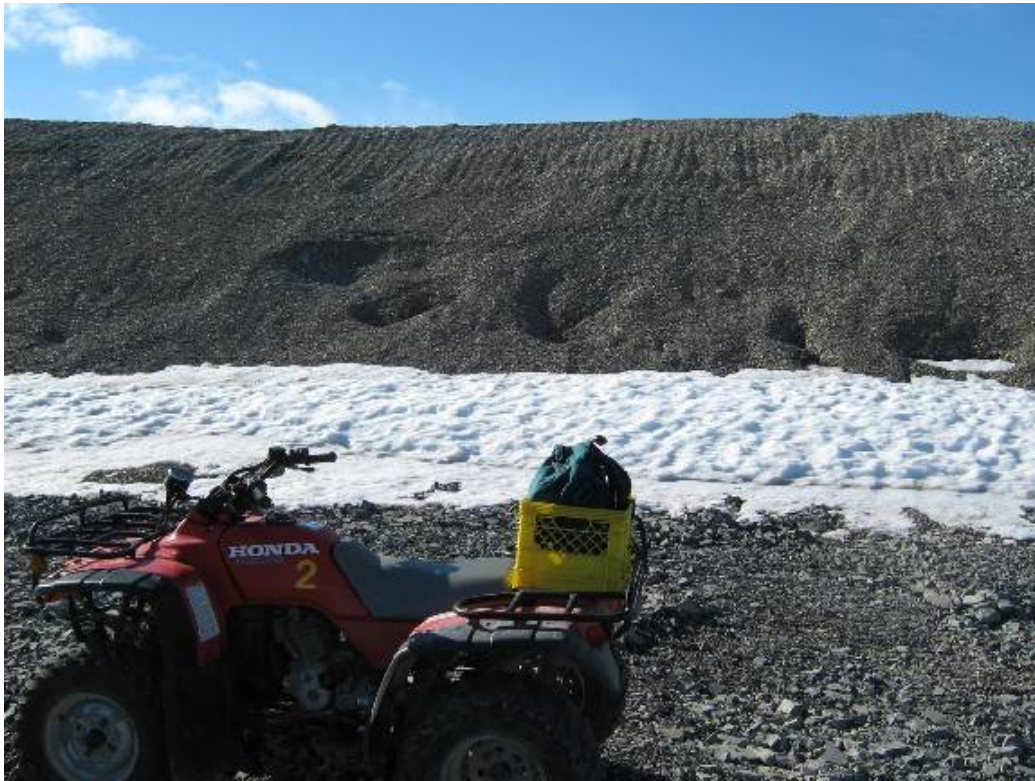
Photo 113- Northing 559027 Easting 8369443 Elevation 20 m  
New quarry area: sink holes on slope potentially caused by snow/ice melt.

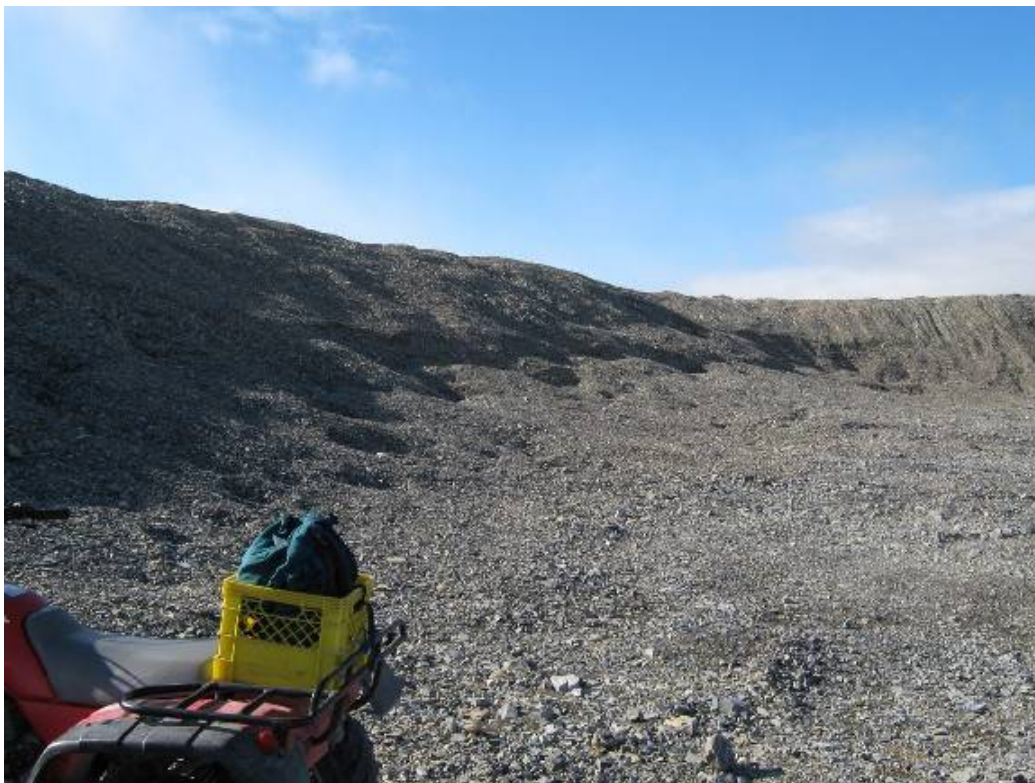
Photo 114- Northing 558950 Easting 8369335 Elevation 15 m  
New quarry area: sink holes on slope potentially caused by snow/ice melt.

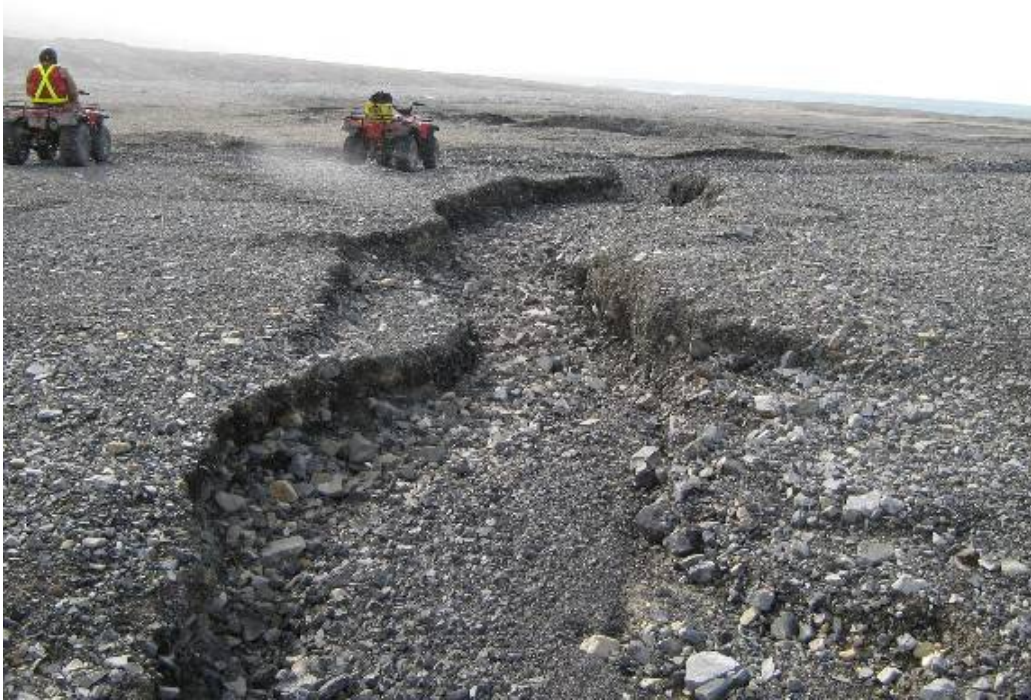
Photo 115- Northing 558779 Easting 8369106 Elevation 9 m  
New quarry area: erosion gullies meandering over floor of quarry

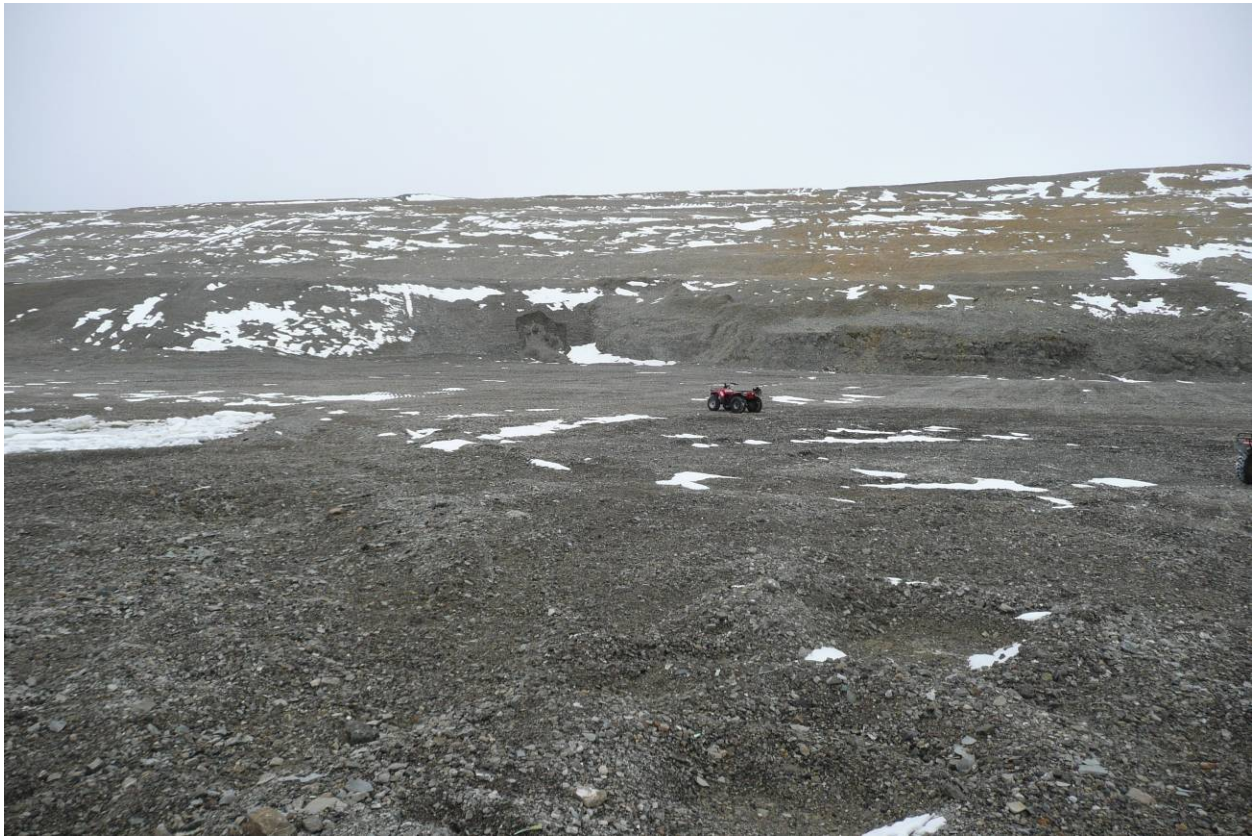
During a subsequent inspection of the site conducted by Teck and Indian and Northern Affairs Canada (INAC) on August 24, 2008 a slope failure was observed at the main portal. Some of the rockfill slope covering the sealed portal appears to have slumped since the July 2008 inspection. The slope failure did not expose the portal seal and access to underground is not possible. Two photographs in Appendix B (taken by Teck) document the condition of the main portal slope during the August 24, 2008 inspection by Teck and INAC. The backfilled slope over the main portal will be repaired and stabilized by Teck in 2009. Placement of additional rockfill at the toe of the slope (i.e., a toe berm) and/or slope flattening is recommended to prevent future slope failures.

Main Portal Slope Failure (ATV for scale) – August 24, 2008

No immediate action or repairs were identified at the time of the July 2008 inspection. However, a subsequent inspection conducted by Teck and Indian and Northern Affairs Canada (INAC) on August, 24 2008 observed a slope failure at the closed main portal. The area where the slope failure occurred was covered with snow during the July 2008 inspection. The backfilled slope over the main portal will be repaired and stabilized by Teck in 2009.

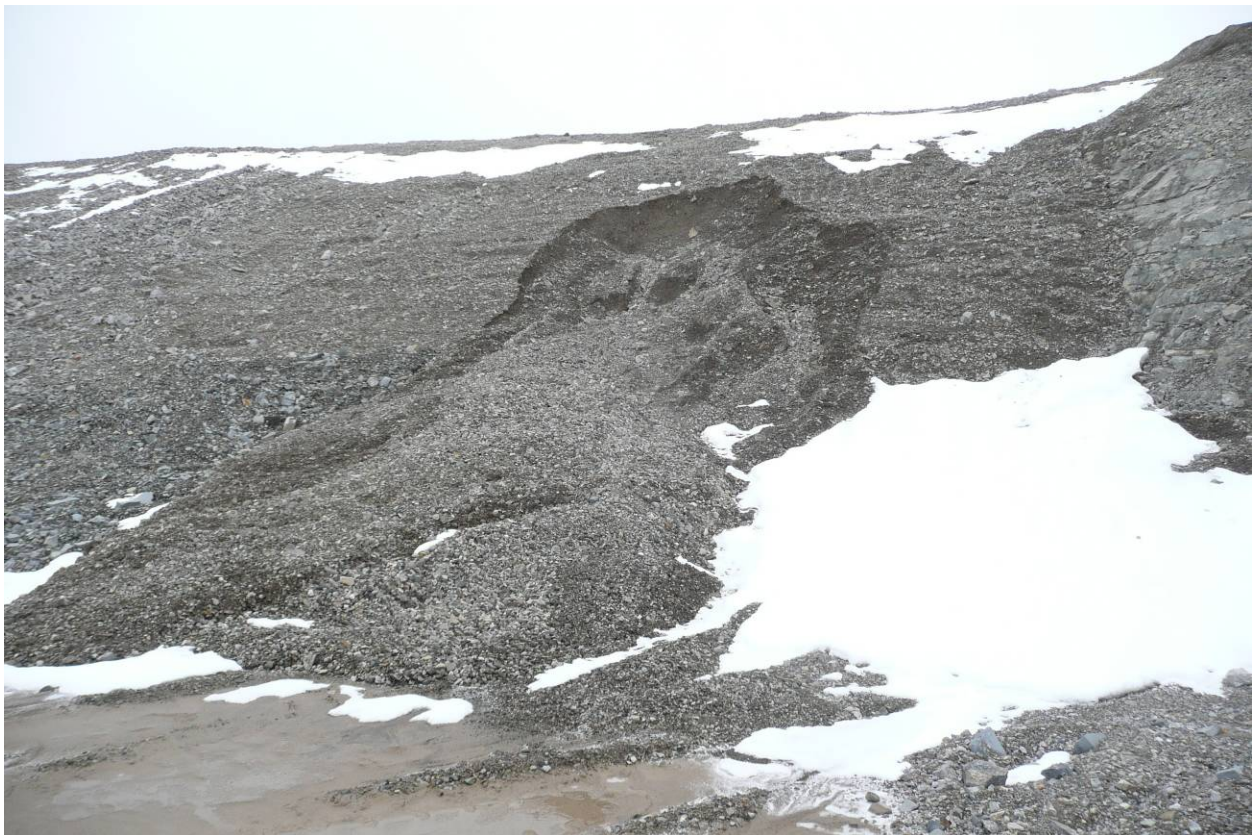
Main Portal Slope Failure (Close-up) – August 24, 2008
