October 9, 2014

# Post-Reclamation Geotechnical Inspection

## FORMER POLARIS MINE, NUNAVUT

**Report Number:** 1408454

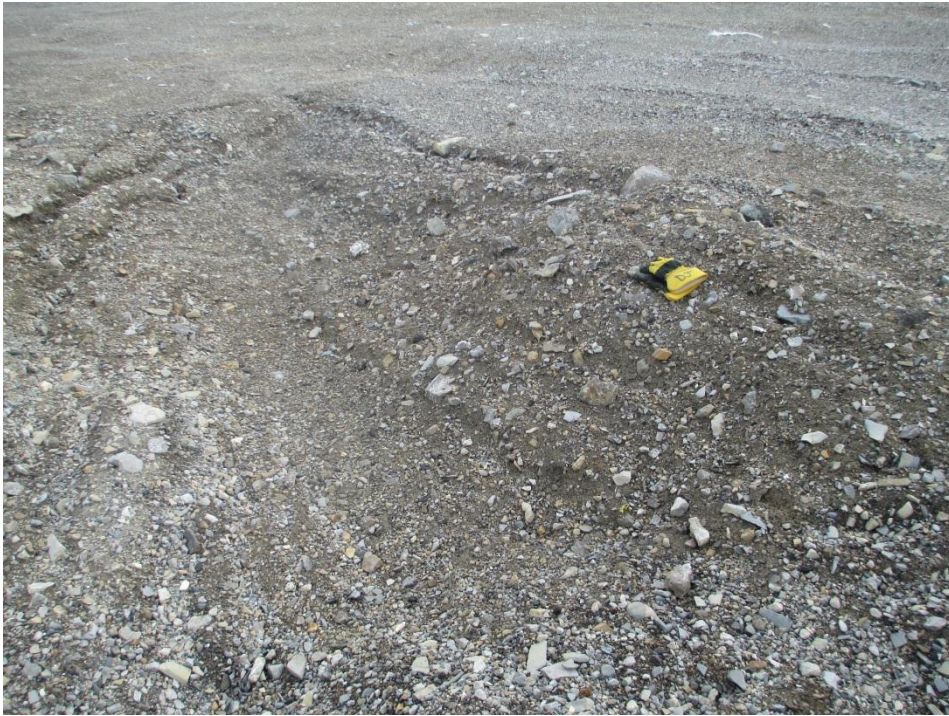
As noted above, much of the subsidence area was backfilled and regraded with frozen rockfill that may have contained ice and snow. Some of the photographs illustrate typical surficial settlement in the subsidence area likely caused by thaw of frozen backfilled material. Again, the observed settlement is not considered to be a result of underground mine related subsidence. The thaw settlement areas have gentle slopes that do not present a risk to either humans or wildlife. Some of these thaw settlement areas have associated tension cracks around the perimeter. There are some longer tension cracks in the subsidence area (see Photos 70 and 71) that have been observed during previous post-reclamation inspections (i.e., are not new) and were previously noted as being related to historic larger-scale subsidence in the area. These previously observed longer tension

Photo 7, Subsidence Area, thaw settlement area with tension cracks (WP#6)

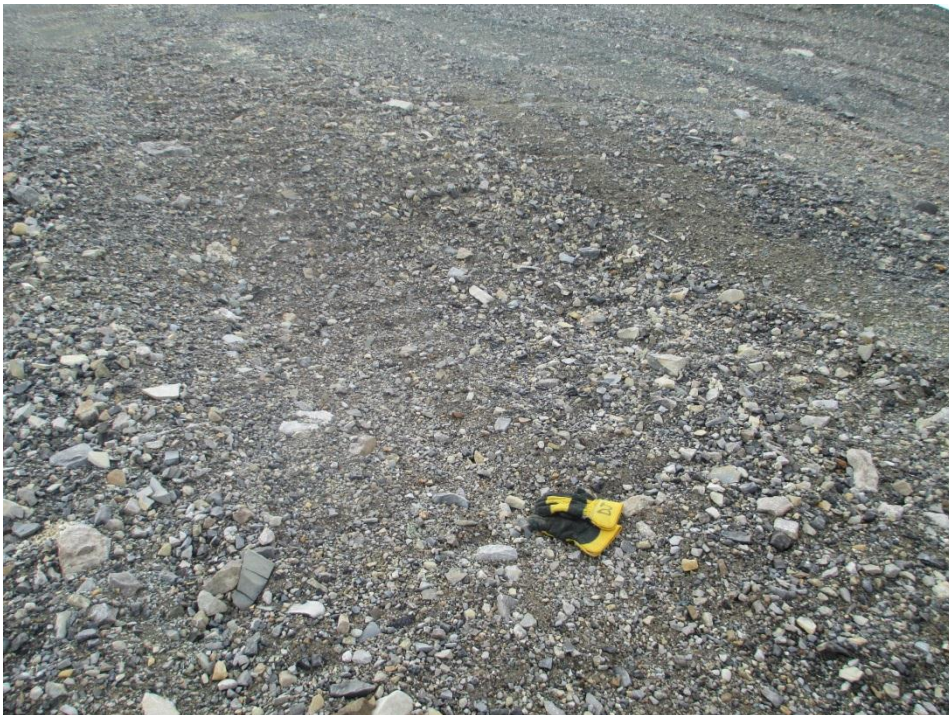
Photo 8, Subsidence Area, shallow thaw settlement area (WP#7)

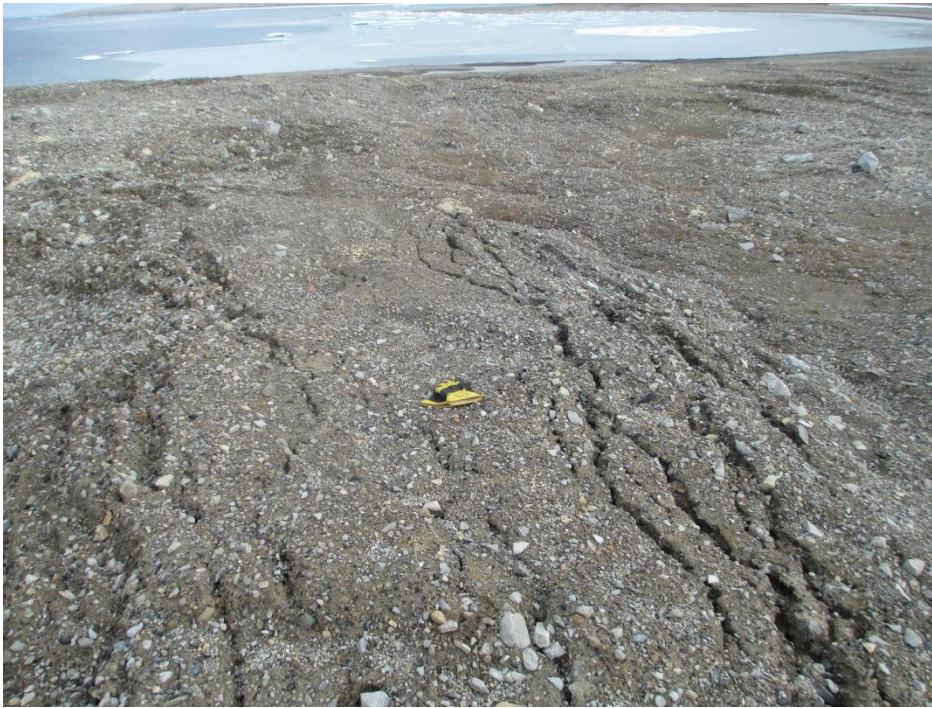
Photo 9, Subsidence Area, tension cracks on slope (WP#8)

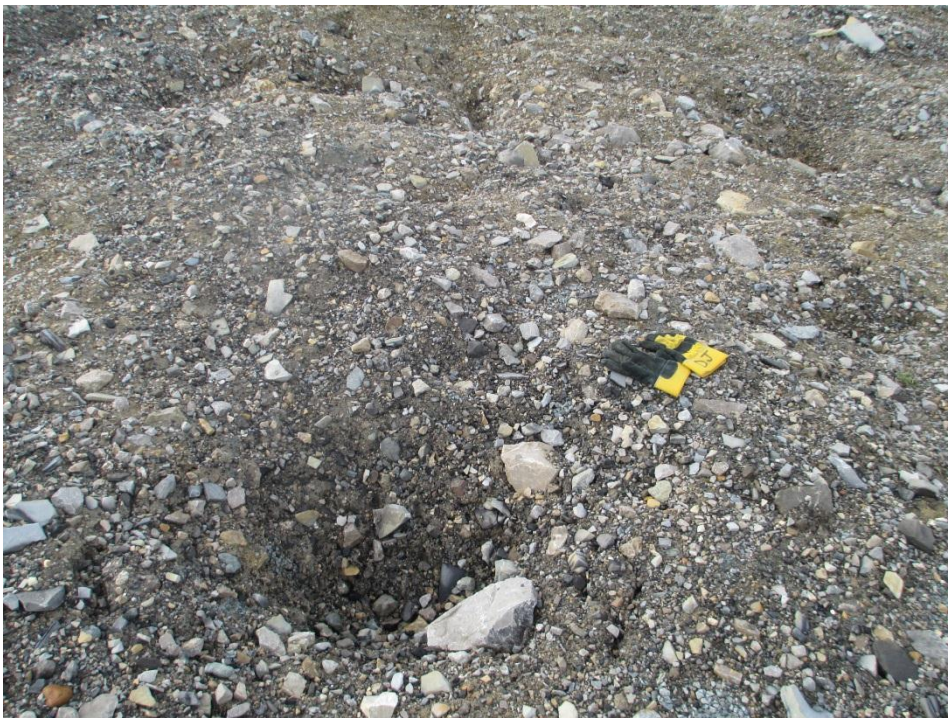
Photo 12, Subsidence Area, minor thaw settlement (WP#11)

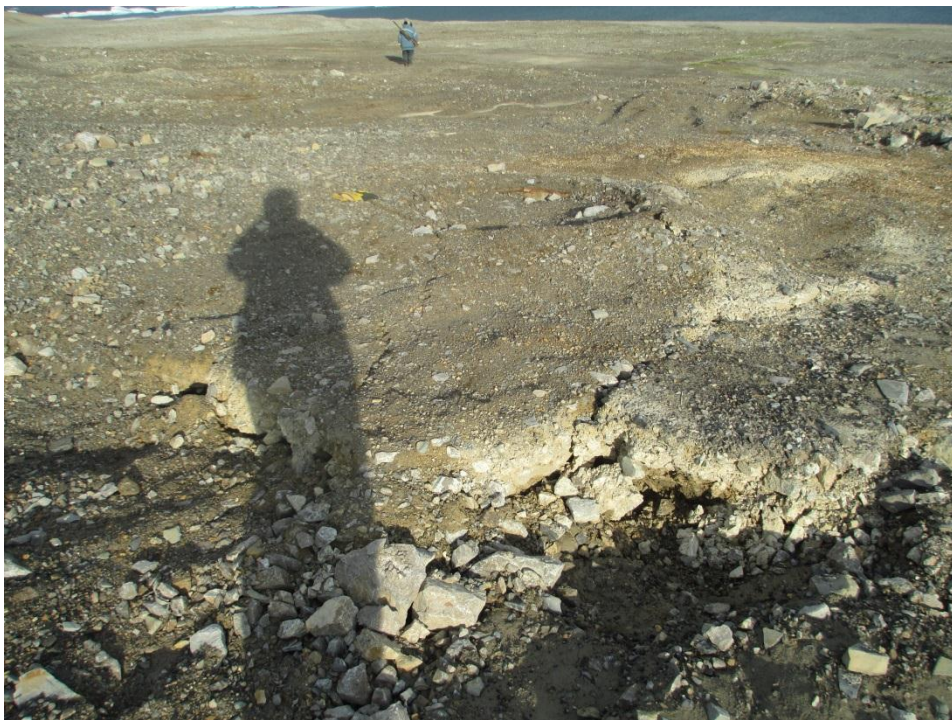
Photo 16, Subsidence Area, thaw settlement adjacent to Vent/Backfill Raise (WP#15)

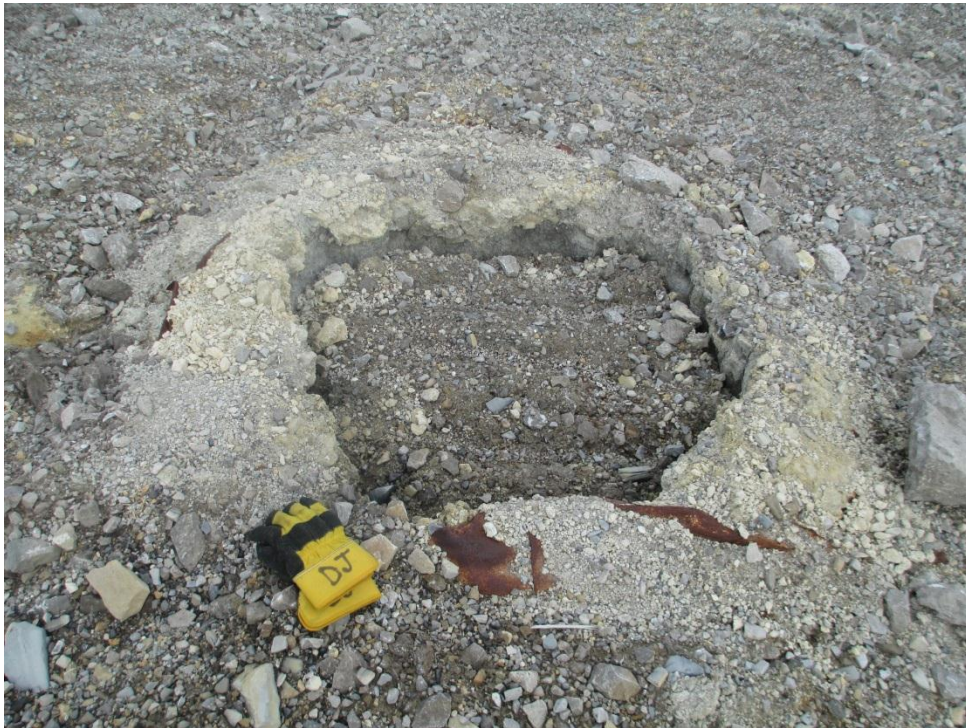
Photos 30, Subsidence Area, Vent/Backfill Raise with ~0.3 m internal settlement (WP#27)

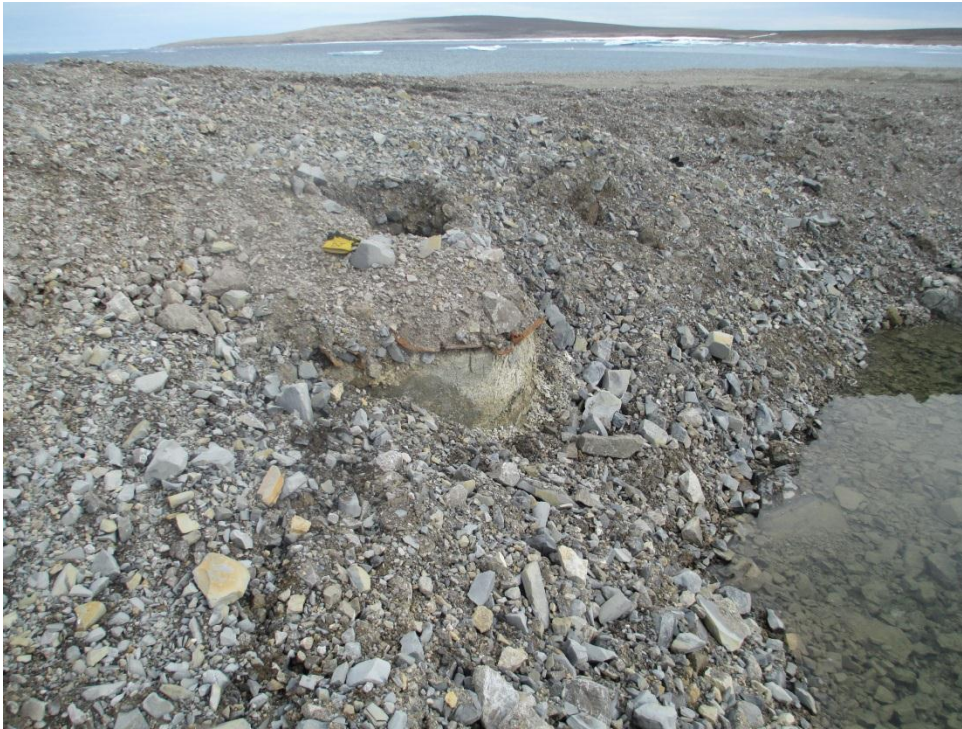
Photo 31, Subsidence Area, Vent/Backfill Raise beside ponded water (WP#28)

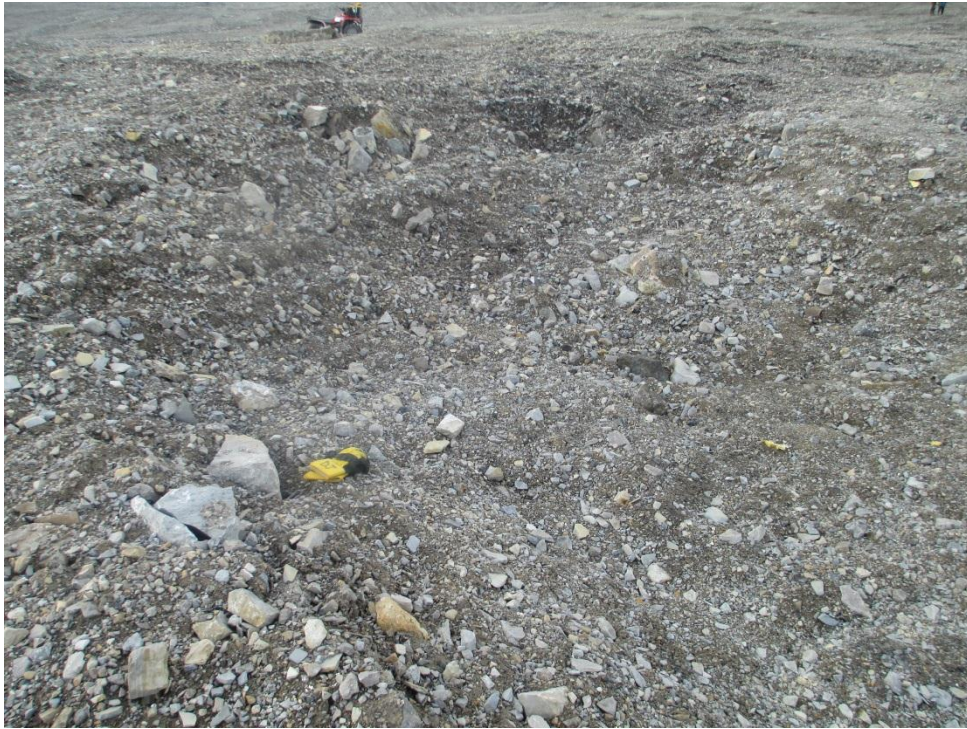
Photo 53, Subsidence Area, thaw settlement area (WP#46/65)

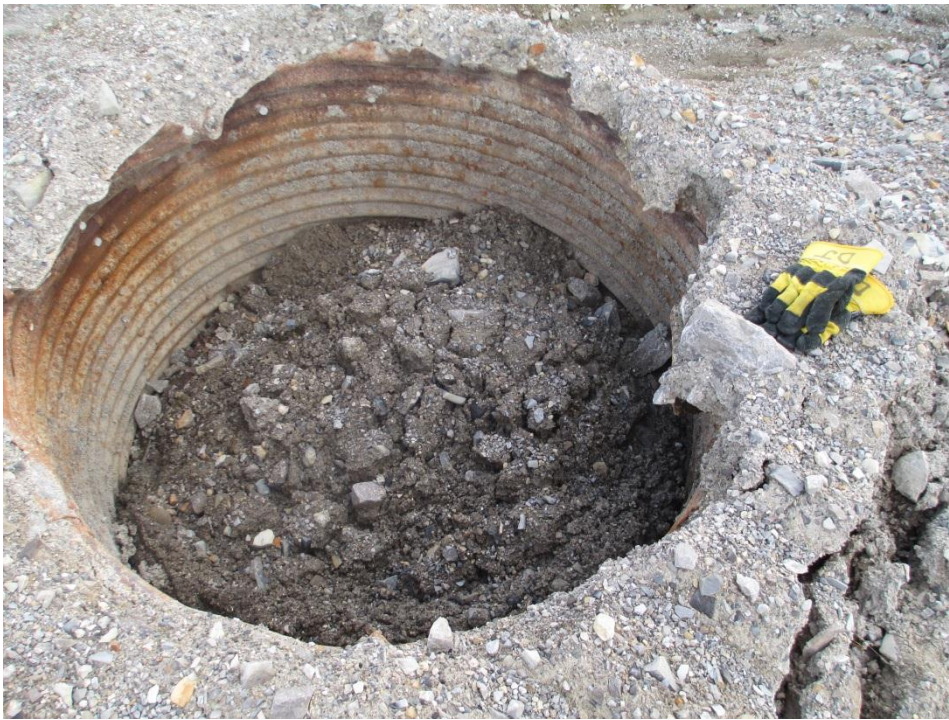
Most of the photographs taken in the subsidence area during the 2014 inspection are of vent/backfill raises that extend to surface. The raise bores are about 1.5 m in diameter and were used to either provide ventilation to the underground mine or deliver rock backfill to mine stopes. Vent/backfill raises have been observed during previous inspections and were not considered a risk to either humans or wildlife so only a few photographs had been taken to document typical conditions. However, the 2014 inspection attempted to photograph and GPS locate all of the vent/backfill raises in the vicinity of the subsidence area for future reference. Most of the vent/raise locations have corrugated steel pipe (CSP) extending slightly above ground surface. This is considered to be the result of near surface thaw settlement of backfill around and inside the CSP. It is assumed that CSP sections were used as casing through the active thaw layer in overburden down to either permafrost or bedrock. It is possible that frost jacking could be pushing the CSP out of the ground at some of the raise locations. However, it is considered more likely that frozen backfill, that may have contained ice and snow, placed around the CSP and down the raise is settling as a result of seasonal thaw. In fact, the CSP sections may have extended above ground surface when they were initially installed during mine operations. The depth of settlement inside the CSP at most raise locations is less than 0.3 m. There are four locations with substantial thaw settlement adjacent to the raise resulting in exposed CSP up to 1 m high (see Photos 31,37,56,59). There is ponded water in some of these thaw settlement depressions beside vent/backfill raises. Previous inspections had observed thaw settlement beside some of the vent/backfill raises, which were assumed to be unchanged since the mine site was decommissioned. However, it appears that the depth of settlement around and inside the CSP at some raise locations may be increasing over time. Even if there has been some post-reclamation settlement at the vent/backfill raises, it is important to note that this settlement is considered to be a result of seasonal thaw of backfill and not related to underground mine subsidence. There are three vent/backfill raise locations with internal settlement (i.e., inside the CSP) more than 0.3 m deep that could potentially pose a risk to either humans or wildlife (see Photos 25, 32, and 57).

Photo 57, Subsidence Area, Vent/Backfill Raise with ~0.7 m internal settlement (WP#48)

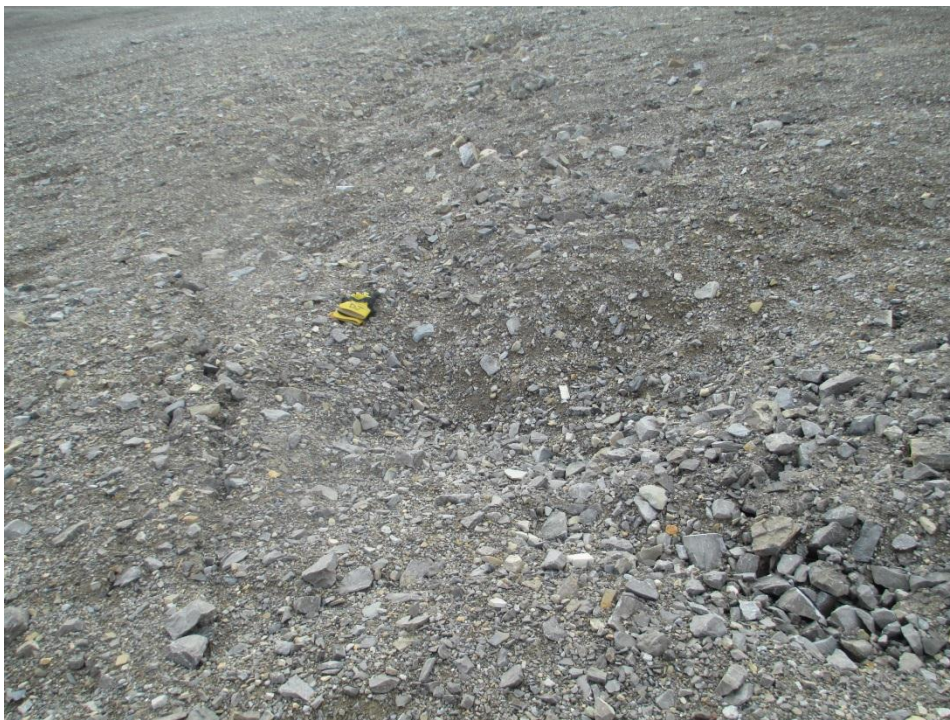
Photo 66, Subsidence Area, thaw settlement (WP#56)

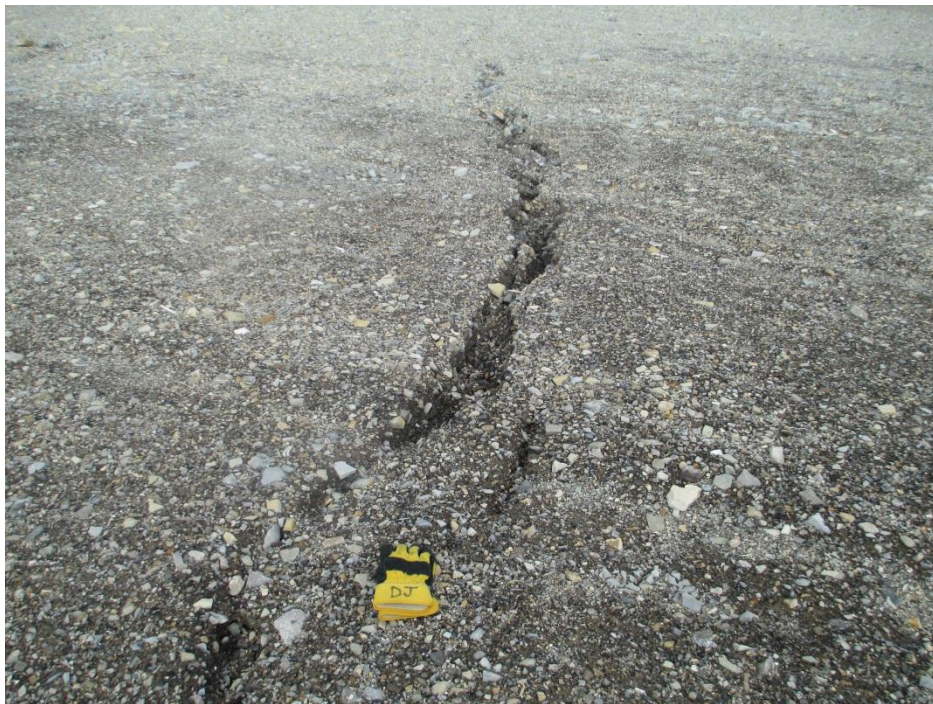
cracks are well weathered with internal erosion that has self-armoured confirming that they are not new. There are also similar previously observed tension cracks that run along the road at the east side of the subsidence area. However, these tension cracks are considered to be related to thaw creep of the gentle slope that extends from the road embankment down to towards the adjacent New Quarry. The road embankment and regraded slope is constructed of rockfill and is considered to be stable.

Photo 70, Subsidence Area, old tension crack (WP#59)

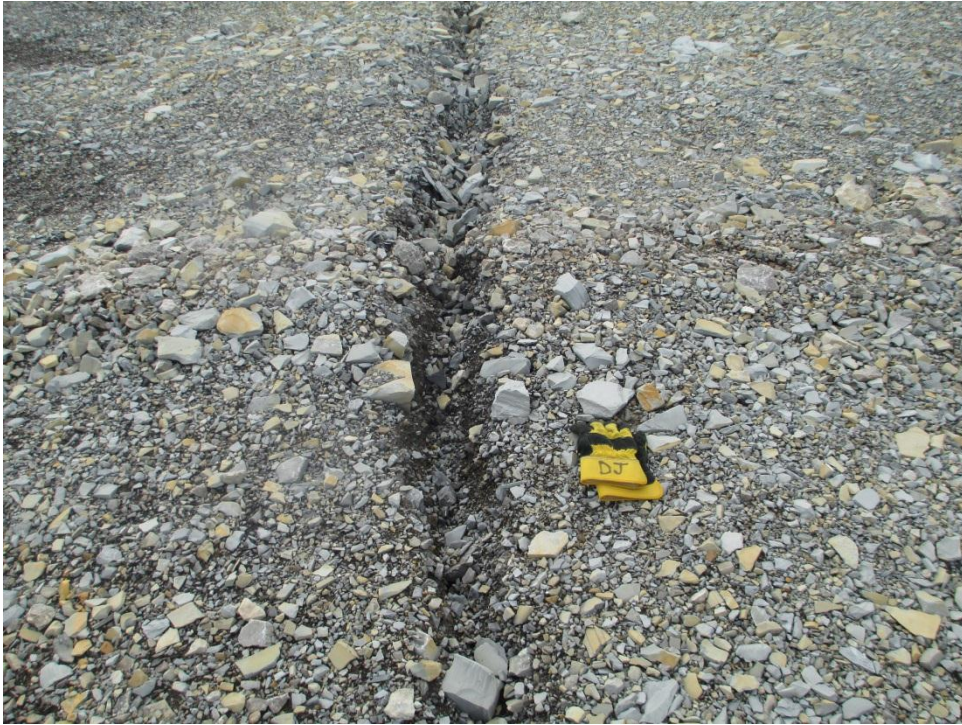
Photo 71, Subsidence Area, old tension crack (WP#60)

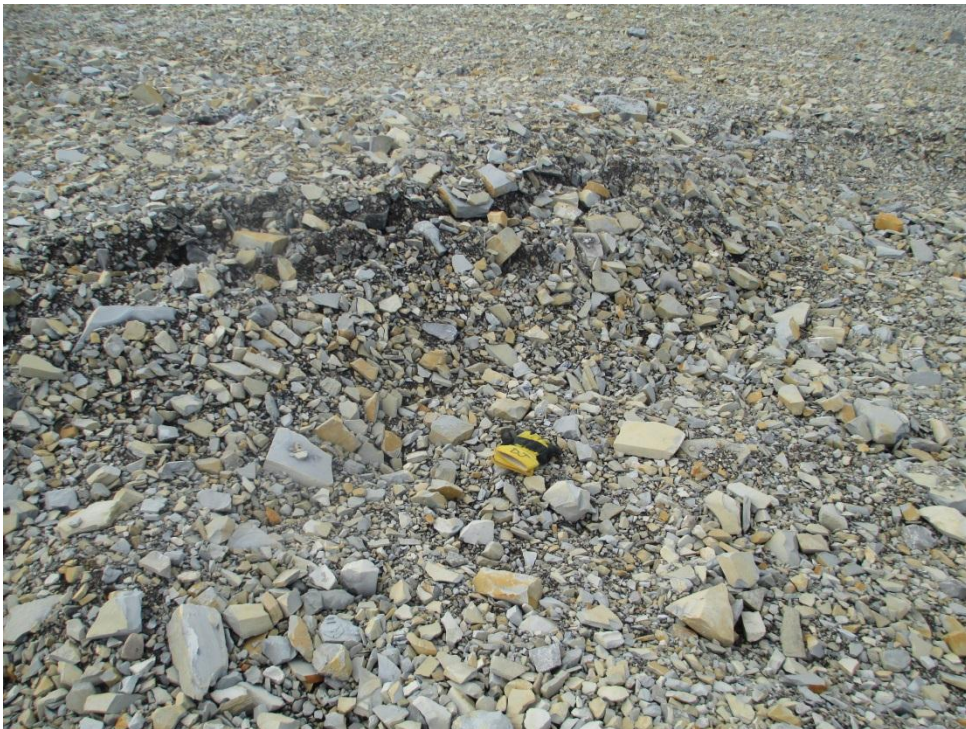
Photo 72, Subsidence Area, thaw settlement (WP#61)

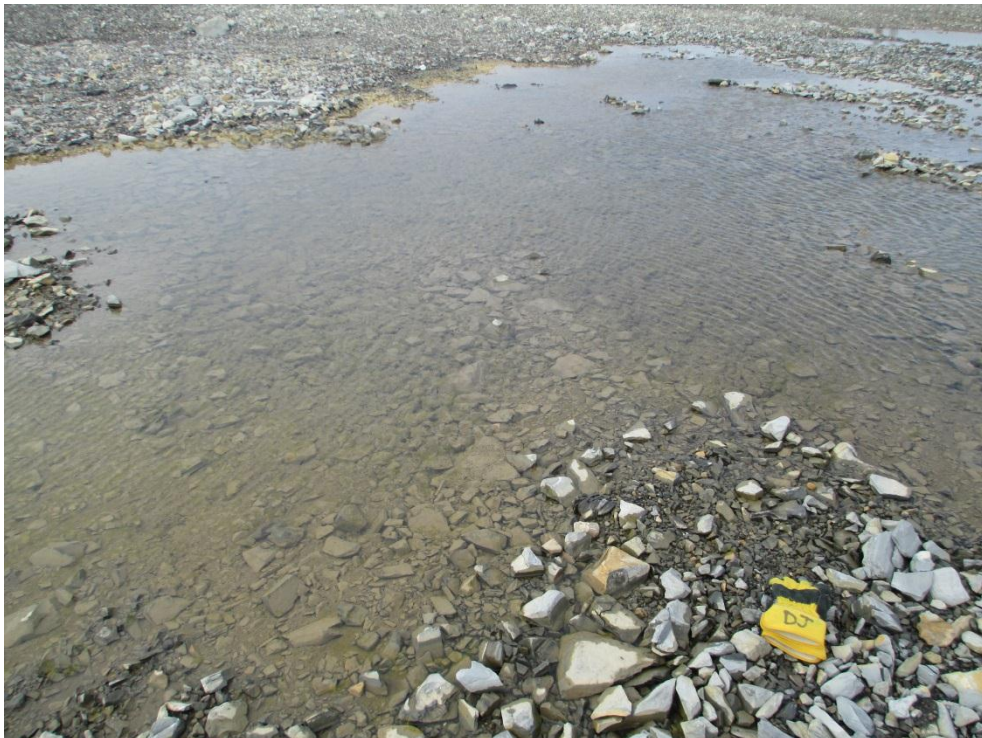
During the current and previous post-reclamation inspections there has been an area with ponded water in the centre of subsidence area (Photos 74 through 76) indicating that permafrost is preventing drainage of surface water from the depression. The shallow ponded water freezes solid each winter and does not interfere with maintaining permafrost conditions in the subsidence area. Because of the climate and depth of permafrost at Polaris, a very large and deep body of water is required to create a talik (i.e., thawed zone) through the permafrost.

Photo 74, Subsidence Area, ponded water (WP#62)

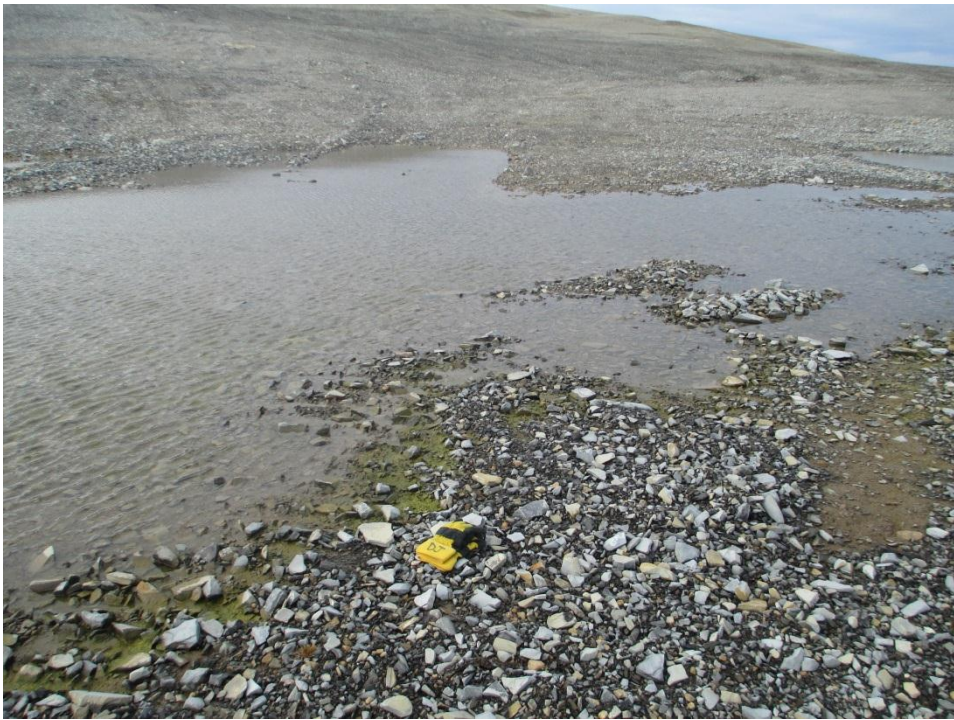
Photo 75, Subsidence Area, ponded water (WP#63)

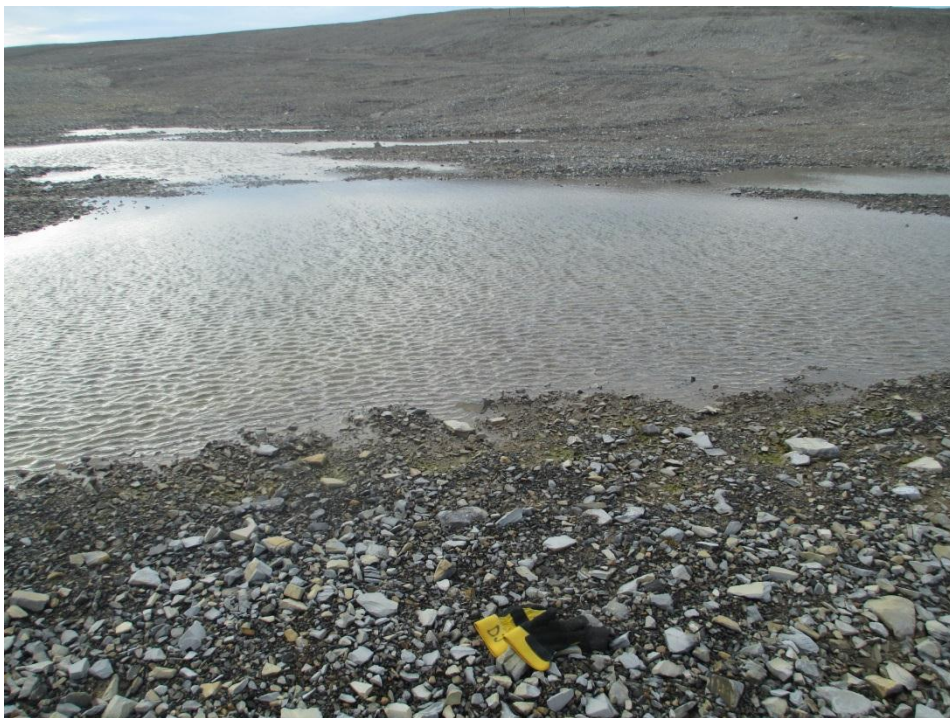
Photo 76, Subsidence Area, ponded water (WP#64)

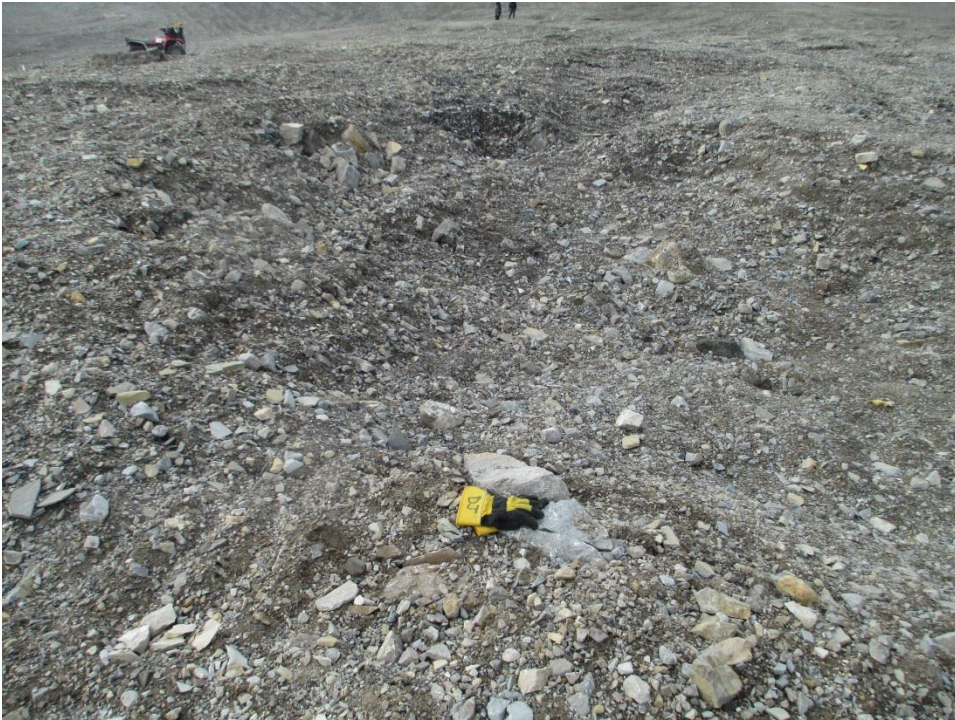
Photo 77, Subsidence Area, thaw settlement (WP#46/65)

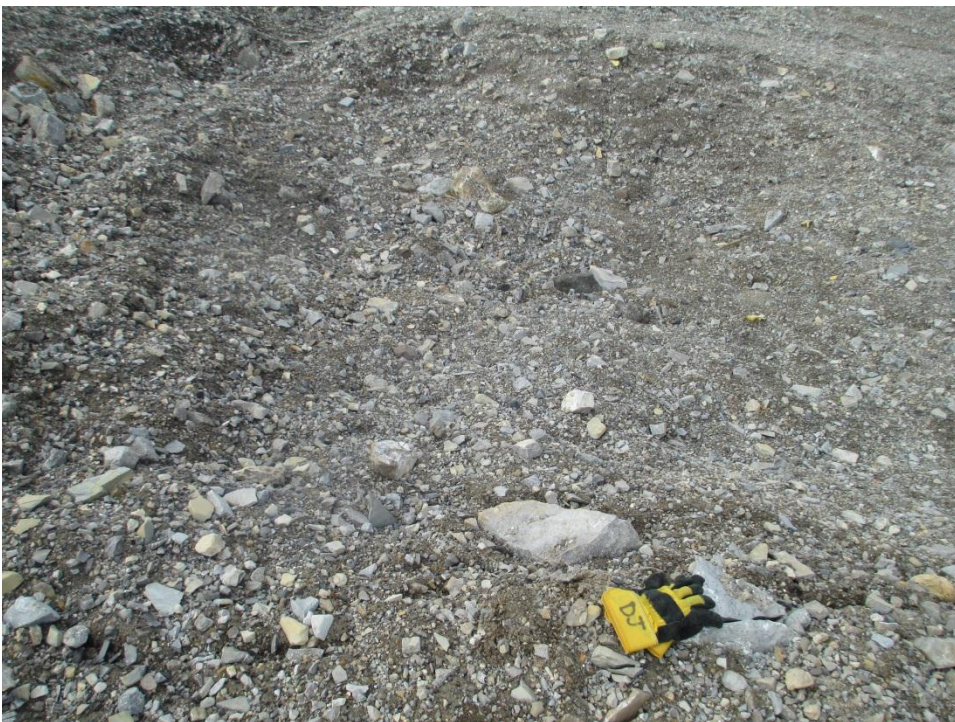
Photo 78, Subsidence Area, thaw settlement (WP#46/65)

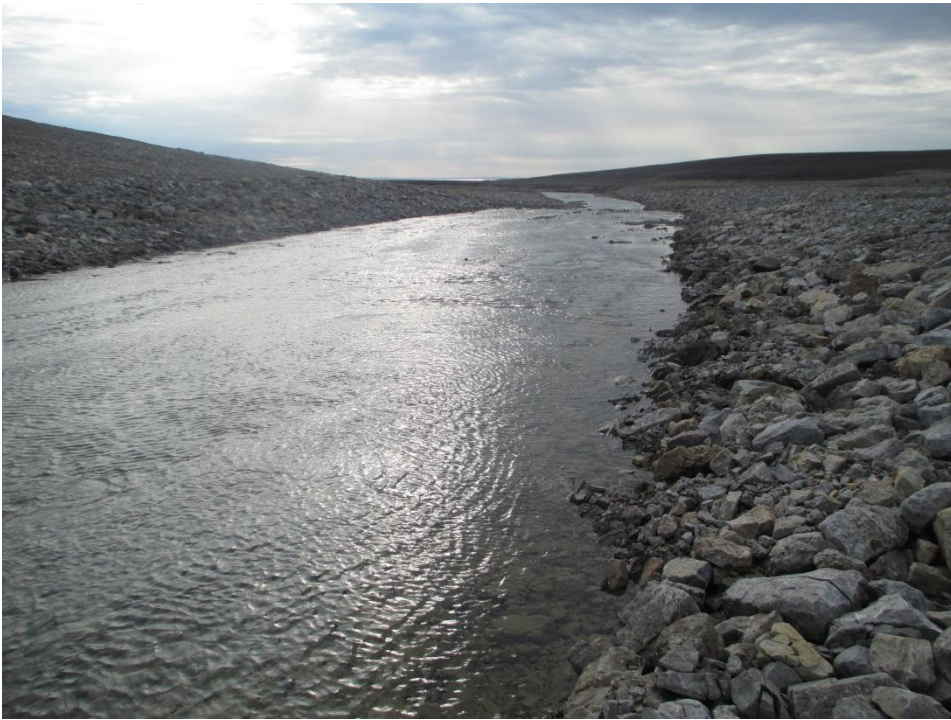
Photographs 89 through 94 illustrate the condition of the breached Garrow Lake Dam and creek channel. Minor thaw settlement on the dam breach slopes appear to be unchanged during post-reclamation geotechnical inspections. Rip-rap at the base of the breach slopes appears to be in good condition and is effectively protecting the breach slopes from channel erosion.

Photo 93, Garrow Lake Dam, dam breach channel (WP#72)

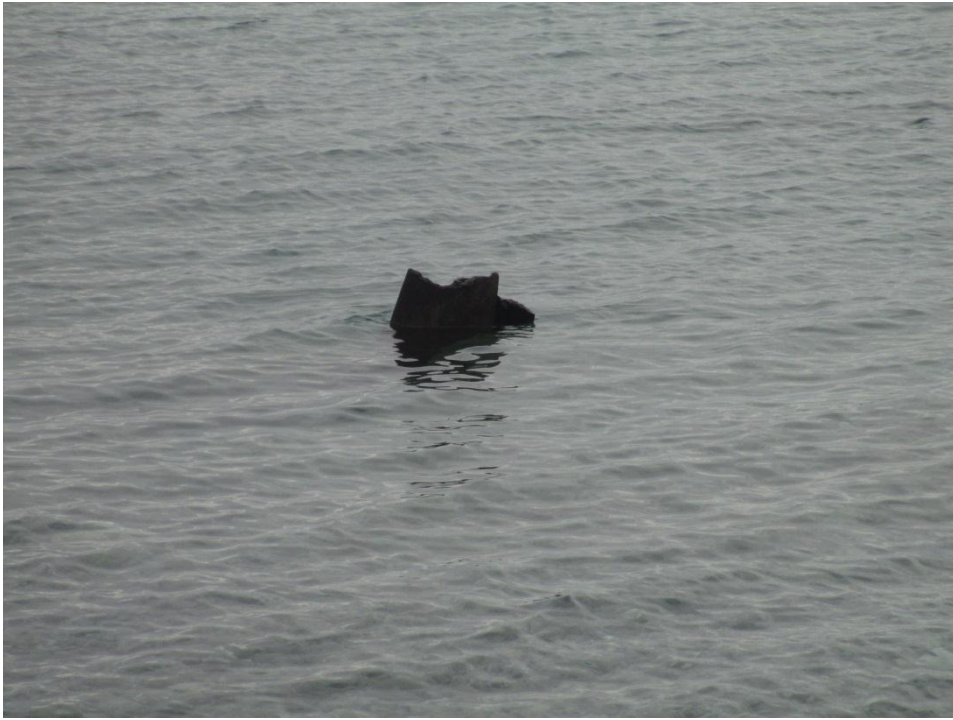
The slopes adjacent to the former dock structure were observed to be stable. No active erosion features discharging sediment were observed in the foreshore area during the September 2014 inspection. Photographs 109 and 110 document a wooden pile observed in the water at the South end of the marine foreshore area. Photograph 114 documents the typical condition at the North end of marine foreshore area during the September 2014 inspection. Thaw settlement and the formation of gravel bars in response to ocean wave and ice action has been observed along the shoreline during previous post-reclamation inspections.

Photo 109, Marine Foreshore, wood pile in water (WP#80)

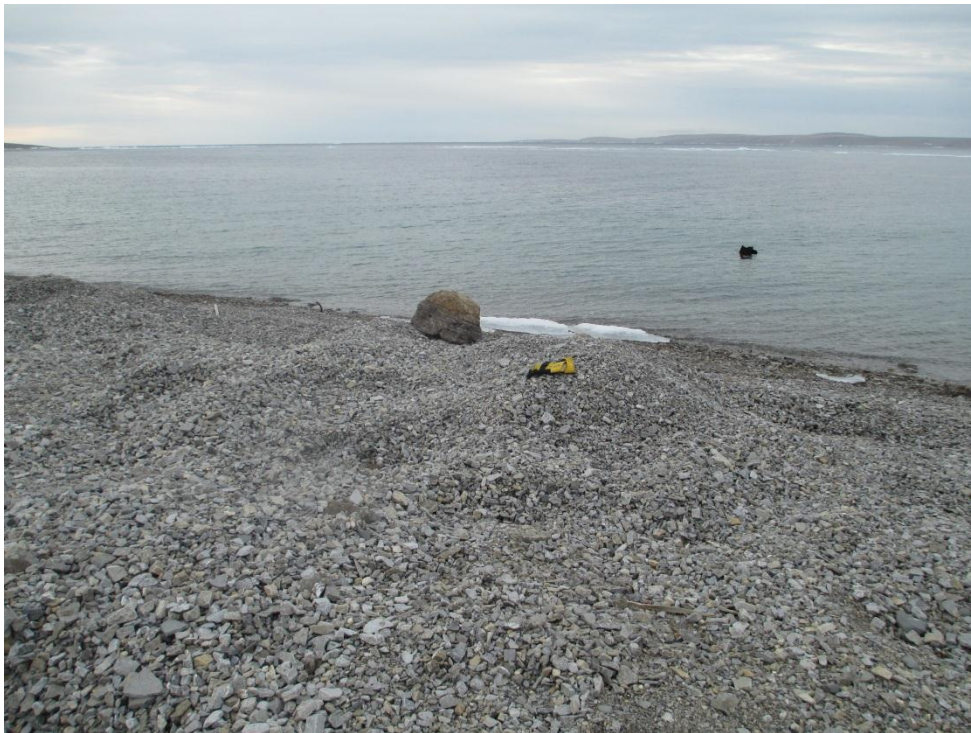
Photo 110, Marine Foreshore, wood pile in water (WP#80)

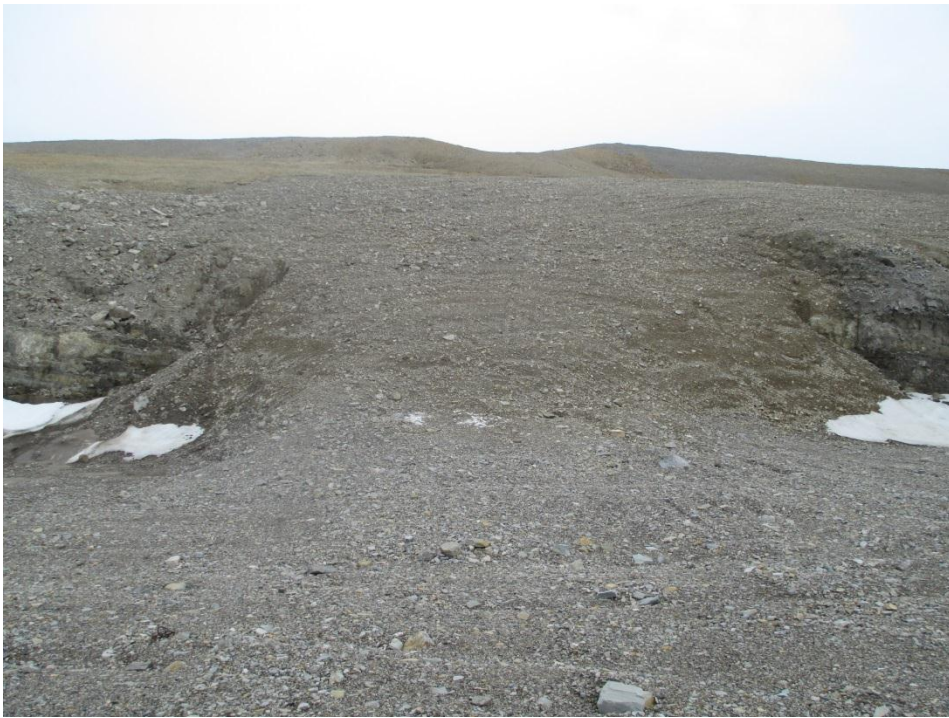
The Conveyor Portal slope was observed to be in good condition during the September 2014 inspection (see Photograph 111). Most of the backfilled slope in front of the Main Portal was snow covered during the September 2014 inspection (see Photograph 112). The slope in front of the Main Portal had been regraded and flattened in 2009 to repair a slope failure. Photograph 113 is a close-up of some new minor slumping above the Main Portal slope.

Photo 111, Conveyor Portal (WP#81)
