# Polaris 2010 Geotechnical Inspection

## FORMER POLARIS MINE, NUNAVUT

**Submitted to:**  
Teck Resources Ltd.

**Report Number:** 10-1118-0019

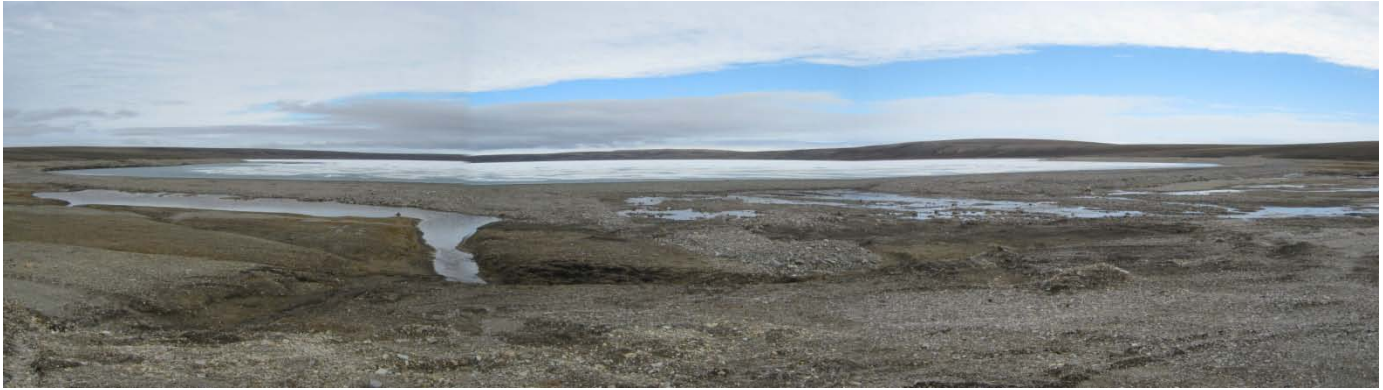
The size of the gravel berm at the time of the July 2010 inspection is documented in a panoramic view of the downstream side of the gravel berm (Photographs 1, 2 and 3). Photograph 4 illustrates the crest width of the gravel berm. The mechanism creating the ridge of gravel is considered to be ice and wave action that relocates gravel from the shallow water near the south shore of Garrow Lake. This appears to be a natural process that likely also occurred prior to mine site development. The relatively coarse nature of the gravel permits a steady flow of water through the gravel ridge from the lake into the creek channel during the summer. However, the gravel ridge appears to be retaining some water and may be influencing the lake water level. At the east end of the wave break structure, seepage through the gravel berm and wave break rockfill has caused some settlement (Photograph 6). At the time of the July 2010 inspection, Garrow Lake was mostly ice covered (Photograph 7).

Photos 1,2,3 (Panoramic), Garrow Lake Wave Break, Gravel Berm Facing Upstream

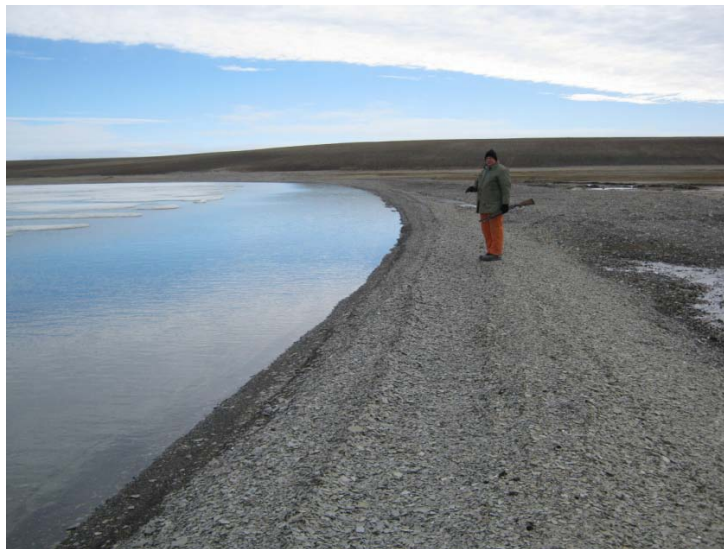
Photo 4, Garrow Lake Wave Break, Crest of Gravel Berm Facing East

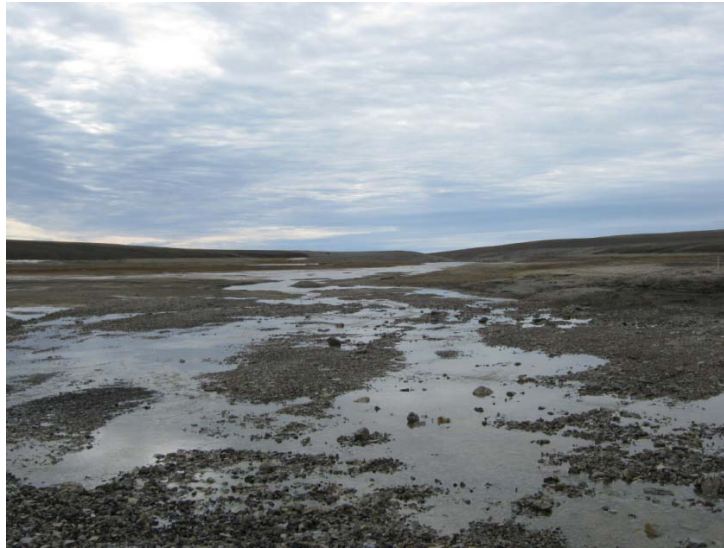
Photo 5, Garrow Lake Wave Break, Facing Downstream Towards Garrow Lake Dam

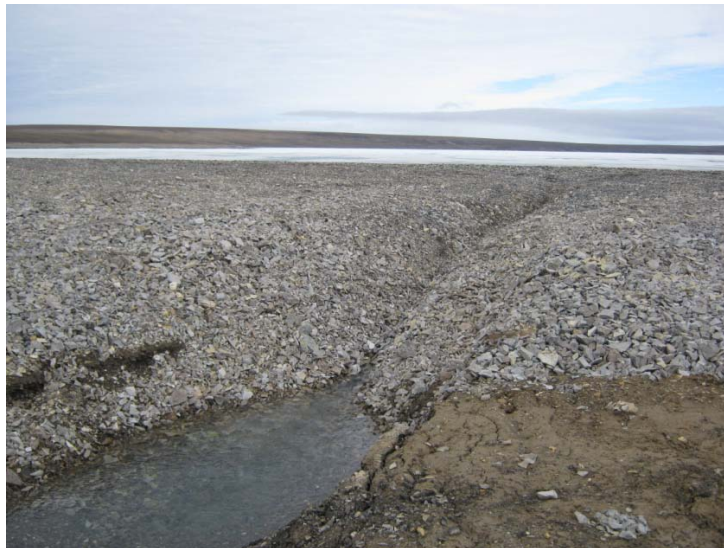
Photo 6, Garrow Lake Wave Break, Thaw Settlement at East End

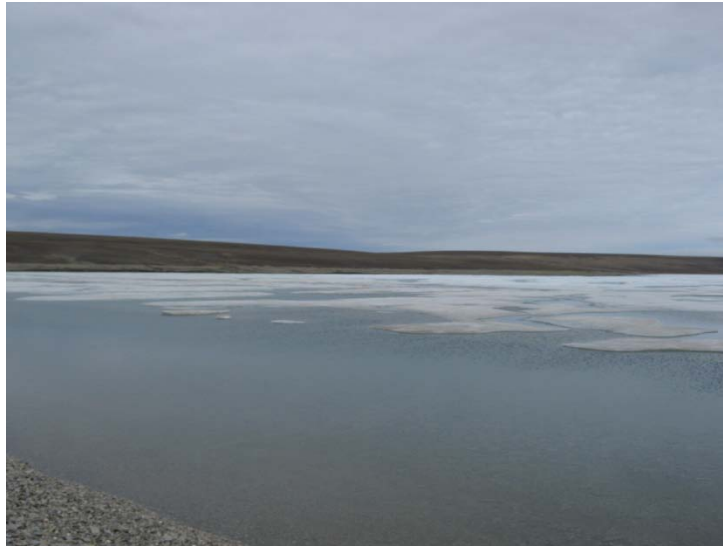
Photo 7, Garrow Lake Wave Break, Ice Cover at South Shoreline

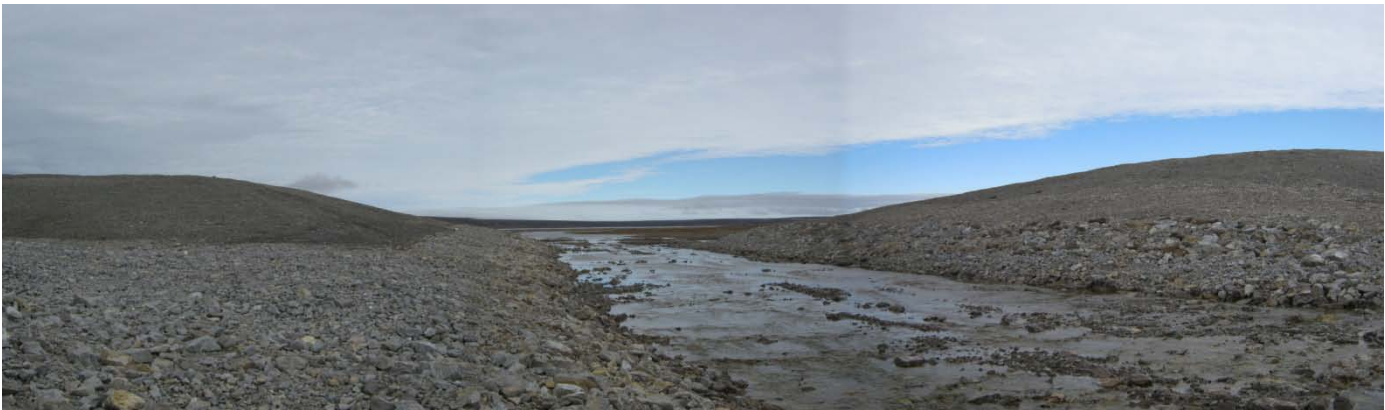
The sideslopes of the Garrow Lake Dam breach were observed to be free of erosion or indications of slope instability during the July 2010 inspection. Photographs 8, 9, 10 create a panoramic view of the dam breach and channel facing upstream towards Garrow Lake. Rip-rap at the base of the breach slopes appears to be in good condition and effectively protecting the breach slopes from channel erosion (Photographs 11 and 12). The condition of the dam crest and breach slopes during the July 2010 inspection is documented in Photographs 11 through 15.

Photos 8,9,10 (Panoramic), Garrow Lake Dam, Dam Breach Facing Upstream

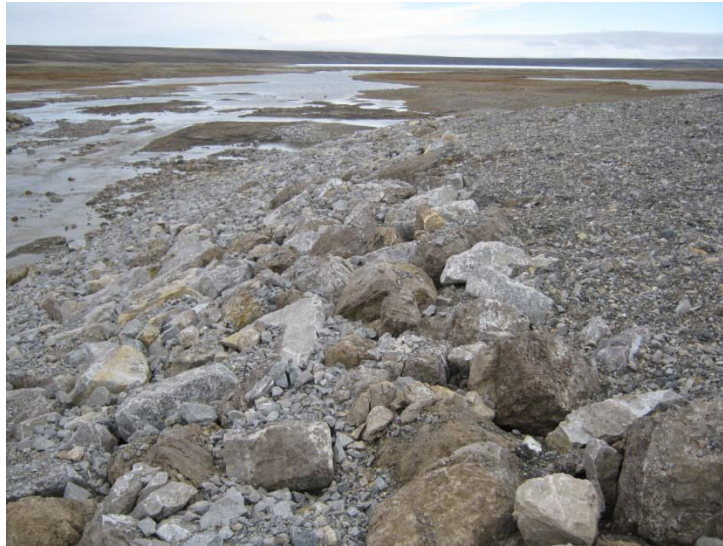
The breached slopes of the decommissioned Garrow Lake Dam appear to be stable after several years of post-closure inspections. The rip-rap on the lower slopes of the dam breach also appear to be stable and have resisted flows experienced in the channel since decommissioning (i.e., post-closure inspections have not observed movement or erosion of the rip-rap).

Photo 11, Garrow Lake Dam, Channel Rip-Rap on East Breach Slope

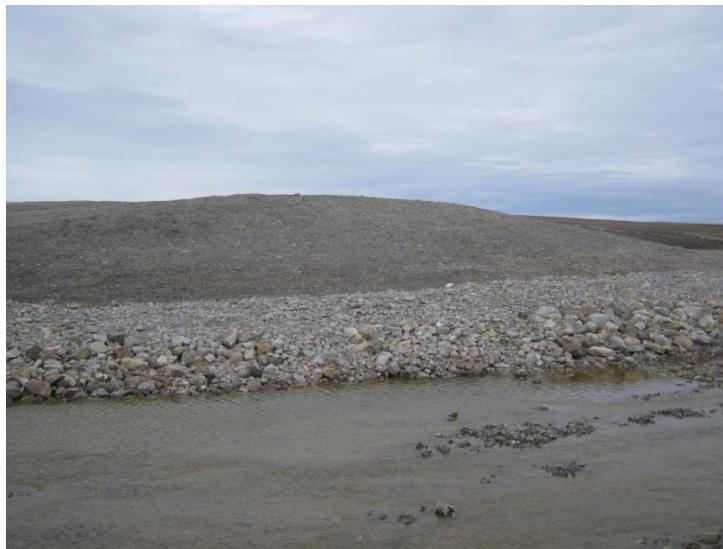
Photo 12, Garrow Lake Dam, West Breach Slope

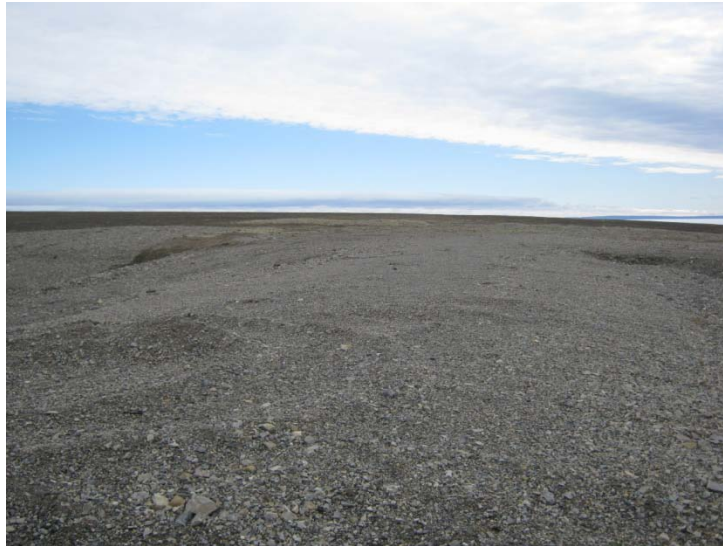
Photo 13, Garrow Lake Dam, East Dam Crest

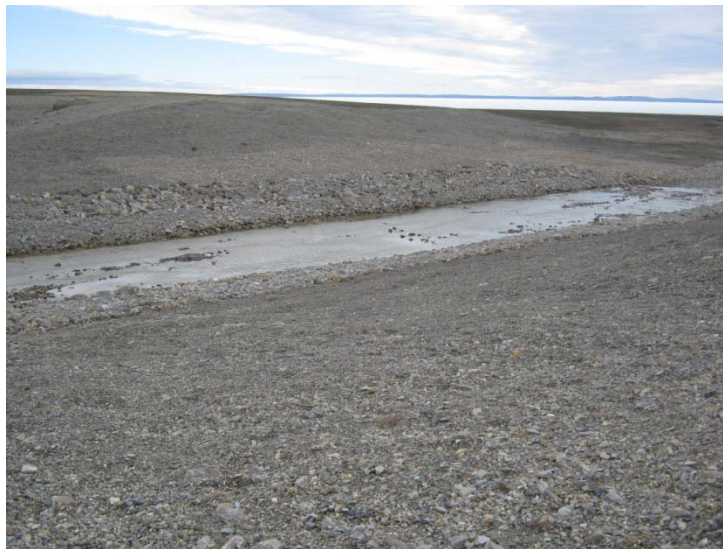
Photo 14, Garrow Lake Dam, Channel and Breach Slopes from West Crest

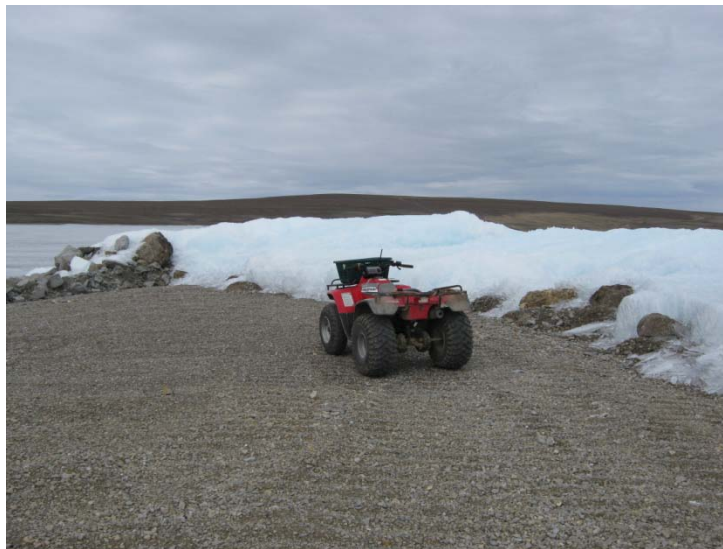
To support mine operations, a rockfill jetty was constructed out into Frustration Lake for the freshwater supply pump station. The pump house and associated water lines were removed during site decommissioning but the jetty remains. Displacement of some jetty rockfill due to ice being pushed up onto the end of the jetty was observed during the July 2010 inspection (Photograph 16). Photographs 17 and 18 document the condition of the jetty crest and edges at the time of the inspection. Lake water around the jetty was observed to be clear during the July 2010 inspection (Photograph 19). Photograph 20 is a view of the jetty from the access road to Frustration Lake. Erosion and displacement of jetty rockfill due to wave and ice action is a natural process and does not appear to be negatively impacting water quality in Frustration Lake.

Photo 16, Frustration Lake, Ice Pushed up onto End of Jetty

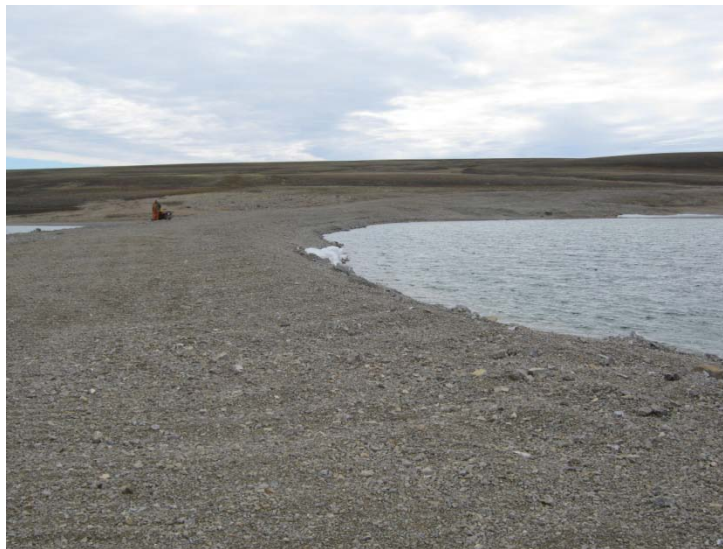
Photo 18, Frustration Lake, Southwest Side of Jetty Facing Shore

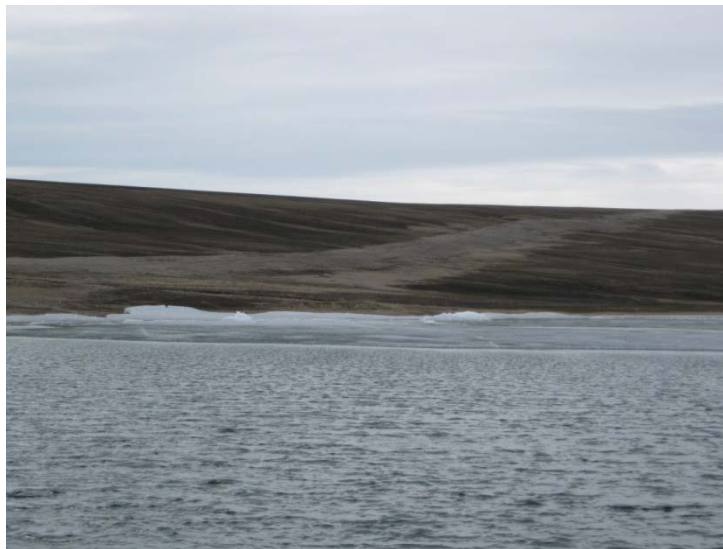
Photo 20, Frustration Lake, Road to Frustration Lake from Jetty

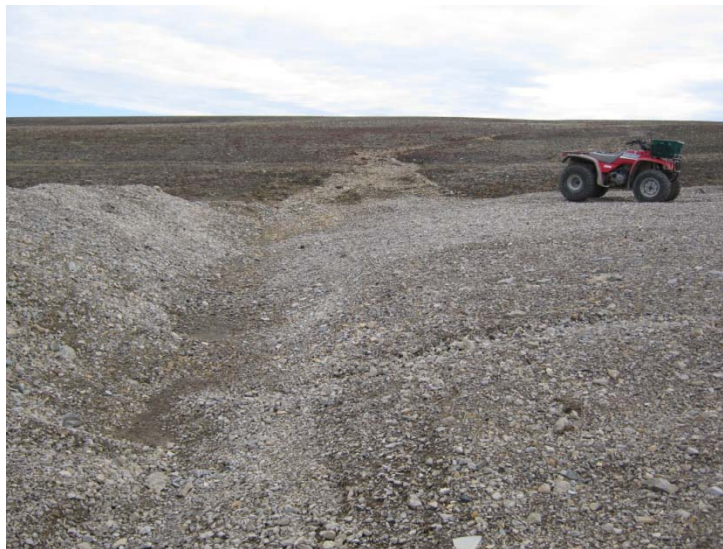
Photograph 21 is a view of the access road down to the jetty at Frustration Lake. The Frustration Lake access road remains in good condition, with some localised erosion at drainage crossings that appear to be self-armouring and stable. Erosion gullies that were repaired in 2006 by regrading slopes, placing gravel/rip-rap and constructing water bars were all observed to be stable during the July 2010 inspection and should not require further attention. Photograph 22 illustrates a typical road drainage crossing that has been resistant to erosion since improvements were made in 2006.

Photo 22, Frustration Lake, Typical Road Drainage Crossing

Repaired drainage crossings and water bars across the Frustration Lake access road have been performing well and should not require any further attention.

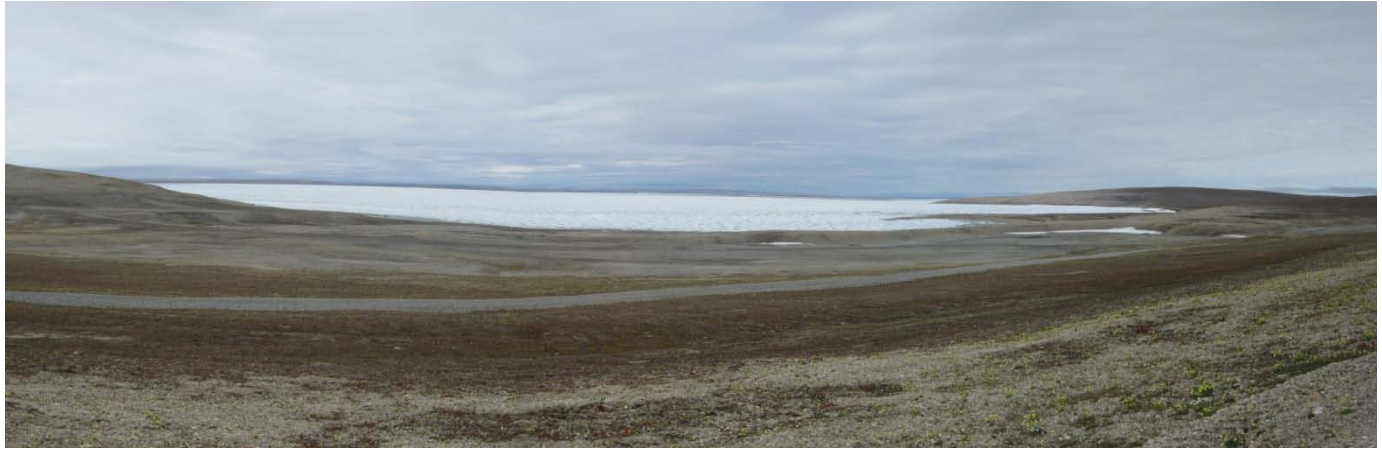
A panoramic view of the New Quarry (Photographs 23, 24 and 25) illustrates the observed condition of the New Quarry area during the July 2010 inspection. Backfilled perimeter sideslopes have not changed significantly from previous post-closure inspections (Photographs 26 through 30). Previously observed settlement and sink holes on backfilled slopes were generally unchanged from previous inspections. Settlement of backfilled slopes is likely the result of buried snow and ice that has melted and is not considered problematic. Photograph 31 illustrates a typical slope tension crack in the New Quarry that may progress into a slump. Photographs 32 and 33 illustrate typical erosion gully development on perimeter sideslopes of the New Quarry. Photograph 34 is a previously observed slump at the south end of the New Quarry (Photograph 56 in 2009 Geotechnical Inspection Report). Minor erosion and slumping of slopes is a normal process in the arctic as slopes reach a state of equilibrium. Minor slumping of the backfilled sideslopes around the perimeter of the New Quarry is not considered problematic and does not pose a safety hazard to humans or wildlife.

Photo 23,24,25 (Panoramic), New Quarry, View from Road Above Facing West

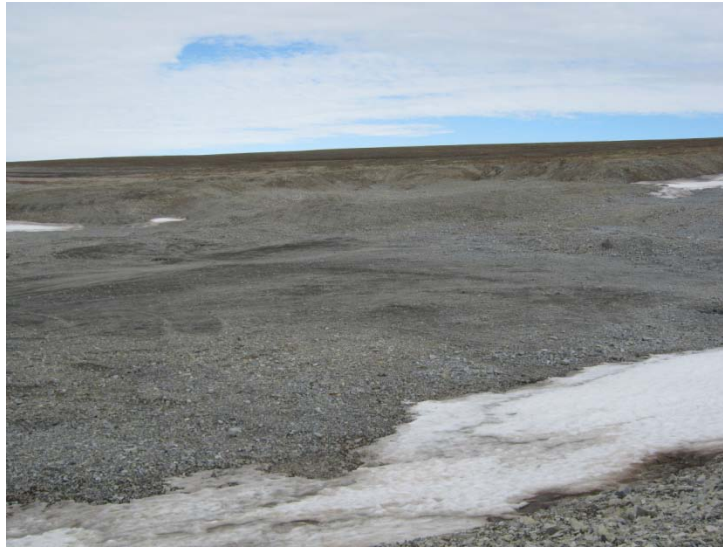
Photo 27, New Quarry, North Sideslopes Facing Northwest

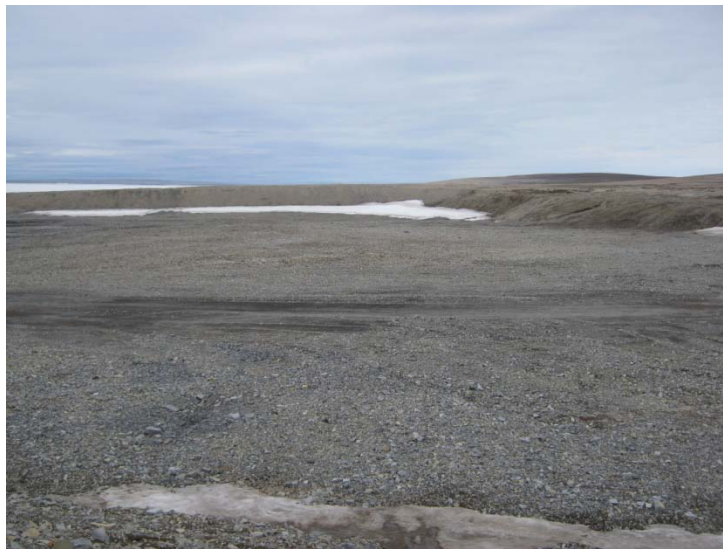
Photo 28, New Quarry, West Sideslopes Facing West

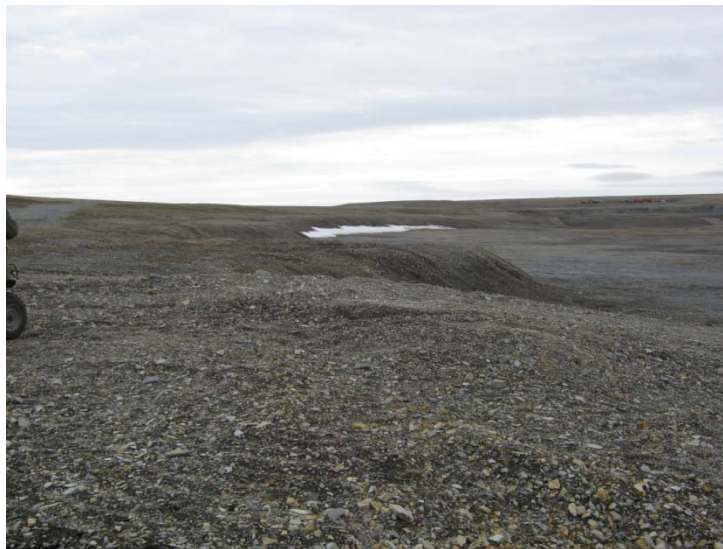
Photo 30, New Quarry, East Sideslopes Facing South

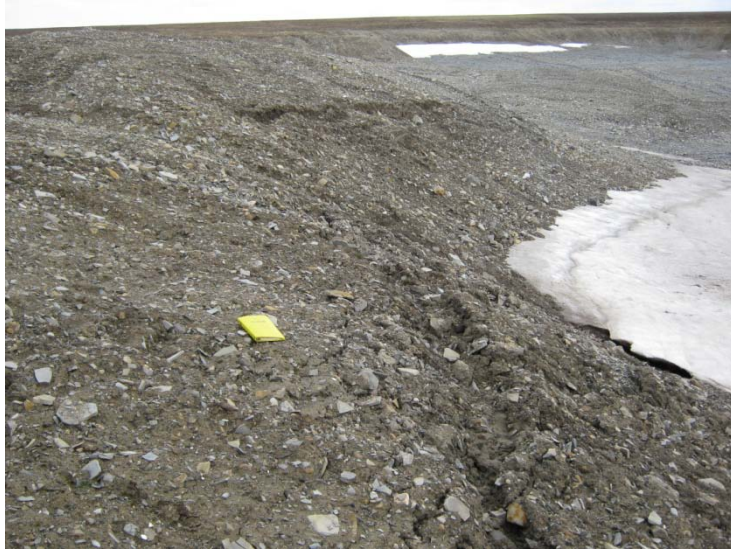
| Location # | Area | Description | Photograph # | Northing (m) | Easting (m) | Elevation (m) |
|---|---|---|---|---|---|---|
| 12 | New Quarry | Minor Tension Cracks | 31 | 8,369,422 | 559,130 | 15 |

Photo 31, New Quarry, Minor Tension Cracks on North Slope

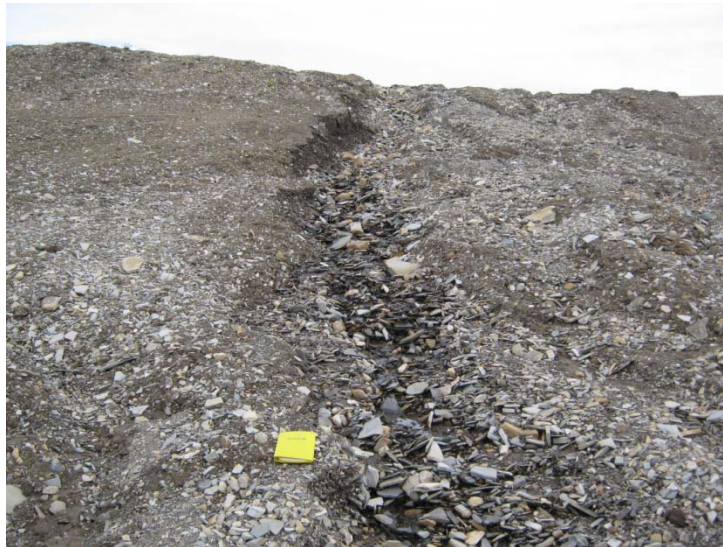
Photo 32, New Quarry, Minor Erosion Gully on North Slope

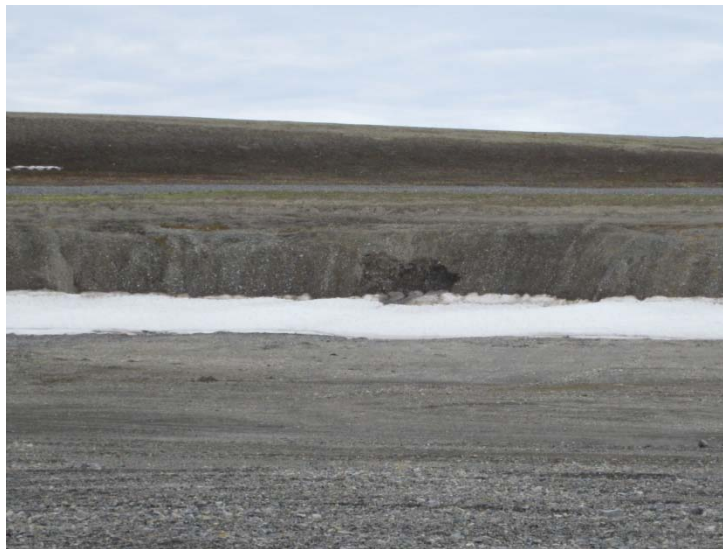
Photo 34, New Quarry, Minor Slump Beneath Snow on East Slope

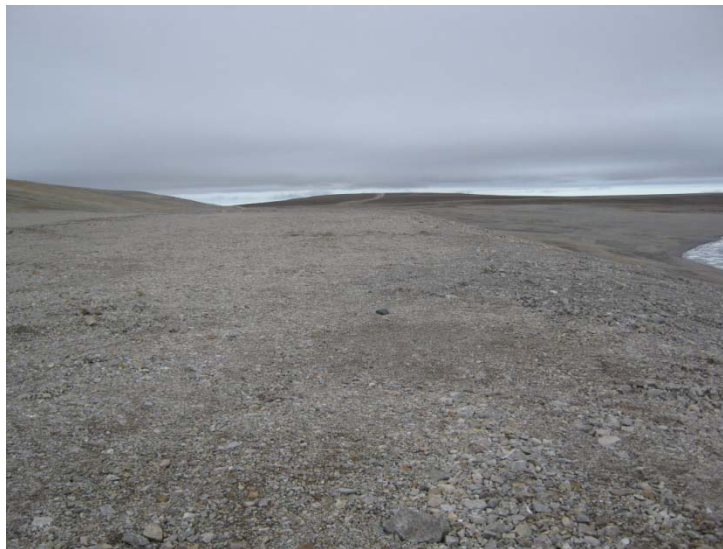
No indications of slope instability or exposed waste were observed at the Operational Landfill during the July 2010 inspection. No tension cracks or settlement depressions were observed on the landfill crest (Photographs 36 through 41). No indications of erosion or slope instability were observed on the landfill slopes from the toe of the landfill (Photographs 42 through 49). No significant seepage was observed from the toe of the Operational Landfill during the July 2010 inspection.

Photo 36, Operational Landfill, South Crest Facing North

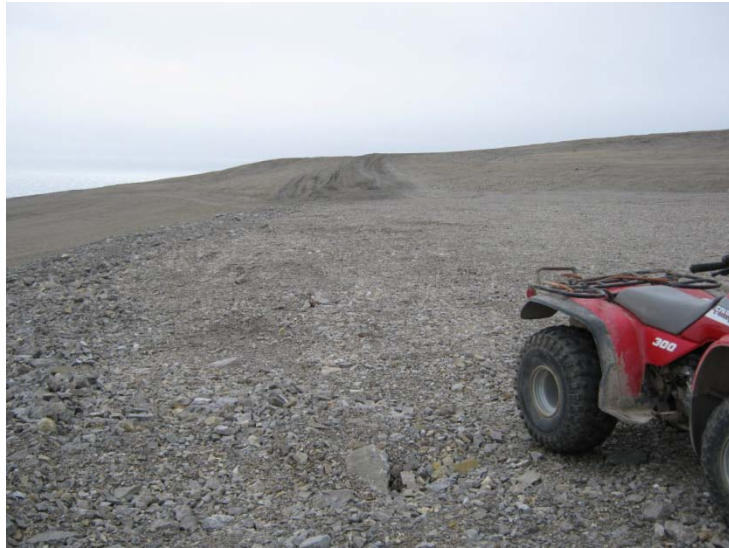
Photo 37, Operational Landfill, South Crest Facing South

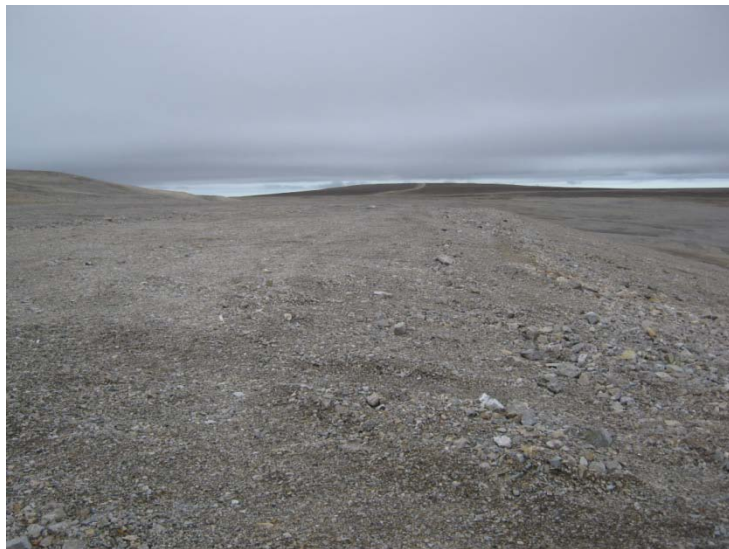
Photo 38, Operational Landfill, Central Crest Facing North

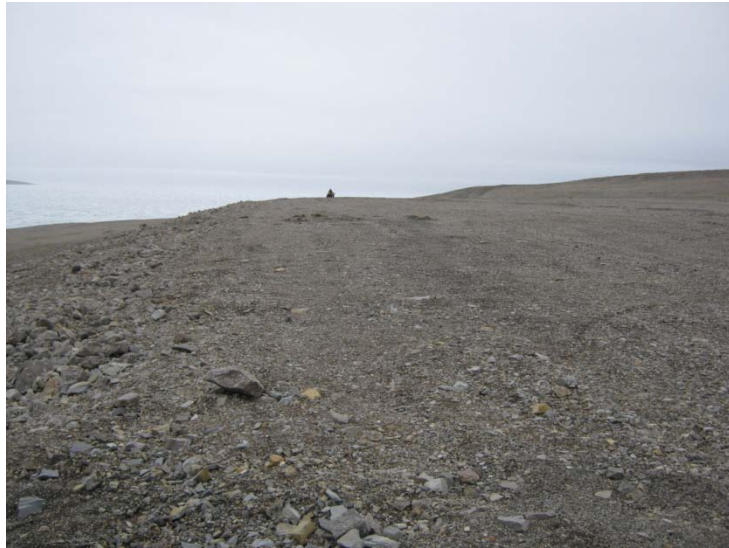
Photo 39, Operational Landfill, Central Crest Facing South

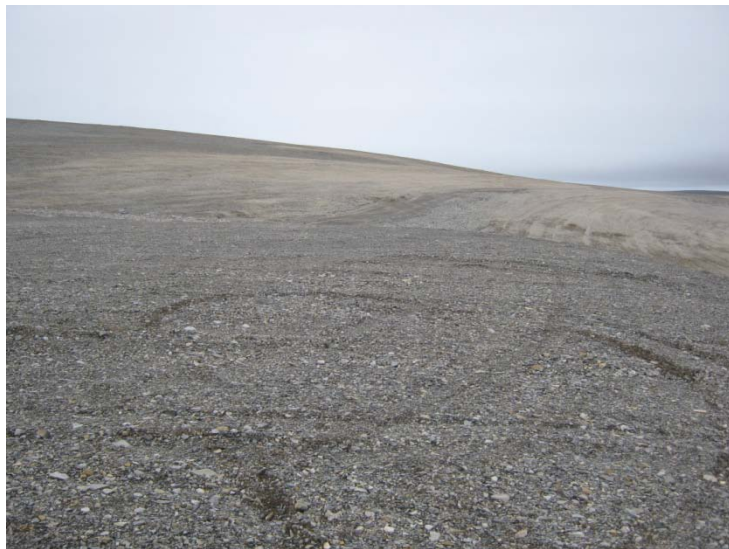
Photo 40, Operational Landfill, North Crest Facing North

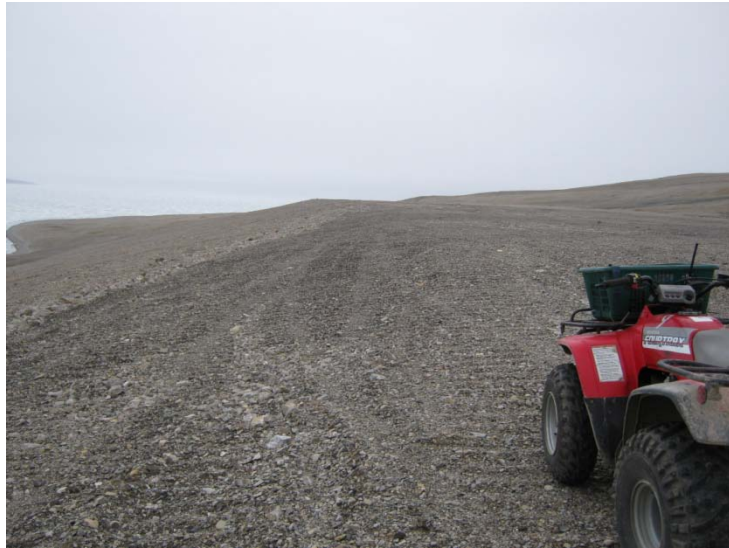
Photo 41, Operational Landfill, North Crest Facing South

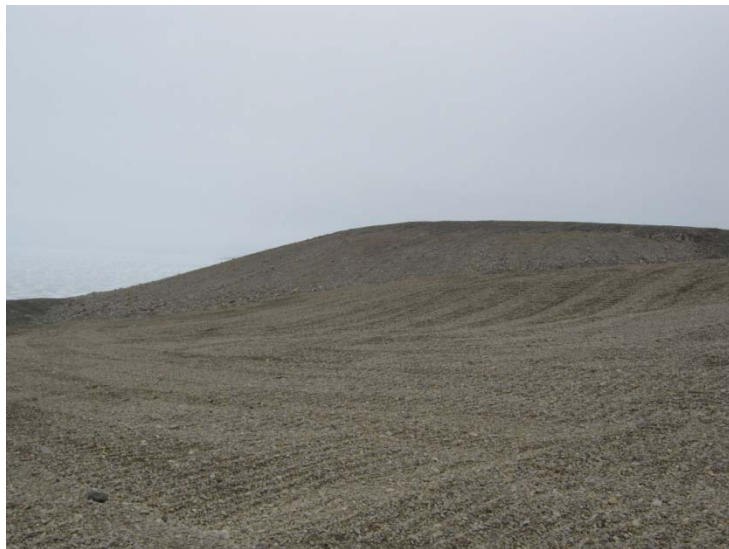
Photo 42, Operational Landfill, North Slope Facing South

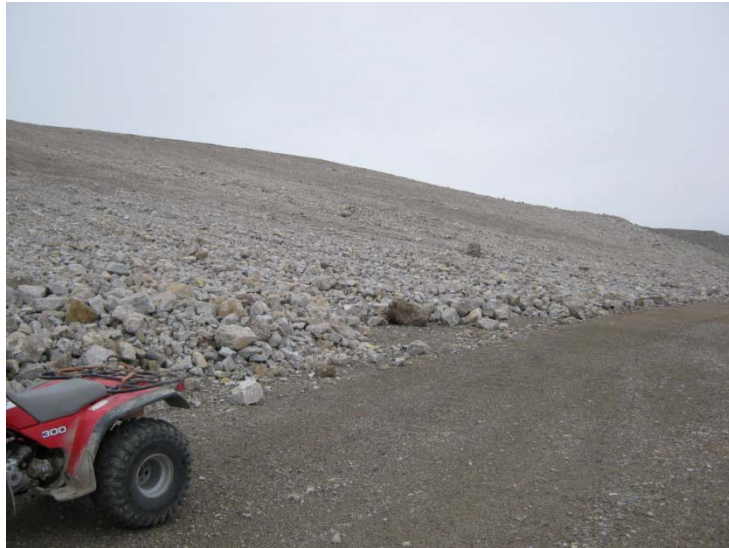
Photo 43, Operational Landfill, North End of East Toe Facing North

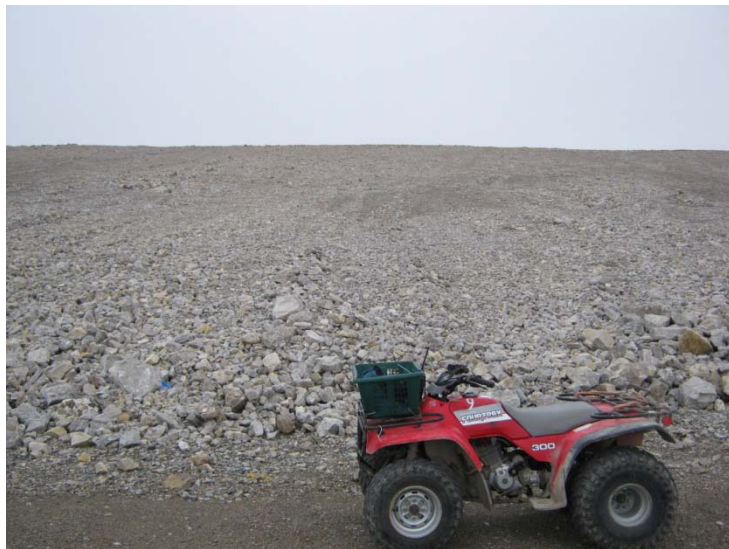
Photo 44, Operational Landfill, North End of East Toe Facing West

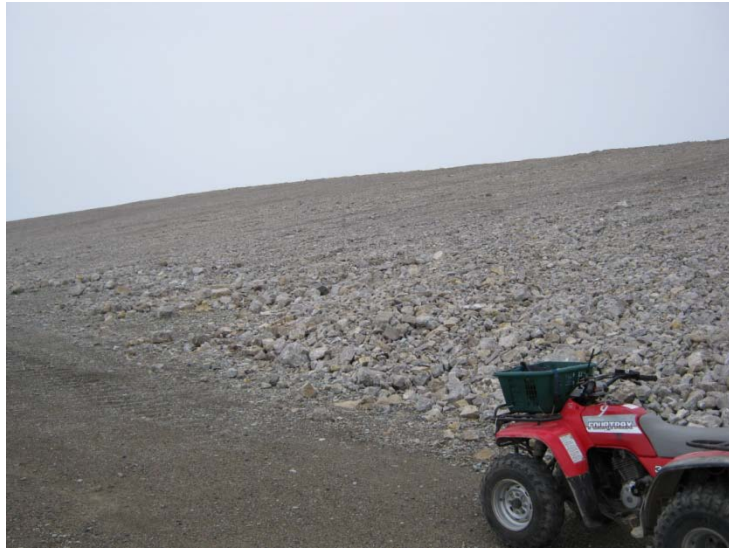
Photo 45, Operational Landfill, North End of East Toe Facing South

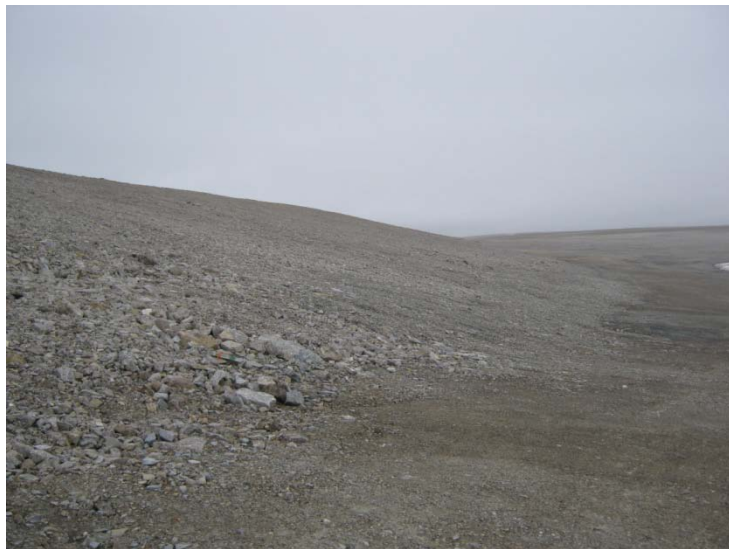
Photo 46, Operational Landfill, South End of East Toe Facing North

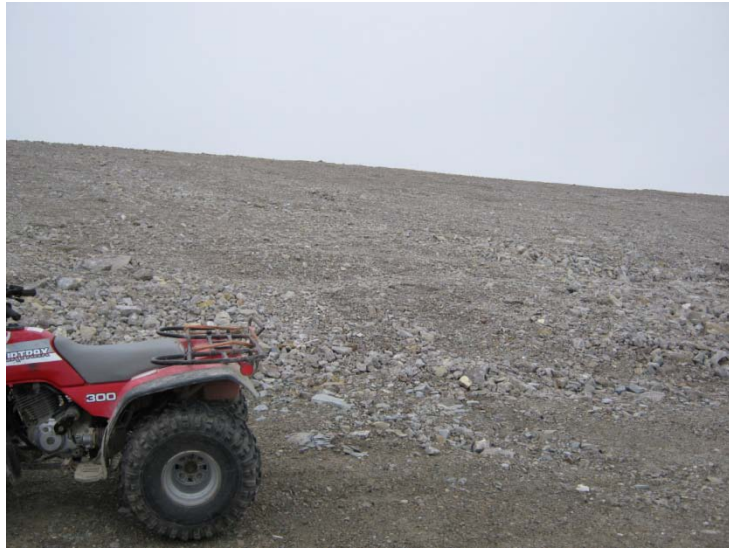
Photo 47, Operational Landfill, South End of East Toe Facing West

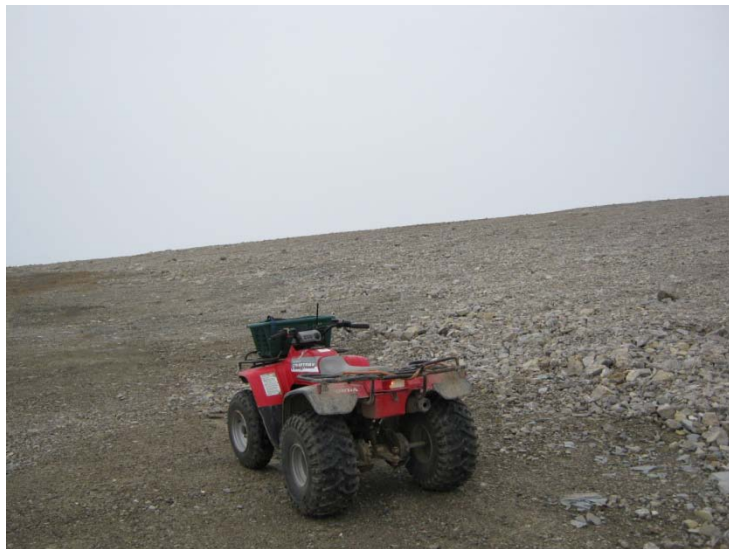
Photo 48, Operational Landfill, South End of East Toe Facing South

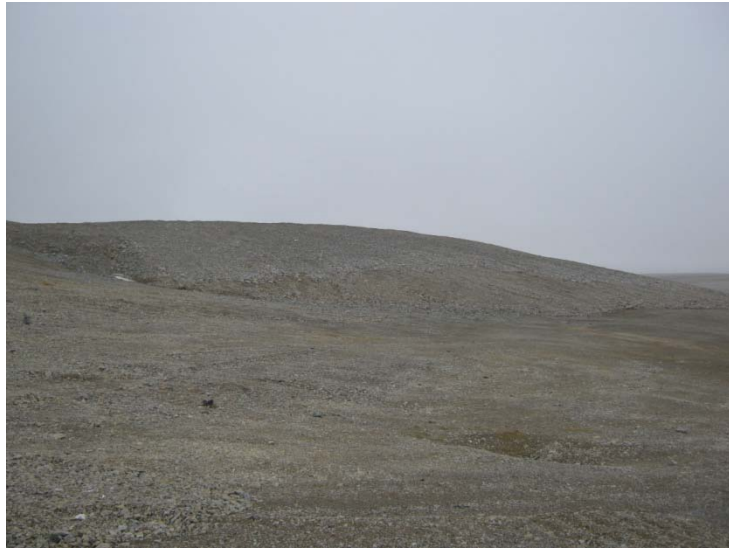
Photo 49, Operational Landfill, South Slope Facing North

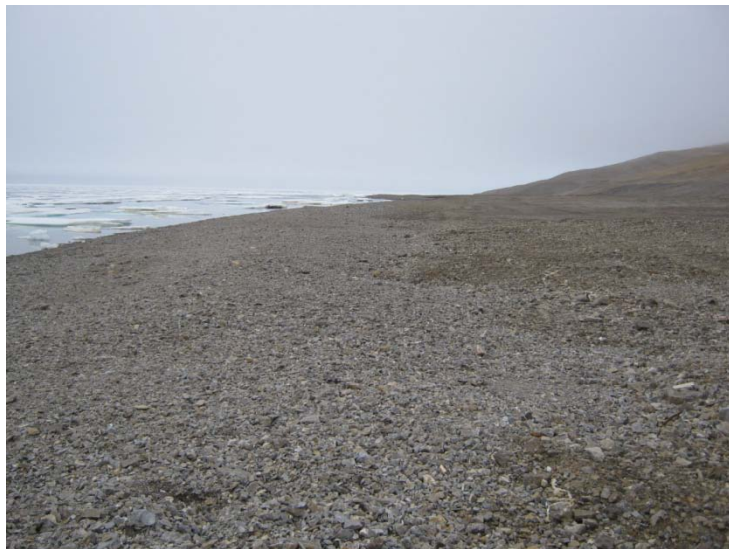
The shoreline and slopes adjacent to the former dock structure were observed to be stable with no significant erosion during the July 2010 geotechnical inspection. Photographs 50 through 53 document the condition of the south end of the foreshore area during the July 2010 inspection. Thaw settlement and the formation of gravel bars in response to ocean wave and ice action has been observed along the shoreline. Photographs 54 and 58 document the current size of two thaw settlement areas at the central and north ends of the foreshore area, respectively. Photographs 55 through 60 document the condition of the north end of the foreshore area during the July 2010 inspection. Photographs 65 and 66 are an elevated view of the north end of the foreshore area from the exploration portal. No active erosion features discharging sediment were observed in the foreshore area during the July 2010 inspection. The water adjacent to the shoreline has been clear during the current and previous geotechnical inspections indicating that discharge of sediment from the reclaimed foreshore area to the ocean does not appear to be a concern. Overall the foreshore area appears to be stable and is not expected to require further attention.

Photo 50, Foreshore, South End Facing North Along Shoreline

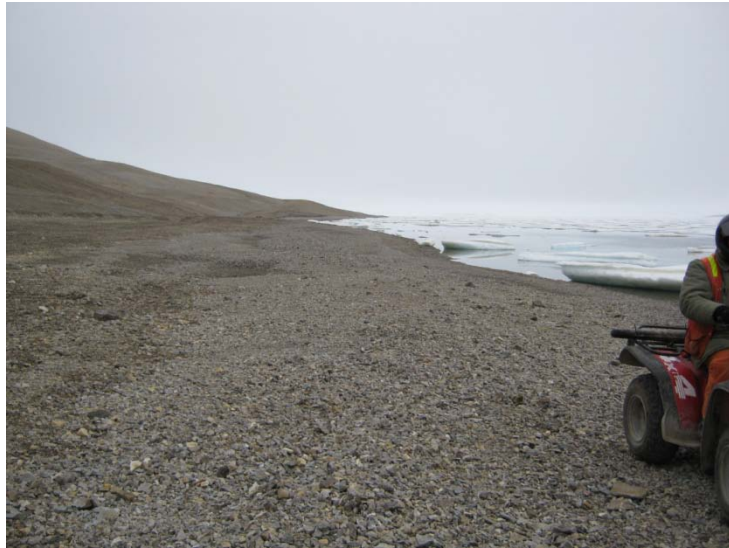
Photo 51, Foreshore, South End Facing South Along Shoreline

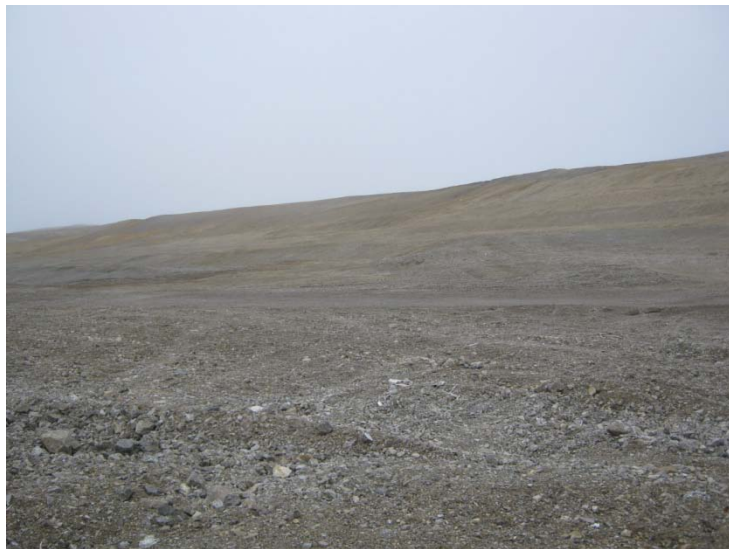
Photo 52, Foreshore, South End Facing Upslope to Northeast

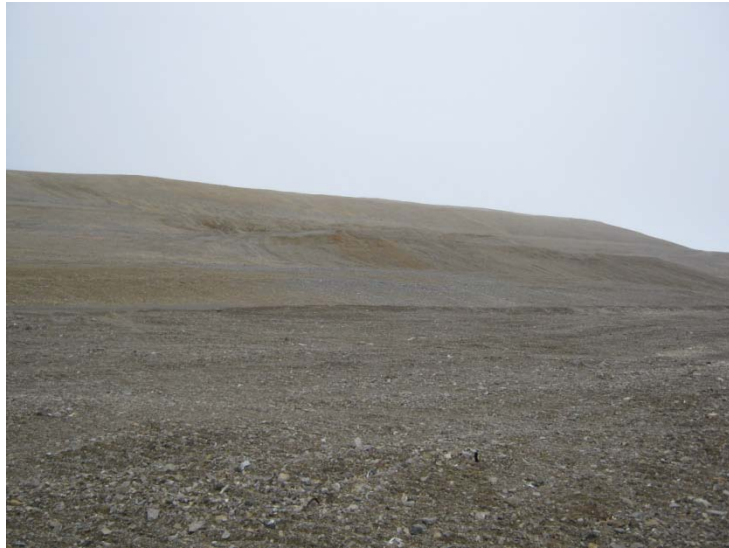
Photo 53, Foreshore, South End Facing Upslope to Southeast

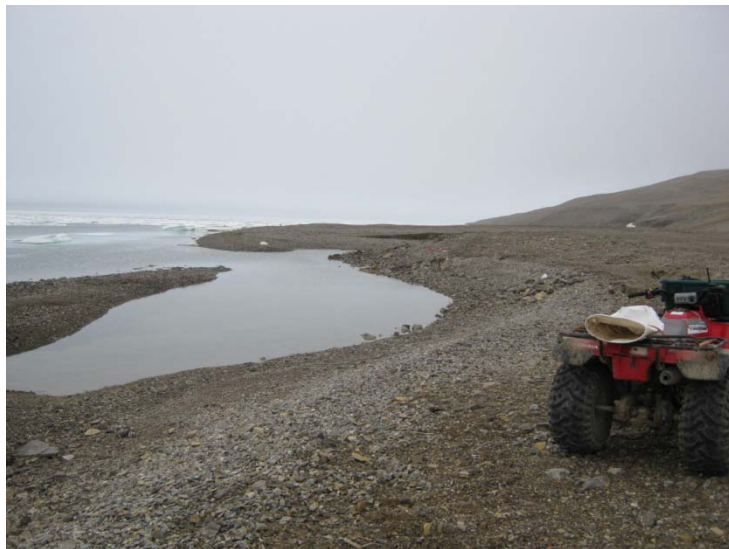
Previously observed gravel bar formation and thaw settlement along the former dock area shoreline appears to be an ongoing response to natural processes including ocean wave and ice action. The water adjacent to the shoreline has been very clear during post-closure geotechnical inspections indicating that the decommissioned foreshore area is not actively discharging sediment to the ocean. Overall the foreshore area appears to be stable and should not require further attention.

Photo 54, Foreshore, Central Thaw Settlement Area

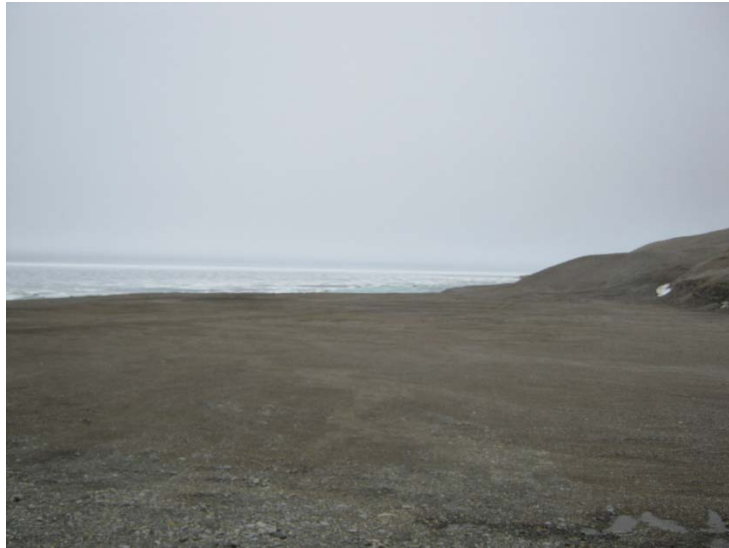
Photo 55, Foreshore, Elevated Pad at North End Facing North

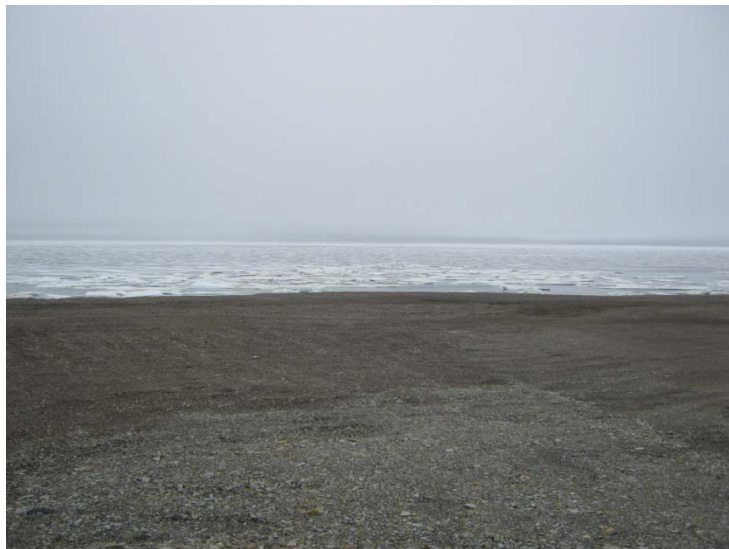
Photo 56, Foreshore, Elevated Pad at North End Facing West

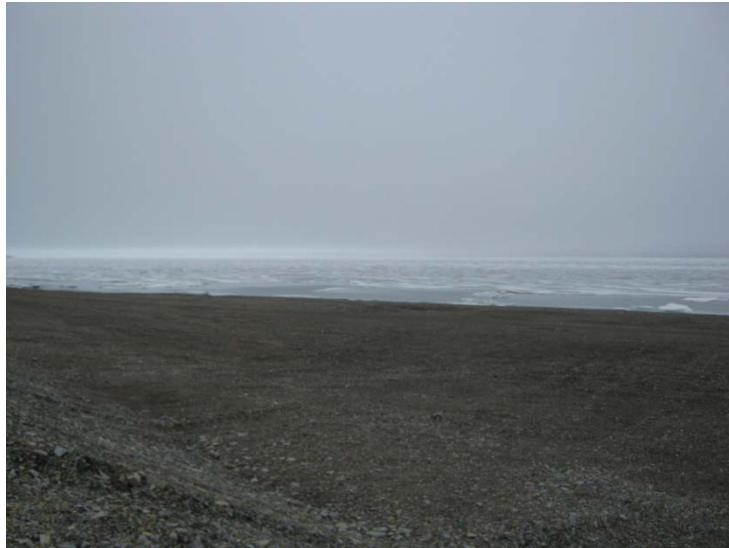
Photo 57, Foreshore, Elevated Pad at North End Facing South

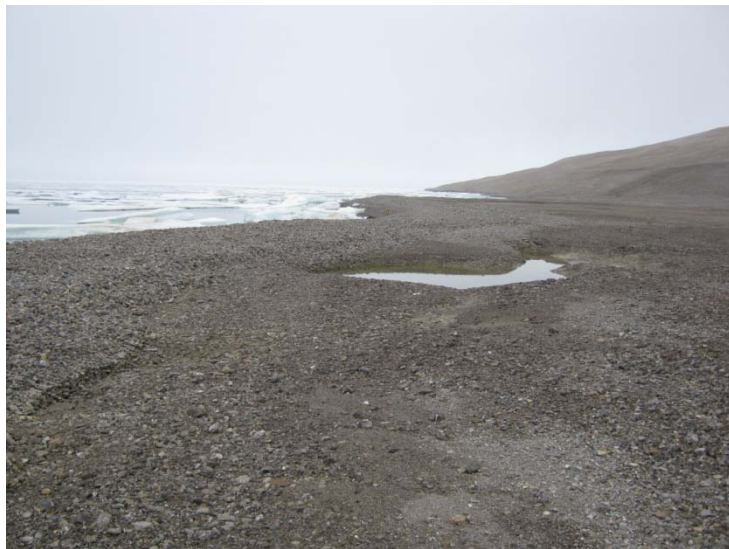
Photo 58, Foreshore, North End Facing North Along Shoreline

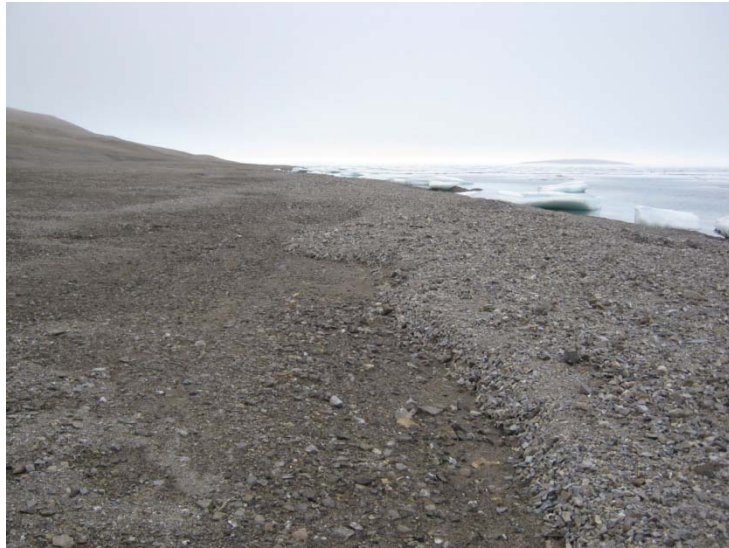
Photo 59, Foreshore, North End Facing South Along Shoreline

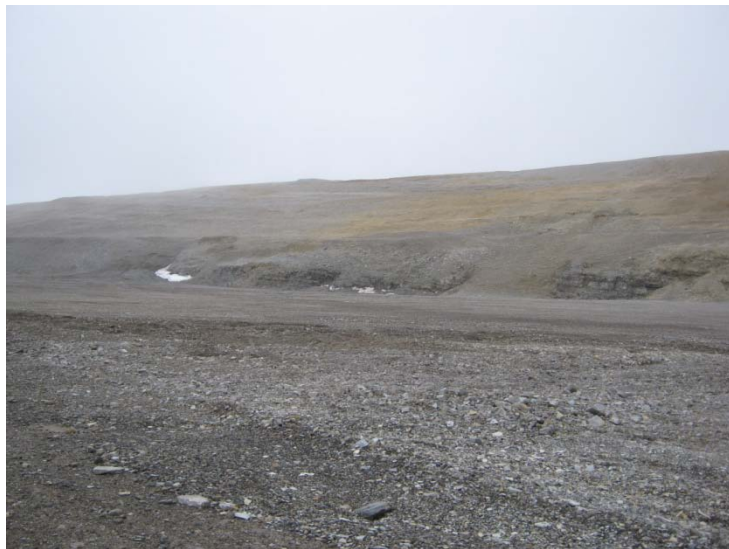
Photo 60, Foreshore, North End Facing East Towards Conveyor Portal

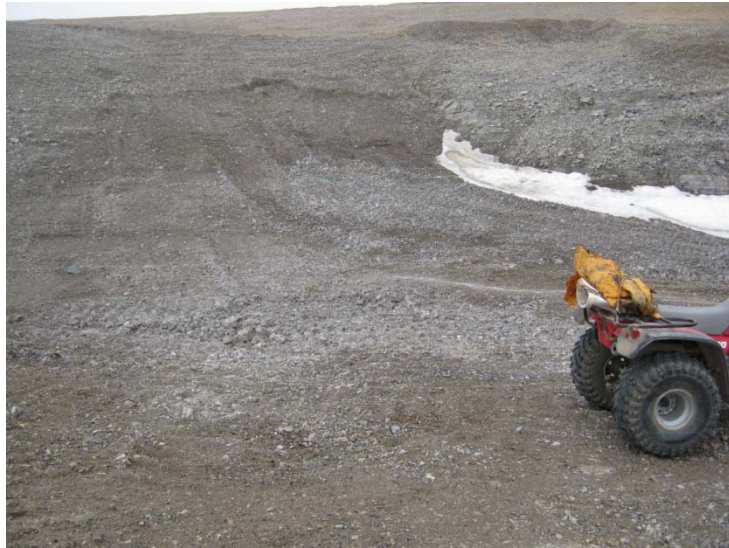
All four portals were observed to be in good condition and free of any signs of instability or erosion during the July 2010 inspection (Photographs 61, 62, 63, 64, and 72). The slope in front of the main portal that was regraded and flattened in 2009 to repair a slope failure was observed to be in good condition (i.e., as repaired in 2009).

Photo 61, Mine Portals, Main Portal Facing East Towards Repaired Slope

All four portals were observed to be in good condition and free of any signs of instability or erosion during the July 2010 inspection. A slope failure at the main portal that was first observed in August 2008 was repaired in July 2009 by pushing rockfill from the surrounding foreshore area up against the main portal slope with a bull dozer. The repaired slope at the main portal was observed to be in good condition during the July 2010 inspection (i.e., as repaired in 2009). The lower half of the main portal slope that was repaired in 2009 is flatter than the upper slope so there may be some future unravelling of the steeper slope above the main portal (i.e., above the repaired area). However, the flatter lower half of the slope should resist large scale slope failures in front of the sealed main portal. Minor slumping of backfilled slopes in front of the sealed mine portals will not expose the mine seals or allow access into the underground mine workings.

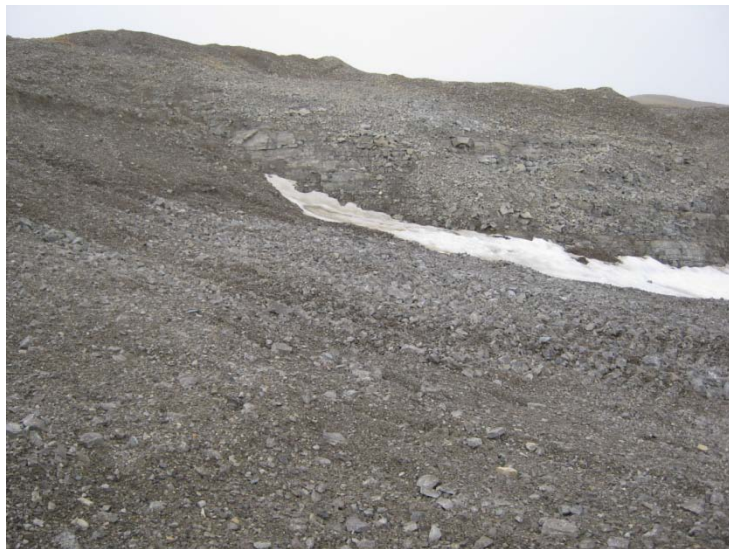
Photo 62, Mine Portals, Main Portal Facing Southeast Across Repaired Slope
