# Polaris 2010 Geotechnical Inspection

## FORMER POLARIS MINE, NUNAVUT

**Submitted to:**  
Teck Resources Ltd.

**Report Number:** 10-1118-0019

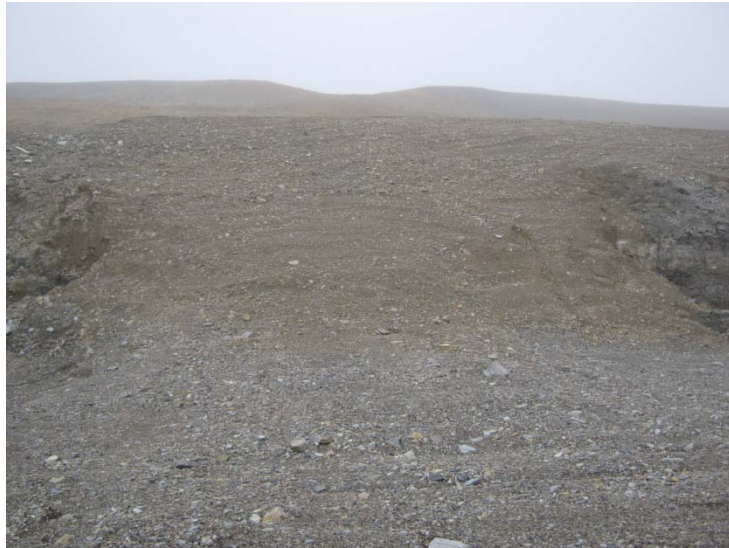
Photo 63, Mine Portals, Conveyor Portal

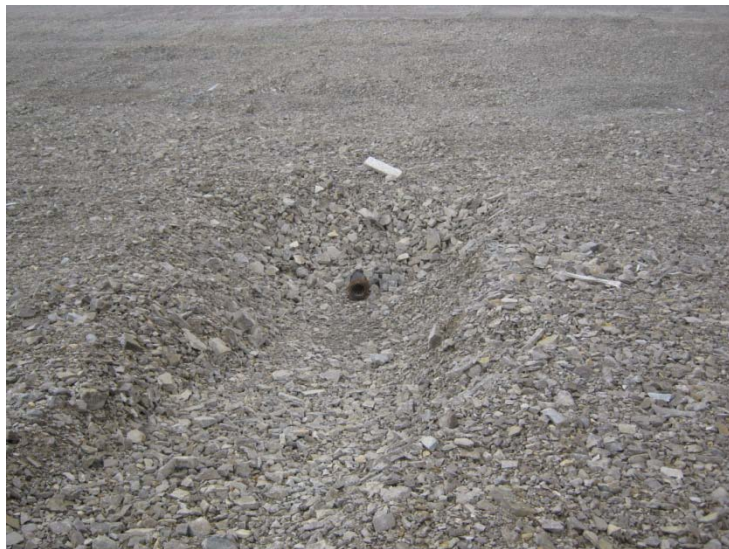
Photo 64, Mine Portals, Exploration Portal

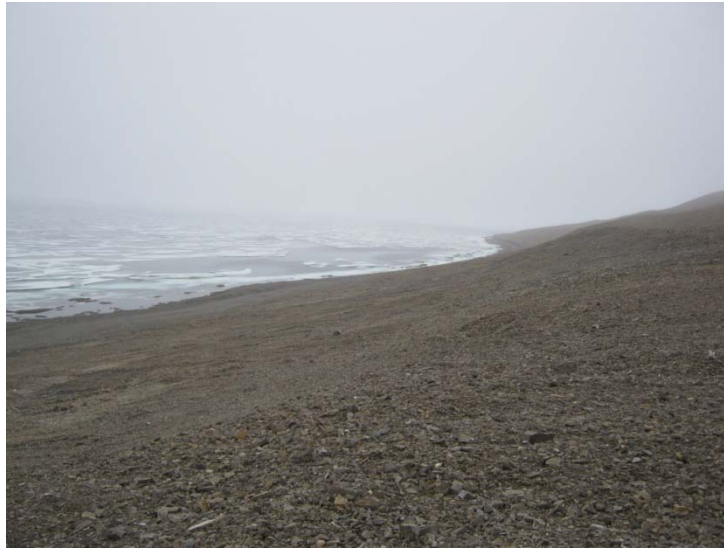
Photo 65, Foreshore, Facing Northwest from Exploration Portal

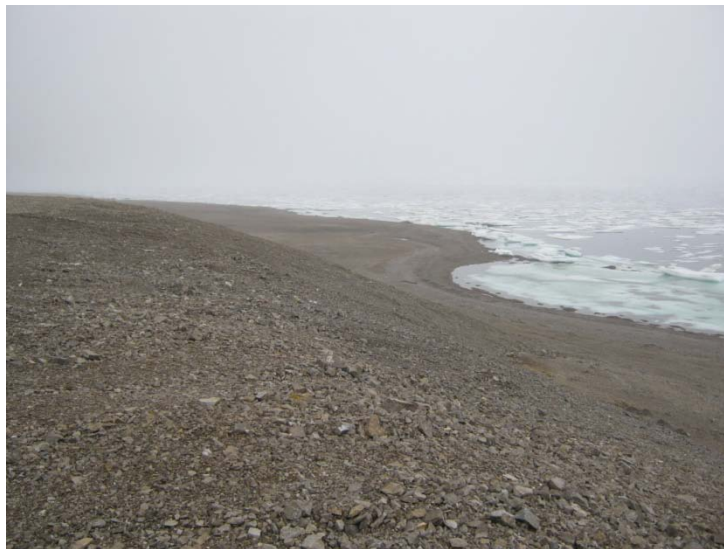
Photo 66, Foreshore, Facing Southwest from Exploration Portal

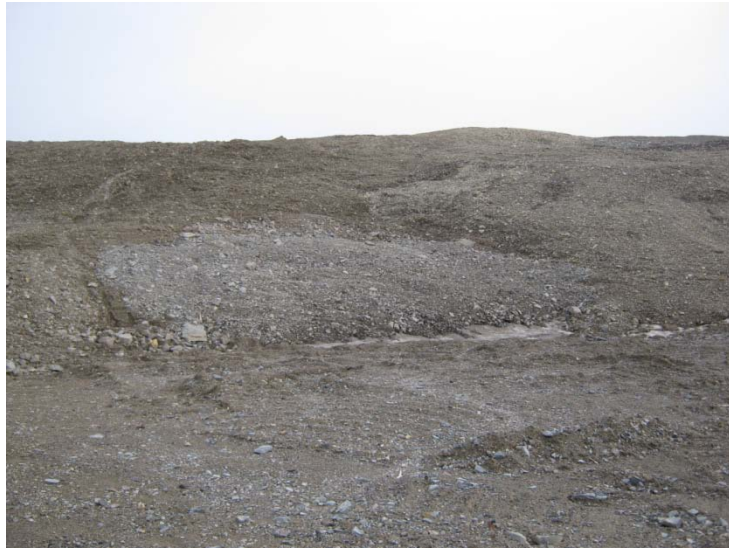
Photo 72, Mine Portals, North Portal

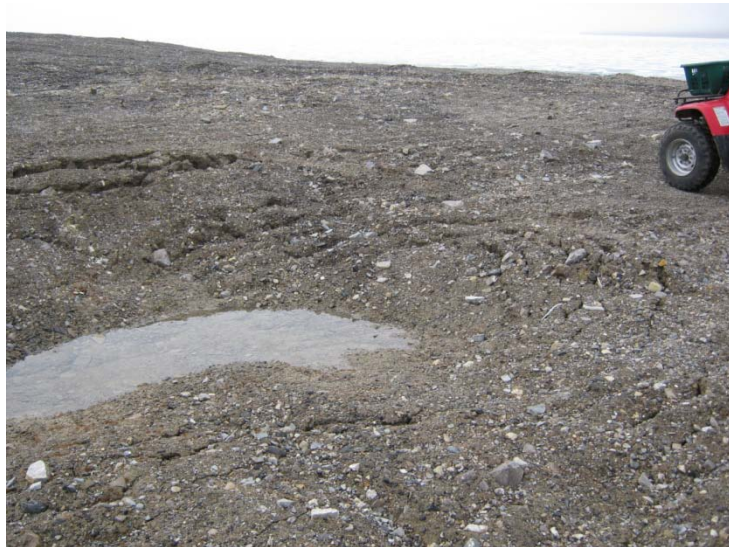
There were no apparent visual changes to the mine subsidence area observed during the July 2010 geotechnical inspection. Photograph 67 is a previously observed small thaw settlement area about 10 m by 10 m. Photographs 68 and 69 are views of ponded surface water on the backfilled subsidence area from the east and north, respectively. Previously observed tension cracks around the perimeter of the subsidence area were up to 0.3 m wide and appear unchanged from previous inspections (Photographs 70 and 71). No features were observed in the subsidence area during the July 2010 inspection that present a risk to either humans or wildlife.

Photo 67, Subsidence Area, Small Thaw Settlement Area (~10m x 10m)

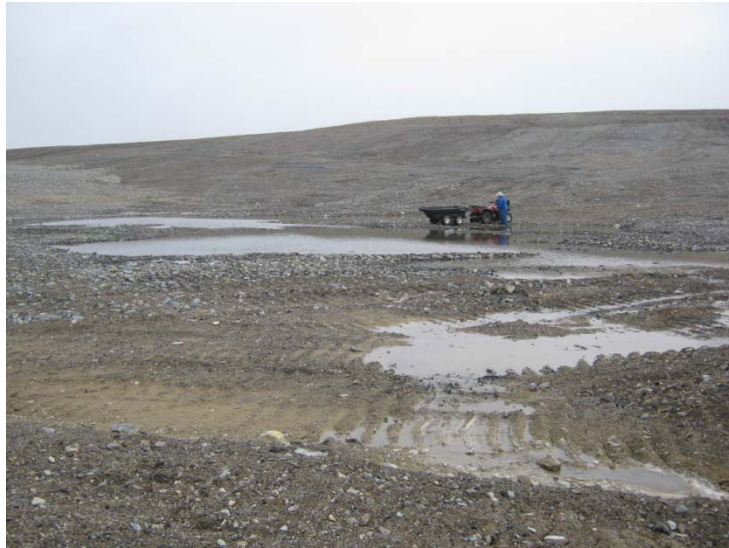
Photo 68, Subsidence Area, Ponded Water and Regraded Area Facing West

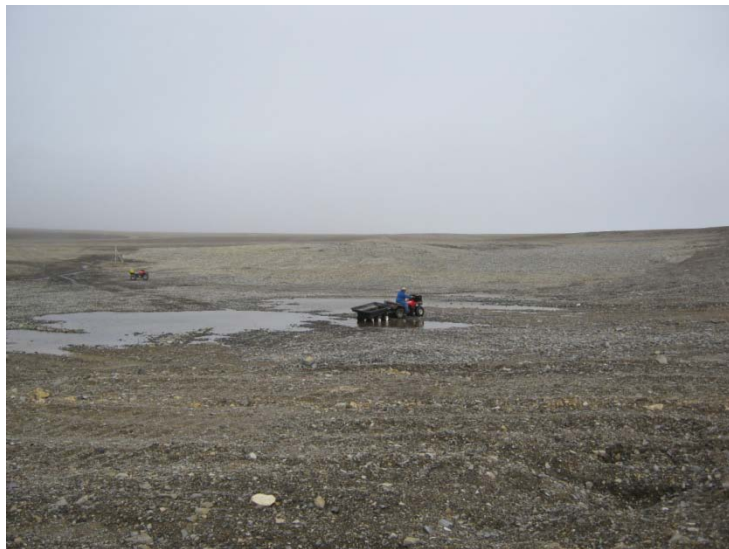
| Location # | Area | Description | Photograph # | Northing (m) | Easting (m) | Elevation (m) |
|---|---|---|---|---|---|---|
| 32 | Subsidence Area | Ponded Water and Cracks | 69,70 | 8,368,989 | 558,501 | 17 |

Photo 69, Subsidence Area, Ponded Water and Regraded Area Facing South

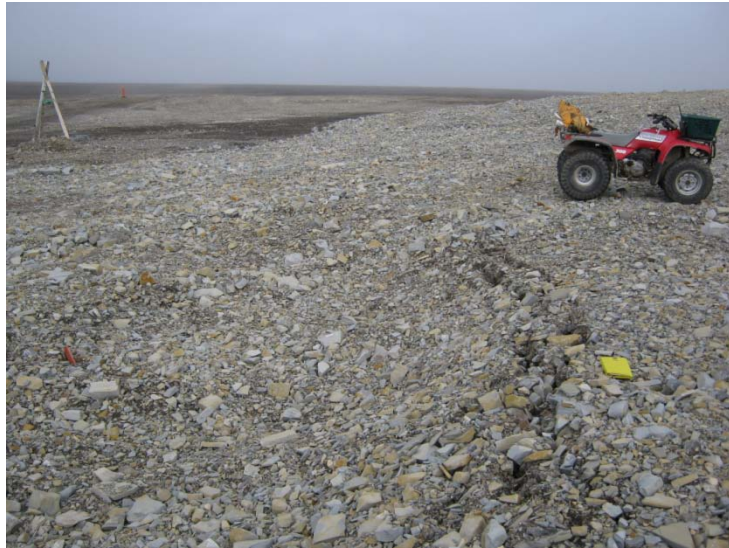
Photo 70, Subsidence Area, Previously Observed Tension Cracks (0.3 m max. width)

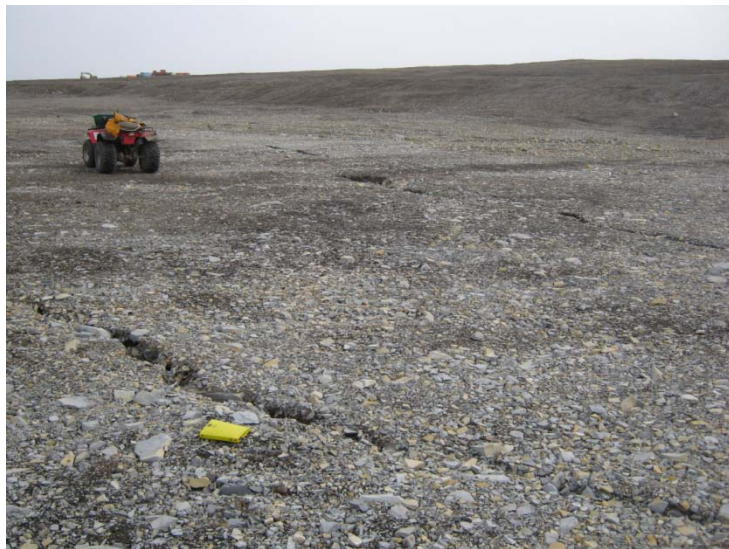
| Location # | Area | Description | Photograph # | Northing (m) | Easting (m) | Elevation (m) |
|---|---|---|---|---|---|---|
| 33 | Subsidence Area | Tension Cracks | 71 | 8,368,945 | 558,547 | 20 |

Photo 71, Subsidence Area, Previously Observed Tension Cracks (0.3 m max. width)

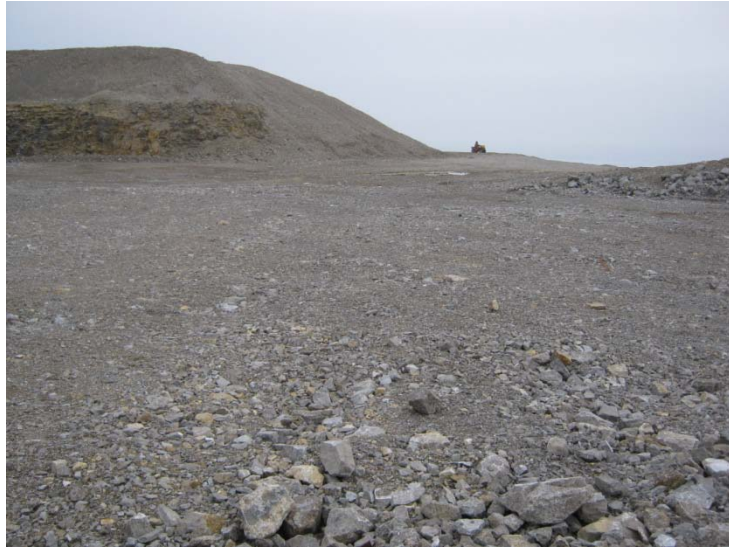
No protruding waste, tension cracks or settlement depressions were observed on the Little Red Dog Quarry Landfill cover during the July 2010 inspection. Photographs 73 through 78 document the condition of the Little Red Dog Quarry Landfill cover during the July 2010 inspection.

Photo 73, Little Red Dog Quarry, North End Facing Entrance

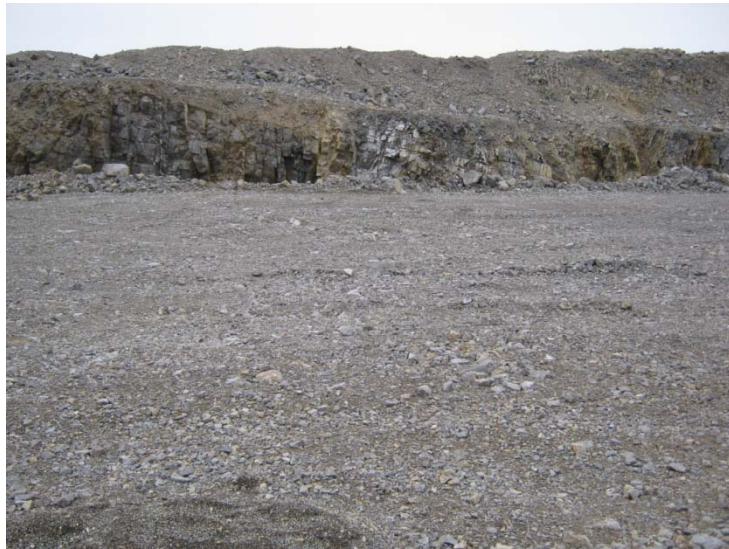
Photo 74, Little Red Dog Quarry, North End Facing North Wall

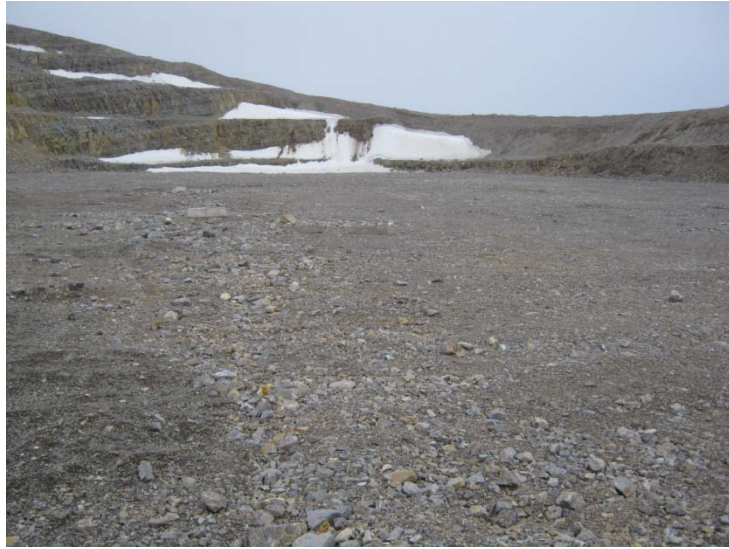
Photo 75, Little Red Dog Quarry, North End Facing Centre

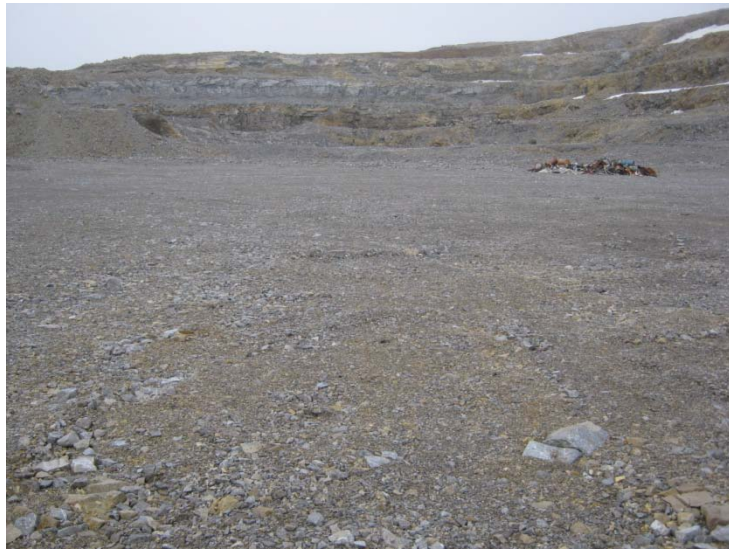
Photo 76, Little Red Dog Quarry, North End Facing East

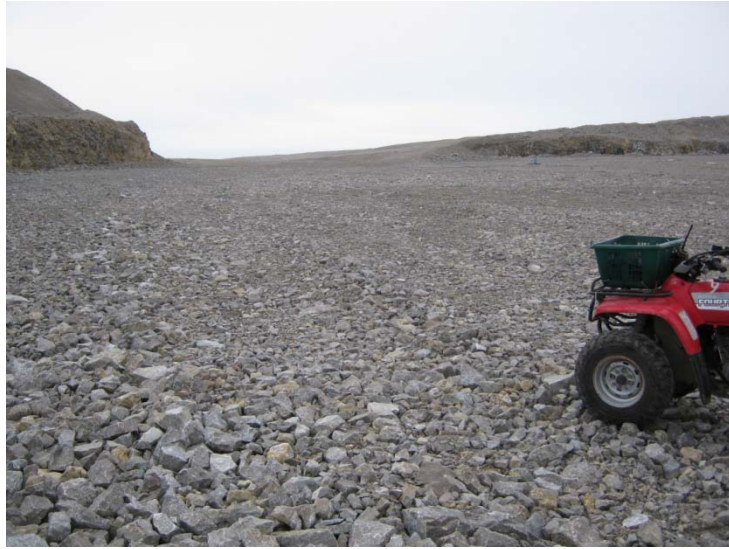
Photo 77, Little Red Dog Quarry, South End Facing Entrance

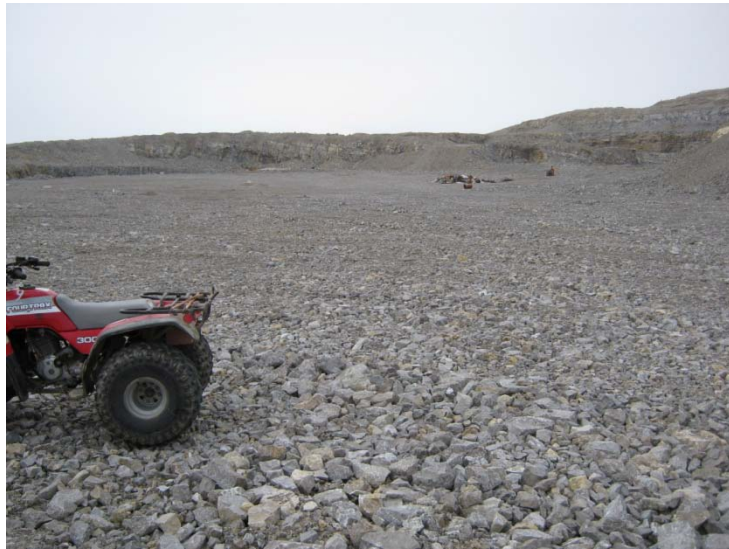
Photo 78, Little Red Dog Quarry, South End Facing East

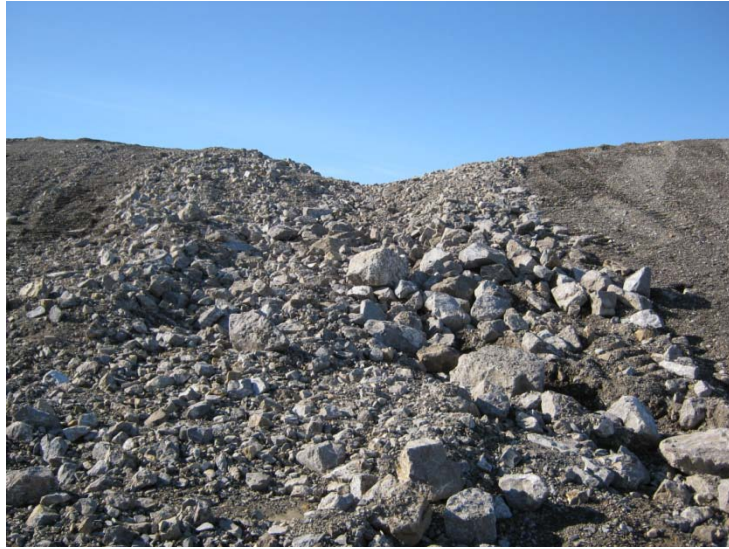
Access road ditches that convey drainage from Loon Lake and the temporary camp area to the southwest corner of the New Quarry were stabilized in 2006 by regrading and rip-rap placement. The rip-rap lined drainage ditches and slopes have been performing well and should not require further attention (Photographs 79 through 82).

Photo 79, Drainage Ditches, Rip-Rap Lined Slope Below Drainage Ditch

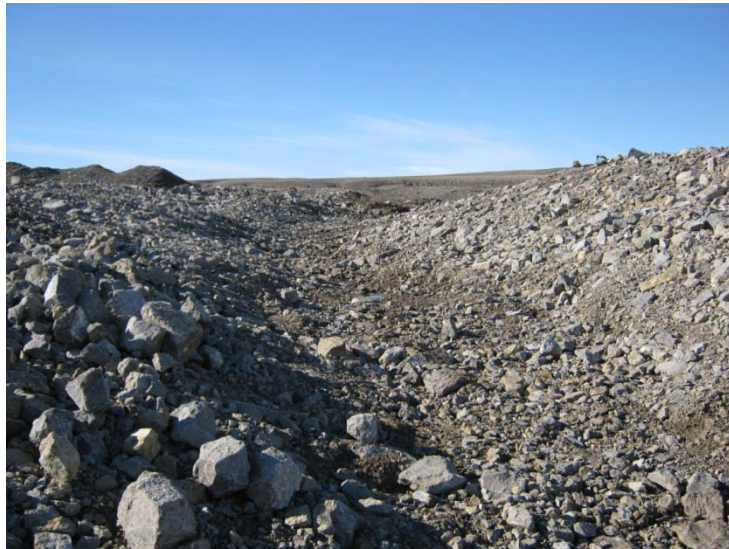
Photo 80, Drainage Ditches, Rip-Rap Lined Ditch Across Road Near Camp

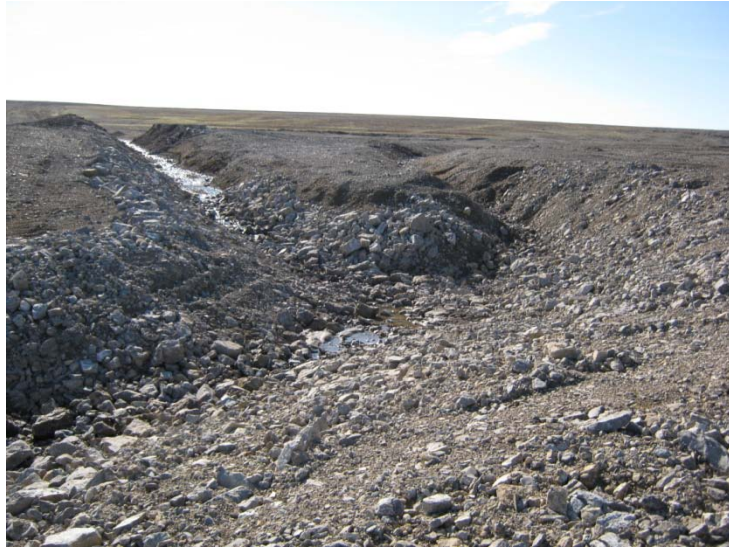
Photo 81, Drainage Ditches, Rip-Rap Lined Slope Below Drainage Ditch

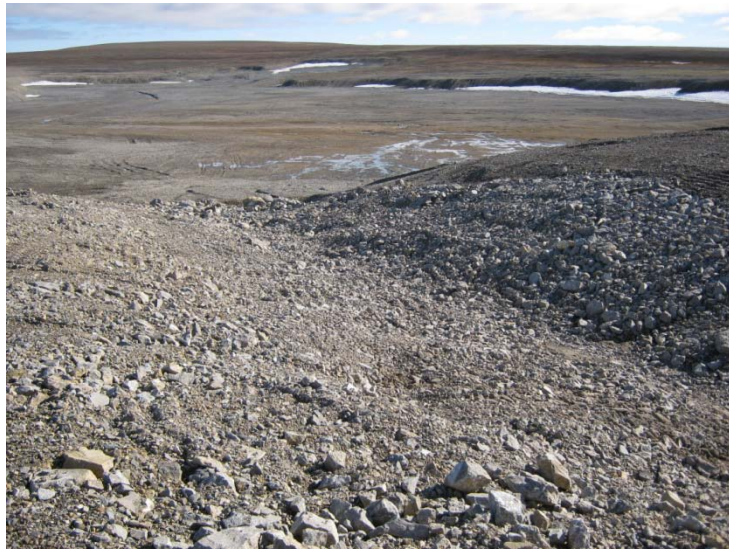
Photo 82, Drainage Ditches, Rip-Rap Lined Ditch Across Road Near Camp
