**POLARIS MINE CLOSURE AND RECLAMATION
PROJECT**

**JUNE 20 TO JUNE 22, 2004, INSPECTION TRIP
REPORT**

PROJECT NO.: 0131-013-01
DATE: JULY 21, 2004

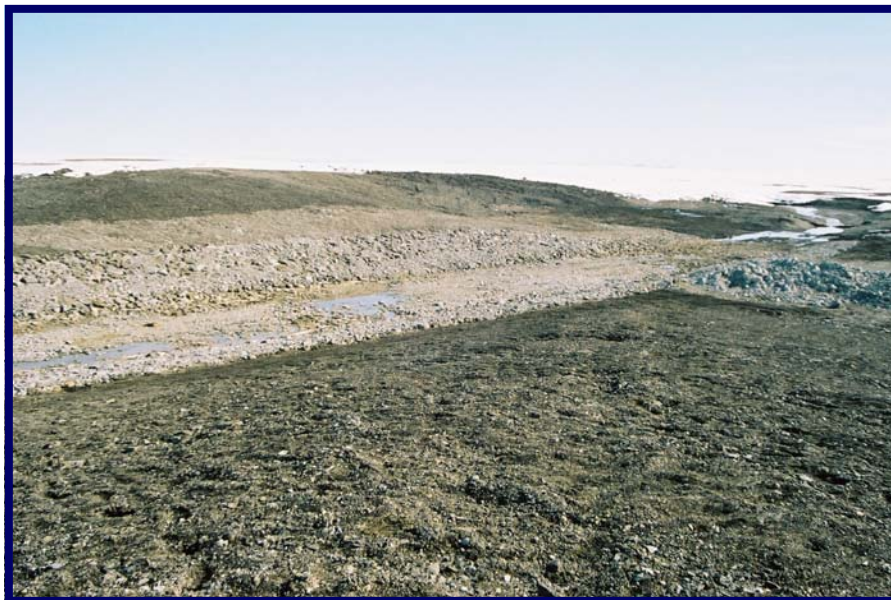
The dam was breached during the spring. Rip rap was placed in the channel bottom and sides. TCL extended the rock lining another 5-10 m upslope to cover the exposed core of the dam so that the soils would not erode into the rip rap as the snow and ice was melting. A channel was cut through the lake ice upstream of the dam to ensure that the water was directed into the excavated channel through the dam as the lake ice melted. At the time of the inspection there was no flow from Garrow Lake through the breach as Garrow Lake remained ice covered.

Garrow Lake Dam, riprap lined channel.

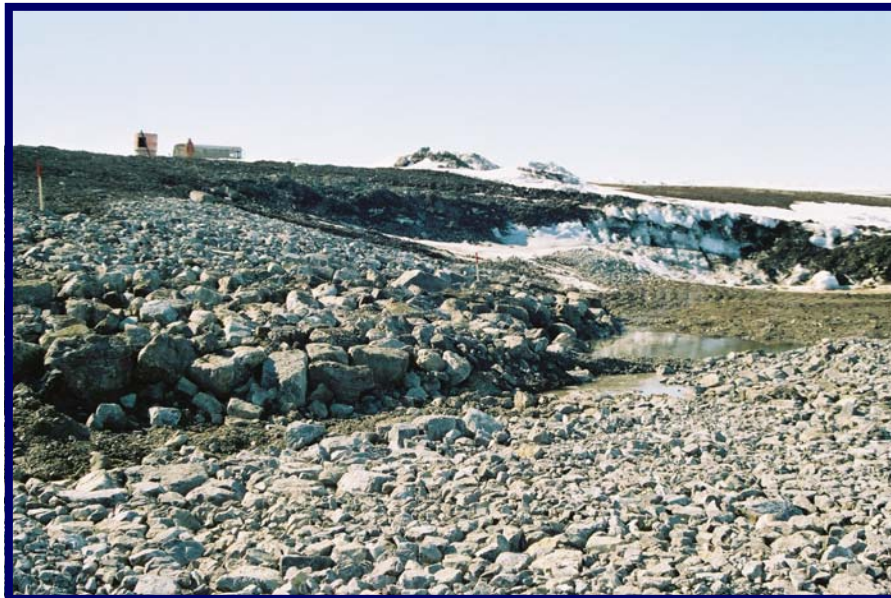
TCL intend to finish grading the downstream area later in the summer when the ground dries out and is able to support equipment traffic. On the upstream side of the dam, regrading and re-sloping will be required once the drifted snow has melted away.

View of upstream face of dam with drifted snow and spoil. This area needs to be re-graded after the snow melts.

- Garrow Lake Dam- regrade and fix up soft areas on downstream side of dam. Final grading on upstream side of dam after snow melts. Monitor cut slopes in dam for erosion.

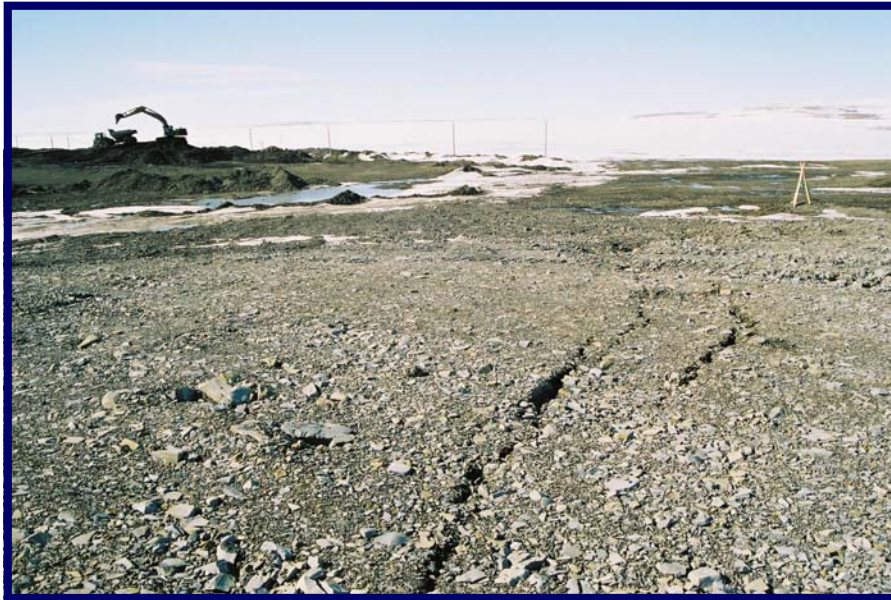
The subsidence area has been covered with shale rockfill and has been contoured into a gentle swale. Cracks were evident in the rockfill cover, indicating that subsidence movements are still occurring. TCL have hired Golder Associates to undertake a review of the historical subsidence data and to prepare an assessment report. In the meantime, TCL will conduct surface monitoring of subsidence movements using a locally based GPS system. The monitoring will take place over the rest of this summer and is planned to take place annually, during the snow free period, over the next 5 years. TCL believes that the subsidence movements are slowing down. The Golder review as well as the ongoing monitoring will provide information from which to assess the long-term management of this area.

Subsidence area, looking north. Note cracks in backfill material.

- Subsidence zone- initiate monitoring of surface movements using GPS. TCL to forward report by Golder assessing subsidence data to INAC as soon as possible. TCL should be prepared to initiate any long-term, post-closure mitigation measures that may be required.

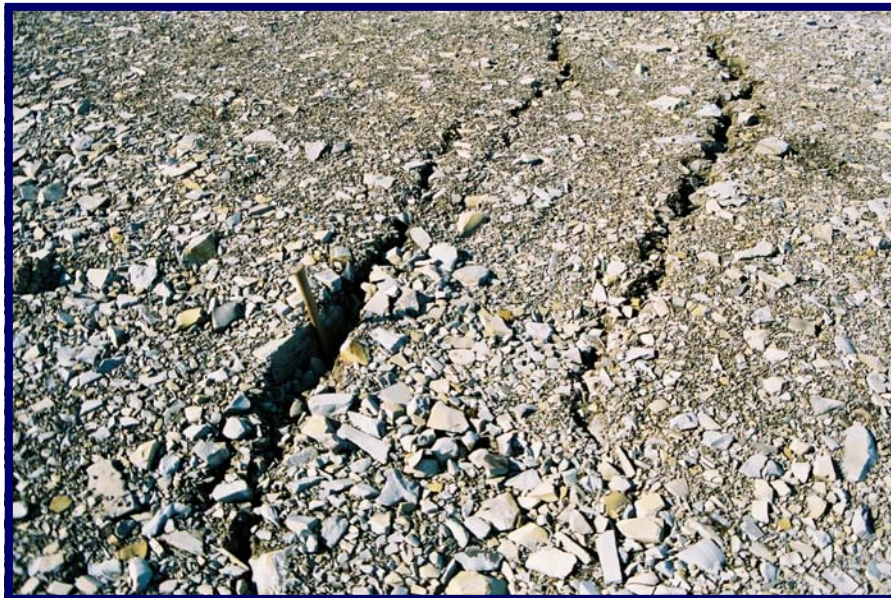
Close-up of cracks in subsidence area. Note rock hammer for scale.

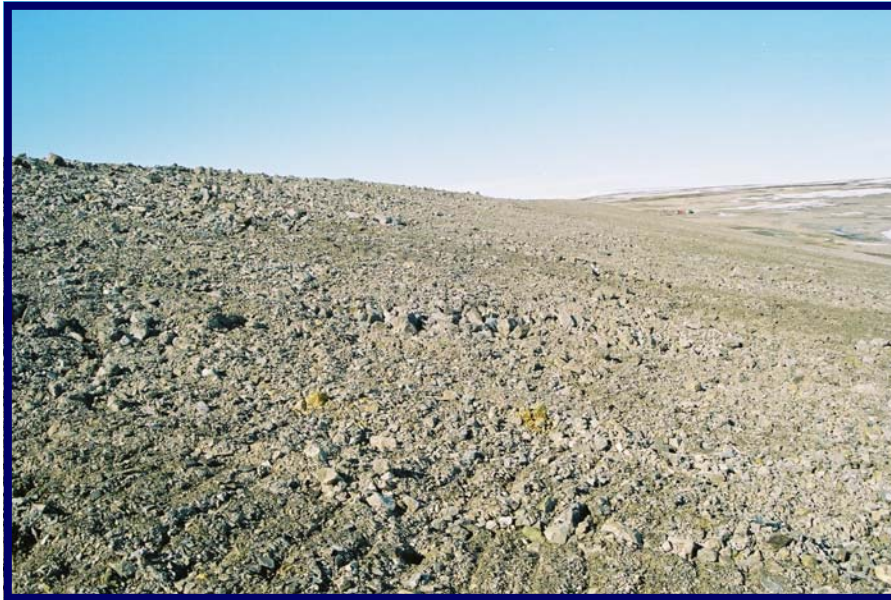
Several areas were noted where the cover consisted mainly of the segregated finer portion of the cover material. These areas were located on the side slopes of the cover and would be susceptible to erosion. TCL has indicated that some regrading will be carried out on the cover and that additional coarser grained cover material would be placed into those areas not meeting the cover material specifications.

Operational Landfill, seaward sloping aspect of cover. Note finer grained nature compared with cover at the top of the slope.

- Excavate test pits to confirm cover thickness over debris placed into Subsidence Zone landfill.
- Operational Landfill- Replace fine-grained cover materials with materials meeting design specifications.

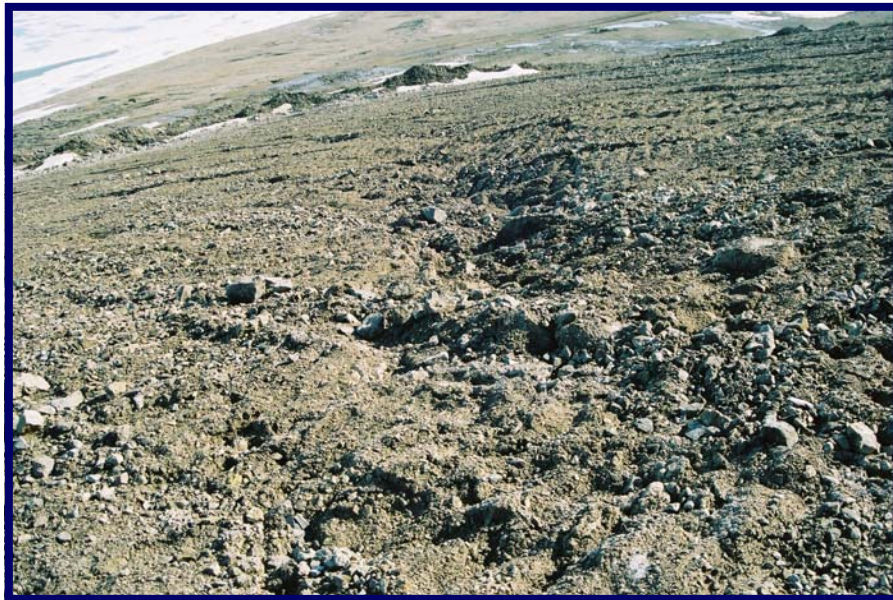
Operational Landfill - minor gully erosions/ subsidence in cover material on seaward facing slope.

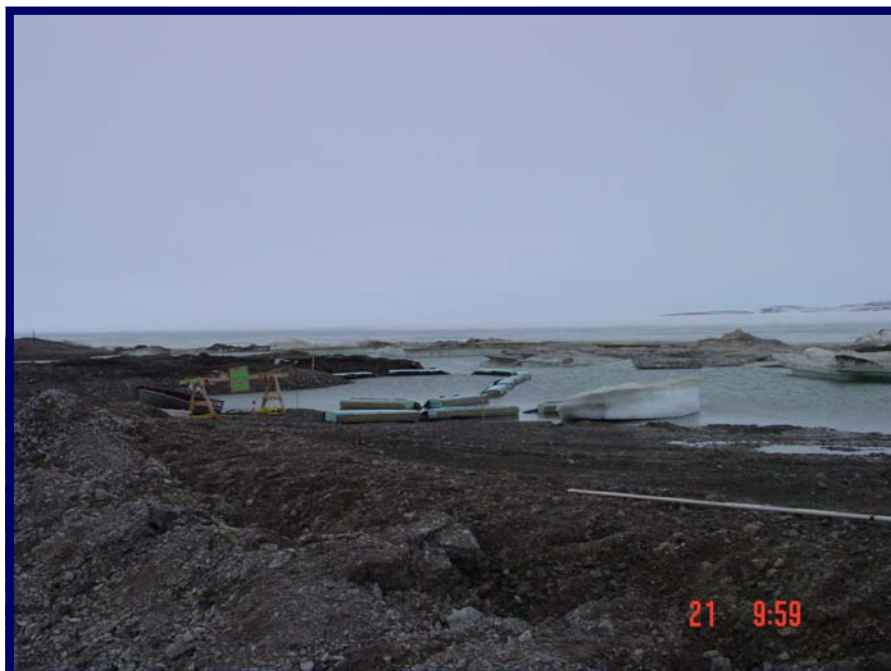
Sorbent boom in dock cell area to contain minor hydrocarbon contamination.

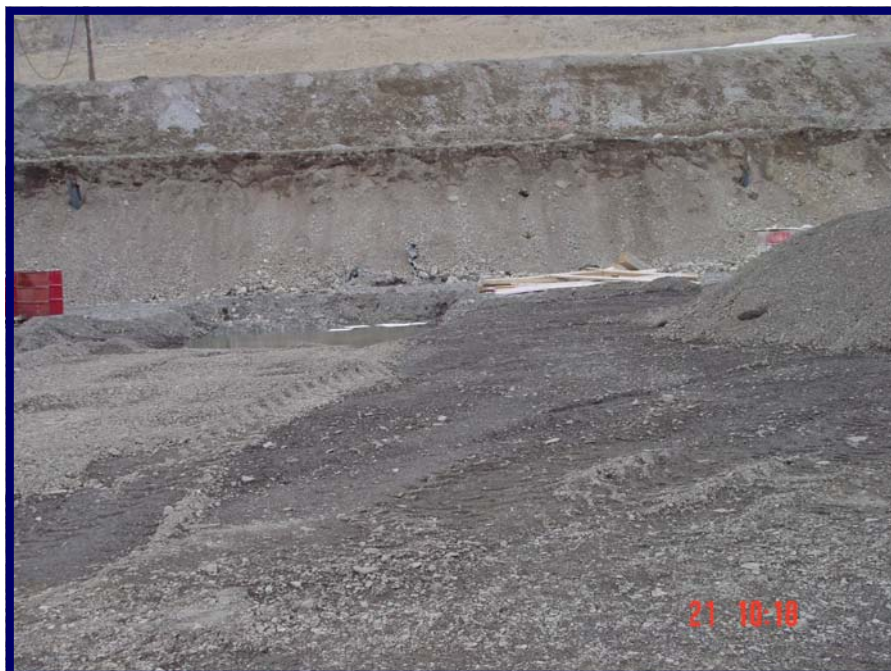
All metals contaminated soils were removed from the product storage area footprint, except for a localized area where some relict metals persisted within cracks in the bedrock surface. It was not possible to remove this material, despite over-excavating into the upper bedrock surface.

Backslope of product storage area. Some metals contaminated soils remain to be removed from this area.

- Product storage area- TCL to write letter explaining testing protocol and presence of minor relict amounts of metals contaminated soil within the bedrock crevices. Justify cover materials and indicate that mixing of metals contaminated soils with cover would not

exceed site remediation target concentrations.

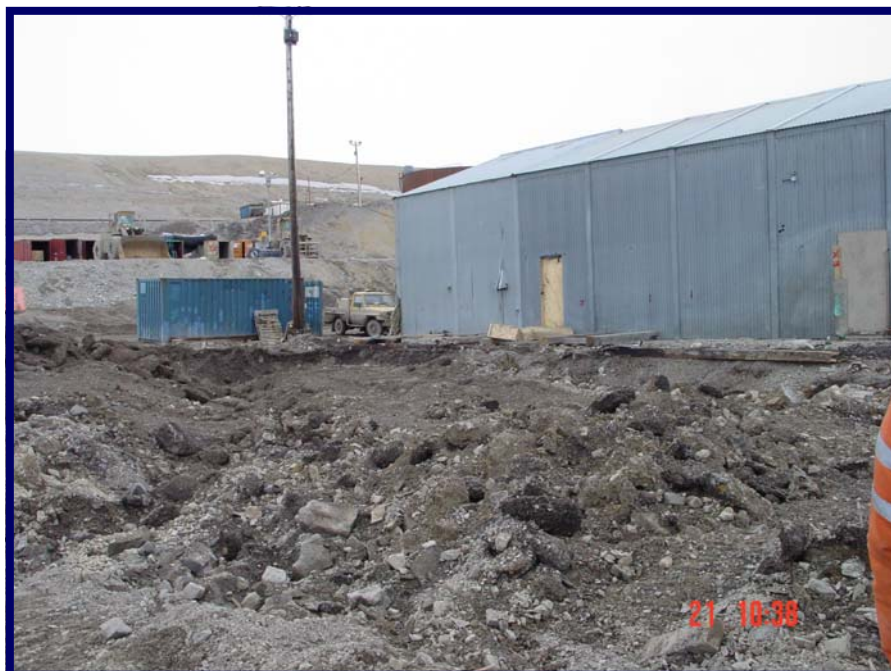
Removal of hydrocarbon contaminated soils was underway in the footprint of the north foldaway building. The excavation of the south foldaway building was essentially completed and was awaiting final confirmatory testing. Excavation was being done with a hoe ram to break up the frozen soils. The soils were then carried by mine trucks for disposal underground.

Excavation of hydrocarbon contaminated soils from footprint of north foldaway buildings.

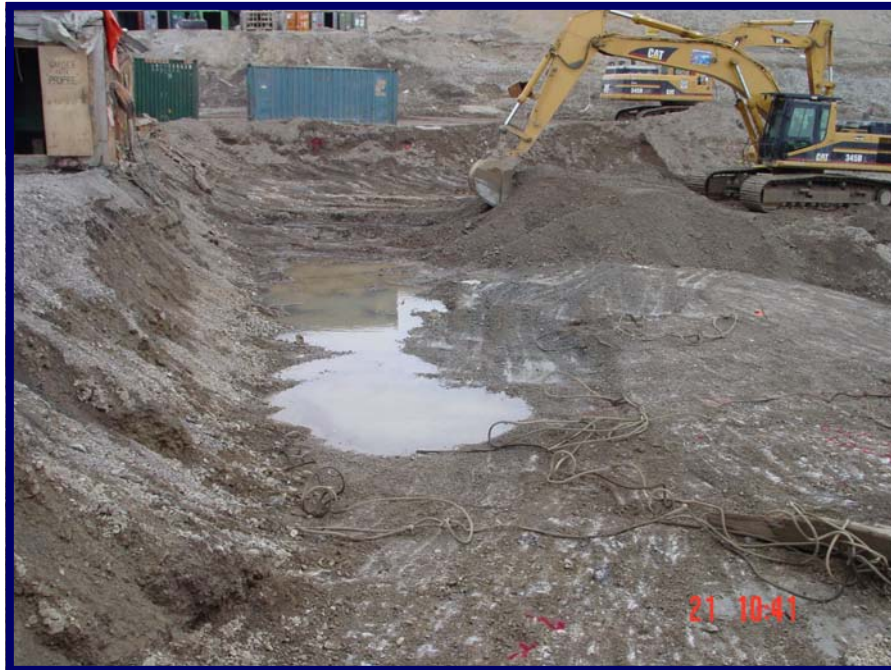
Excavation of contaminated soils down to frozen soils in footprint of south foldaway building.
