INDIAN AND NORTHERN AFFAIRS CANADA

POLARIS MINE ABANDONMENT AND RECLAMATION

AUGUST 24, 2008 SITE VISIT AND INSPECTION

PROJECT NO.: 0131-013-06
DATE: NOVEMBER 6, 2008

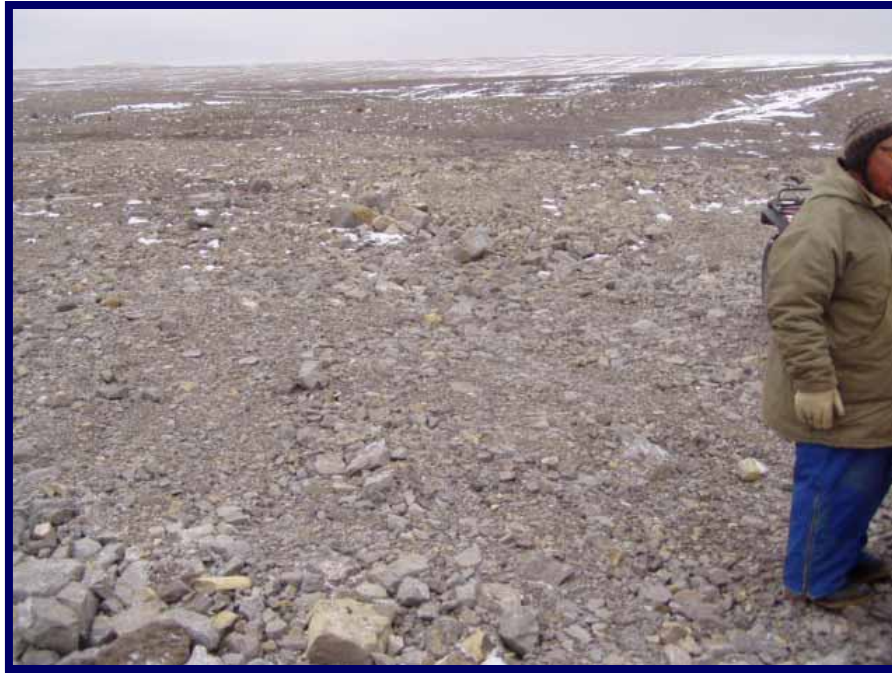
Photo 40: Erosion protection extending across top of right bank of Garrow Creek, downstream of dam.

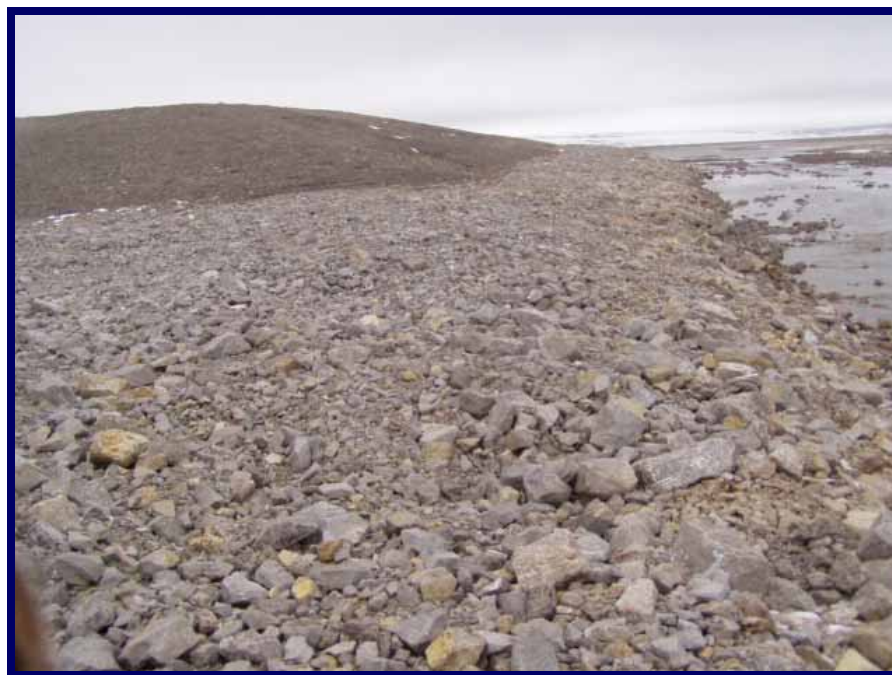
BGC conducted a visual inspection of the breached section of the dam. Foot access was to the right abutment area (facing downstream) only. The riprap lining the channel through the breached embankment appears to be in sound condition, with no obvious signs of physical breakdown or deterioration. The channel base appears stable with no signs of scour or erosion. Flow in Garrow Creek was clear and across the full width of the channel, to an average depth of 10-15 cm. A section of exposed channel liner noted in previous inspections was cut out by Teck Cominco this year as placing additional rip rap on top of it would have raised the creek bed enough to impede flow. The creek bed appears stable and armoured at that location and should be of no further concern. Downstream of the breached toe, the right bank has been armoured with riprap by Teck Cominco in response to erosion caused by tributary streams entering Garrow Creek. This area is now stabilized.

Photo 35: Looking upstream along right bank towards breached section of dam. Note riprap lined channel and flat slopes of breached cut in dam, seen in section in this photo.

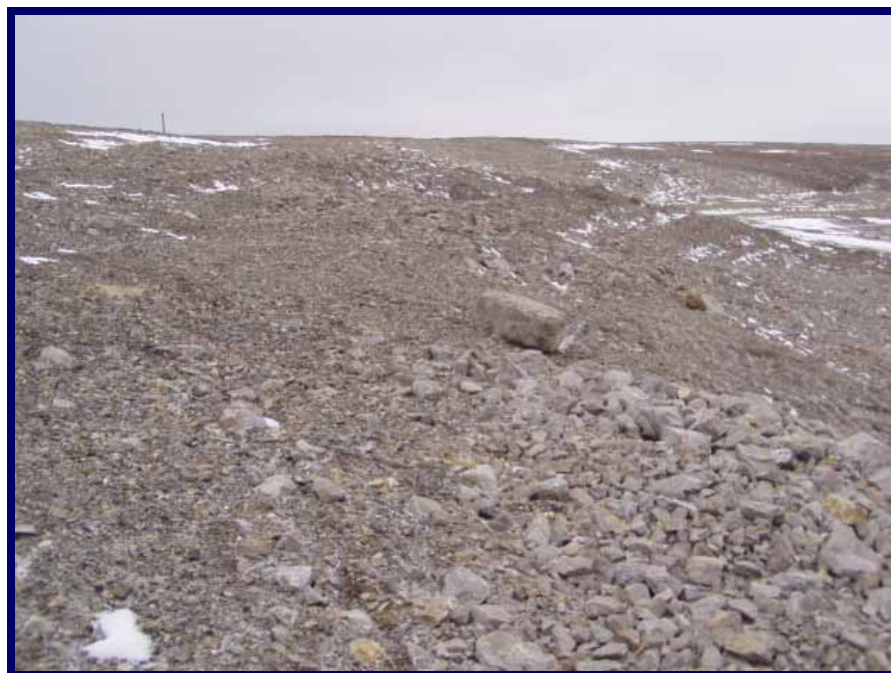
Photo 37: Upstream slope of dam on right side of Garrow Creek. Slope surface is irregular as this material was originally placed on top of snow and ice, which has since melted out and drained away.

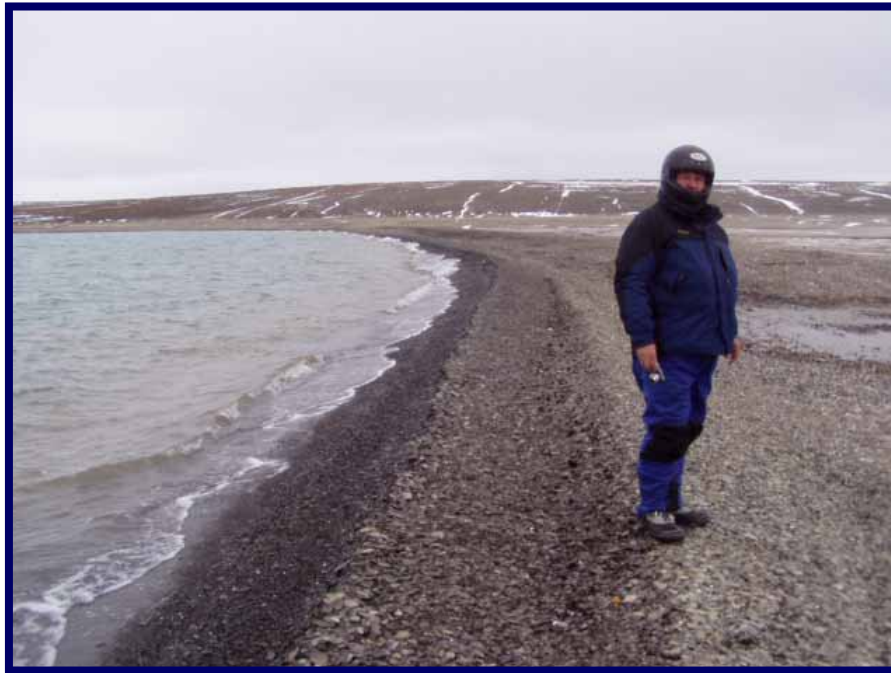
At the east side of the lake, the height of the gravel bar is about 30 cm and there are signs of periodic breaching. The side slopes of the dam are at the natural angle of repose for the material and currently appear to be free draining. Seepage is evident through the downstream toe and slope of the material as well as the foundation, composed of granular lake bed materials.

Photo 41: Naturally formed berm composed of a bar of shaly gravel at south end of Garrow Lake on east side. Maximum height above water level is in the 20-30 cm range. This area was originally breached when the Wave Break structure was removed and has formed by ice action over subsequent seasons.

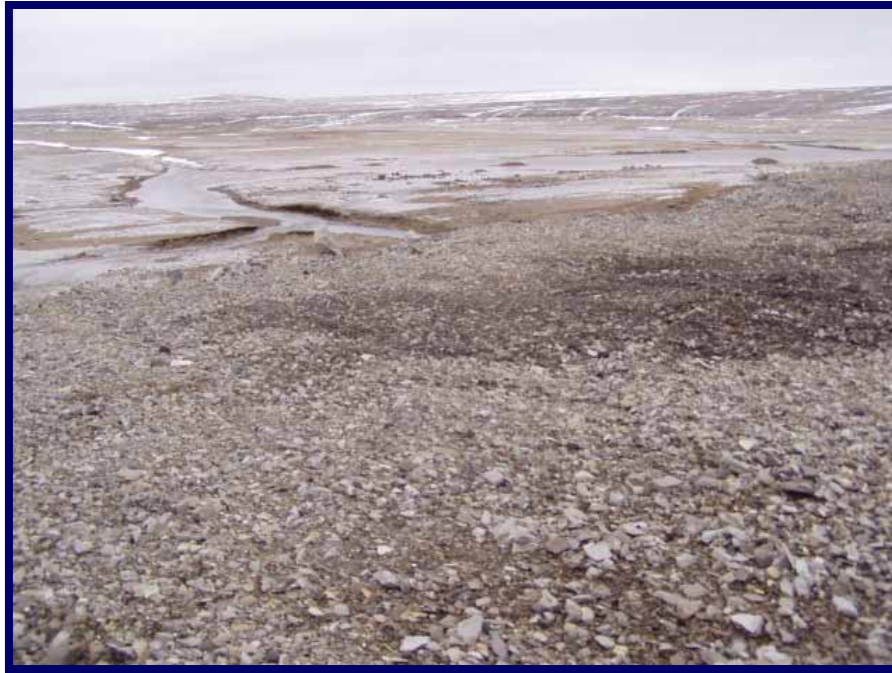
Photo 45: Seepage through the foundation along downstream side of gravel bar at east end. Note old scour channel from previous breach in this area.

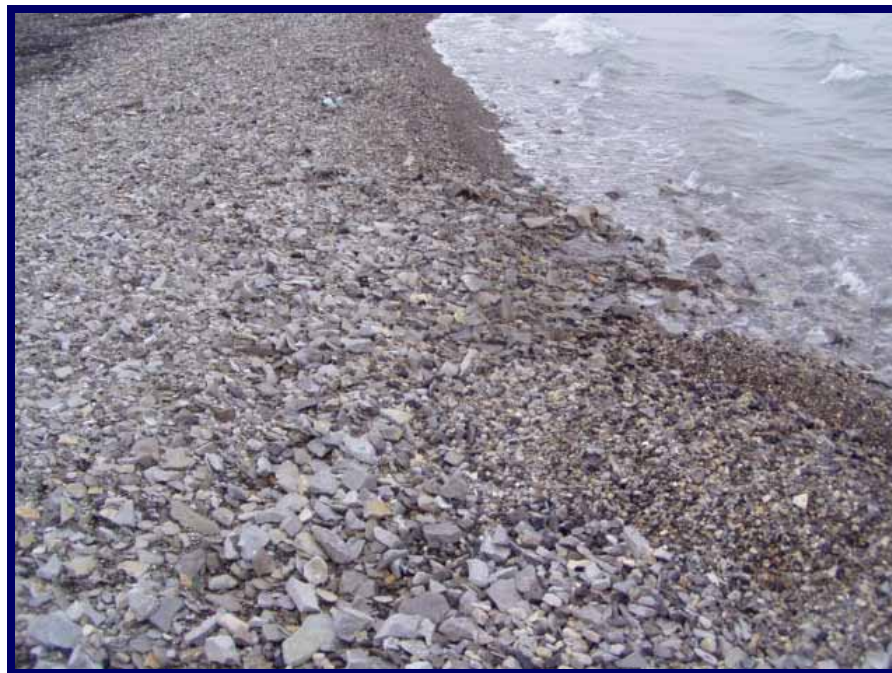
The formation of the gravel bar does not appear to be affecting the elevation of Garrow Lake significantly. It is suspected that in late winter, the interior of the natural embankment is frozen and acts as a more effective seepage barrier, possibly raising the level of the lake slightly. The gravel bar is then likely breached at local low spots along the crest and Garrow Lake water levels drop back to stable levels. As the open water season progresses, seepage through the gravel bar and its granular foundation controls flow out of Garrow Lake.

Photo 46: Slightly coarser material marks channel where berm was breached for a brief period. This may occur in the spring when the body of the gravel bar is still frozen and lake levels rise to overtopping. Once the bar thaws out, the water balance of the lake is maintained by seepage through the berm and foundation.

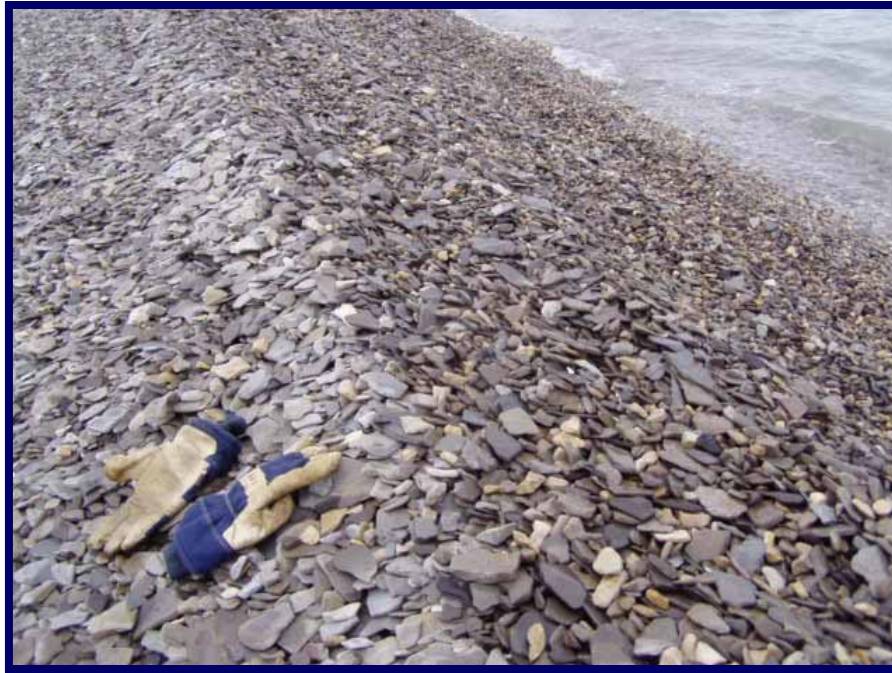
Photo 47: Close up view of natural berm showing imbricated structure of gravel on upstream side, suggesting thrusting by ice.

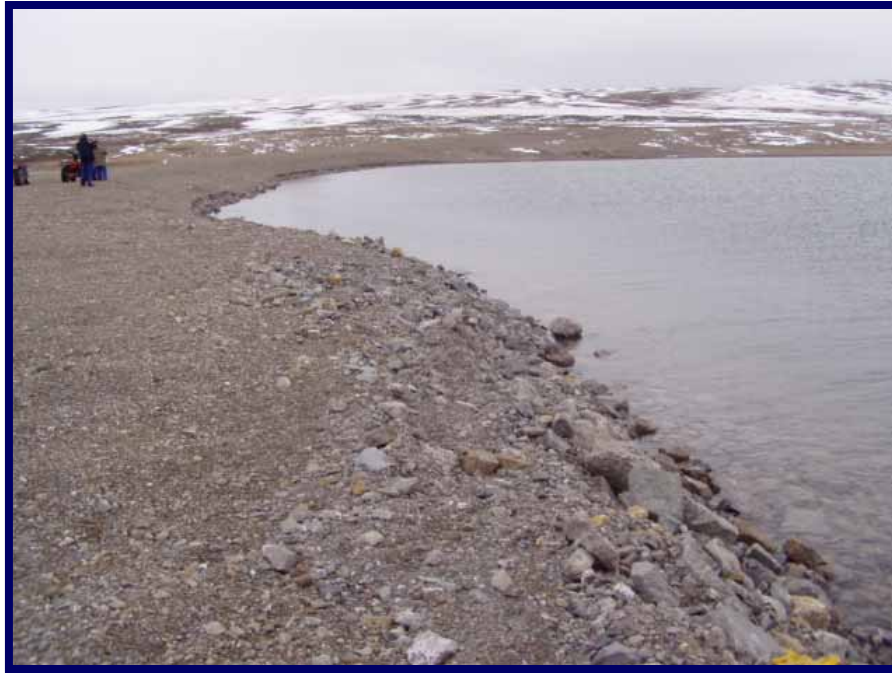
The windward slopes of the causeway have become armoured with larger rock fragments, whereas little or no erosion was noted on the leeward side. Since decommissioning, there has been relatively limited degradation of the causeway. The water surrounding the structure is clear, even with waves acting against the sides.

Photo 54: Leeward (south) side of causeway. Generally causeway looks in sound shape, with no real degradation or erosion.

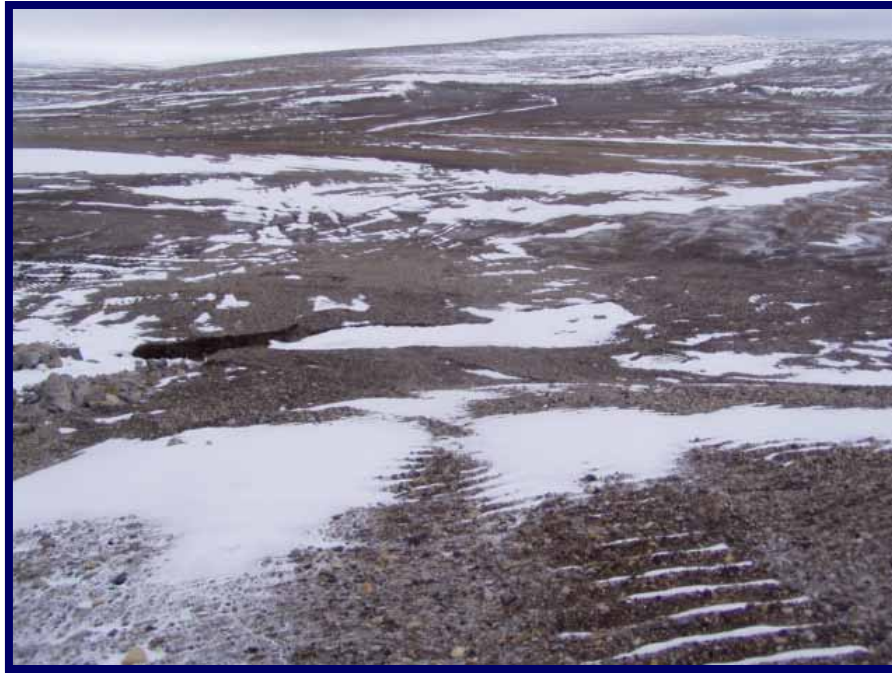
During the 2006 site inspection, BGC noted several erosional gullies that had developed around the perimeter slopes of the New Quarry. Notably, two deep gullies had incised across the fill of the decommissioned haul road along the southwest side of the quarry. These gullies formed as a result of runoff from existing drainage courses further upslope, including the outlet of Loon Lake. Debris fans of material were washed onto the floor of the quarry. In 2006, Teck Cominco completed remedial work on these areas has flattened the gully slopes and armoured the channels with riprap. No water was flowing in either channel at the time of the inspection, however the channel sides appeared to be stabilized and have shown no deterioration over the last 2 years of service.

Photo 56: General view looking east, from crest of reclaimed slope on west side. A fan of eroded material can be seen at the toe of the slope on left side of photo. This material was eroded in 2006 along an ephemeral stream channel due to concentrated flow along the slope during spring melt. The channel was subsequently armoured with riprap in 2006 and is now stable.

Further monitoring of these gullies is recommended for the remainder of the licence period. The channels appear to have become stabilized, however minor repairs may be necessary if the flow regime in the drainage course is increased by an intense rainfall event or rapid snowmelt.

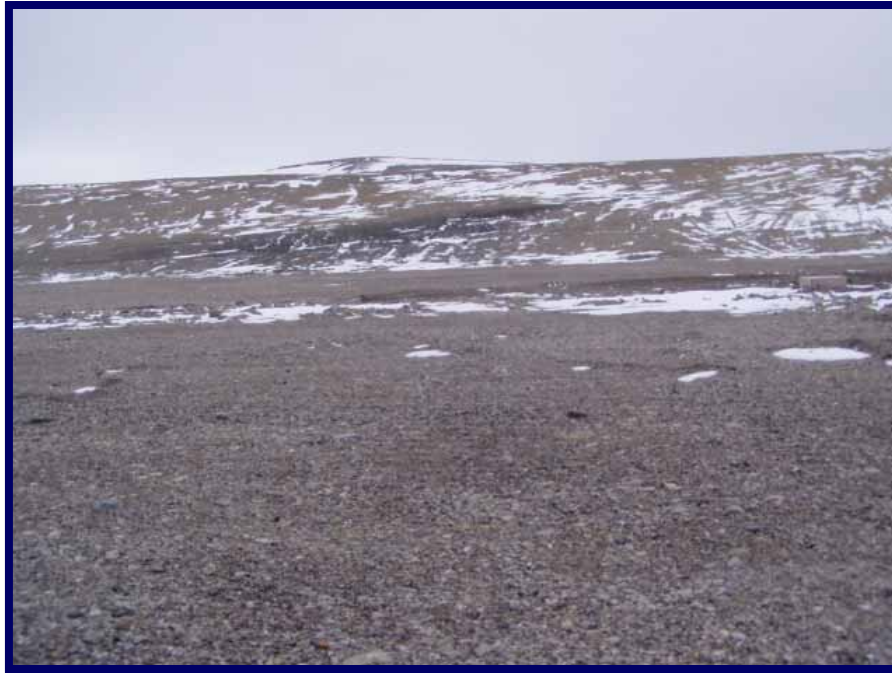
Photo 71: Looking north across horizontal portion of landfill cover. Note thermistor box on right side of photo. Cover shows no signs of erosion, settlement or heave.

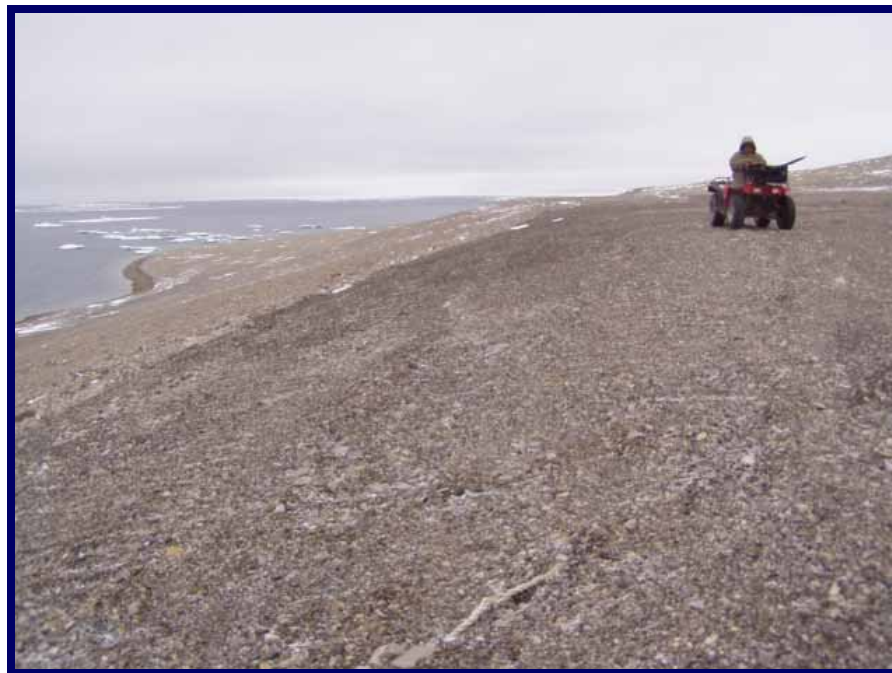
Photo 73: Looking west along south-facing slope portion of cover. No signs of any erosion, settlement or heaving.

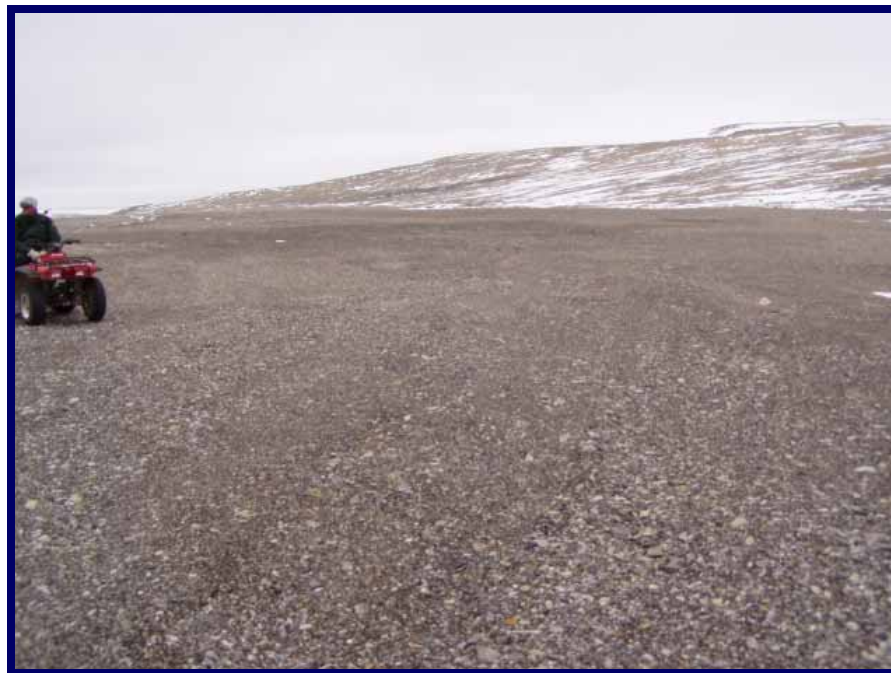
Previous inspections noted an area of erosion along the slope above the landfill. During this inspection, it was difficult to find where this area was located, so it appears to have become stabilized and no further concerns were noted.

Photo 75: General view of reclaimed backslope above landfill, looking west from top of landfill at eastern end. The area of seepage and erosion previously noted by Gartner Lee geotechnical inspection in 2006 was not visible during this inspection.

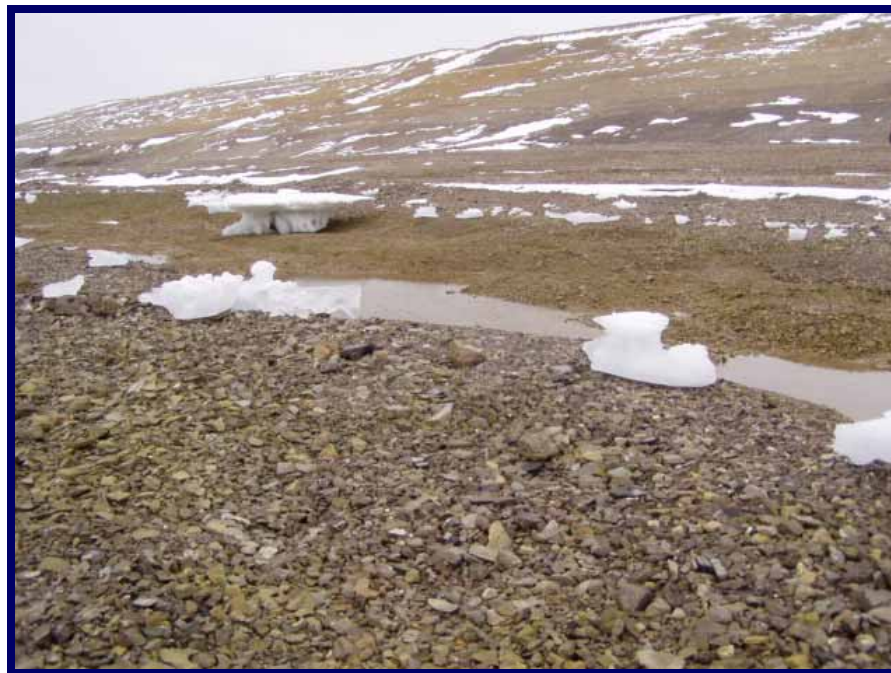
An extensive area of the shoreline appears to have settled with respect to the overall profile. This was noted in several of the previous inspections and is possibly due to melting out of ice that was buried when the foreshore area was backfilled. The settled zone does not seem to be progressing further and there is no concern about instability.

Photo 77: General view of restored beach condition. The depressed area parallel to beach may be the result of some subsidence due to melting out of ice buried in the foreshore fill and/or ice scouring along the beach in the winter.

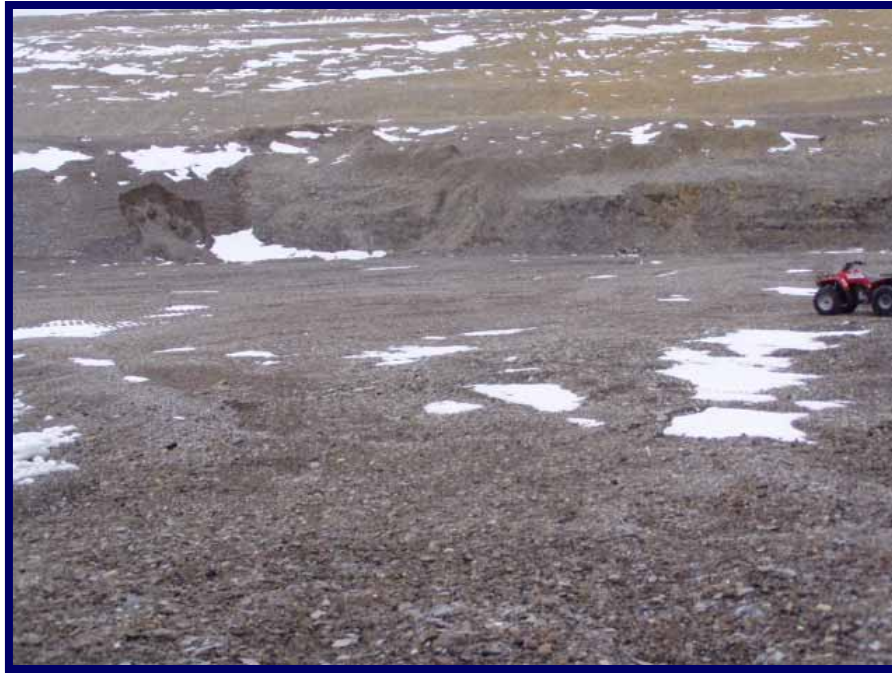
The Main and Conveyor portals are located adjacent to the marine foreshore area, where the toe of the hill slope meets the beach. A significant slump has occurred in the Main Portal backfill. According to Teck Cominco, it must have occurred in the past month, as the backfill appeared undisturbed in July 2008. The tongue-shaped flow slide appears to have affected only the surficial backfill material. The tunnel opening itself remains sealed. The cause of the slump may be due to the use of backfill containing a higher percentage of fines, combined with excessive water from snowmelt and slightly oversteepened slope angle.

Photo 89: Slump in backfill of Main Portal. Reclaimed barge/plantsite area in foreground.

BGC recommended that the overall slope angle of the backfill should be reduced by placing a berm of coarser grained rockfill along the toe. This material can be borrowed from the adjacent slope without undercutting any of the slope above. Teck Cominco will undertake this repair work in 2009.

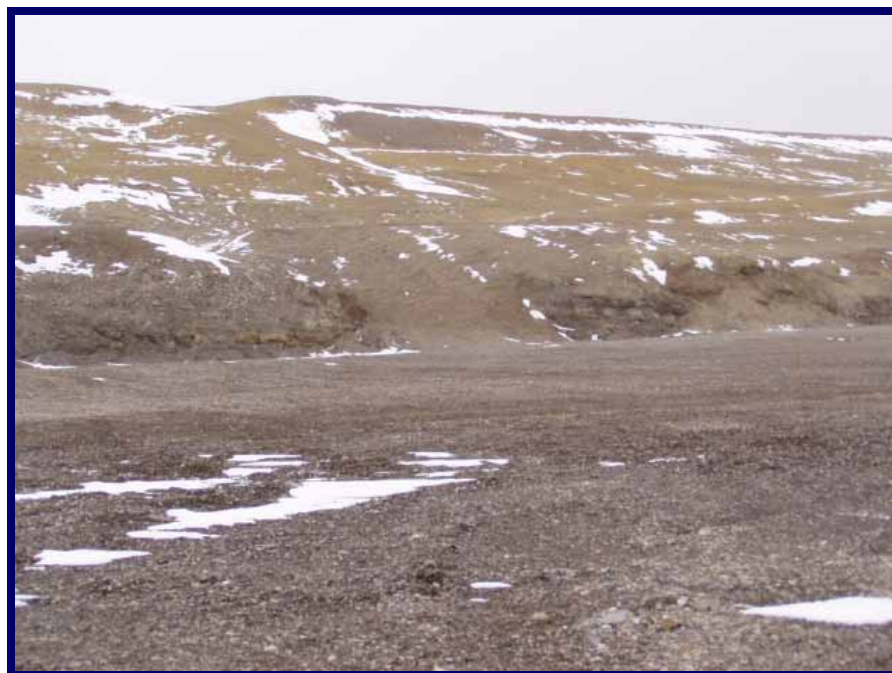
The Conveyor Portal backfill looks stable. It should be noted that the average slope angle of the Conveyor Portal backfill appeared flatter than the Main Portal backfill.

Photo 90: Conveyor portal backfill appears intact and stable.

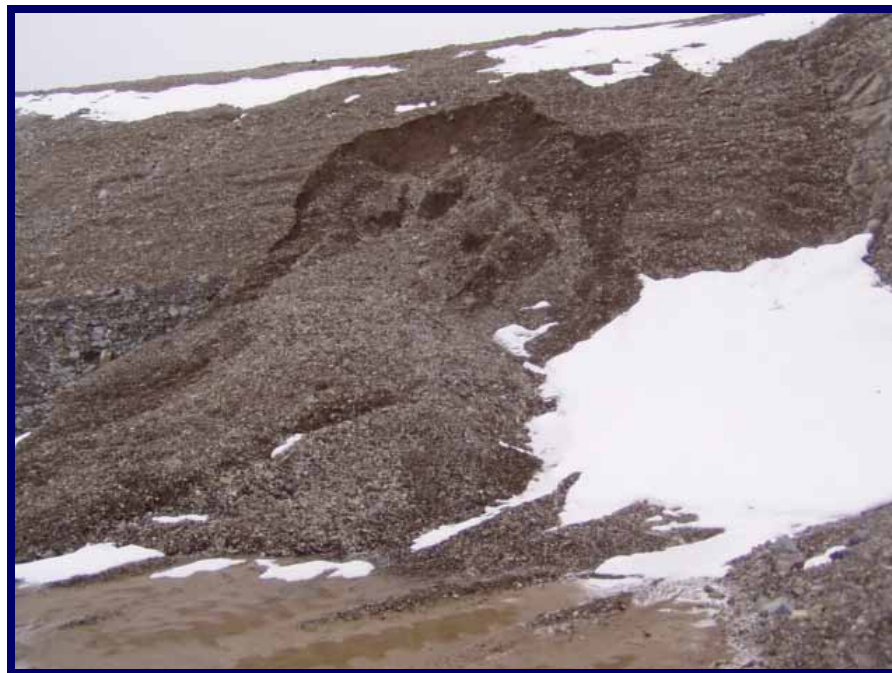
Photo 93: Close-up view of slump in Main Portal backfill. It appears this was due to backfill being placed too steeply and becoming saturated with snowmelt from a snowdrift.

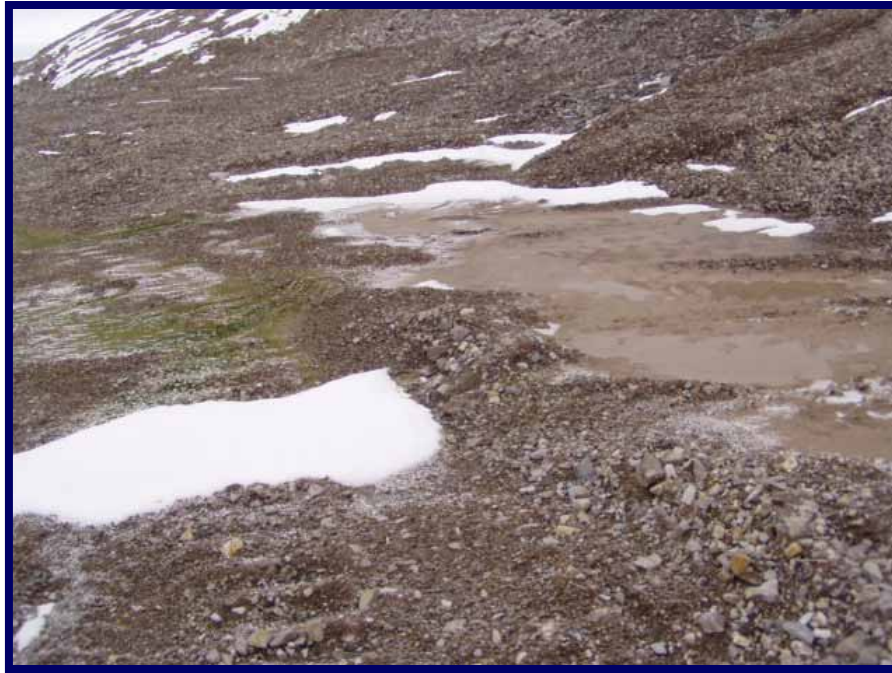
Photo 94: Seepage water coming from slumped material at toe of failure zone.

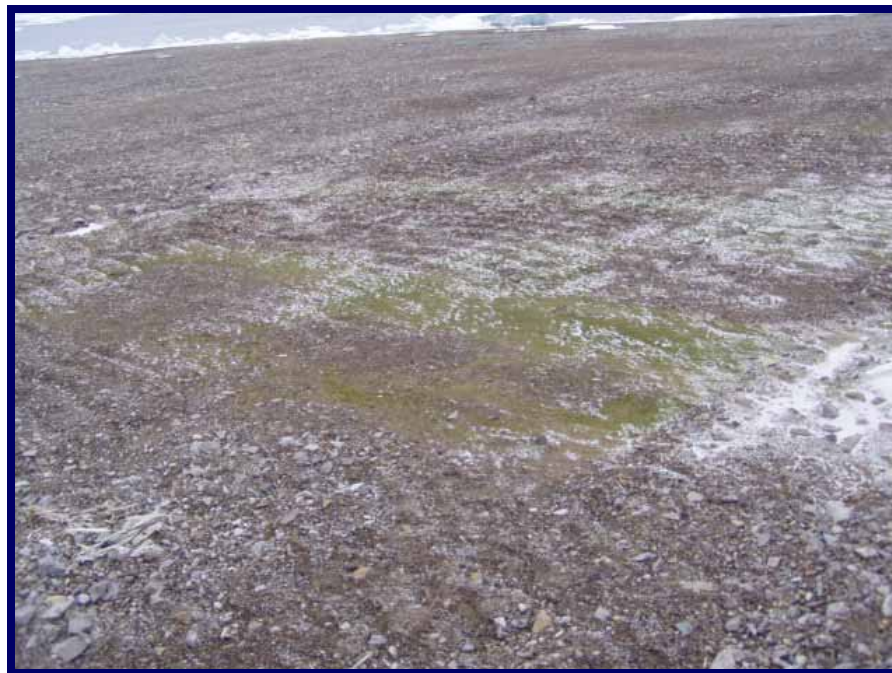
Photo 95: Some green vegetation that has grown around the seepage zone in front of the Main Portal backfill indicating a long-term source of water in this area.

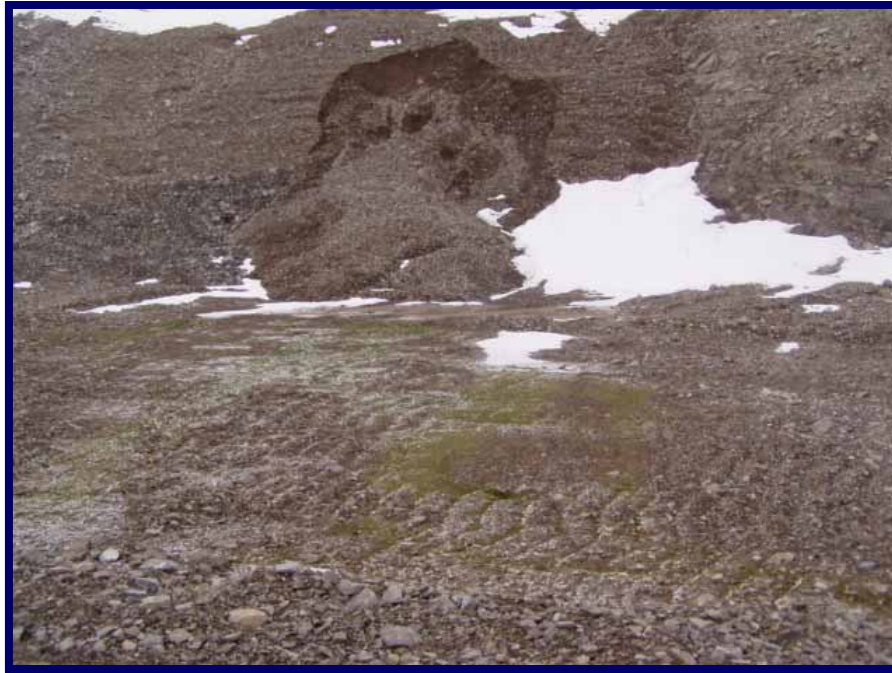
Photo 96: General view of Main Portal showing classic tongue-shaped flow slide and green zone of vegetation associated with seepage from the backfill.

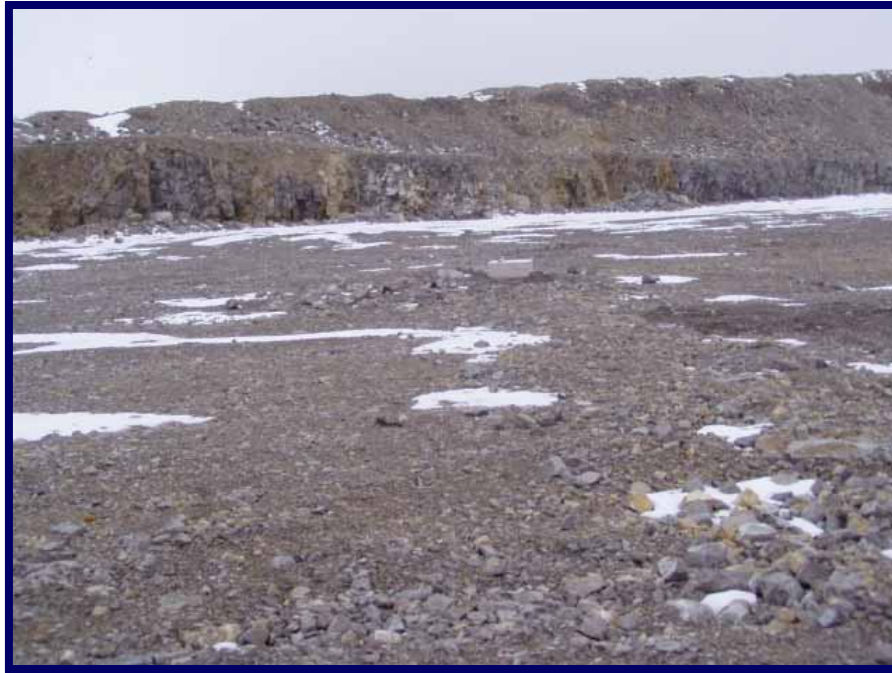
Photo 99: Looking northeast across landfill cover. In general cover looks stable with no signs of erosion, settlement or heaving.

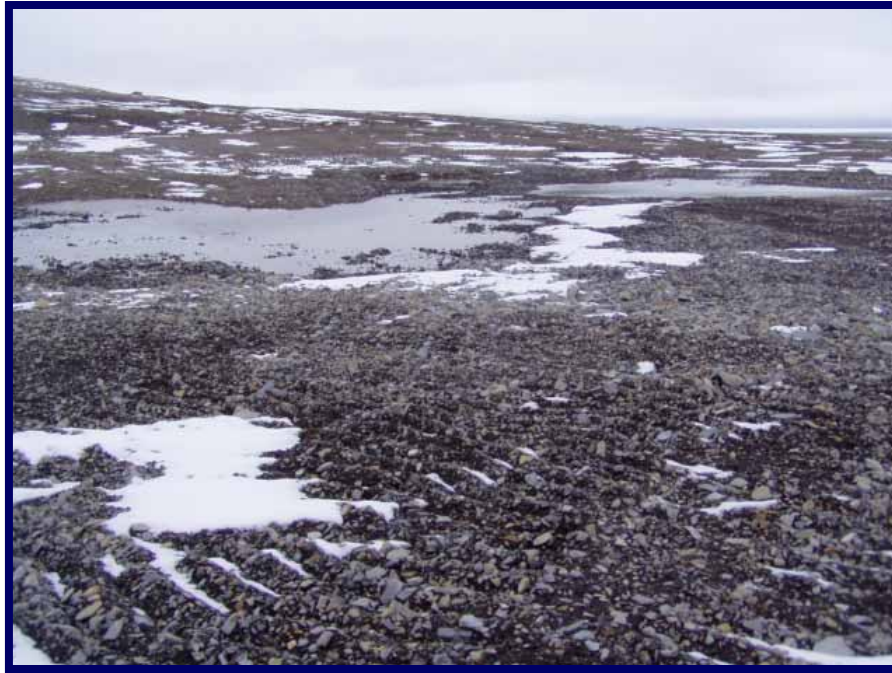
The surface expression of the subsidence zone has not changed visually from previous inspections. The subsidence trough runs roughly north-south and is flanked by several large cracks that were noted in all previous inspections. Teck Cominco conducts an annual survey of the topography across the subsidence zone that showed no significant change from year to year. This year, Teck Cominco initiated mapping of the visible cracks by survey. This information will help to support the interpretation from past surveys that the subsidence zone has stabilized since closure.

Photo 104: Looking north-northwest across north end of subsidence zone. There is no noticeable visual change in this area from previous inspections.

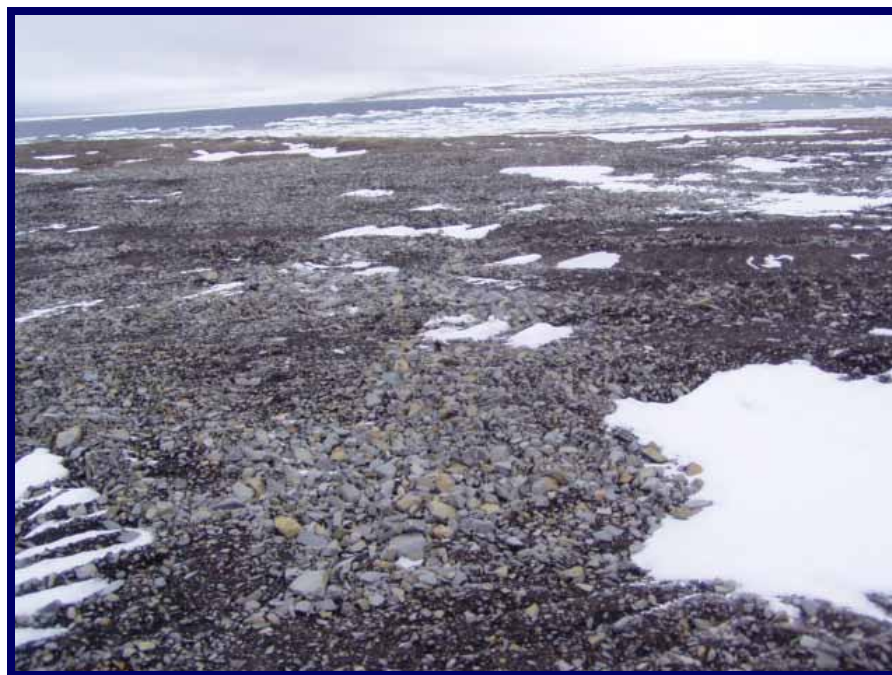
Photo 105: Looking north across subsidence zone. No sign of any change from previous inspections.

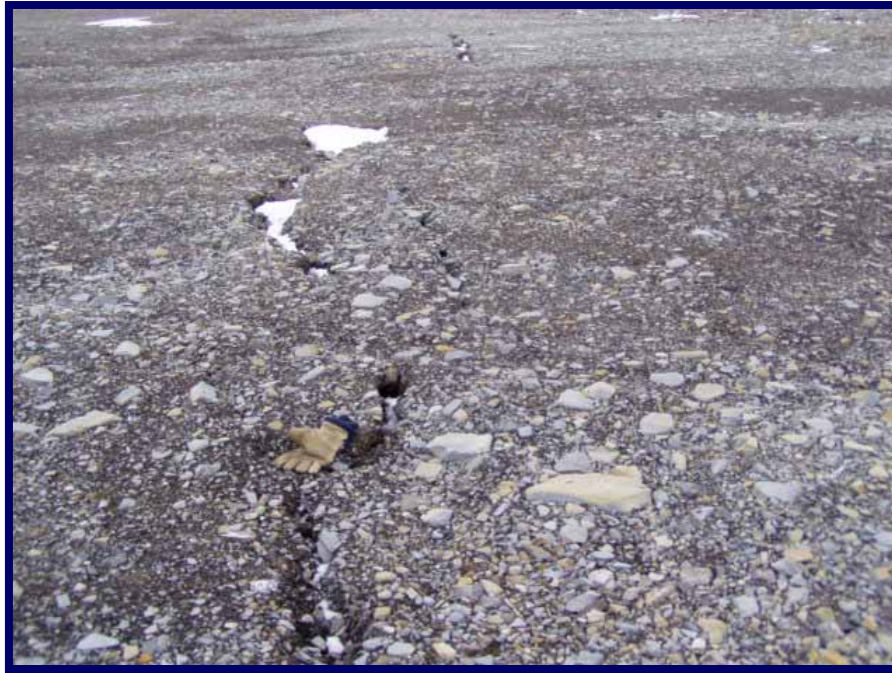
Photo 106: Looking south along one of several large cracks found in subsidence zone. Crack can be traced for several tens of metres. Width varies up to 150 mm and ground is open 10 to 30 cm deep. These have been reported in previous inspections and there is no obvious change. Teck Cominco has now surveyed all these in for record purposes.
