WATER LICENCE INSPECTION FORM

Licensee		Licensee Representative	
Teck Resources Ltd. (Teck Cominco Ltd.)		None on site – Bruce Donald	
Licence No. / Expiry		Representative's Title	
1AR-POL0311		Manager, Dormant Properties	
Land / Other Authorizations		Land / Other Authorizations	
N2002Q0017, 68H/8-1-3, 68H/8-2-2, 68H/8-3-3, 68H/8-8-2, 68H/8-9-2.		Mining Lease 2346	
Date of Inspection		Inspector	
10/07/2014		A. Keim	
Activities Inspected			
<input type="checkbox"/> Camp <input type="checkbox"/> Drilling <input type="checkbox"/> Mining <input type="checkbox"/> Construction <input checked="" type="checkbox"/> Reclamation <input type="checkbox"/> Fuel Storage			
<input type="checkbox"/> Roads/Hauling <input type="checkbox"/> Other: Water Discharge <input checked="" type="checkbox"/> Other : Monitoring

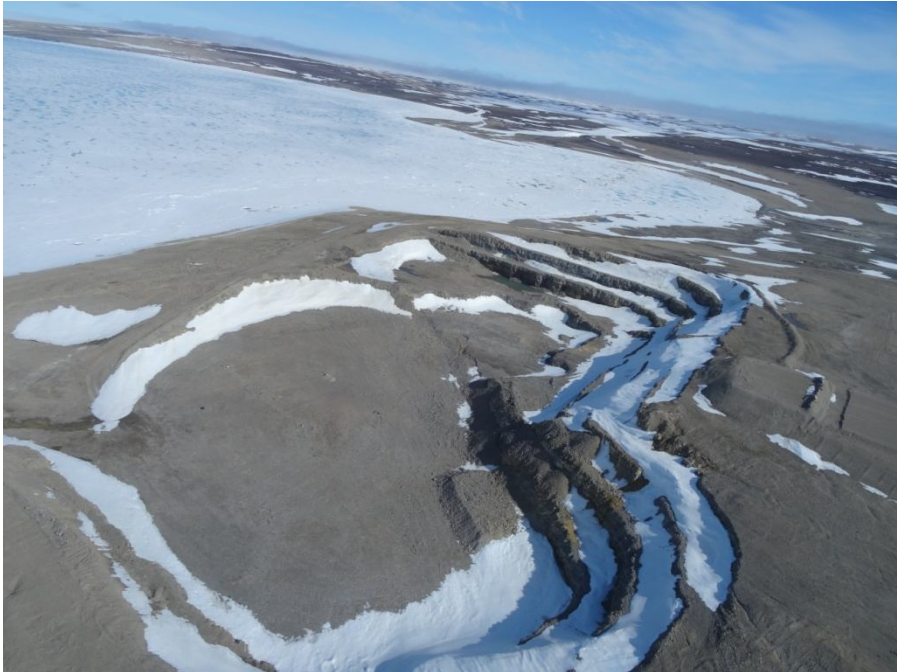
The little Red Dog Quarry had a quantity of snow remaining on the steps (benches) cut during the use of the facility. Large stones and a constructed buttress at the end of the run way all preclude access to the top edge of the quarry. It is noted that there remained no signage on site to warn the public about the Quarry however, it is unclear if there remains a requirement (post closure) for this to remain on site.

Figure 1 Red Dog Quarry. Land fill located at bottom.

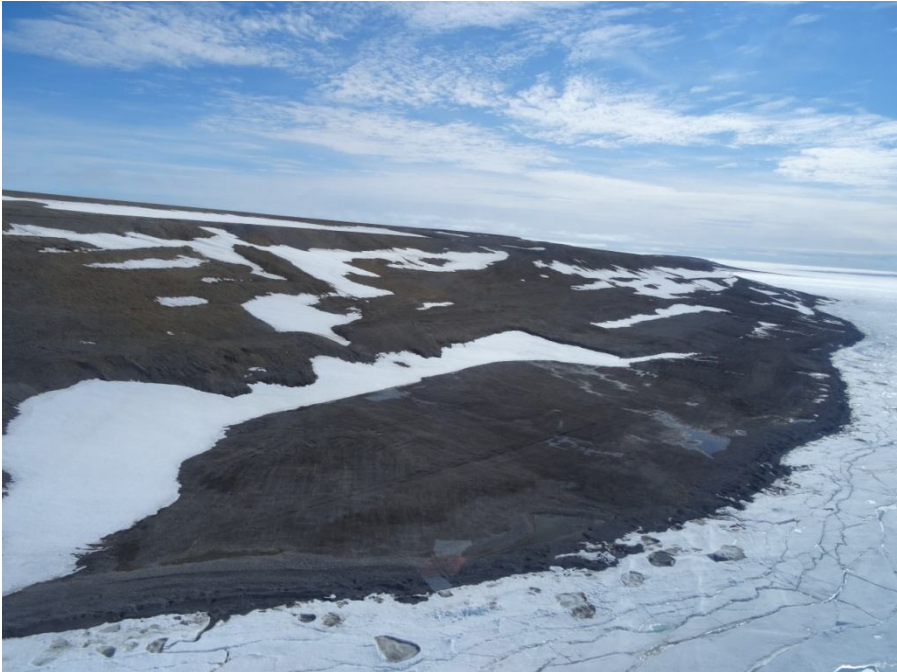
Figure 2 Beach and dock side area

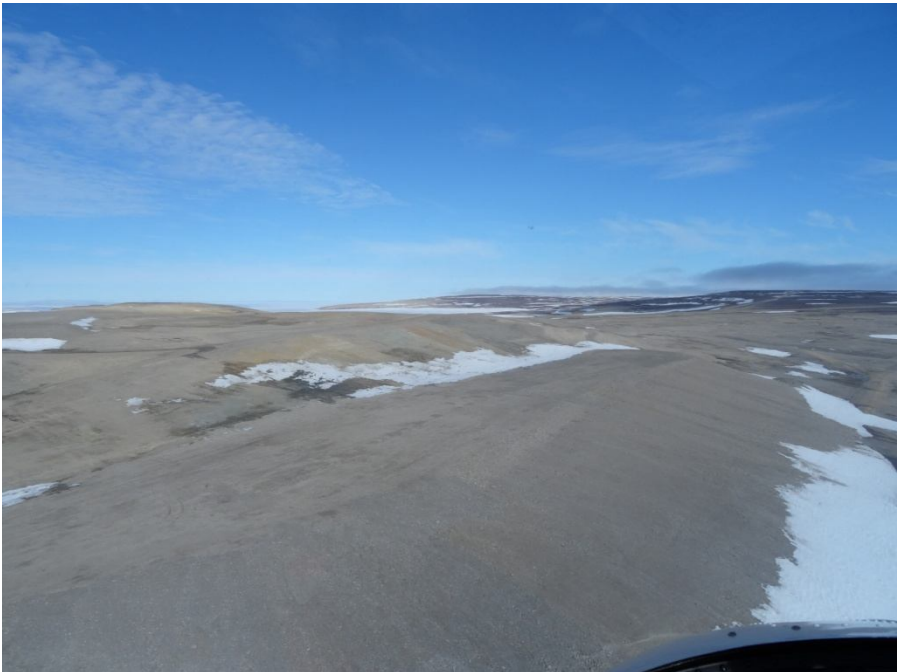
Landfills were found to be well covered with little to no signs of slippage or sloughing of cover material.

Figure 3 Main Land fill.

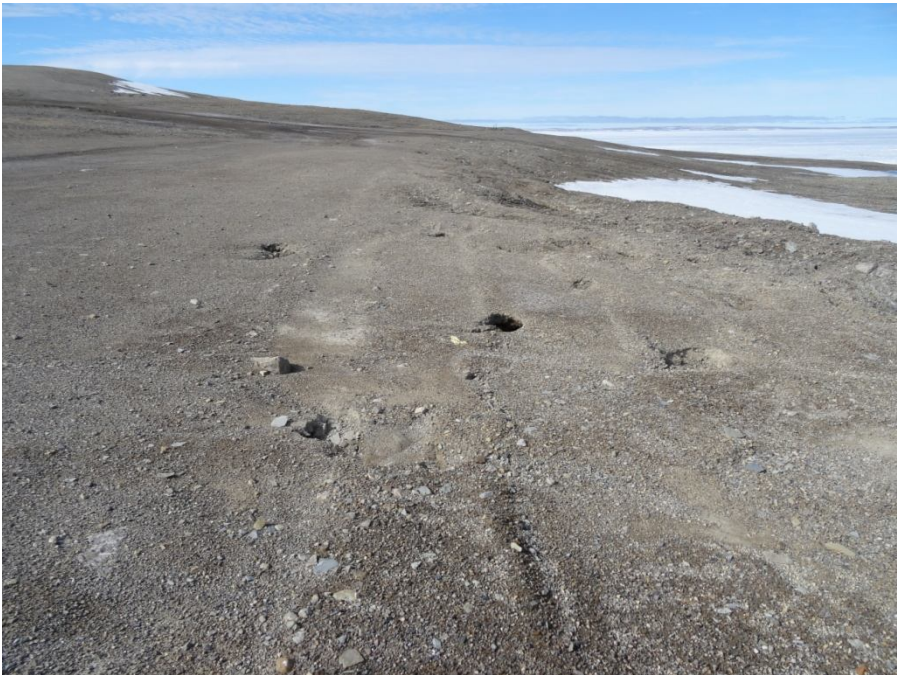
Upon entering this location the Inspector noted a number of areas where the ground was noted to have sunk a depth of approximately 1 meter. Other areas where the substrate had either washed away or fallen away leaving a small hole at the surface but much larger hollow below it were photographed and appended to this report. Finally a number of locations were old “vent raises had been established during the operational life of the mine and then subsequently filled in were found to have settled or slumped around the diameter of the pipe.

Figure 4 Subsidence holes.

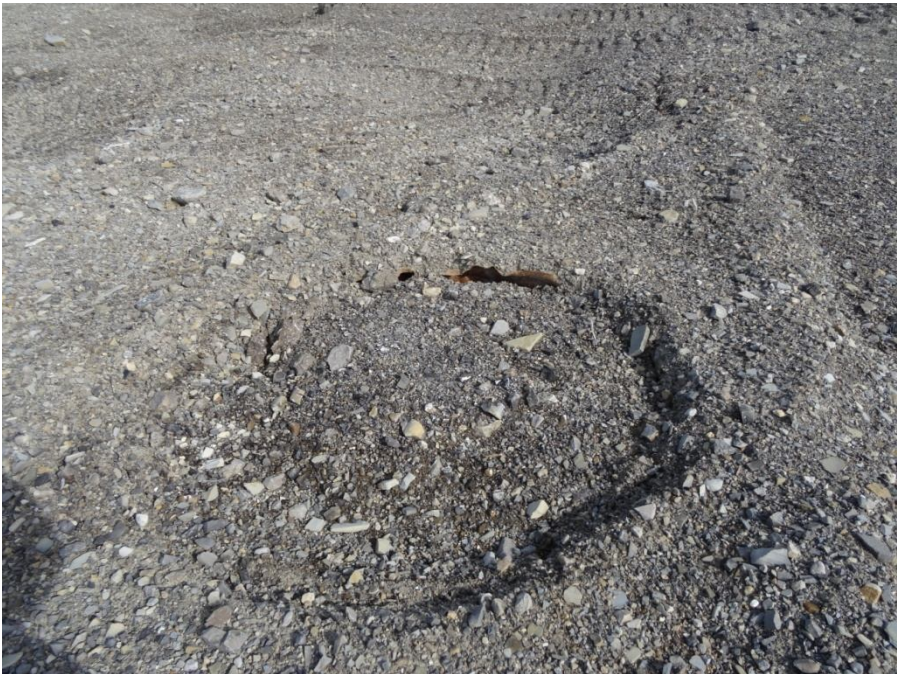
Figure 5 Vent raise .. Settling around and within the Culvert

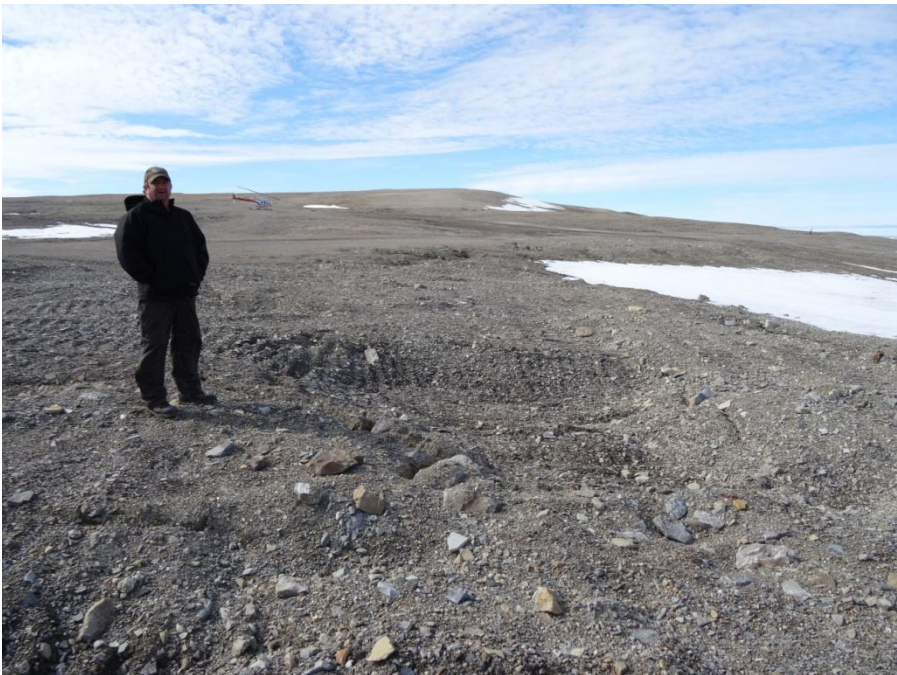
Figure 6 Settling of surface materials - subsidence

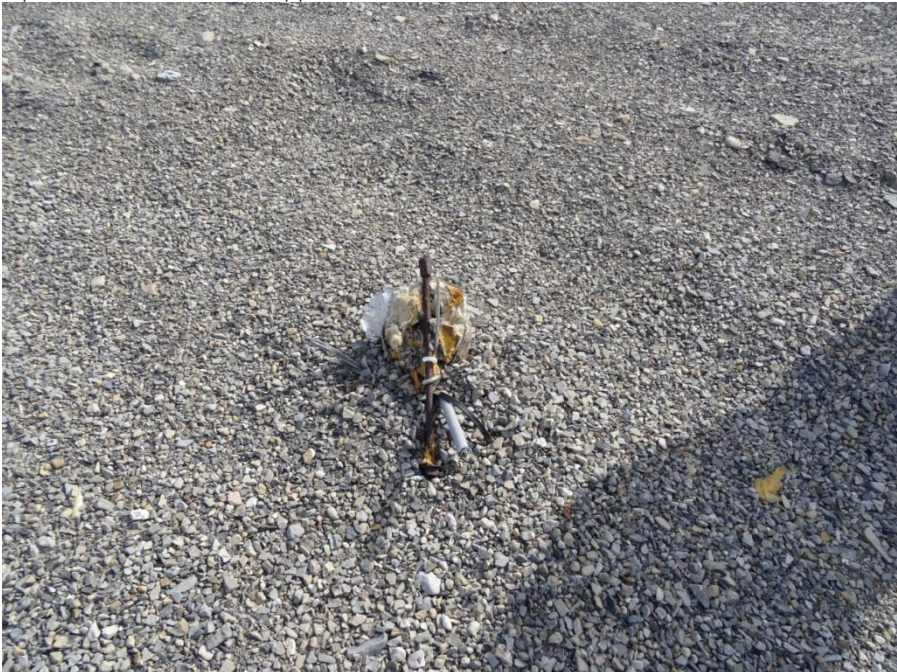
At the same location as the subsidence was identified there were metal rods, glass and wires poking up out of the ground. It was the understanding of the Inspector that all materials from the mine infrastructure were placed within the underground sections prior to the Portal being sealed. There appears to be a large area where materials may have been buried on surface that was not identified in the literature that was investigated prior to the inspection. If the licensee could shed light on this it would be most helpful to the Inspector.

Figure 7 Pipes, steel rods and Electrical bacles poking through the earth in locations

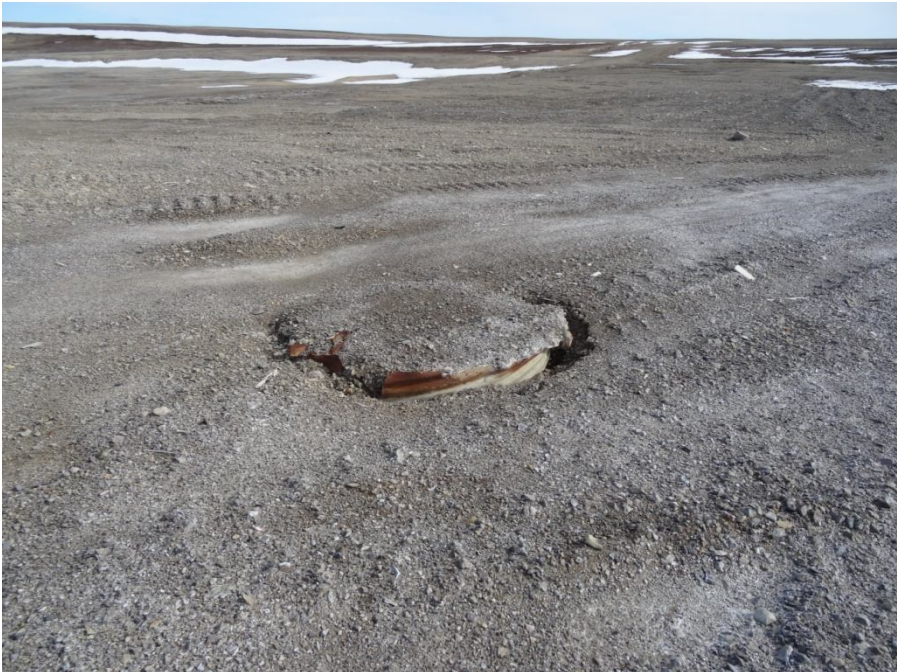
Figure 8 Vent raise - settling and subsidence
